INSPECTION REPORT

SAMPLE REPORT

ANY PLACE, NY 11545

Prepared for: CLIENT HOME
Inspection Date: Tuesday, February 25, 2025
Prepared by: Rob Byrne

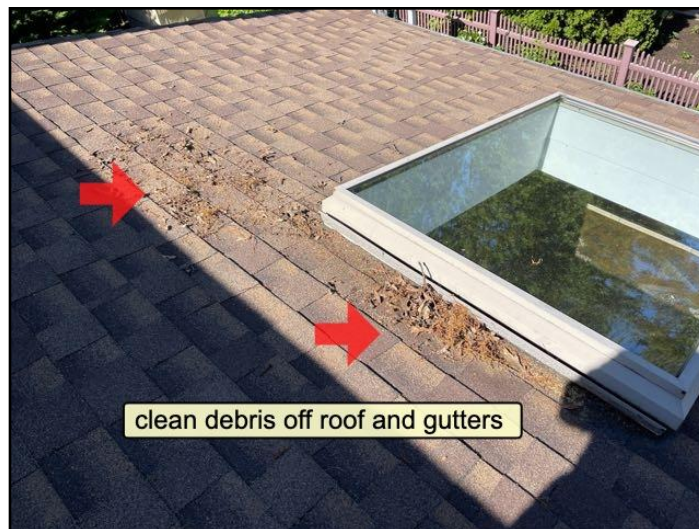
3. **Condition:** • Debris/moss

Implication(s): Shortened life expectancy of material

Debris/moss

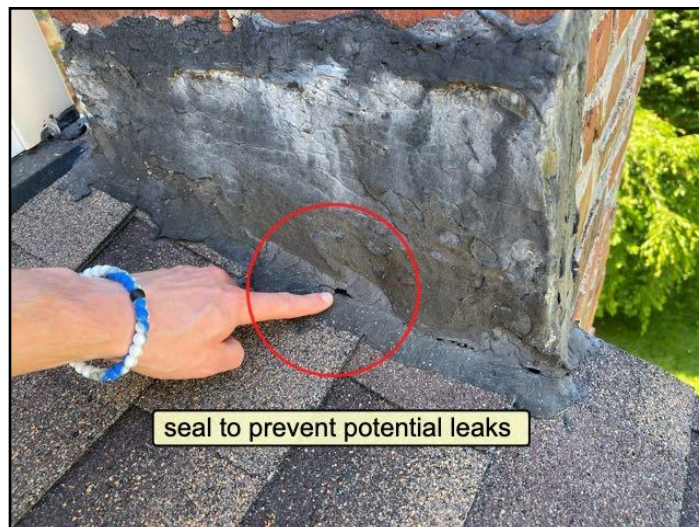
4. **Condition:** • [Damage, loose, open seams, patched](#)

Implication(s): Chance of water damage to structure, finishes and contents

Damage, loose, open seams, patched

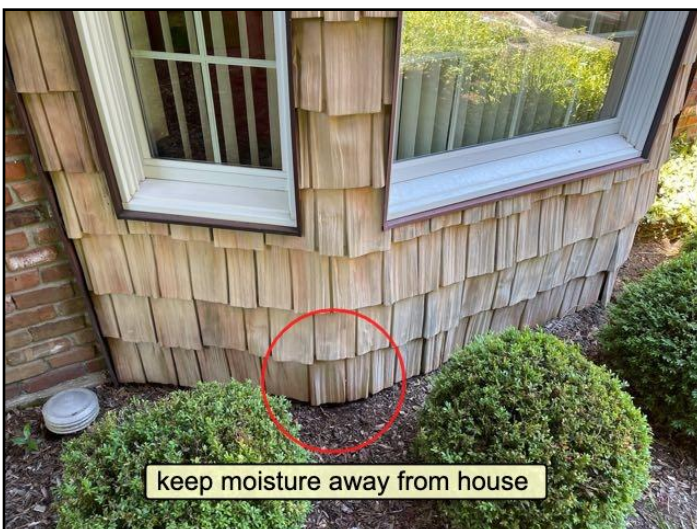
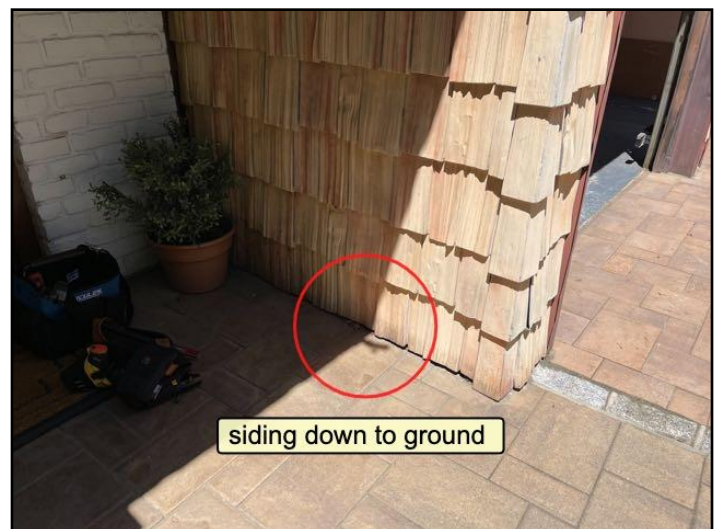
6. Condition: • [Too close to grade](#)

Implication(s): Chance of water damage to structure, finishes and contents

Too close to grade

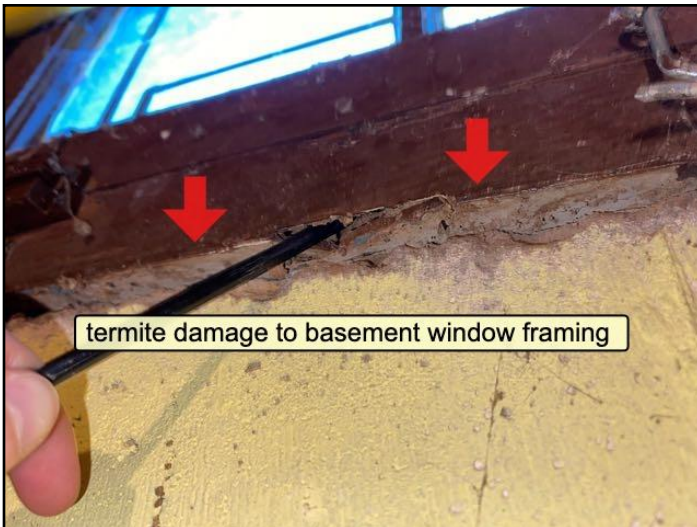
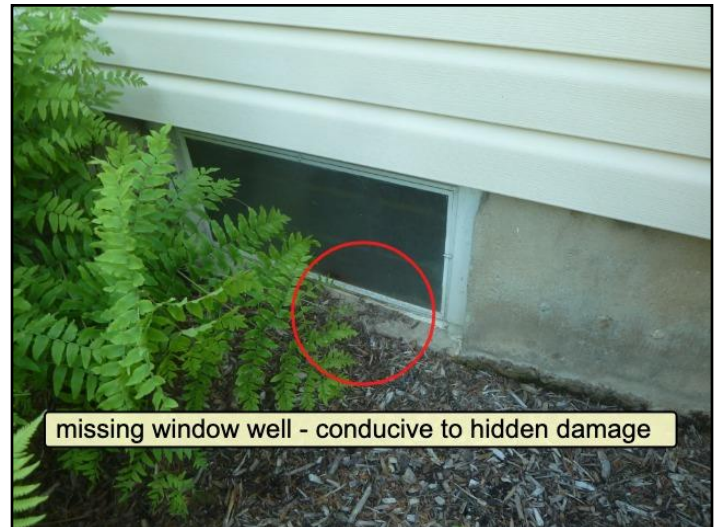
7. Condition: • Insect damage

Implication(s): Material deterioration

Location: Basement

Insect damage

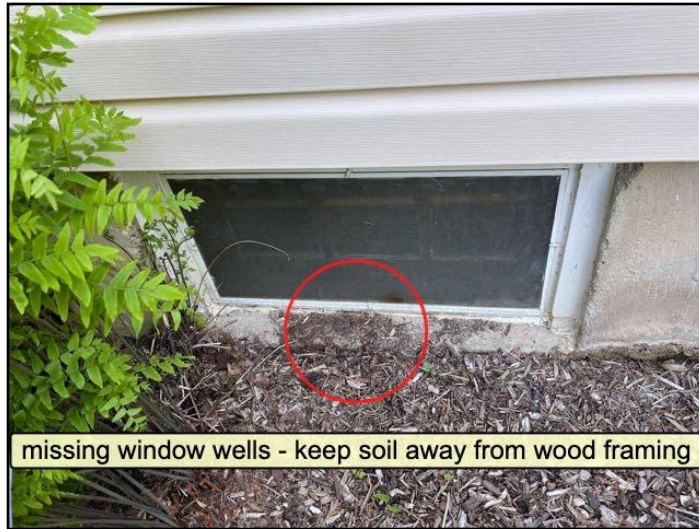
8. Condition: • [Missing](#)

Implication(s): Chance of water damage to structure, finishes and contents | Material deterioration

Location: Rear

Missing

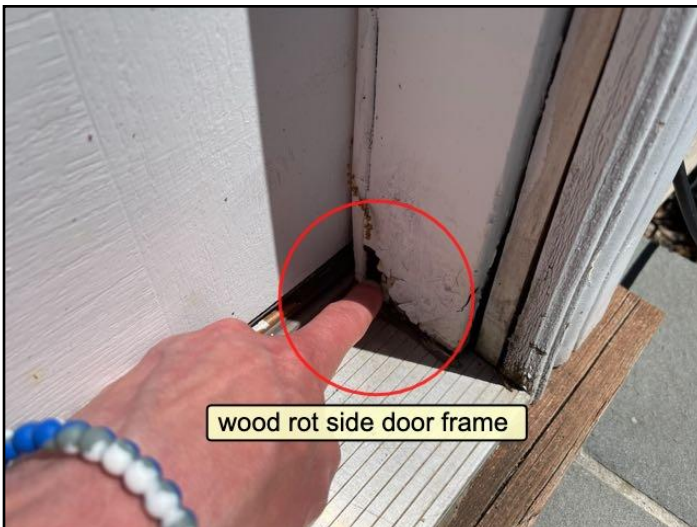
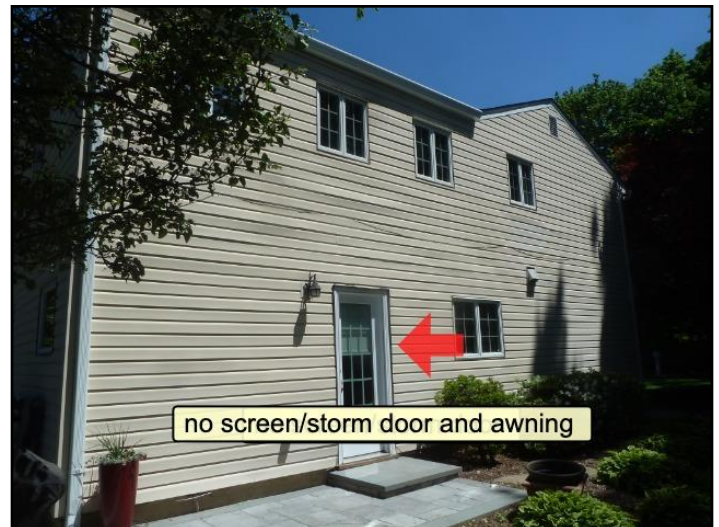
9. Condition: • [Rot](#)

Implication(s): Chance of damage to finishes and structure

Location: Left Side

Rot

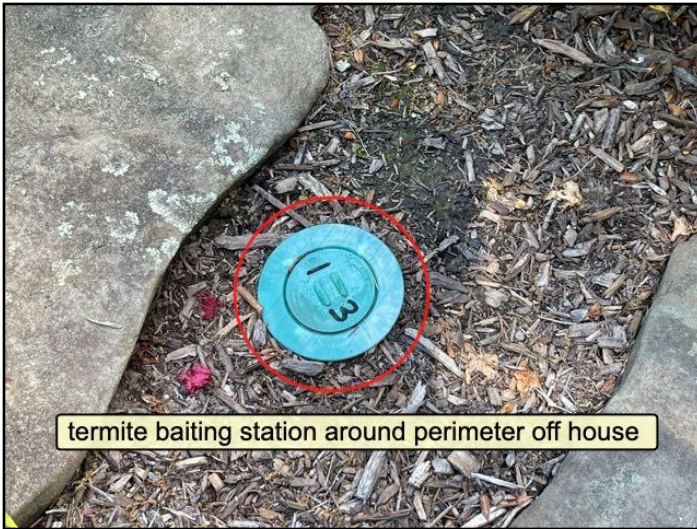
termite baiting station around perimeter off house

10. Condition: • Request termite disclosure and paperwork from home owner for current up to date contract. Termite damage in basement recommend seller provide current paperwork for treatment.

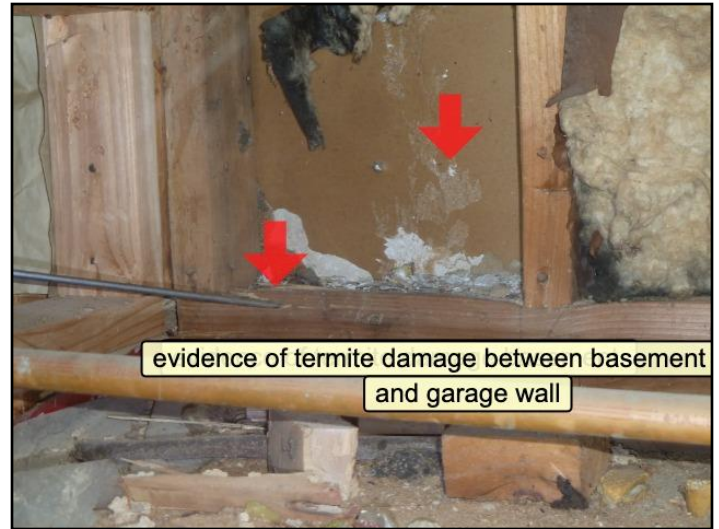
Condition: • Request termite disclosure and paperwork from home owner for current up to date contract.
Termite damage in basement recommend seller provide current paperwork for treatment.

evidence of termite damage between basement and garage wall

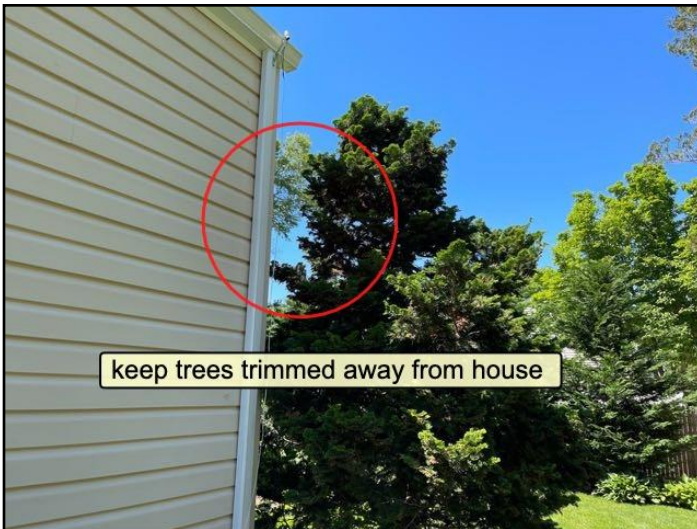
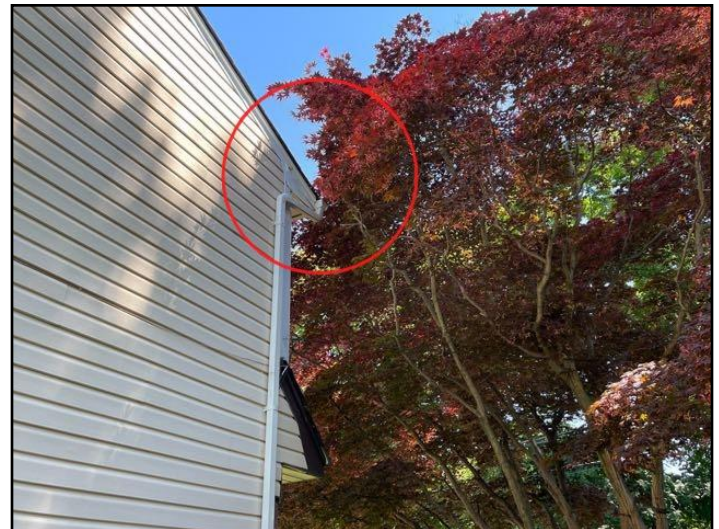
11. Condition: • Trim tree branches

Trim tree branches

keep trees trimmed away from house

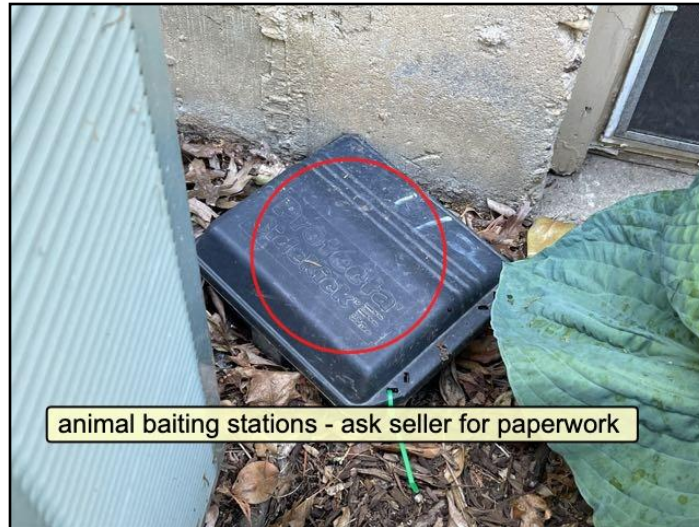
12. Condition: • Animal bating station

Animal baiting station

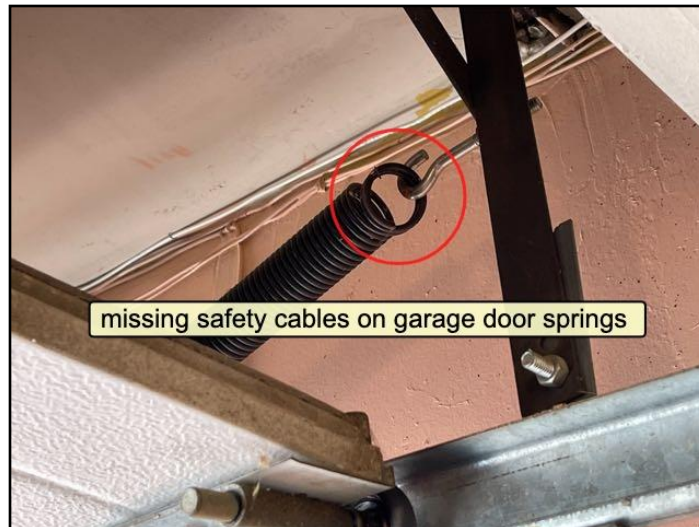
13. Condition: • [Missing safety cables through extension spring](#)

Implication(s): Chance of damage to contents, finishes and/or structure | Physical injury

Missing safety cables through extension...

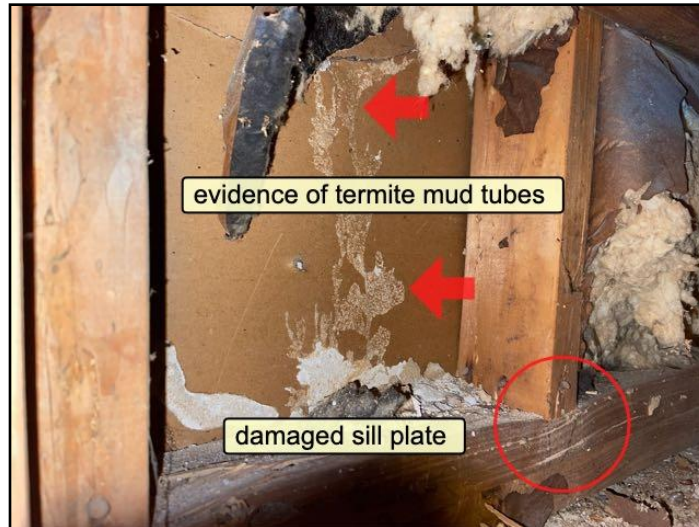
Condition: • Termite mud tubes
Recommend asking seller for existing treatment contract.
Location: Basement

16. Condition: • Termite mud tubes

Location: Basement

Termite mud tubes

Recommend asking seller for existing treatment contract.

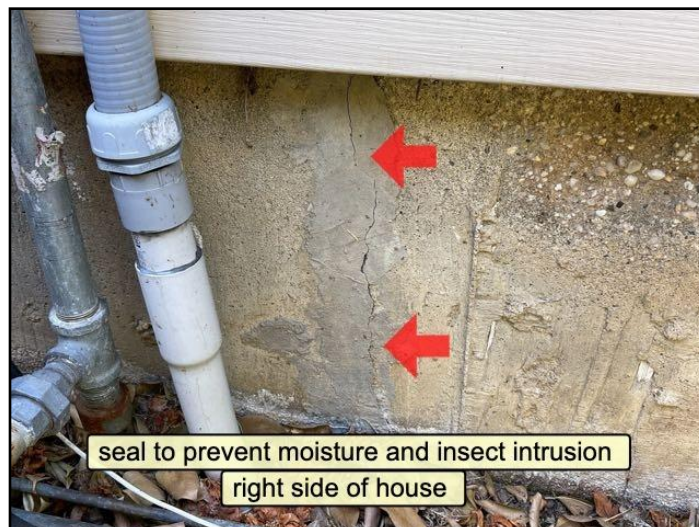
17. Condition: • Typical minor cracks

Implication(s): Chance of water entering building

Typical minor cracks

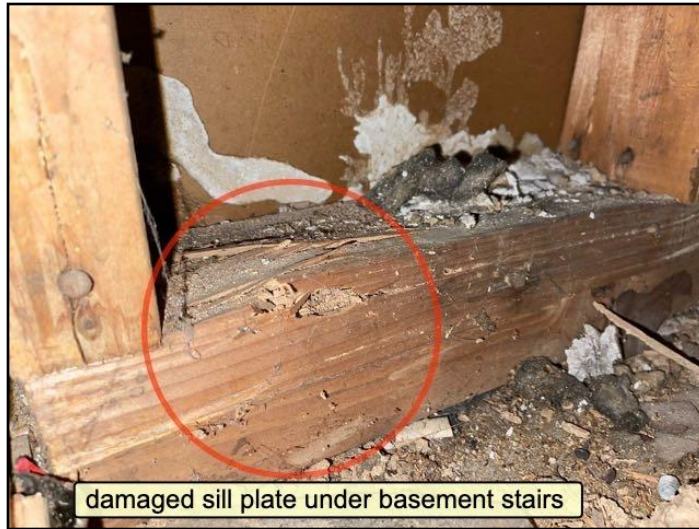
18. Condition: • Termite damage

Location: Basement

damaged sill plate under basement stairs

Termite damage

Replace damaged wood when renovating.

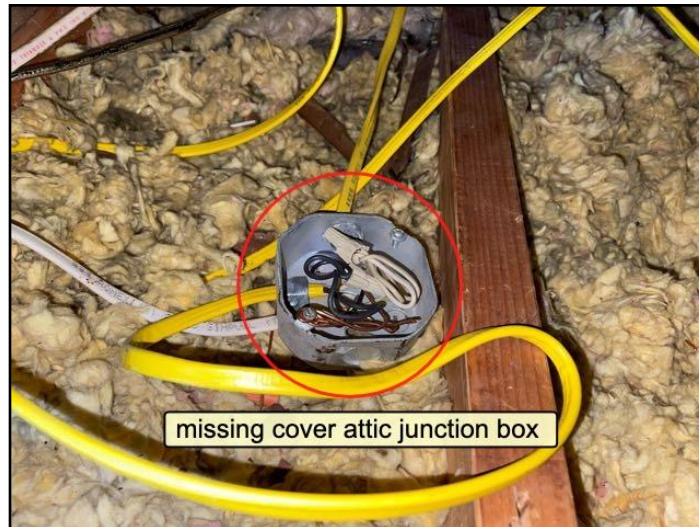
19. Condition: • Missing cover

Location: Attic

Missing cover

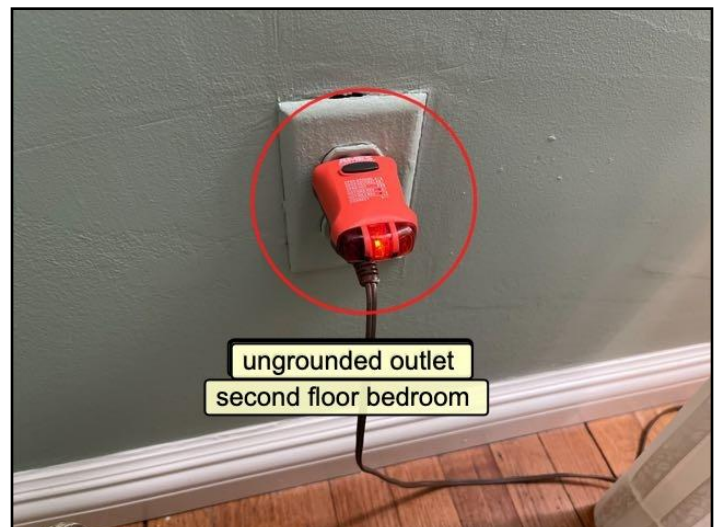
20. Condition: • [Ungrounded](#)

Implication(s): Electric shock

Location: Second Floor Bedroom

Ungrounded

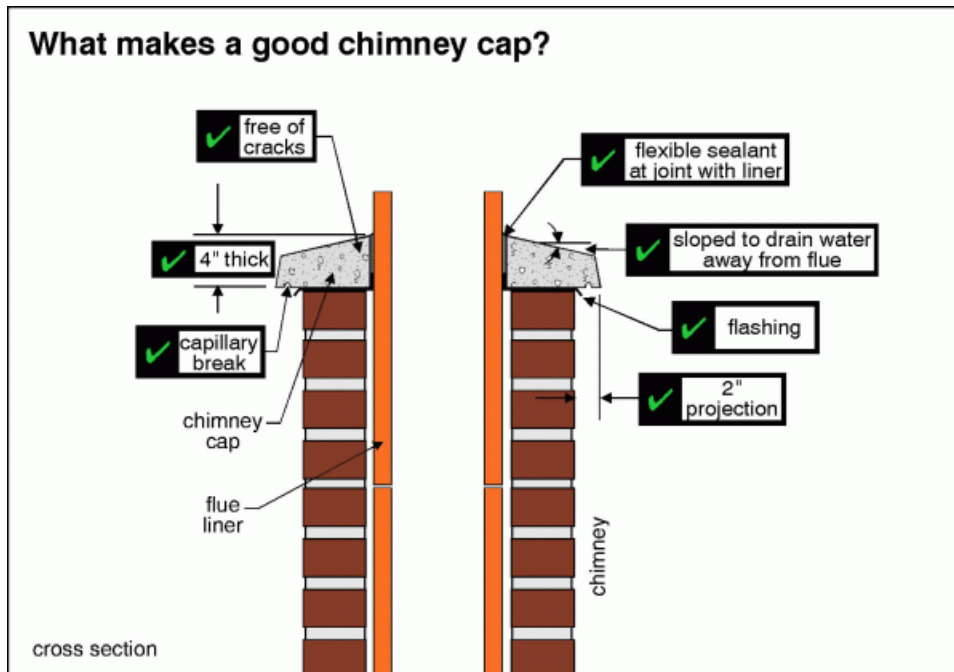
23. Condition: • Inspect (and/sweep if needed) before using. Recommend annual inspection.

Implication(s): Fire hazard

General: • Older houses with a masonry chimney need to be visually inspected by a professional chimney sweep to further evaluated condition of chimney prior to closing.

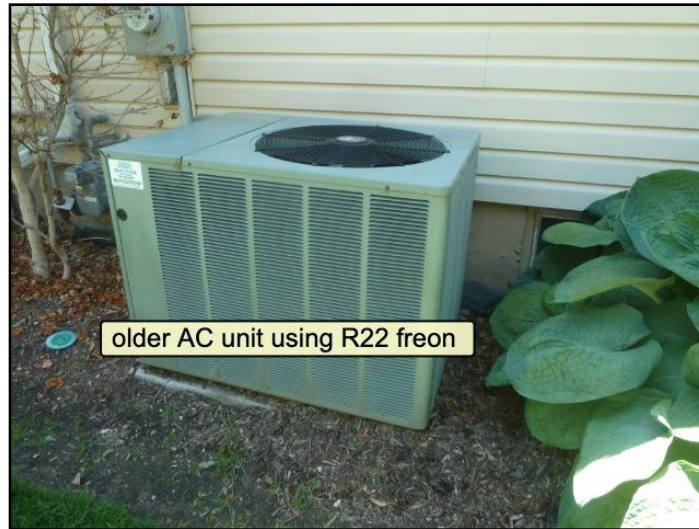
Condition: • AC is old using R-22 freon in system. This freon will not be available in the near future and is very expensive. Budget for replacement of AC unit when needed.
Air handler in attic and compressor are 14 years old and using R22 refrigerant - budget for replacement when needed.

24. Condition: • AC is old using R-22 freon in system. This freon will not be available in the near future and is very expensive. Budget for replacement of AC unit when needed.
Air handler in attic and compressor are 14 years old and using R22 refrigerant - budget for replacement when needed.

AC is old using R-22 freon in system. This...

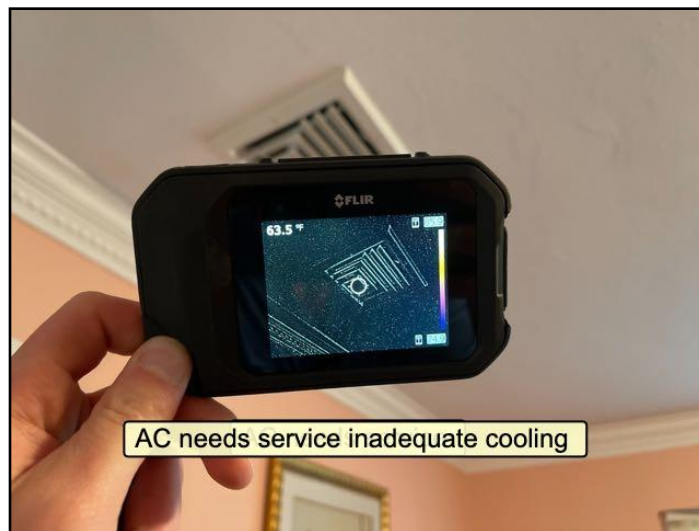
Condition: • [Inadequate cooling](#)
Air conditioner not working at time of inspection recommend further evaluation.
Implication(s): Increased cooling costs | Reduced comfort

25. Condition: • [Inadequate cooling](#)

Air conditioner not working at time of inspection recommend further evaluation.

Implication(s): Increased cooling costs | Reduced comfort

Inadequate cooling

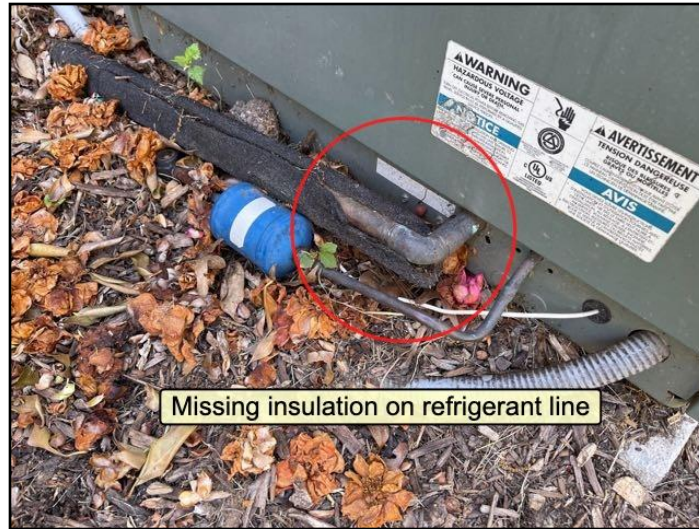
26. Condition: • Insulation - missing

Implication(s): Reduced system life expectancy | Increased cooling costs | Reduced comfort

Missing insulation on refrigerant line

Insulation - missing

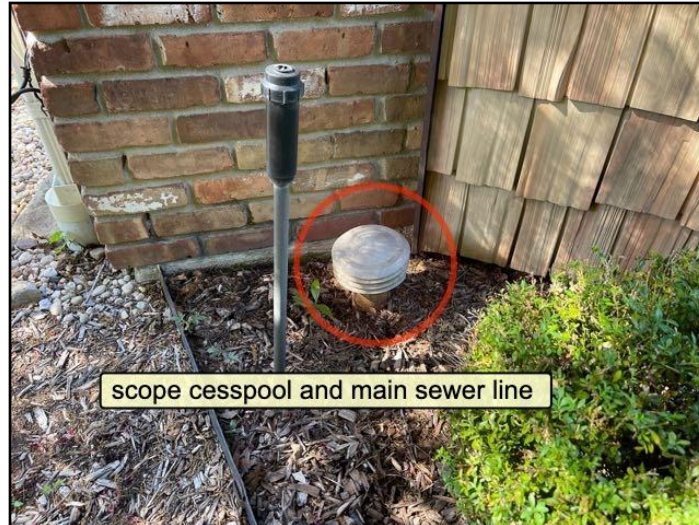
27. Condition: • Scope cesspools

Scope cesspools

General: • Recommend having sewer main scoped to determine condition of line prior to closing. Ask home owner when cesspool/septic system was last serviced request paperwork.

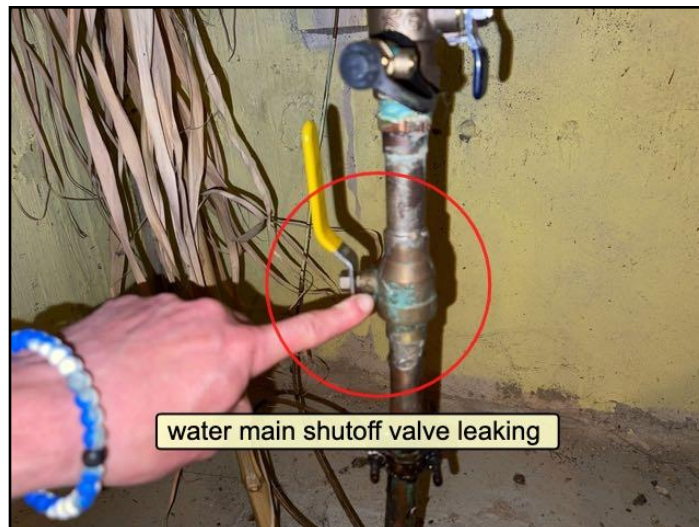
Condition: • [Leak](#)
Implication(s): Chance of water damage to structure, finishes and contents | No water
Location: Basement

28. Condition: • [Leak](#)

Implication(s): Chance of water damage to structure, finishes and contents | No water

Location: Basement

Leak

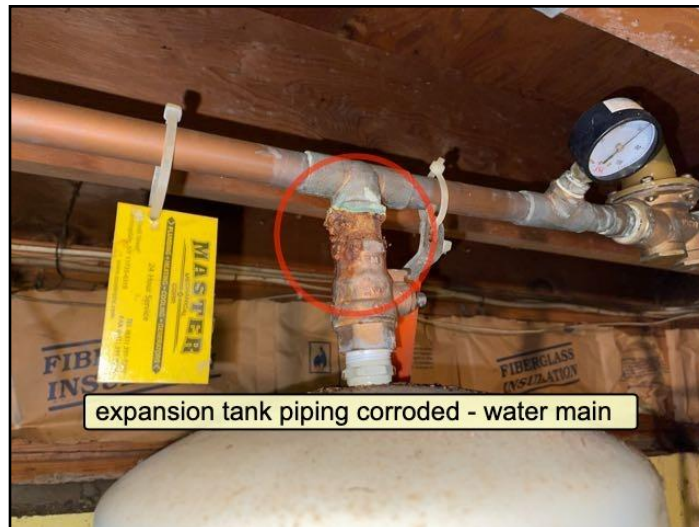
29. Condition: • Corrosion

Implication(s): Chance of water damage to structure, finishes and contents | Leakage | Reduced system life expectancy

| Equipment failure

Location: Basement

expansion tank piping corroded - water main

Corrosion

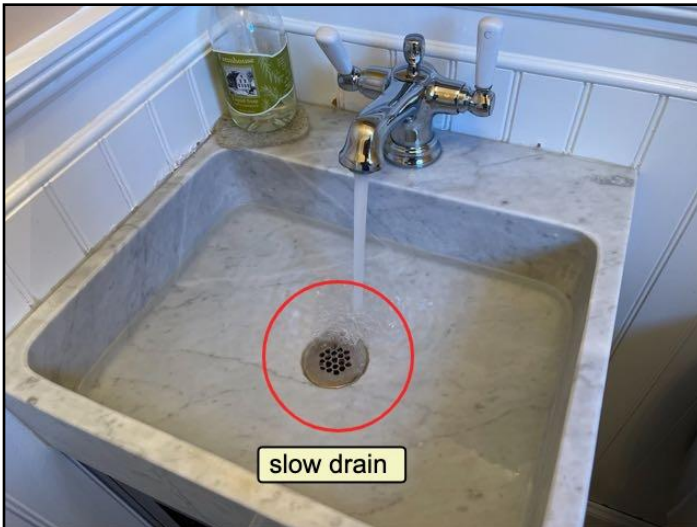
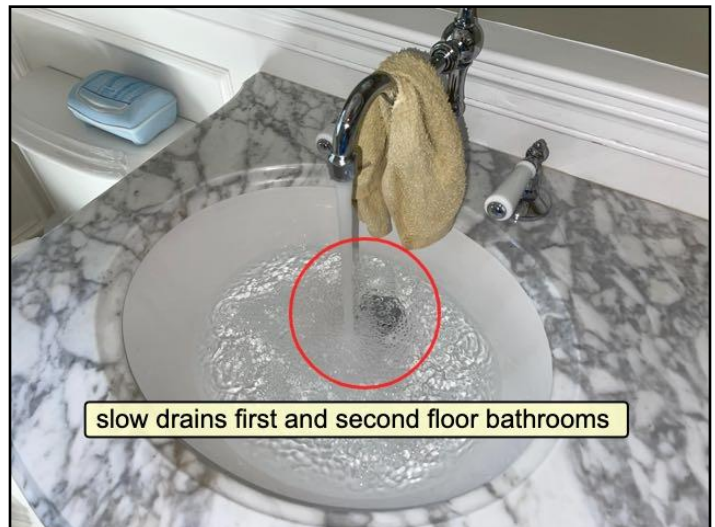
30. Condition: • [Slow drains](#)

Implication(s): Chance of water damage to structure, finishes and contents

Location: First/Second Floor Bathroom

Slow drains

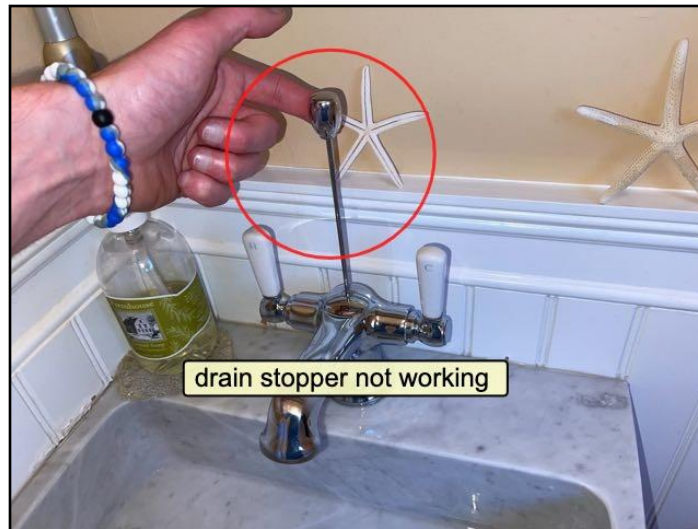
Drain stop ineffective

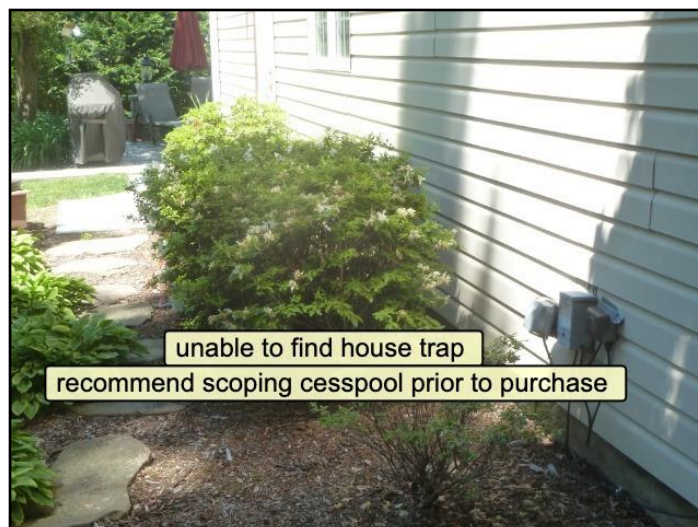
- Main house trap not visible

Main house trap not visible

UNABLE TO MAIN DRAIN AND HOUSE TRAP. RECOMMEND SCOPING MAIN SEWER LINE AND CESSPOOL PRIOR TO PURCHASE.

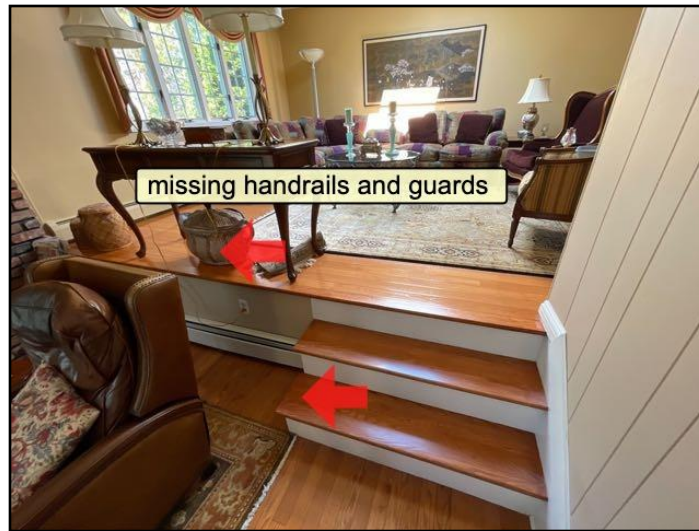
Condition: • [Missing](#)

31. Condition: • [Missing](#)

Implication(s): Fall hazard

Location: First Floor

Missing

INSTALL FOR SAFETY
