# YOUR INSPECTION REPORT

FOR THE PROPERTY AT:  
209 Indian Road Cres  
Toronto, ON

INSPECTION DATE:  
Tuesday, August 1, 2017

RE: Report No. 2145  
209 Indian Road Cres  
Toronto, ON

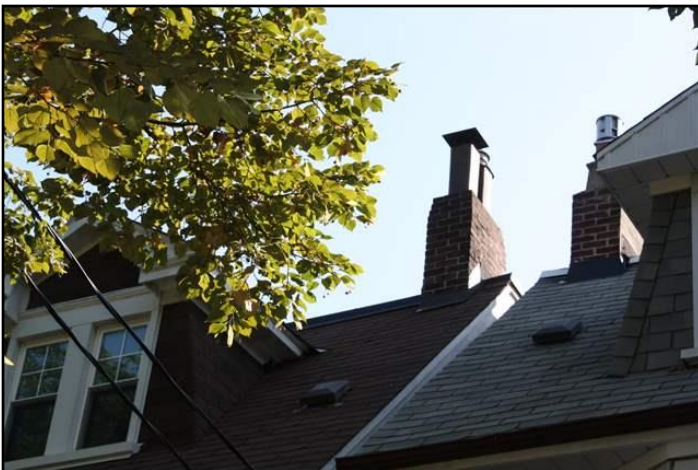
Typical life expectancy for this type of roof covering is 13-17 years. The current sloped roof covering at front and Mud room is aging with typical wear - Granule loss, widening tabs due to shrinkage.

1. Near end of life expectancy

**Task:** Replace

**Time:** Less than 2 years

**Cost:** \$2,000 - \$4,000

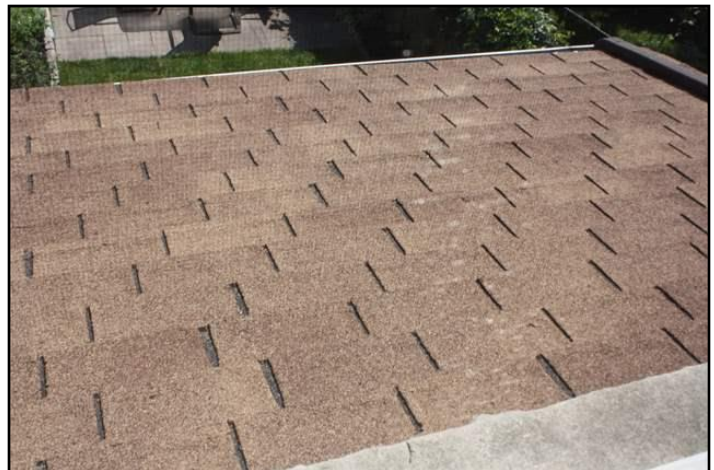
2. Near end of life expectancy

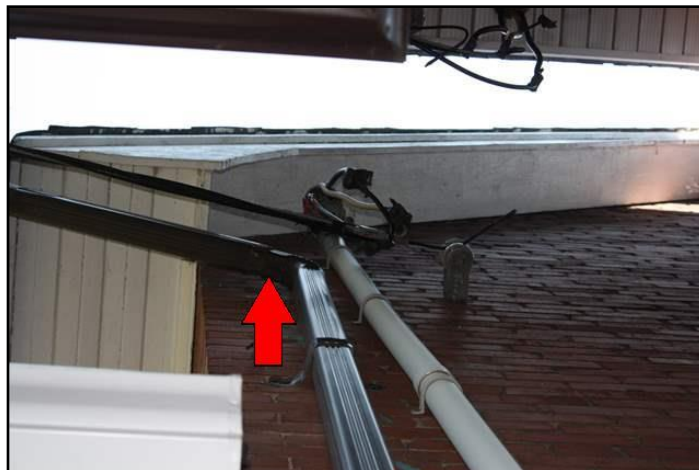
Implication(s): Leakage

3. Loose connections

Task: Correct

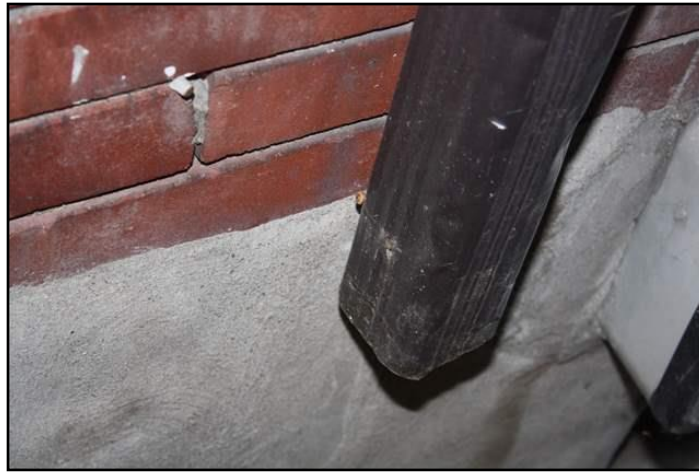
Implication(s): Chance of water damage to contents, finishes and/or structure

4. Should discharge 6 feet from building

Task: Improve

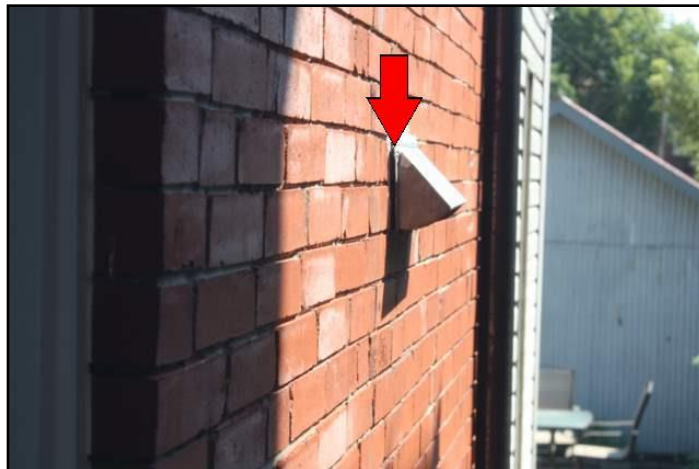
**Implication(s):** Chance of water damage to contents, finishes and/or structure

5. Caulking missing or ineffective

**Task:** Improve

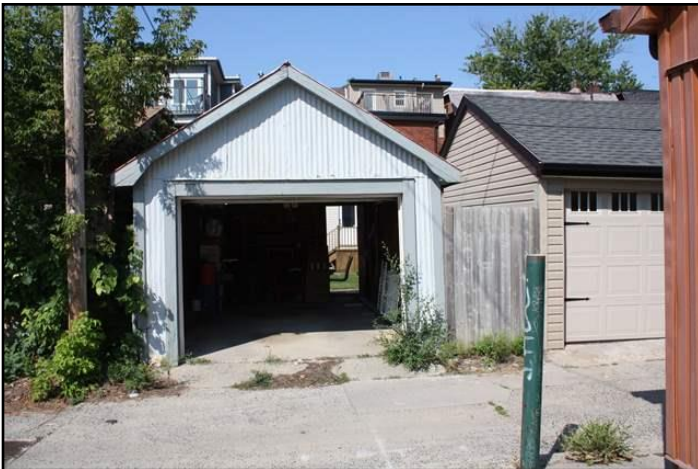
This is your standard older style lower-quality Toronto Garage. Improvements have been made to the electrical system. The metal cladding is old. The metal roof is old. Repairs ongoing as needed. Cost to replace a garage this size is expensive. \$15,000 and up.

6. Typical low quality structure

**Task:** Repair

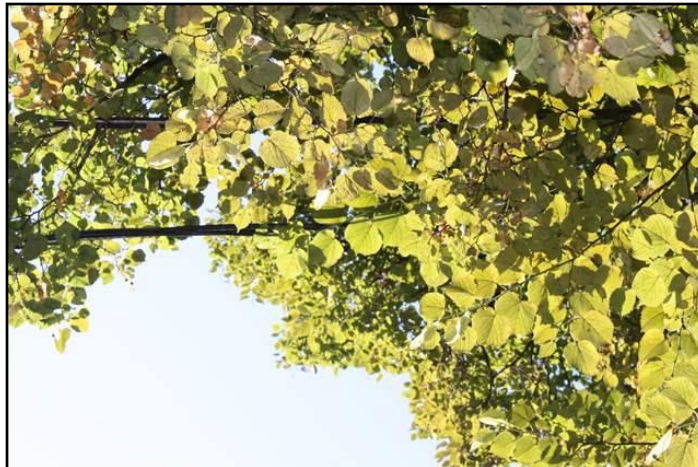
**Implication(s):** Interruption of electrical service | Electric shock | Damage to wire

9. Branches, vines interfering with wires

**Task:** Correct

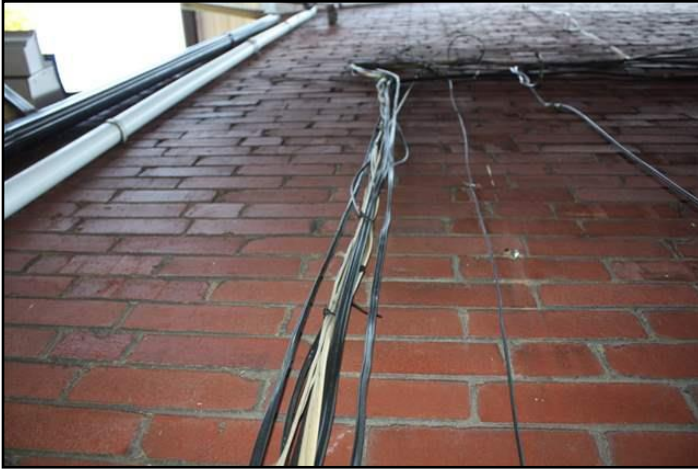
10. Flexible conduit needed

**Task:** Provide conduit for conductors

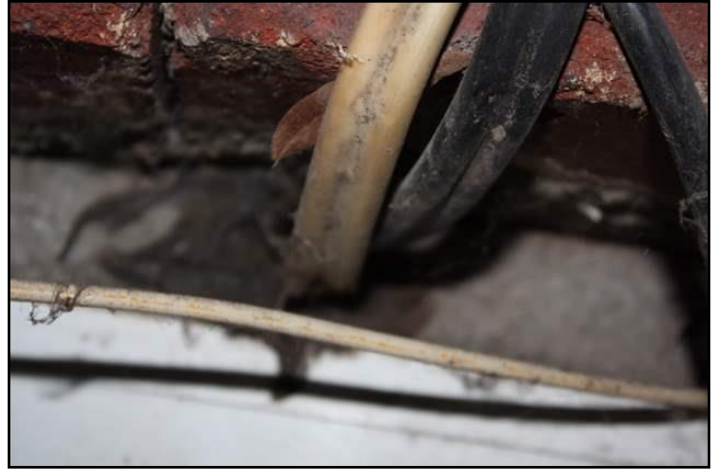
11. Flexible conduit needed

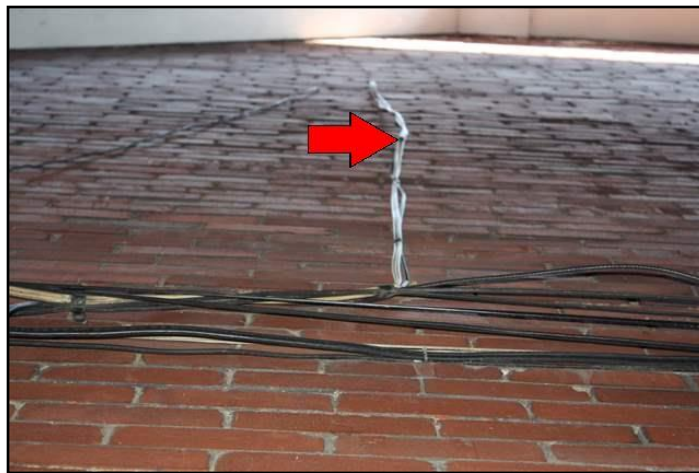
12. Flexible conduit needed

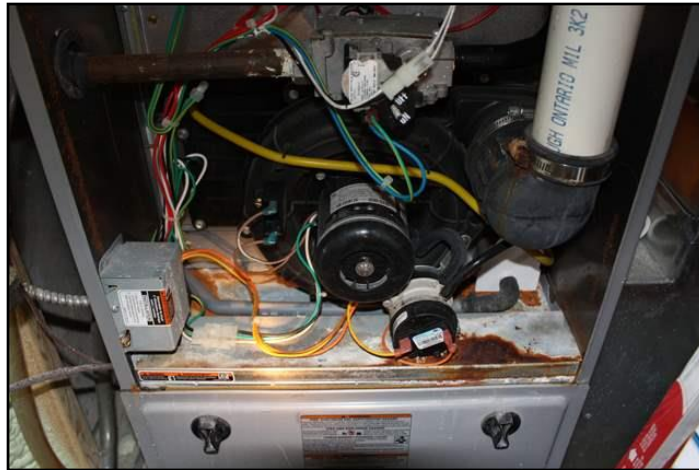
The furnace is only 4 years old however we noted rust and some moisture inside the unit. This is likely a furnace condensate leak. Also note that sometimes the A/C evaporator coil/tray inside the furnace can leak into the furnace. Service the furnace

13. Rust

**Task:** Service

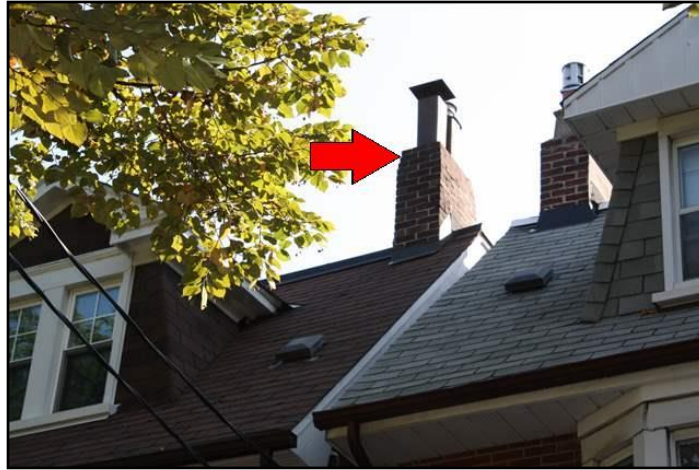
Implication(s): Chance of water damage to contents, finishes and/or structure | Shortened life expectancy of material

14. Missing Chimney Cap

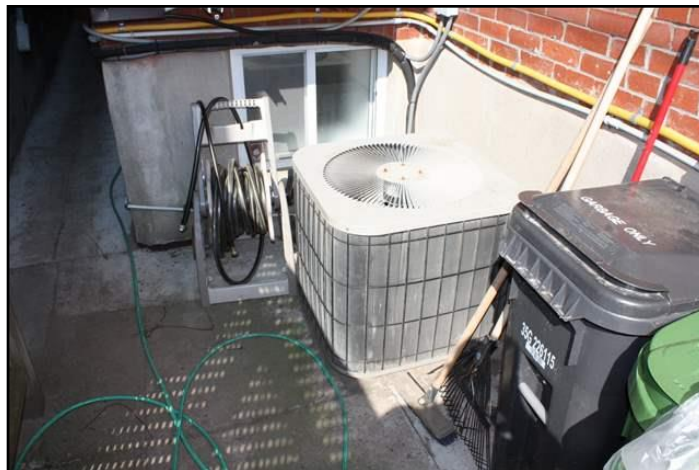
Typical life expectancy for a/c units are 10-15 years. The current unit is 17 years old and is beyond its life expectancy. The unit functioned when tested. Continue to use and plan for replacement.

15. Aging

**Task:** Replace

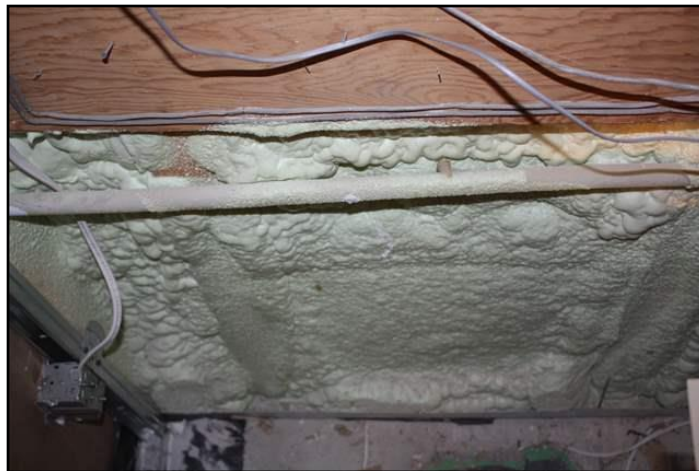
**Condition:** • [Exposed combustible insulation](#)

**Implication(s):** Fire hazard

16. Example

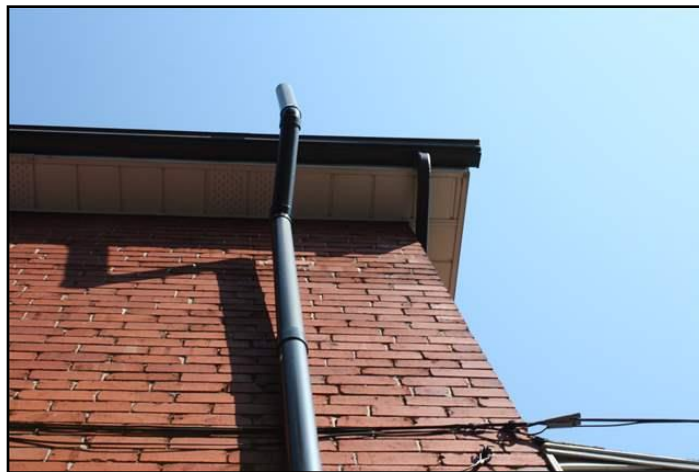
17.

**Condition:** • Venting pipe noted on exterior wall. We often see this application in older homes where fixtures have been added after original construction where venting through the house is too invasive. We always recommend that a licensed plumber check and verify that the installation work.

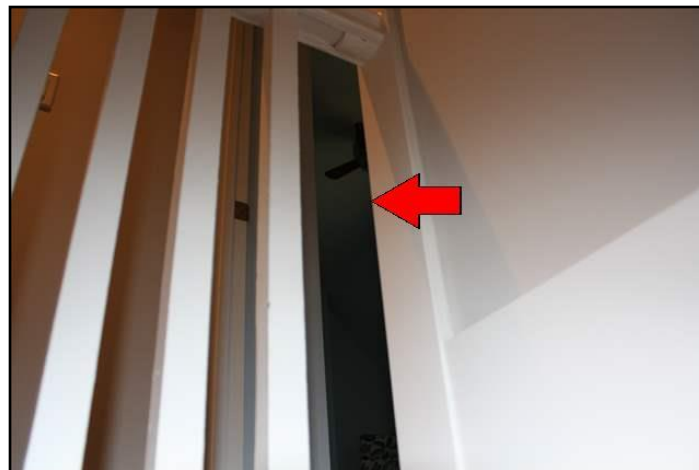
**Condition:** • [Too far apart](#)

**Implication(s):** Fall hazard

18. Too far apart

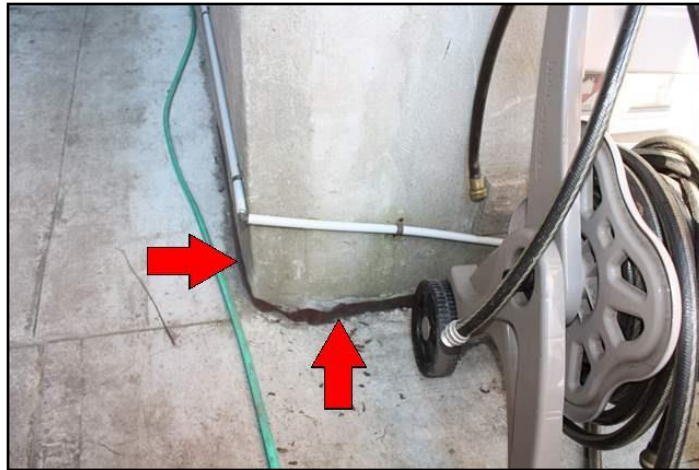
For Your Information - Homeowner noted that a drainage membrane was added to the foundation wall

19. Example Drainage membrane

**Task:** Monitor
