# YOUR Inspection Report

75 Sample Crt  
Pittsburgh, PA 15149

Friday, May 22, 2015

RE: Report No. 1498, v.4  
75 Sample Crt  
Pittsburgh, PA  
15149

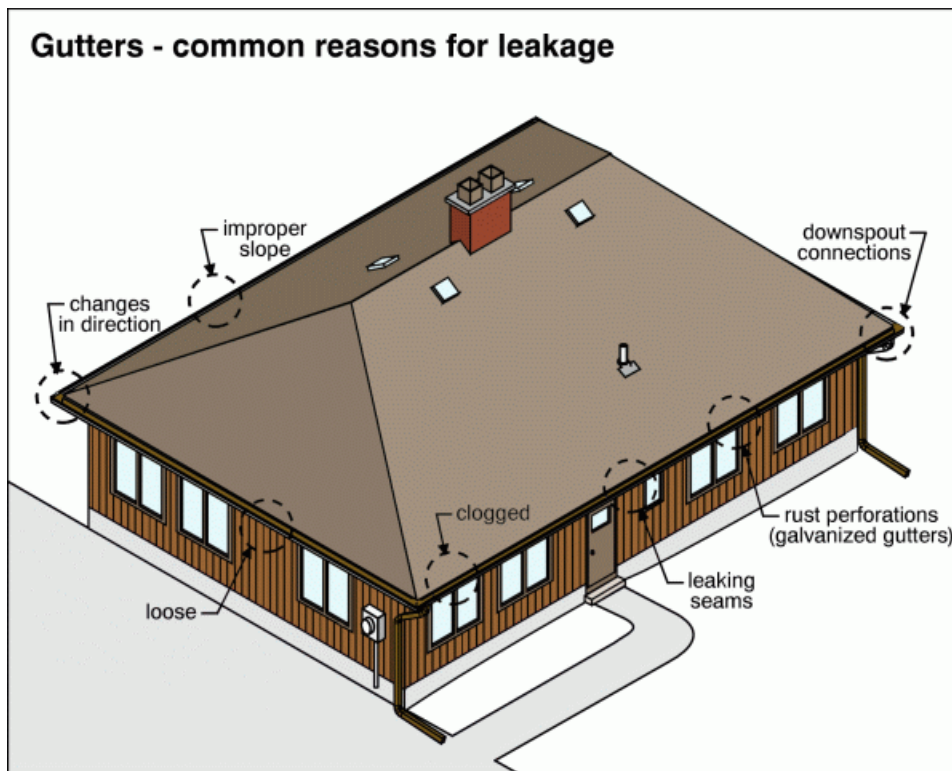
#### 3. Condition: • Clogged

The rear gutters were clogged at the time of the inspection (see pictures). Improve/clean ASAP and as part of regular maintenance to ensure proper rain water drainage in order to prevent water damage to finished areas and/or structure. It is highly recommended to have the entire gutter system cleaned/ maintained on a yearly basis, due to the abundance of mature trees around the property.

*Clogged*

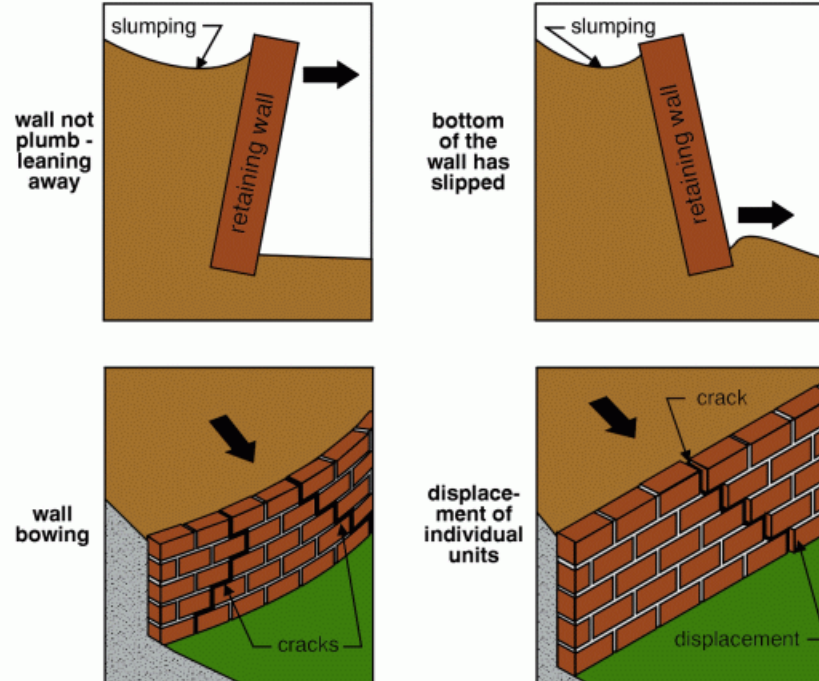
### **4. Condition:** • Leaning

The short rear stone retaining/ landscaping wall is visibly leaning and a minor crack/ out of plane movement was observed, as a result of water and soil horizontal pressure (see picture). This short wall does not effect the stability/ performance of the house. Although not an immediate concern, the buyer should be aware that this wall may need to be replaced in the near future. I would suggest to patch the crack and monitor for further movement.

*Leaning*

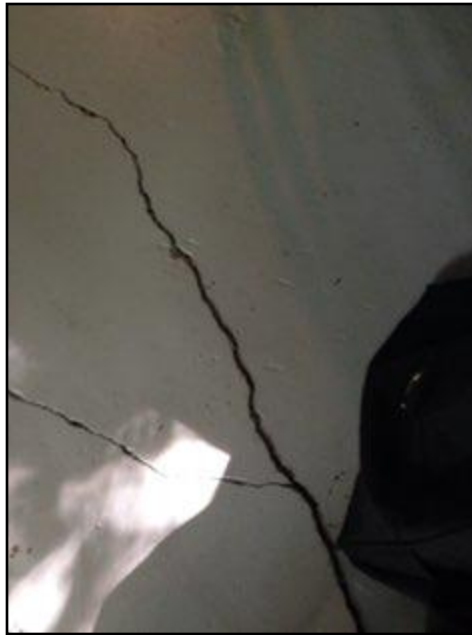
#### 5. Condition: • Cracked

Several cracks were observed at the basement concrete slab on grade (see picture). This condition is typical to an old concrete slabs and is not a structural concern; seal as part of regular maintenance.

*Cracked*

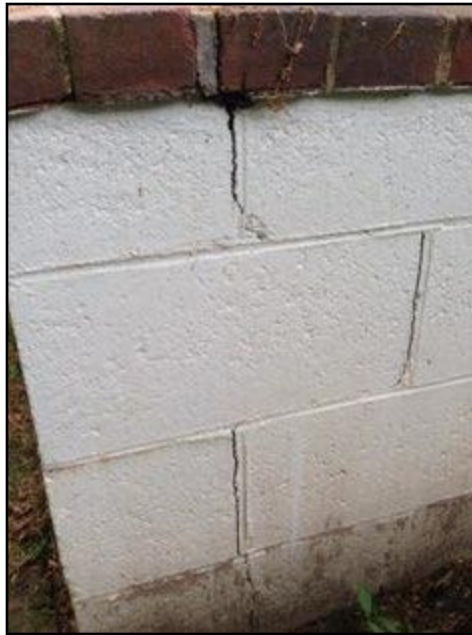
### **6. Condition:** • Cracked

A minor settlement crack was observed in the front foundation wall under the green house for the cottage. This crack occurred sometime in the past most likely due to accumulation of water next to the foundation from watershed from the greenhouse. I did not observe any out of plane movement or large gaps that would concern me at time of inspection. I would suggest to patch and seal all cracks and if possible divert the water away from this area.

*Cracked*

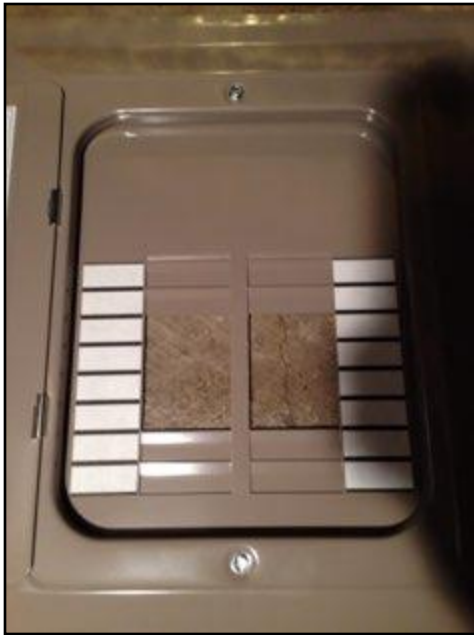
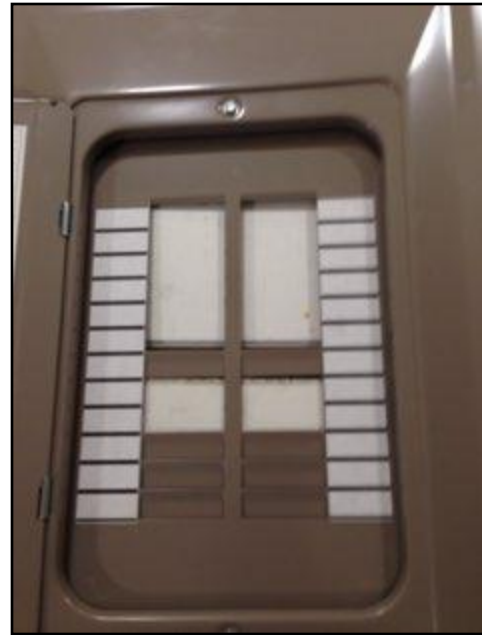
- The circuits are not labeled at the panel

*The circuits are not labeled at the panel*

I would suggest to ask the current owners to identify and label each individual circuit in the sub electric panels for safety and convenience.

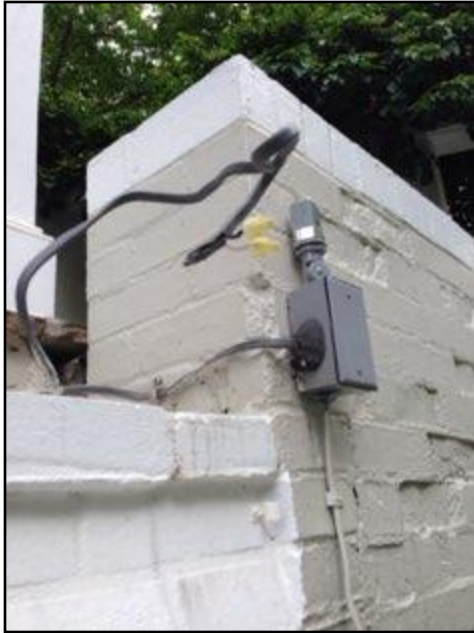
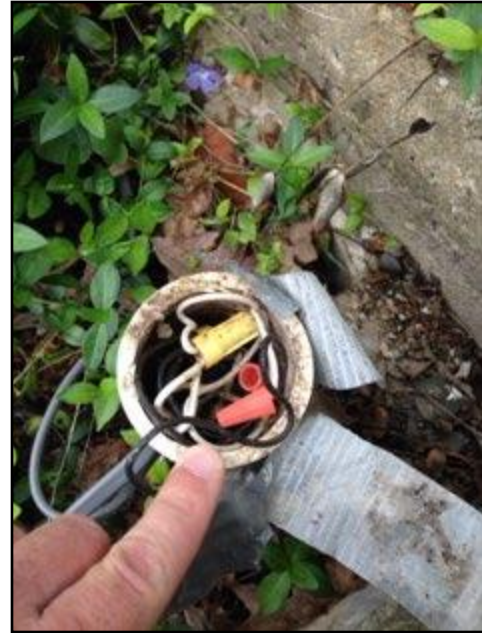
8. **Condition:** • Observation: exposed electrical wires were detected at rear left stairs to lower driveway. Although these wires did not have active electricity running through them, they should be terminated inside a junction box or if no longer in use eliminated. This should be done by a licensed electrician.

**Task:** Install junction box/ eliminate/ improve

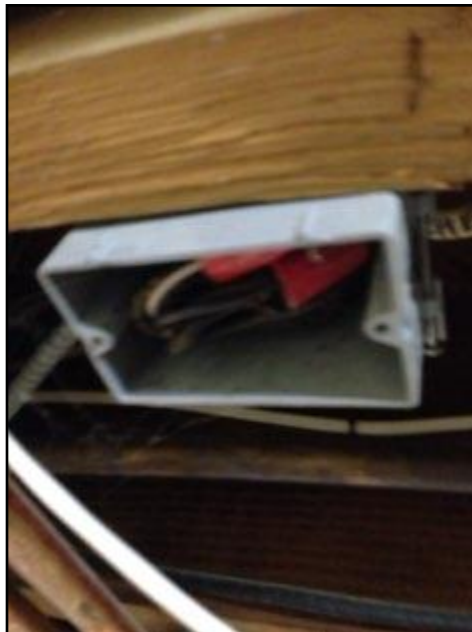
### **9. Condition:** • Cover loose or missing

A cover was missing on a junction box. I would recommend a licensed electrician install a junction box plate cover for safety.

*Cover loose or missing*

**Task:** Install cover/ improve

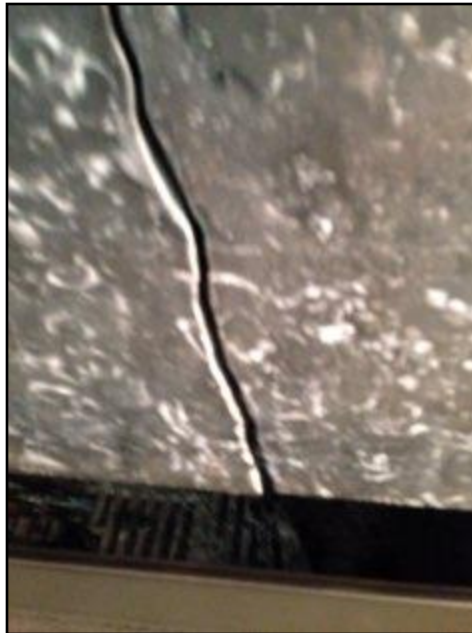
Formal living room cracked stone mantle. Repair/ replace as needed

*Wood-burning fireplace*

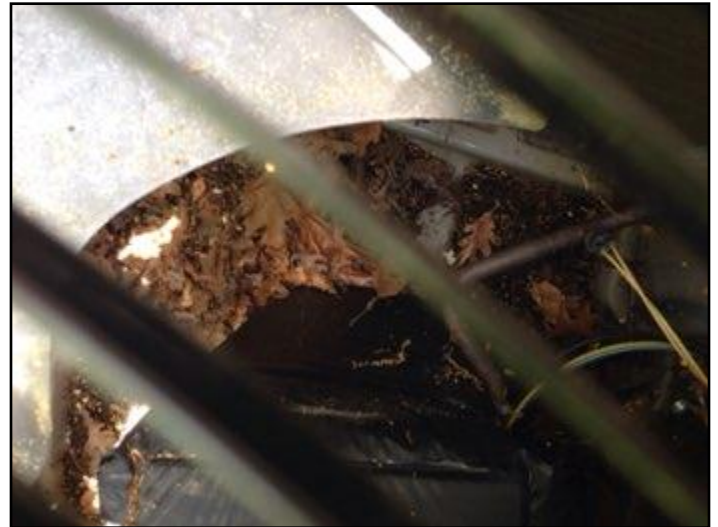
12. Condition: • Dirty

Dirty

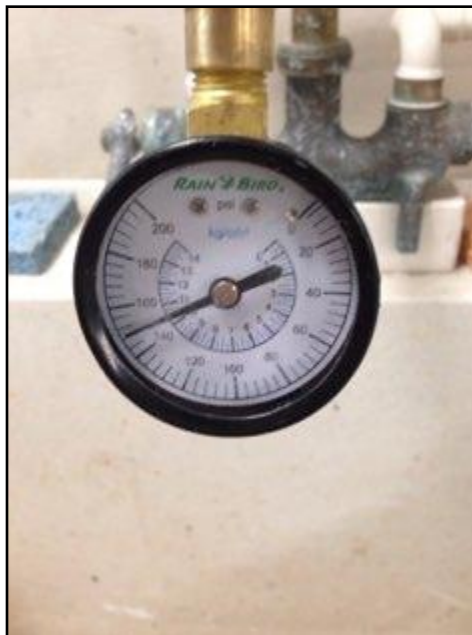
**13. Condition:** • Recommended due to high supply water pressure

148psi was measured at laundry tub in basement. The standard water pressure for residential systems should not exceed 80 psi, when the water pressure exceeds 80, it can harm the supply plumbing system ex. Plumbing joints/connections, faucets, fixtures, etc.. I would recommend a licensed plumber to repair/ replace the water pressure regulator.

*Recommended due to high supply water...*

**Task:** Repair/ replace pressure regulator/ improve

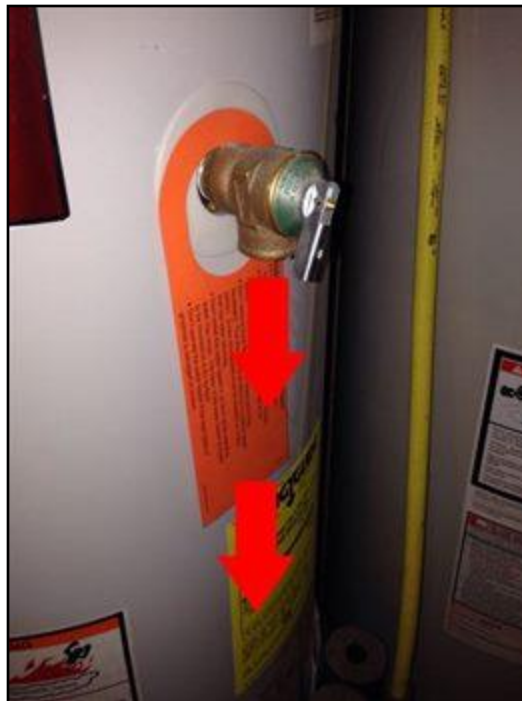
**14. Condition:** • Discharge tube missing

The water heater was missing the discharge tube that is connected to the temperature relief valve. I would suggest to have a licensed plumber install in order to prevent hot water being discharged uncontrollably and causing an unintentional accident. This is a safety concern.

*Discharge tube missing*

**Task:** Install discharge tube / improve

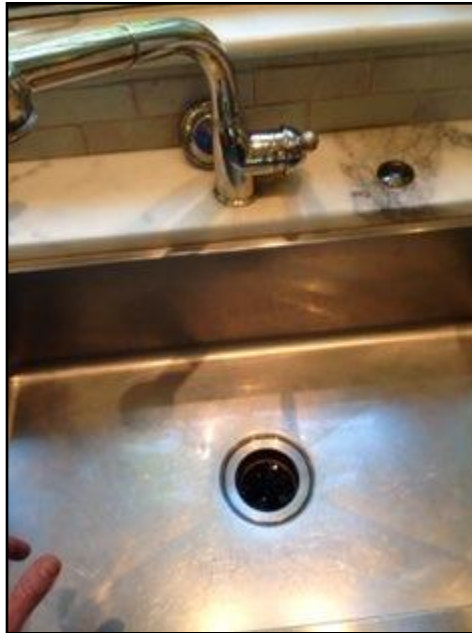
### **15. Condition:** • Slow drains

Very slow drain/ clogged drain was observed at the kitchen sink; have a plumber inspect and repair as needed.

*Slow drains*

**Task:** Repair/ improve

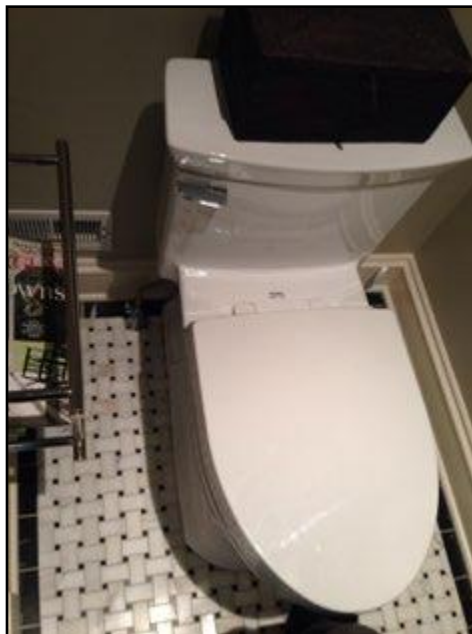
**16. Condition:** • Loose

The toilet in the masterbathroom is loose and should be secured ASAP to prevent future leakage (see illustration). Note: wax ring may also need to be replaced.

Loose

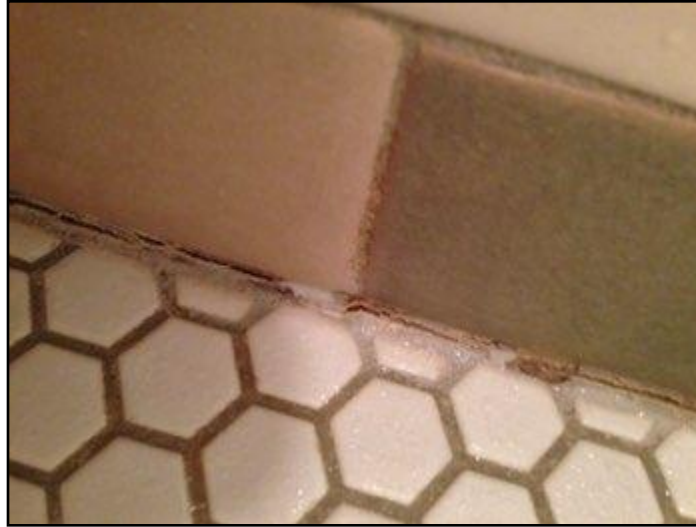
**17. Condition:** • Caulking loose, missing or deteriorated

The caulking at the corner of the front left side bathroom shower enclosure is deteriorated and a minor gap where water can penetrate into the wall/ structure was observed (see picture); improve/seal to prevent water penetration and possible damage to the structure.

*Caulking loose, missing or deteriorated*

**Task:** Seal/ caulk/ improve

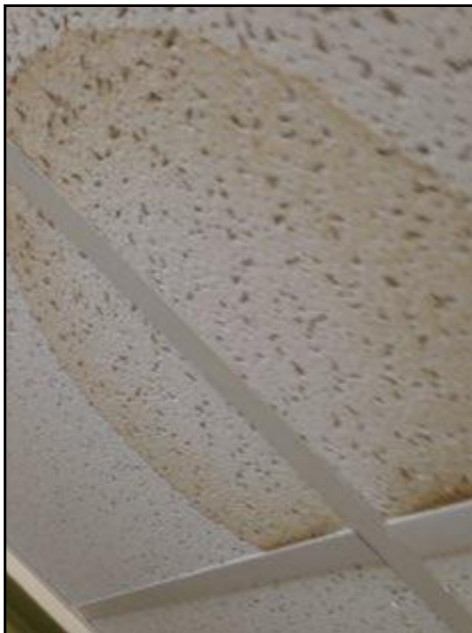
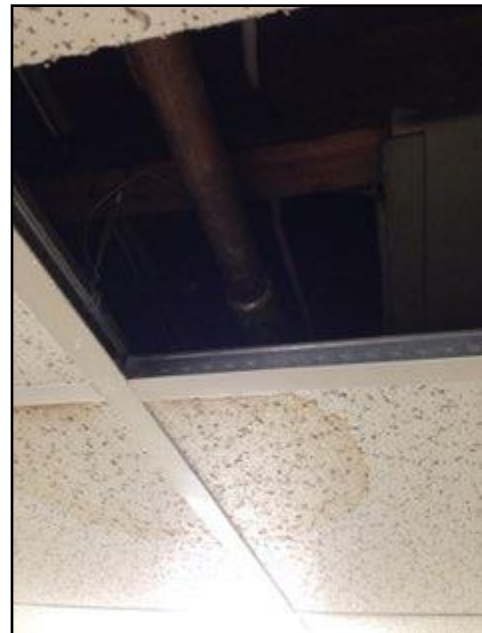
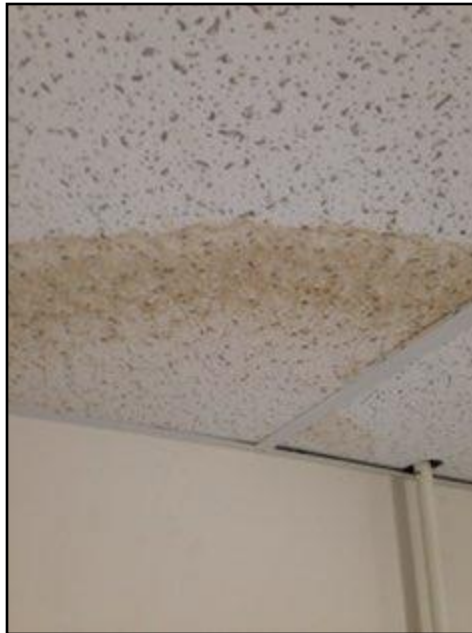
**22. Condition:** • Water damage

Water stains visible at laundry room in basement drop ceiling. I tested those areas with a tramex moisture meter and they were found to be dry at time of inspection.

Water damage

*Water damage*

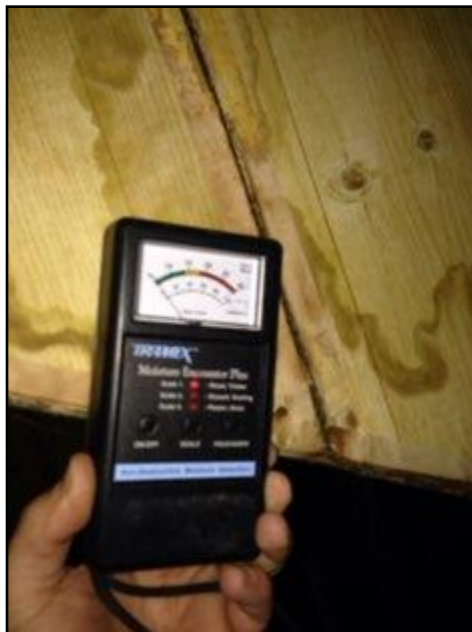
## 23. Condition: • Stains

Water stains were observed at the dormer of the attic (see pictures); no moisture was detected at the time of the inspection; Request more information if available regarding these stains from current owners (old repaired leak? Active under certain conditions?), eliminate the water source if still active.

*Stains*

**Task:** Eliminate if still active / improve

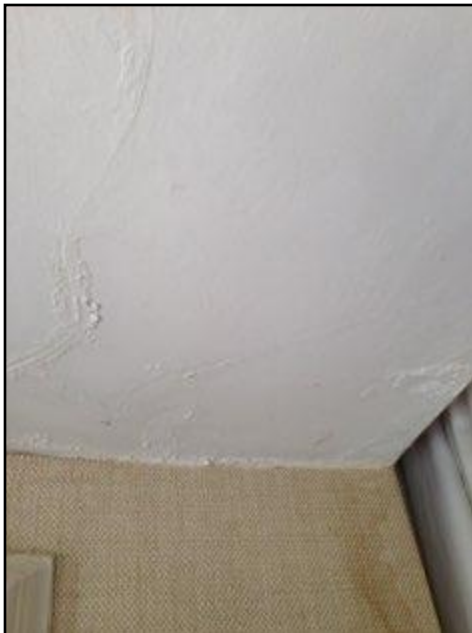
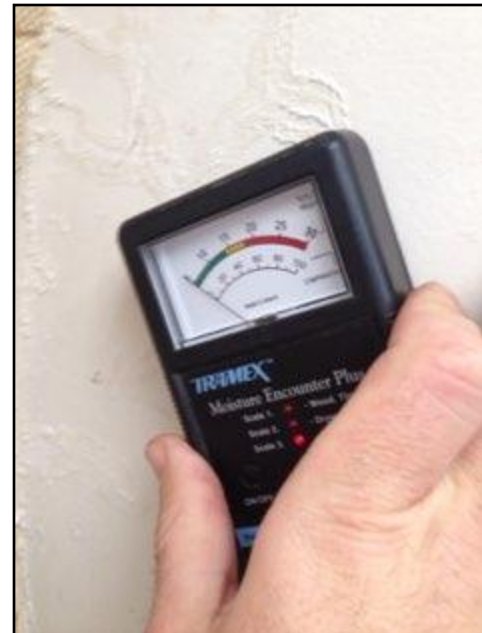
### **24. Condition:** • Crumbly or powdery

Signs of water damage were observed on the ceiling near the rear French doors . This area was tested with the moisture meter and found to be dry at the time of the inspection.

*powdery*

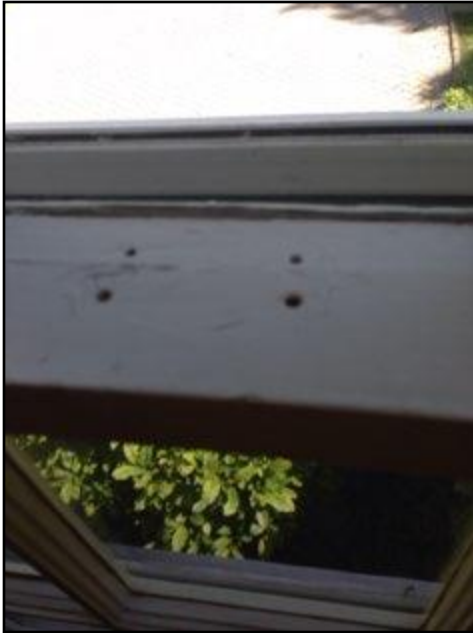
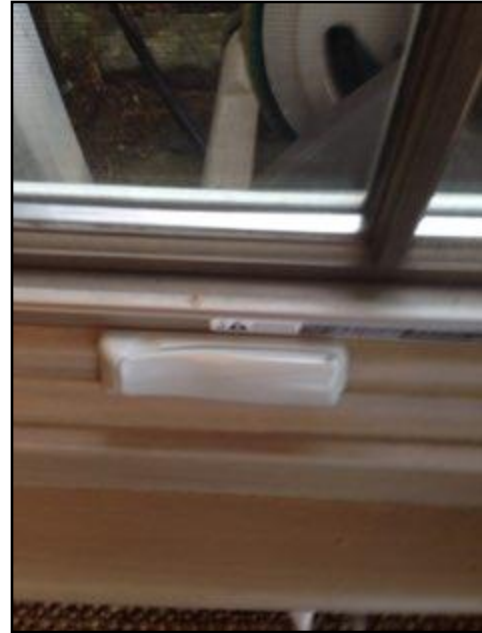
### **25. Condition:** • Inoperable

Several of the windows throughout were either missing the locking mechanisms or the locks did not operate as intended. Also, one of the casement windows in the kitchen did not operate at all. I would suggest to have a licensed contractor install or repair so as the windows operate as intended.

*Missing*

*Inoperable*

**Task:** Repair/ replace/ improve

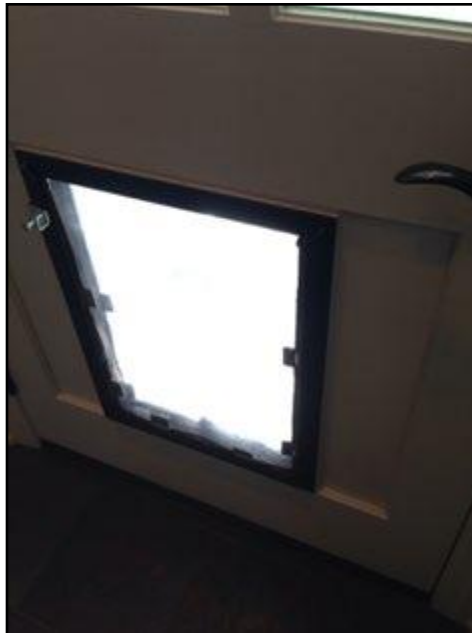
### **26. Condition:** • Damage

The left side entry door has been customized for a dog door. If you do not own a pet or pets are not in your future plans, this door should be replaced.

*Damage*

**Task:** Replace door/ improve

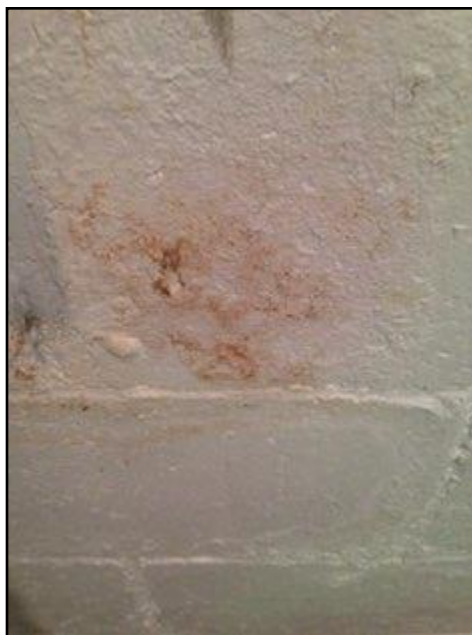
**27. Condition:** • Some typical signs of moisture like efflorescence were visible. Efflorescence is a mineral deposit present in the foundation wall due to some moisture. This condition is very typical and expected to be present in old basement. Monitor for any change in current condition.

*Some typical signs of moisture like...*
