Your Inspection Report

Somewhere Lane
Osseo, WI 54758

INSPECTION DATE:
Tuesday, September 18, 2018

RE: Report No. 1041, v.2
Somewhere Lane
Osseo, WI
54758

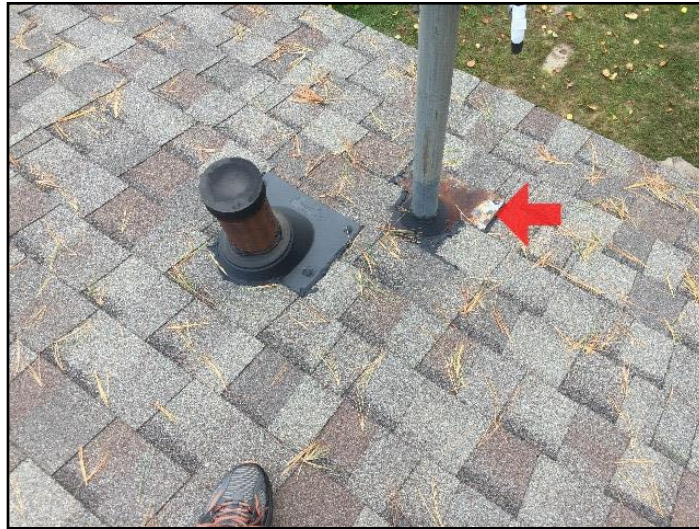
Service mast flashing

A build up of roofing tar was visible around the electrical service mast flashing. Recommend monitoring for future leaks and resealed when needed.

Task: Monitor

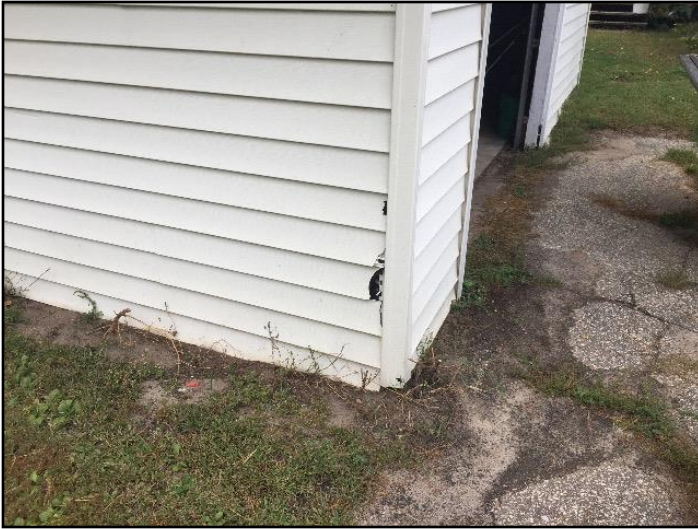
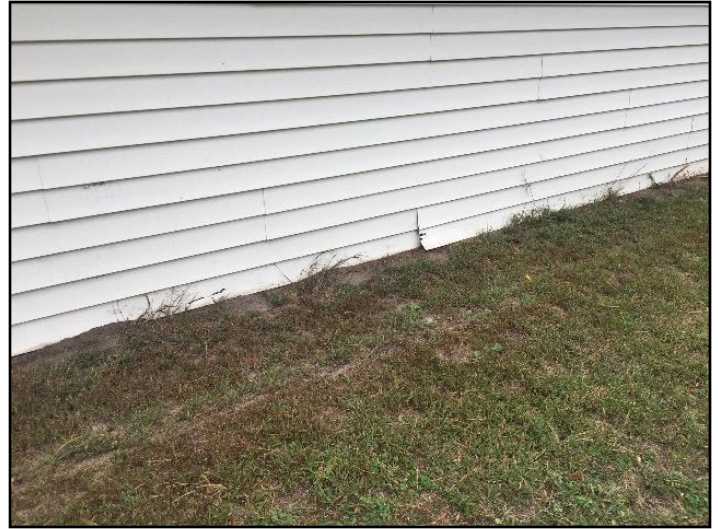
9. Condition: • [Mechanical damage](#)

Garage siding damaged

Task: Repair or replace

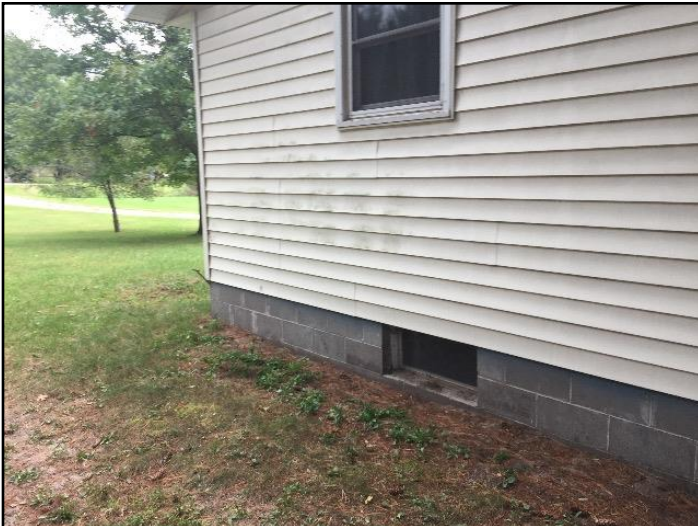
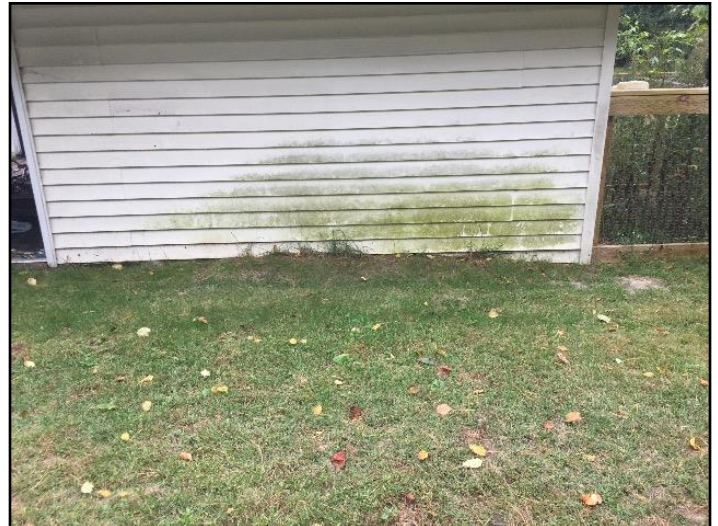
On the day of the inspection mildew was visible on the north side of the house and garage. Recommend cleaning as regular maintenance.

Discolored

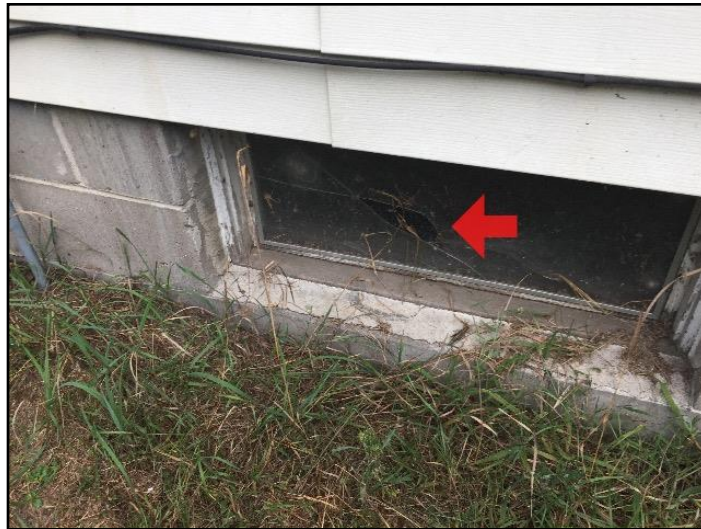
On the day of the inspection the basement windows were in need of general maintenance and repair.

Broken window

Task: Repair or replace

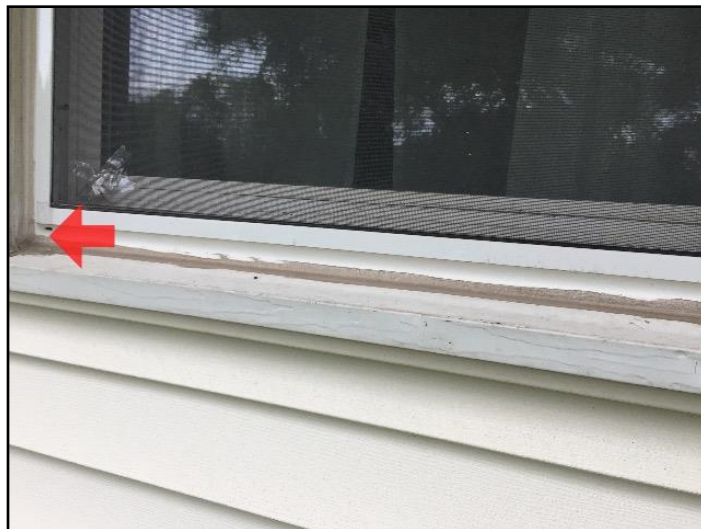
On the day of the inspection chalk was visible around the exterior of the window frames. Recommend monitoring and resealing as regular maintenance to prevent water intrusion.

Paint and Caulking - deteriorated / missing

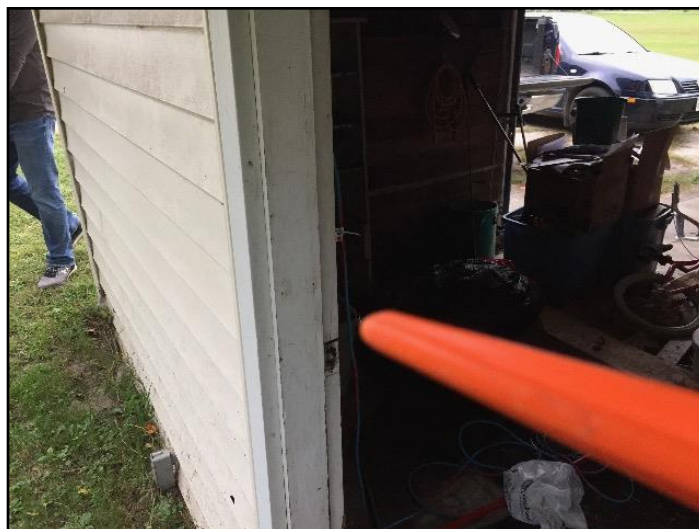
On the day of the inspection the garage service door latch was missing.

Marginal

Task: Repair or replace

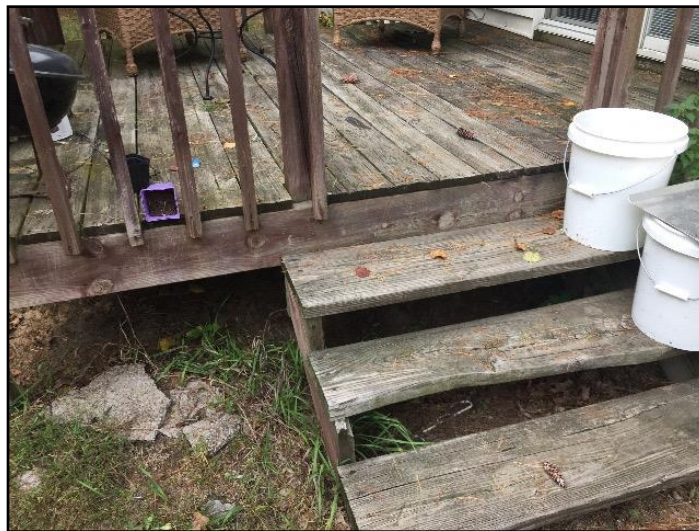
22. Condition: • [Missing](#)

Implication(s): Fall hazard

Missing hand rail on deck

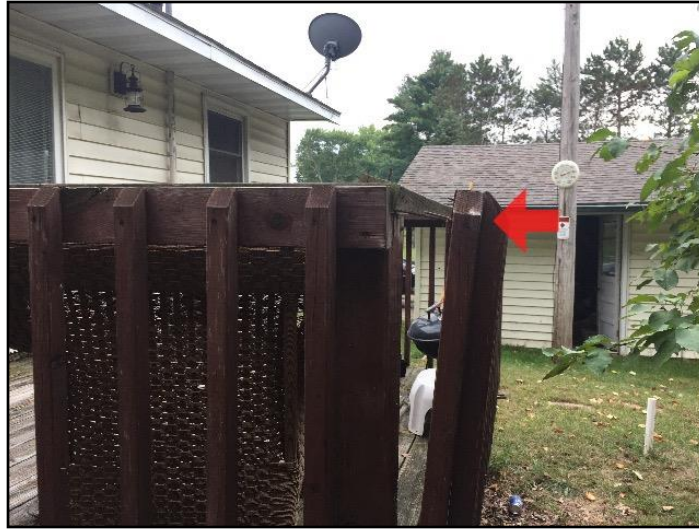
23. Condition: • [Loose](#)

Implication(s): Fall hazard

Loose guard rail on deck.

Task: Repair

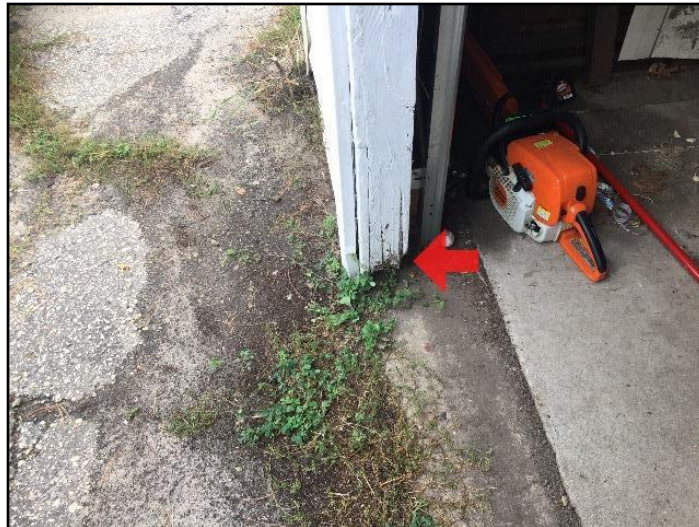
The garage appears to be in satisfactory condition structurally. Areas of rot at the bottom of the structure may be in need of repair or replacement.

Rot at the bottom of garage door frame

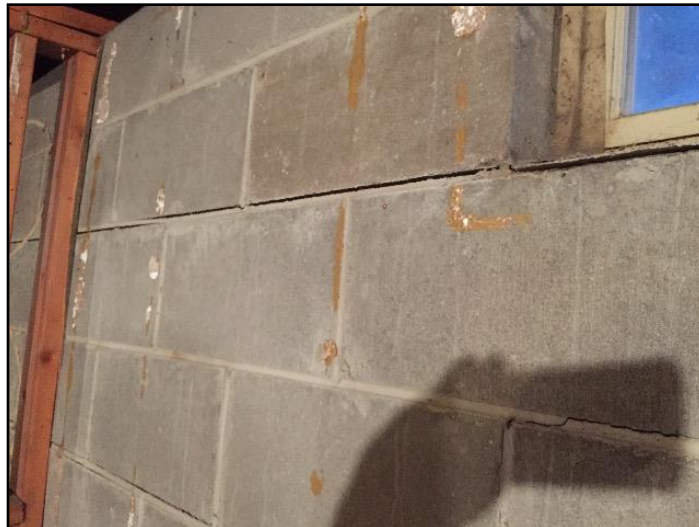
32. Condition: • [Cracked horizontally](#)

Implication(s): Chance of structural movement

Cracked horizontally

Recommend further evaluation by a qualified contractor.

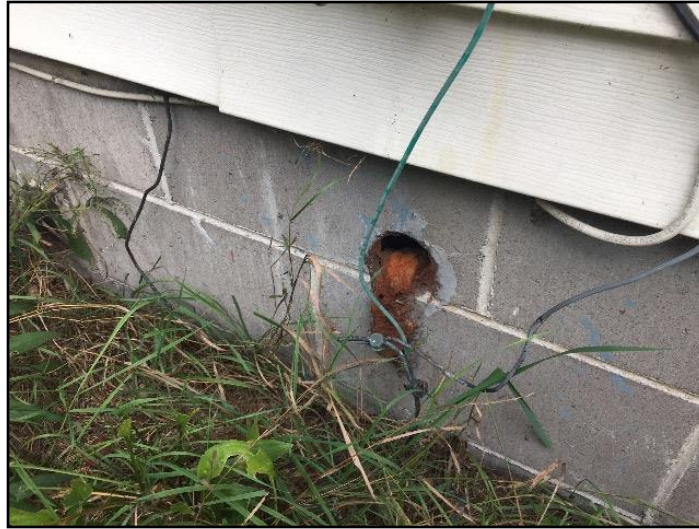
On the day of the inspection a hole was visible from the rear exterior of the house. Recommend filling to prevent water intrusion and insect intrusion.

Hole in block

Task: Repair

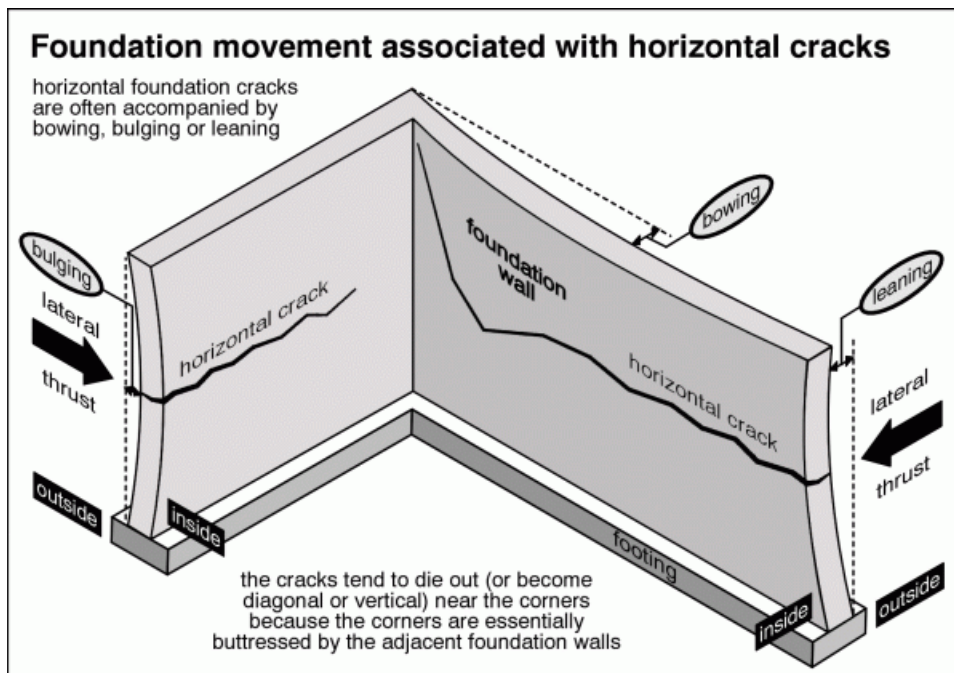
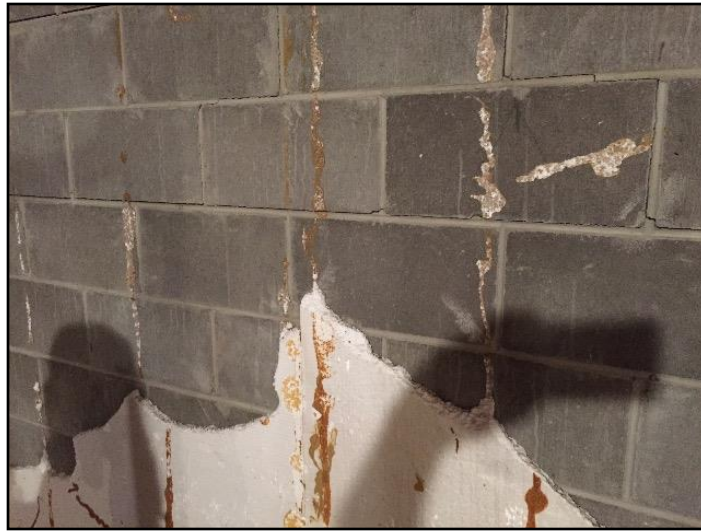
34. Condition: • [Bowed, bulging or leaning](#)

Implication(s): Chance of structural movement | Weakened structure

Bowed, bulging or leaning

Recommend further evaluation by a qualified contractor.

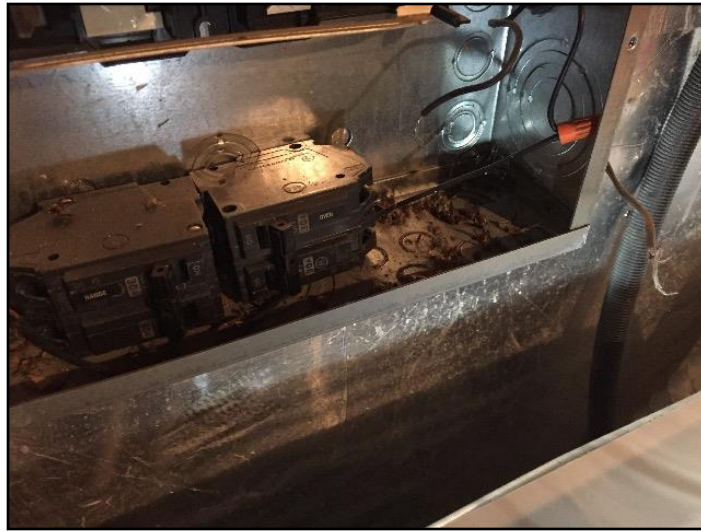
42. Condition: • On the day of the inspection dead insects were visible at the bottom of the service box.

Dead insects in electrical service box.

Task: Clean

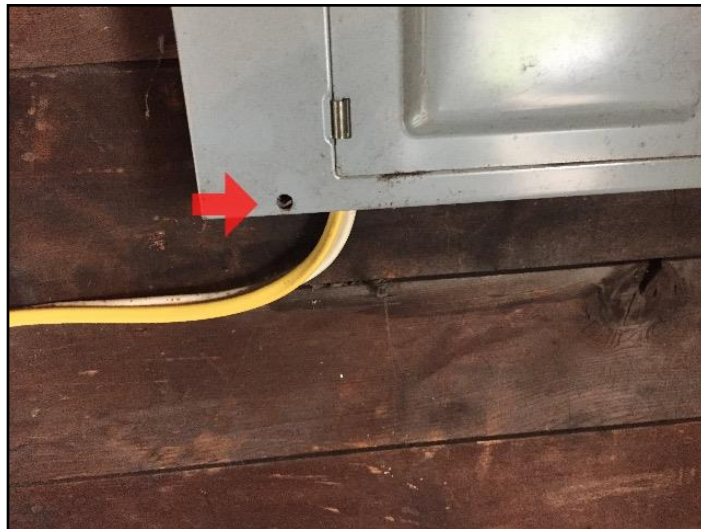
Missing screw

43. Condition: • Recommend flat end screw be installed on the panel.

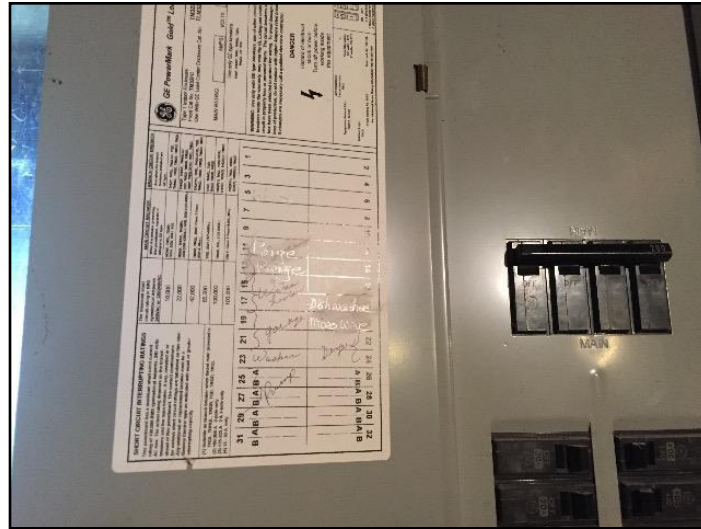
46. Condition: • [Circuits not labeled](#)

Circuits not labeled

Recommend updating the electrical ledger to include all circuits.

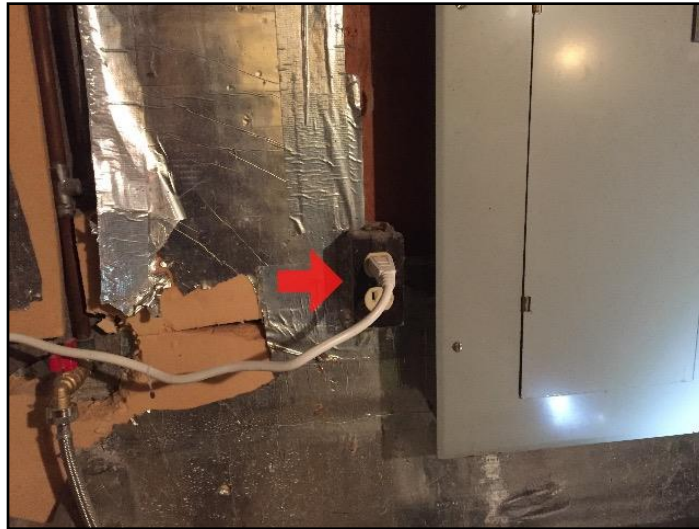
50. Condition: • [GFCI/GFI needed \(Ground Fault Circuit Interrupter\)](#)

GFCI/GFI needed (Ground Fault Circuit...

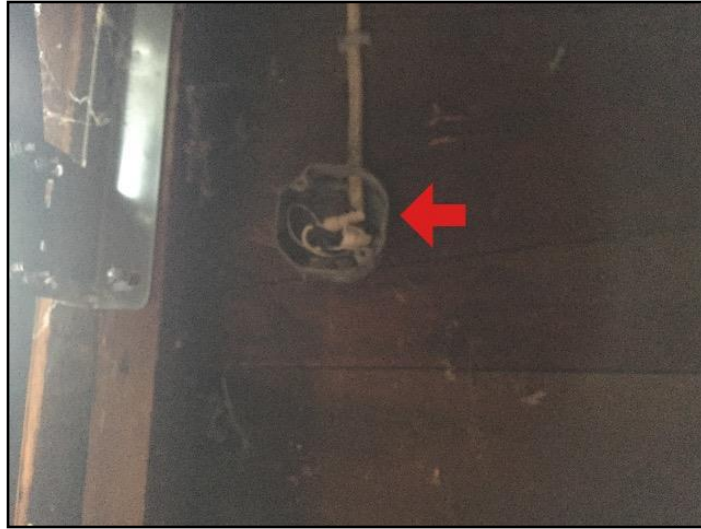
On the day of the inspection the cover plate on the exterior garage light was missing. Recommend repairing.

Missing cover plate

Task: Provide

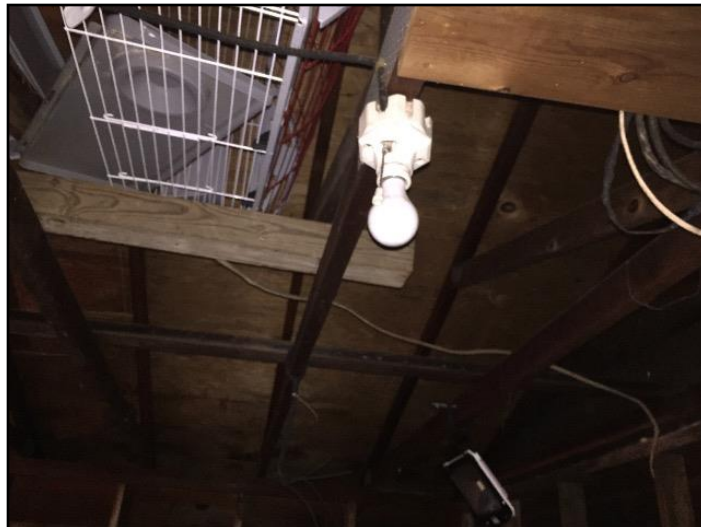
54. Condition: • [Inoperative](#)

Inoperative garage light.

Task: Repair or replace

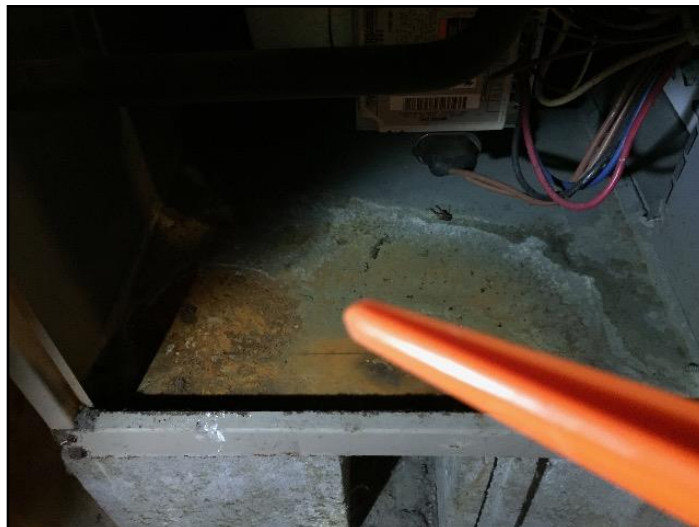
On the day of the inspection the hose connections inside the furnace cabinet had prior leaking issues causing rust. Recommend repairing the connections.

Rust in furnace cabinet

Task: Repair

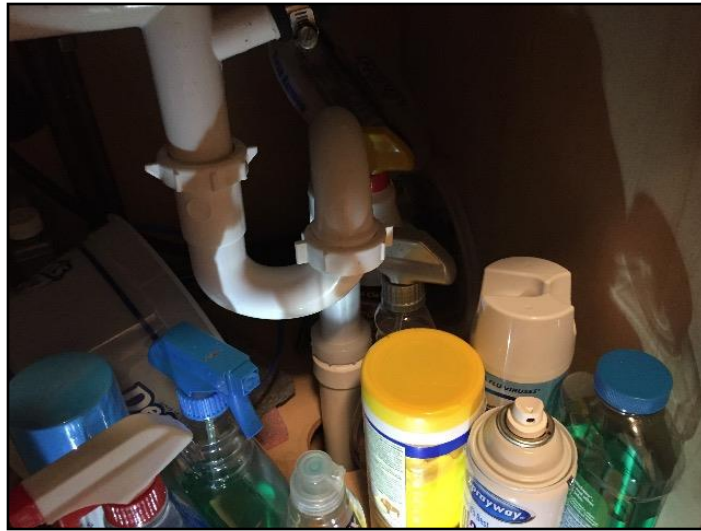
S-trap is visible at the kitchen sink. May cause the water to be siphoned out of the trap.

S-trap

Task: Monitor

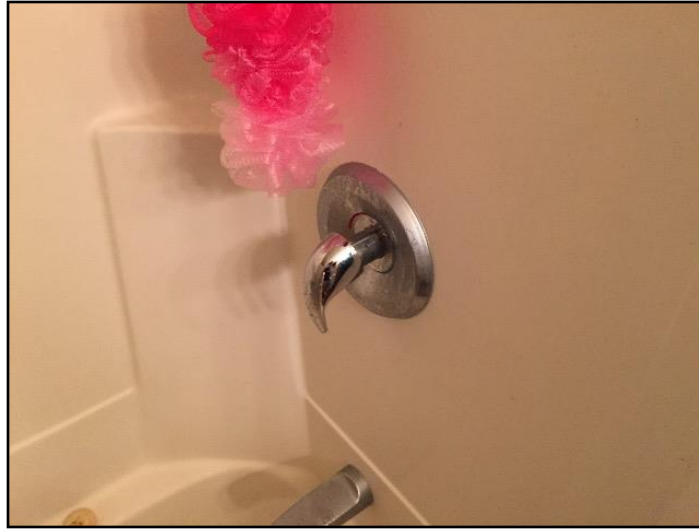
83. Condition: • [Loose](#)

Loose facet control

Task: Improve

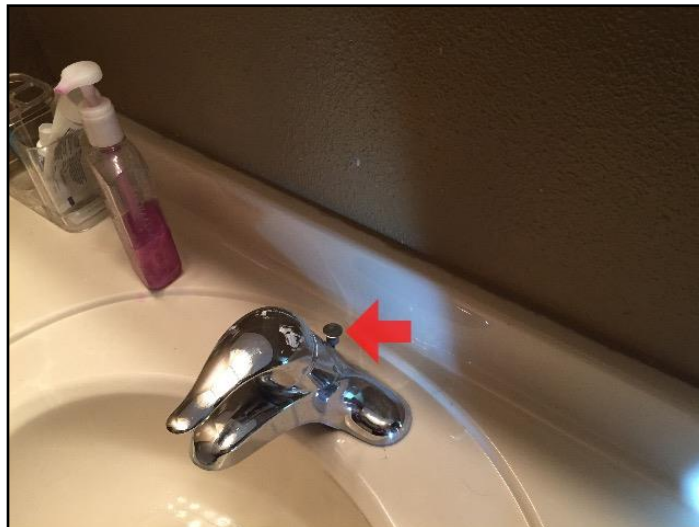
85. Condition: • Drain stop ineffective

Drain stop ineffective

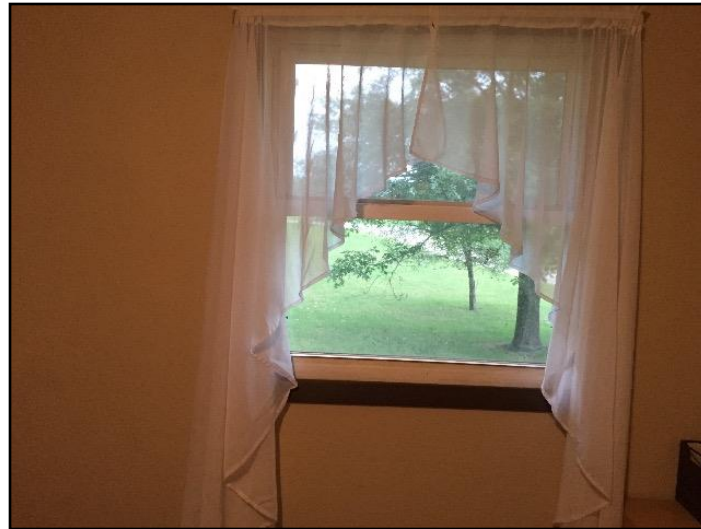
91. Condition: • Difficult to operate

Difficult to operate

Task: Improve
