# YOUR INSPECTION REPORT

FOR THE PROPERTY AT:  
106 Magwood Court  
Toronto, ON M6S 2M6

INSPECTION DATE:  
Tuesday, September 8, 2020

RE: Report No. 2734, v.4  
106 Magwood Court  
Toronto, ON  
M6S 2M6

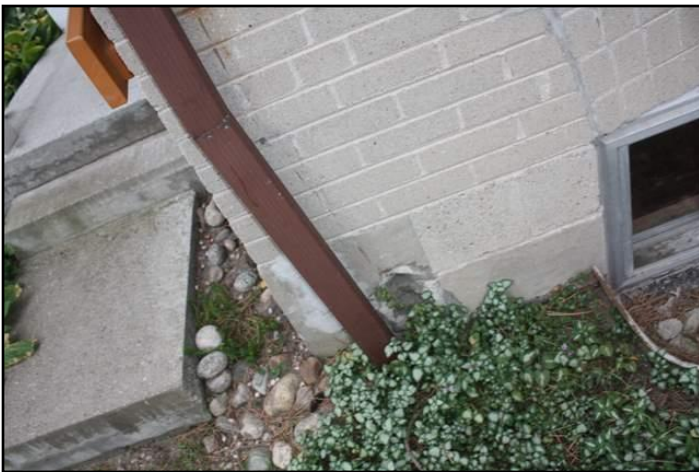
**Condition:** • Discharge below grade

**Implication(s):** Chance of water damage to contents, finishes and/or structure

1. Discharge below grade

**Task:** Improve

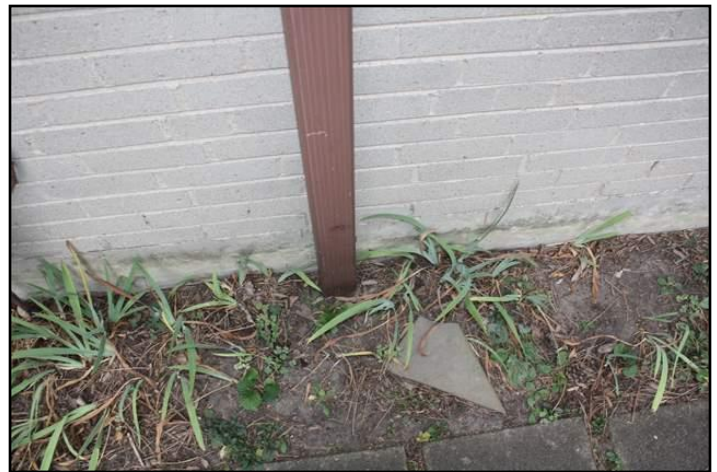
2. Discharge below grade

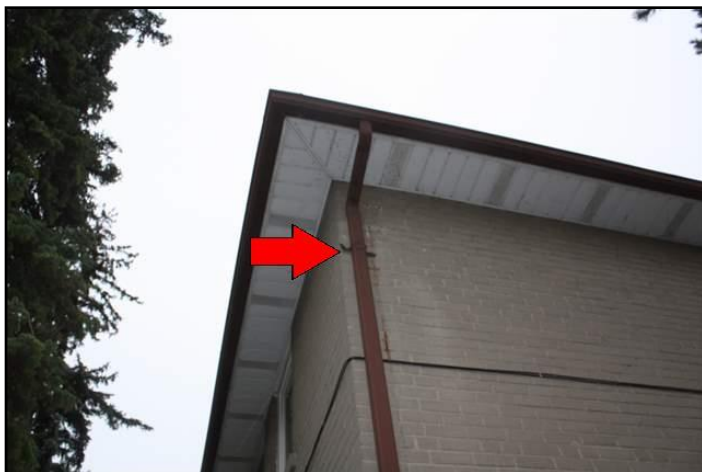
**Condition:** • [Not well secured](#)

Not attached to wall

**Implication(s):** Leakage

3. Not well secured

**Task:** Repair

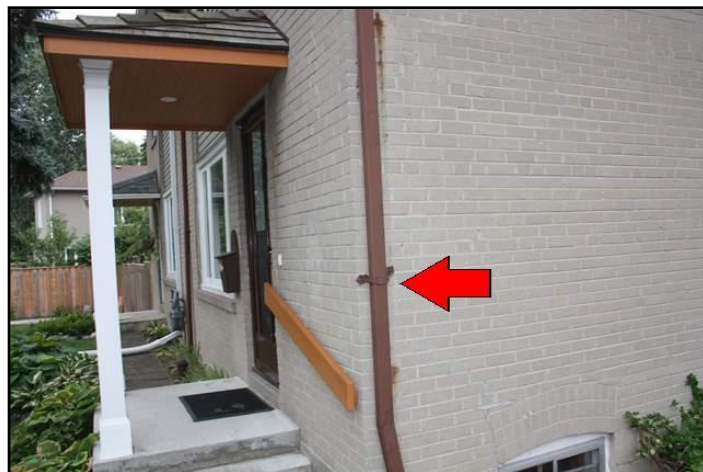
4. Not well secured

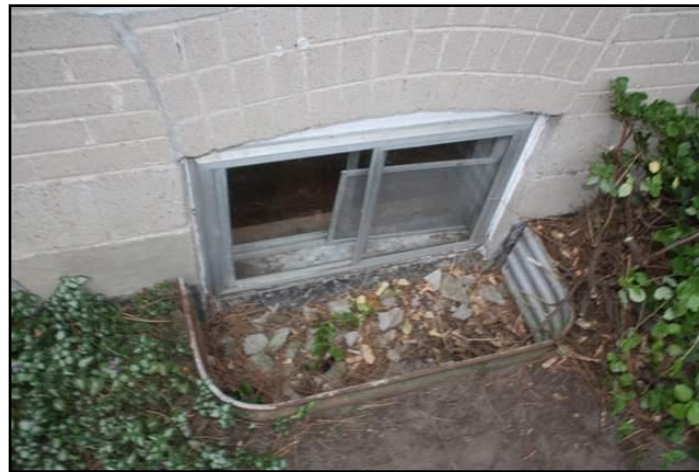
**Condition:** • [Less than 6 inches below window](#)

**Implication(s):** Chance of water entering building

5. Less than 6 inches below window

**Task:** Improve

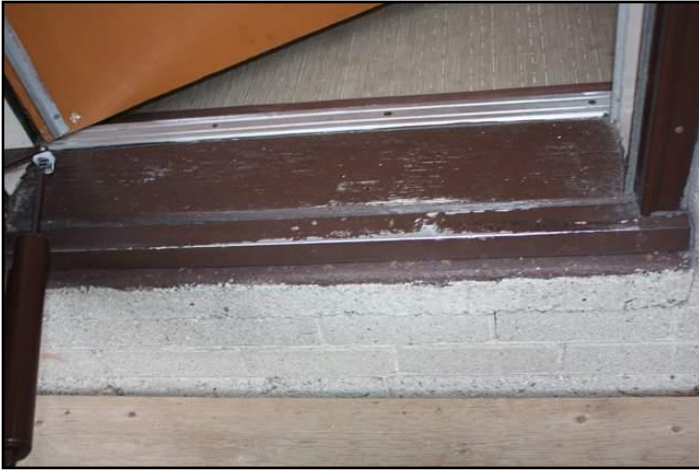
**Condition:** • [Sill deteriorated](#)

Also inadequate sill projection.

**Implication(s):** Chance of damage to finishes and structure

6. Inadequate sill projection

**Task:** Repair sill

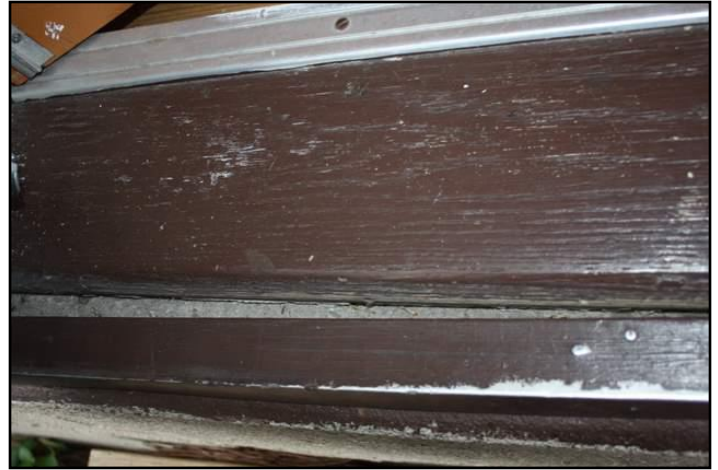
7. Sill damage

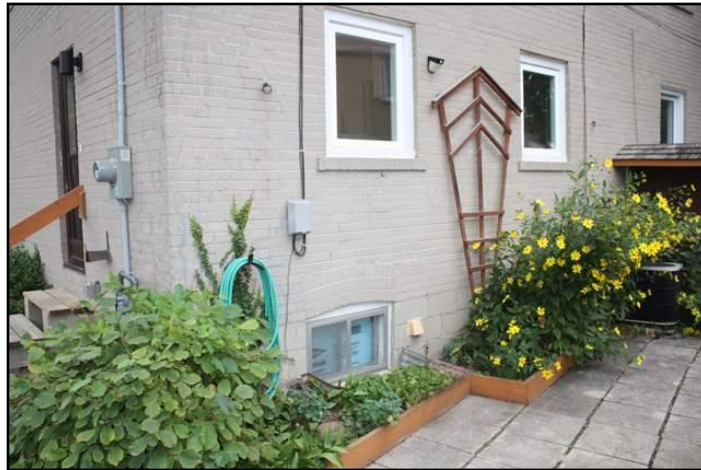
**Condition:** • [Planters and gardens against walls](#)

Planters around the home prevent good drainage away from the home.

**Implication(s):** Chance of water entering building | Chance of damage to structure | Chance of structural movement

8. Planters and gardens against walls

**Task:** Monitor / Improve

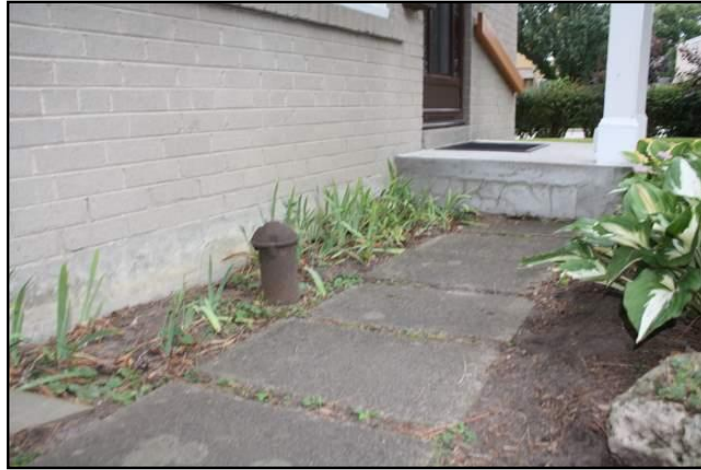
**Condition:** • Low Areas.

9. *example*

**Task:** Correct

**Condition:** • During rainfall, walk the exterior to view if any water is draining towards the home. Improve these areas as needed

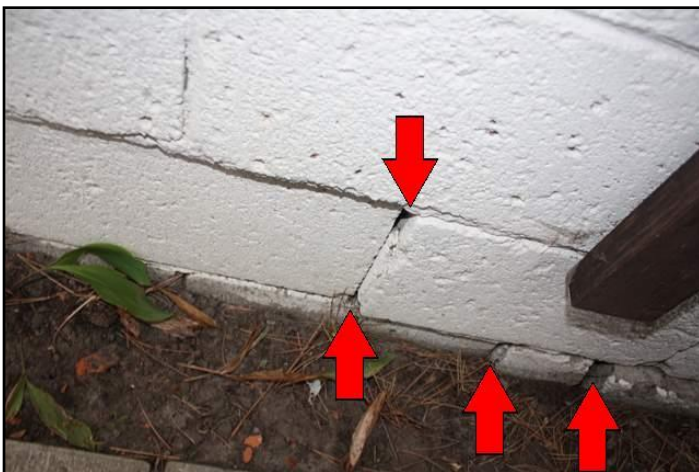
**Condition:** • [Typical minor settlement](#)

The garage floor slab at corner as spalled / cracked and garage wall at corner has moved/settled

10. Typical minor settlement

**Task:** Repair floor slab and wall. (Patch all gaps with masonry)

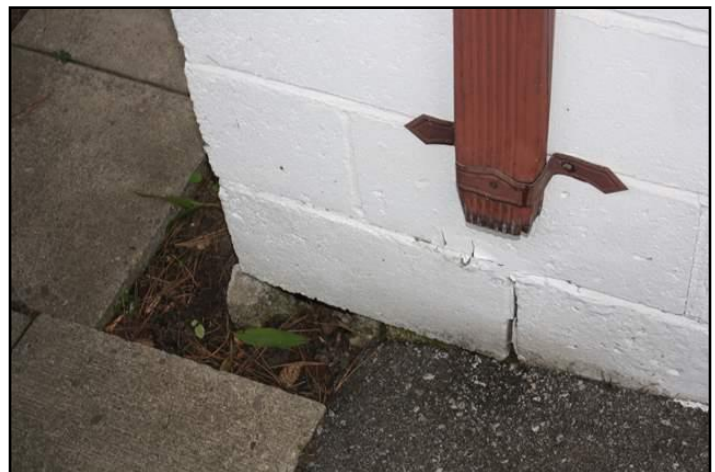
11. Typical minor settlement

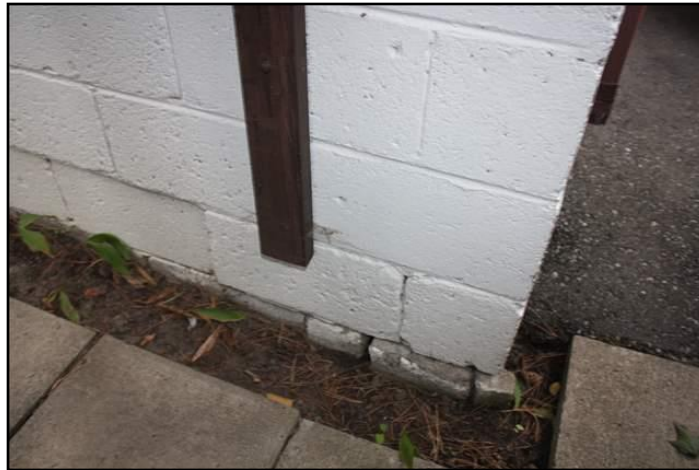
12. Typical minor settlement

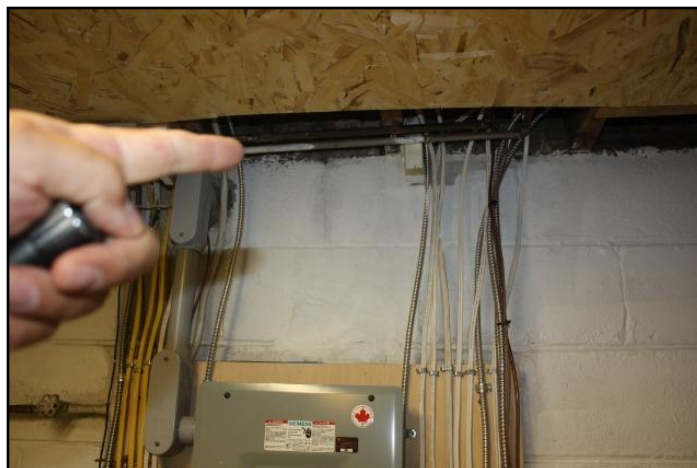
13.

**Condition:** • Supply plumbing piping over electrical panel.

The wiring was upgraded approximately 2 years ago. During the upgrade the panel was relocated to a location below supply plumbing. This is not ideal as there is a small risk of condensation or leakage from piping to panel.

**Task:** Reroute plumbing

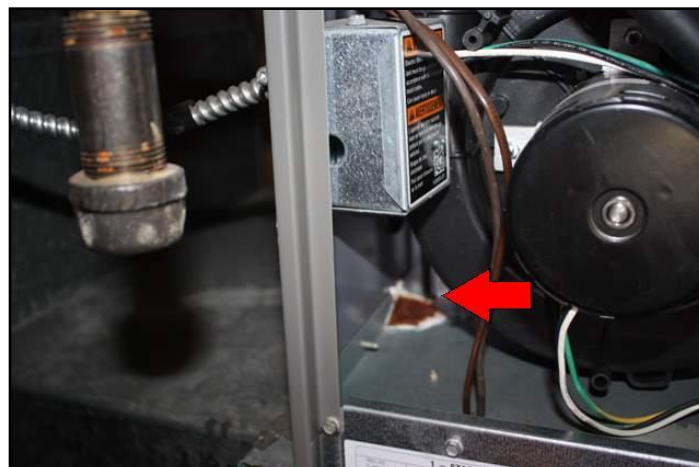
**Condition:** • [Rust](#)

Rust noted inside furnace cabinet. Prior minor condensate leak. Unknown if still active or intermittent. Was dry at time of inspection

**Implication(s):** Material deterioration | Reduced system life expectancy

14. Rust

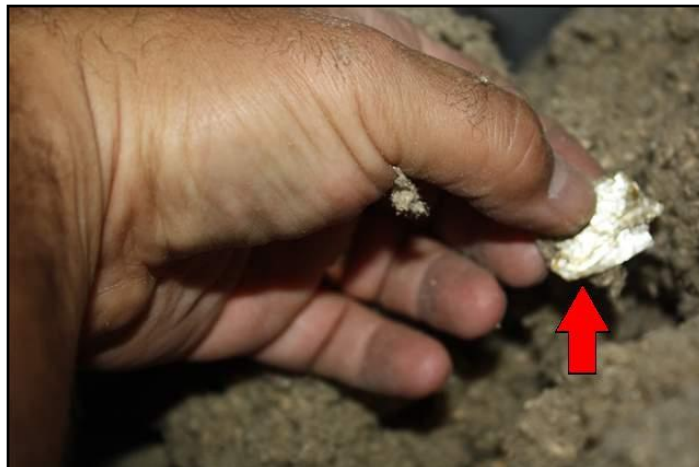
**Condition:** • [Possible Zonolite](#)

Vermiculite insulation was found in the attic (below the cellulose fiber). This type of insulation often contains some asbestos, which can be confirmed with proper laboratory testing. Health Canada's position is that vermiculite insulation is best left in place, and health precautions should be taken if working in the attic or disturbing the insulation. More information can be found on Health Canada's website at

15. Vermiculite - Possible Zonolite

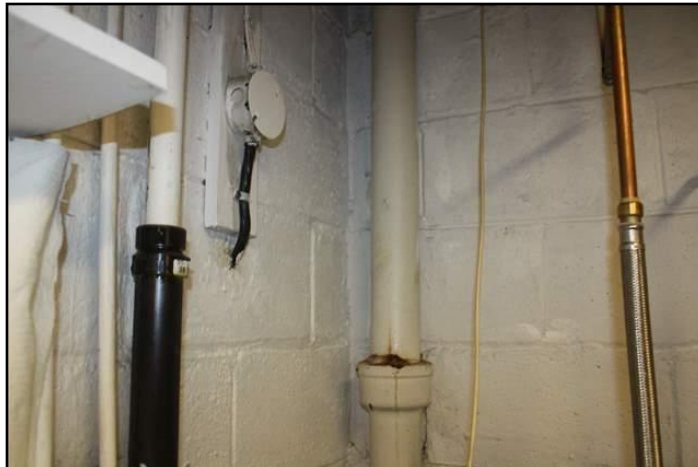
**Condition:** • The cast iron waste piping is near the end of its normal life expectancy and is prone to rusting through or splitting. Replacement may be required in the near future.

17. Cast Iron Life Expectancy

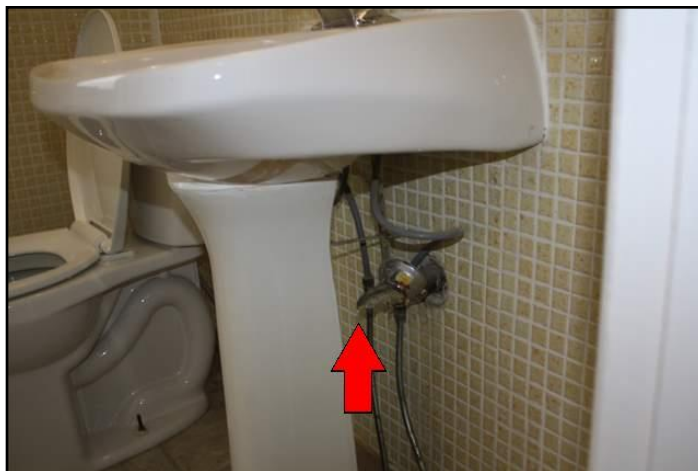
**Condition:** • [Missing](#)

Replacement in progress

18. Missing

**Task:** Seller is having repaired

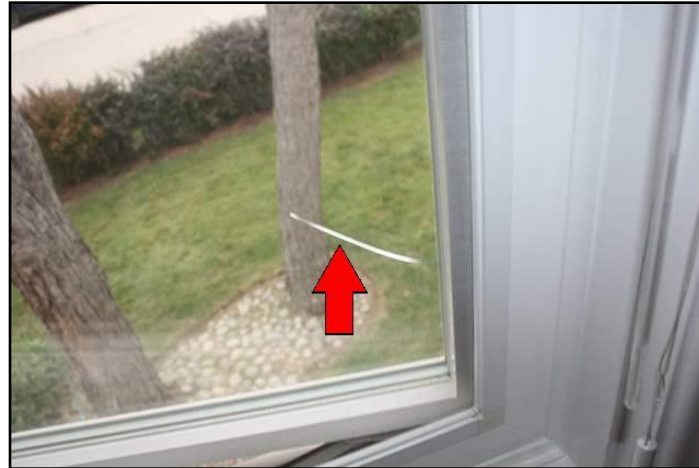
**Condition:** • [Cracked](#)

19. Cracked

**Task:** Replace

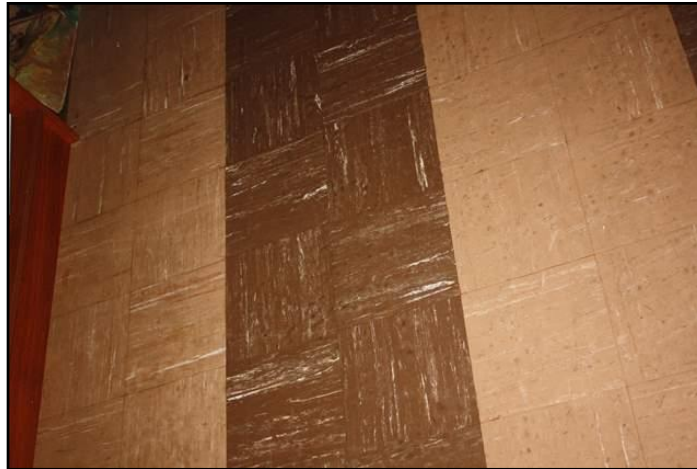
**Condition:** • Possible asbestos containing materials

Old 9"x 9" resilient floor tiles or the mastic glue often contain some asbestos. This type of floor tile is commonly found in older homes. Further evaluation is recommended before removing/disturbing these tiles. According to Health Canada, there are no significant health risks if materials containing asbestos in your home are: tightly bound in products and are in good condition sealed behind walls or floorboards isolated and left undisturbed. More information can be found

**Implication(s):** Health hazard

20. Possible asbestos containing materials

**Task:** Test before disturbing/removing
