INSPECTION REPORT

For the Property at:
5756 GREENSBORO DRIVE
MISSISSAUGA, ON L5M 5T8

Prepared for: ANDREW NICHOLSON HEATHER SHAW
Inspection Date: Tuesday, June 4, 2024
Prepared by: Michael Tita

Elite Team Home Inspections
2325 Hurontario Street, Suite 322
Mississauga, ON L5A 4K4
416-453-4192

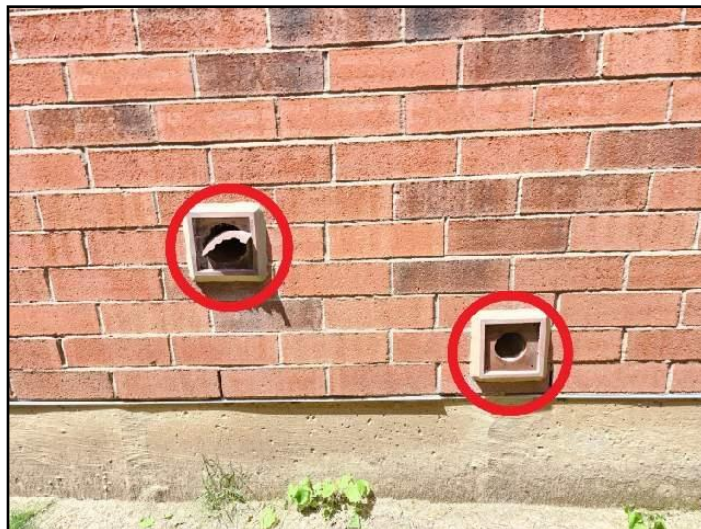
- 1. Condition:** • Vent covers missing, loose or damaged
- Task:** Replace, repair
- Time:** Unpredictable - Immediate
- Cost:** Very Minor

4. Vent covers missing, loose or damaged

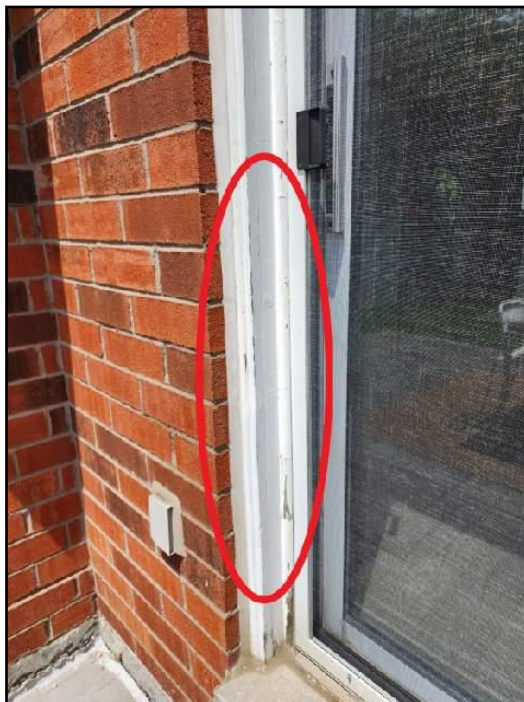
2. Condition: • Paint or stain - deteriorated / missing

Location: Rear sliding door

5. *Paint or stain - deteriorated / missing*

Task: Reseal

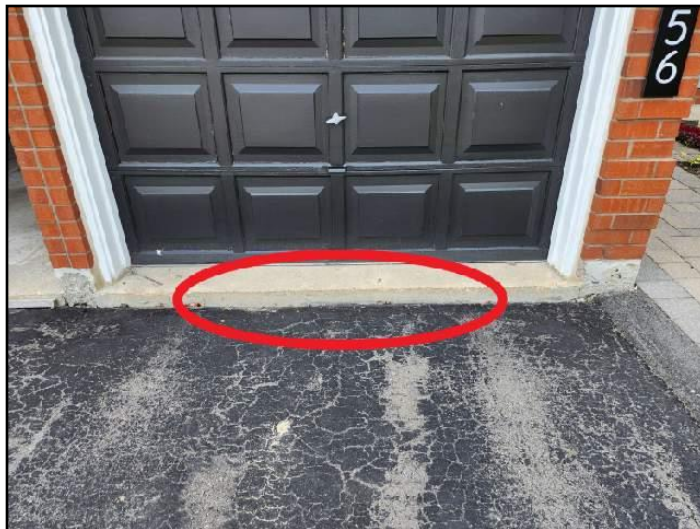
3. Condition: • Driveway dropped/ settled at garage entry (trip hazard)

Also more difficult too drive vehicles into garage

Location: Garage entry area

6. Driveway dropped/ settled at garage entry...

Task: Repair - Adjust/ Correct

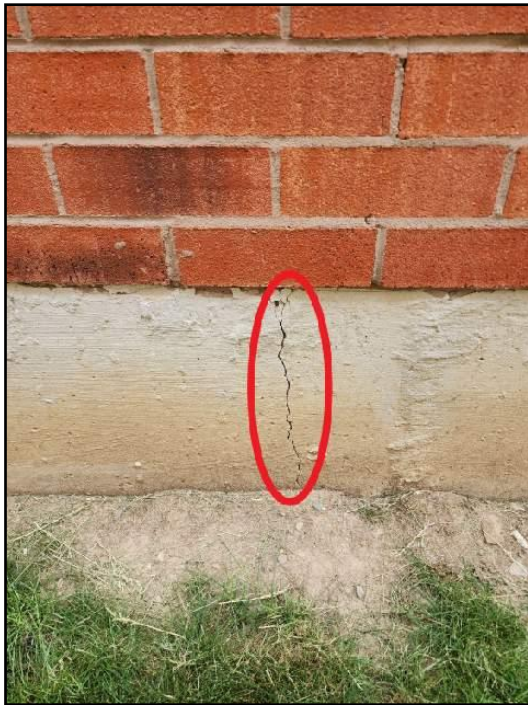
4. Condition: • Typical minor cracks

Location: Various

9. Typical minor cracks

Task: Monitor

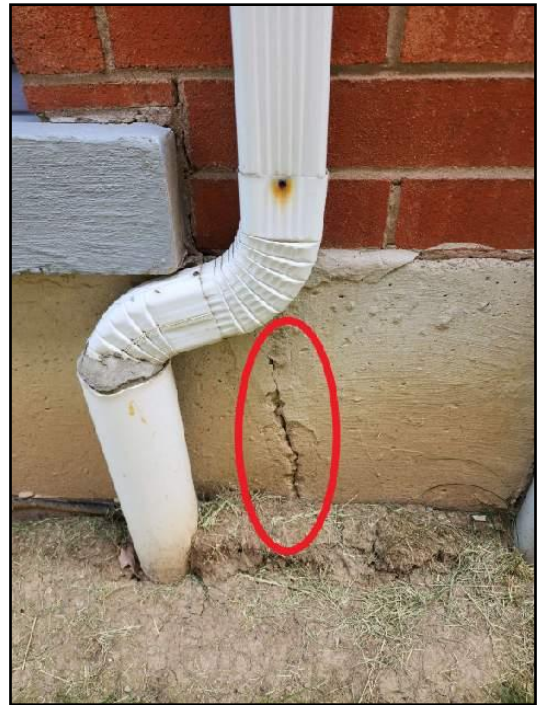
10. Typical minor cracks

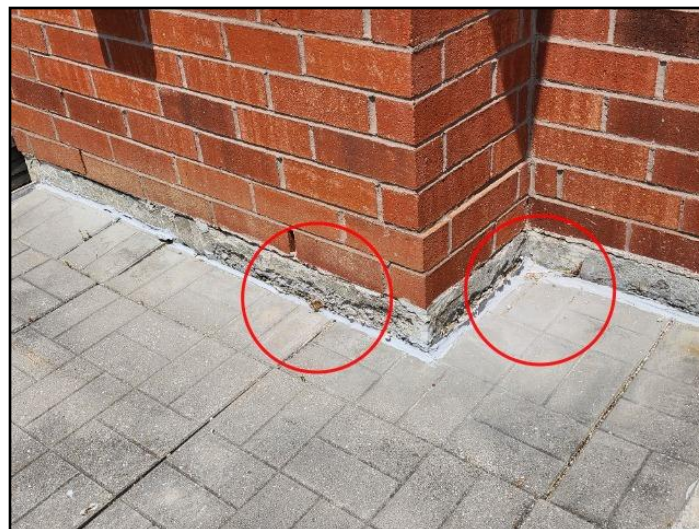
6. Condition: • [Spalling, crumbling or broken material](#)

The spalling concrete doesn't seem to be affecting the overall structural integrity of the home
(Comment above is based on just what is visible and no invasive or structural testing is part of the scope of this inspection)

Location: Rear wall
Task: Monitor
Time: Ongoing
Cost: Depends on work needed

11. Spalling, crumbling or broken material

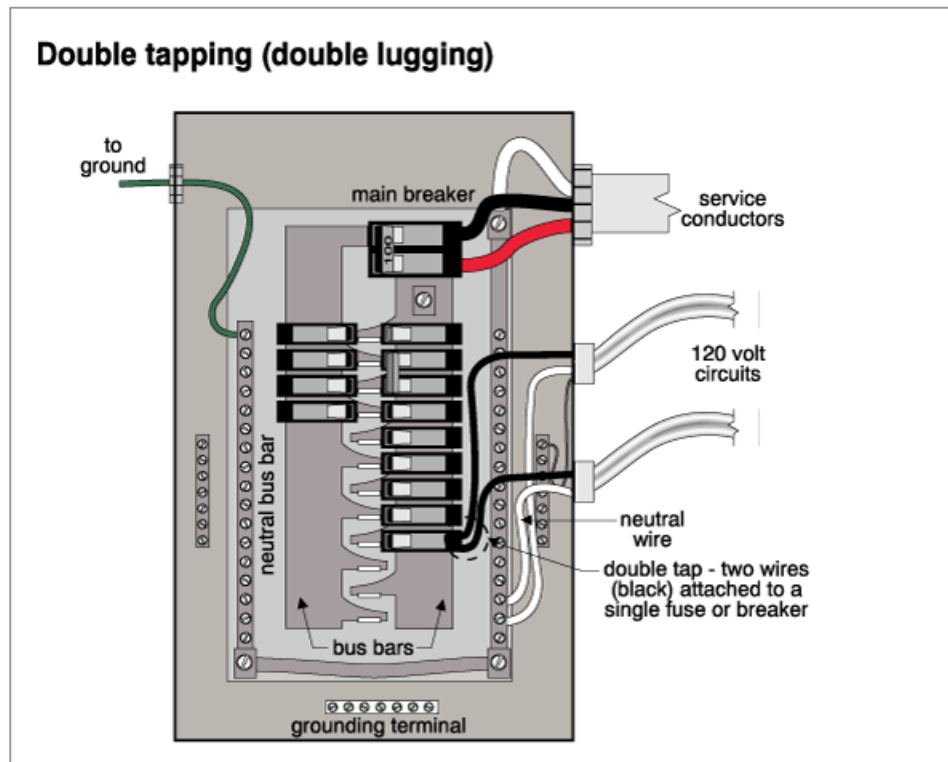
7. Condition: • [Double taps](#)

1 circuit(s) noted with this issue (panel plug)

Location: Inside the panel

Task: Repair

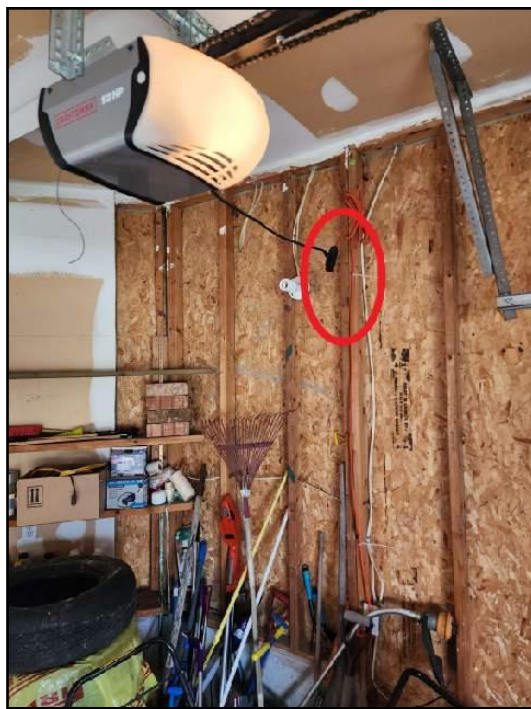
9. Condition: • Extension cord for garage door operator (opener)

Location: Garage

13. Extension cord for garage door operator...

Task: Install / Add New (as needed)

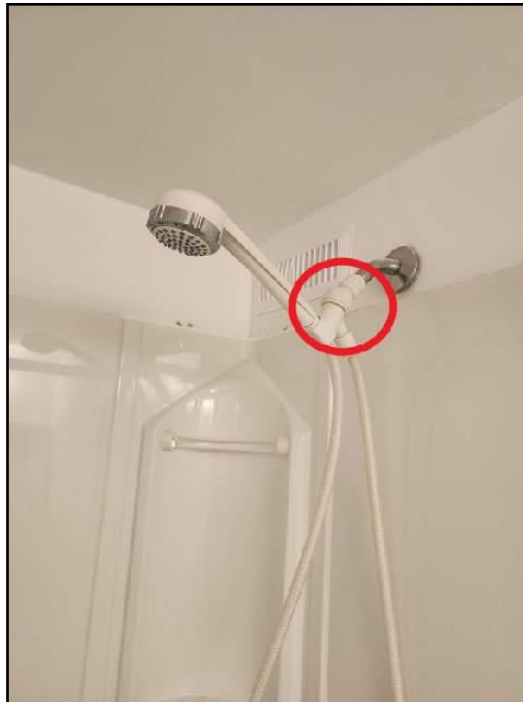
13. Condition: • [Drip, leak](#)

Poor connection of showerhead and leaks only when in use

Location: Basement washroom showerhead

20. *Drip, leak*

Task: Repair or replace

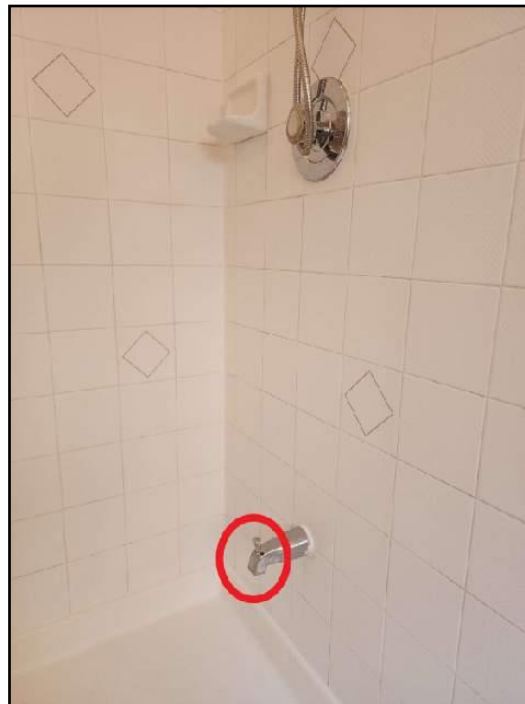
14. Condition: • [Shower diverter inoperative or defective](#)

Diverter lever ceased, lubricate & work free to adjust it again

Location: 2nd floor primary washroom shower spout

21. Shower diverter inoperative or defective

Task: Repair/ lubricate

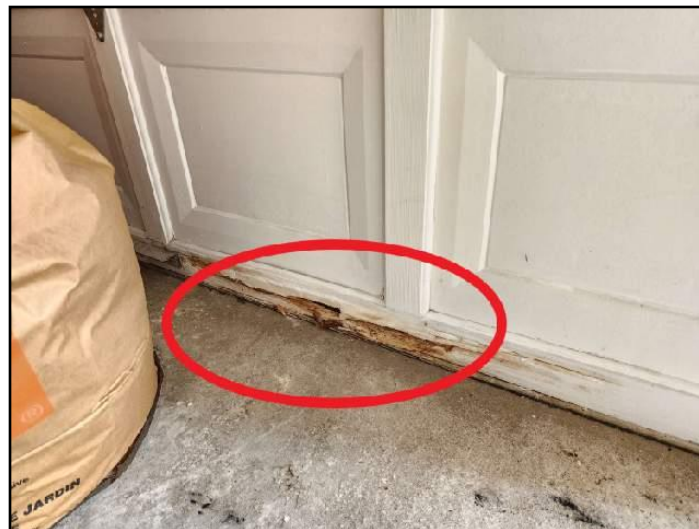
- 17. Condition:** • Deterioration, rot or rust
- Location:** Only visible from inside the garage
- Task:** Repair
- Time:** Unpredictable
- Cost:** Regular maintenance item - Depends on approach

27. Deterioration, rot or rust
