# INSPECTION REPORT

For the Property at:  
**6266 SKY-VIEW DRIVE**  
PARK CITY, UT 84098

Prepared for: SAMPLE REPORT  
Inspection Date: Wednesday, September 21, 2016  
Prepared by: Mathew Stouffer

RE: Report No. 6398, v.5  
6266 Sky-View Drive  
Park City, UT  
84098

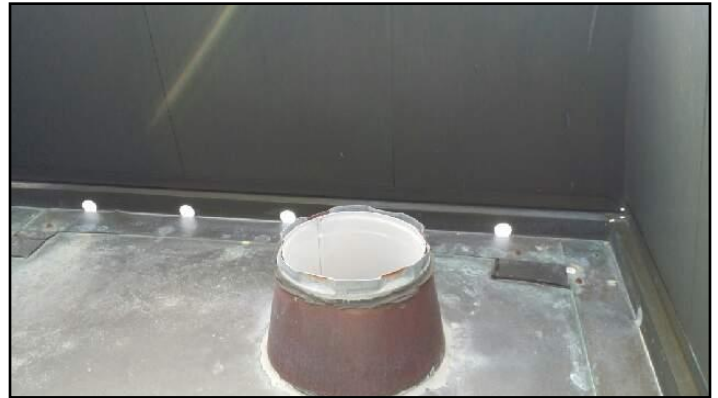
1. • The weather cap is missing on the west vent termination, spark arrestors are missing on the three flue terminations within the south chimney shroud and the termination in the southwest chimney, and various stones around all three chimneys are detaching from the chimneys. Furthermore, copper flashing around the southwest and west chimneys is poorly installed, there are gaps around the flashings, and the flashings have been faced nailed. Repair is recommended.

Gaps

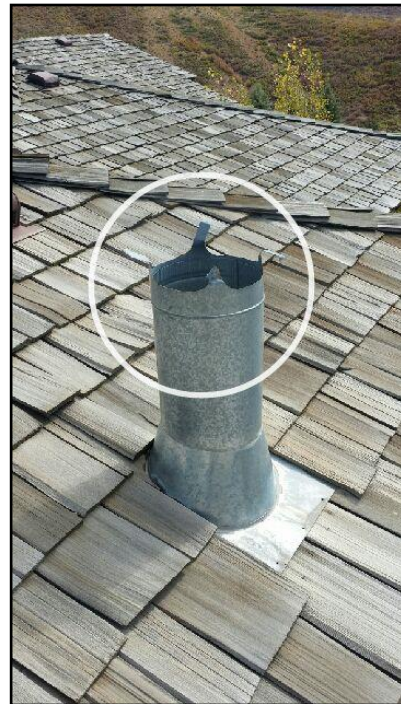
*Gap*

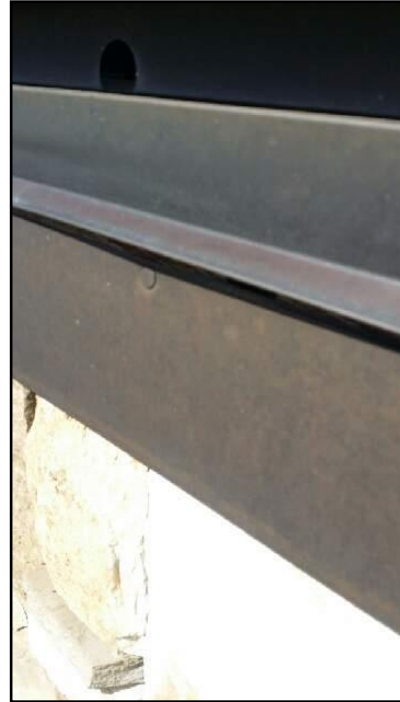
Gap

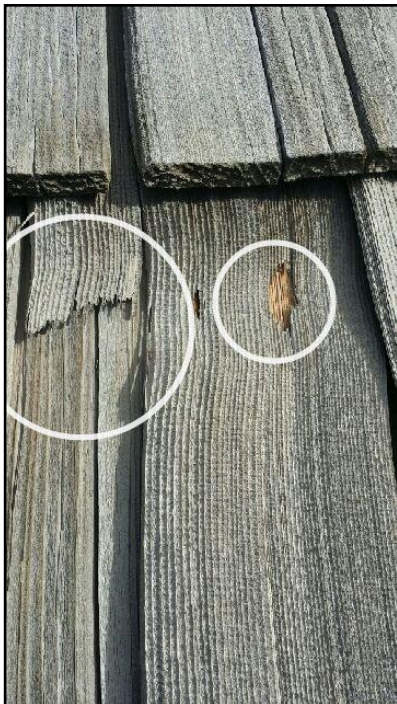
The home is equipped with a wood shake roof. According to industry standards and averages, wood shake roofing typically has a 15 to 22 year life span in this area. Loose shakes, damaged shakes, splitting and UV burn through are present on various aspects of the roof. Based on age, condition and average life expectancy for cedar shake roofing in this area, the roof is nearing the end of its useful life span. Additional evaluation by a roofing contractor is recommended to provide a bid for maintenance, remaining useful life, and replacement cost.

*Burn through*

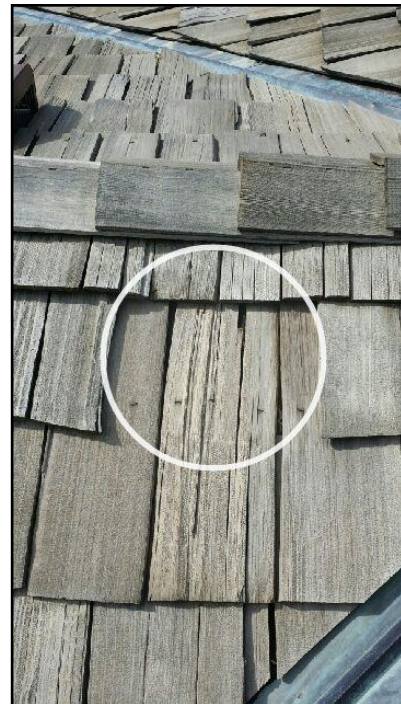
*Missing shakes*

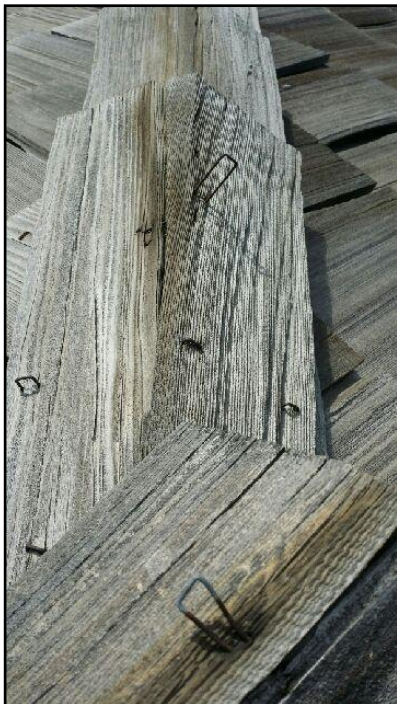
Loose staples

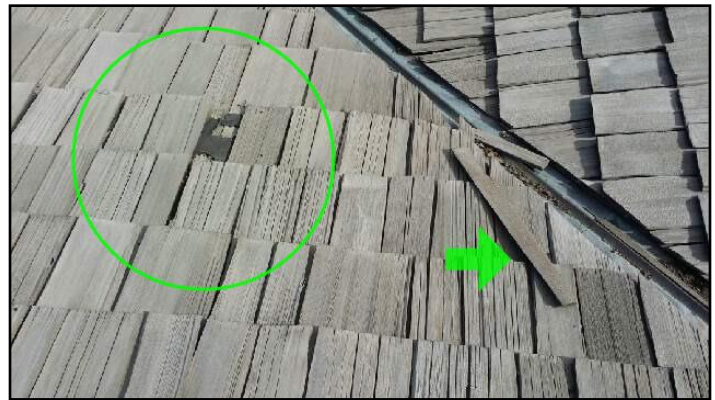
Missing shakes

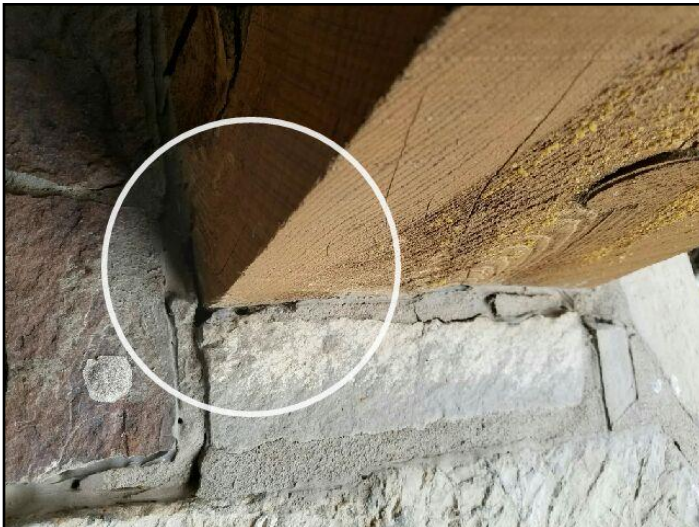
5. • Maintaining the seal around exterior timber columns at the penetration into the capstones is recommended, and sealing any checking within the columns is also recommended to prevent moisture penetrating the timber columns and masonry. Furthermore, capstones around several exterior timber columns are loose.

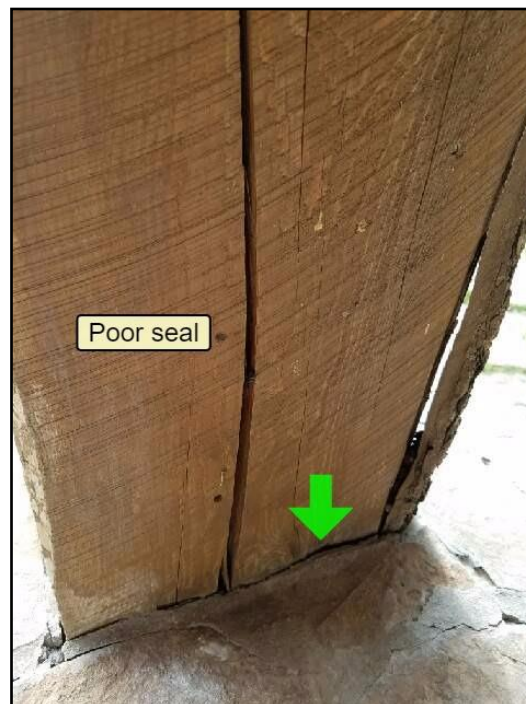
Checking

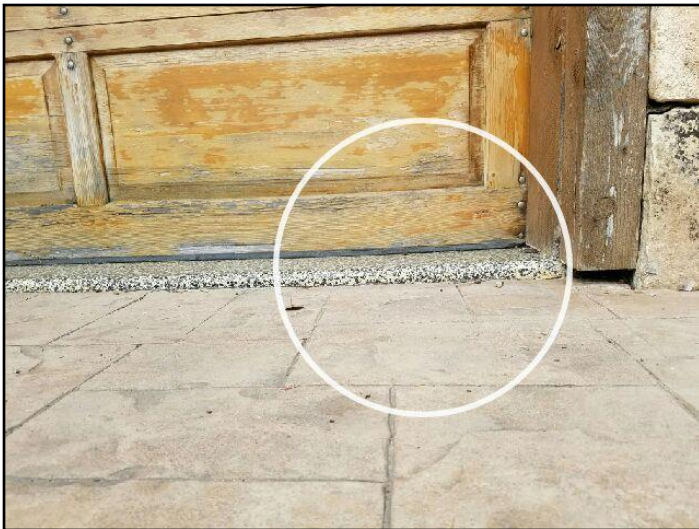
Roof lines drain onto the driveway, decks, and adjacent to exterior concrete surfaces which has resulted in settlement and cracking of the surfaces, deterioration of the sealed deck surface, trip hazards approaching the garage slabs, and will likely result in slip hazards during winter months. Installation of gutters is recommended; although, this is not required.

*Settlement/trip hazard*

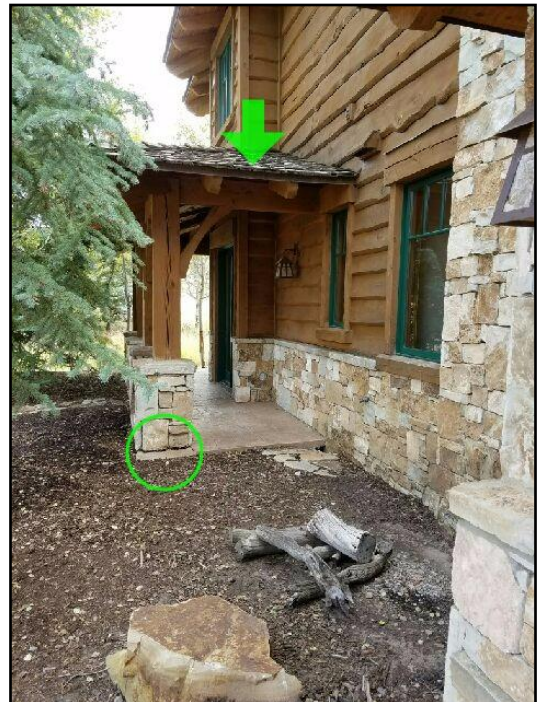
*Settlement*

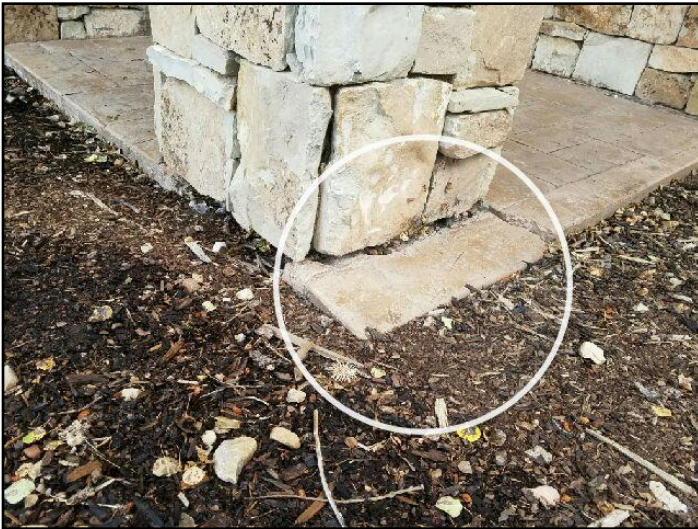
Cracked

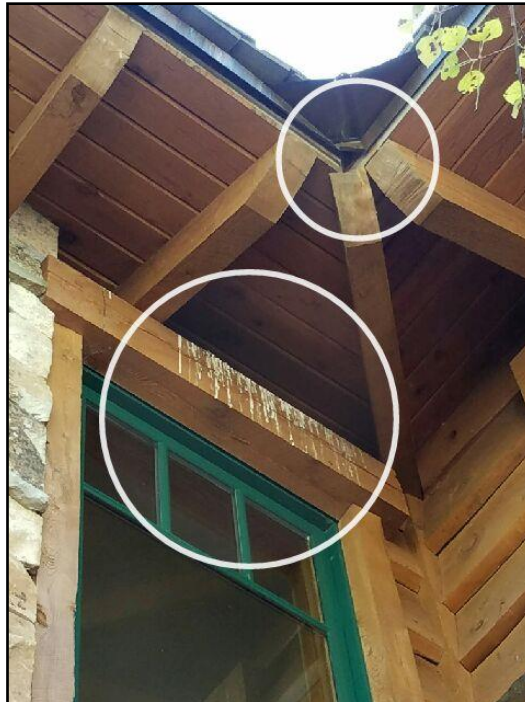
**7. Condition:** • Signs of bird activity is present in the soffit to the west of the entry porch, and an opening is present the corner of the soffit as well.

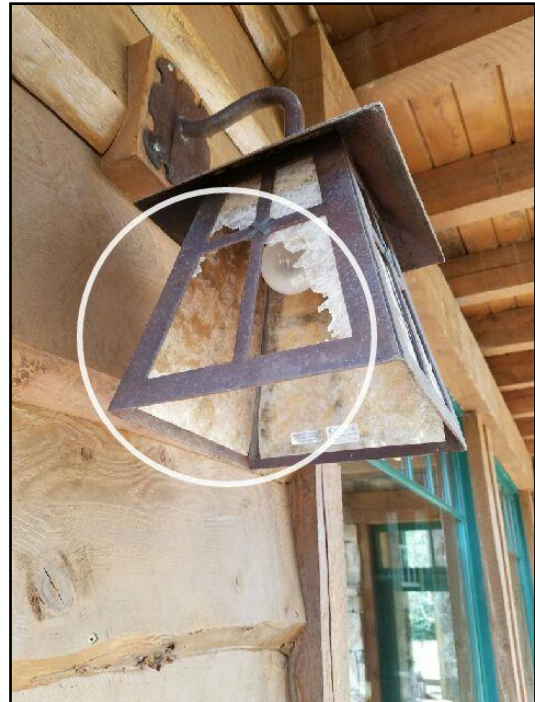
*Damaged*

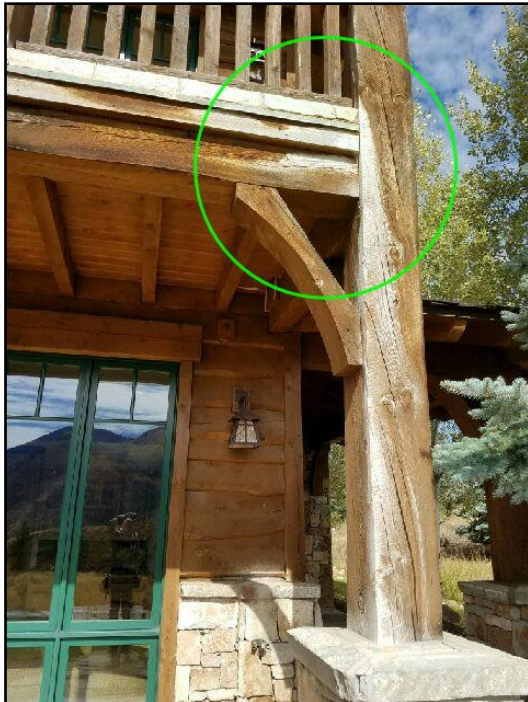
**9. Condition:** • Signs of moisture penetration are present beneath the deck floors. Moisture staining is also present along the perimeter of the decks and on the beams and columns. Dry rot is visible along the underside of the west deck floor. Evaluation of the decks by a licensed decking contractor is recommended to determine a course of action. A significant portion of the water penetration is likely due to cracking in the concrete decking and gaps between the concrete floor, walls, and around newel posts. All of the deck guardrails need to be refinished as well, and checking in the horizontal rails and vertical newel posts need to be sealed.

*Staining*

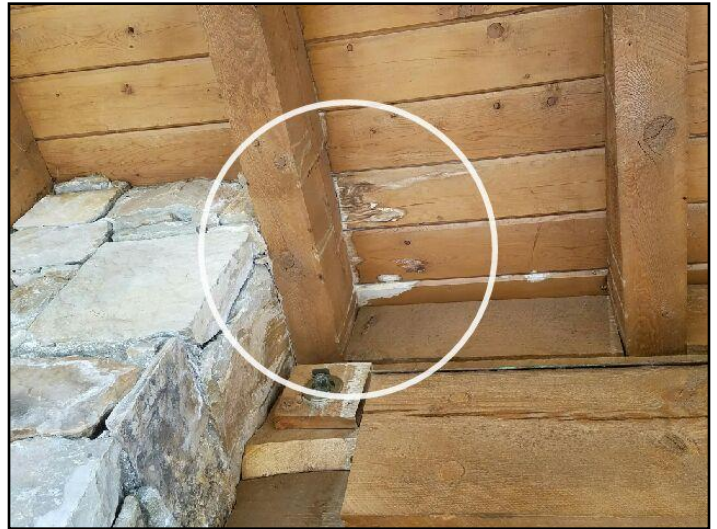
*Staining*

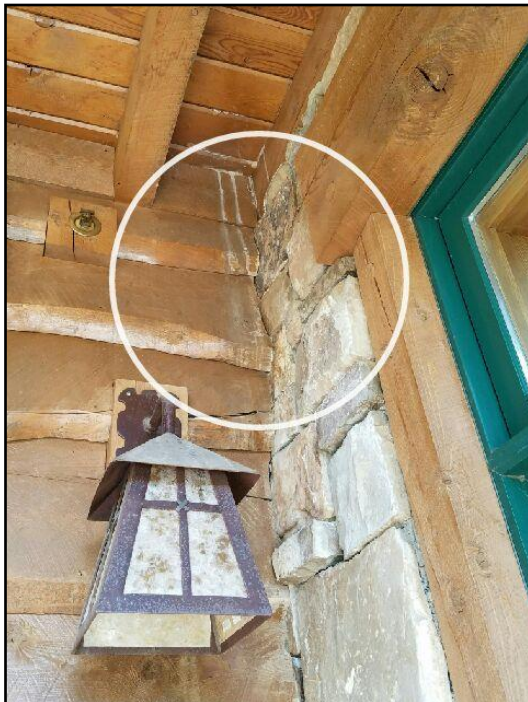
*Signs of previous leakage*

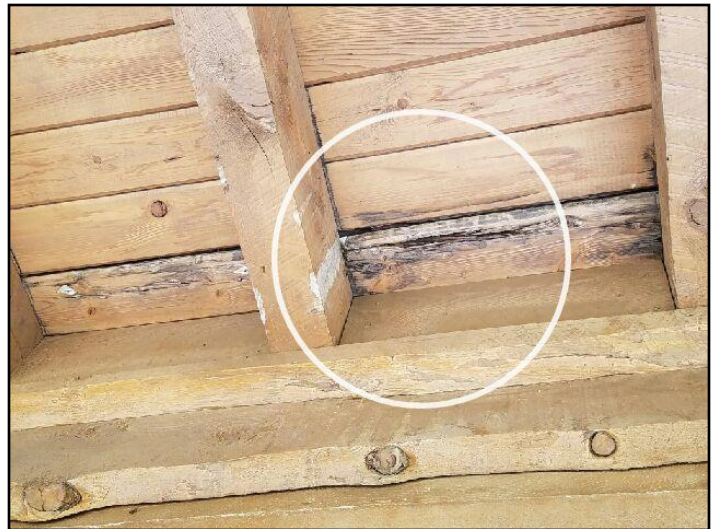
*Dry rot*

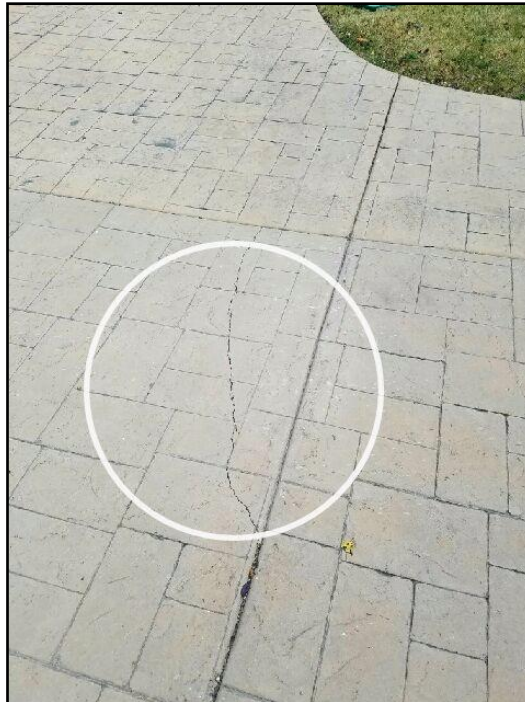
**10. Condition:** • Cracking, typically associated with concrete settlement, is present in the driveway surface.

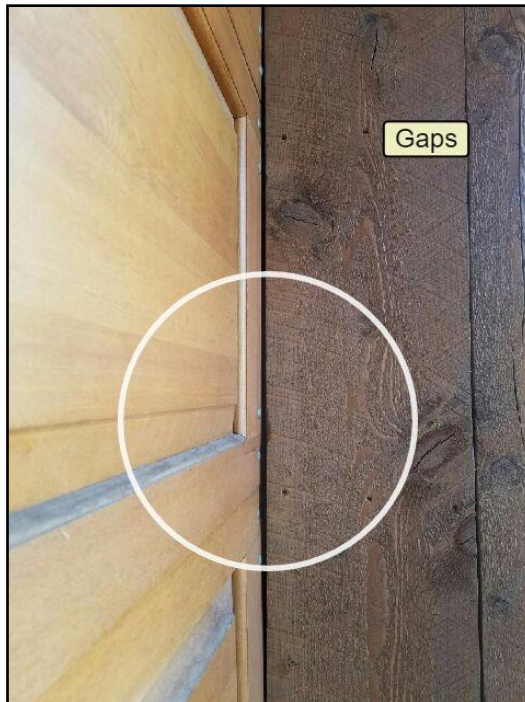
**11. Condition:** • Small gaps are present around the garage door/doors. This is minor.

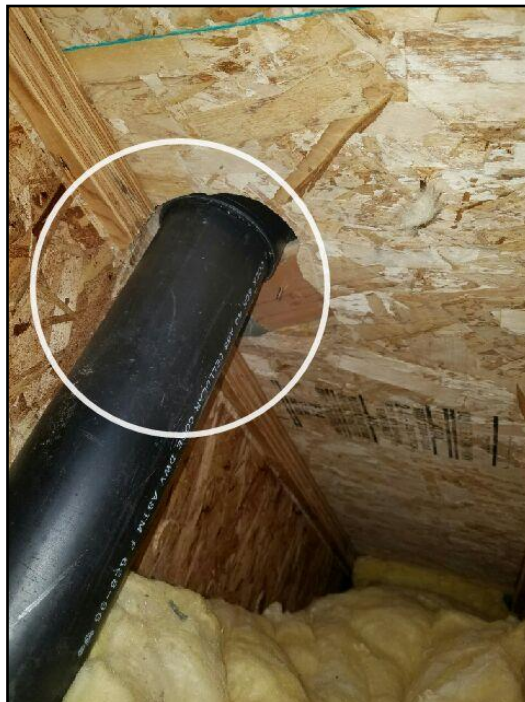
**12. Condition:** • A manufactured joist in the northeast crawl space has been cut. Cutting the top or bottom chord of a manufactured joist is not recommended. Repair is recommended.

*Notched*

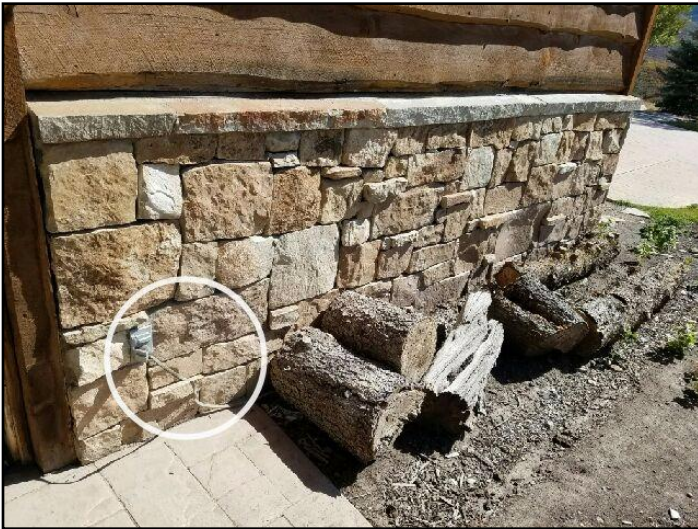
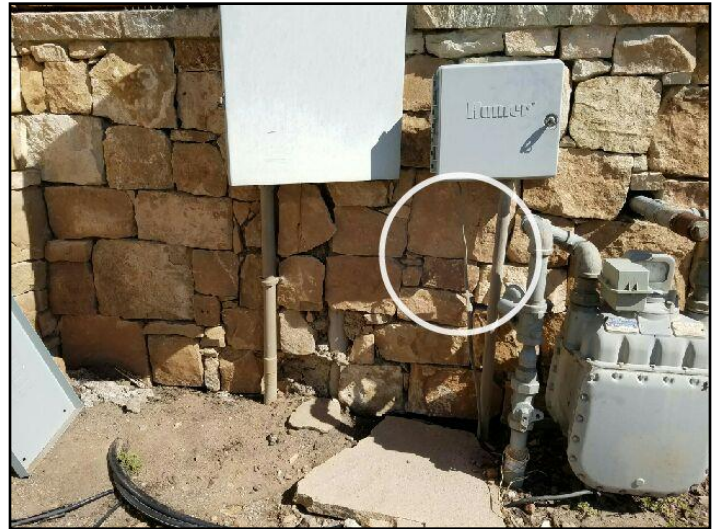
**14. Condition:** • Modified Romex electrical cable is utilized as an extension cord for the irrigation timer along the west exterior wall and the Romex is susceptible to mechanical damage. Installation of a factory power cord is recommended for the timer.

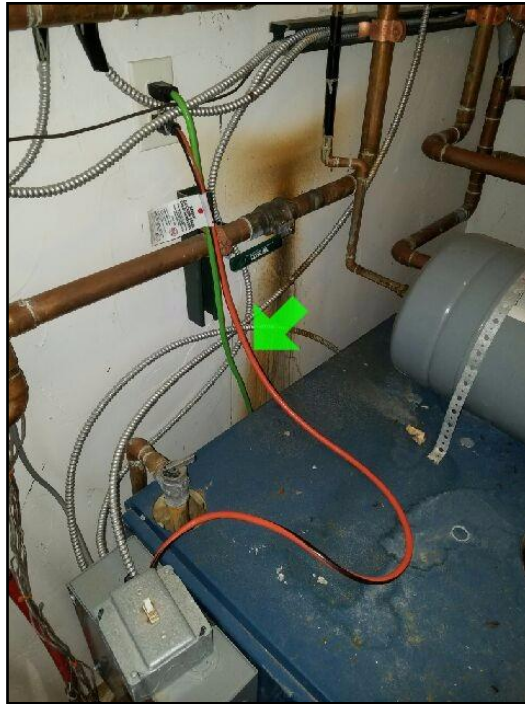
16. • Modified extension cords are utilized for the boiler and boiler circulation pump. Installation of factory power cords is recommended.

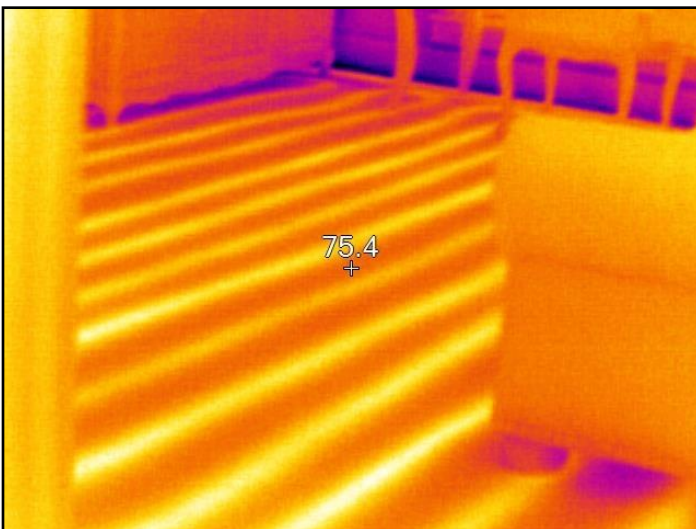
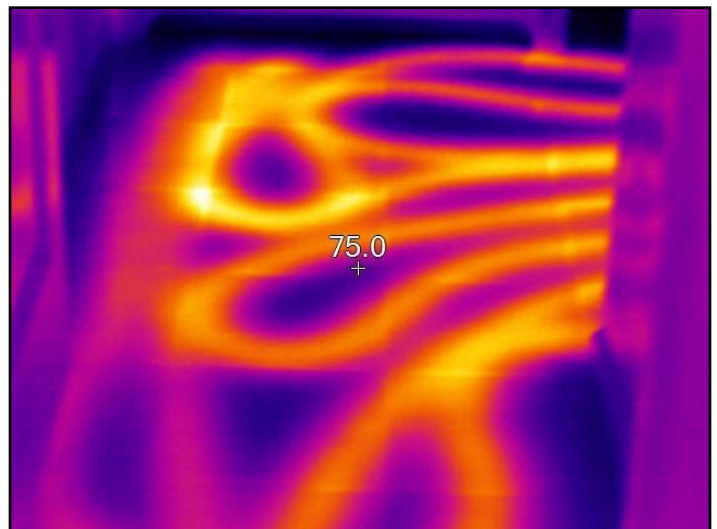
17. • Annual service of radiant heating systems/boilers is recommended. Determine the last date of service and service accordingly. During inspection, in-floor radiant heating was functional and each zone responded to the corresponding thermostat, with the exception of the zone in the foyer/living room. Service and repair is needed.

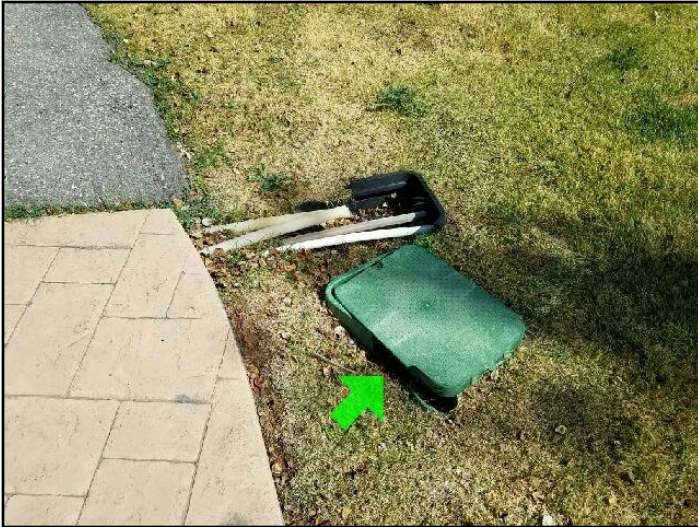
19. • Radiant heat tubing for an exterior snowmelt system appears to be present in the driveway; although, the system is incomplete. The radiant heat manifold along the east aspect of the lower driveway is damaged.

*Damaged*

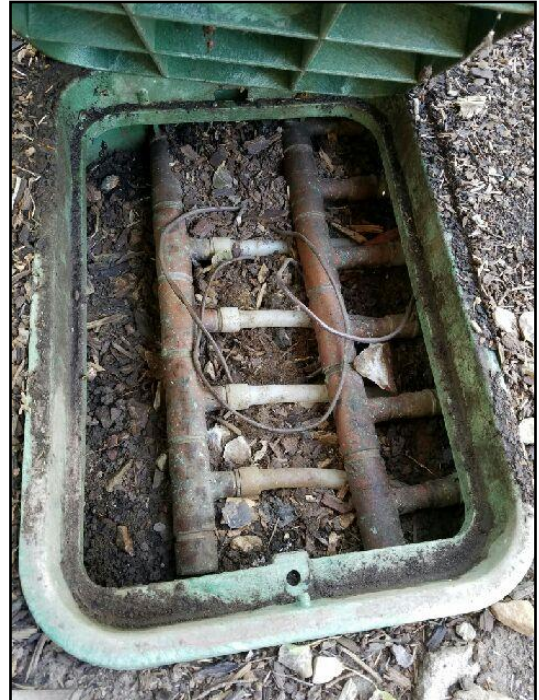
*Radiant heat tubing*

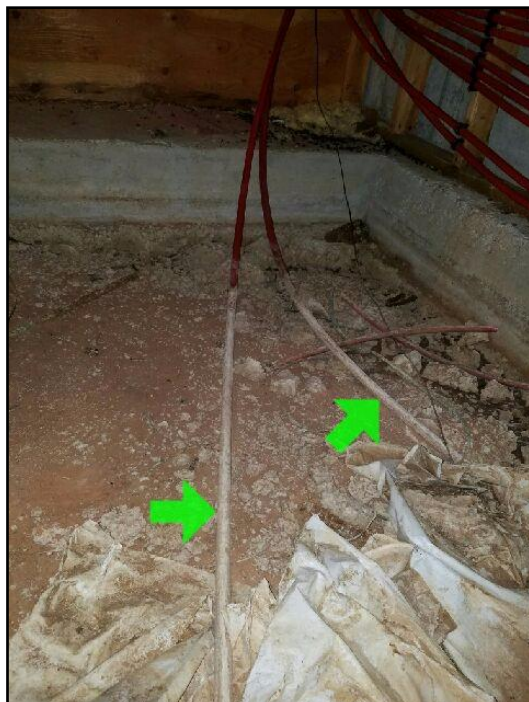
Various radiant heat piping and water lines are loose in the crawlspace and need to be properly secured, and corrosion is present on a manifold in the central crawlspace.

Loose

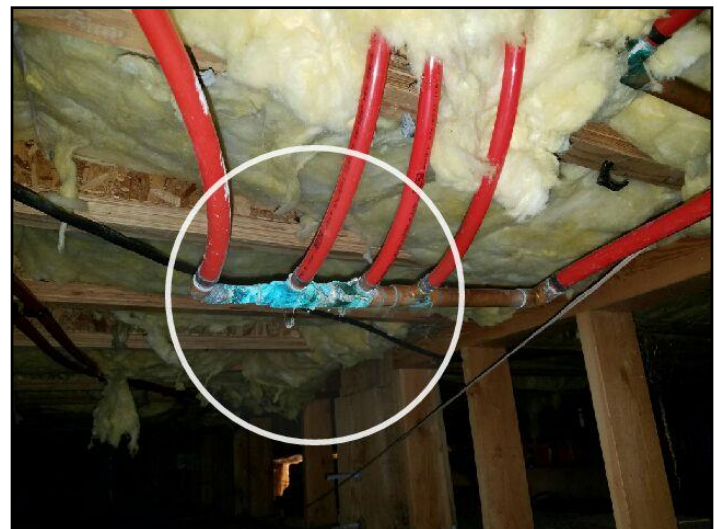
Corrosion/loose

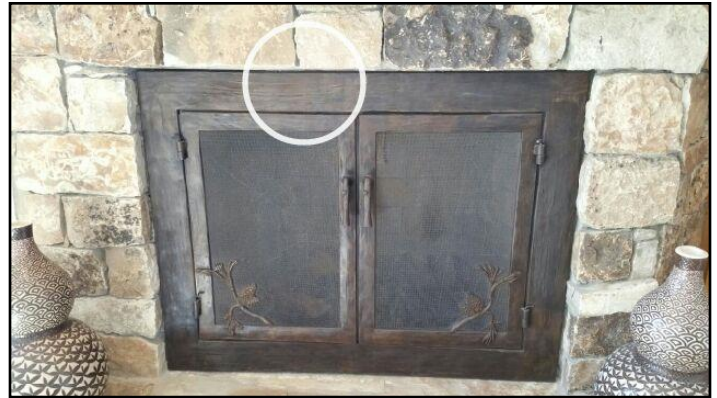
There are combustible materials present within the fireplace of the master bedroom. Repair is needed. Strand board is not intended to be present within the firebox of a wood burning fireplace.

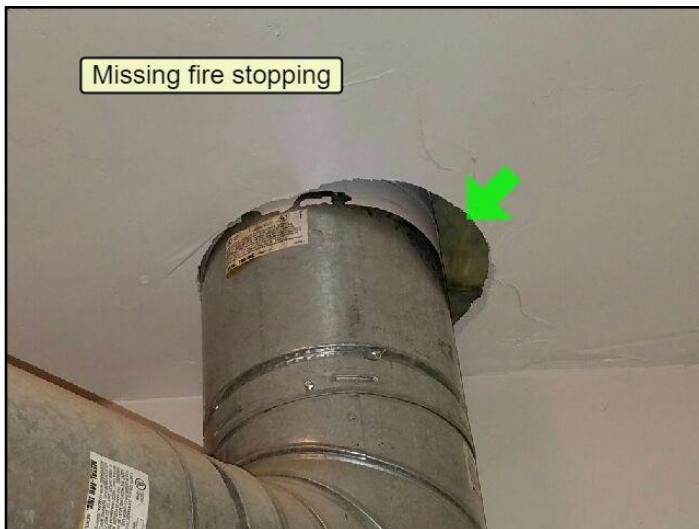
Fire stopping is missing around the boiler exhaust vent at the penetration into the utility room ceiling. Furthermore, small areas of moisture staining and corrosion are present on the boiler exhaust vent which is likely caused by a poor seal around the roof vent flashing.

Missing fire stopping

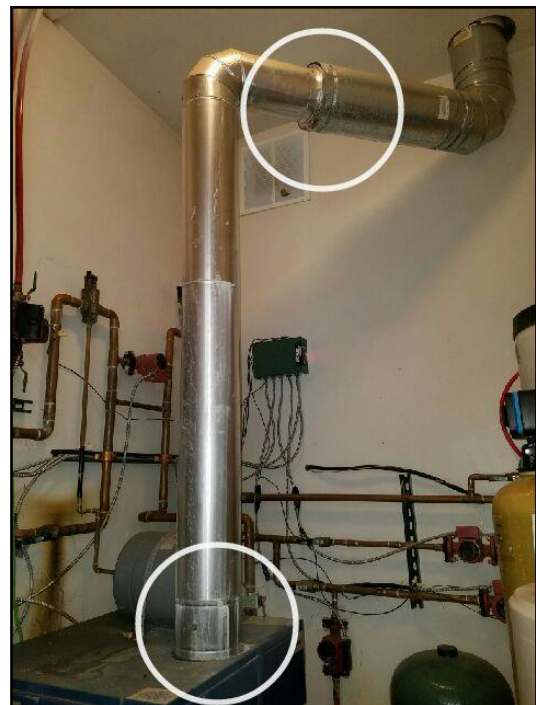
Moisture staining/corrosion

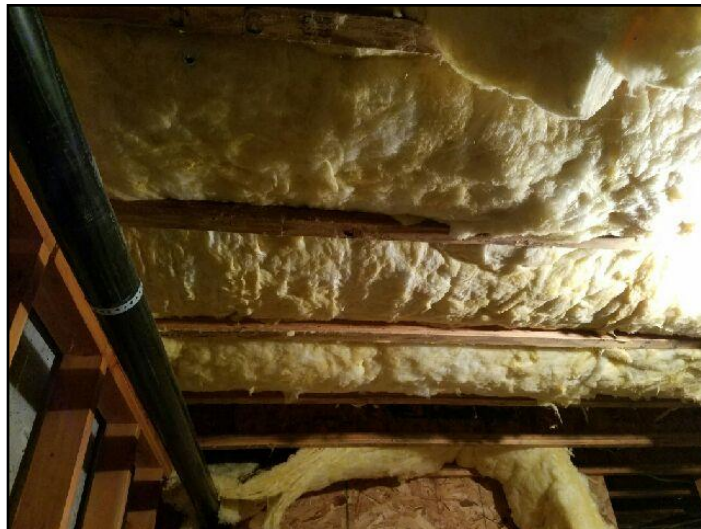
**Inspection prevented by no access to:** • Insulation installed between the floor joists in the crawlspace limited inspection.

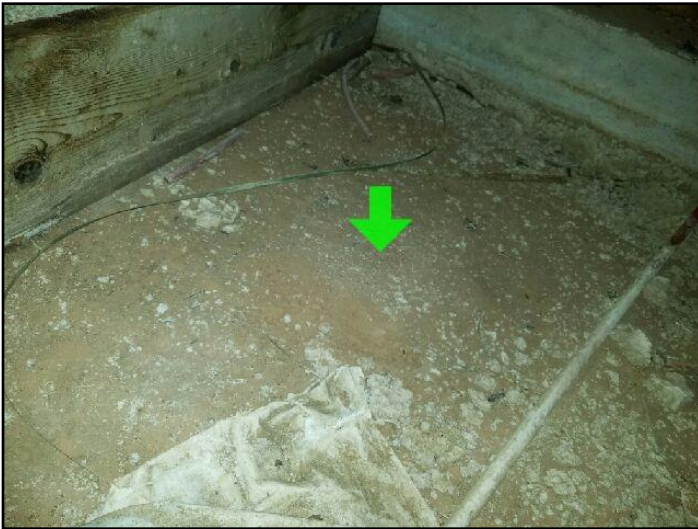
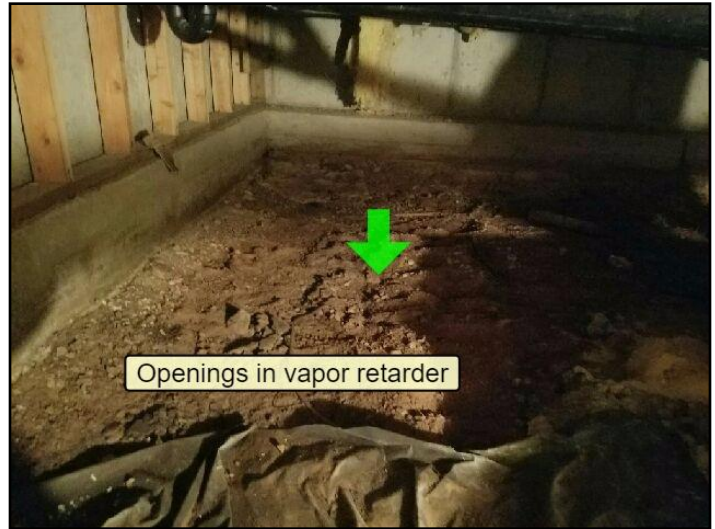
**27.** • Improving installation of the vapor retarder is recommended. Sections are missing, damaged, and bunched up. Vapor retarder is the plastic covering the floor of the crawl space designed to impede moisture vapor from entering the crawl space.

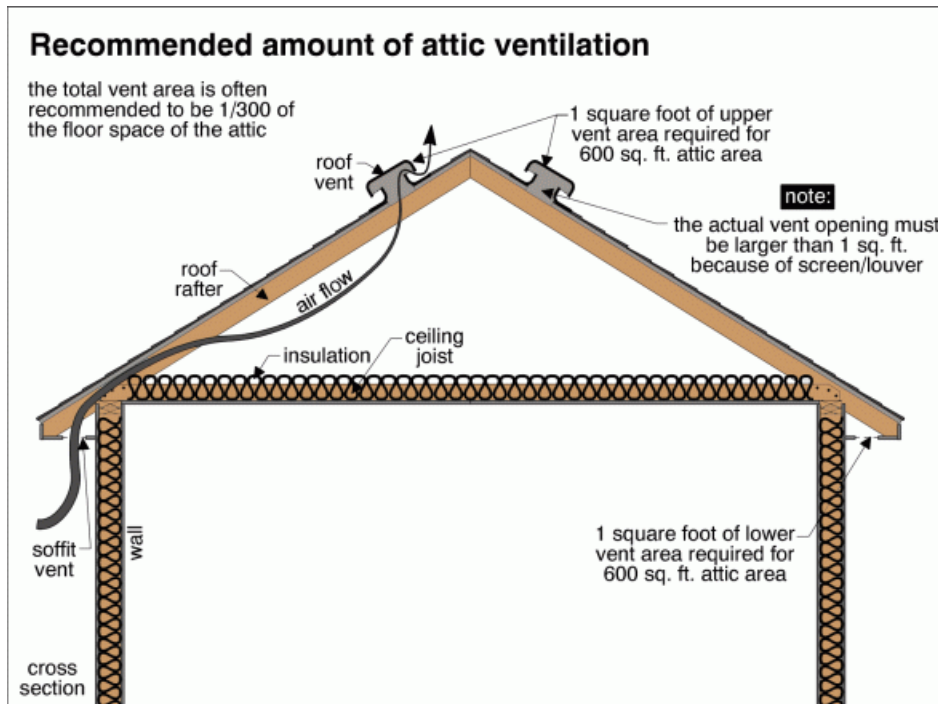
Attic ventilation MAY be inadequate. The soffit vents may be insufficient due to various incomplete soffit vents, and the venting may be obstructed by insulation.

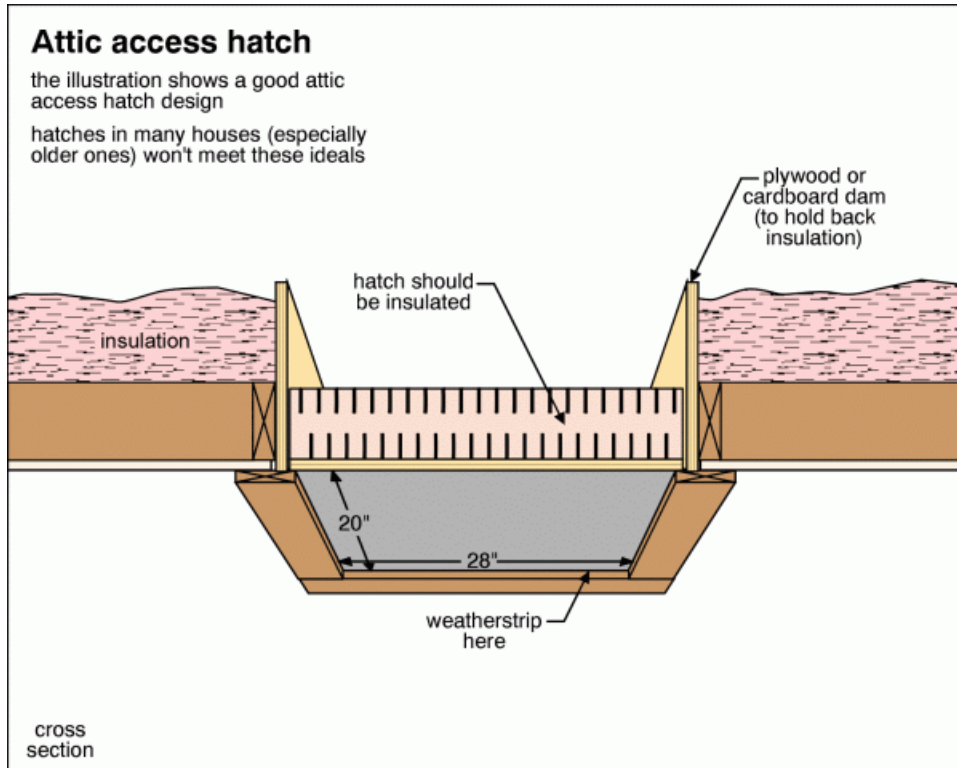
The south attic above the second floor is lacking an access, preventing access and inspection of the attic. Attic spaces require accesses. Furthermore, the north attic in the master bedroom closet is difficult to access, and once in the attic the space is inaccessible due to lack of head room and framing. However, insulation in this area has been damaged and compressed due to rodent activity. Improving insulation in the north attic is needed, and installation of an access for the

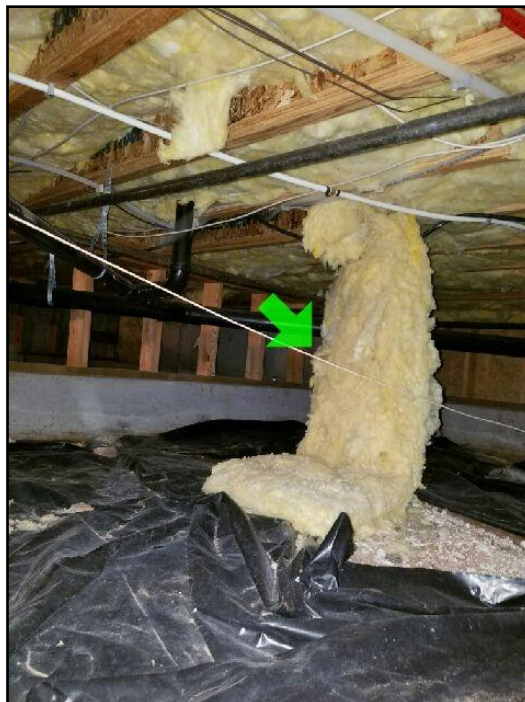
**30. Condition:** • Insulation is loose or missing in various areas of the crawlspace.

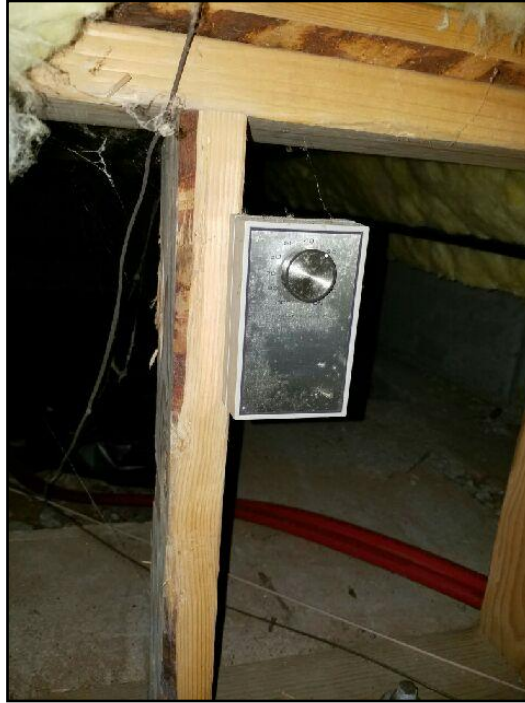
**31. Condition:** • Crawl space ventilation appears to be provided by a power exhaust vent controlled via humidistat; although, the system failed to engage.

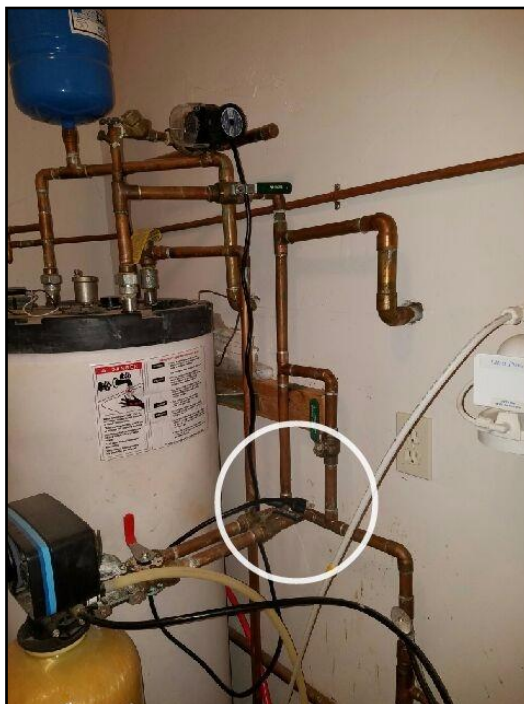
**Items excluded from a building inspection:** • The hot water circulation pump was unplugged in the utility room during inspection. The unit was not engaged during inspection.

*Unplugged*

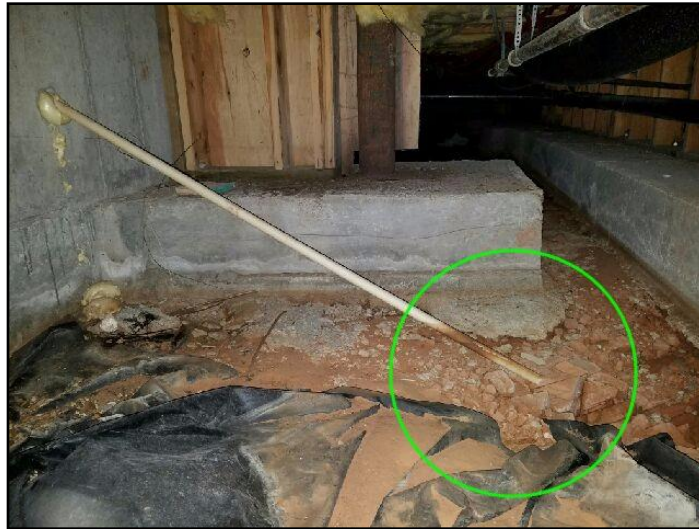
**32.** • I was unable to determine the purpose of the PVC drain line in the central aspect of the north crawlspace. However, the PVC line drains into the crawlspace

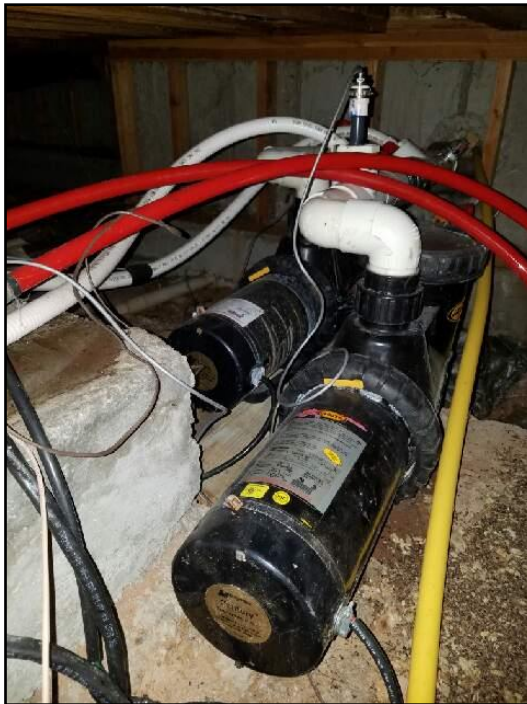
**33.** • Active leakage is present at the pumps located in the southeast crawlspace which appear to be dedicated to the exterior hot tub. Repair is needed

*Pumps noted*

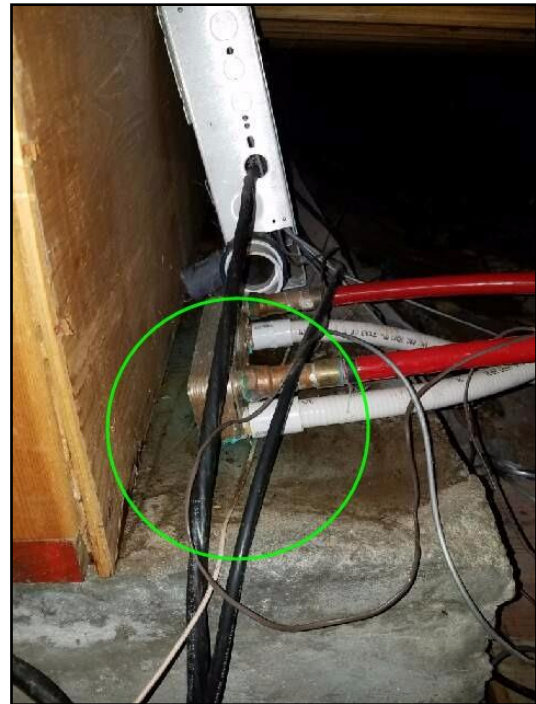
*Active leakage*

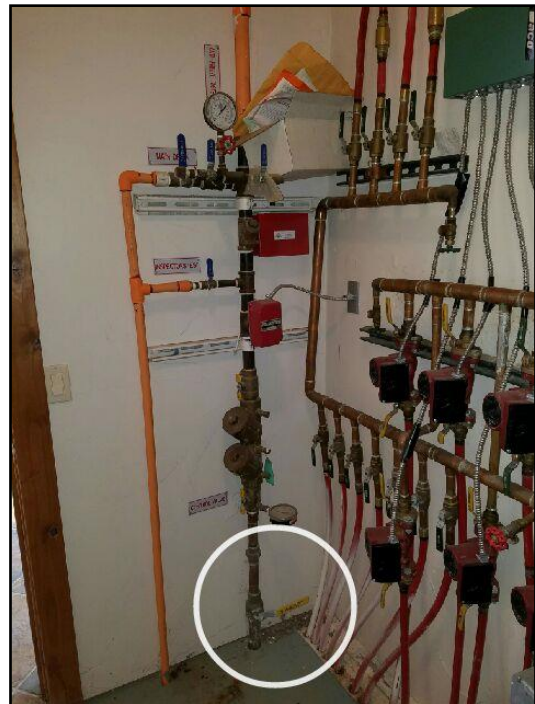
**34.** • The home is equipped with a fire suppression system. These systems require annual inspection and service by a fire suppression system contractor to verify the system is in functioning condition and the system is compliant. Furthermore, verify service records.

The system was shut off. Service is needed.

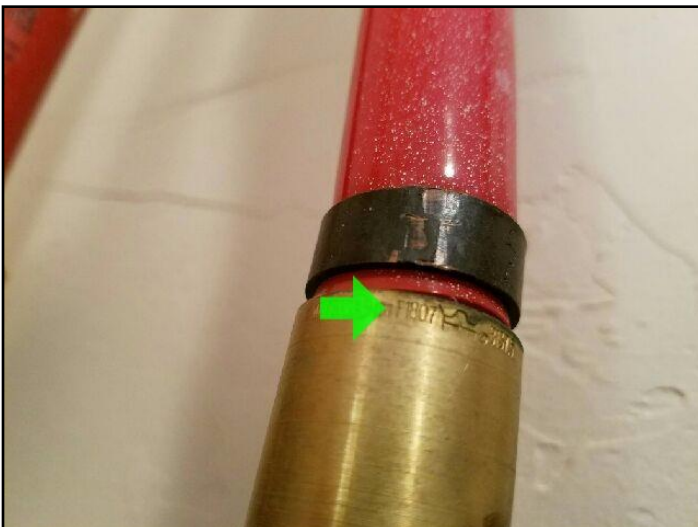
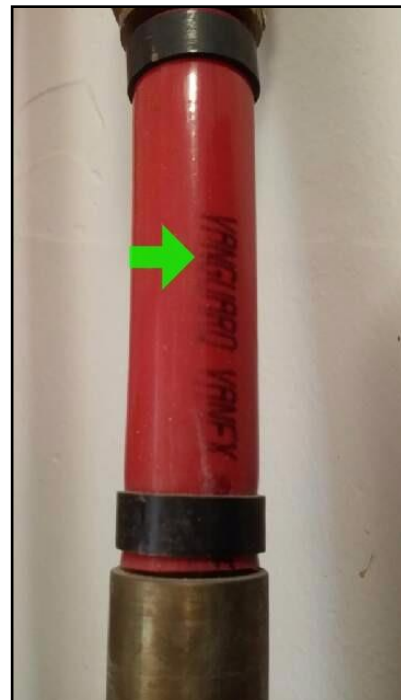
**35. Condition:** • [Various fittings on water lines and radiant lines in the home may be involved in a class action lawsuit.](#) Fittings marked with F 1807 may be manufactured by Zurn and are alleged to have higher failure rates. Visible fittings in the home appeared to be in good condition, with the exception of corrosion noted on one of the manifolds in the crawlspace.

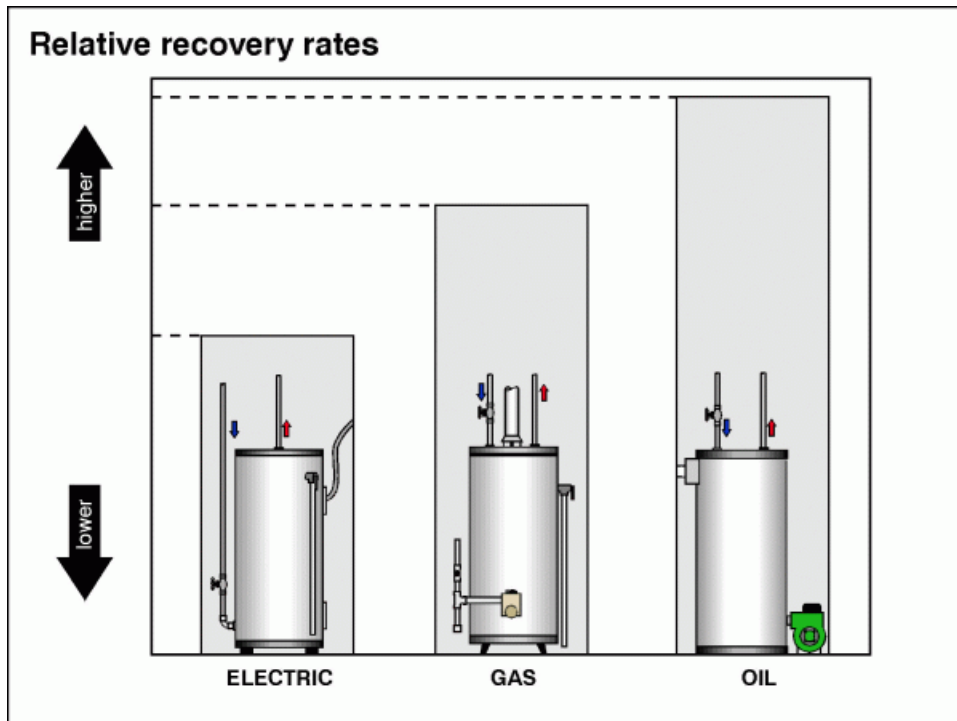
heater is only a 60 gallons tank.

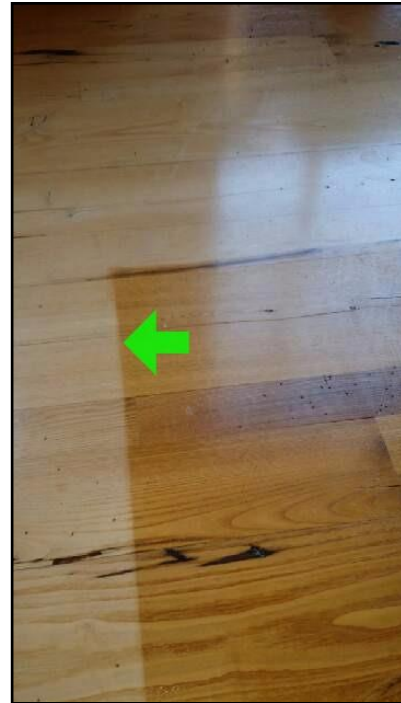
There is damage present to the wood floor in the master bedroom and small areas in the room have been patched.

*Fading*

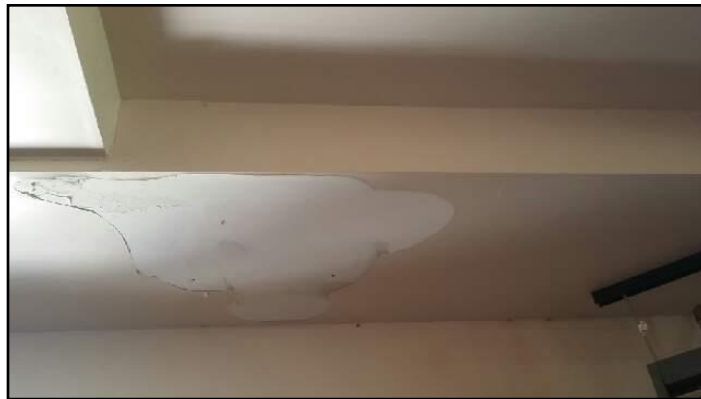
**53. Condition:** • Water damage is present in the west ceiling of the garage. This was likely due to previous ice damming.

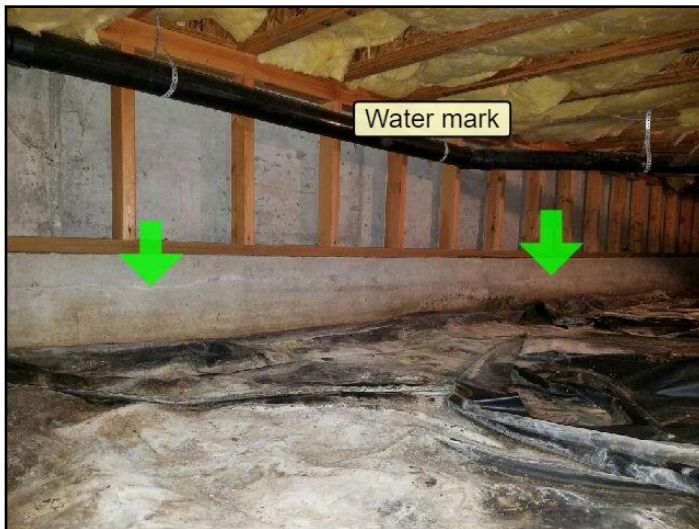
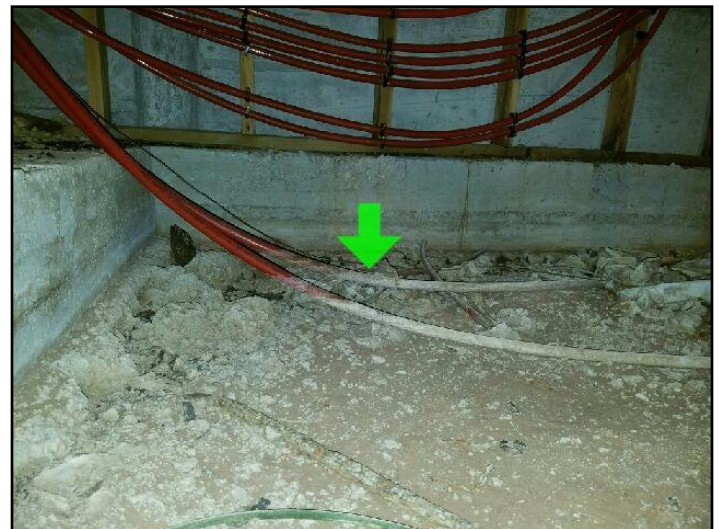
Moisture staining is present on the vapor retarder and high water marks are present throughout the crawlspace likely caused by moisture penetration. Additional evaluation by a contractor specializing in crawl space drainage is recommended to determine if installation of sump pumps are needed.

Signs of moisture

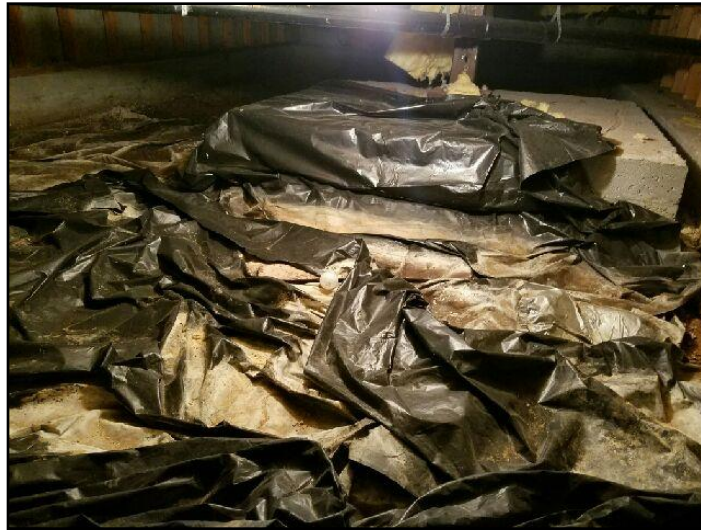
*Moisture staining*
