# INSPECTION REPORT

For the Property at:  
**194 PICKERING STREET**  
TORONTO, ON M4E 3J8

Prepared for: KAREN LAW  
Inspection Date: Monday, March 6, 2023  
Prepared by: Stefano Ramacciato

RE: Report No. 2884, v.3  
194 Pickering Street  
Toronto, ON  
M4E 3J8

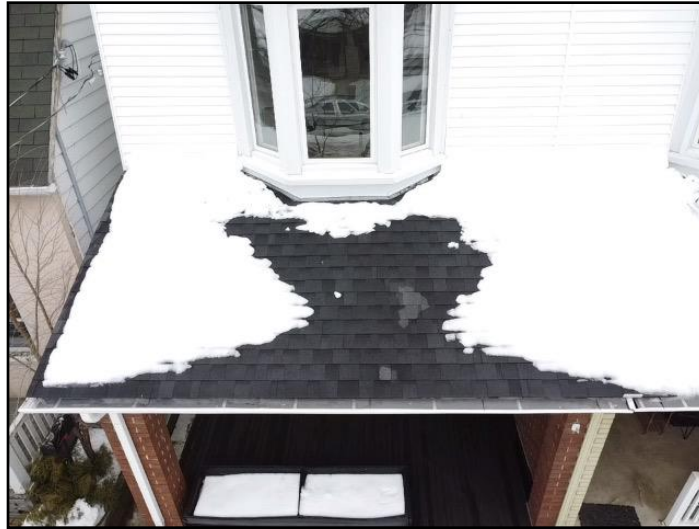
1.

- [Asphalt shingles](#)

On the front porch overhang

Recently installed

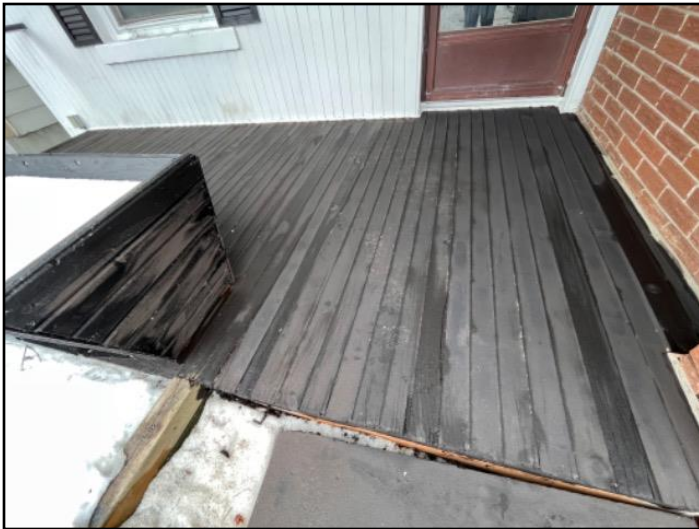
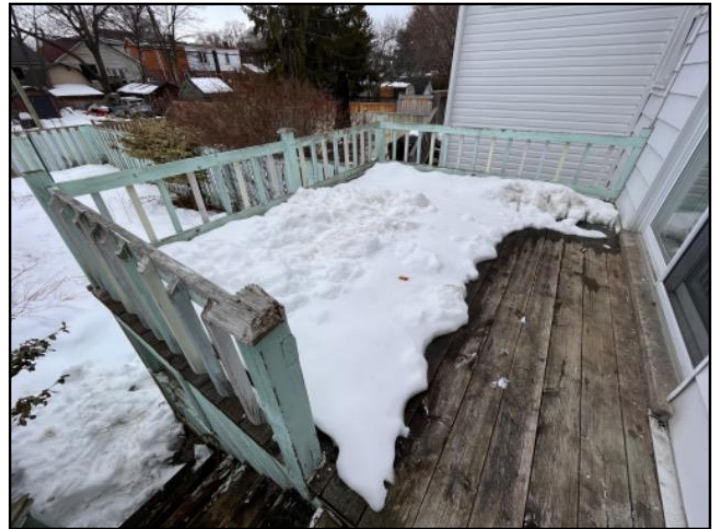
**Condition:** • Noticed rotten boards

Also missing some pickets on the front porch.

**1. Condition:** • Noticed rotten boards

**Location:** Front & Rear Exterior Porch

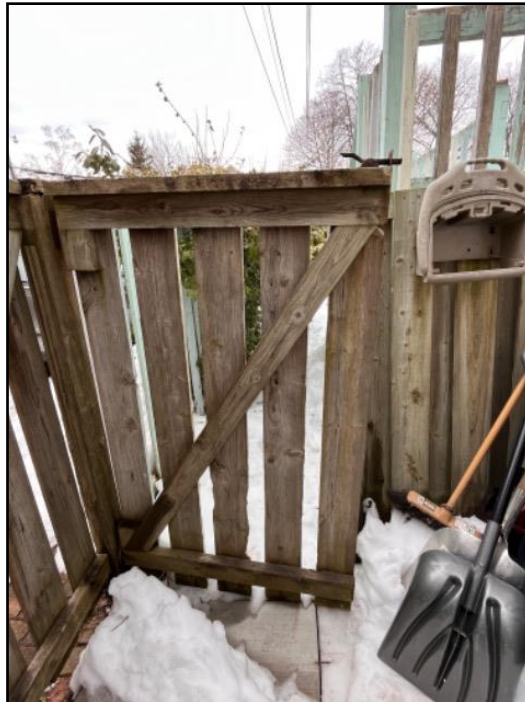
8.

**Condition:** • Gate damaged

**2. Condition:** • Gate damaged

**Location:** Left Side Exterior

**Task:** Repair

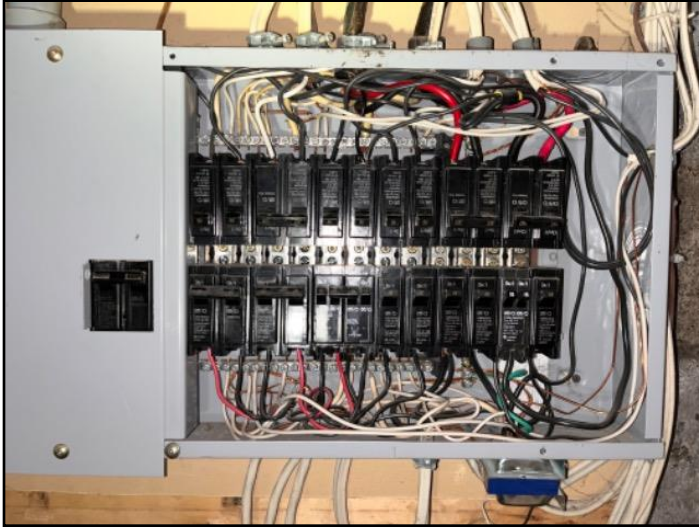
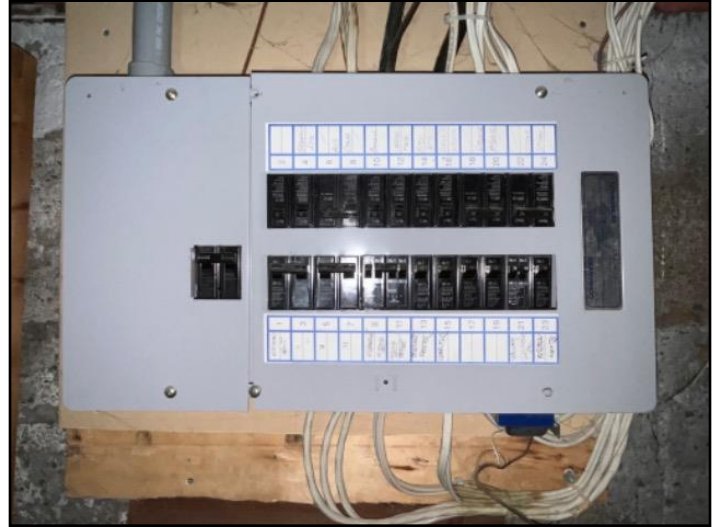
Located front basement.

Missing a few screws on the front panel.

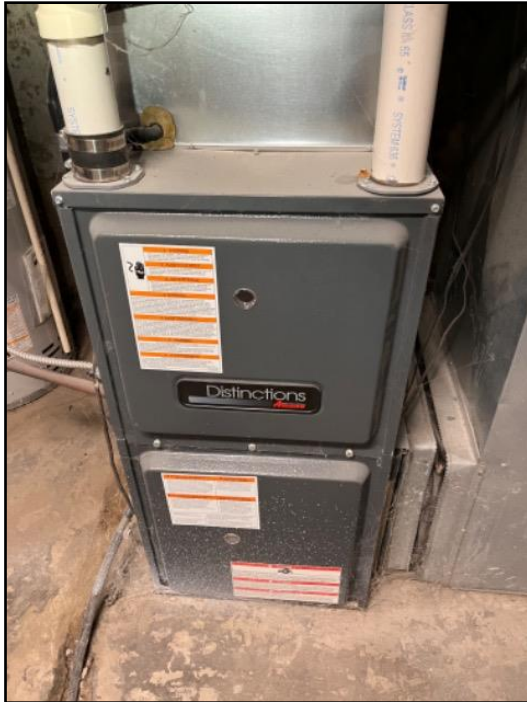
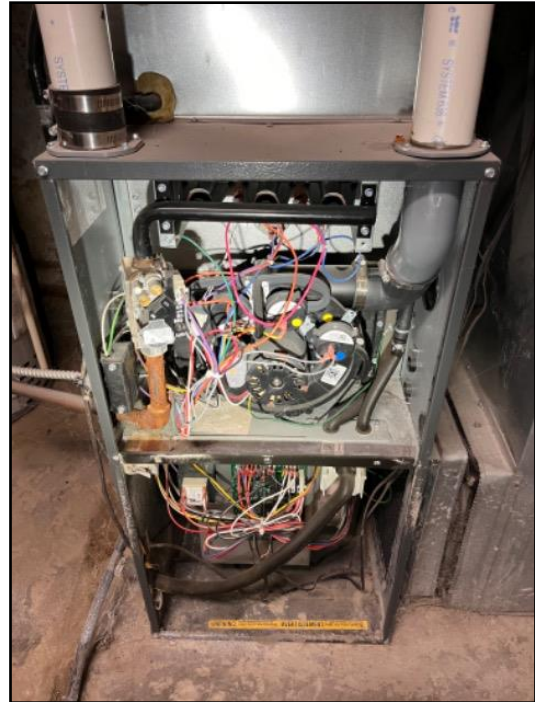
Model Year 2015

High Efficiency

60,000 BTU's

Missing filter cover

Replace filter every 3 months

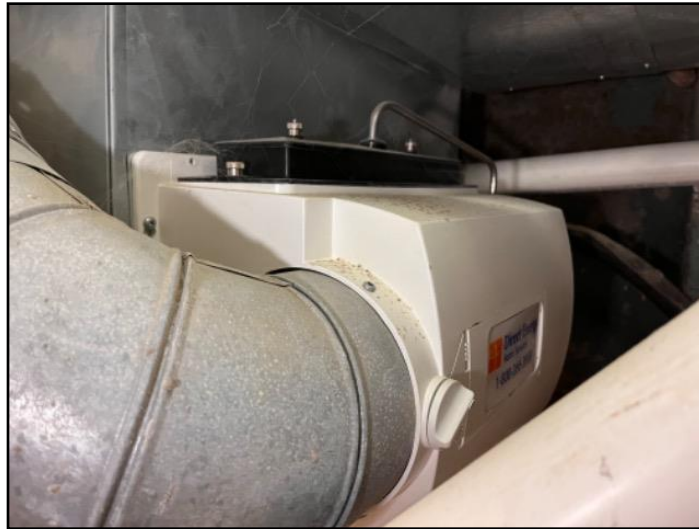
13. Trickle/cascade type

Replace filter every fall.

Make sure the water valve is on.

Make sure the damper flap is opened for the winter and closed for the summer.

Make sure the humidistat is at 35%.

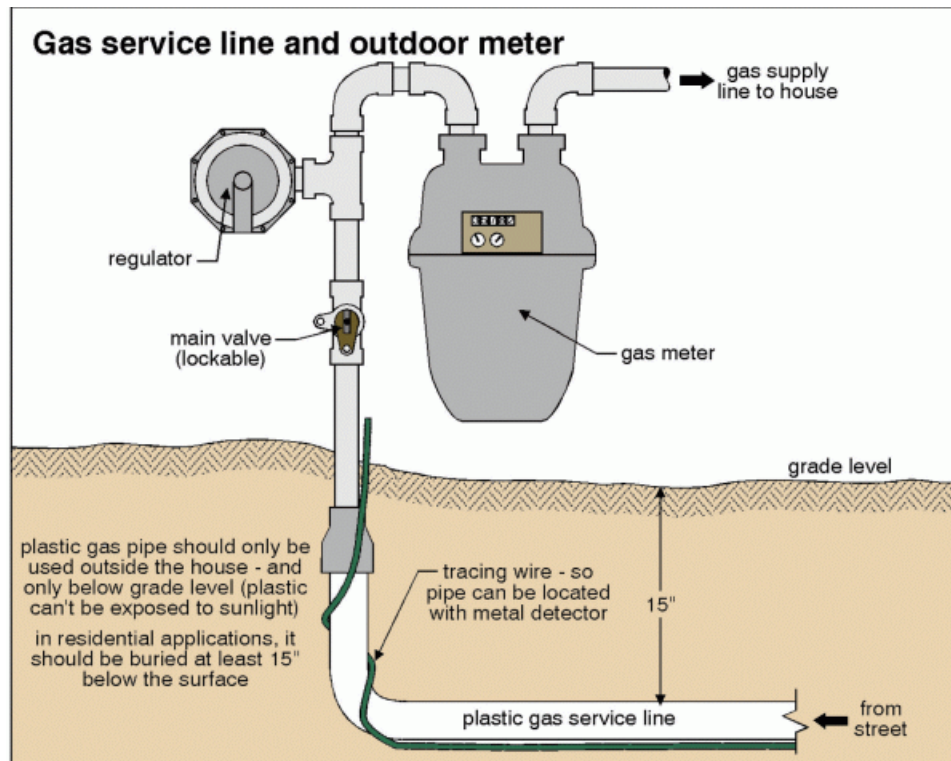
#### 4. Condition: • [Rust](#)

Rusty gas pipe.

**Implication(s):** Reduced system life expectancy | Equipment not operating properly

**Location:** Front Left Side Exterior Wall

Contact Consumers Gas

**Task:** Service

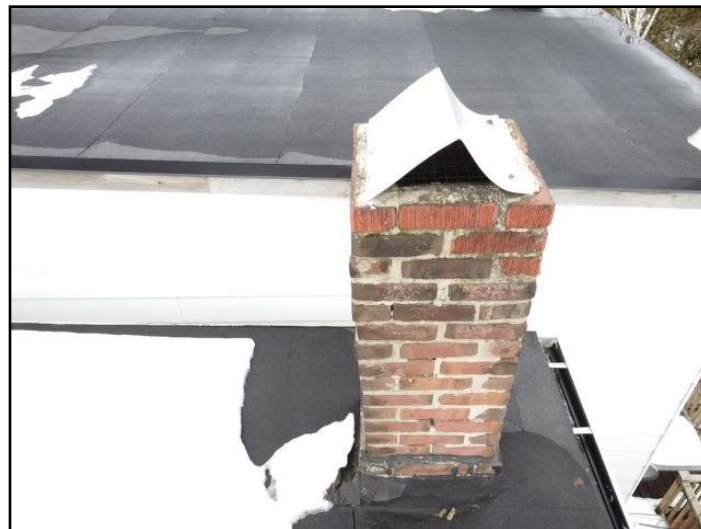
15.

**5. Condition:** • Rain cap missing.

Also noticed some deterioration on the mortar.

**Implication(s):** Chance of water damage to contents, finishes and/or structure.

**Location:** Rear Roof

**Task:** Repair
