INSPECTION REPORT

For the Property at:
8 KENYON ROAD
VERNON, BC V1H 2C6

Prepared for: R G
Inspection Date: Friday, September 20, 2019
Prepared by: Matt Bramall

Report No. 1021, v.3

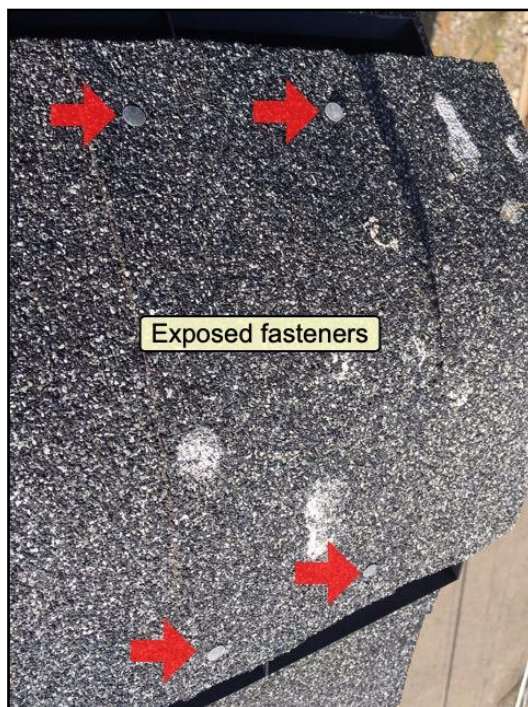
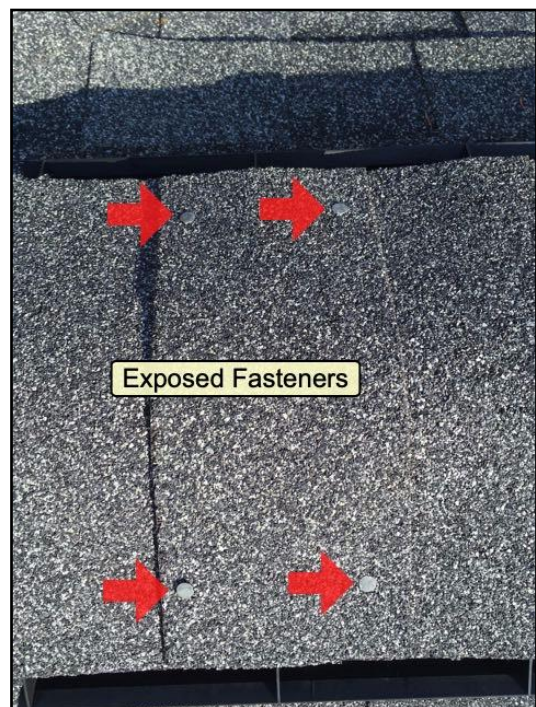
Condition: • [Exposed fasteners](#)

There are exposed fasteners in the shingles at the ends of the ridge caps which require caulking.

Exposed fasteners

Task: Caulk roof fasteners penetrating shingles

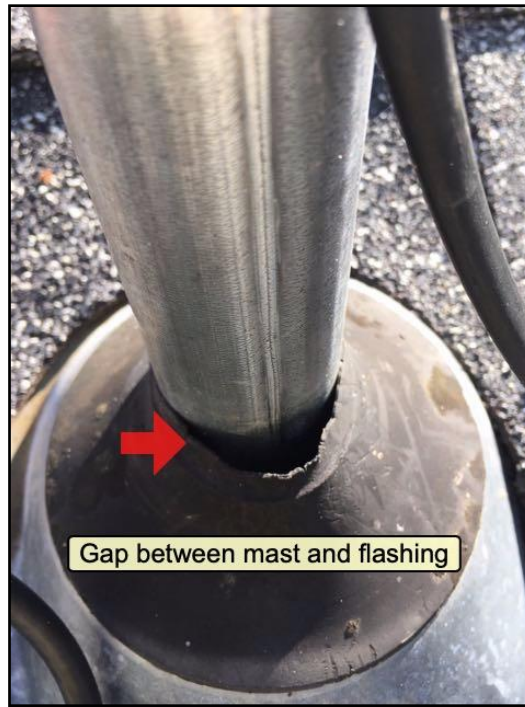
Condition: • Loose

Flashing for cable tv/ mast loose, potential for water ingress, and the associated damage to structure, finishings and contents.

Loose Flashing

Task: Seal gap with caulking

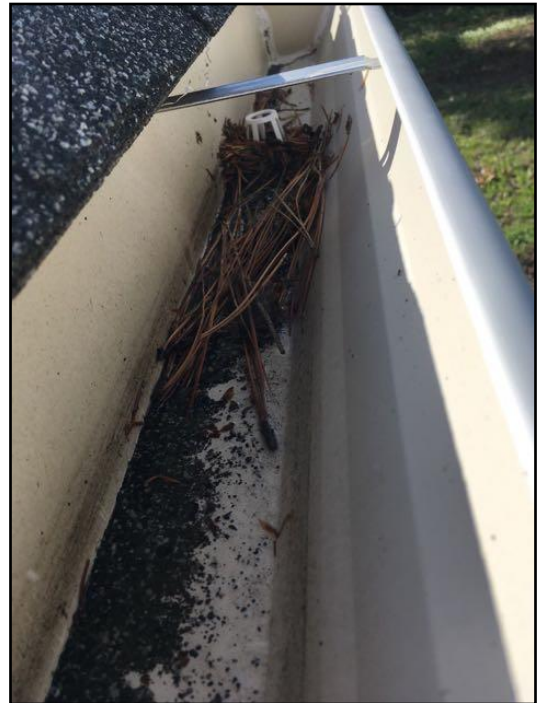
Condition: • Dirty/debris

The asphalt shingles were recently installed, and have lost a normal amount of granules for a newly installed roof. The gutters also have accumulated some leaves and needles at this time. Clean gutters seasonally to ensure proper drainage and to prevent overflows. Overflowing gutters can damage the fascia and structure below.

Dirty/debris

Task: Clean

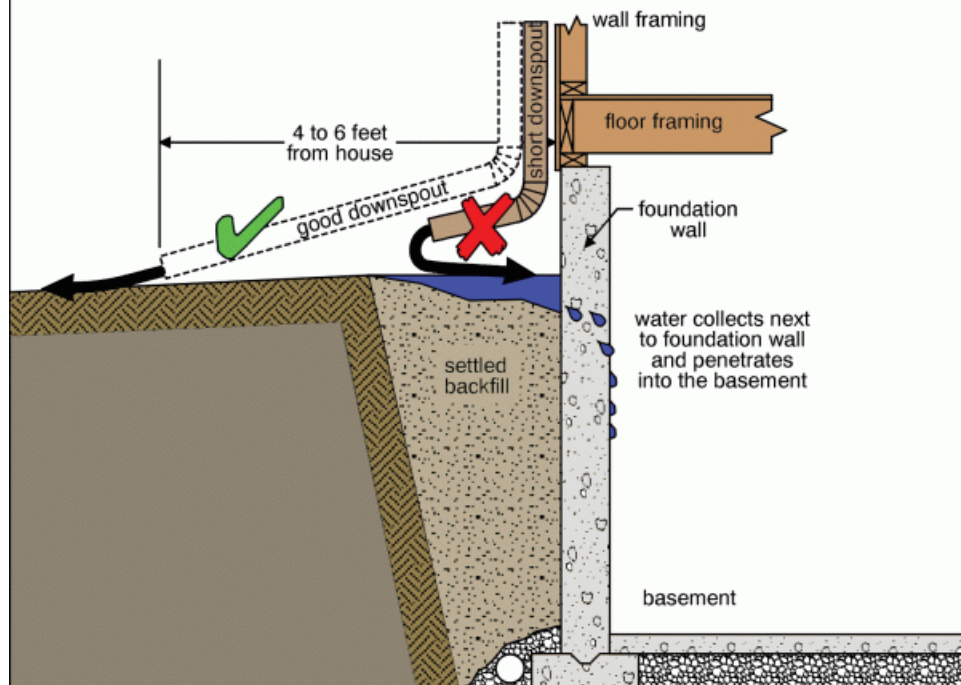
Downspout extension too short

Task: Extend downspouts 6 feet from house

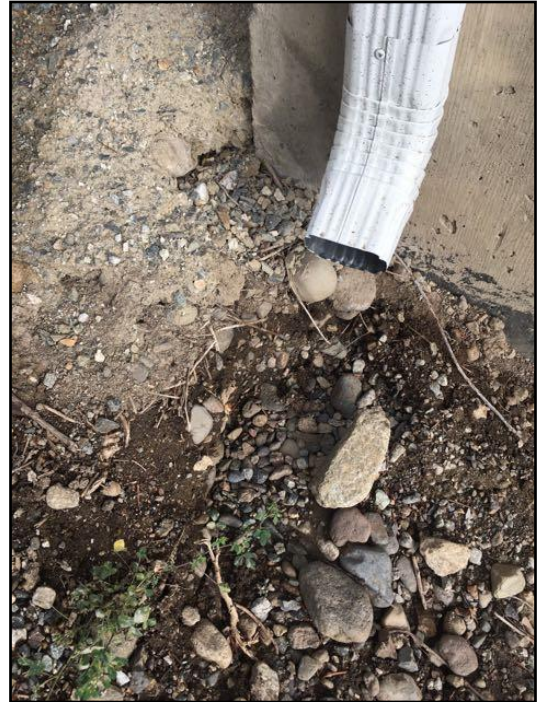
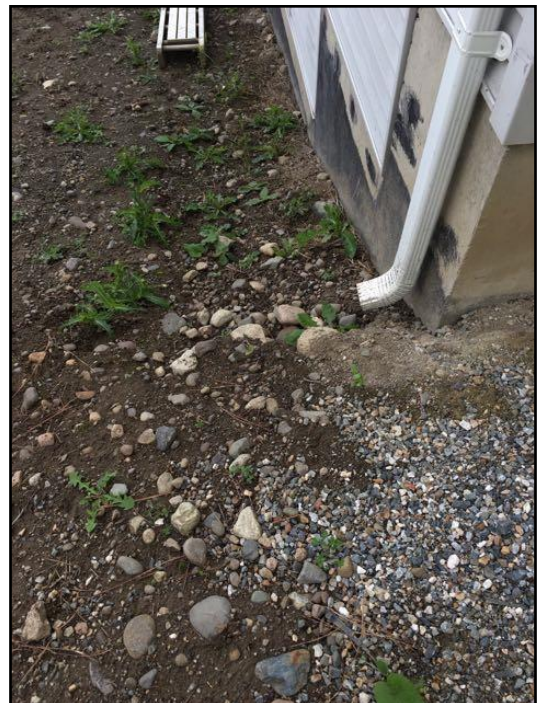
Condition: • [Should discharge 6 feet from building](#)

Downspouts should discharge 6 feet from the house.

Should discharge 6 feet from building

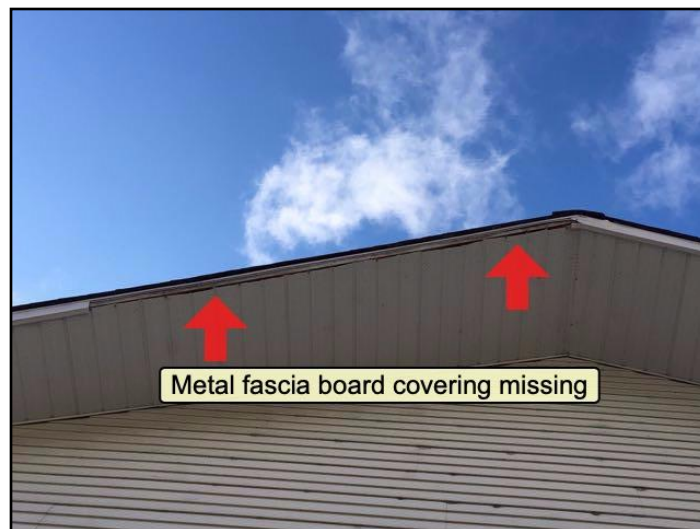
Condition: • [Loose or missing pieces](#)

There is a missing piece of fascia board covering missing on the north side of the home.

Loose or missing pieces

Task: Install fascia covering

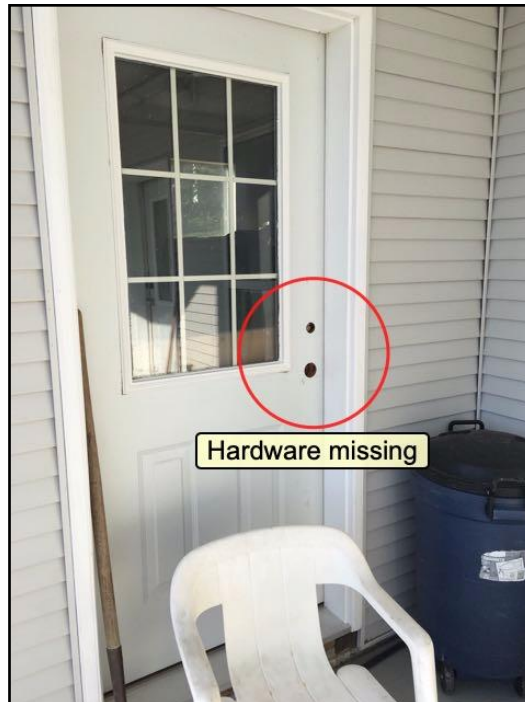
Condition: • Missing or damaged

Missing or damaged

Task: Install hardware

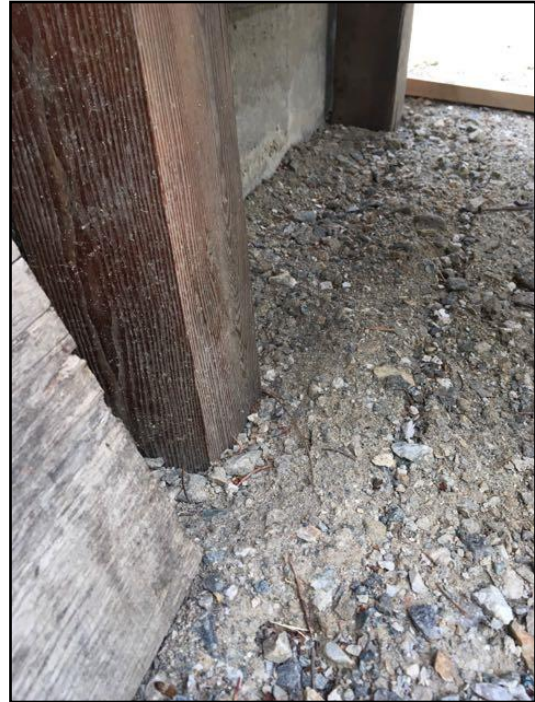
Condition: • [Wood/soil contact](#)

Wood/soil contact

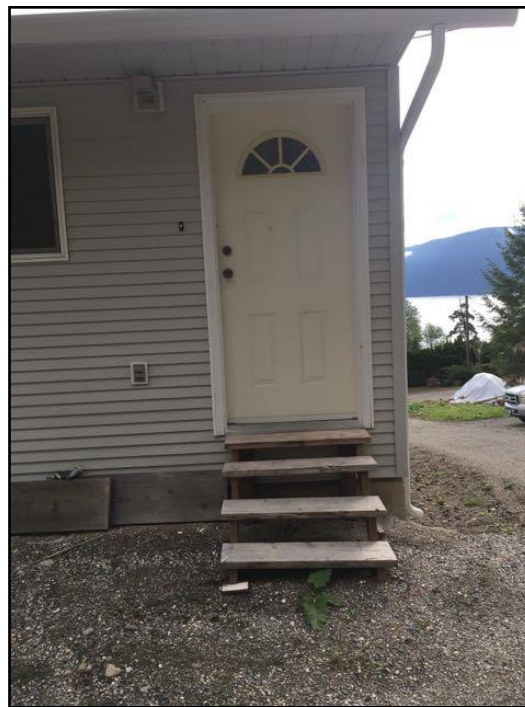
Condition: • [Missing](#)

Missing

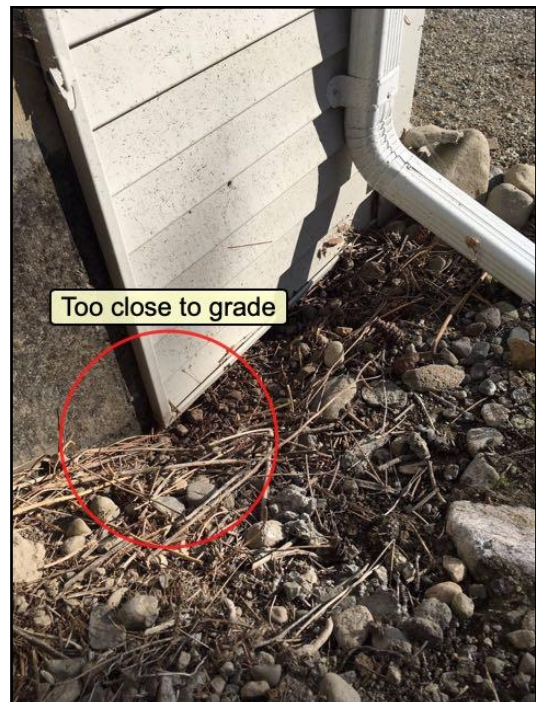
The siding which is covering the wood framed walls along the north and south sides of the home is too close to grade. There should be a minimum of 8" of clearance from the ground to the wood framing. This is particularly concerning with this home, as the above-grade downspouts uphill of these areas are directing a lot of water up against the foundation wall.

Too close to grade or wood/soil contact

Task: Increase clearance from ground to wood framing, slope ground away from structure.

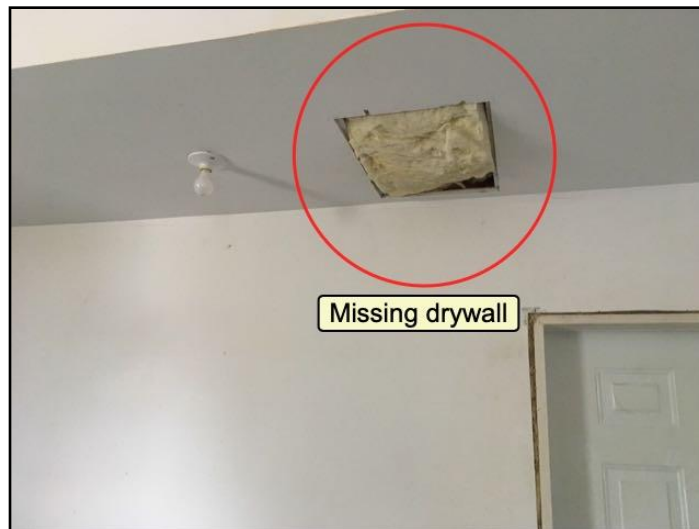
There is a section of drywall in the ceiling of the garage that is missing. This needs to be replaced, and mudded and taped to ensure the garage is gas tight from the home.

Not gastight

Task: Replace drywall, mud and tape seams

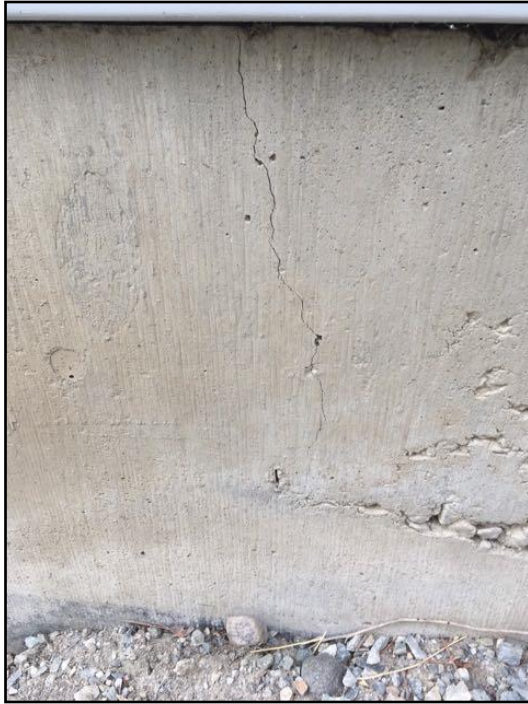
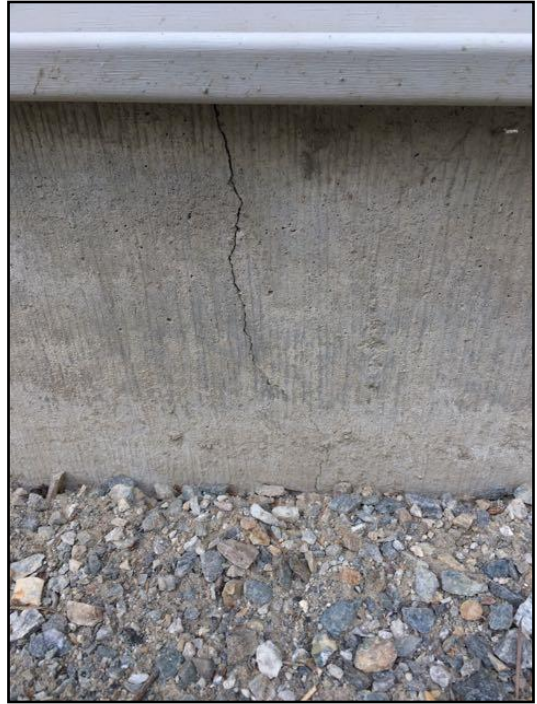
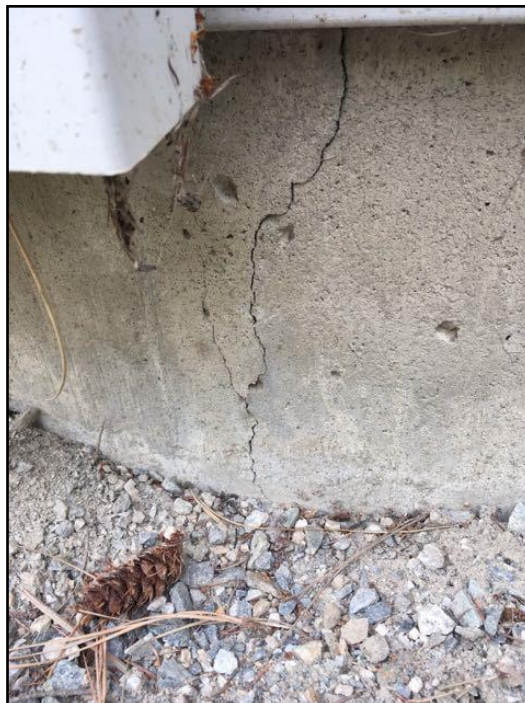
Condition: • Typical minor cracks

Typical shrinkage cracks

Typical shrinkage crack

Task: Seal cracks

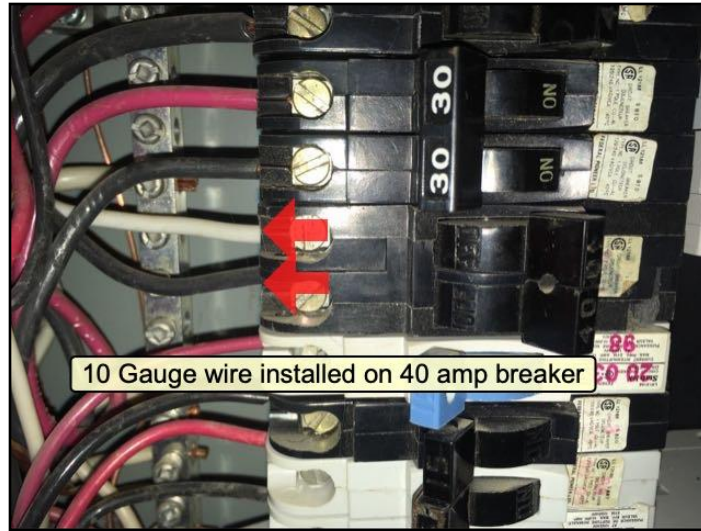
Condition: • [Undersized wire](#)

Undersized wire

Task: Qualified electrical contractor to match breaker size to wire size depending on required garage application.

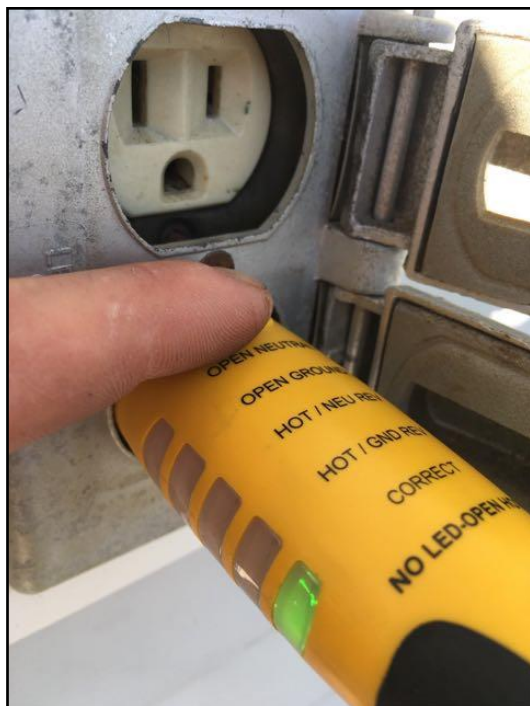
Condition: • [No GFCI/GFI \(Ground Fault Circuit Interrupter\)](#)

No GFCI/GFI (Ground Fault Circuit...

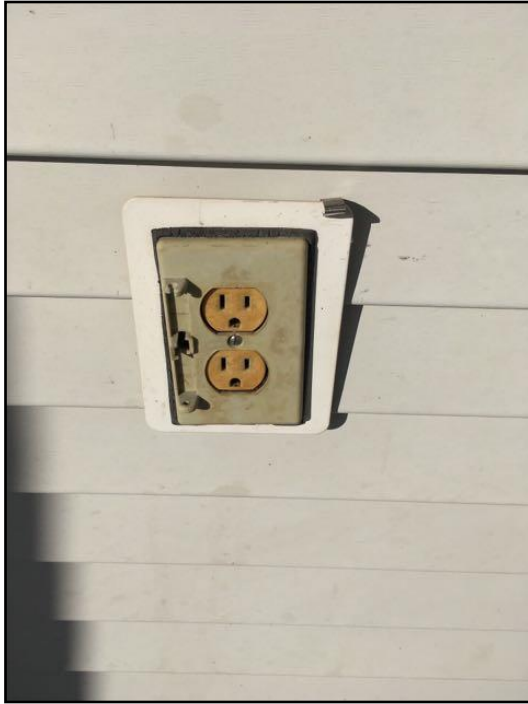
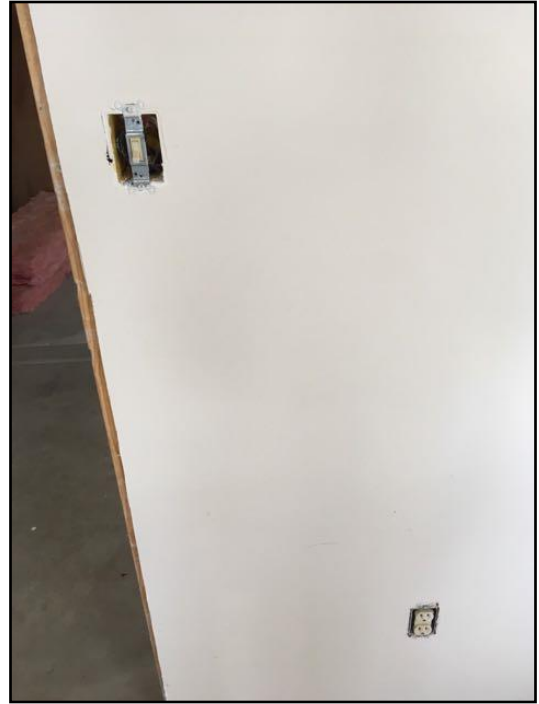
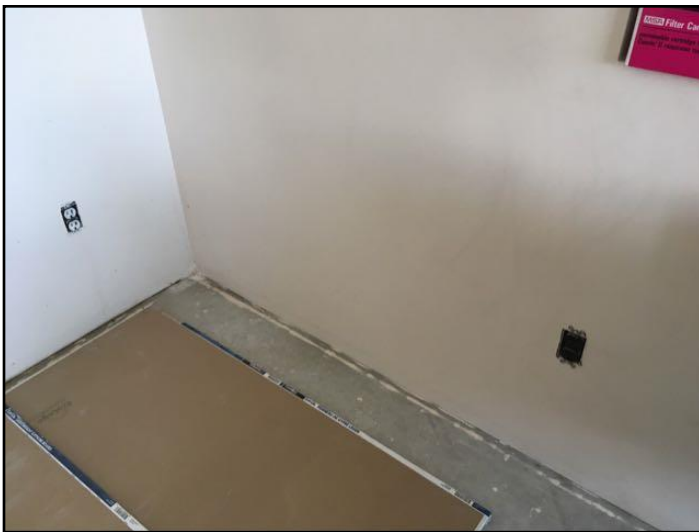
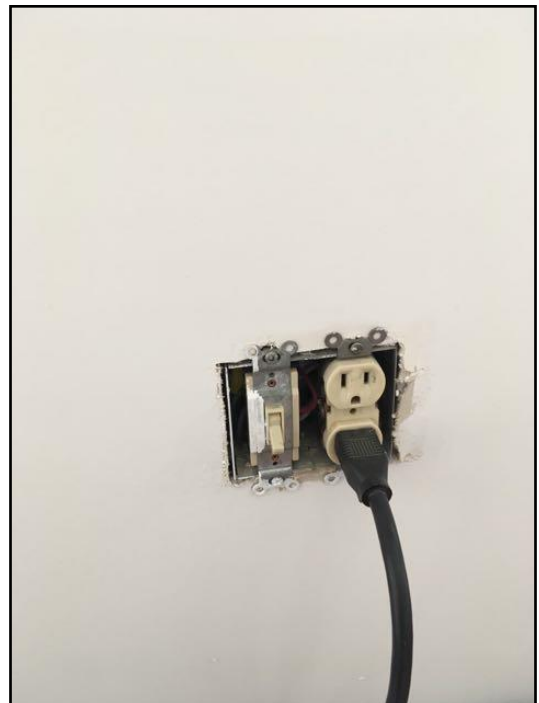
There are a large number of electrical outlets missing cover plates throughout the house.

Missing Coverplate

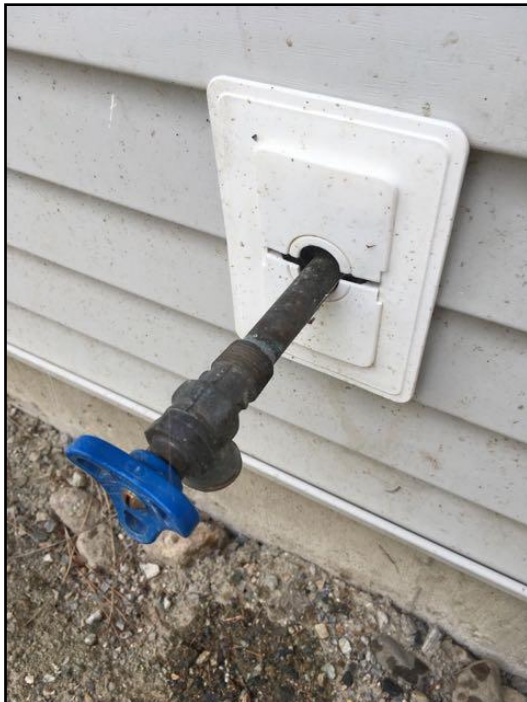
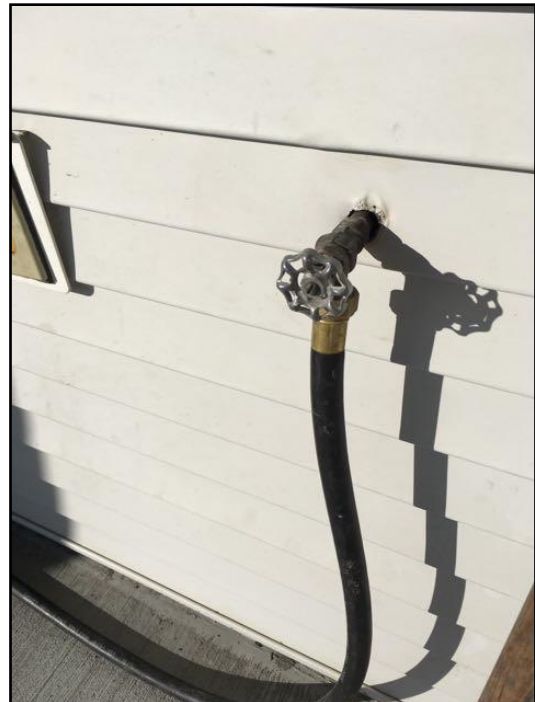
Condition: • [Not Frost Free](#)

A frost-free hose bib has a stem that is 6-12" long which means that the seat of the valve is located on the inside of your house. This prevents cold weather from freezing your pipes.

Not Frost Free

Task: Replace with frost free hose bib

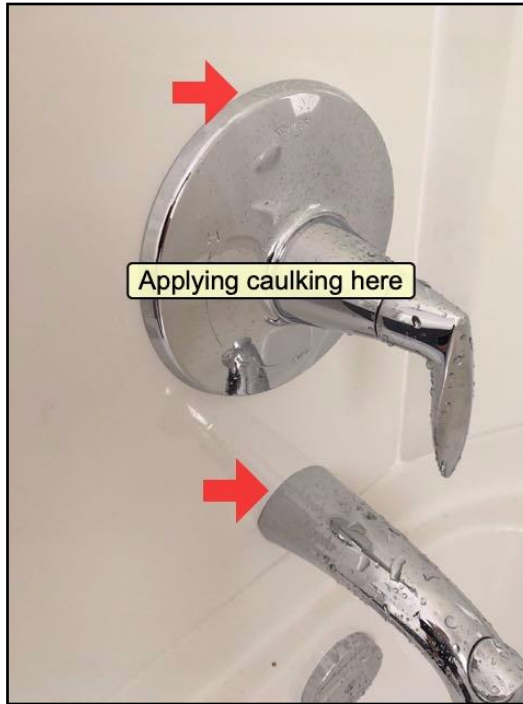
Condition: • [Caulking loose, missing or deteriorated](#)

Caulking loose, missing or deteriorated

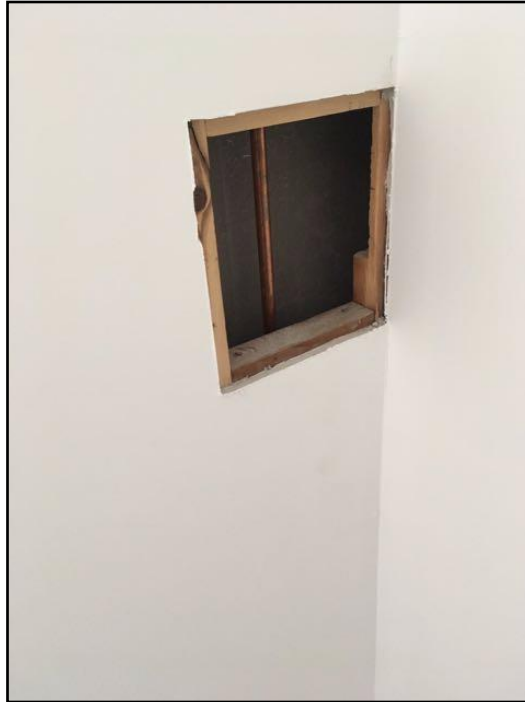
There is a section of drywall missing from a wall in the laundry area. There is a water pipe located in the wall cavity here, but there is no shut off, visible repairs, or other readily apparent reason for this access. Ask seller for history of this access.

Loose or missing

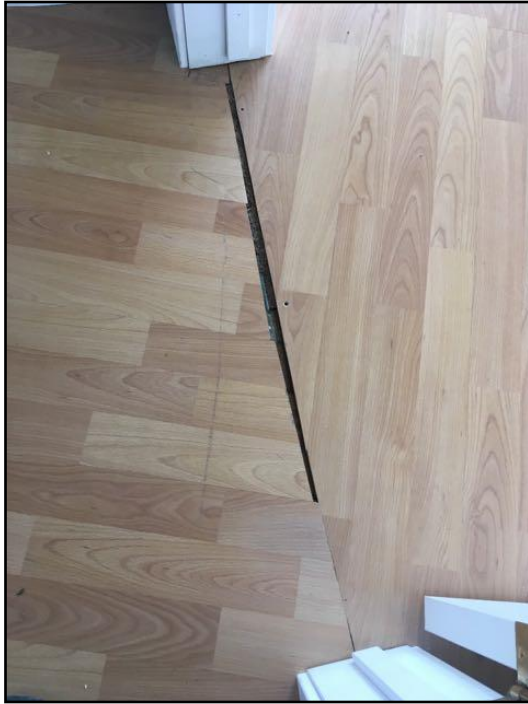
There is a section of flooring missing from the upstairs hall closet, as well as a missing transition strip at the master bedroom.

Missing threshold trim

Task: Install transition strip at master bedroom, install missing floorboard at hall closet

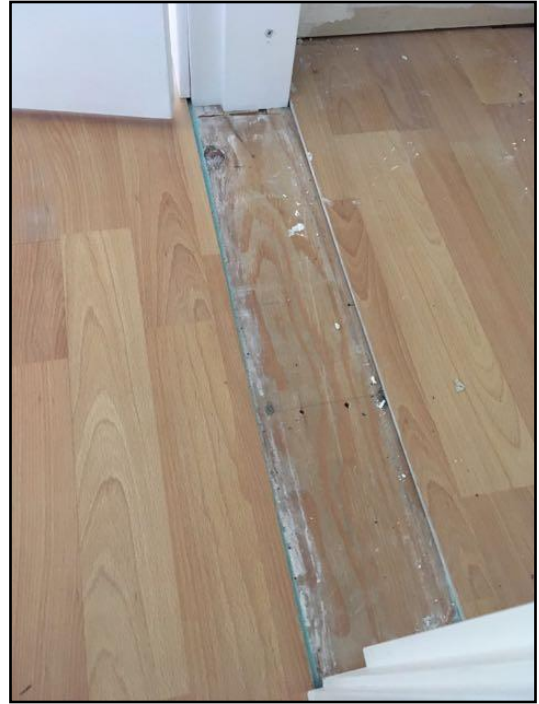
Missing flooring

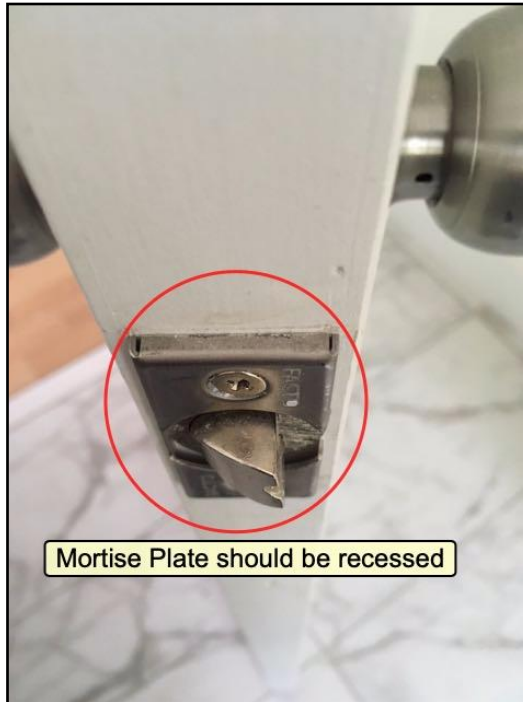
Condition: • Binds

Binds

Task: Recess mortise plate into door

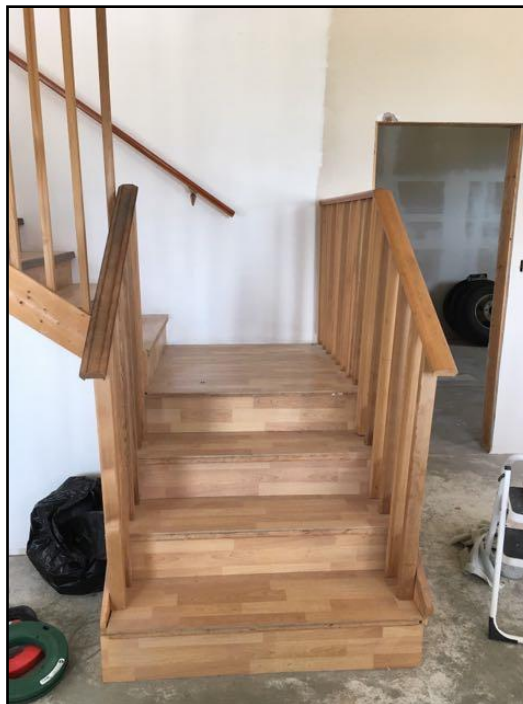
Condition: • [Loose](#)

Loose
