# YOUR Inspection Report

1000 Just Built Rd  
Simpsonville, KY 40069

Thursday, February 15, 2018

RE: Report No. 1031, v.2  
1000 Just Built Rd  
Simpsonville, KY  
40069

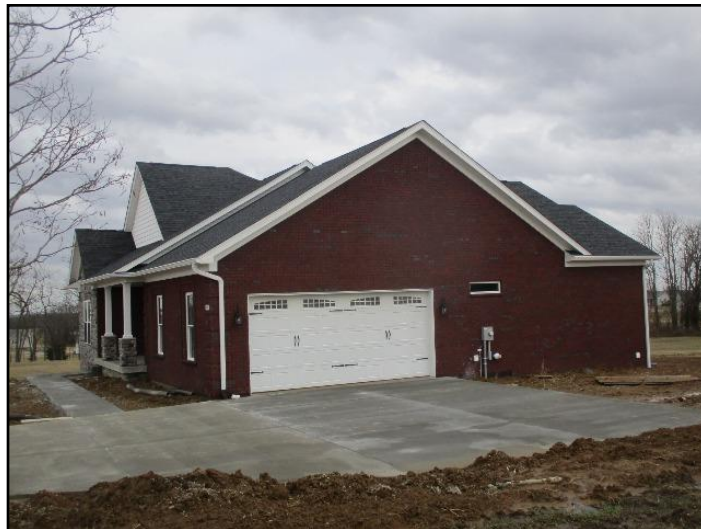
4. Towards building

The front and right side of the house drains towards the building and the left and rear side of the house slopes away from the building. Recommend rechecking the final grade to assure all drainage will be diverted away from or around the house.

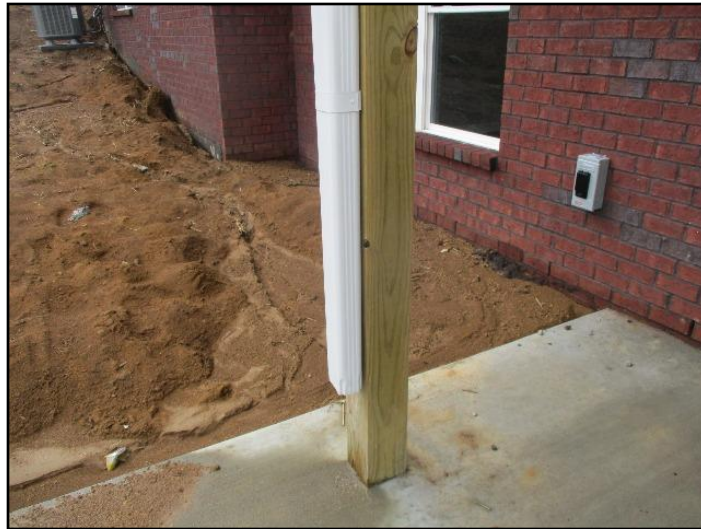
**1. Condition:** • [Should discharge 6 feet from building](#)

6. Missing elbow and discharge

**Task:** Provide discharge

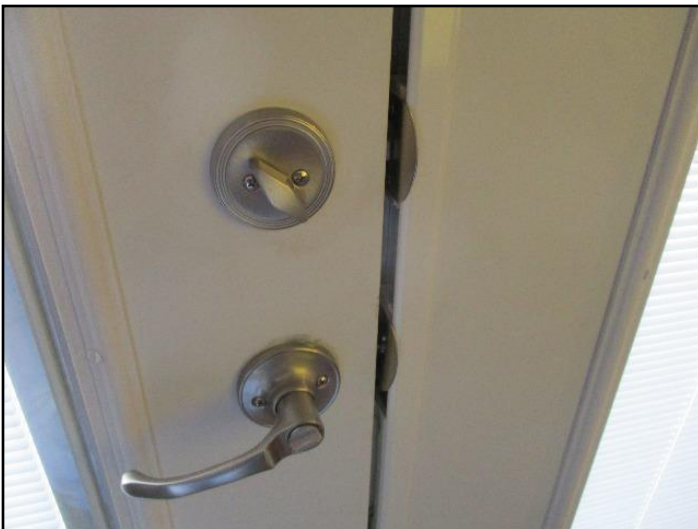
### 2. Condition: • Damaged door latch

Door would not lock properly. The bottoms of the door pair were not straight and had a gap.

7. Damaged door latch

**Task:** Repair

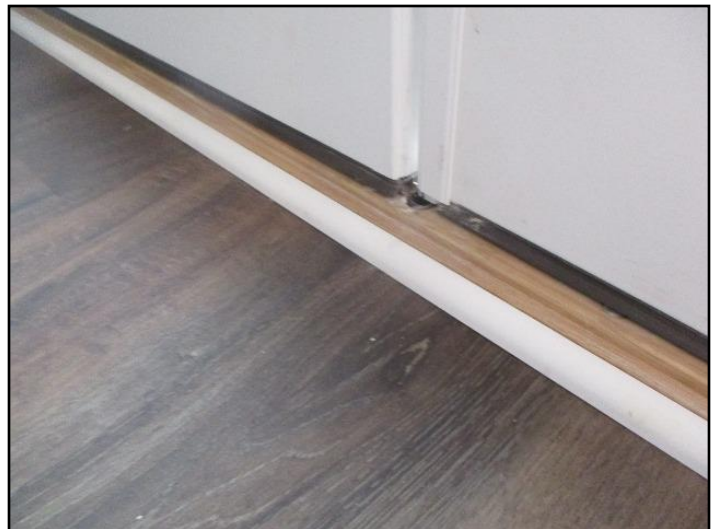
8. Doors not aligned and with gap

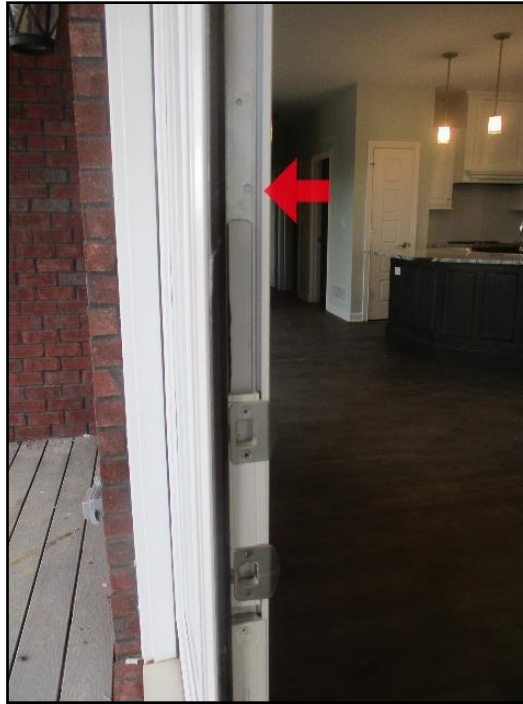
Missing door jam cover plate

**Location:** Upper level, right side door to deck

9. Missing cover plate

**Task:** Provide

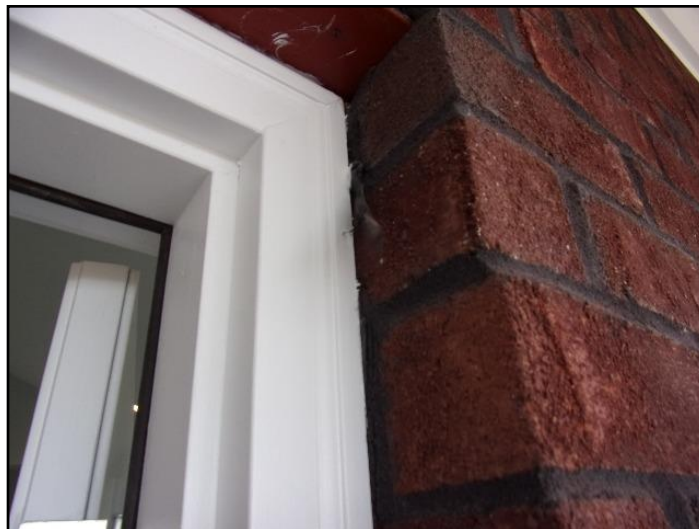
5. **Condition:** • [Caulking missing, deteriorated or loose](#)

**Location:** Back double doors to deck

10. Caulking missing, deteriorated or loose

**Task:** Provide caulk around all doors and windows where there are none.

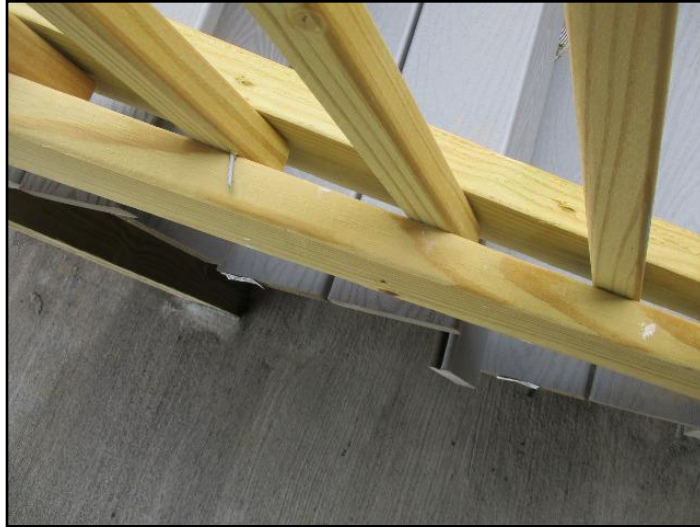
**6. Condition:** • Several stair treads were cut too long.

11. Uneven stair treads

**Task:** Trim stair treads to equal sizes

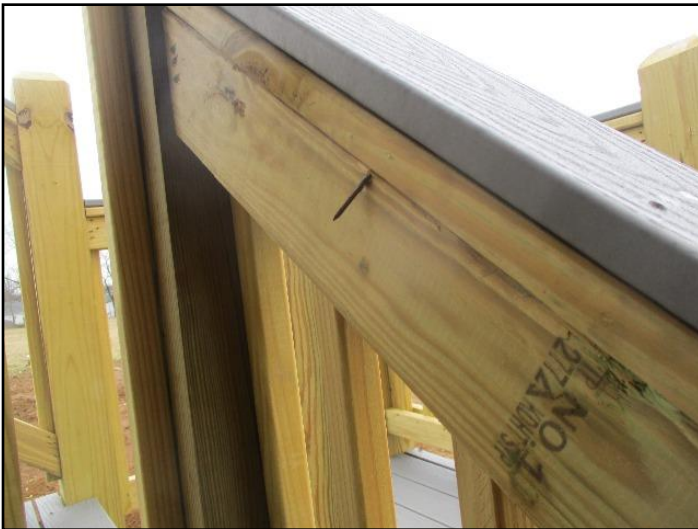
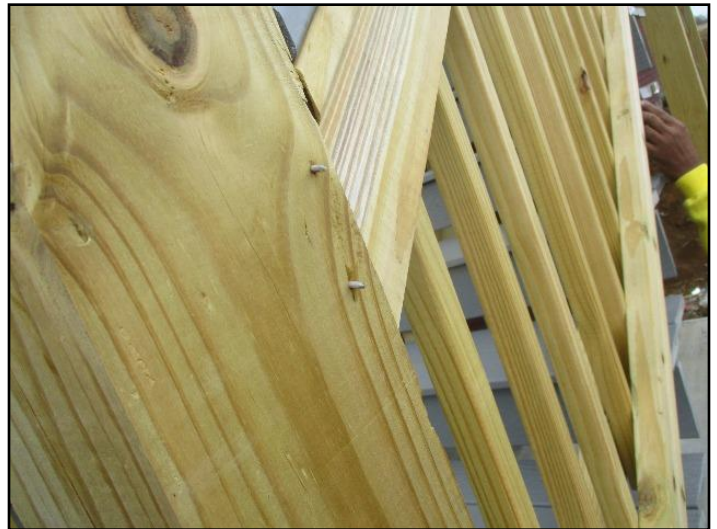
**7. Condition:** • Protruding nails

**Implication(s):** Safety hazard

12. Protruding nails

**Task:** Remove protruding nails and re-nail

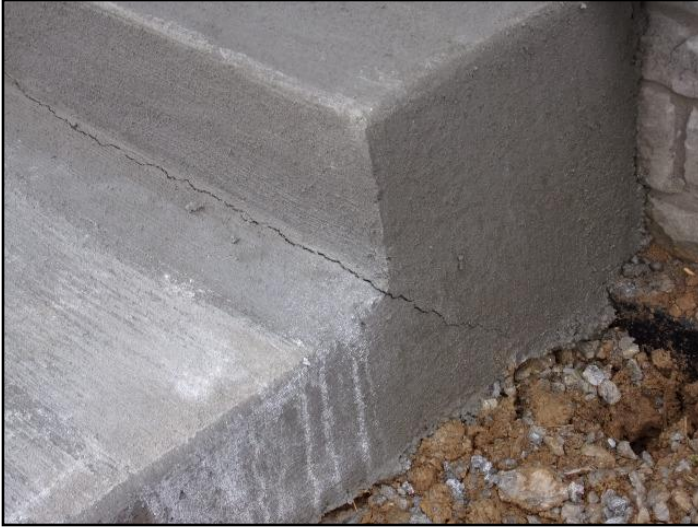
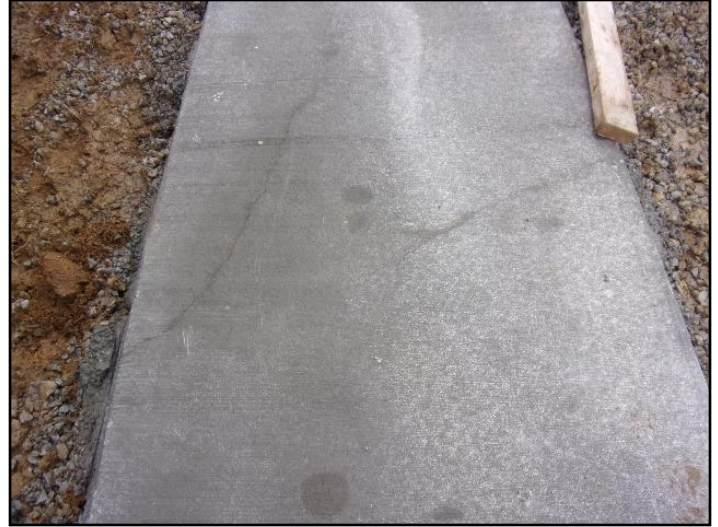
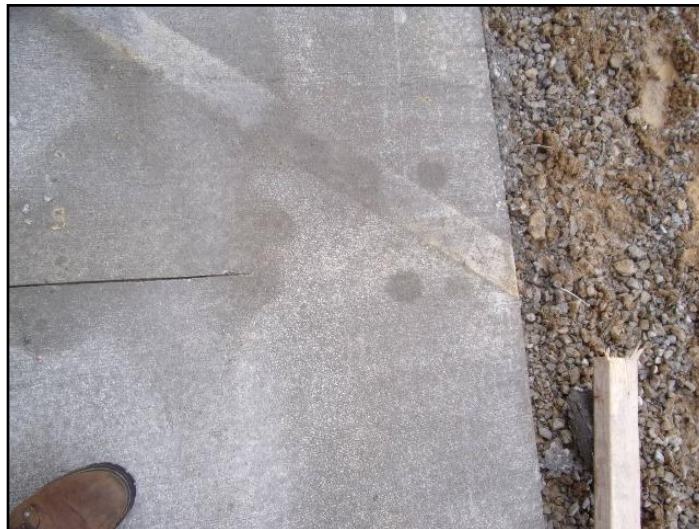
Front sidewalk had cracks and the saw joint (for crack control) was not completed. Also, the steps to front porch was cracked and had begun to separate from the house.

14. Cracked front steps

15. Cracked or damaged surfaces

16. Saw joint incomplete

**Task:** Remove damage concrete and replace

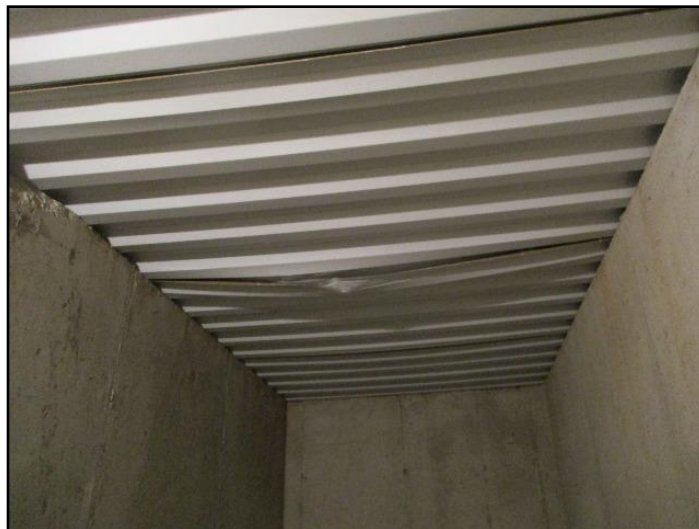
Damaged steel deck

**Implication(s):** Chance of water entering building | Weakened structure | Chance of structural movement

17. Mechanical damage

**Task:** repair damaged metal deck

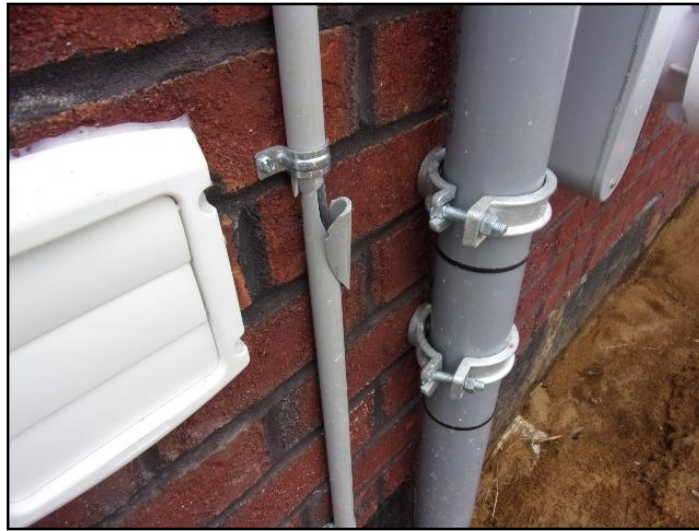
**11. Condition:** • Damage grounding cable conduit

20. Damaged grounding conduit

**Task:** Repair or replace

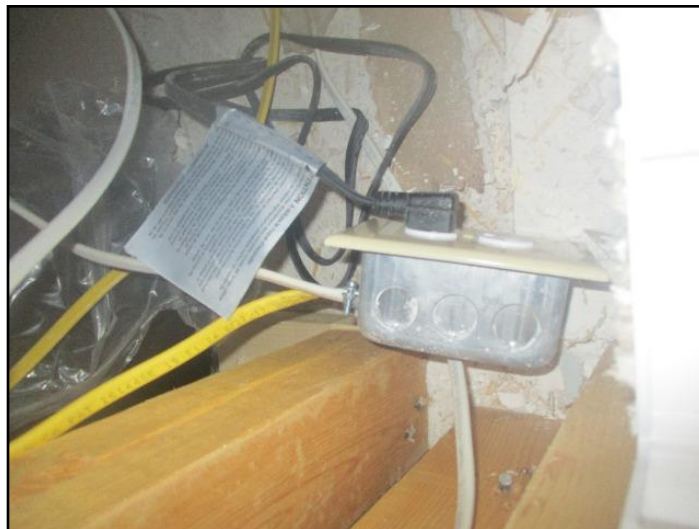
12. Condition: • Outlet box was not attached to anything

21. Loose outlet box

Task: Attach outlet box to structural

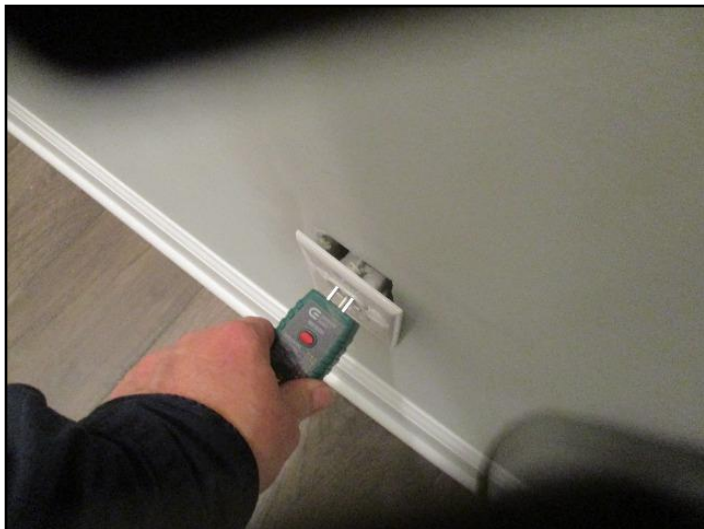
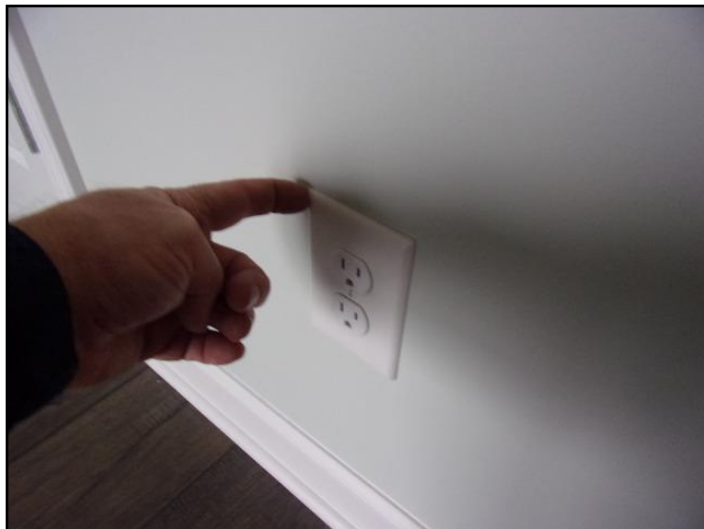
13. Condition: • [Loose](#)

Implication(s): Electric shock | Fire hazard

22. Loose

Task: Repair or replace

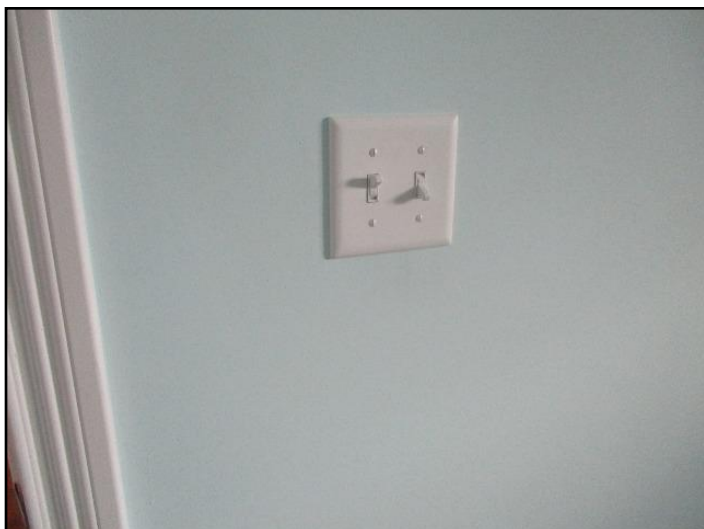
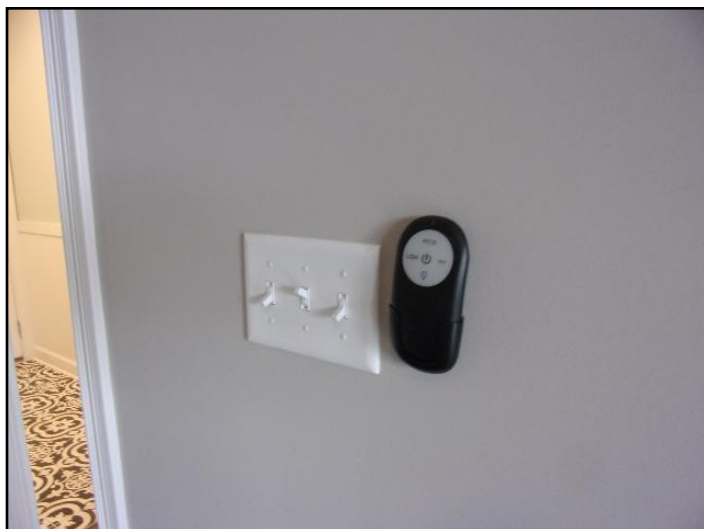
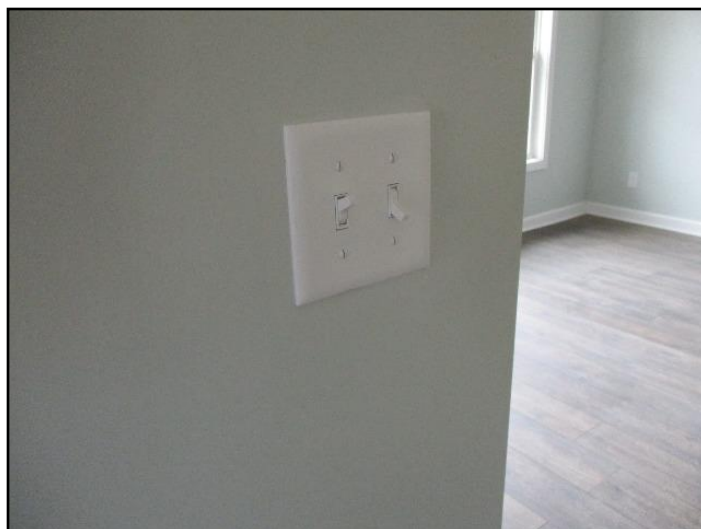
Several wall switches did not appear to operate any fixture

24. Inoperative switch in basement

25. Inoperative switch in master bedroom

26. Inoperative switch by dining room

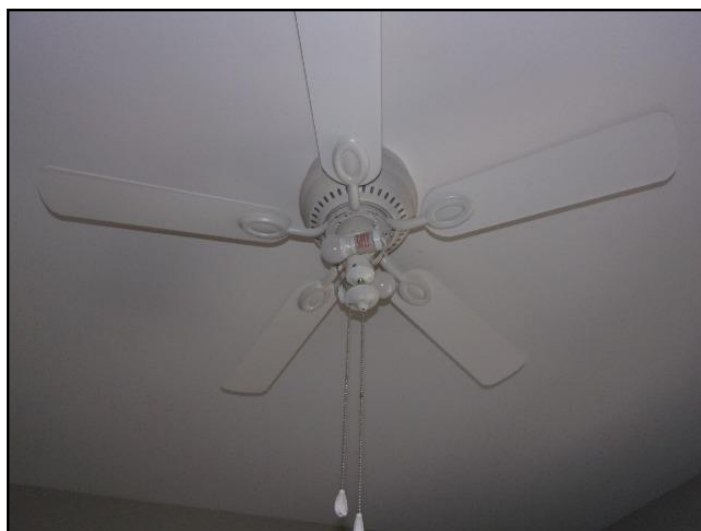
Lamp cover was missing

27. Missing lamp cover

**Task:** Furnish lamp cover

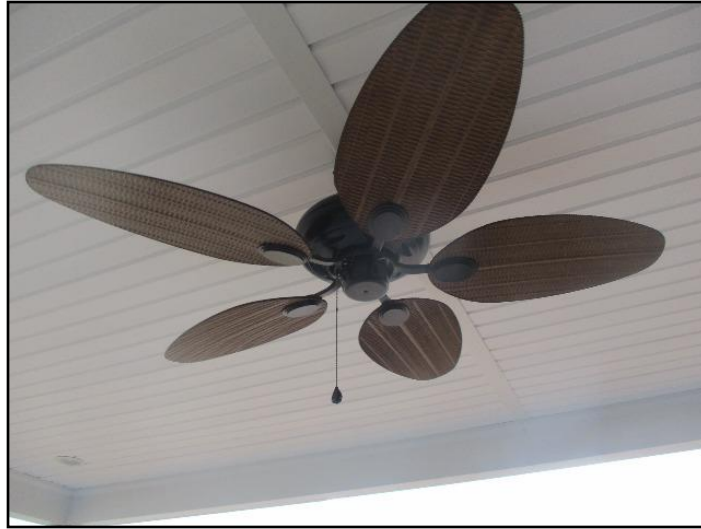
No switch to operate the ceiling fan was found.

**28.** *Ceiling fan problems*

**Task:** Repair or replace

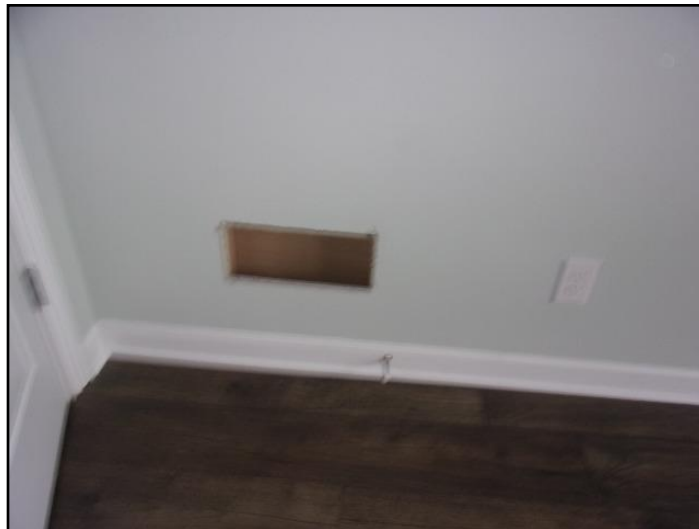
**17. Condition:** • [Missing](#)

29. Missing grill

**Task:** Furnish grill

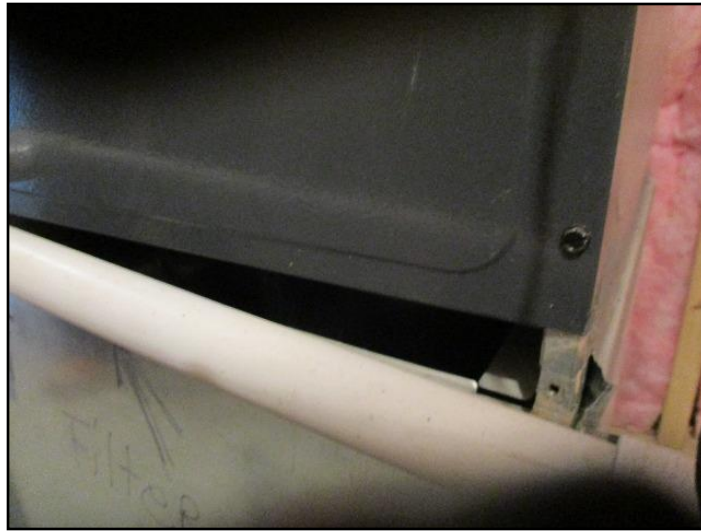
30. Missing

**18. Condition:** • [Missing](#)

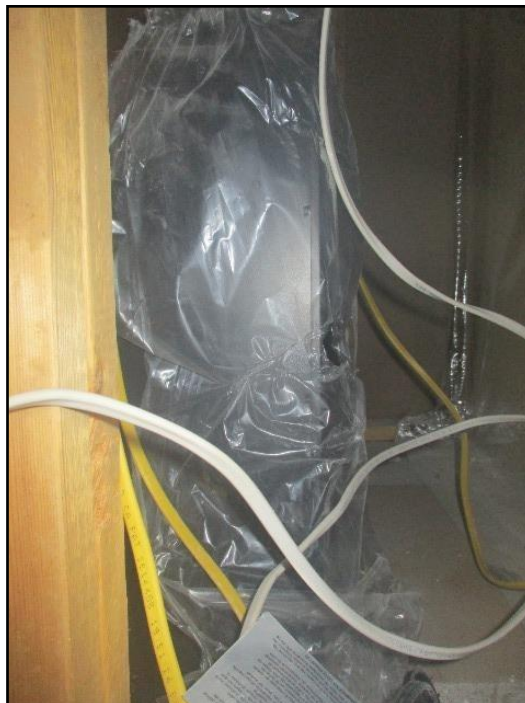
**19. Condition:** • Electrical fireplace insert was new and appeared to be wrapped with plastic.

31. Plastic wrap fireplace insert

**Task:** Confirm with builder if plastic is to be removed before using

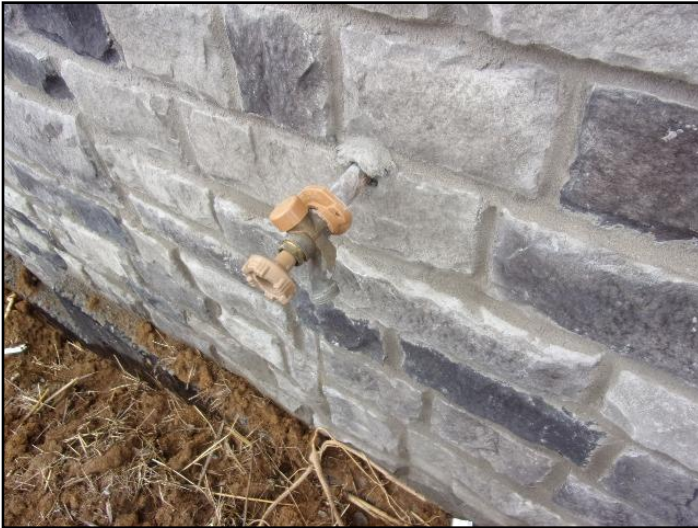
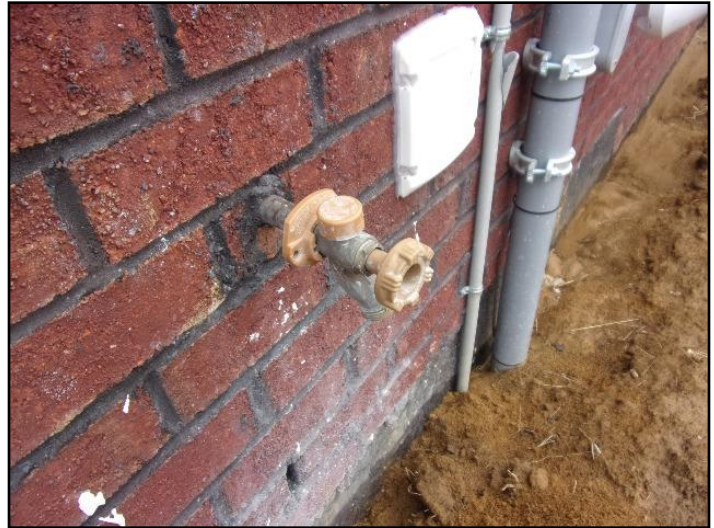
**21. Condition:** • Hose bibs installed too far from house

33. Hose bib-front of house

34. Hose bib-right side of house

**Task:** Relocate hose bibs closer to house

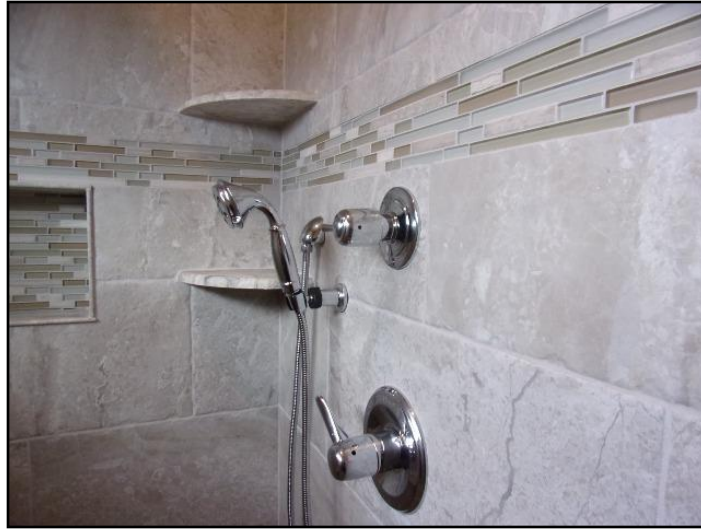
**22. Condition:** • [Shower diverter inoperative or defective](#)

35. Shower diverter inoperative or defective

**Task:** Repair or replace

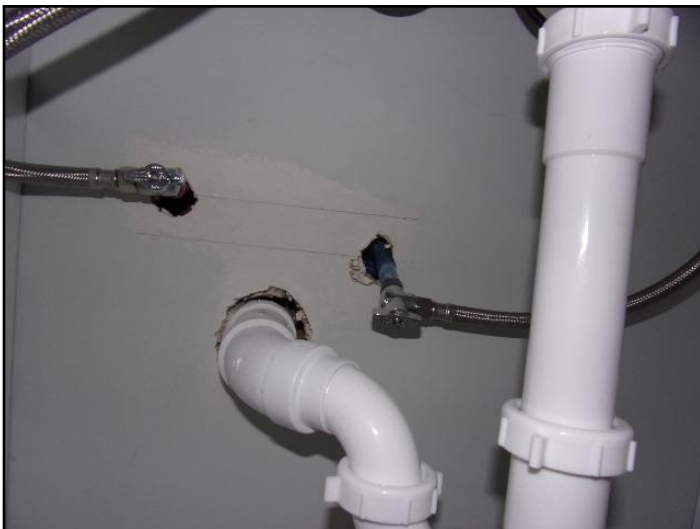
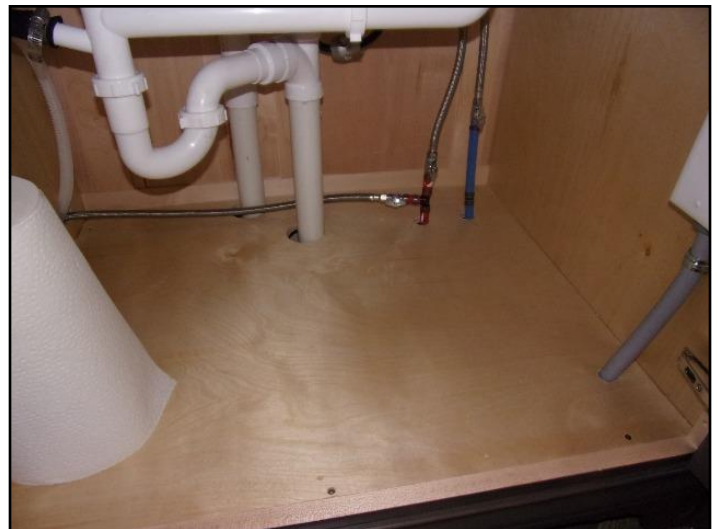
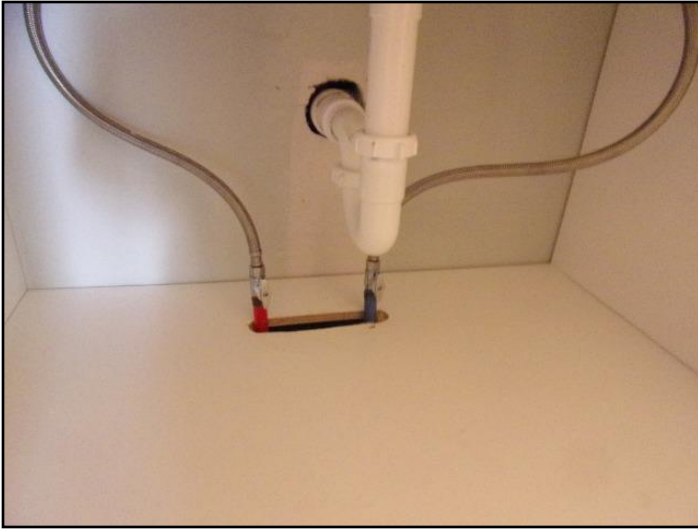
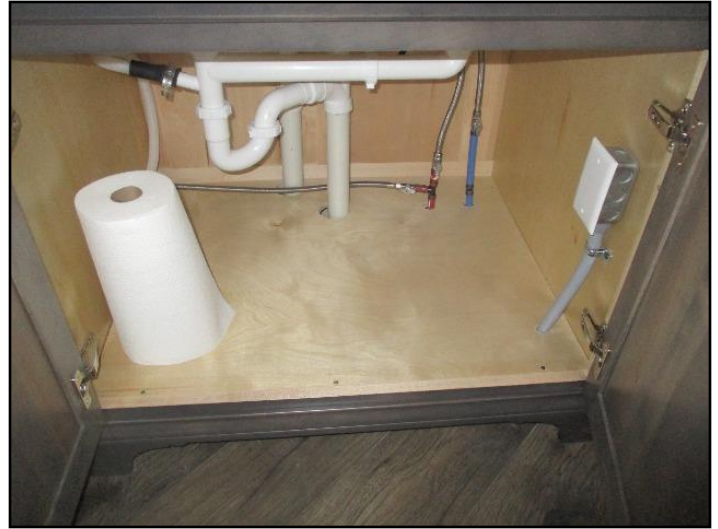
**23. Condition:** • Water supply lines and drain penetrations through the wall were missing escutcheons.

**Task:** Provide escutcheons or cover plates

36. Provide cover plates

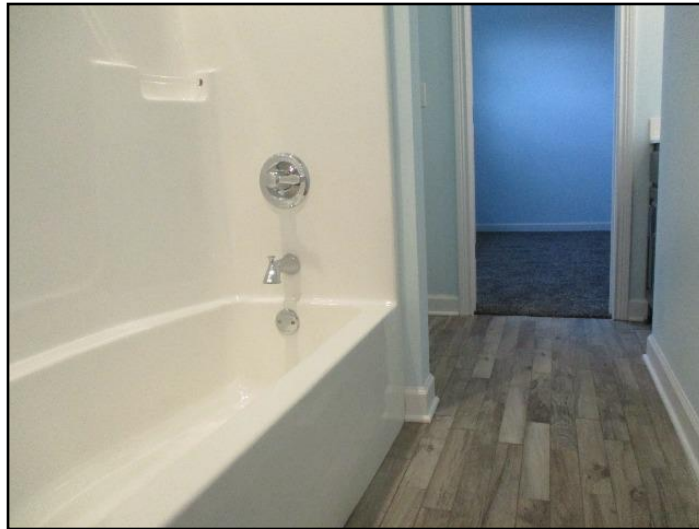
**24. Condition:** • The hot water was not working in the basement tub

40. No hot water

**Task:** Repair or replace

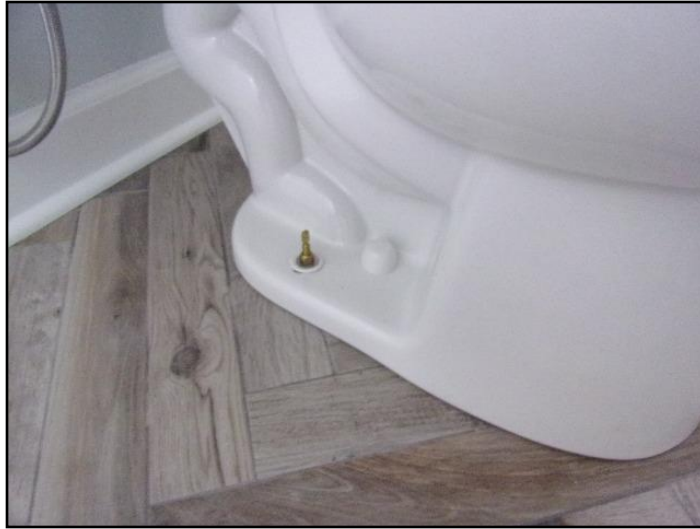
**25. Condition:** • [Surface defects](#)

**41.** *Too long toilet bolts*

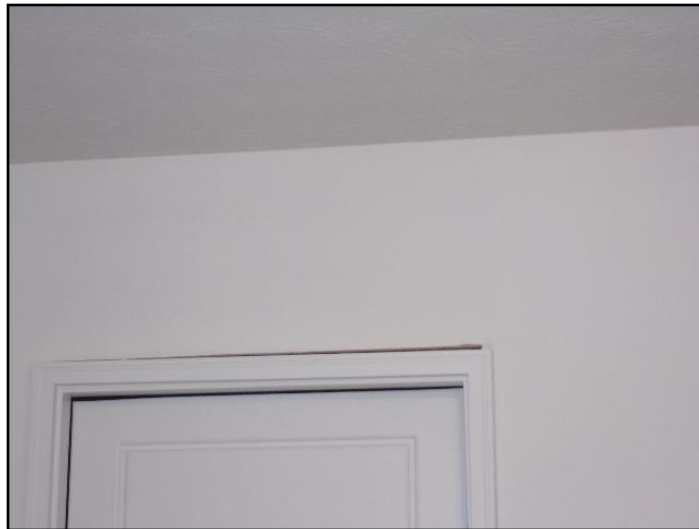
**26. Condition:** • Gap above garage man door.

42. Gap above door

**Task:** repair drywall gap above door

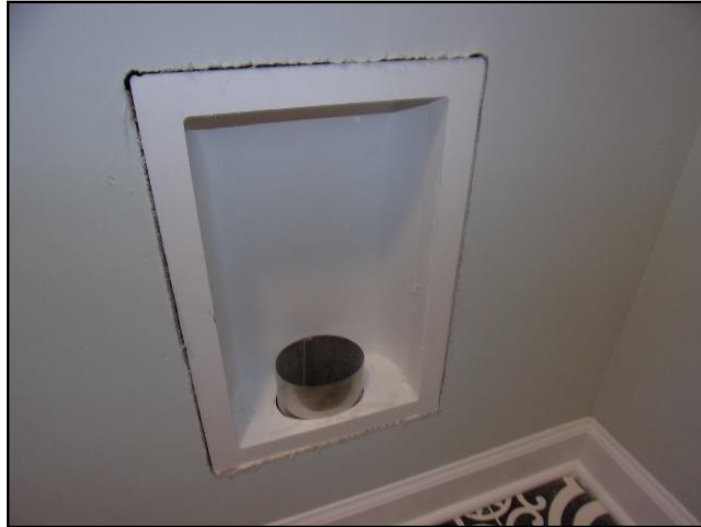
**27. Condition:** • [Loose or missing](#)

43. Loose vent box

**Task:** secure dryer vent box

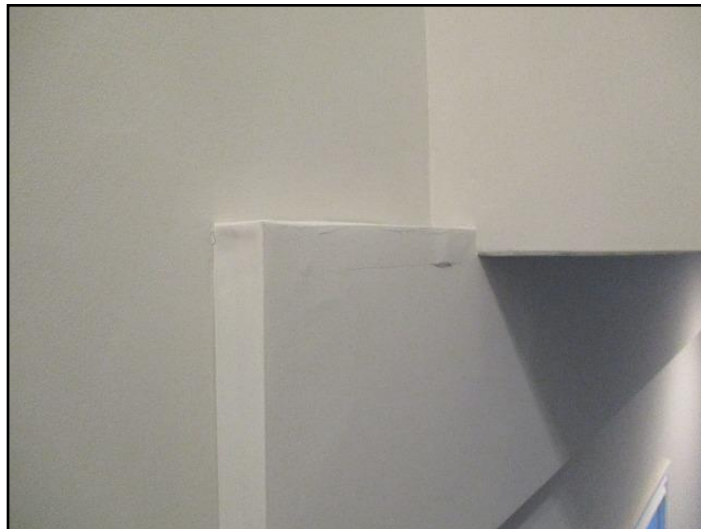
Minor drywall damage

44. Typical flaws

**Task:** Repair and repaint

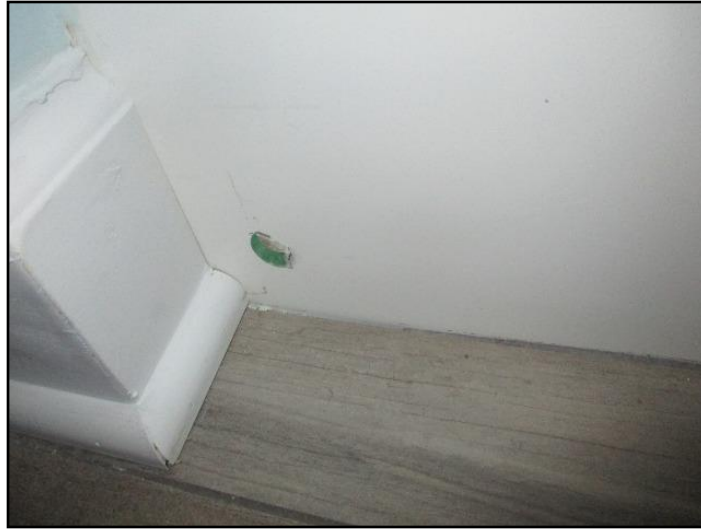
**29. Condition:** • Missing tub caulk

45. Missing caulk

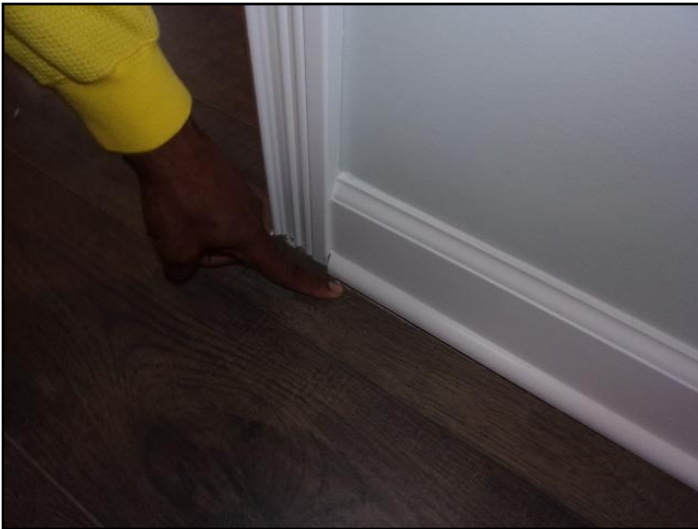
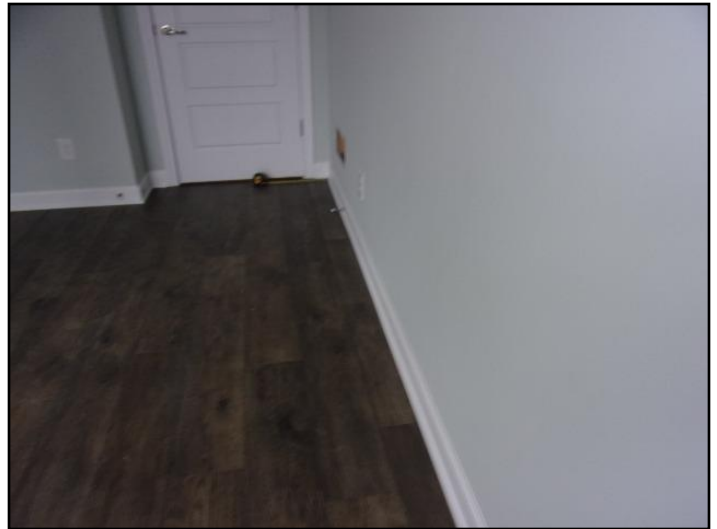
**30. Condition:** • Improper installation

46. Improper installation

47. Improper installation

**Task:** Correct crooked tiles, fill gaps

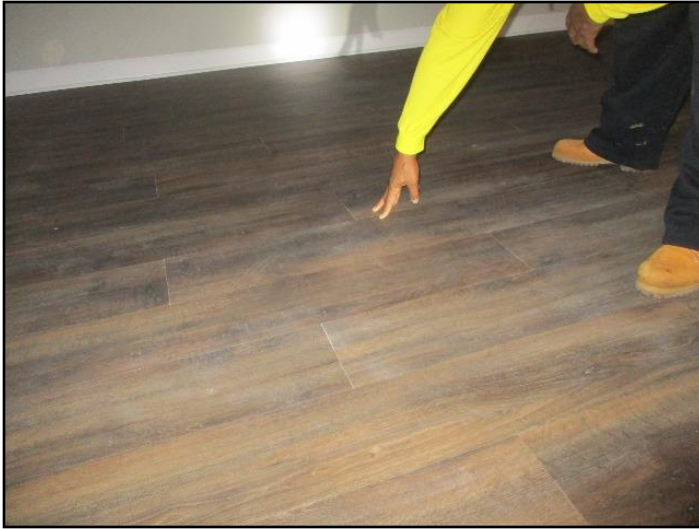
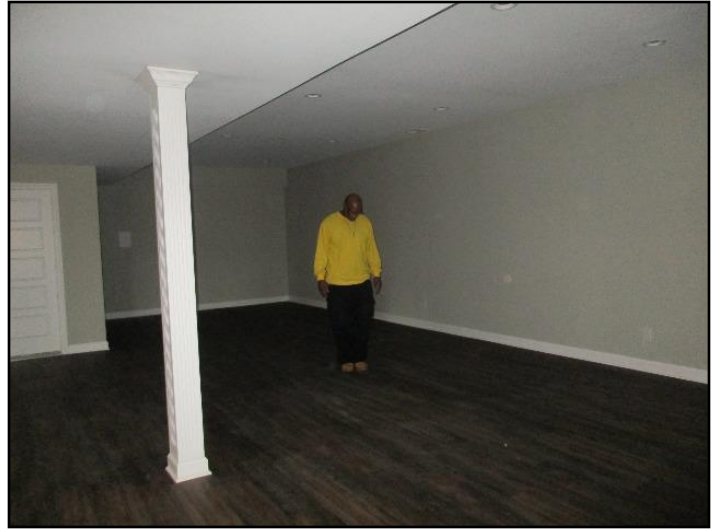
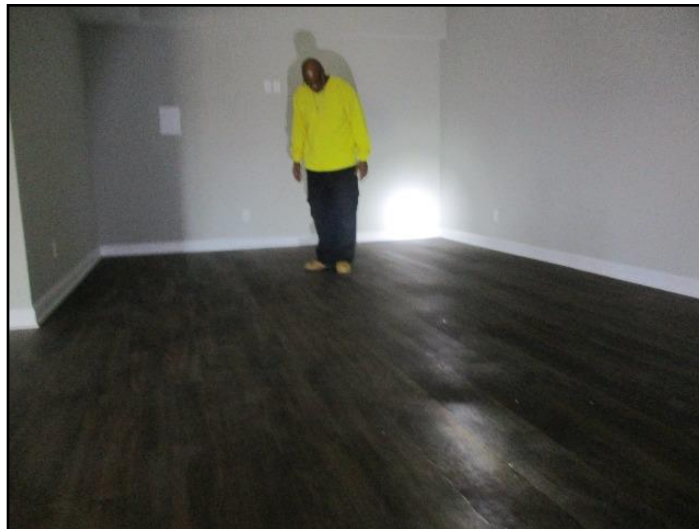
Several "bubbles" were noted in vinyl floor in the basement preventing the floor from laying flat.

48. "Bubbles" in floor

49. "Bubbles" in floor

50. "Bubbles" in floor

**Task:** Repair faulty floor spots

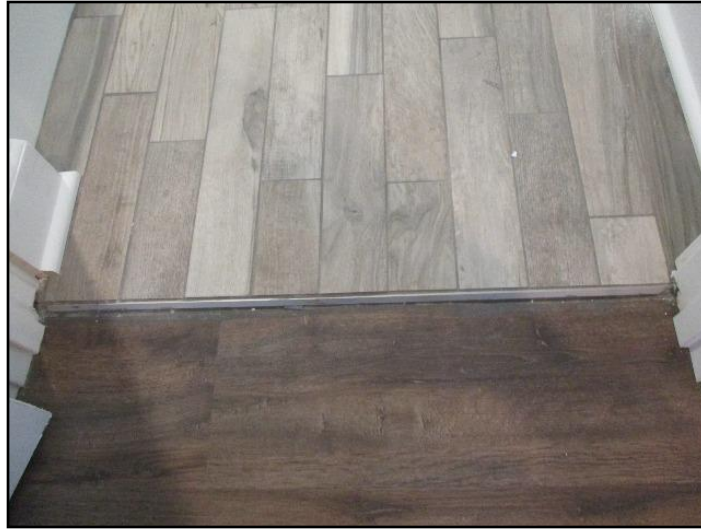
## 32. Condition: • [Open seams](#)

51. Threshold gap

**Task:** Repair threshold gap

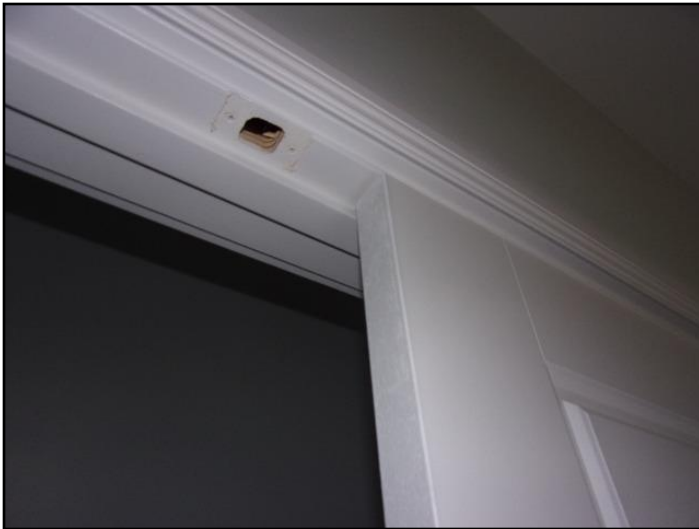
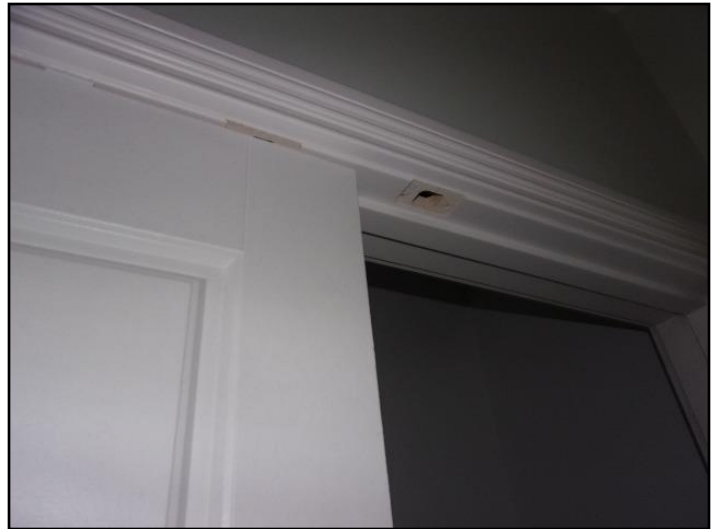
### 33. Condition: • [Missing](#)

**Task:** Install door latch

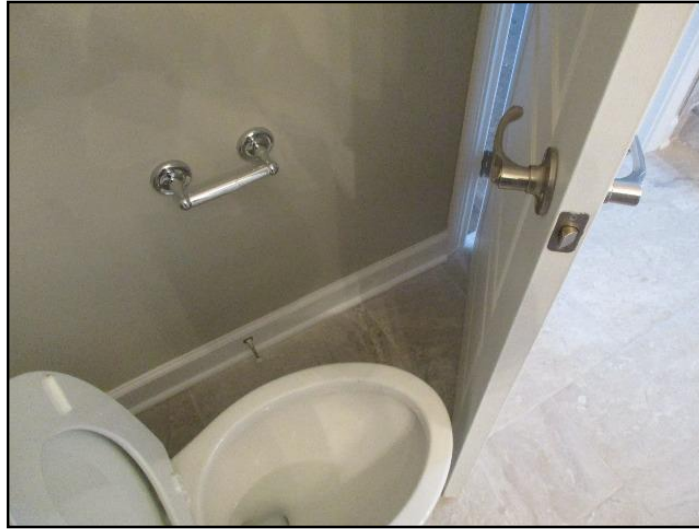
### 34. Condition: • [Ineffective](#)

54. Ineffective door stop

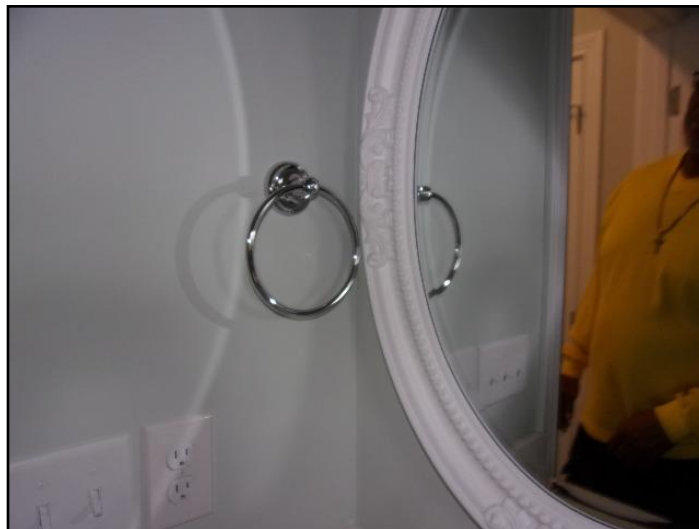
**35. Condition:** • Towel ring was installed too close to the bathroom mirror.

55. Towel ring

**Task:** Relocate towel ring

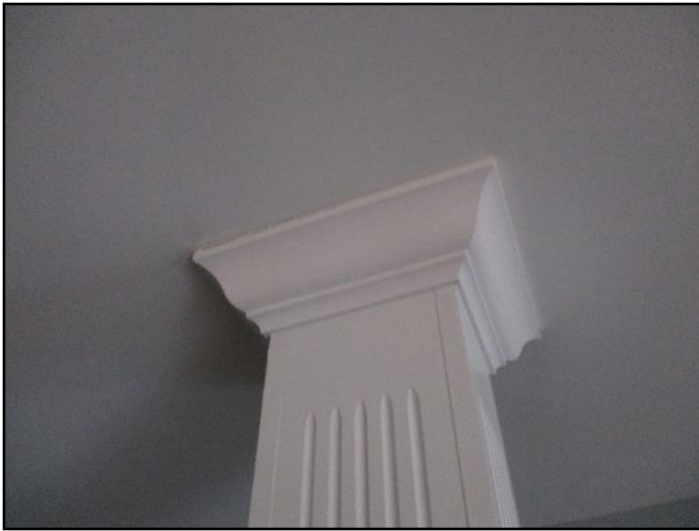
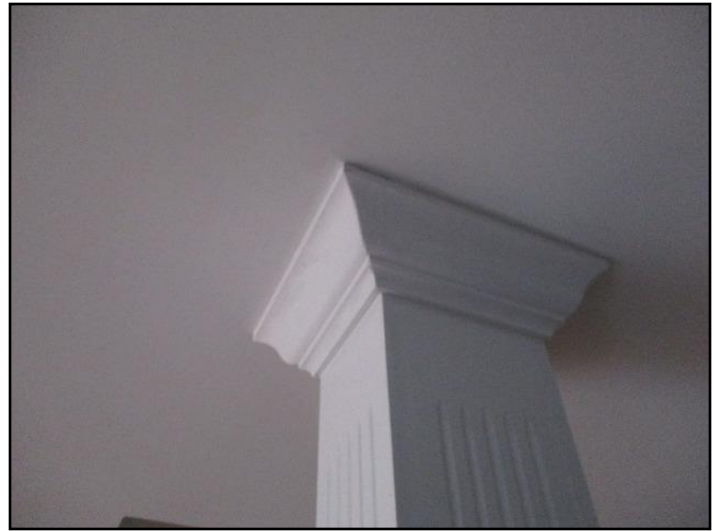
**36. Condition:** • Trim paint appeared to be applied to the ceiling and the two columns needed touch-up paint

56. Need touch-up paint

57. Need touch-up paint

**Task:** Touch up paint columns and ceiling

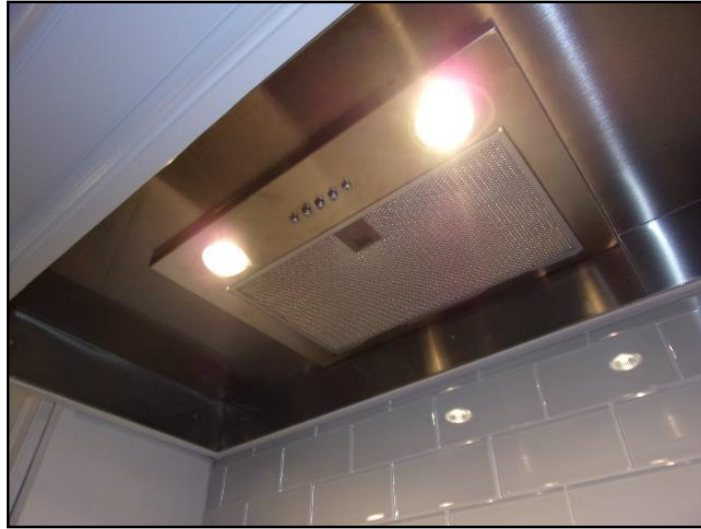
37. Condition: • Not vented to exterior

**Implication(s):** Chance of condensation damage to finishes and/or structure

58. Not vented to exterior

**Task:** Verify with the building the range exhaust fan discharges to the exterior and the fan is operating properly.
