Your Inspection Report

42 Kawaihani Circle
Kihei, HI 96753

INSPECTION DATE:
Tuesday, October 8, 2019

RE: Report No. 1012
42 Kawaiiani Circle
Kihei, HI
96753

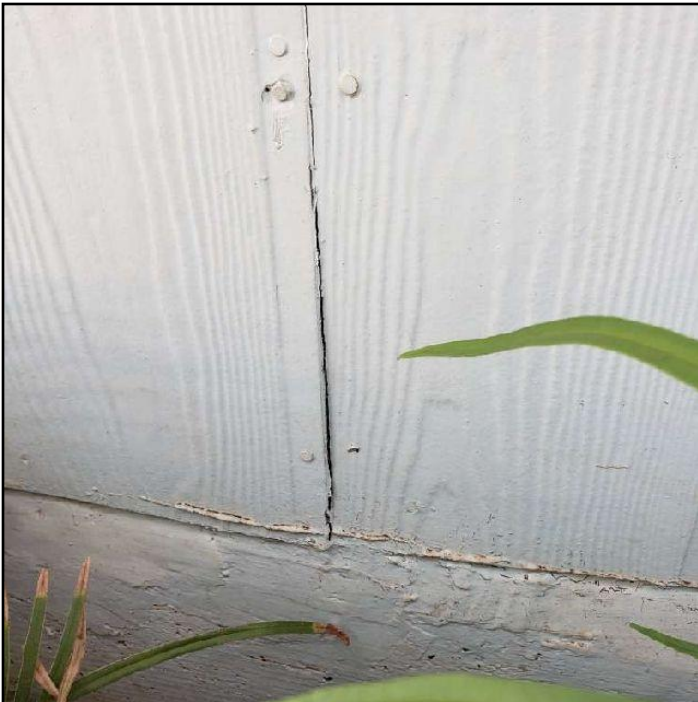
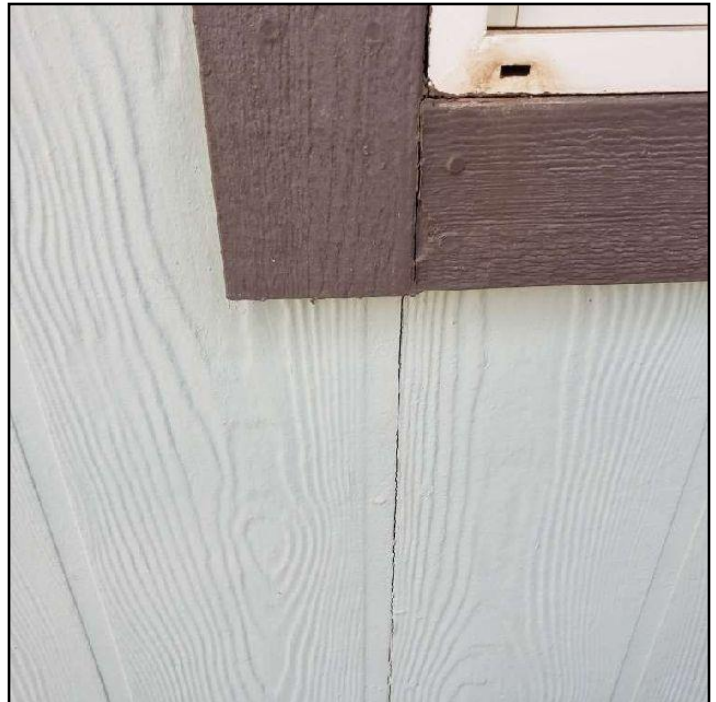
2. Condition: • [Missing paint or caulking](#)

Siding on right side is in need of caulking maintenance. Could lead to water intrusion.

Missing paint or caulking

Task: Service annually

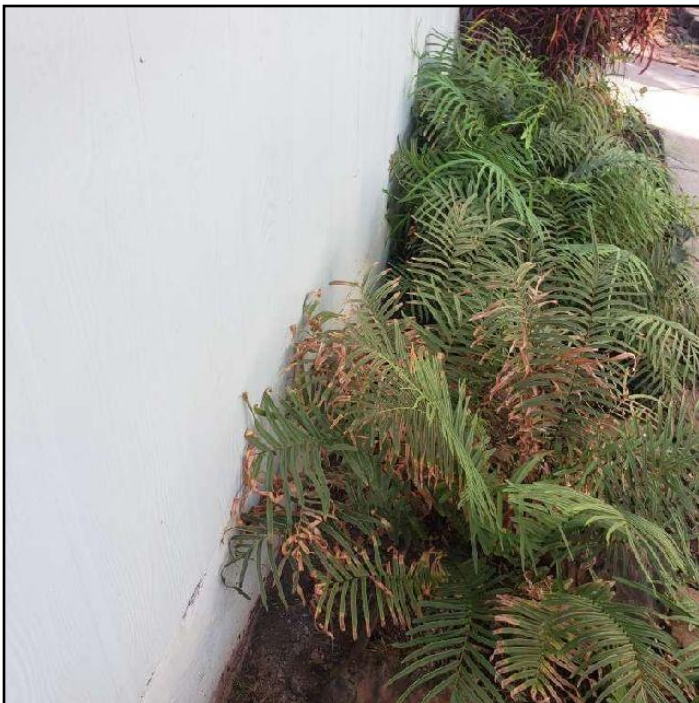
Tree at the left front of house which is in contact with the roof which compromises the life expectancy of the roofing material. Also observed plant material against the home on the right side of the home which may also lead to water intrusion.

Trees or shrubs too close to building

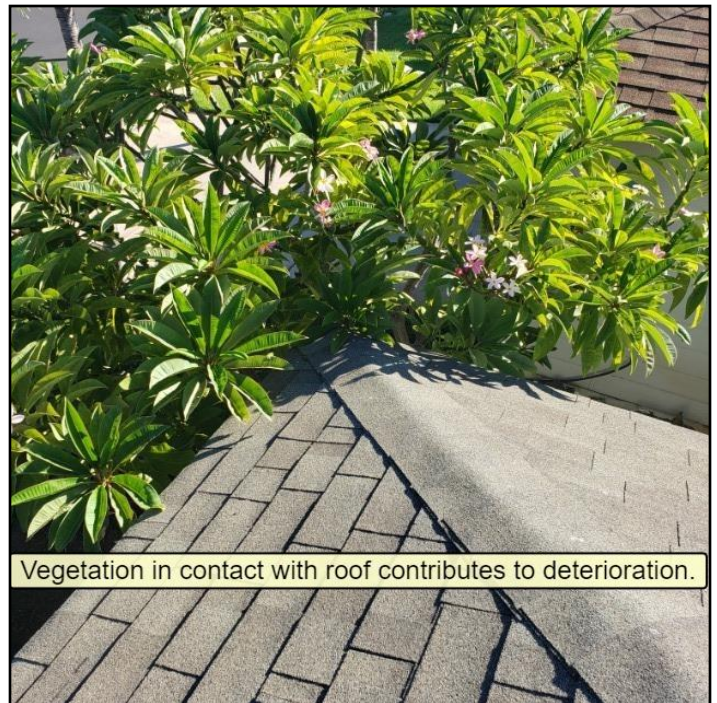
Vegetation in contact with roof contributes to deterioration.

Trees or shrubs too close to building

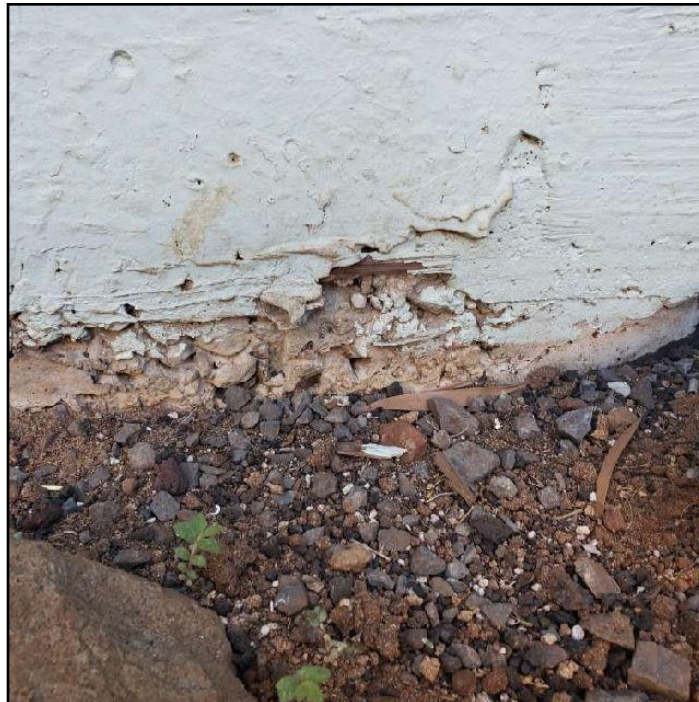
4. Condition: • [Spalling](#)

Minor spalling in two places along right side of home toward the front.

Spalling

Task: Monitor

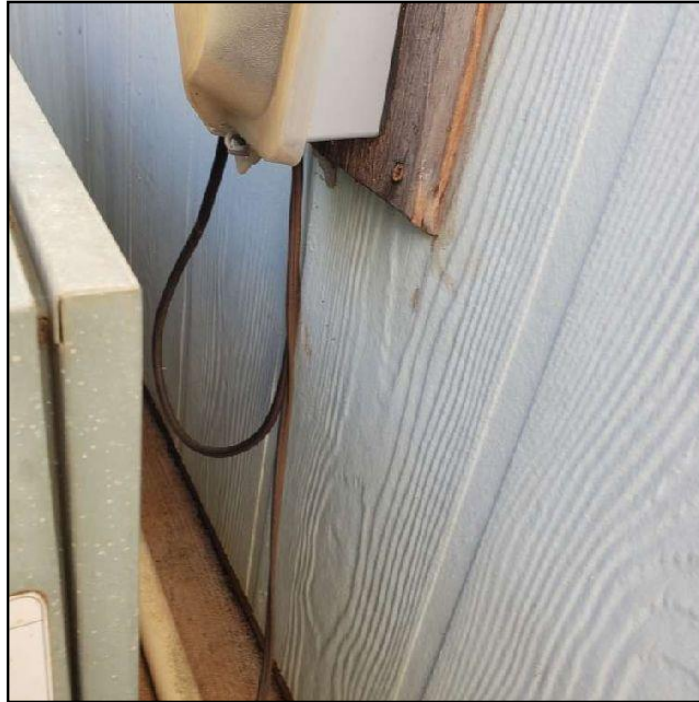
5. Condition: • [Extension cord used as permanent wiring](#)

Implication(s): Electric shock | Fire hazard

Extension cord used as permanent wiring

Task: Improve

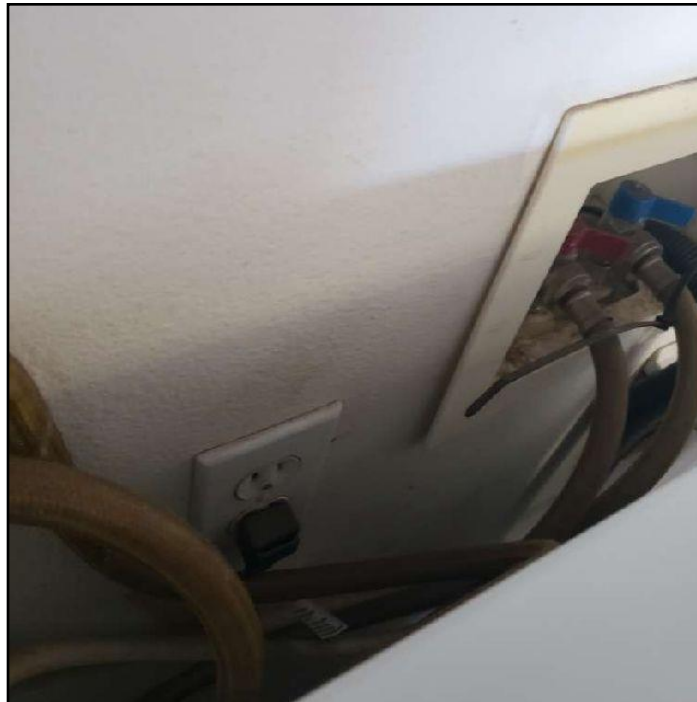
6. Condition: • [GFCI/GFI needed \(Ground Fault Circuit Interrupter\)](#)

GFCI needed nest to wash basin within 6 ft. Safety

GFCI/GFI needed (Ground Fault Circuit...

Task: Replace
