INSPECTION REPORT

For the Property at:
1234 NEW HOME
SE WISCONSIN, WI

Prepared for: EXAMPLE REPORT
Inspection Date: Friday, December 11, 2020
Prepared by: David Gross

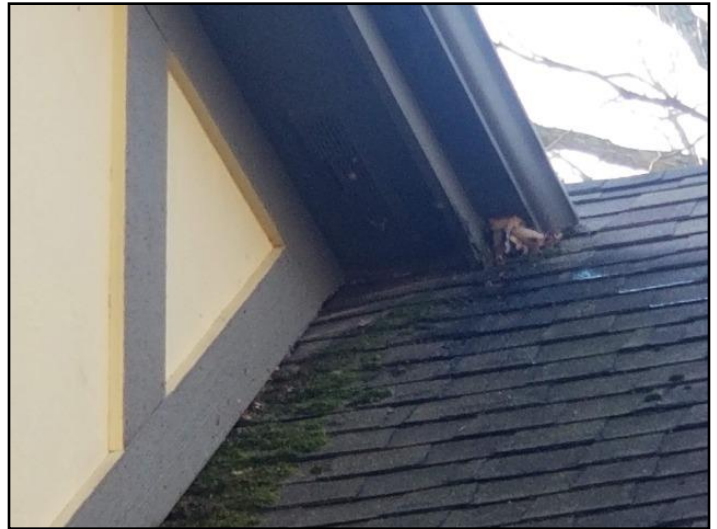
1. Condition: • Organic growth on north side of roof. Clean with appropriate cleaners to extend roof life

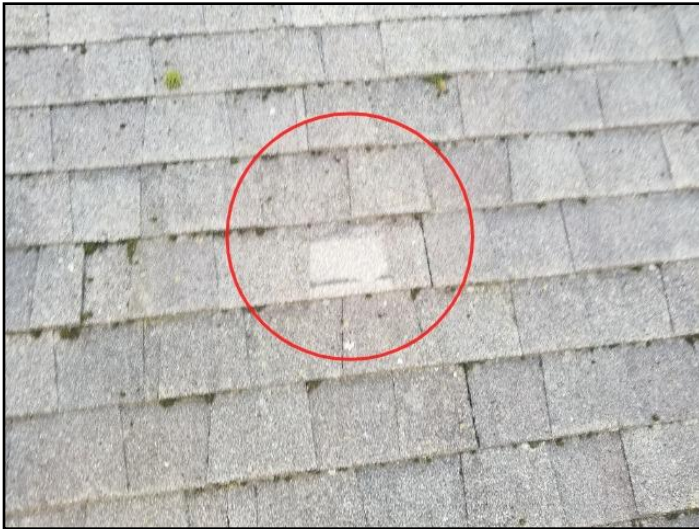
Various shingles have damage to them on West side of roof above flat roof. Have repaired by roofing contractor

3. Missing, loose or torn

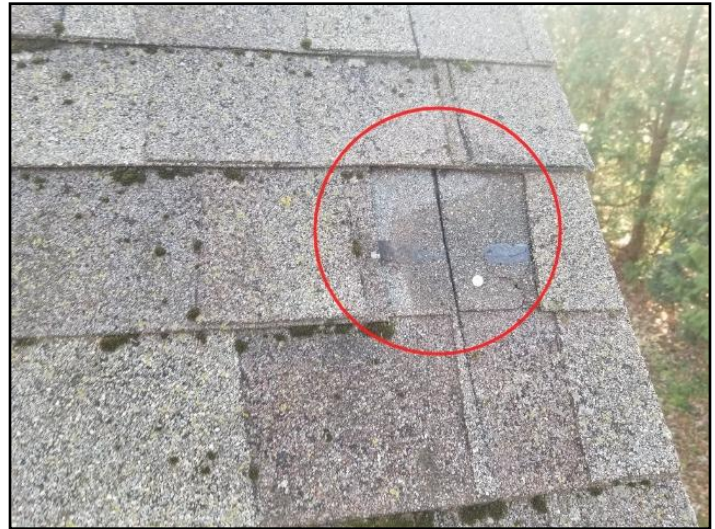
4. Missing, loose or torn

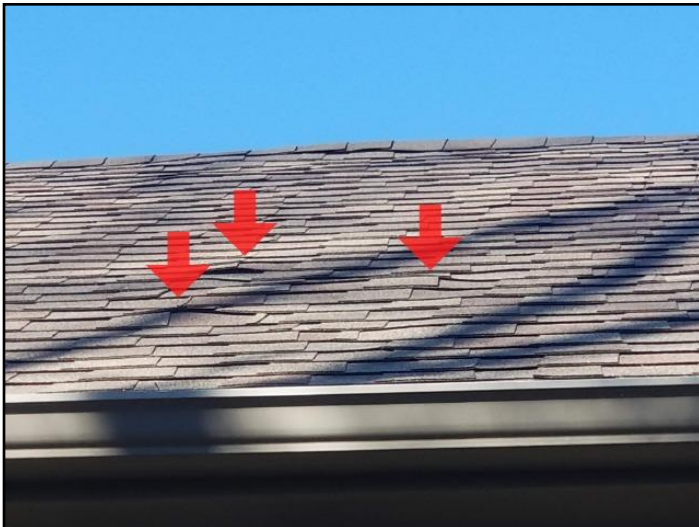
3. Condition: • Nail Pop Have roofer or handyman correct nail prior to having it back out through the shingle. Noted various nail pops on roof. Have handyman or roofer repair as needed.

5. Nail Pop Have roofer or handyman correct...

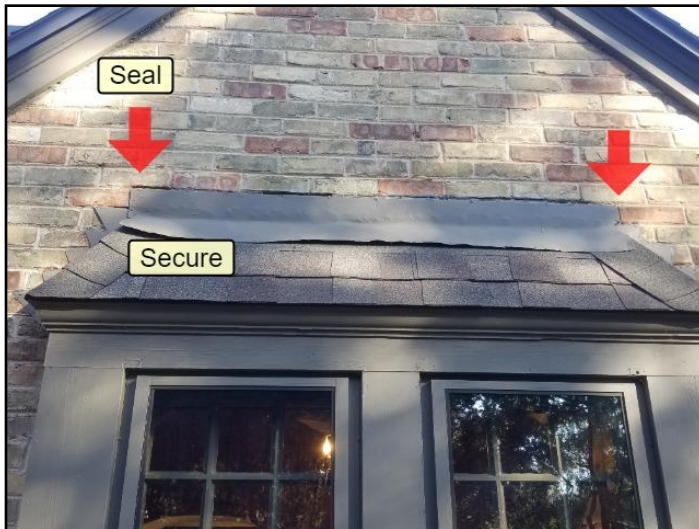
4. Condition: • Damage, loose, open seams, patched

7. Damage, loose, open seams, patched

Have mason or reputable handyman correct flashing on bay window. Seal gaps with appropriate sealant, secure flashings and seal nail heads as needed.

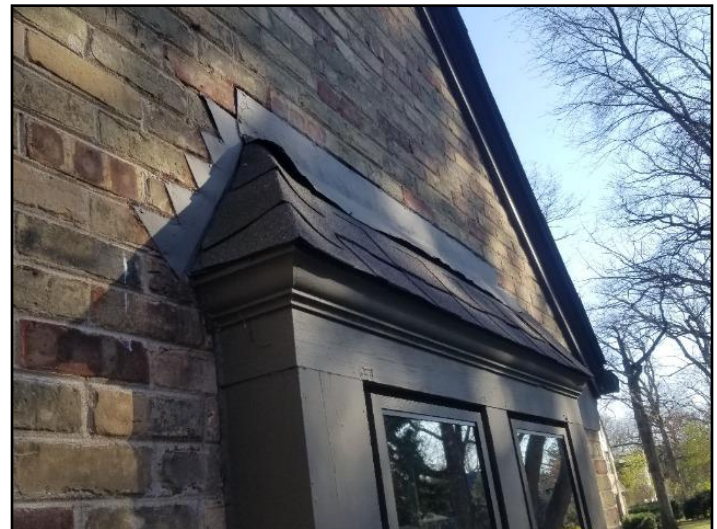
8. Damage, loose, open seams, patched

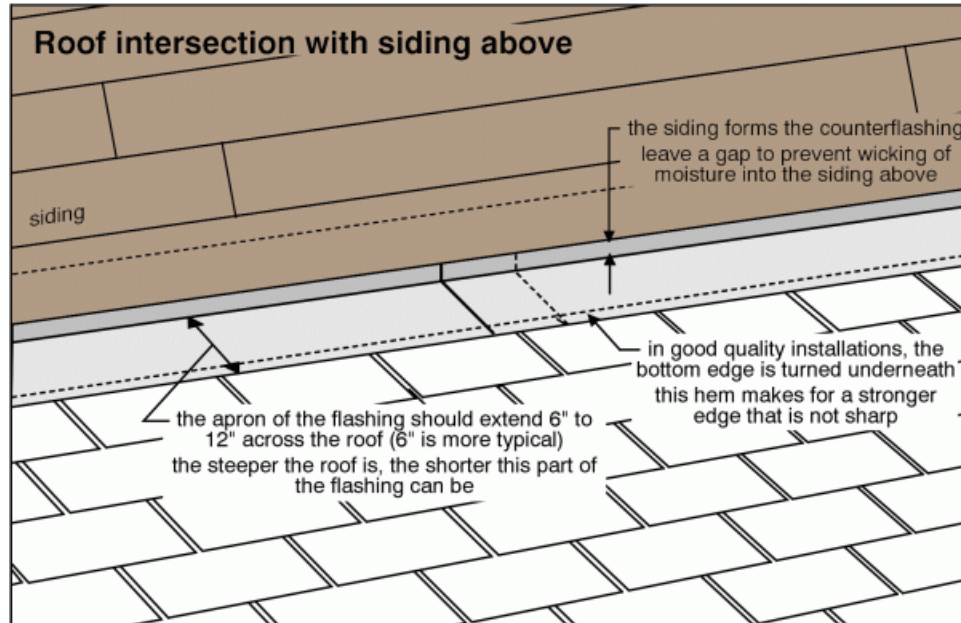
Areas of roofing have wood trim and siding in direct contact with roof. Have corrected by having wood cut back 1-2" and painted when replacing roof.

9. Siding not cut back

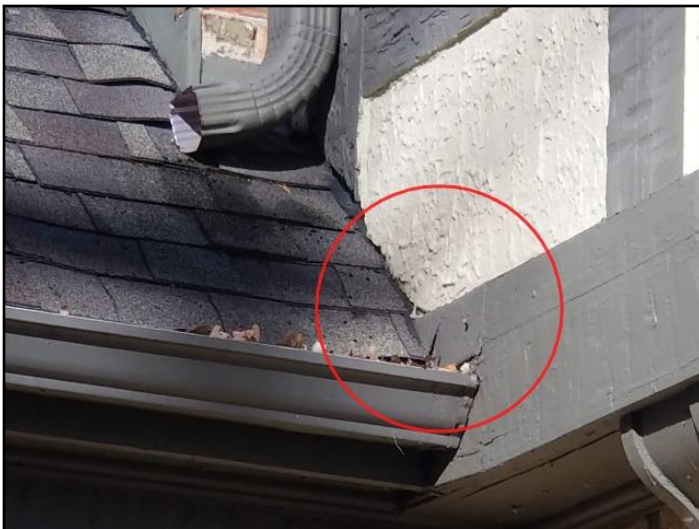
6. Condition: • Kickout flashing - missing

11. Kickout flashing - missing

Kick out flashings not present have reputable roofer, handyman, siding or gutter contractor install kickout flashings as needed.

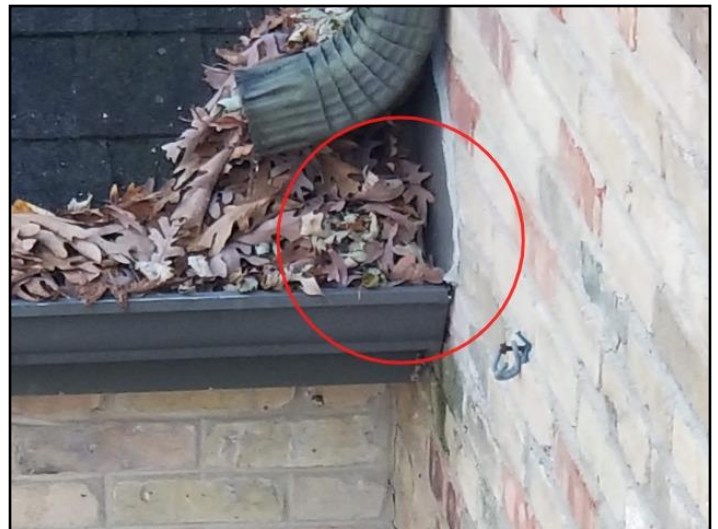
12. Kickout flashing - missing

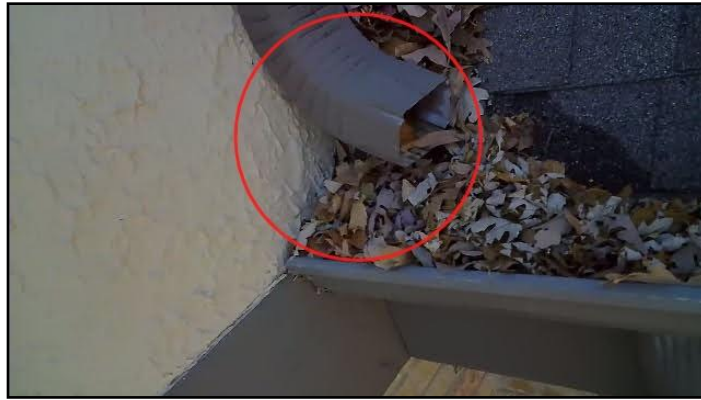
13. Kickout flashing - missing

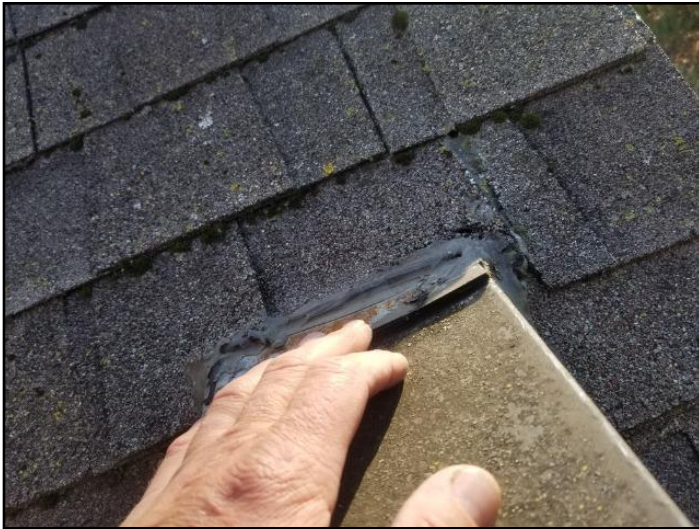
Flat roof has few areas where the caulking has failed. Have roofer point up the areas on parapet to roof flashing, and along chimney.

14. Failed caulking

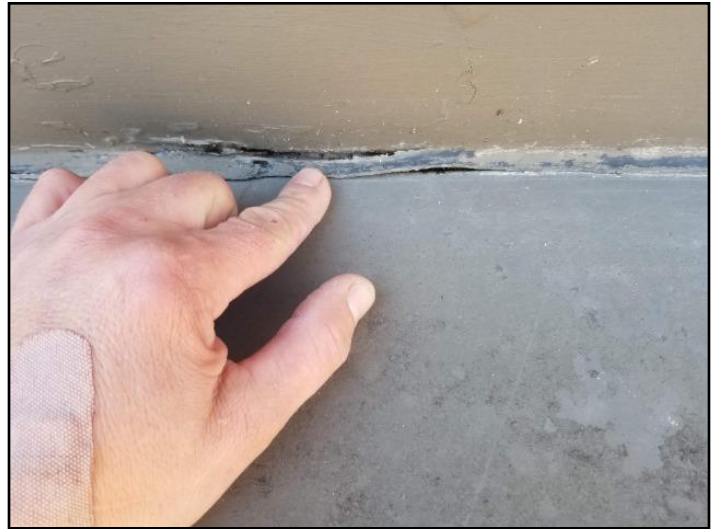
15. Failed caulking

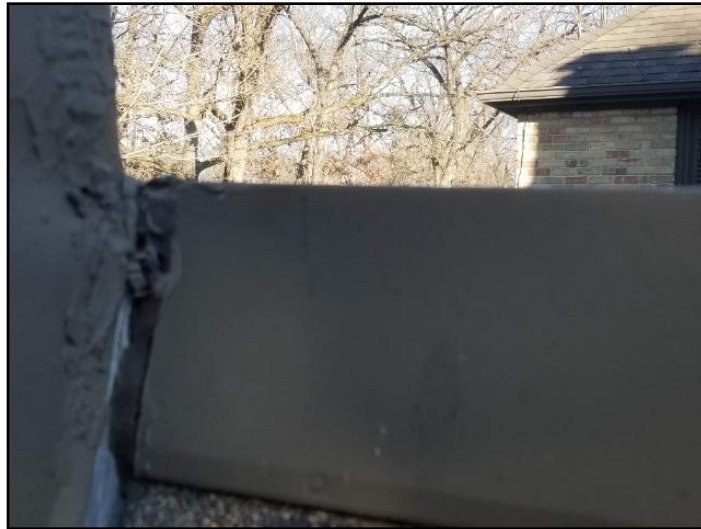
16. Failed caulking

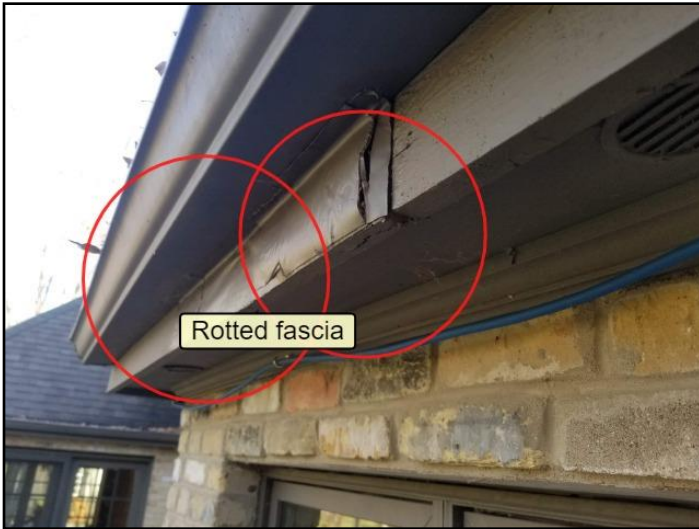
Fascia on North side of home under scupper is rotted and needs replaced. Noted damage to corner on southside of home. Have carpenter replace or repair wood as necessary on these areas.

18. Damage

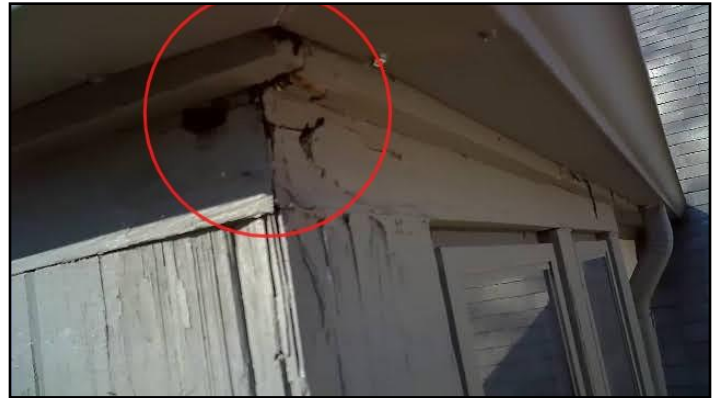
19. Damage

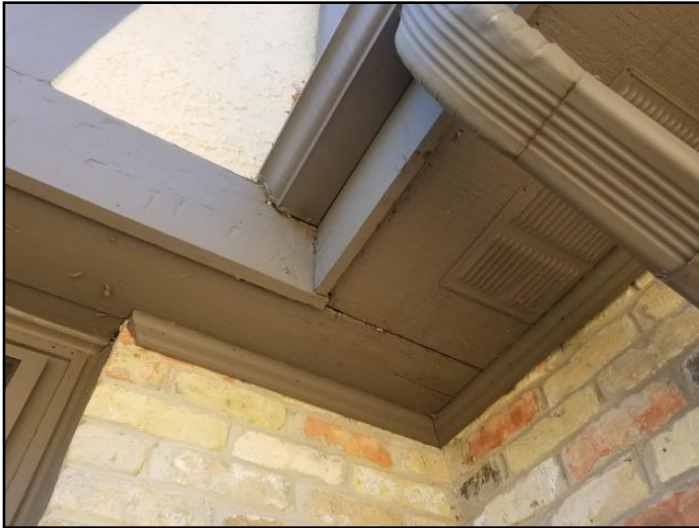
Noted areas of rot on soffit under the sidewall roof junctions by kitchen window. Recommend having contractor repairing rotted wood and installing kickout flashing above wood

20. Rot or insect damage

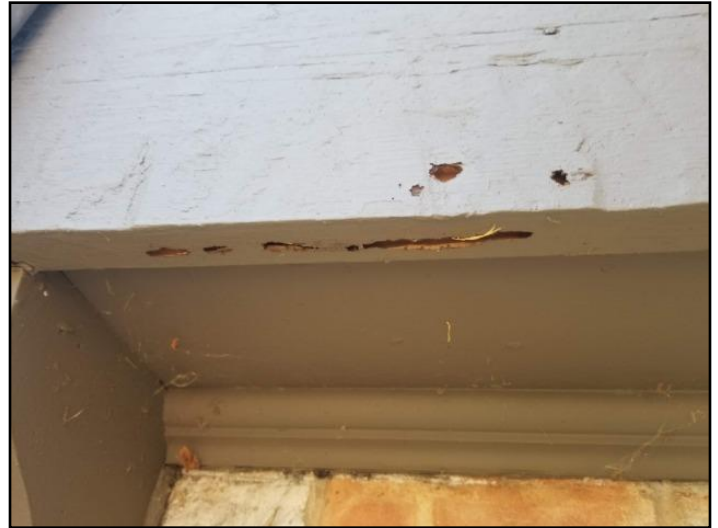
21. Rot or insect damage

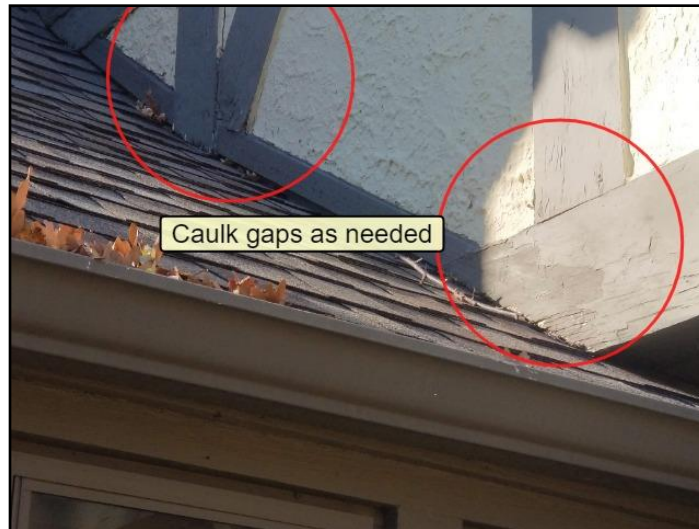
22. Caulking missing or deteriorated

Apply caulking in gaps and junctions of different wall materials to decrease moisture penetration

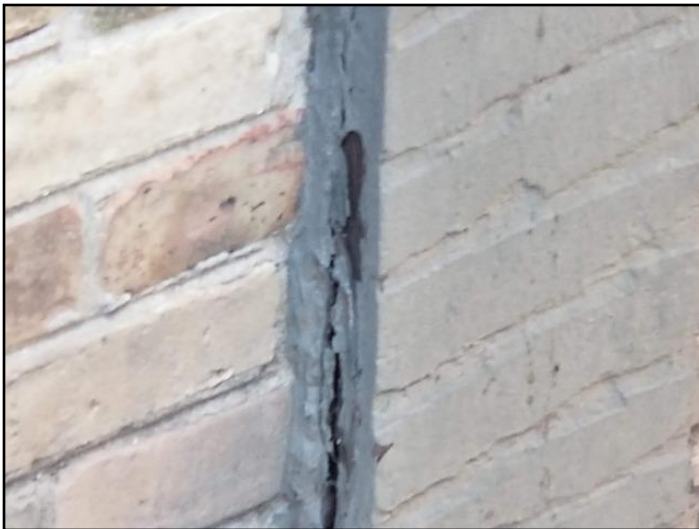
Minor cracks on North side of home. Have qualified contractor seal cracks with exterior concrete caulking for vertical application.

23. Cracked

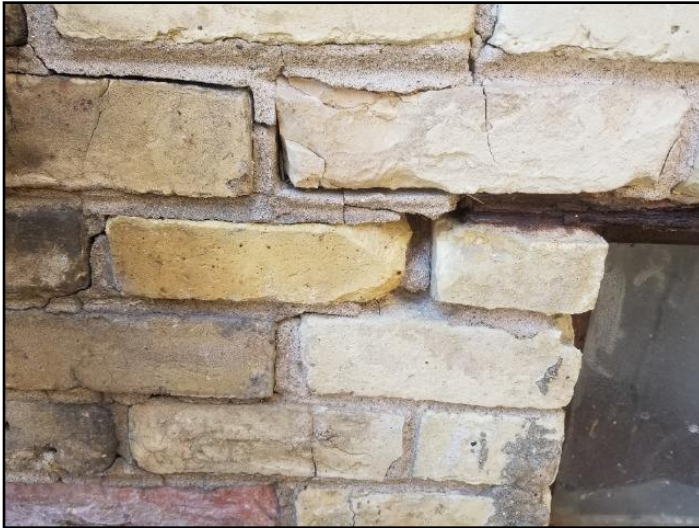
Noted motion of archway bricks over front door. Noted loose brick soldiers on West side of house. Have mason evaluate and repair as needed.

26. Masonry deterioration

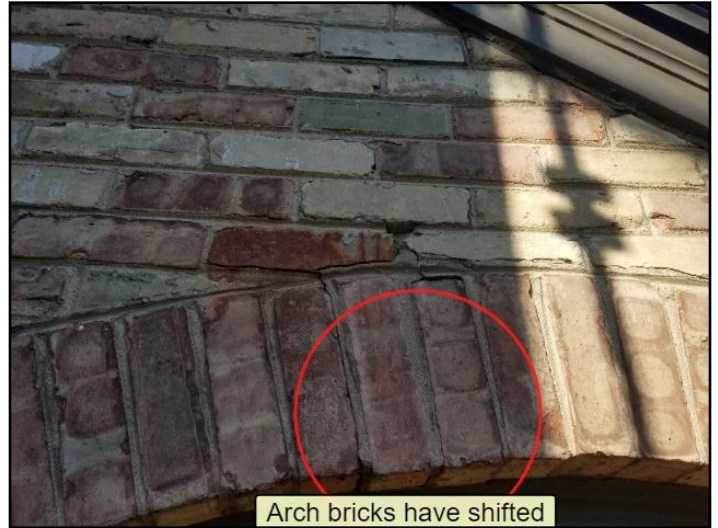
27. Masonry deterioration

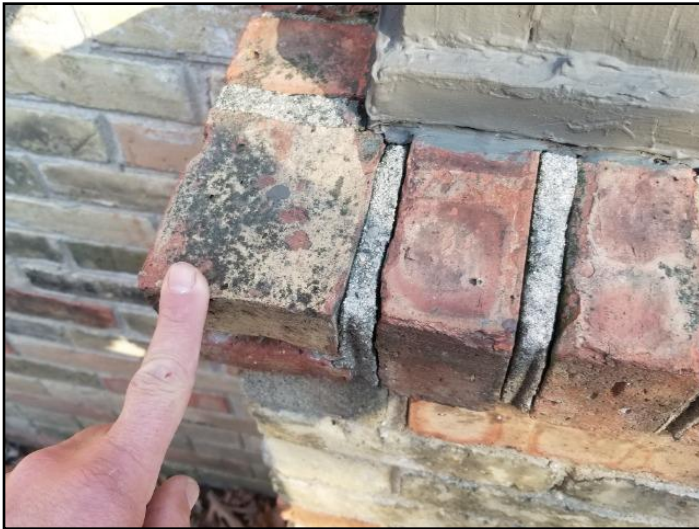
28. Masonry deterioration

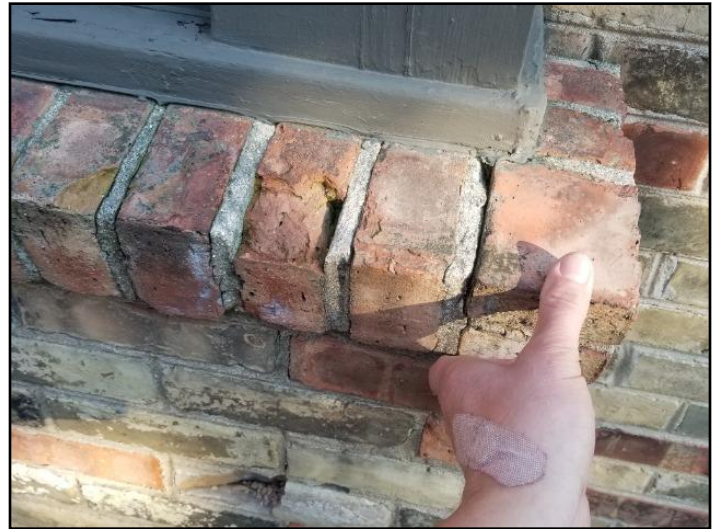
29. Masonry deterioration

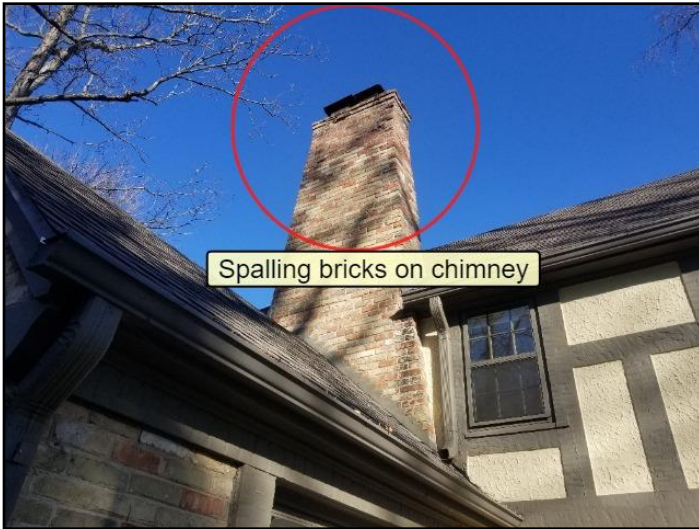
30. Spalling

Have mason repair various spalled bricks on chimney, rear patio and near front porch.

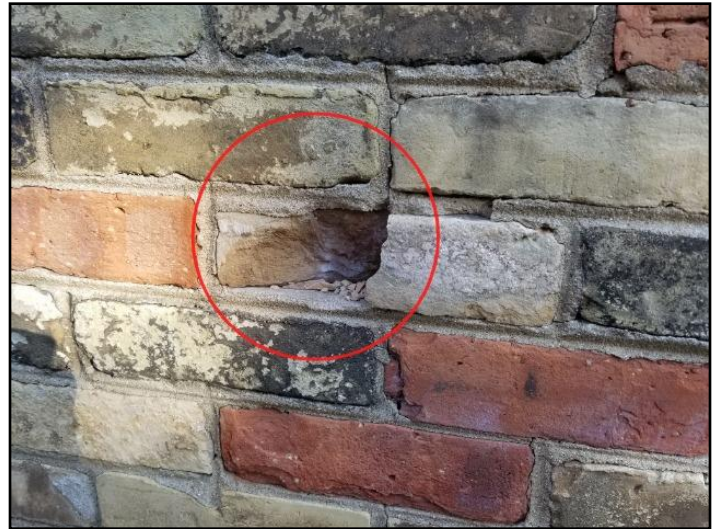
31. Spalling

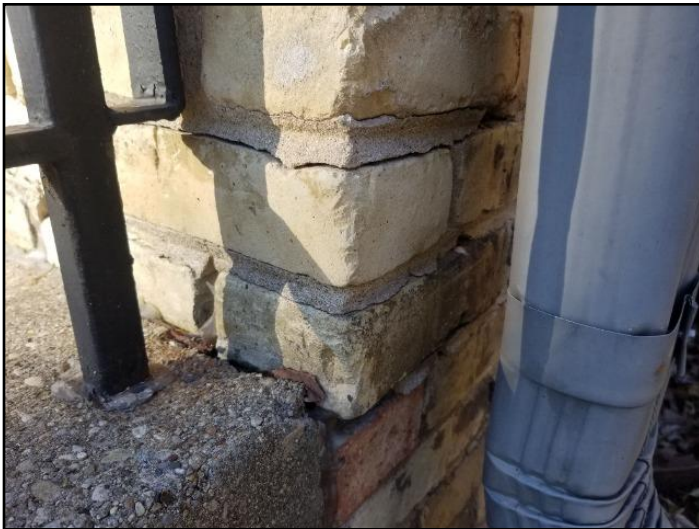
32. Mortar deterioration

Have mason contractor tuckpoint areas around the house as needed.

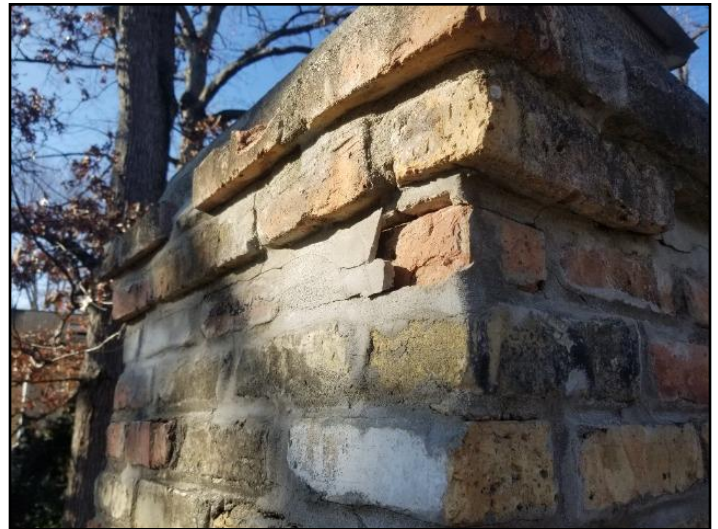
33. Mortar deterioration

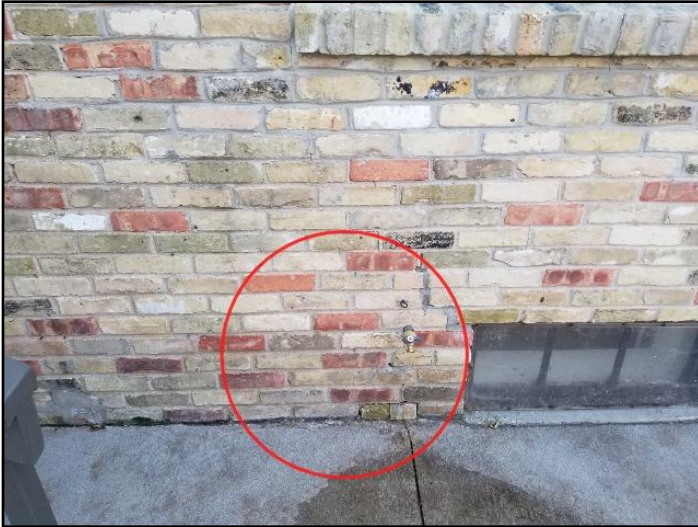
34. Mortar deterioration

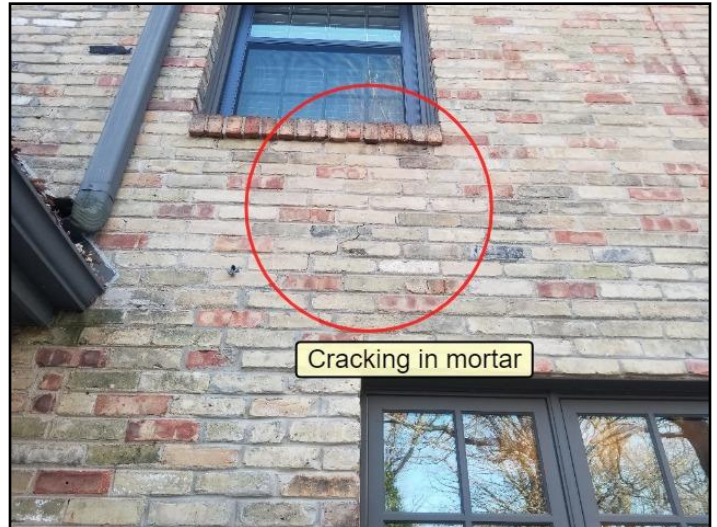
35. Mortar deterioration

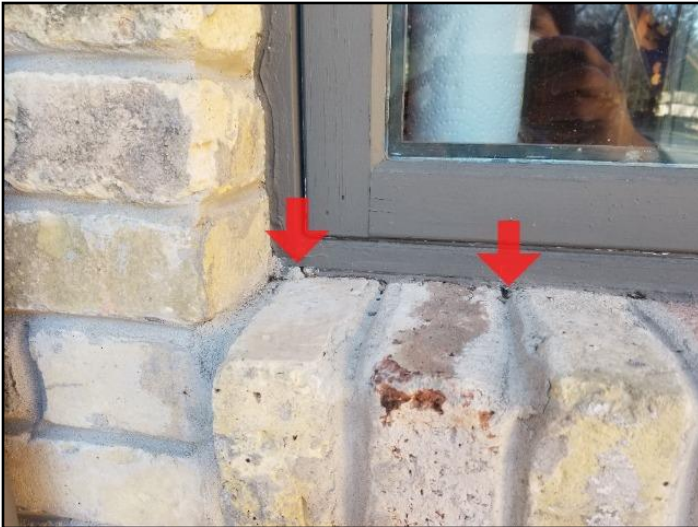
Noted minor gaps between bricks and trim around windows and doors. Clean joints and install appropriate caulking to decrease moisture intrusions.

36. Caulking loose, missing or deteriorated

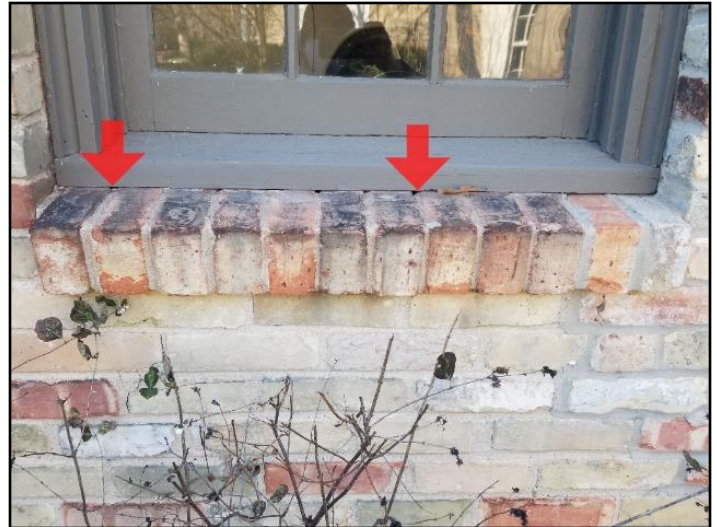
37. Caulking loose, missing or deteriorated

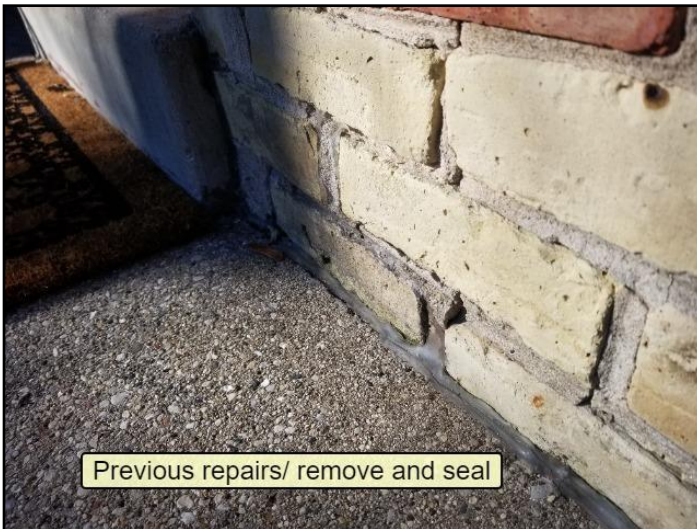
Front porch pitched towards home. Seal gaps along home to decrease moisture intrusion. In future have contractor correct porch pitch as needed.

42. Improper slope or drainage

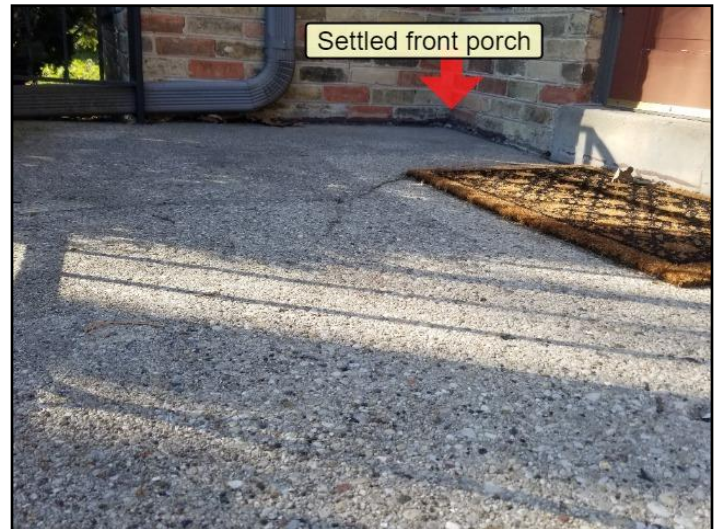
43. Improper slope or drainage

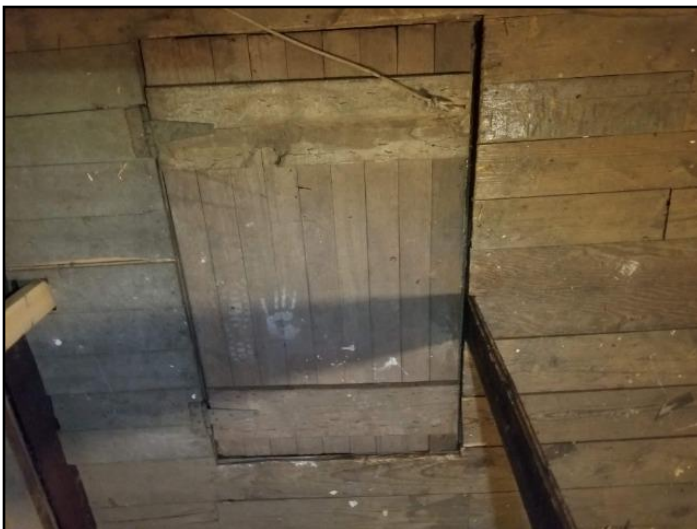
44. Not fireproof

Seal all penetrations with appropriate rated fire blocking and caulking as needed to increase the safety of the wall between the house and garage. Have attic hatch door covered to 5/8" drywall.

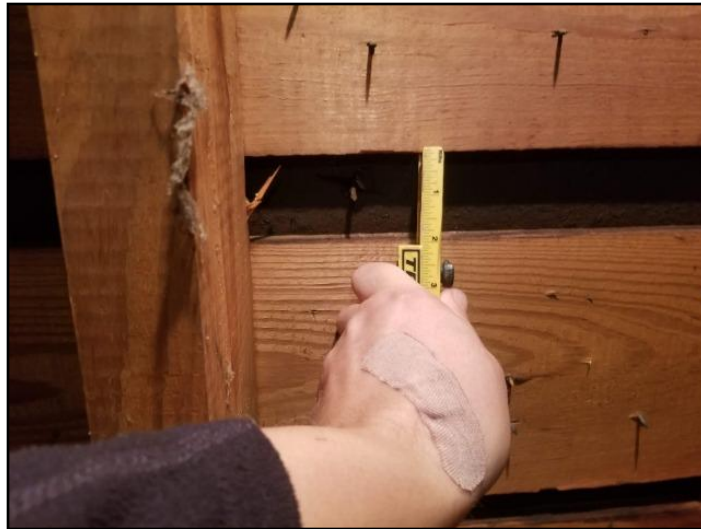
46.

27. Condition: • Roof decking is planking. Large gaps between boards. When having roof replaced it will need to have new sheathing/decking installed over the existing planks.

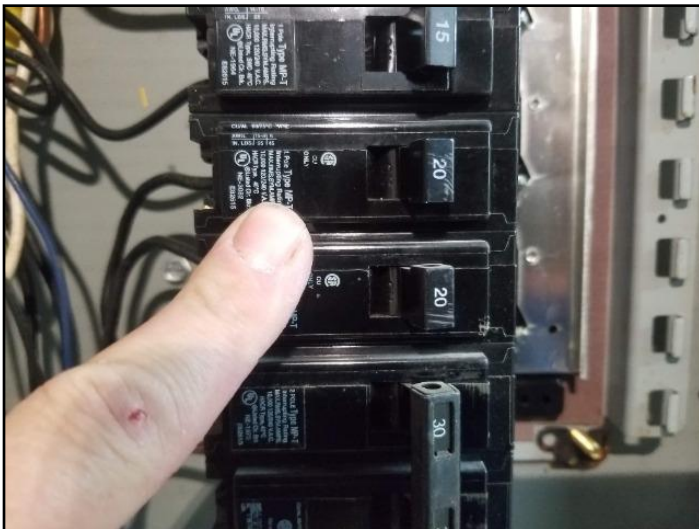
Noted multiple 2 wire circuits sharing a common neutral in both panels. Each panel had 4-6 circuits sharing the neutrals. Have qualified contractor, or electrician repair as needed.

47. Breaker bridge missing

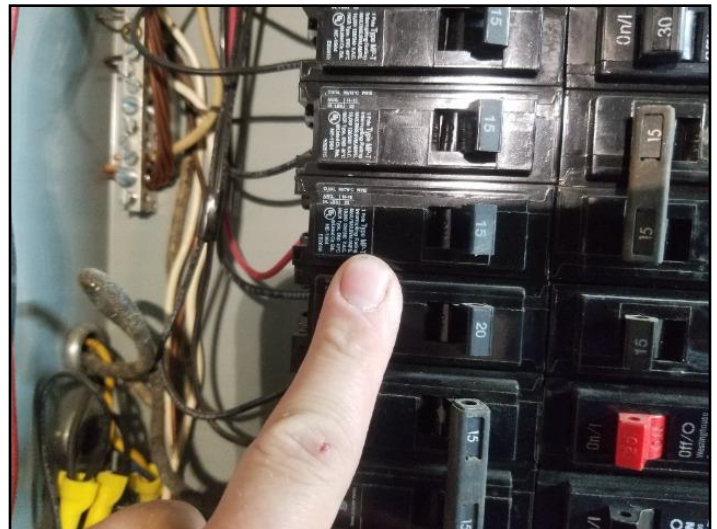
48. Breaker bridge missing

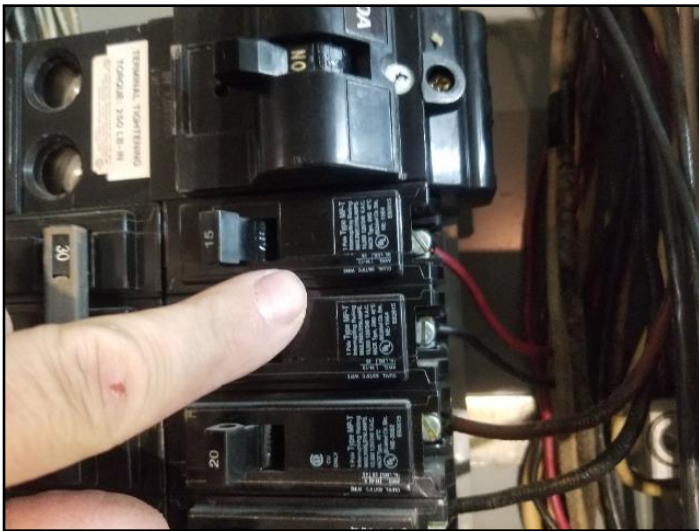
49. Breaker bridge missing

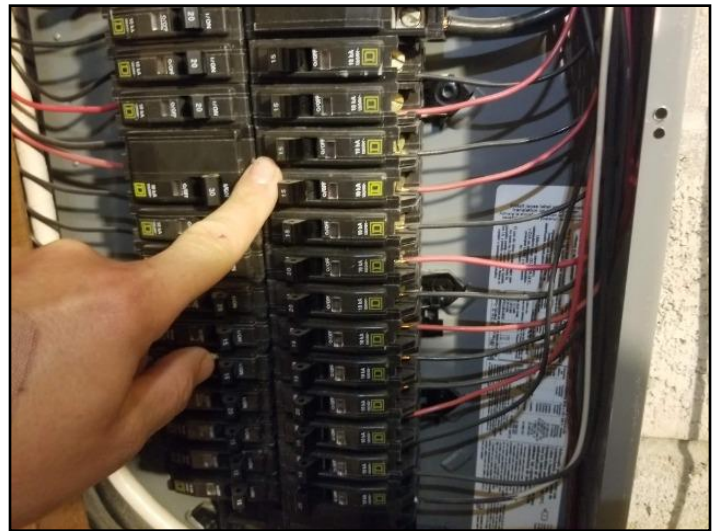
50. Breaker bridge missing

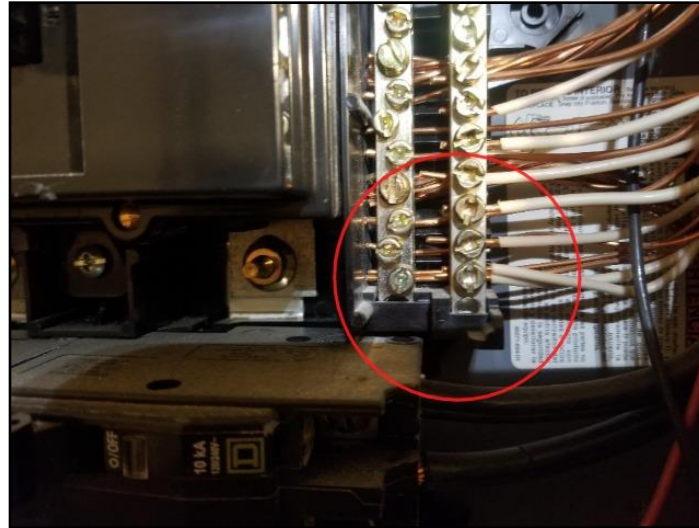
51. Double taps

Have electrician correct neutral double tap in main panel.

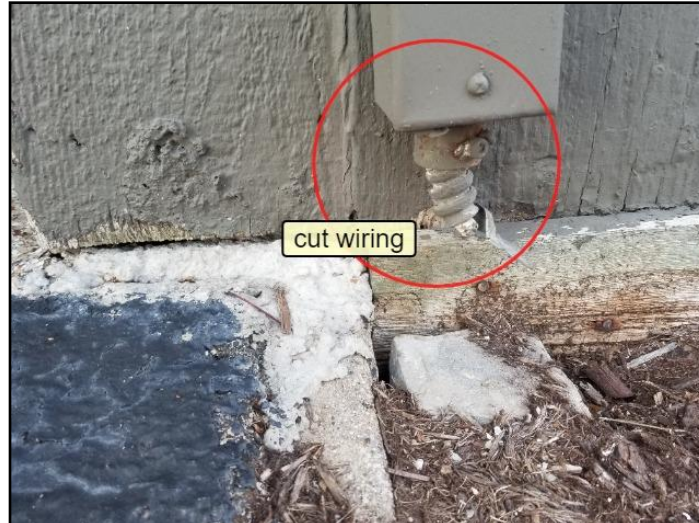
53. Abandoned wire

Have abandoned cut wire removed. Seal and correct box to be weather tight. Wire was not live during inspection.

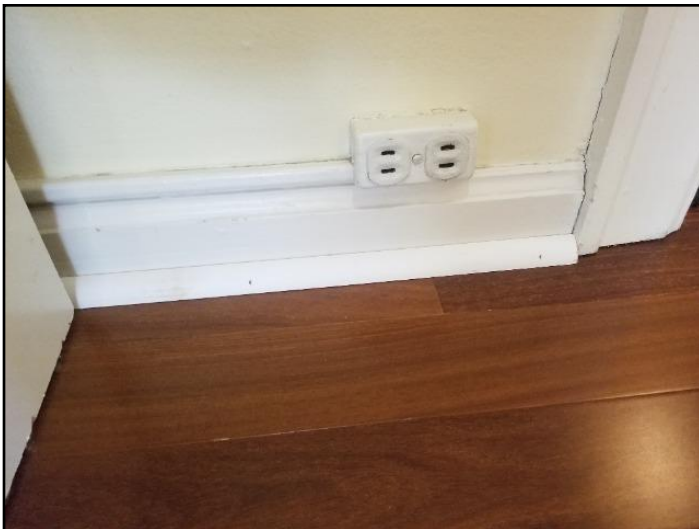
Outlets in NW bedroom, basement, master bath were not grounded. Have electrician correct grounds at these various outlets.

57. Ungrounded

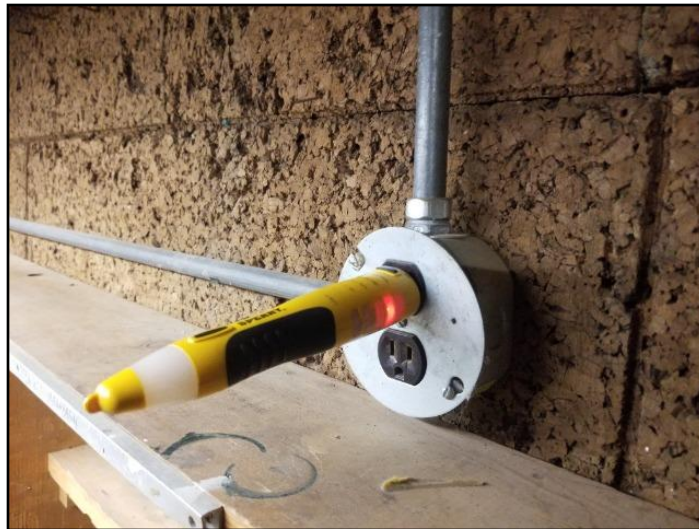
61. Ungrounded

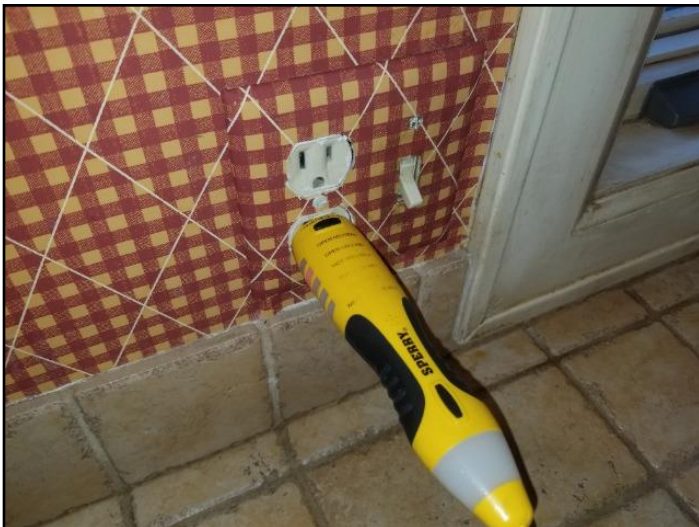
GFCI's are needed in the kitchen and basement. Have qualified contractor install new GFCI's as needed. If exterior the outlets need to be weather resistant rated and have an inuse cover installed on them.

62. GFCI/GFI needed (Ground Fault Circuit...

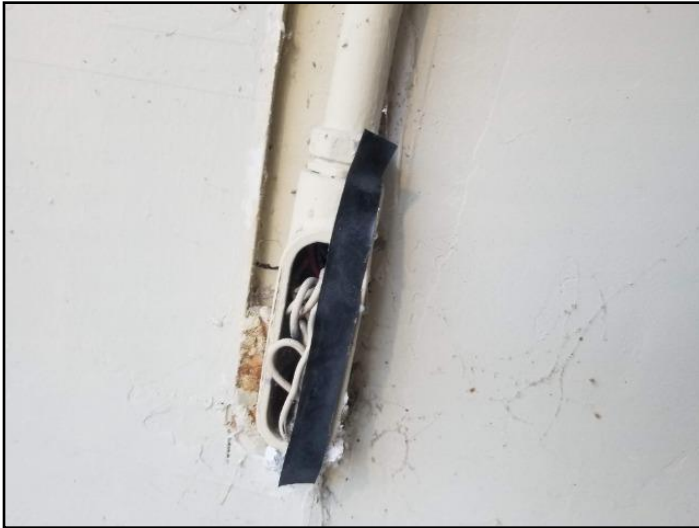
65. Missing

Install cover plate as needed in basement by fireplace and on garage LB conduit fitting.

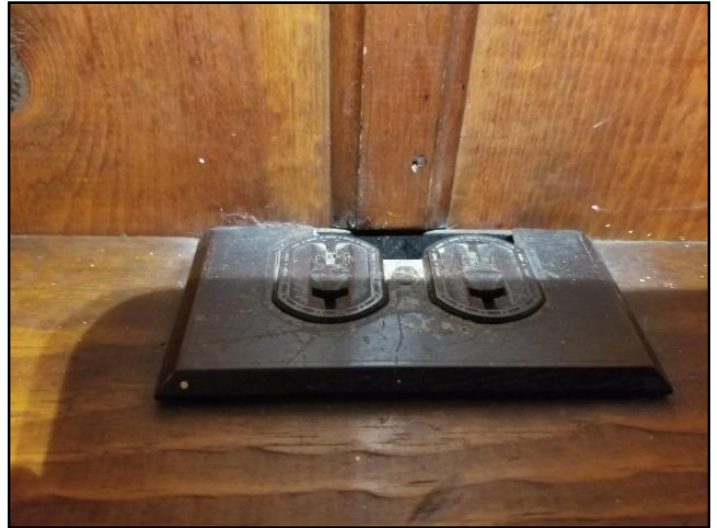
66. Missing

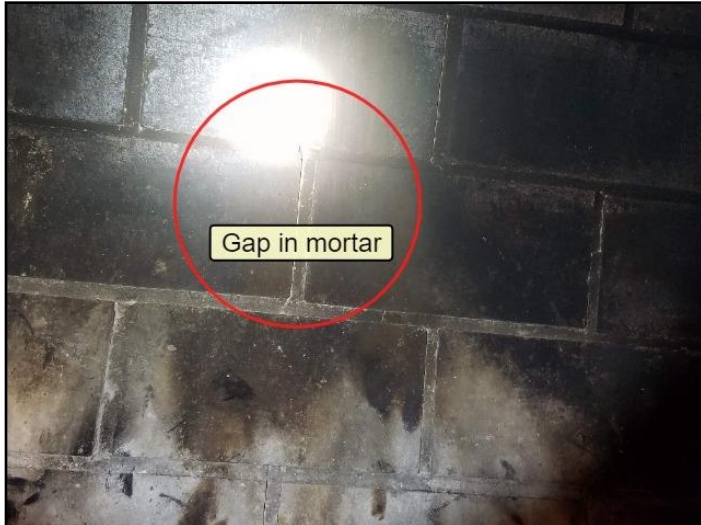
70. Deteriorated, missing or loose masonry or...

Have mortar fireplace corrected by reputable chimney company in NW living room and basement fireplace.

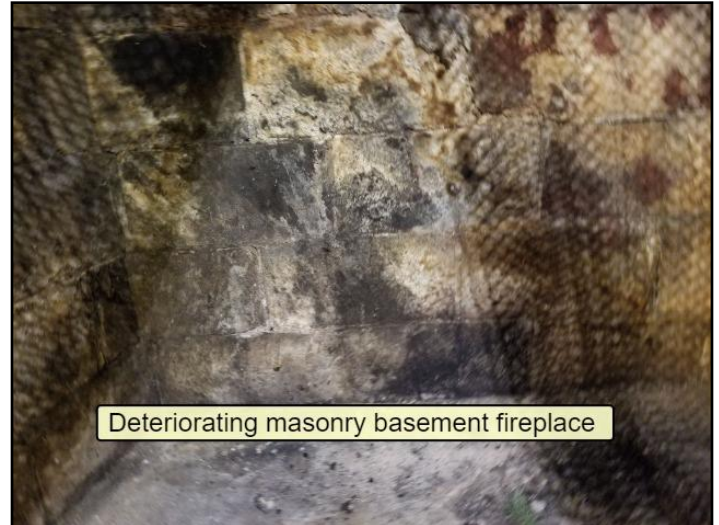
71. Deteriorated, missing or loose masonry or...

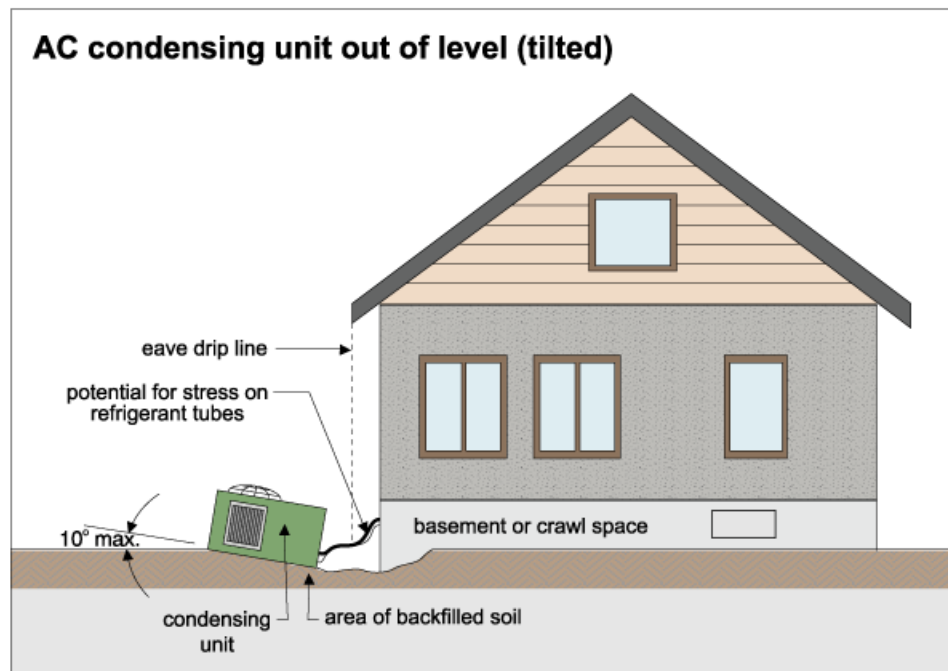
74. Out of level

Have HVAC contractor correct level of condensing unit.

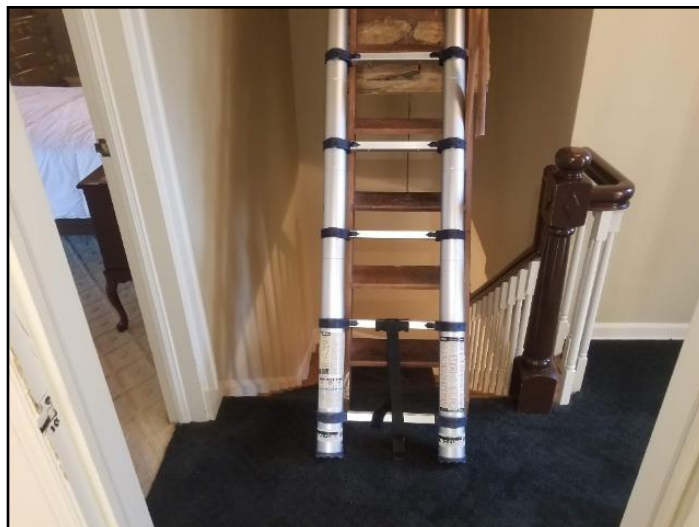
75. Unsafe to climb

Attic pull down ladder should be replaced or removed. A scuttle hatch or different stairs can be created for installed. Contract reputable contractor for options.

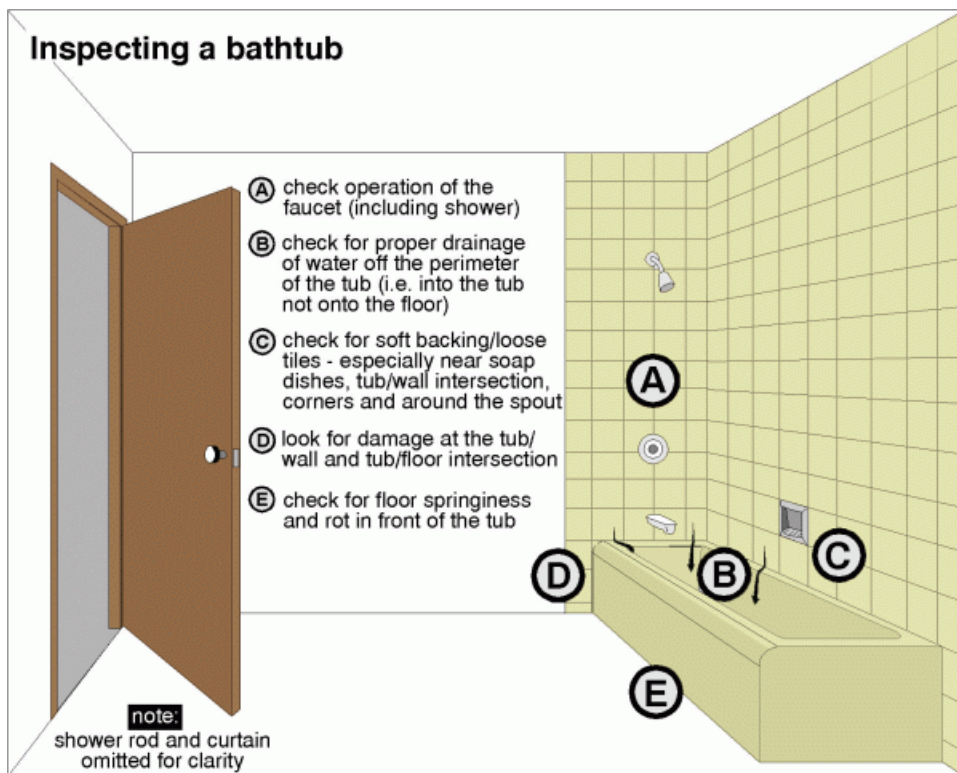
77. Slow drain

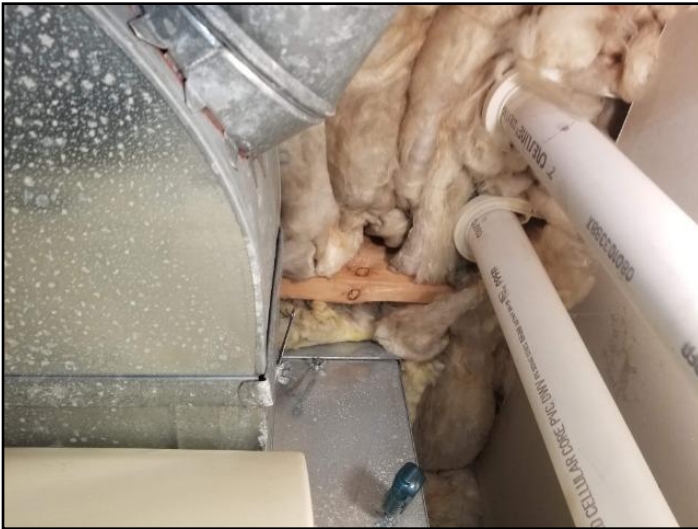
Furnace closet has no ceiling. Recommend having air sealing installed to decrease heat loss into attic. Contact reputable insulation or drywall contractor for options on correct.

78. Missing

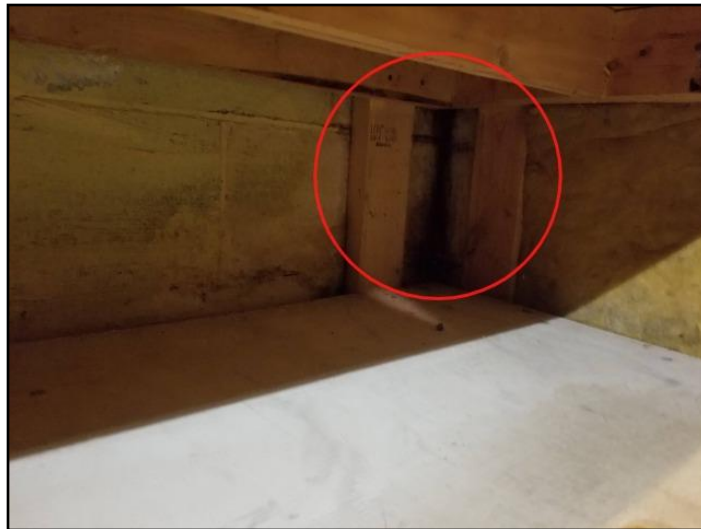
Noted organic growth on wall under gun cabinet. Mold Control is available at most hardware stores. If treating yourself, be sure to follow all safety precautions by wearing personal protection equipment.

81. Organic Growth

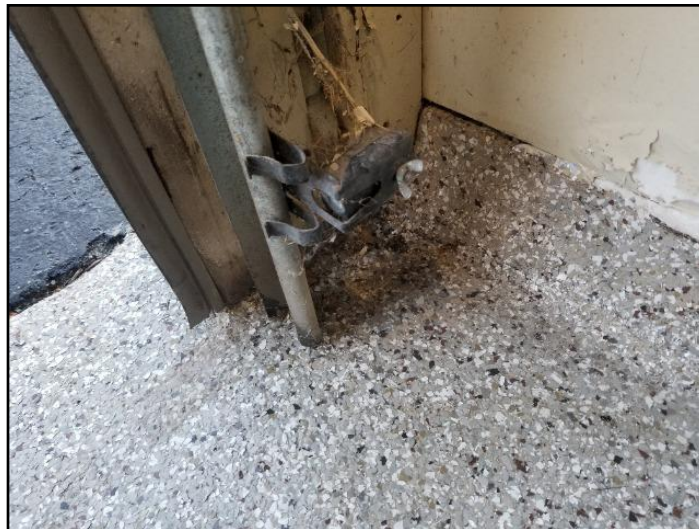
82. Sensors poorly located
