# Your Inspection Report

9 Bernice Ave  
Toronto, ON

**INSPECTION DATE:**  
Monday, February 13, 2017

RE: Report No. 56798  
9 Bernice Ave  
Toronto, ON

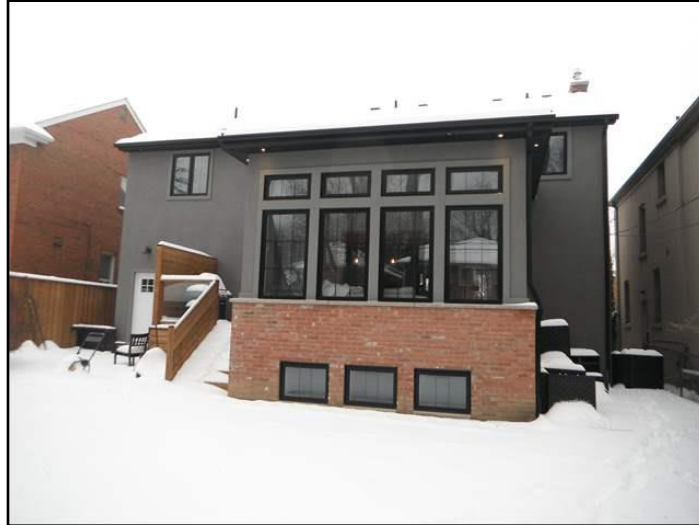
*View from rear*

**General:** • The exterior has been well maintained and is in good condition.

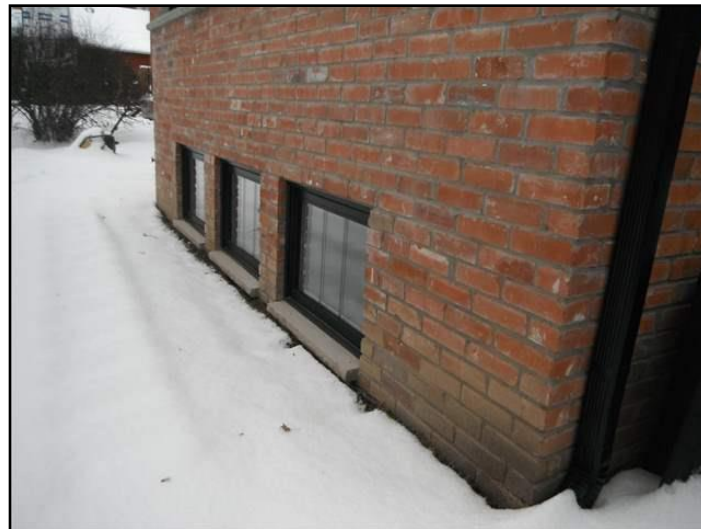
**Condition:** • Window Well - missing 6 to 8 inches clearance below window

Window Well - missing 6 to 8 inches...

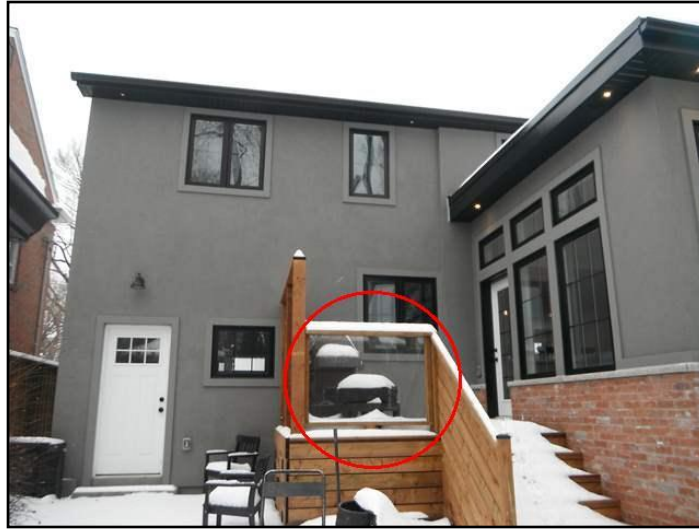
**Condition:** • Glass serving as guard for open area is reported to be safety glass.

*Safety glass*

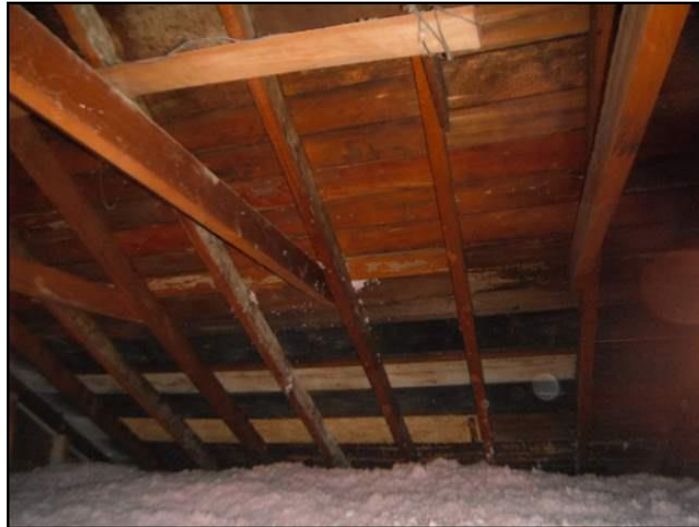
*Rafters / Collar ties*

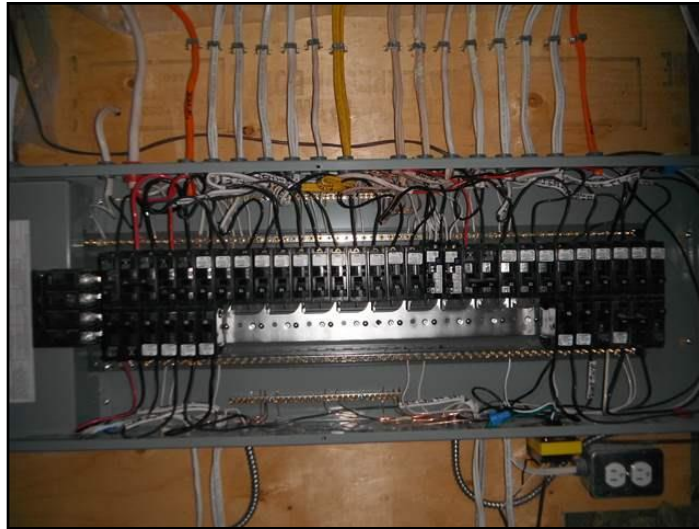
*Breakers - Utility Room*

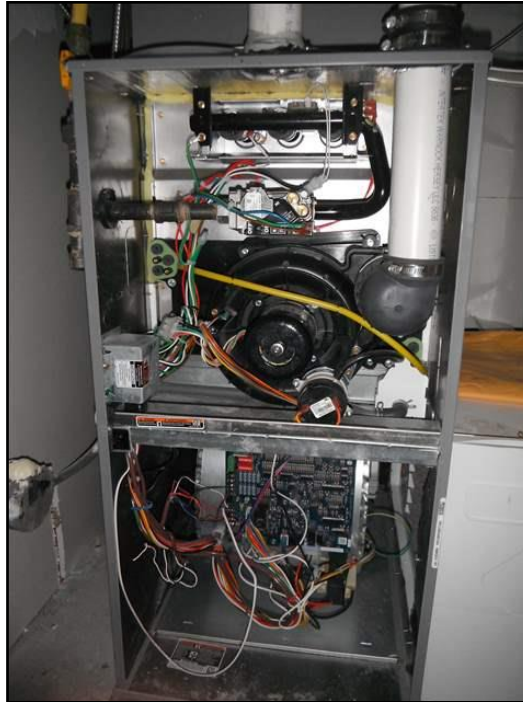
*High efficiency*

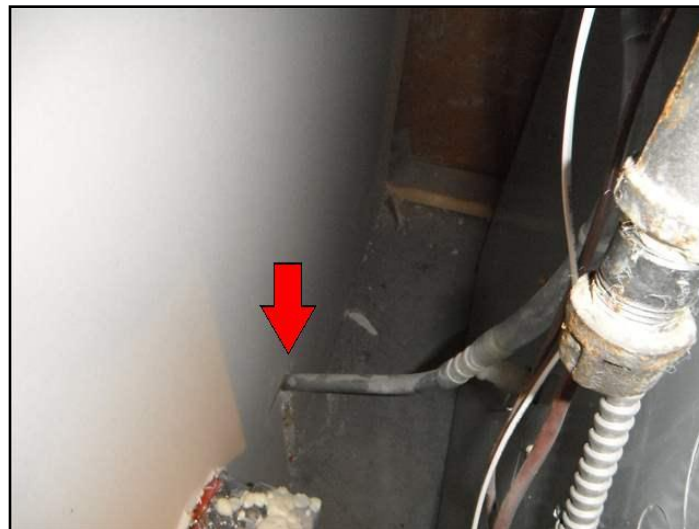
**Condition:** • [Condensate Line – poorly routed to drain](#)

Condensate Line - poorly routed to drain

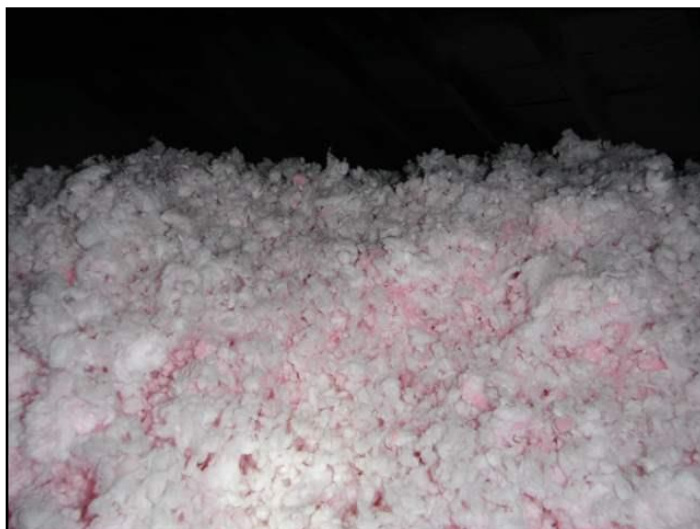
*Fiberglass*

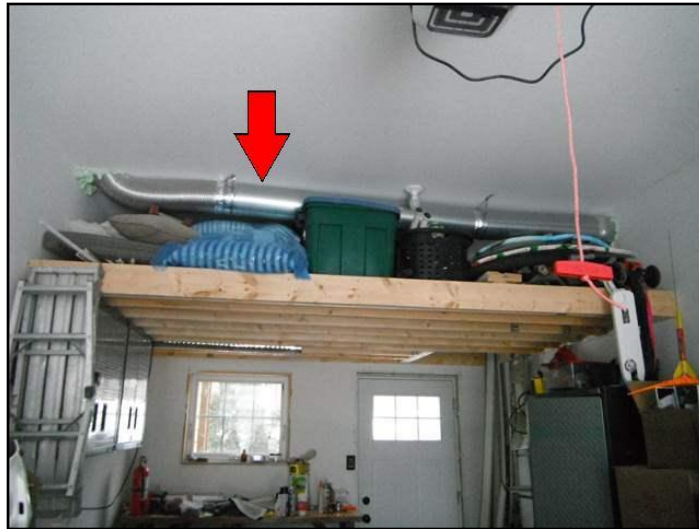
**Condition:** • Exhaust duct for the stove fan travels thru unconditioned space.

*Ensure joints are well sealed / Insulate duct*
