# YOUR Inspection Report

123 Home Sweet Home Lane  
Louisville, KY 40212

Wednesday, August 23, 2017

RE: Report No. 1005, v.6  
123 Home Sweet Home Lane  
Louisville, KY  
40212

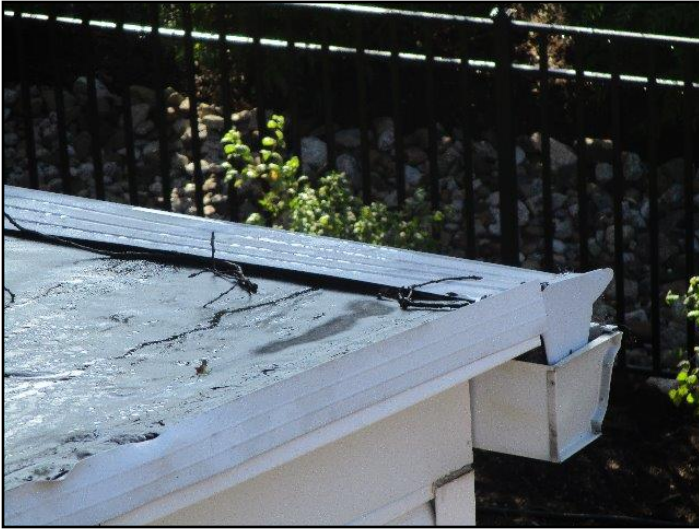
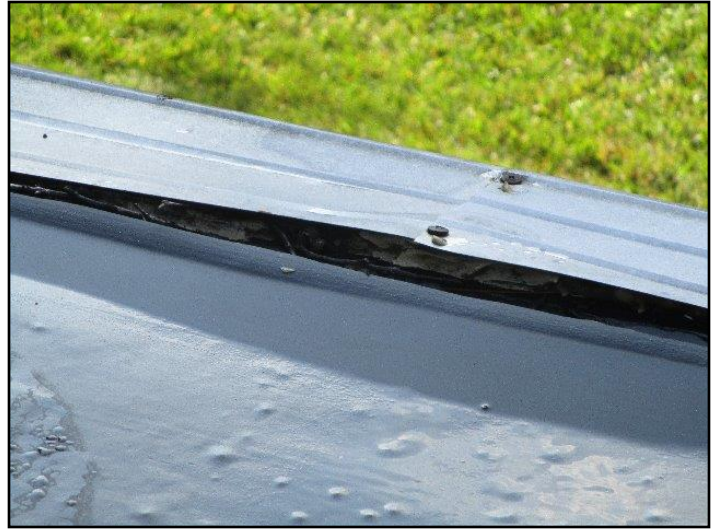
#### 1. Condition: • [Open at seams or ends](#)

Gutter-Guard type gutter protectors were damaged and had created a space for water to enter the building.

**Implication(s):** Chance of water damage to contents, finishes and/or structure

7. Open at seams

8. Open at seams

**Task:** Repair or replace

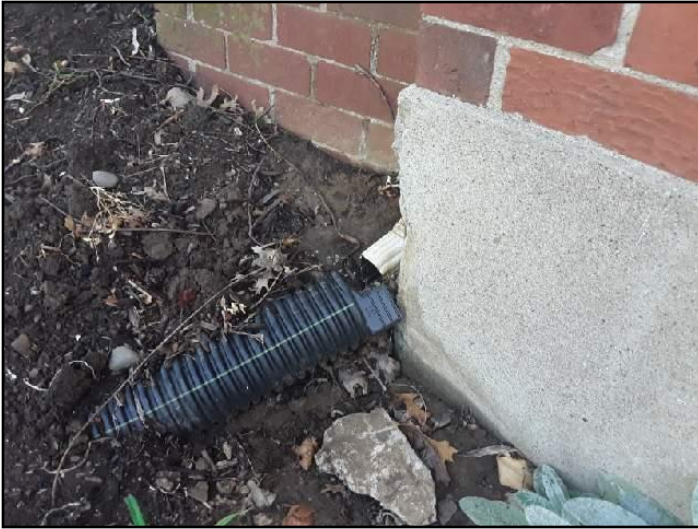
**2. Condition:** • [Connections loose](#)

**Implication(s):** Leakage

9. Loose connections

**Task:** Secure loose downspout

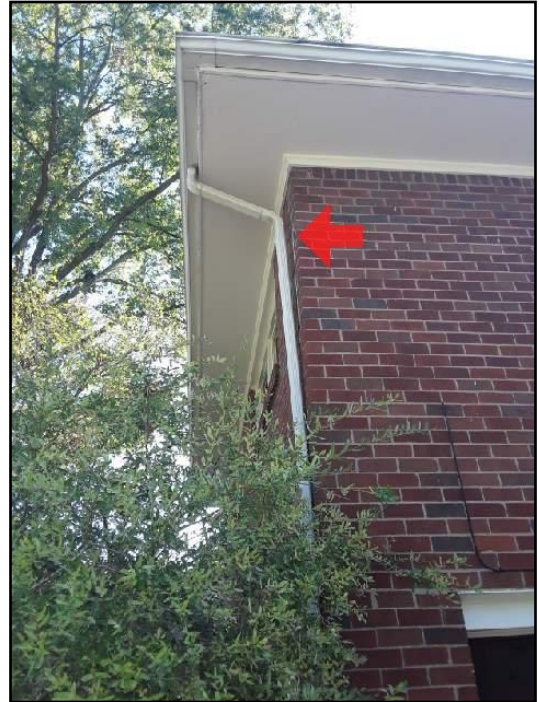
10. Not well secured

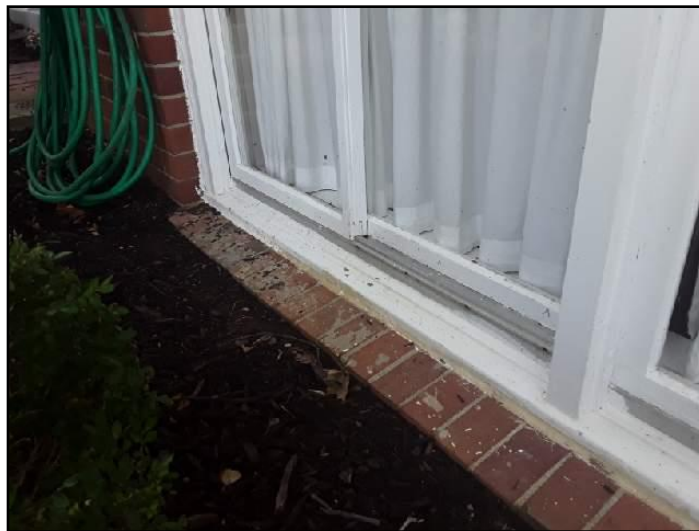
11. Garage window

**3. Condition:** • Ground level to close to wood window sash.

**Implication(s):** Any wood to ground contact may cause wood decay.

**Task:** Lower ground level to 6" below any wood material. However, be certain water drainage is still away from building.

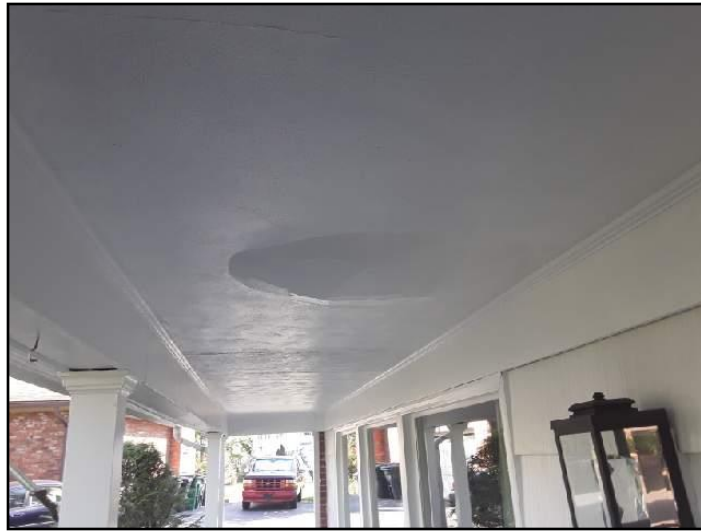
12.

4. **Condition:** • Ceiling sagging due to roof leak

**Task:** Have evaluate by a roofing contractor

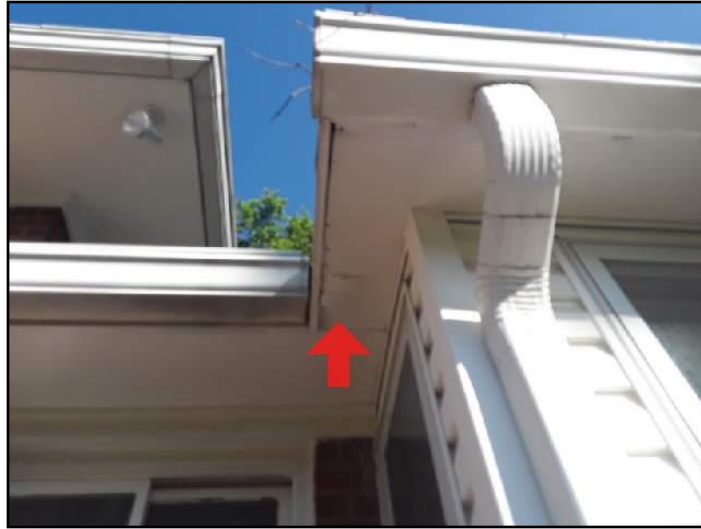
5. Condition: • [Paint or stain - deteriorated / missing](#)

Implication(s): Chance of water damage to contents, finishes and/or structure | Shortened life expectancy of material

13. Paint needed

Task: Paint as needed

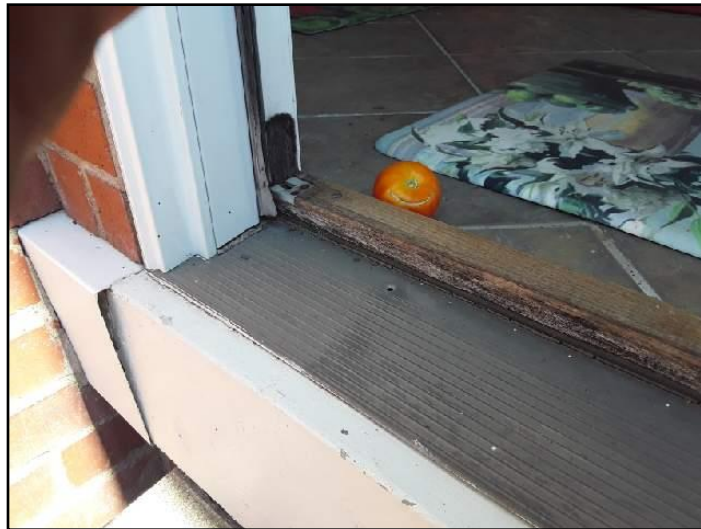
14. Back door threshold

6. Condition: • Threshold is too high

Implication(s): Trip hazard

Task: Reduce height of threshold

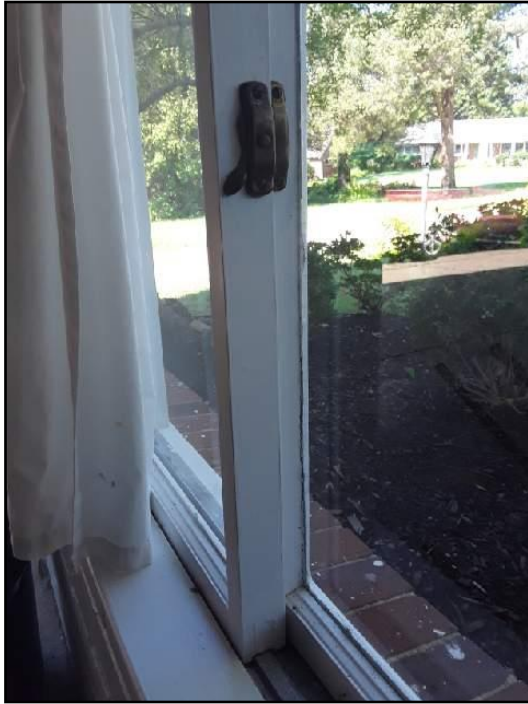
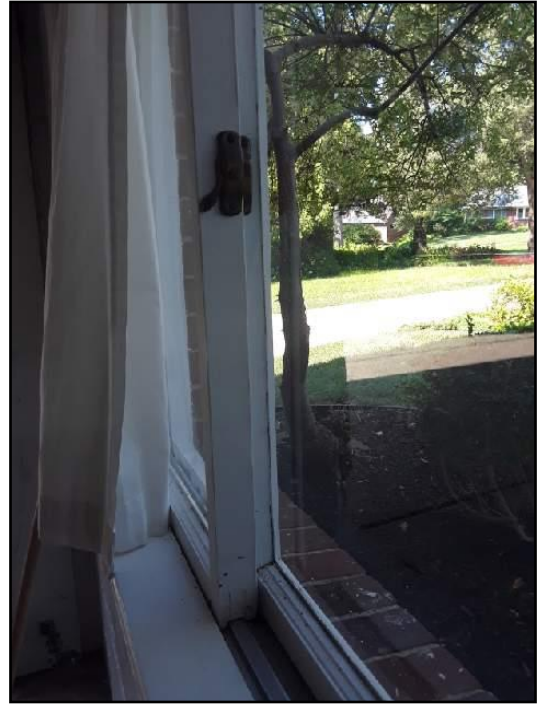
15. Garage Window

7. Condition: • Window did not fully close and lock. Typical both windows.

Implication(s): Security risk

Task: Repair/adjust as needed

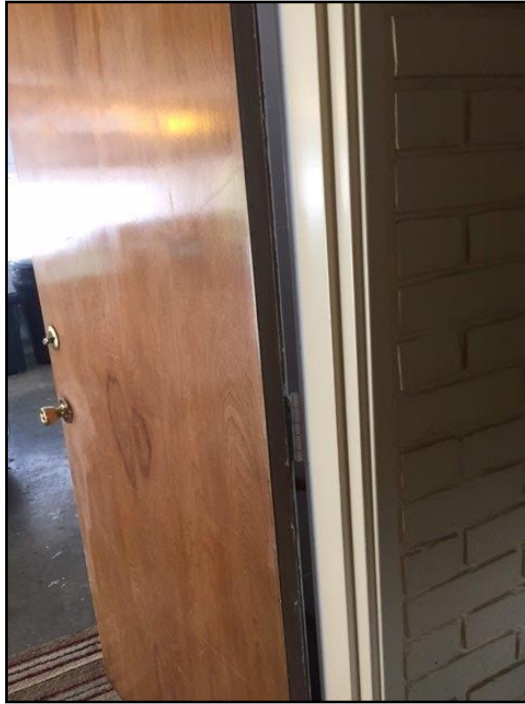
The entry door between the house from the garage was the hollow core type door. These doors are not fire rated. Fire rated door have a label on the hinge side stating there are fire rated. Typically 20 minutes for residential applications. If the door is not labeled, a steel door or solid wood door is an acceptable alternative.

**Implication(s):** Increased fire hazard

17. Garage door not fire rated

**Task:** Recommend upgrading to a fire rated door

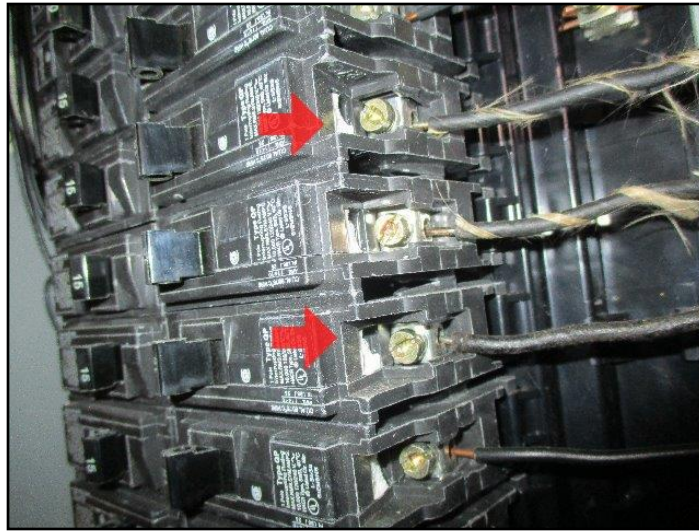
Some branch circuit wiring was solid aluminum. Solid aluminum is not used for branch circuit anymore. However, braided aluminum is acceptable.

**Implication(s):** Electric shock | Fire hazard

18. Outdated type wiring

**Task:** Recommend further evaluating by qualified electrician

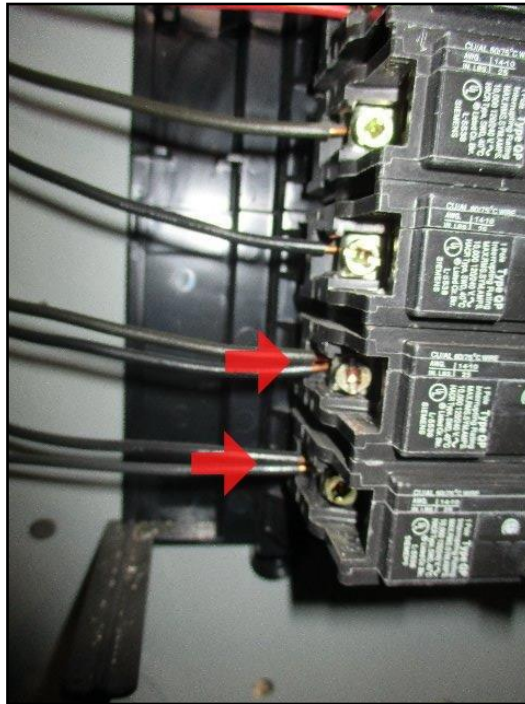
10. Condition: • [Double taps](#)

Implication(s): Fire hazard

19. Double taps

Task: Recommend further evaluating by qualified electrician

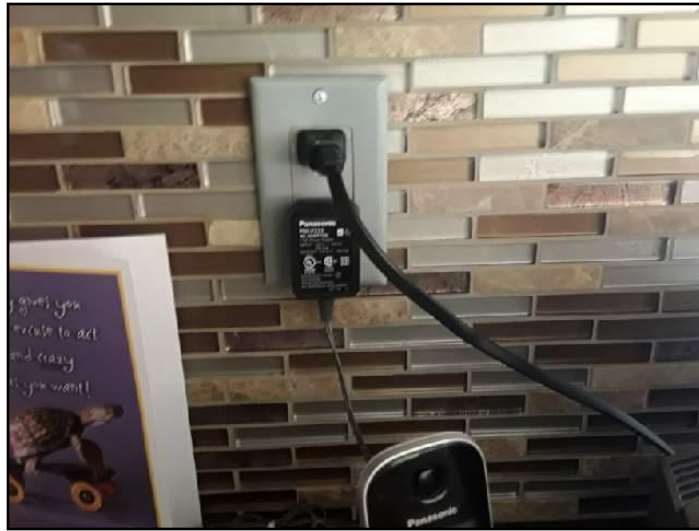
11. Condition: • [GFCI/GFI needed \(Ground Fault Circuit Interrupter\)](#)

Implication(s): Electric shock

20. GFCI needed for outlets 6' from kitchen sink

Task: Replace outlet that are not GFCI and should be

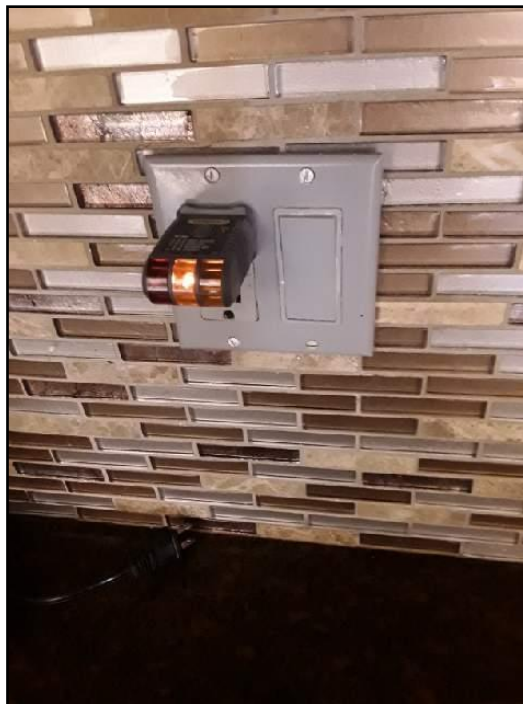
**12. Condition:** • [Test faulty on GFCI/GFI \(Ground Fault Circuit Interrupter\)](#)

GFCI receptacle wired incorrectly.

**Implication(s):** Electric shock

21. Test faulty on GFCI

**Task:** Have evaluate by a qualified electrician

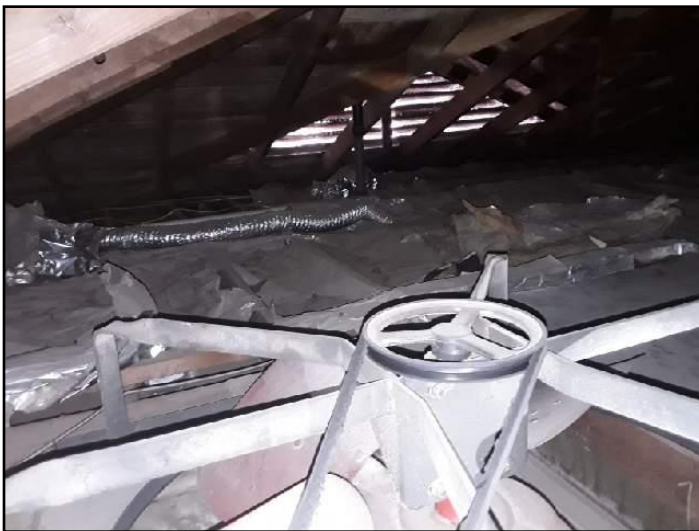
30. no cover on whole house fan

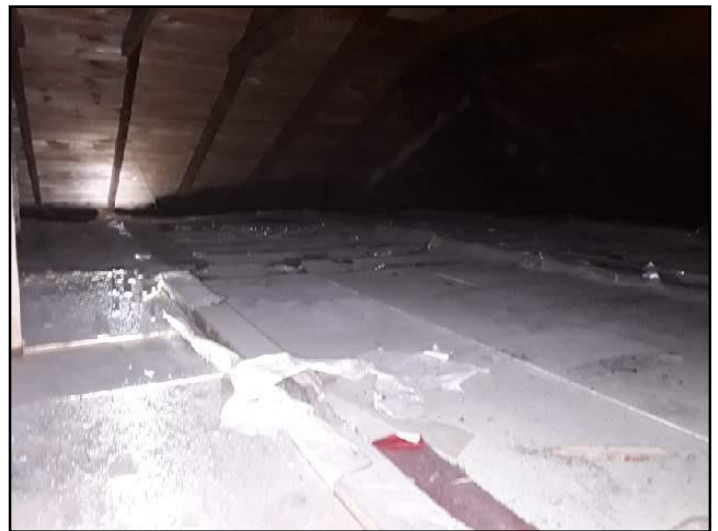
14. Condition: • [Amount less than current standards](#)

Implication(s): Increased heating and cooling costs

31. Amount less than current standards

Task: Have evaluate by a qualified contractor

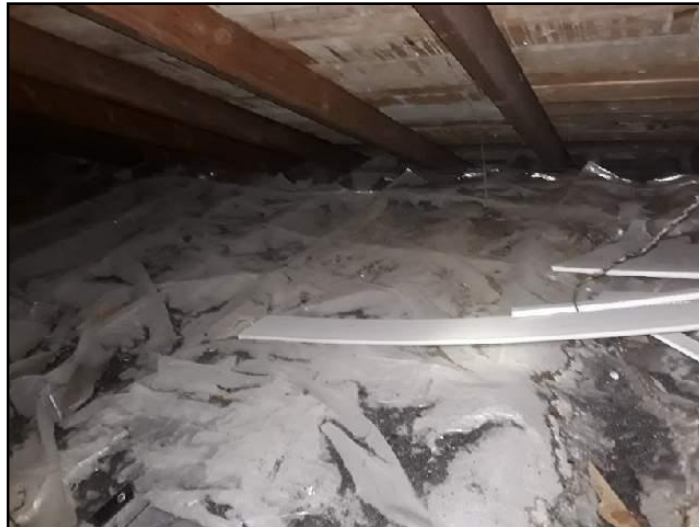
#### 15. Condition: • [Wrong location](#)

**Implication(s):** Chance of condensation damage to finishes and/or structure

32. Wrong location

**Task:** Upgrade attic insulation recommended

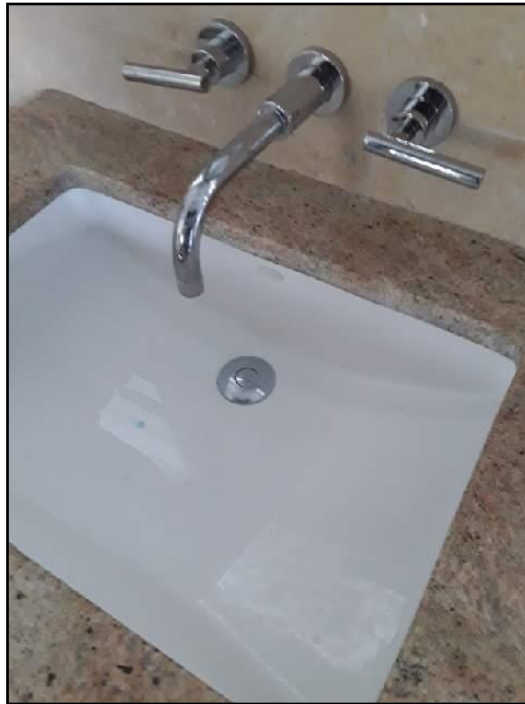
**16. Condition:** • Drain stop ineffective

35. Drain stop ineffective

**Task:** Repair

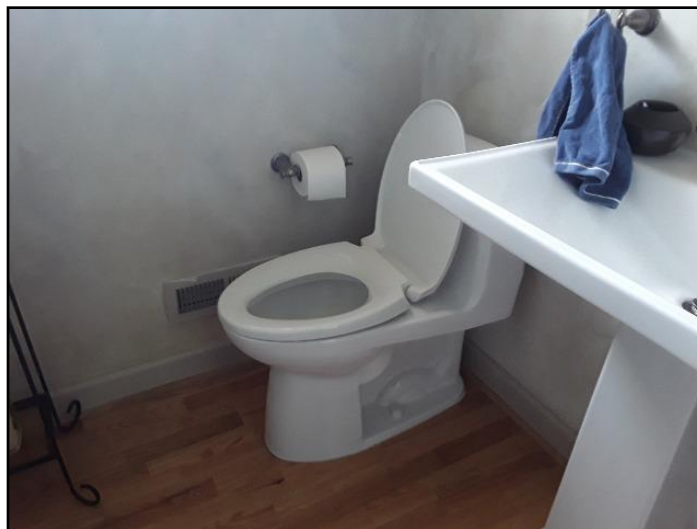
### 17. Condition: • [Running toilet](#)

36. Running toilet

**Task:** Have evaluate by a qualified plumber

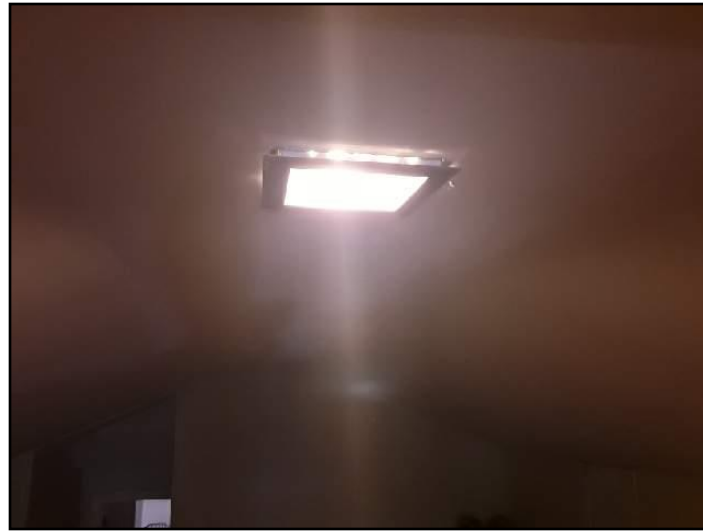
**18. Condition:** • Loose ceiling light fixture

37. Loose light fixture

**Task:** Secure loose light fixture
