YOUR INSPECTION REPORT

FOR THE PROPERTY AT:
23 Durie Street
Toronto, ON M6S 3E5

INSPECTION DATE:
Wednesday, March 4, 2020

RE: Report No. 2617, v.2
23 Durie Street
Toronto, ON
M6S 3E5

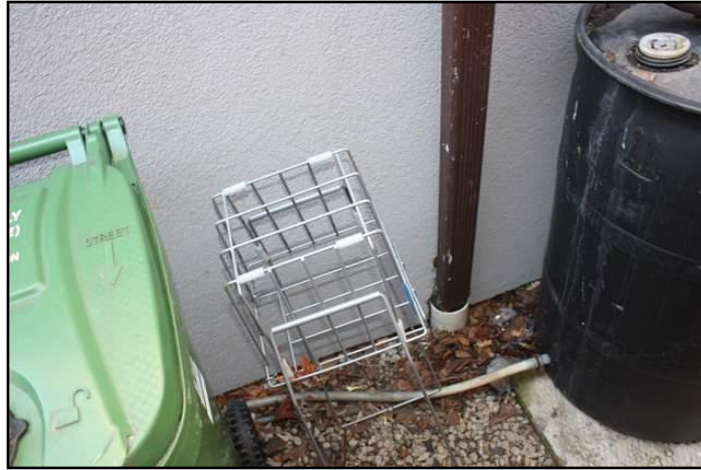
Condition: • The City of Toronto requires downspouts be disconnected from the city sewers. Storm water does not need to be treated and therefore, the city requires that downspouts drain above grade onto the property at least 6 feet from the home.

2. The City of Toronto requires downspouts be...

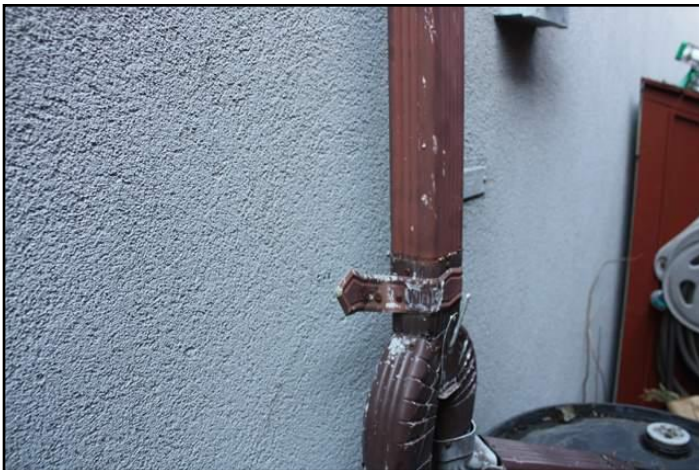
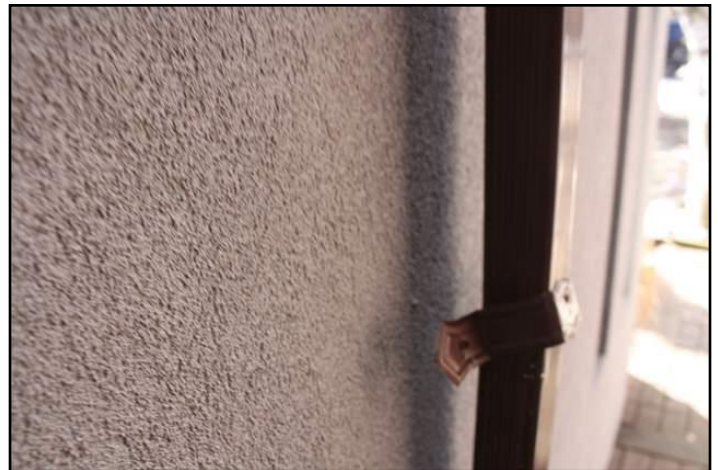
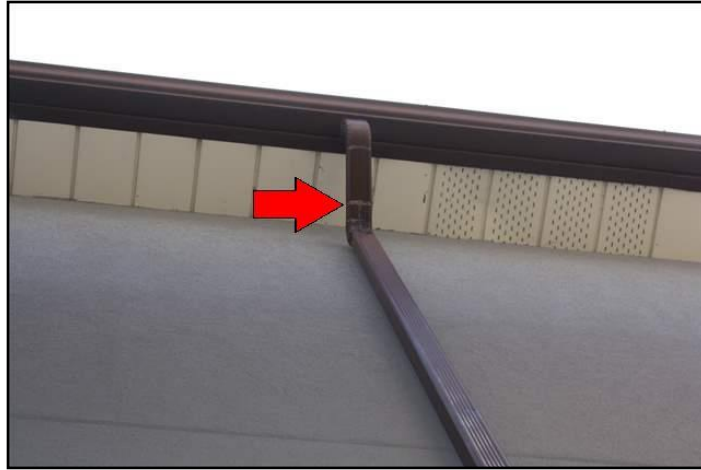
Condition: • [Not well secured](#)

Implication(s): Leakage

Task: Repair

Time: As Soon As Possible

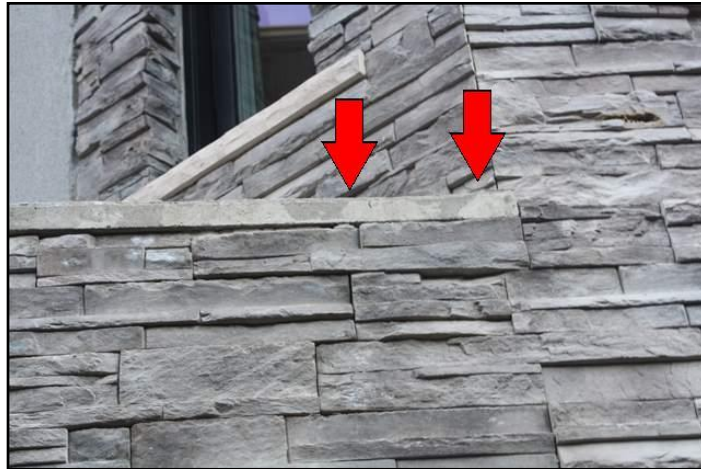
Condition: • [Flashings missing](#)

Vulnerable area for masonry deterioration. Capping does not project out. May consider cap flashing in future

Implication(s): Chance of water damage to contents, finishes and/or structure

Task: Monitor / Improve

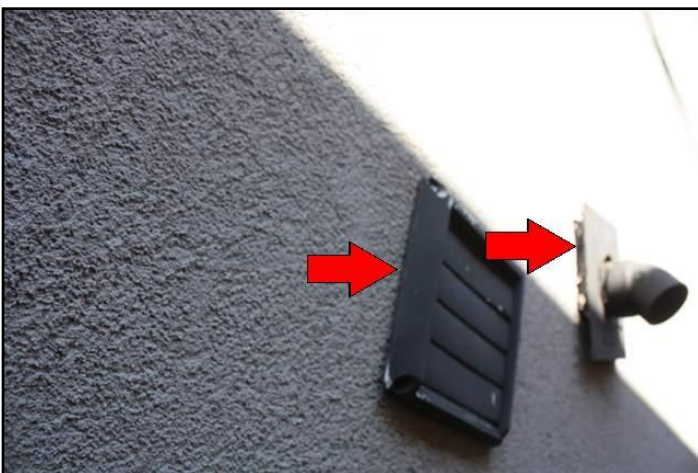
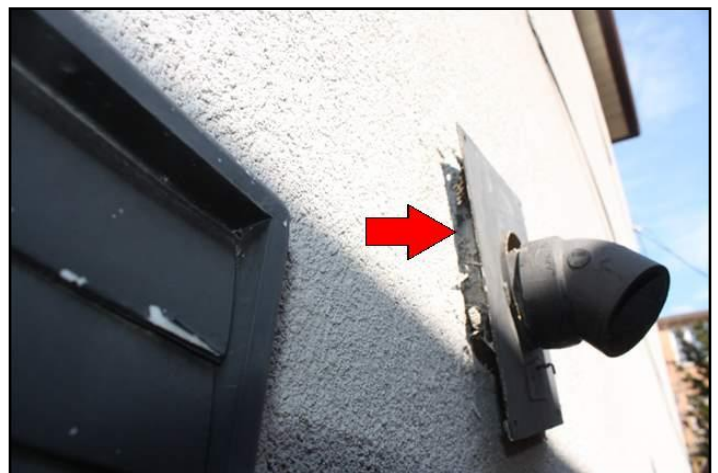
Condition: • [Caulking missing or ineffective](#)

Implication(s): Chance of water damage to contents, finishes and/or structure

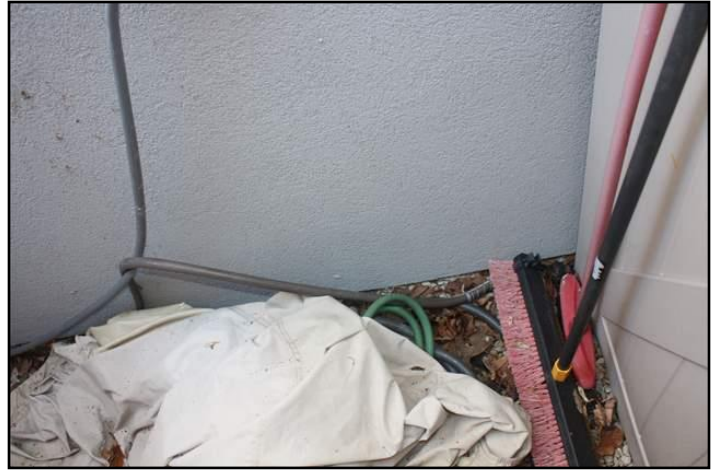
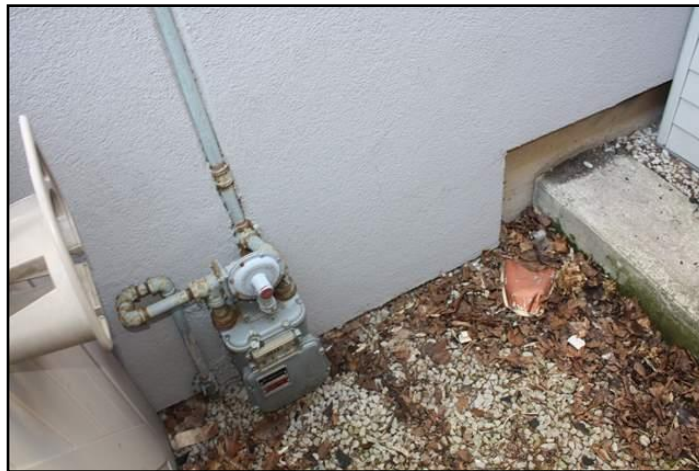
Condition: • [Too close to grade](#)

Implication(s): Chance of water damage to contents, finishes and/or structure | Material deterioration

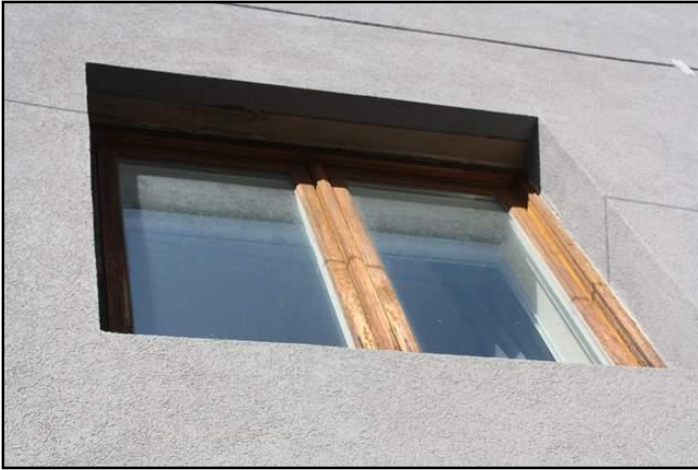
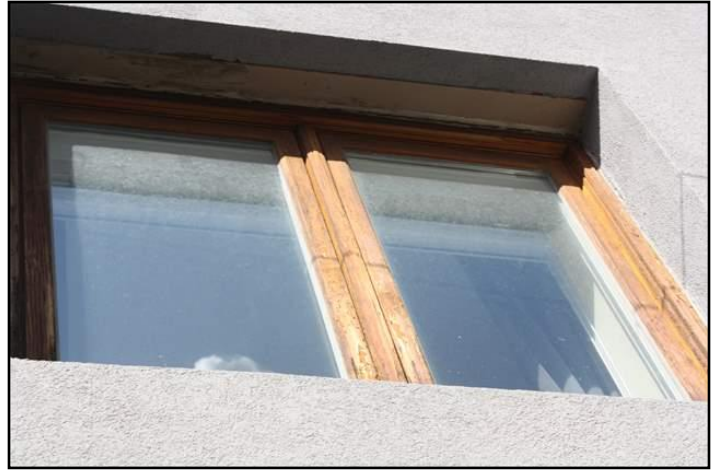
Condition: • [Paint or stain needed](#)

Implication(s): Material deterioration

Task: Provide paint or stain or capping

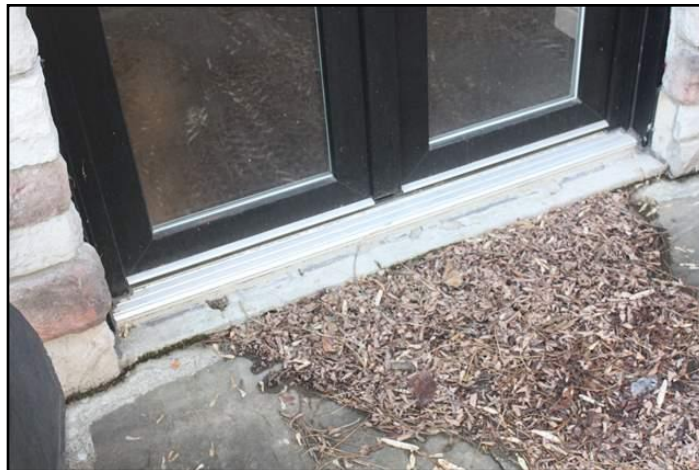
Condition: • Threshold too low

Task: Monitor / Correct

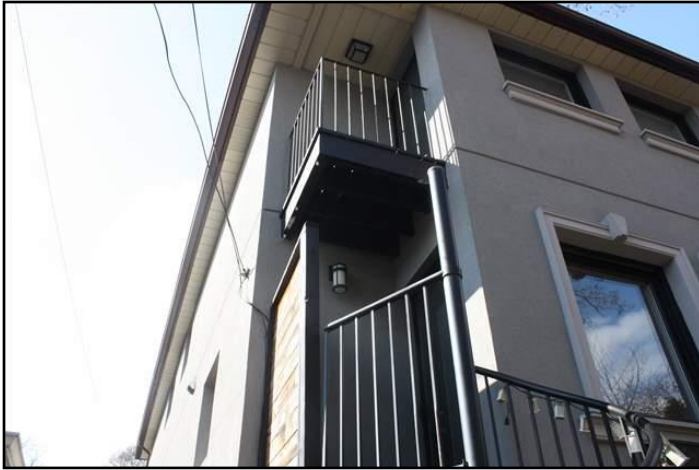
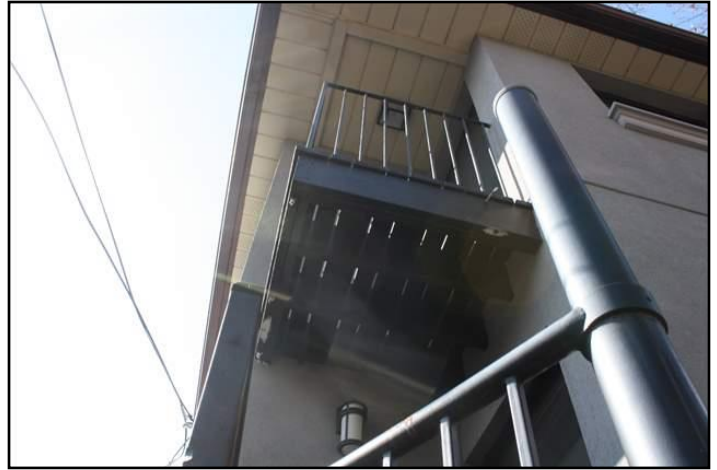
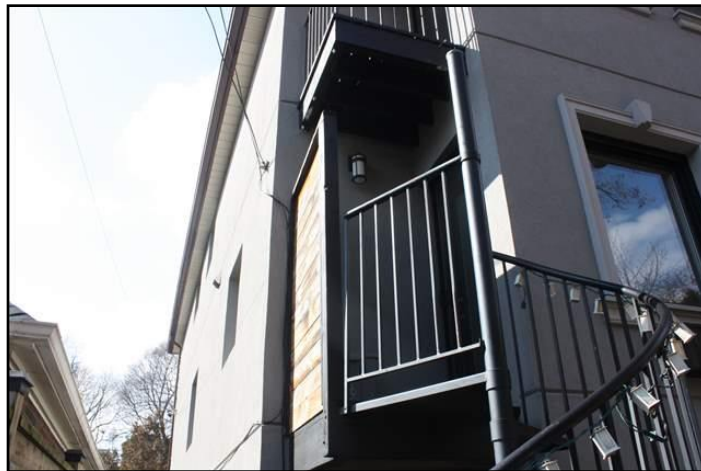
Condition: • Cantilevered joist supports are not a defect, however these types of supports can sometimes lead to failure if not regularly checked for rot or integrity. We recommend improving support of these areas by providing post/columns

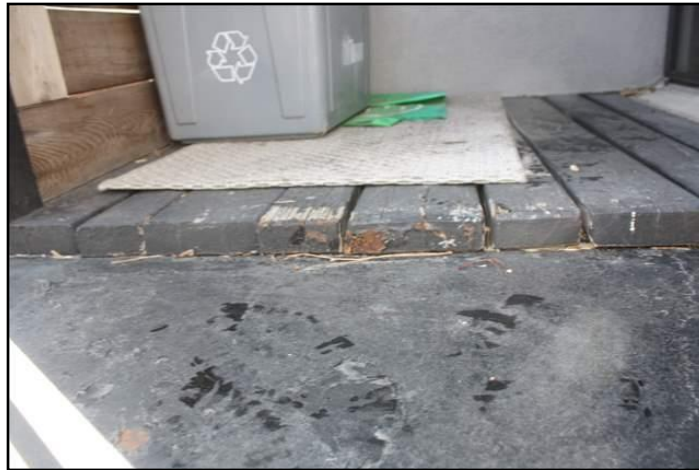
Condition: • [Paint or stain needed](#)

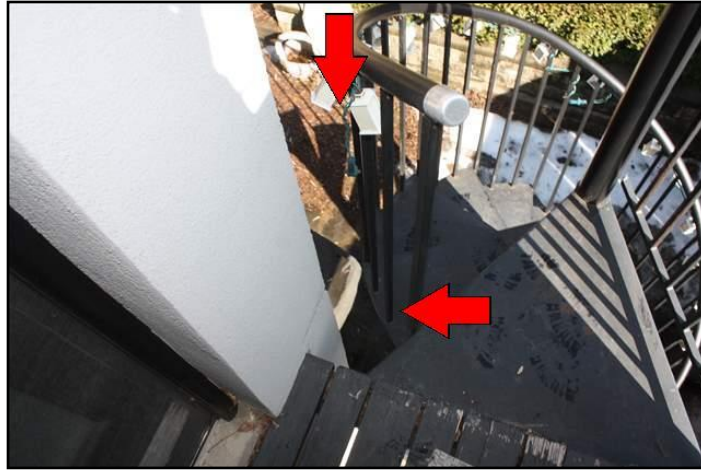
Condition: • [Openings between spindles \(balusters\) too large](#)

Large opening between home and stairs. Fall Hazard

Implication(s): Fall hazard

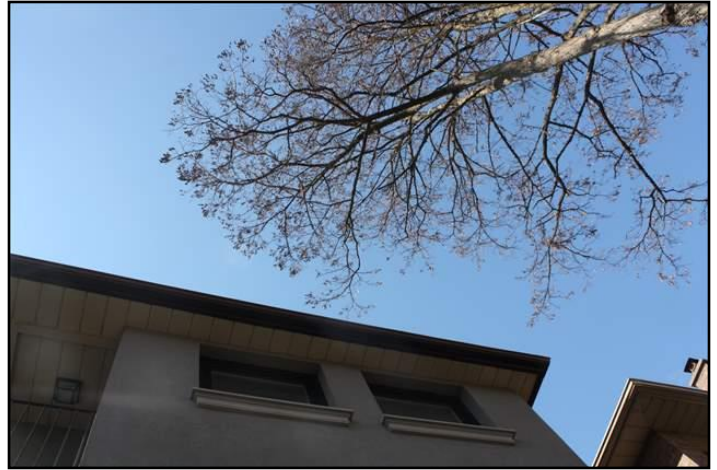
Condition: • [Trees or shrubs too close to building](#)

Implication(s): Chance of water damage to contents, finishes and/or structure | Chance of pests entering building | Material deterioration

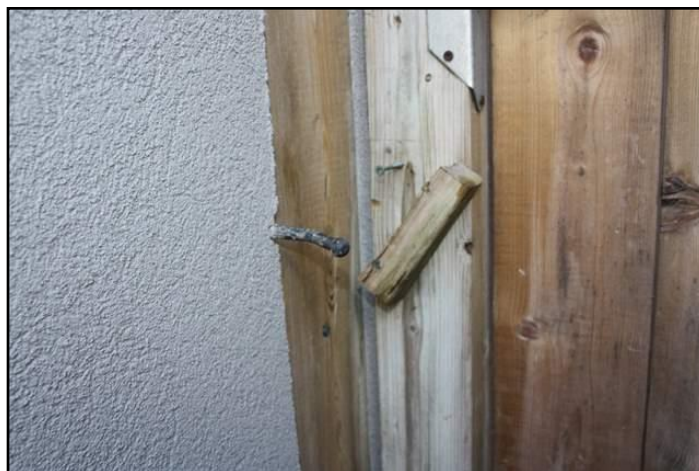
Condition: • Gate latch inoperative

Task: Repair / Replace

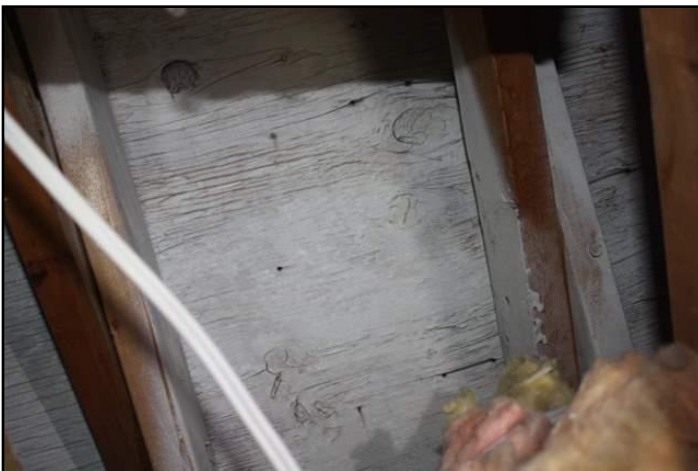
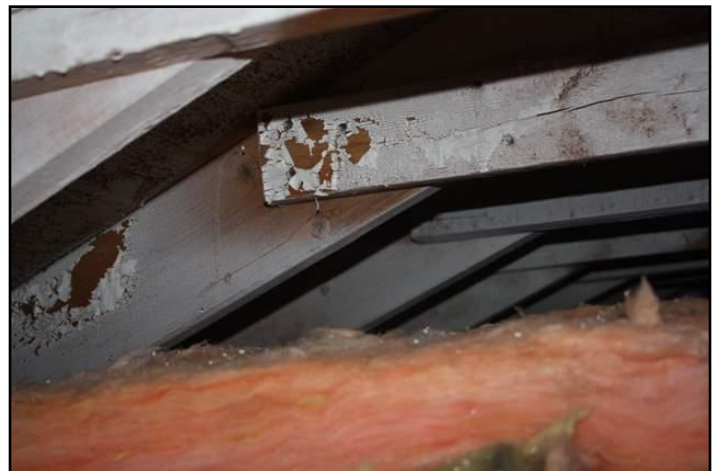
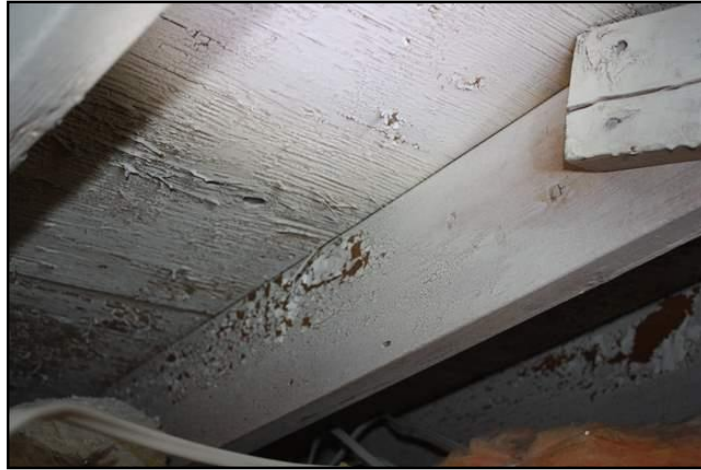
Condition: • Fire damage

White paint observed on Attic sheathing and rafters. Often paint or paint like product is used in the attic during fire damage remediation and restoration. The current homeowner was unaware of this treatment. We cannot verify when this treatment occurred or the extent of repairs. Prudent to check prior insurance claims if any.

Task: Further evaluation

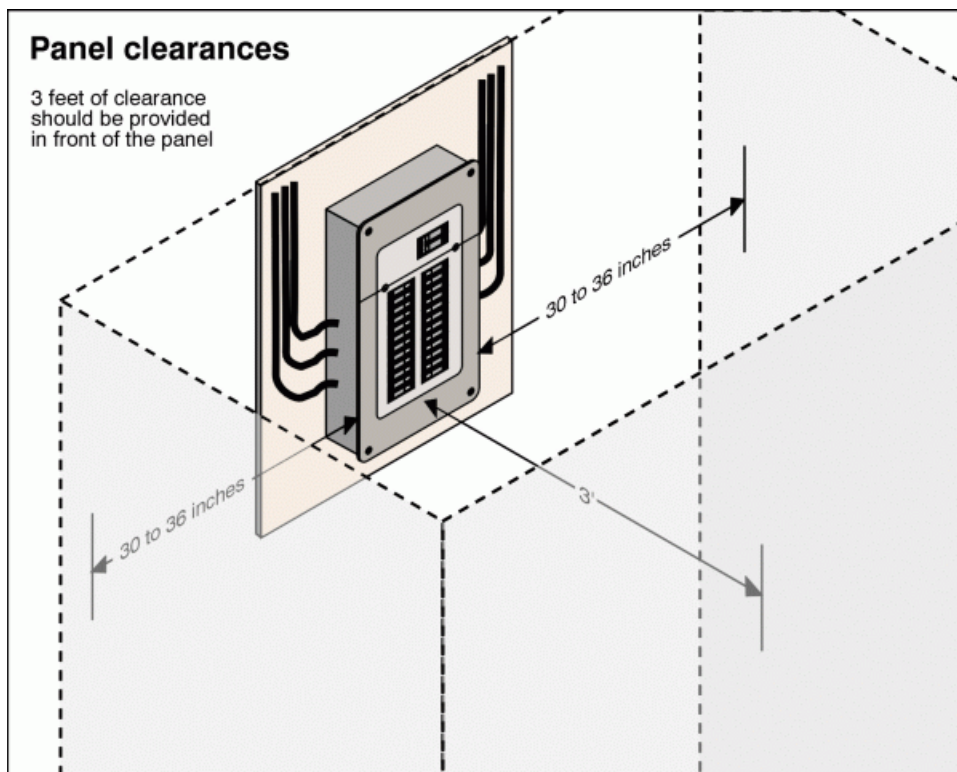
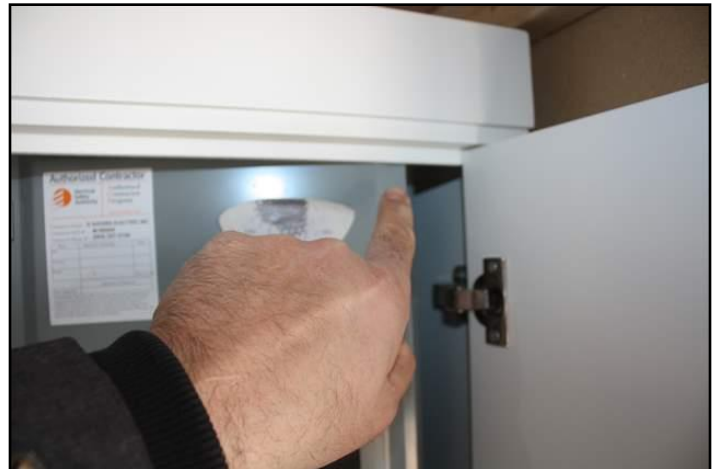
Condition: • [Poor access](#)

Task: Remove Cover and inspect

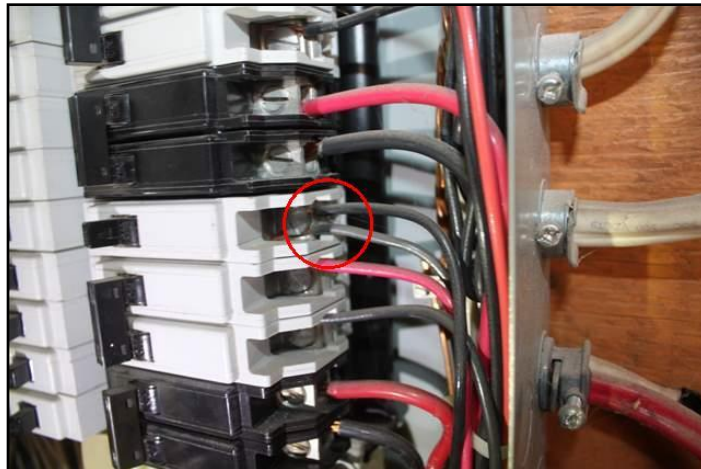
Condition: • [Double taps](#)

Implication(s): Fire hazard

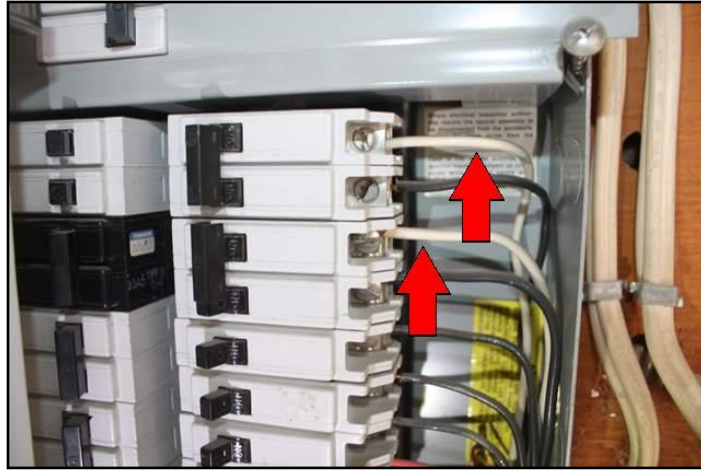
Condition: • [Improper color coding](#)

Implication(s): Electric shock | Fire hazard

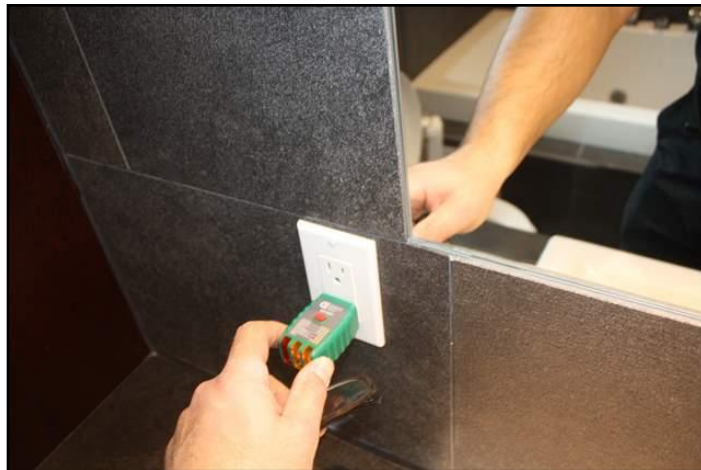
Condition: • [Loose](#)

Implication(s): Electric shock | Fire hazard

Task: Repair

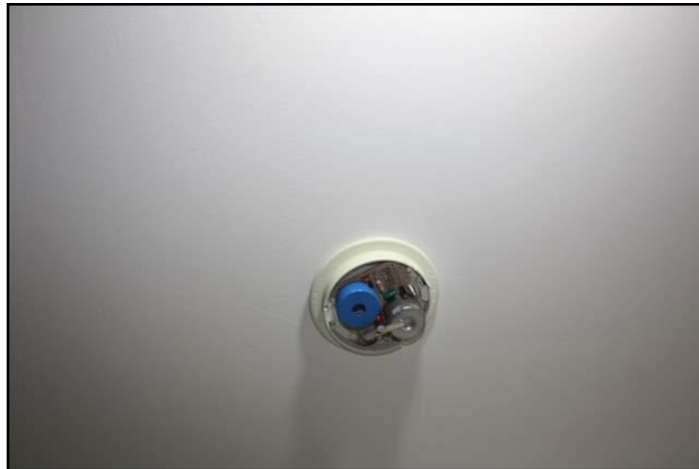
Condition: • [Damaged](#)

Implication(s): Fire hazard

Task: Replace

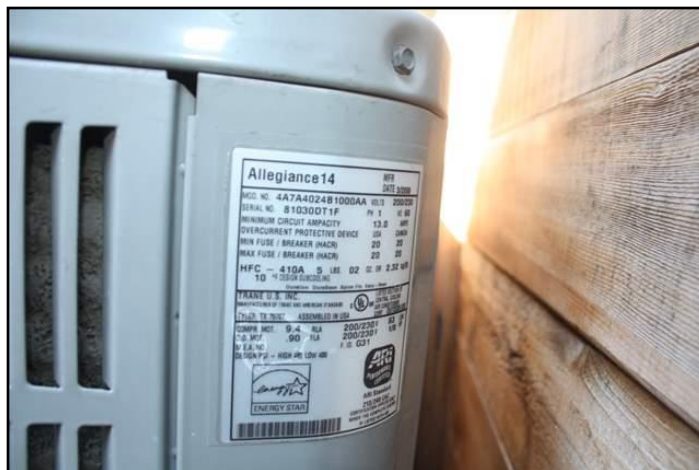
Condition: • [Near end of life expectancy](#)

Implication(s): Equipment failure | Reduced comfort

Task: Replace

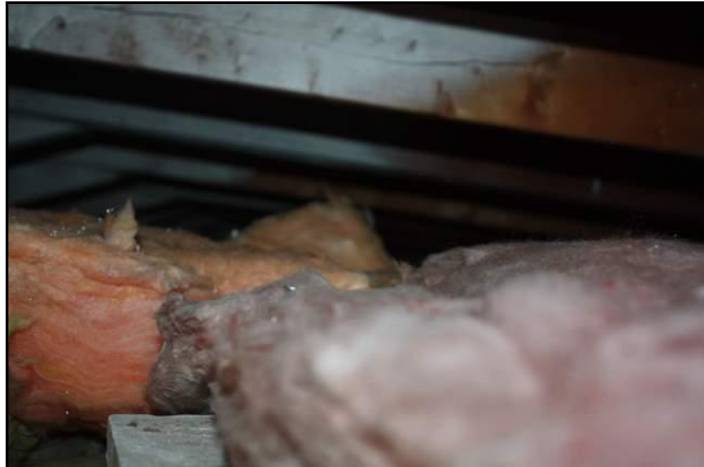
Condition: • [Gaps or voids](#)

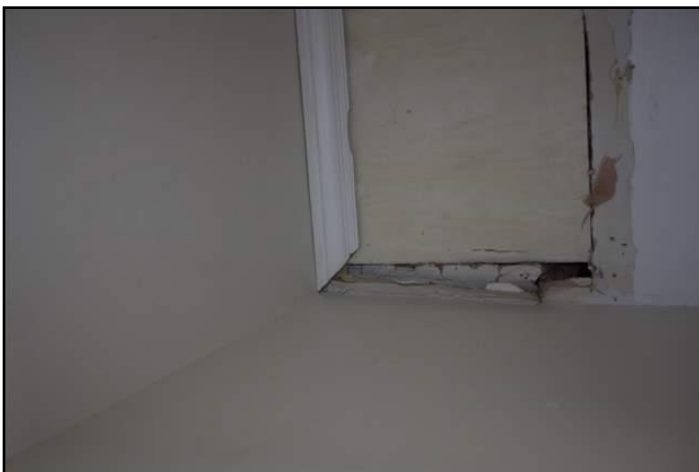
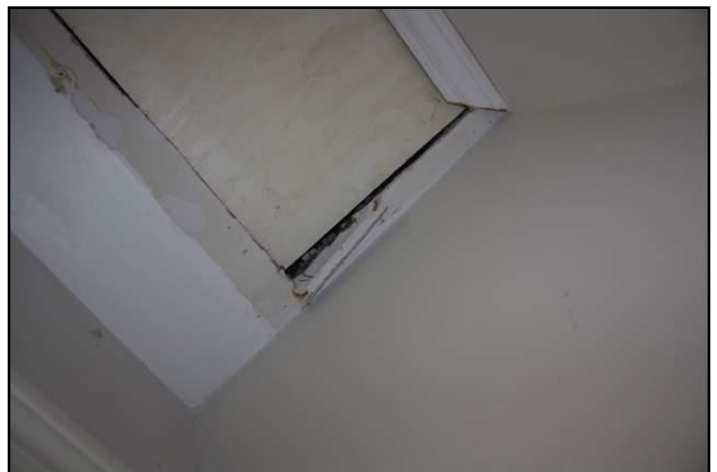
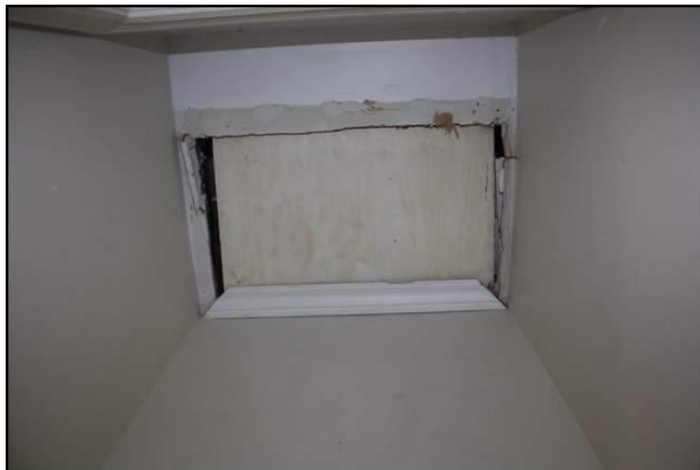
Condition: • Damaged

Air leakage into attic

Task: Repair / Replace

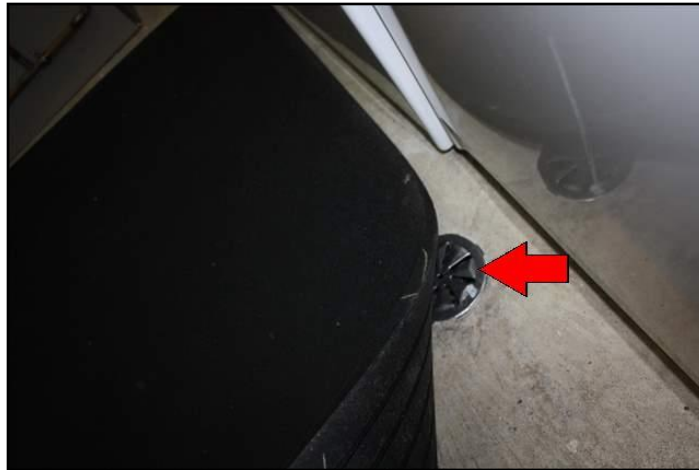
40.

Condition: • Rubber mat obstructing floor drain

Task: Expose drain

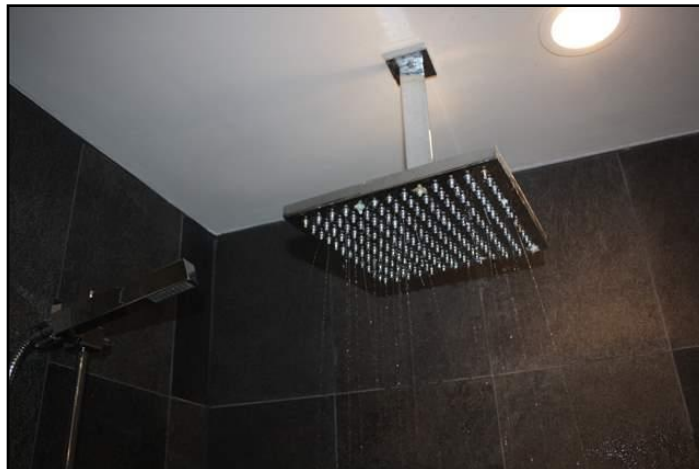
Condition: • Shower head damaged
Calcification.

Task: Clean

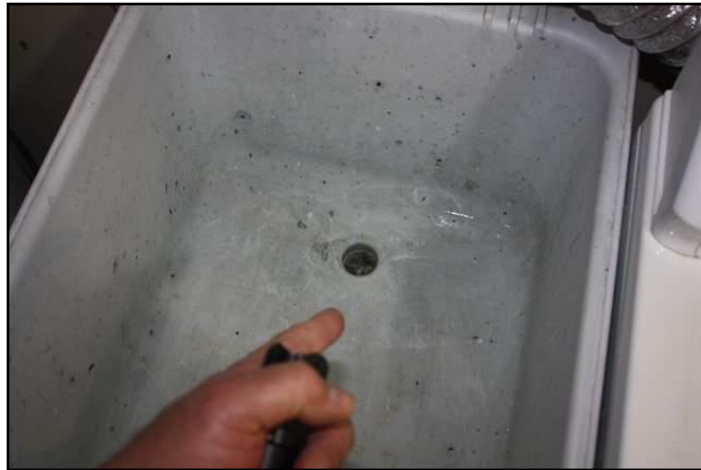
Condition: • [Slow drains](#)

Implication(s): Chance of water damage to contents, finishes and/or structure

Task: Correct

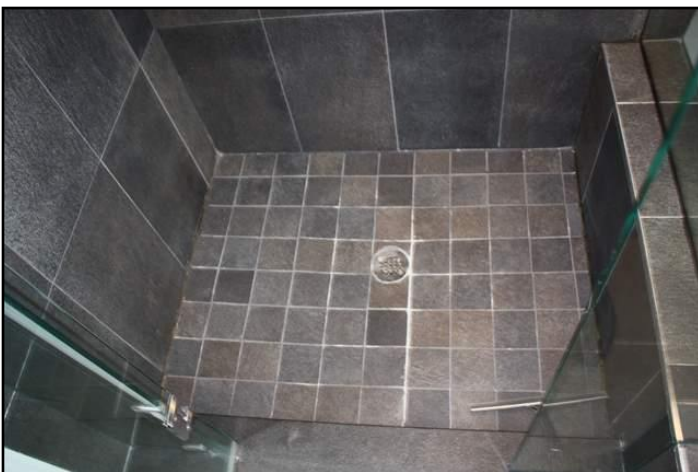
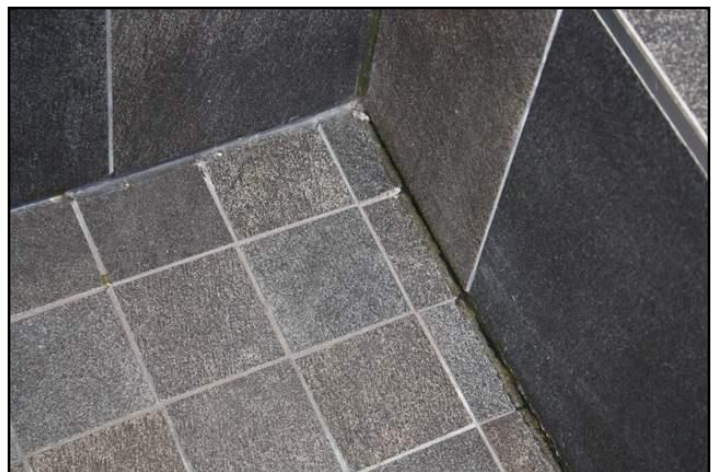
Condition: • [Grout loose, missing or deteriorated](#)

Implication(s): Chance of water damage to contents, finishes and/or structure

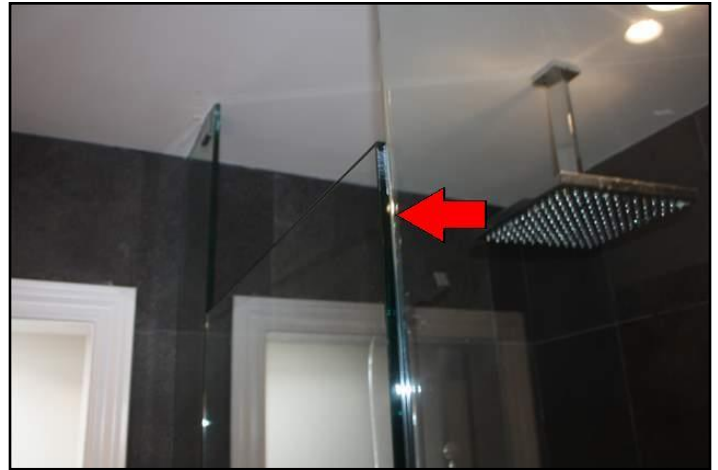
Condition: • [Entrance problems](#)

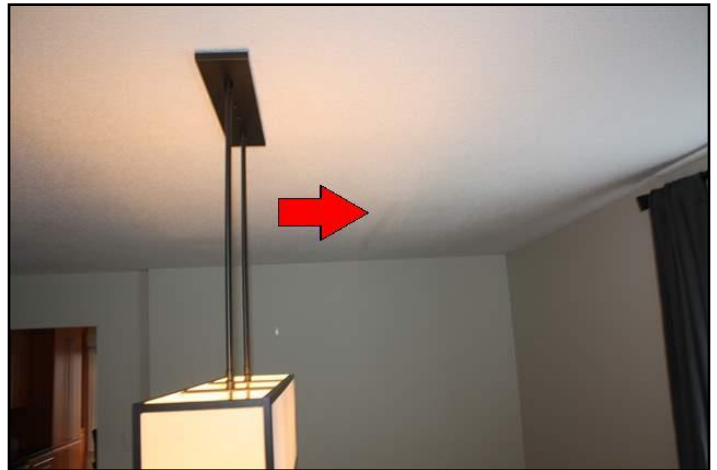
Condition: • [Patched](#)

Area below bathroom. Tested with a moisture meter. Dry at time of inspection.

Implication(s): Chance of damage to contents, finishes and/or structure

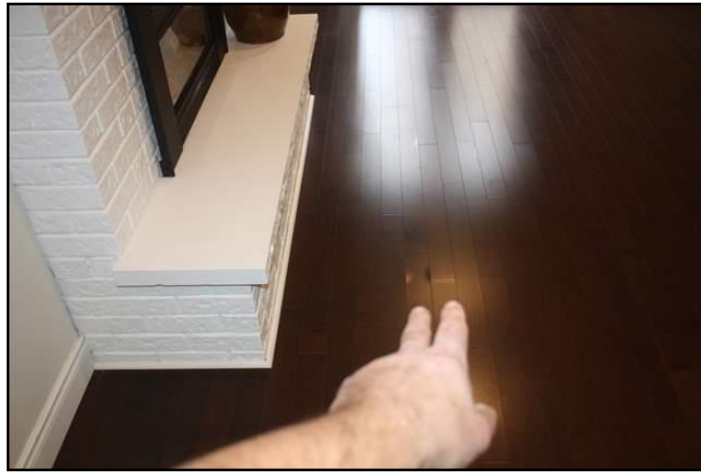
Condition: • Typical flaws

Task: Repair / Replace

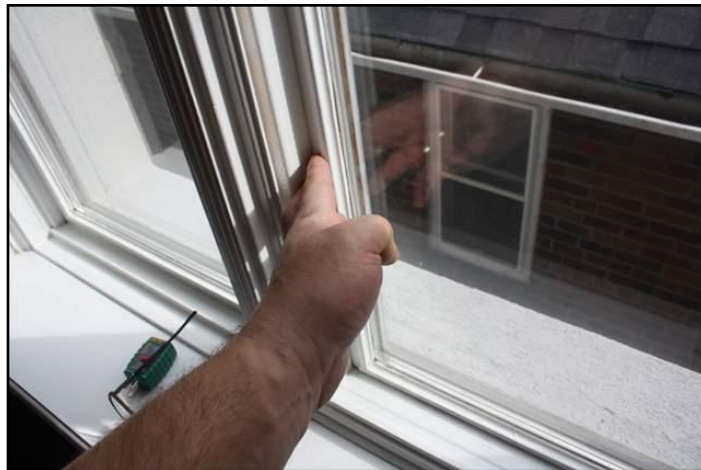
Condition: • Painted shut

Task: Improve

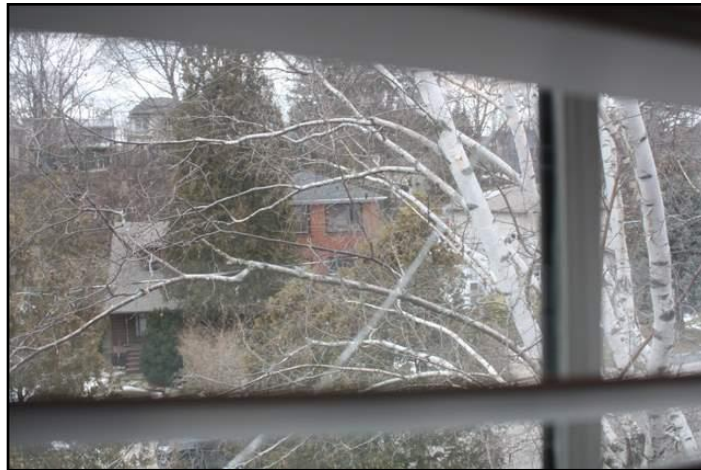
Condition: • [Cracked](#)

Task: Replace

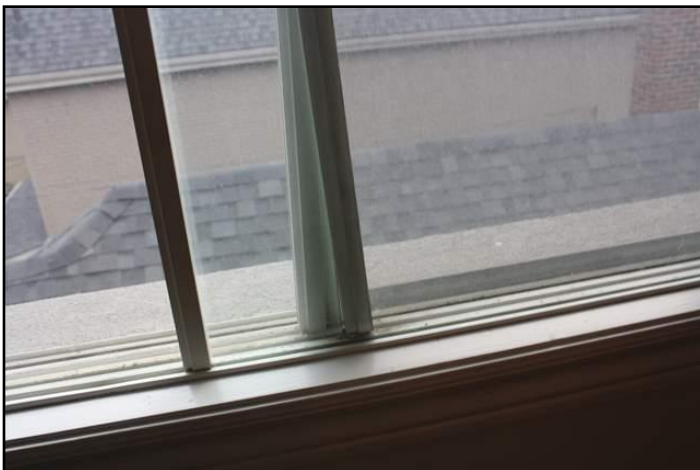
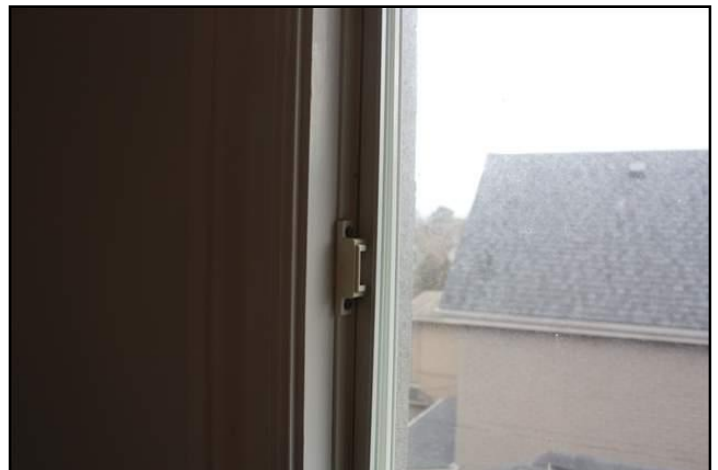
Condition: • [Sash coming apart](#)

Implication(s): Chance of damage to finishes and structure | Glass breaking

Task: Repair or replace

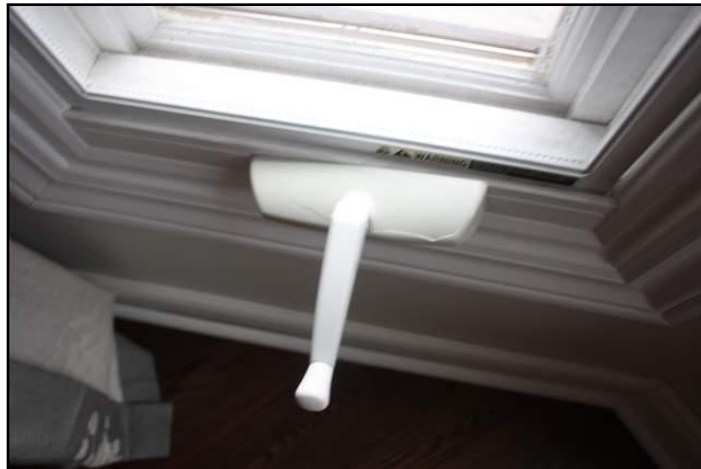
Condition: • [Loose](#)

loose or damaged in some areas

Implication(s): Equipment failure

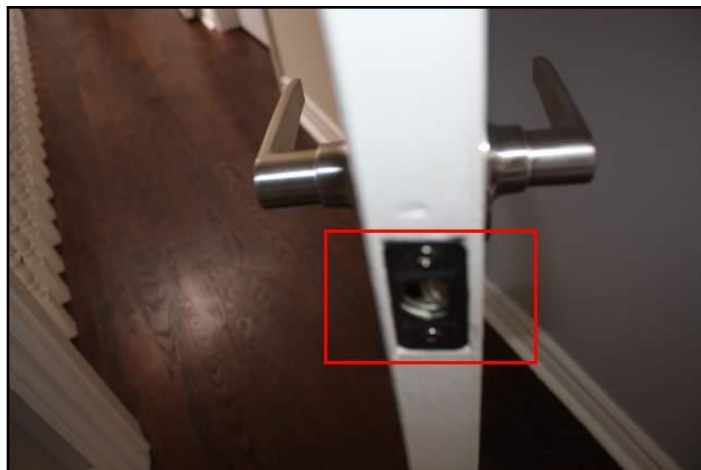
Condition: • [Broken](#)

Task: Repair / Replace

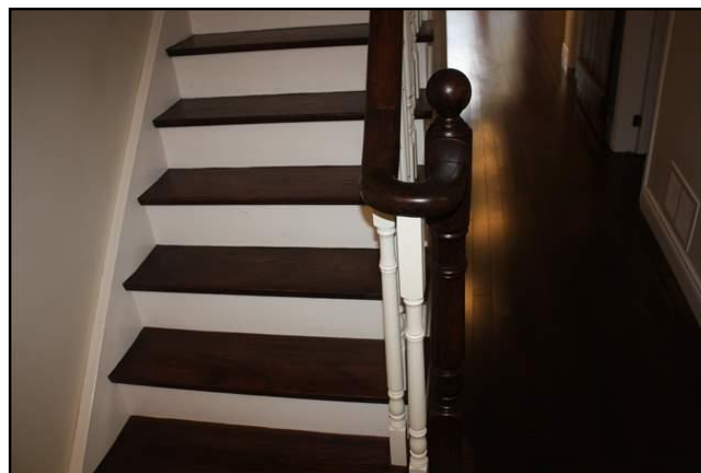
Condition: • [Loose](#)

Implication(s): Fall hazard
