Your Inspection Report

494 Durie Street
Toronto, ON M6S 3G7

INSPECTION DATE:
Thursday, May 14, 2026

RE: Report No. 9379
494 Durie Street
Toronto, ON
M6S 3G7

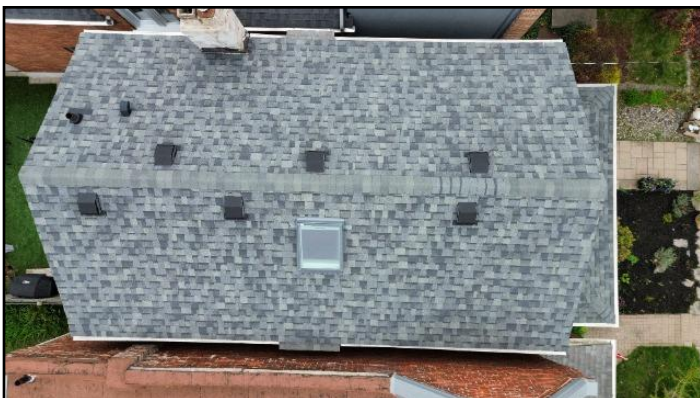
1. Asphalt shingles -- Good condition

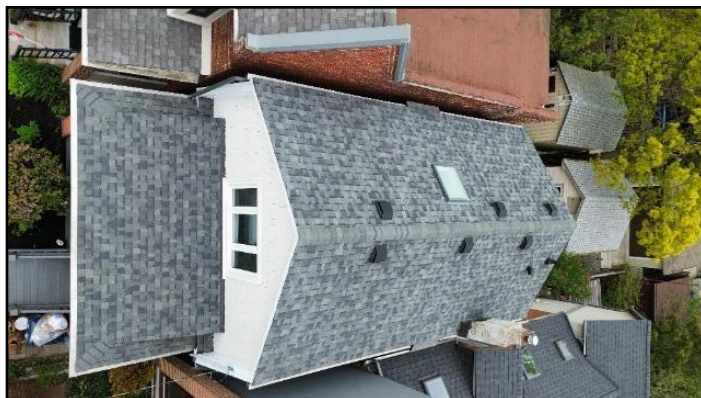
2. Asphalt shingles -- Good condition

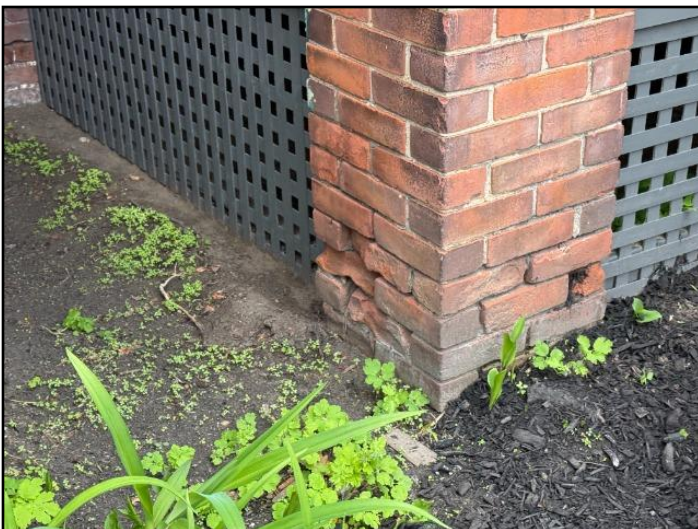
Condition: • Masonry and/or mortar deterioration

Tuckpoint / Repoint mortar and patch/repair spalled masonry. This is typical maintenance for a home of this age. photos show a sampling

3. example at column

Task: Repair

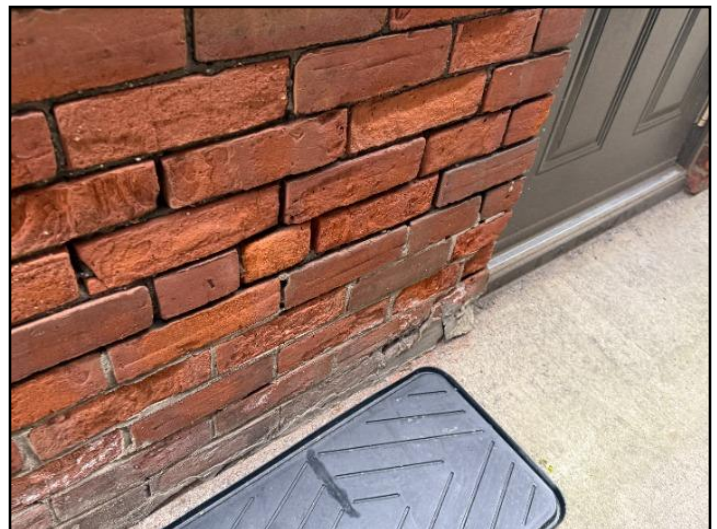
4. example at right side

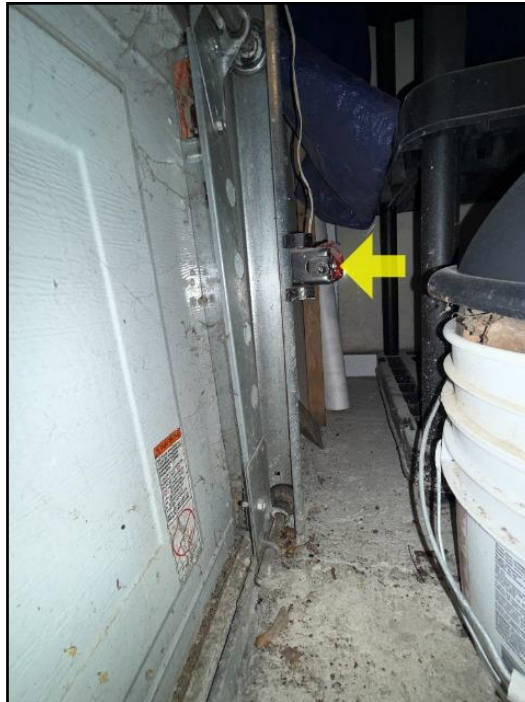
Condition: • Photoelectric sensor more than 6 inches above the floor

5. Photoelectric sensor more than 6 inches...

Task: Correct - Lower sensors to within 6 inches from floor

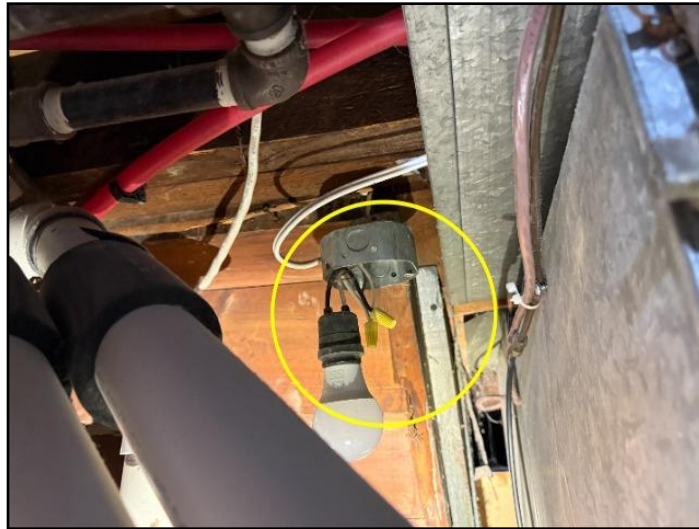
7. one example

Condition: • [Loose](#)

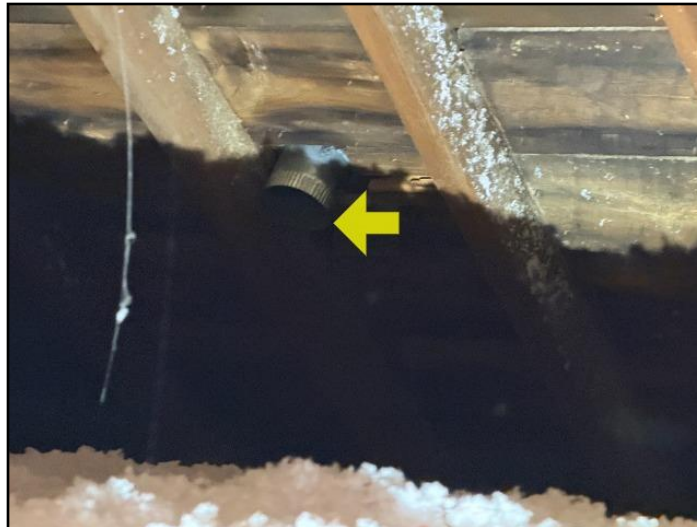
Condition: • [Termination point not found](#)

The bathroom exhaust fan operated, but the duct termination/connection was not visually confirmed in the attic. An apparent roof sheathing opening was noted. Verify the fan is properly connected and exhausting to the exterior.

9. Termination point not found

Task: Verify / Correct
Time: As soon as practical
Cost: Minor
