# Your Inspection Report

374 Spadina Road  
Toronto, ON M5P 2V8

**INSPECTION DATE:**  
Thursday, September 17, 2026

RE: Report No. 9837, v.2  
374 Spadina Road  
Toronto, ON  
M5P 2V8

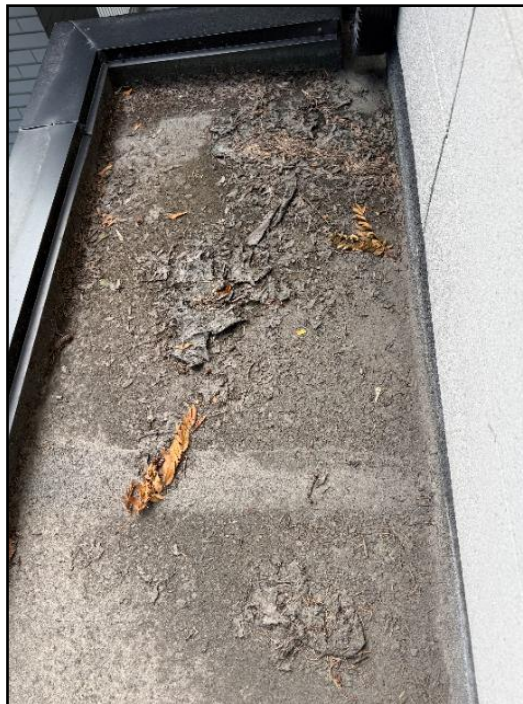
**Condition:** • [Debris on roof](#)

4. Debris on roof

**Task:** Clean

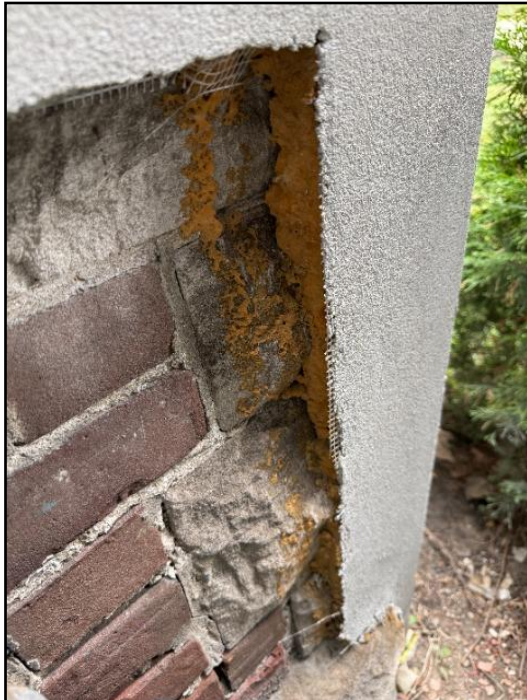
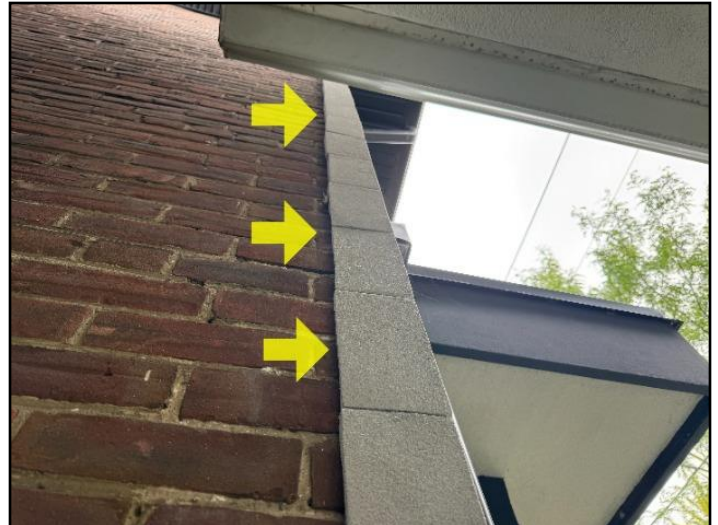
5. example at left side

**Condition:** • [Caulking missing or ineffective](#)

Open/unsealed joints and incomplete finishing were noted at various cladding transitions. Exposed reinforcing mesh/adhesive was also visible in some areas.

**Task:** Seal / finish as needed

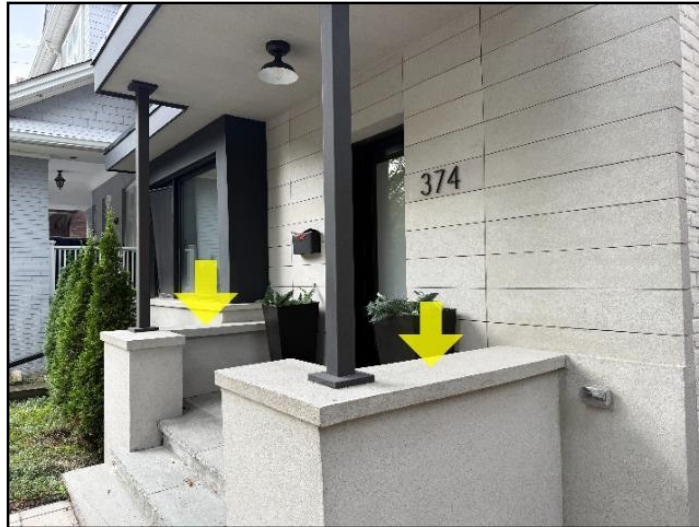
**Condition:** • [Too low](#)

7. Too low

**Task:** Upgrade

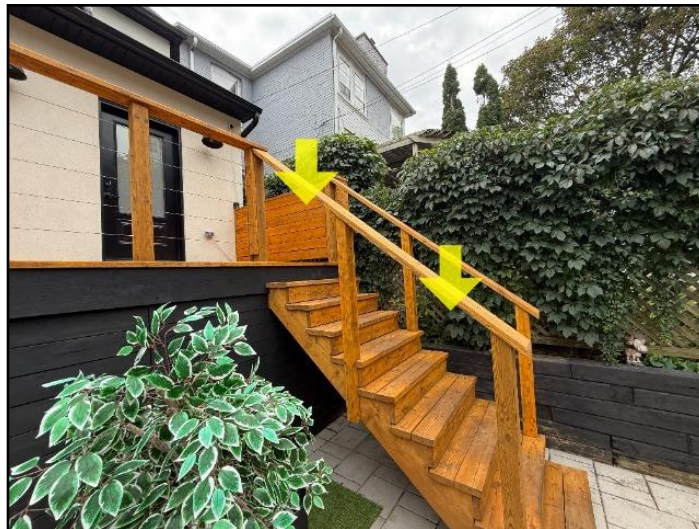
**Condition:** • [Spindles \(balusters\) missing](#)

8. Spindles (balusters) missing

**Task:** Provide spindles

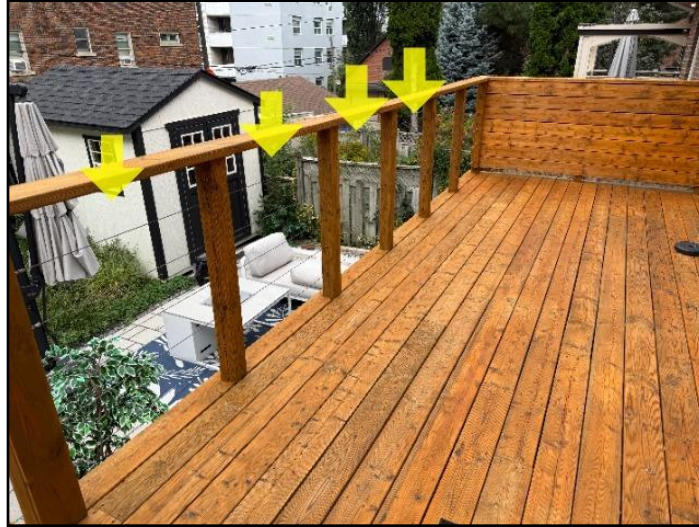
**Condition:** • Horizontal cable guard infill flexible / climbable

9. Horizontal cable guard infill flexible /...

**Task:** Upgrade / Improve

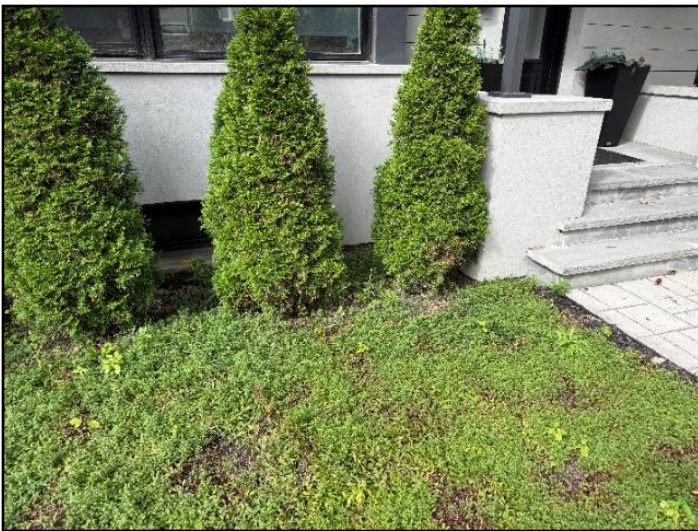
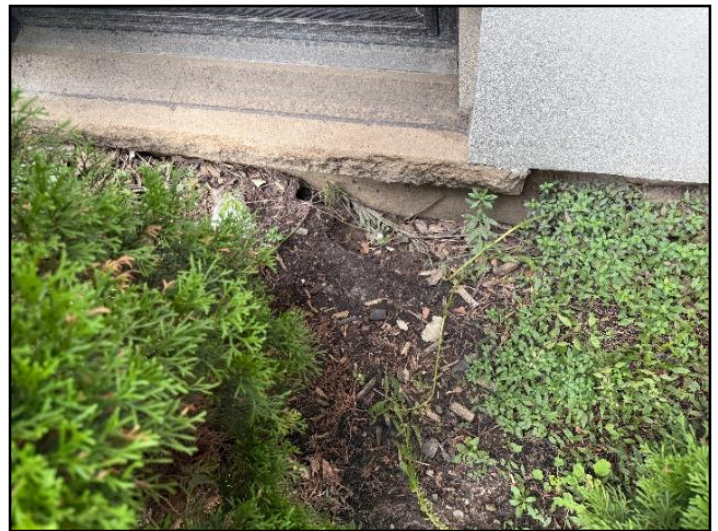
**Condition:** • Low Areas.

Low grading was noted at the landscaped /shrub area beside the foundation. A more pronounced localized depression/void was also present below the front basement window.

**Task:** Correct / Fill in low areas

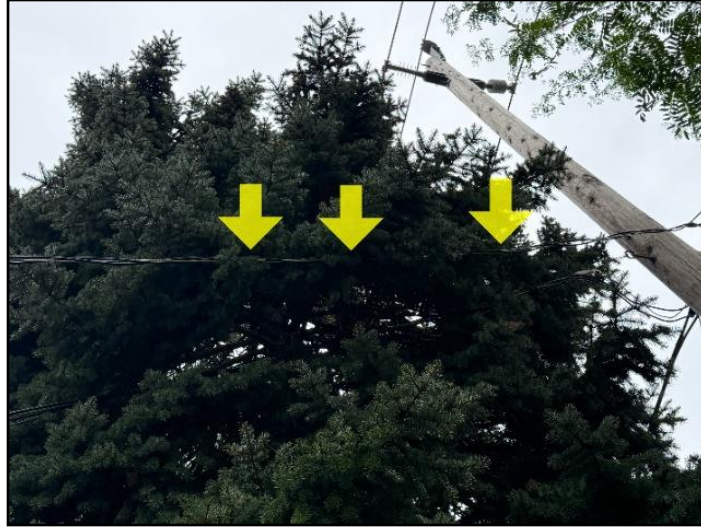
**Condition:** • [Branches / vines interfering with wires](#)

**13.** Branches / vines interfering with wires

**Task:** Trim

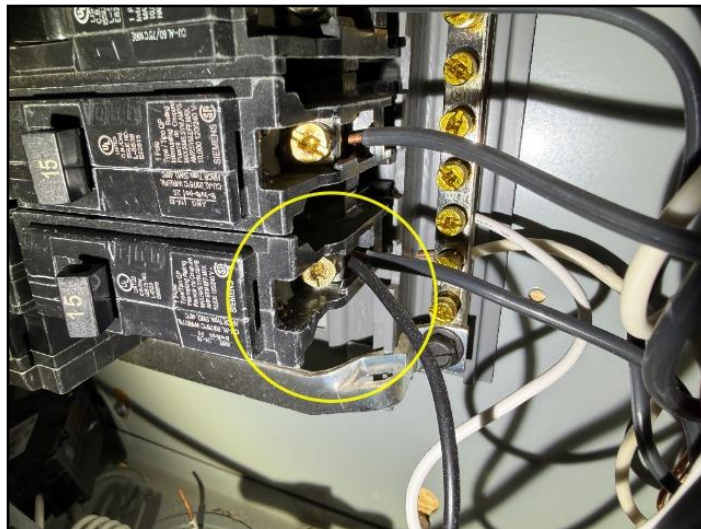
**Condition:** • Double tap - low voltage transformer supply

**14.** Double tap - low voltage transformer supply

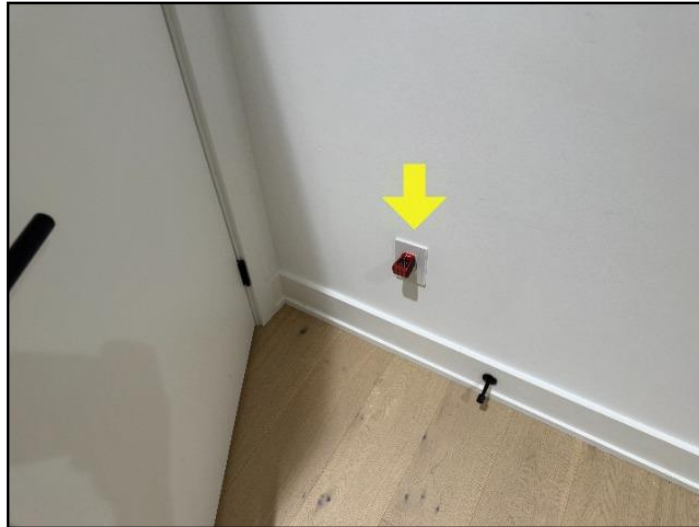
**Condition:** • [Inoperative](#)

15. Inoperative

**Task:** Repair / Replace

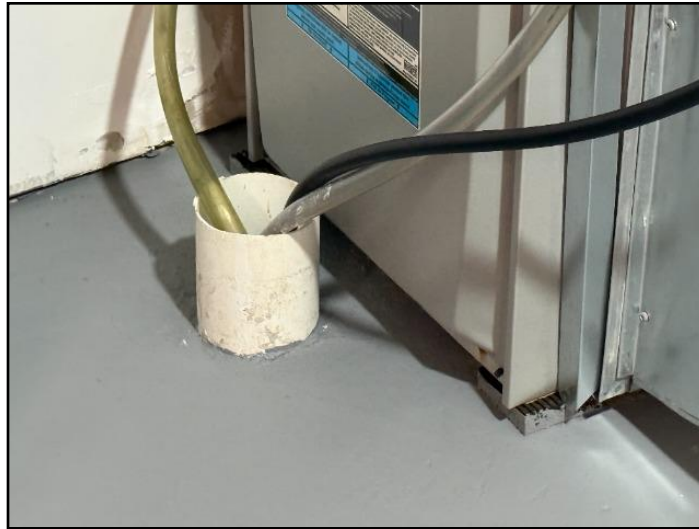
**Condition:** • Floor drain not flush with floor

21. Floor drain not flush with floor

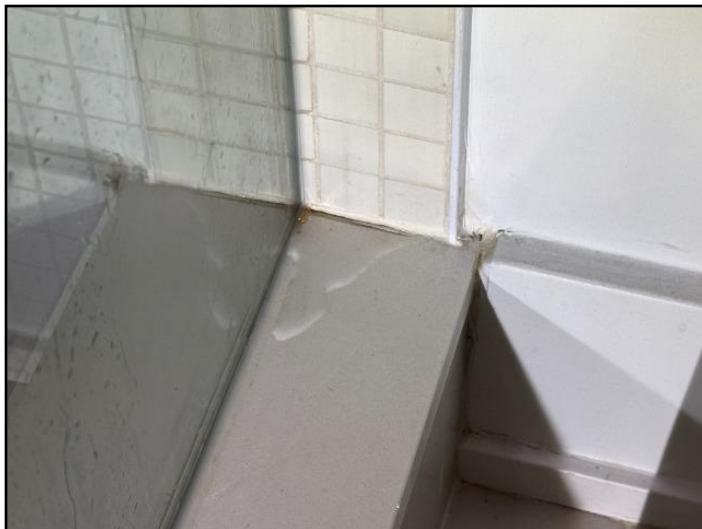
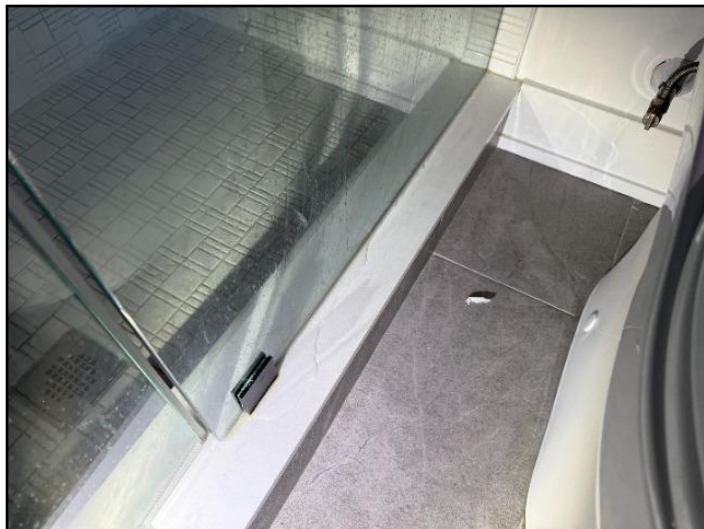
**Condition:** • [Leak](#)

22. Leak

**Task:** Seal / Caulk

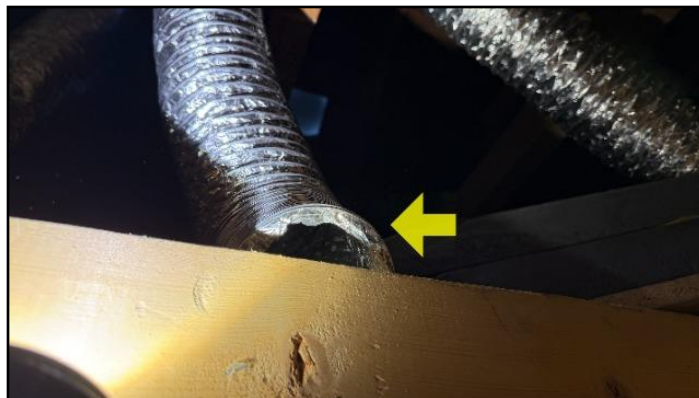
**Condition:** • [Not vented to exterior](#)

24. Not vented to exterior

**Task:** Confirm configuration / Vent active exhaust to exterior and repair fan as needed
