Your Inspection Report

123 West Drive
Your Town, LA 70000

INSPECTION DATE:
Thursday, June 8, 2017

Report No. 1004, v.3

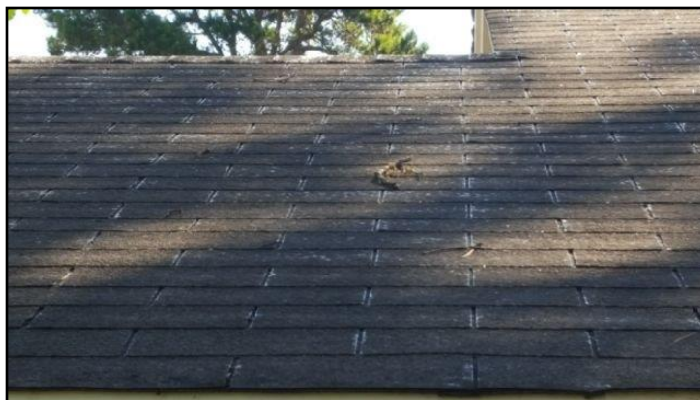
2. Condition: • [Granule loss](#)

Implication(s): Chance of water damage to contents, finishes and/or structure

Granule loss

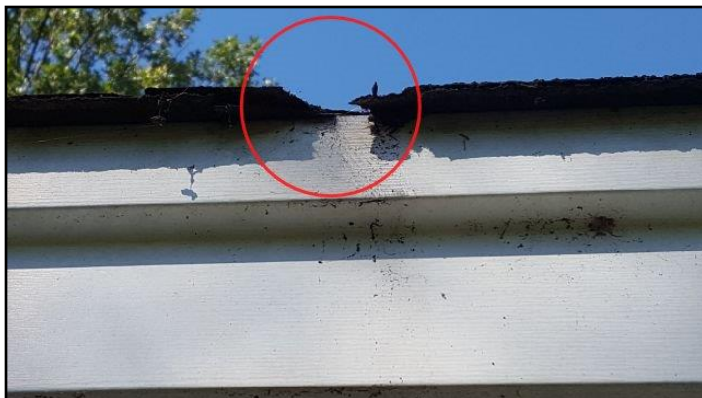
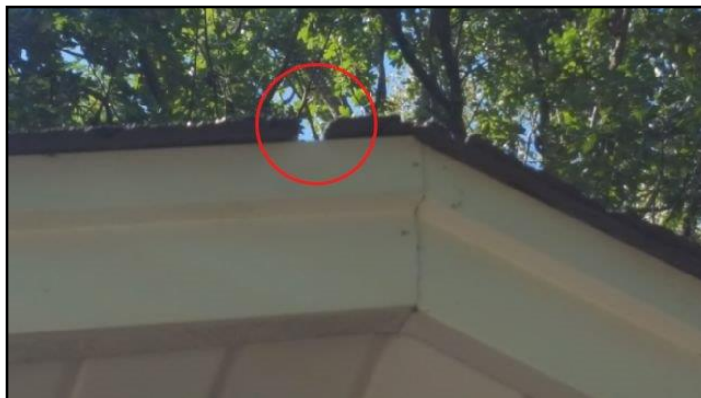
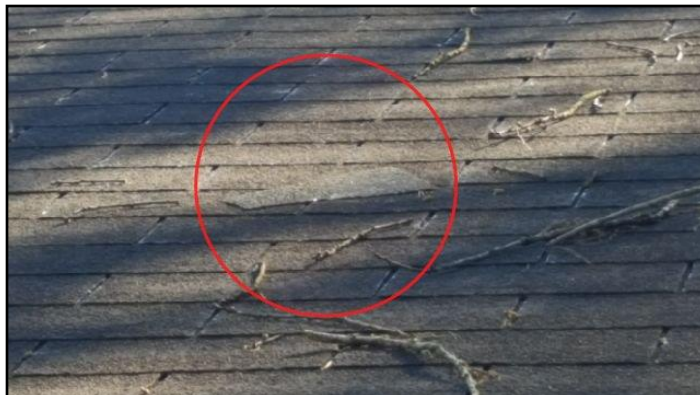
3. Condition: • [Missing, loose or torn](#)

Implication(s): Chance of water damage to contents, finishes and/or structure

Missing, loose or torn

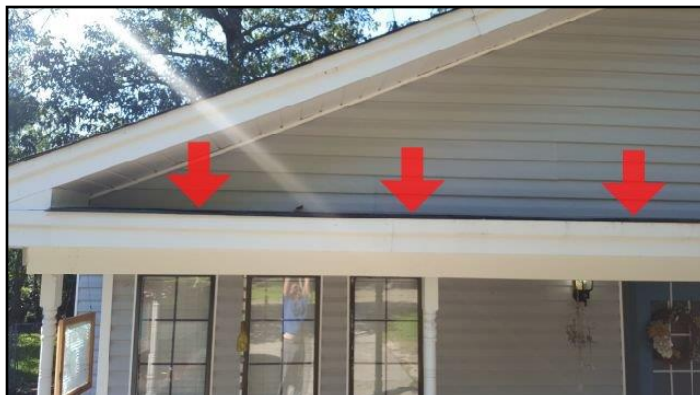
4. Condition: • [Slope too low](#)

Implication(s): Chance of water damage to contents, finishes and/or structure

Slope too low

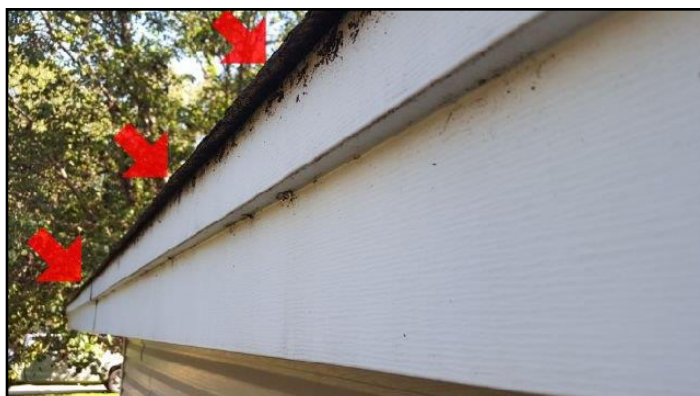
5. Condition: • [Overhangs too big or too small](#)

Implication(s): Chance of water damage to contents, finishes and/or structure

Overhangs too small

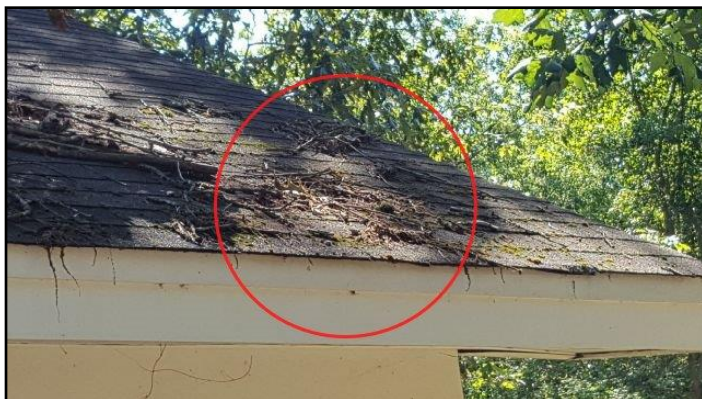
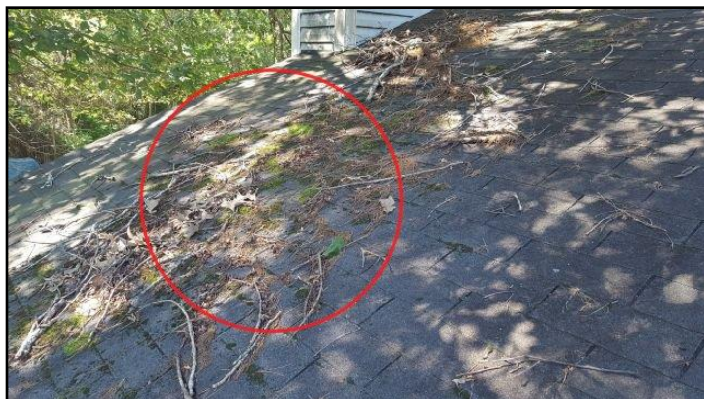
6. Condition: • Debris/moss

Debris/moss

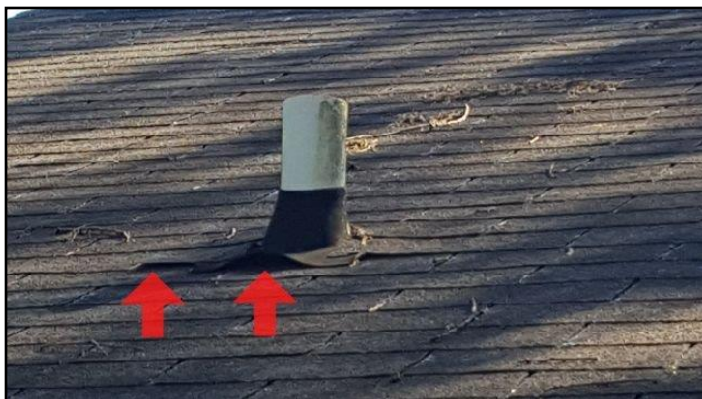
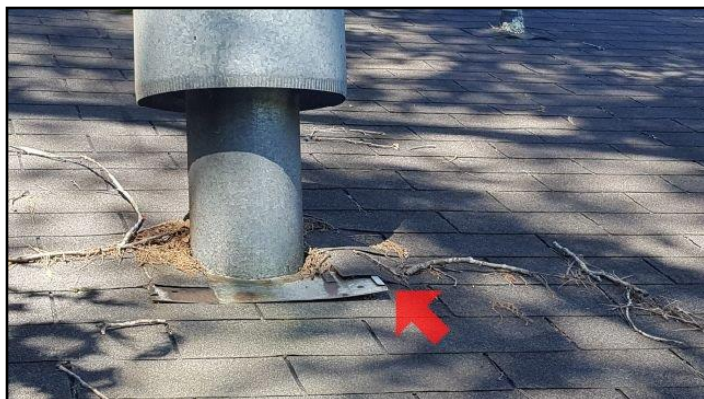
7. Condition: • Warped and raised

Implication(s): Water intrusion

Warped and raised

Task: Further evaluation by a qualified roofing contractor

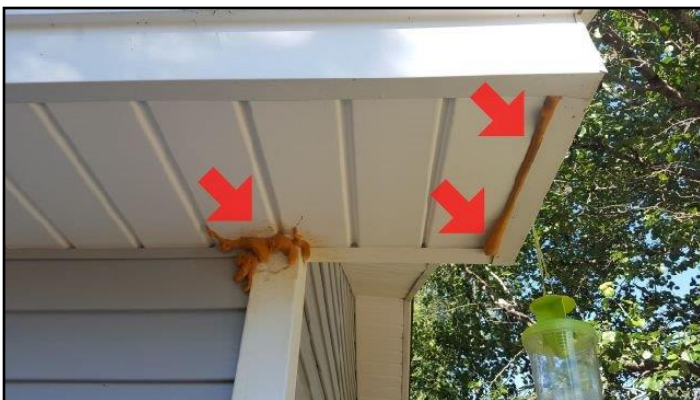
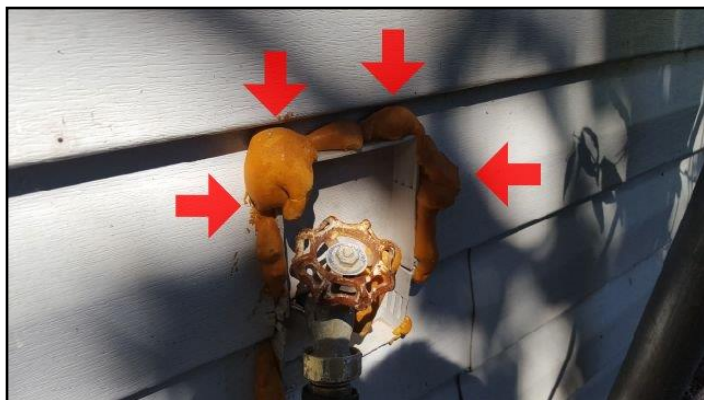
8. Condition: • Excess use of spray foam

Excess use of spray foam

Task: Clean

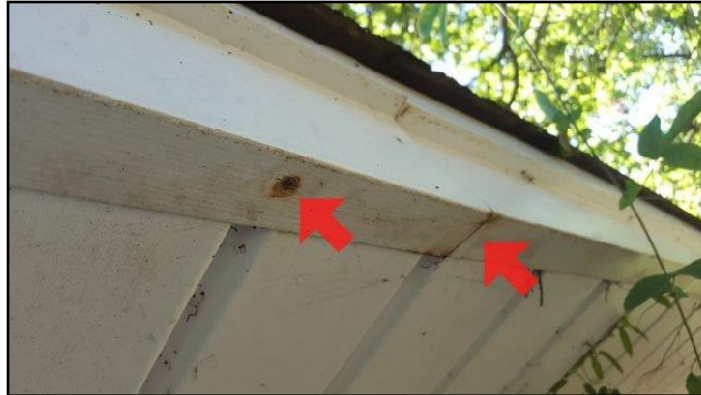
9. Condition: • Rusting fascia

Implication(s): Shorten life expectancy of material

Rust

Task: Repair

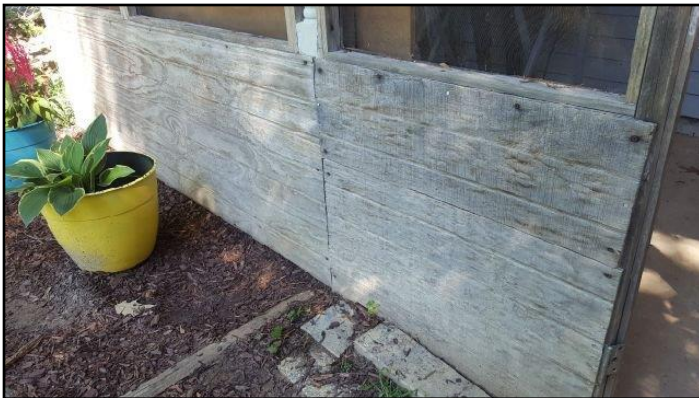
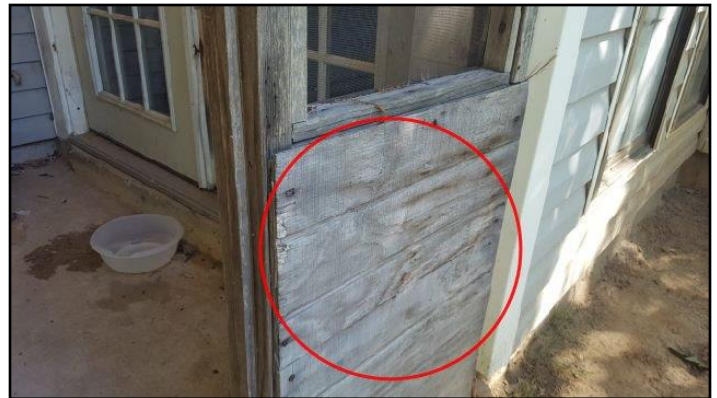
10. Condition: • [Paint or stain - needed](#)

Implication(s): Shortened life expectancy of material

Paint or stain - needed

Task: Improve

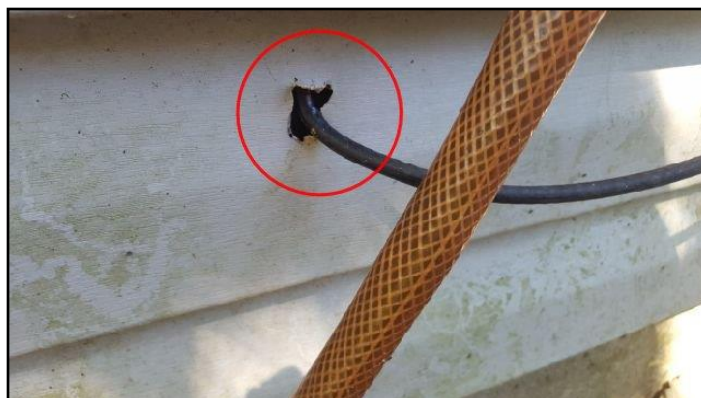
11. Condition: • Unsealed opening in the siding

Implication(s): Water damage to internal structure

Task: Improve

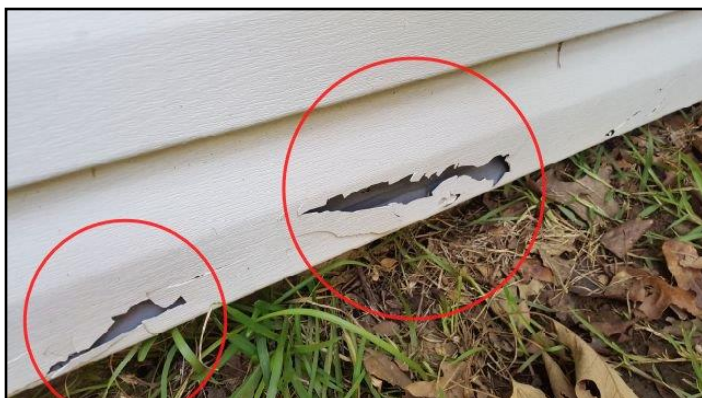
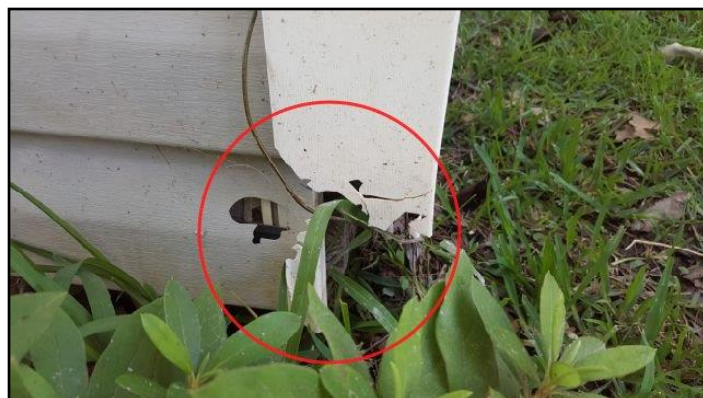
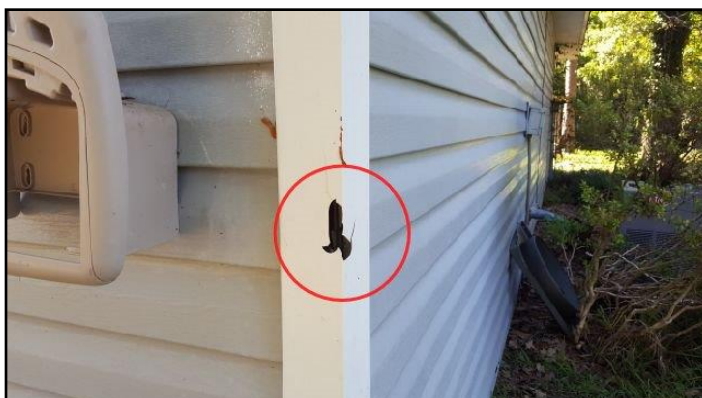
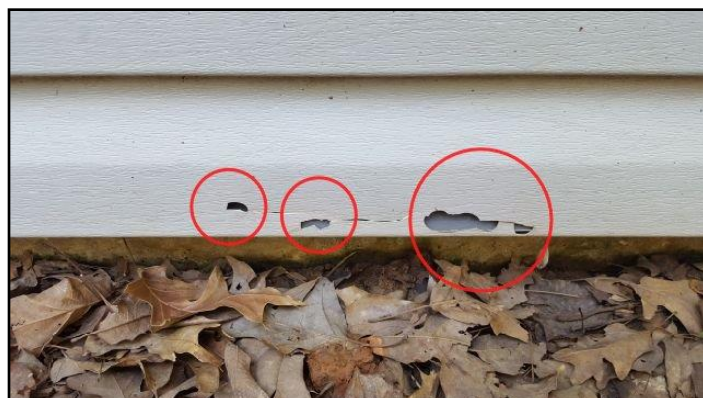
12. Condition: • [Mechanical damage](#)

Implication(s): Chance of water damage to contents, finishes and/or structure

Mechanical damage

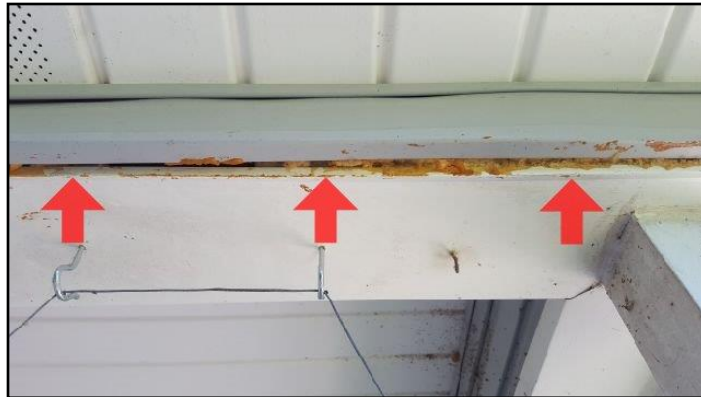
13. Condition: • [Buckled or wavy](#)

Opening in the siding

Implication(s): Chance of water damage to contents, finishes and/or structure

Buckled or wavy

Task: Improve

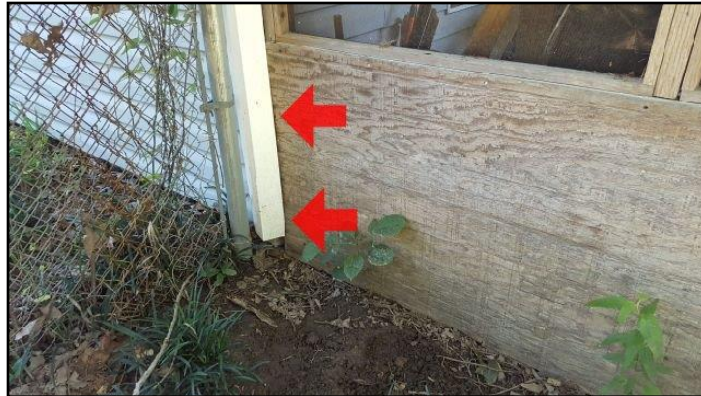
14. Condition: • [Loose or missing pieces](#)

Implication(s): Chance of water damage to contents, finishes and/or structure

Loose or missing pieces

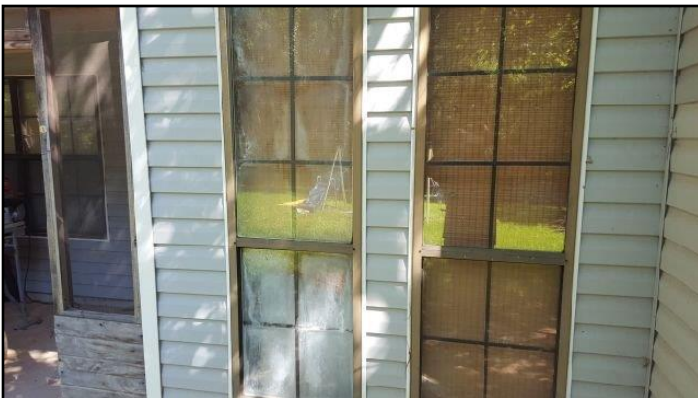
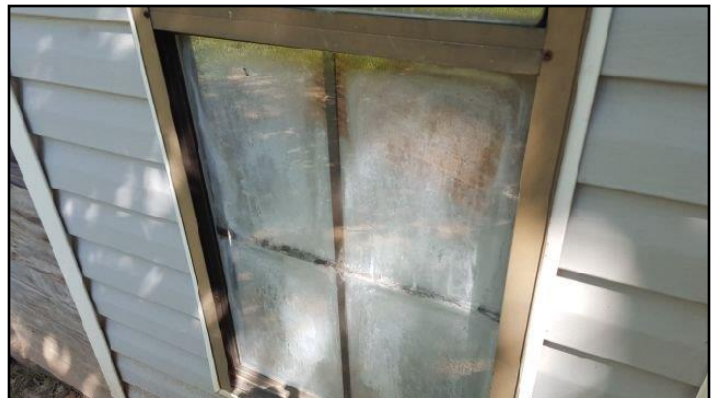
15. Condition: • [Lost seal on double or triple glazing](#)

Implications(s): Increased heating and cooling costs

Lost seal on double glazing

Task: Repair or replace

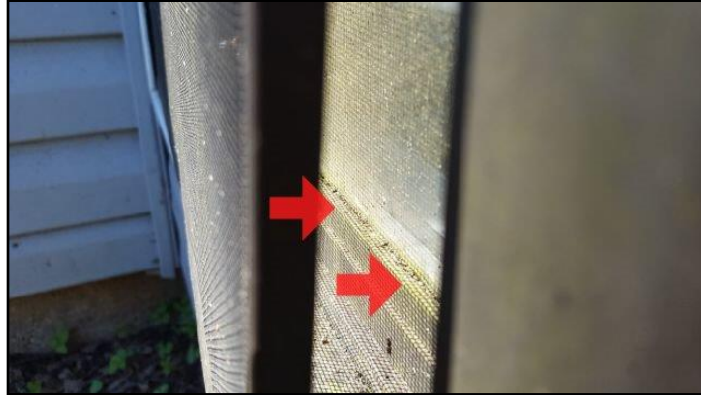
16. Condition: • [Caulking loose, missing or deteriorated](#)

Implication(s): Chance of water damage to contents, finishes and/or structure | Increased heating and cooling costs

Caulking loose, missing or deteriorated

Task: Repair or replace

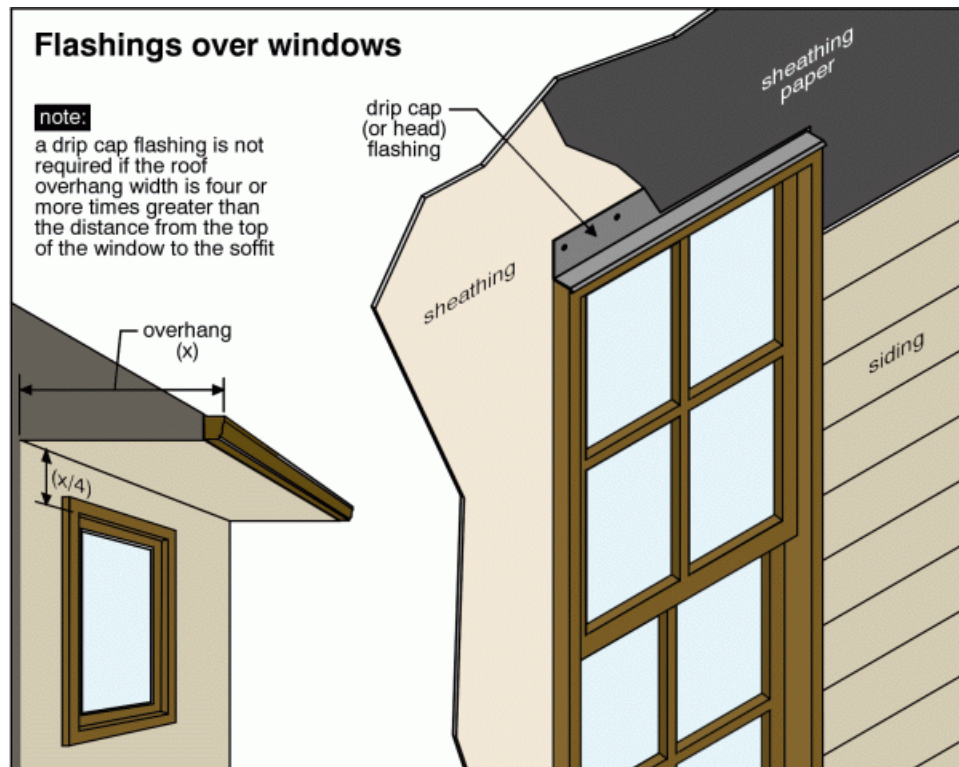
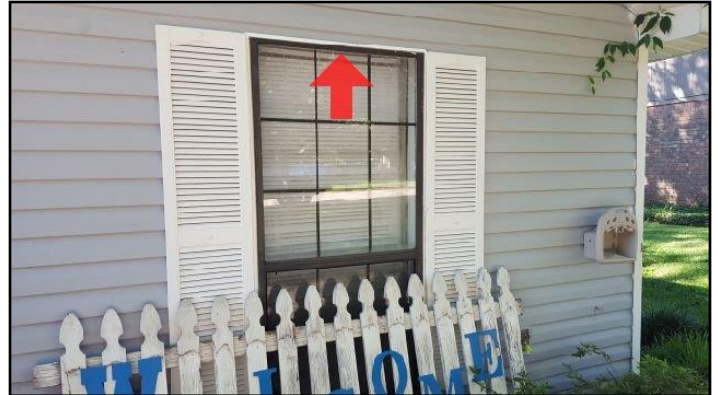
17. Condition: • [Ineffective](#)

Implication(s): Chance of water damage to contents, finishes and/or structure

Ineffective

Task: Monitor

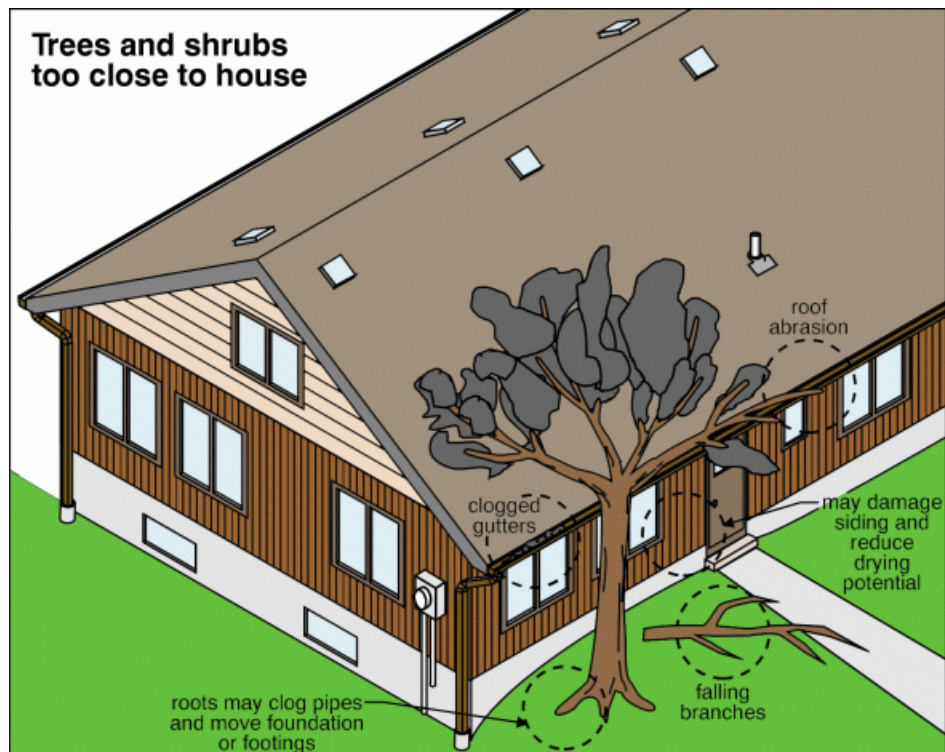
18. Condition: • [Trees or shrubs too close to building](#)

Implication(s): Chance of water damage to contents, finishes and/or structure | Chance of pests entering building | Material deterioration

Trees or shrubs too close to building

Task: Improve

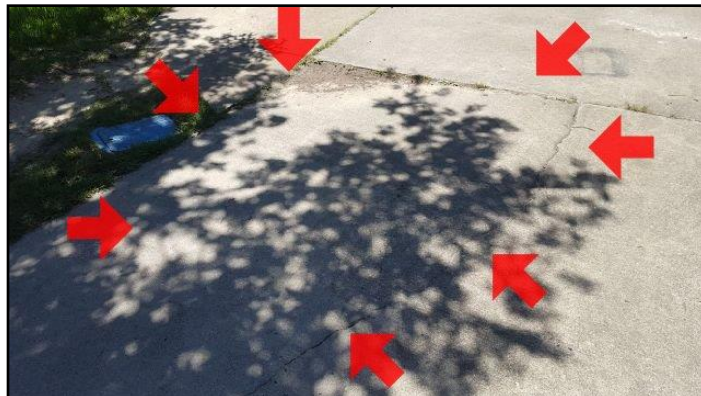
19. Condition: • [Improper slope or drainage](#)

Evidence of ponding

Task: Monitor

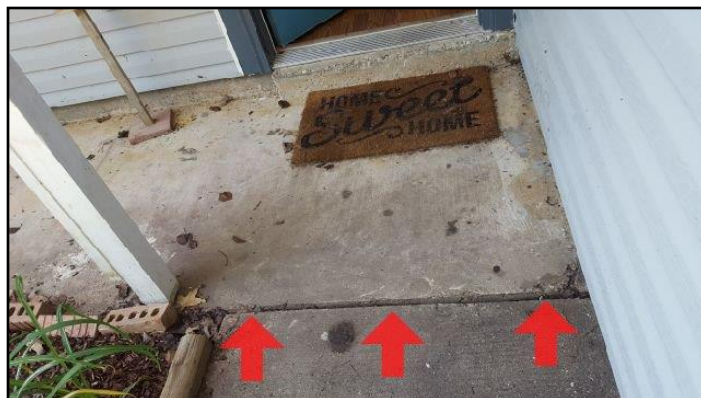
20. Condition: • [Unsealed gap at building](#)

Tripping hazard

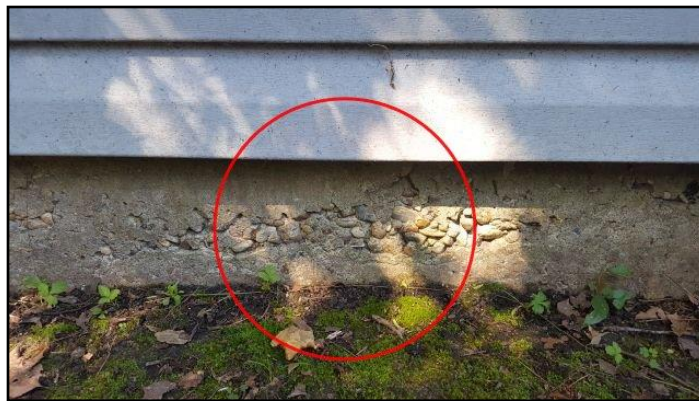
21. Condition: • [Honeycombing](#)
Implication(s): Weakened structure | Leakage
Location: West Exterior Wall

Honeycombing

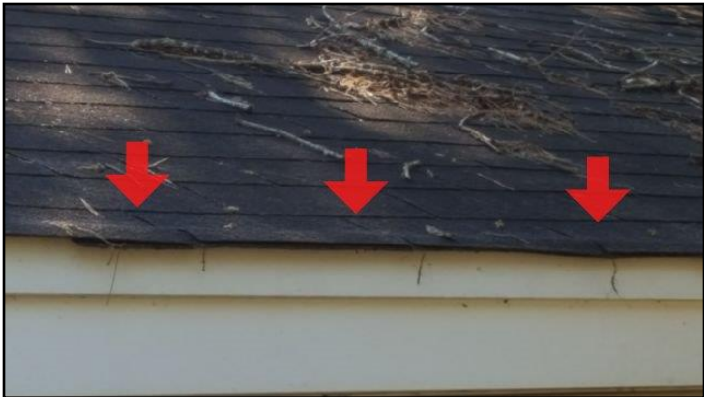
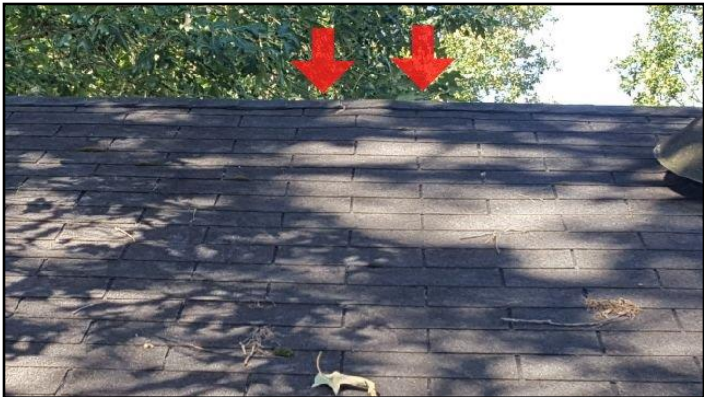
22. Condition: • [Sagging](#)
Implication(s): Weakened structure | Chance of structural movement
Location: Various Roof
Task: Further evaluation by a qualified roofing contractor

Sagging

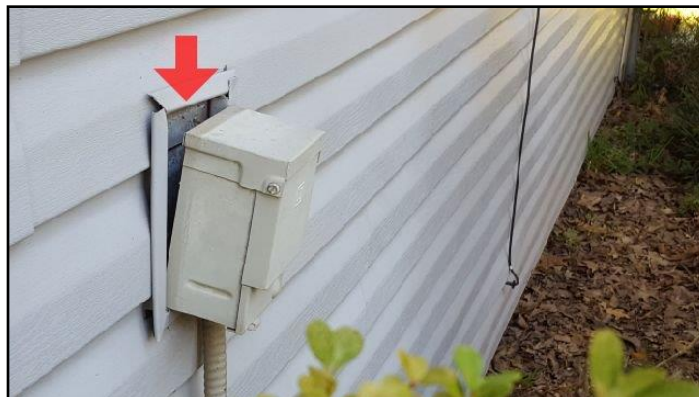
23. Condition: • [Loose panel](#)

Implication(s): Electric shock | Fire hazard

Loose panel

Task: Correct

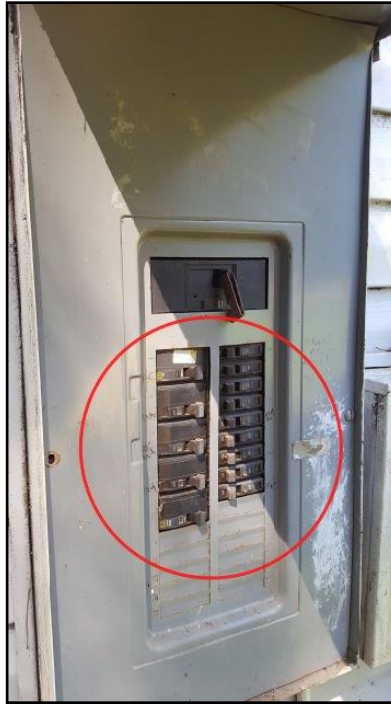
24. Condition: • [Circuits not labeled](#)

Circuits not labeled

Task: Correct

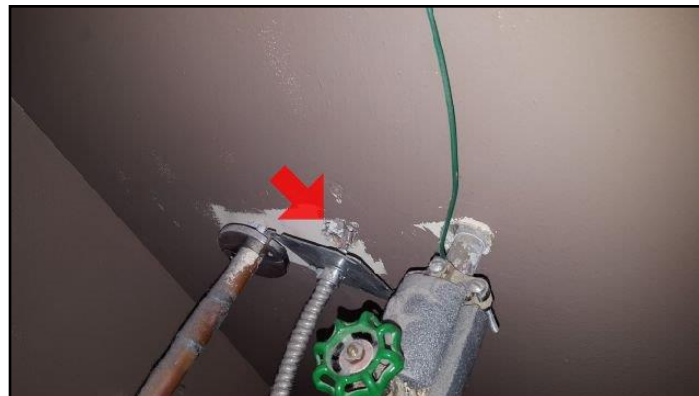
25. Condition: • [Exposed on walls or ceilings](#)

Implication(s): Electric shock

Exposed on walls

Task: Repair

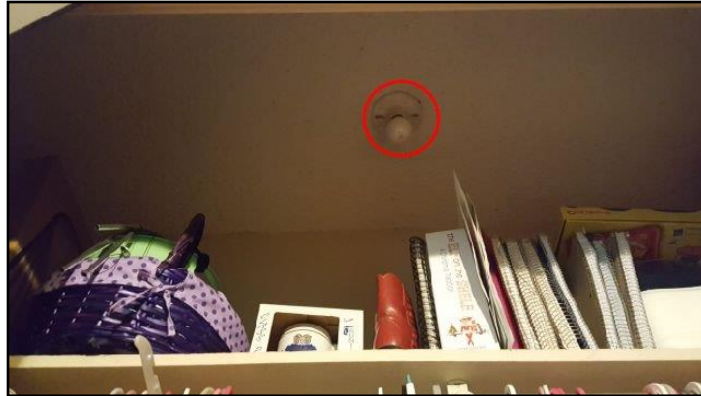
26. Condition: • [Improper closet lighting](#)

Implication(s): Fire hazard

Improper closet lighting

Task: Improve

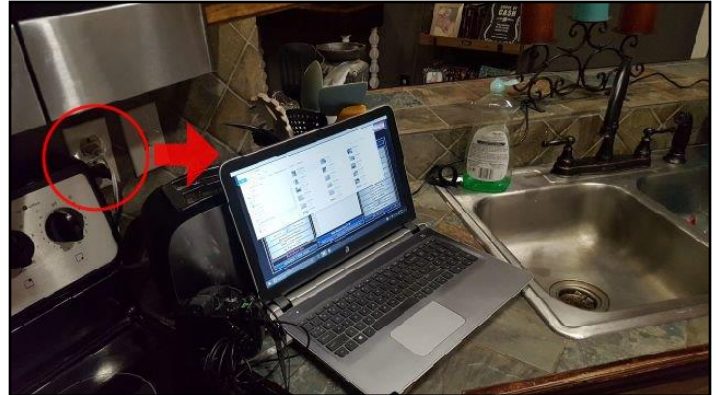
Kitchen

27. Condition: • [No GFCI/GFI \(Ground Fault Circuit Interrupter\)](#)

Implication(s): Electric shock

Task: Improve

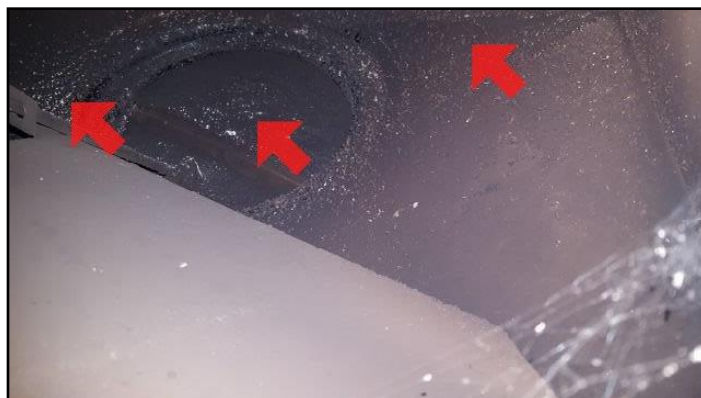
28. Condition: • [Creosote buildup](#)

Implication(s): Hazardous combustion products entering home | Increased fire hazard

Creosote buildup

Task: Clean

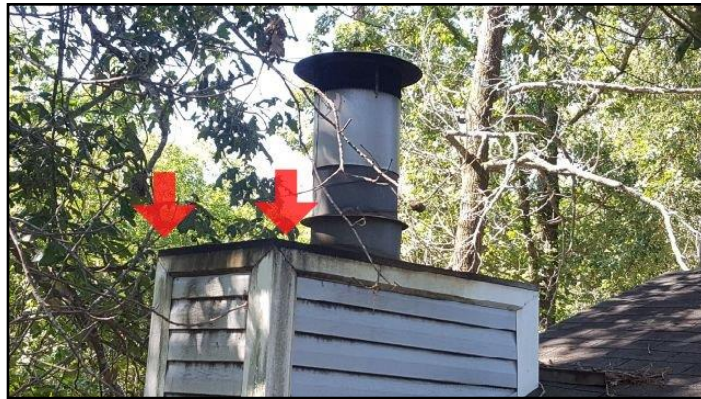
29. Condition: • Rust

Implication(s): Reduced system life expectancy

Rust

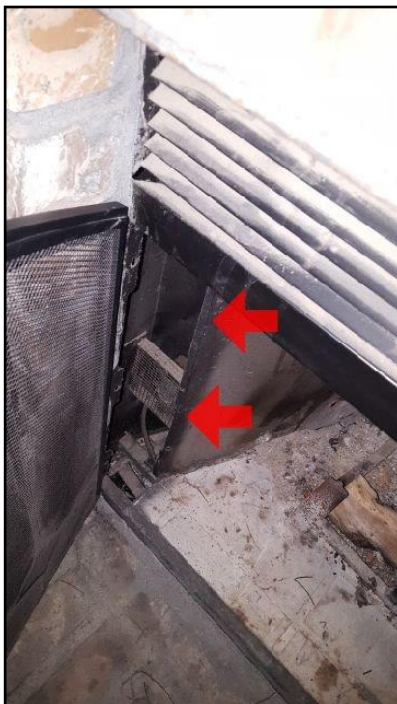
30. Condition: • Openings in the firebox

Flashing missing

Task: Correct

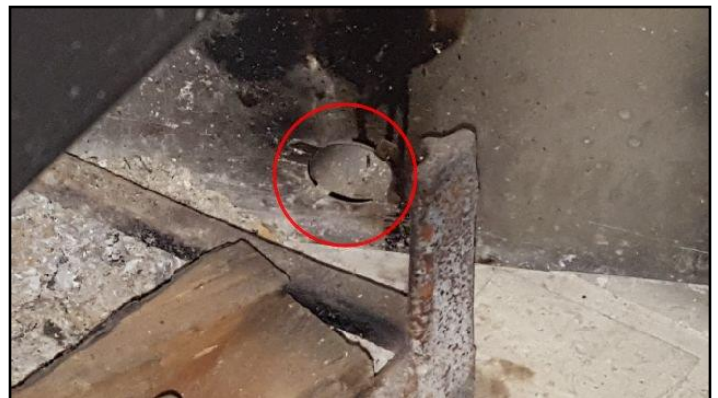
Gas line opening not sealed shut

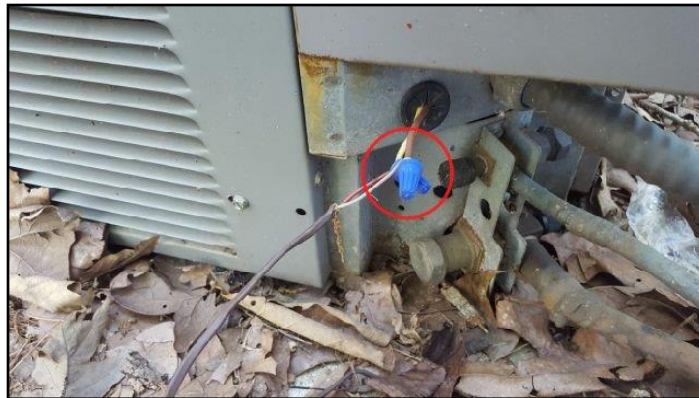
31. Condition: • Exposed electrical wires and splices

Exposed electrical wires and splices

Task: Further evaluation by a qualified HVAC contractor

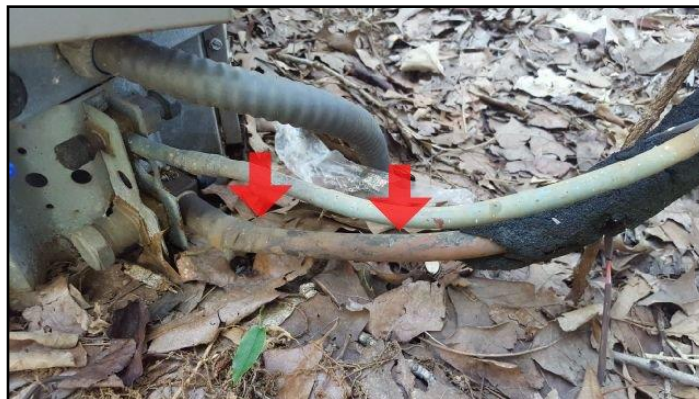
32. Condition: • [Insulation - missing](#)

Implication(s): Reduced system life expectancy | Increased cooling costs | Reduced comfort

Insulation - missing

Task: Further evaluation by a qualified HVAC contractor

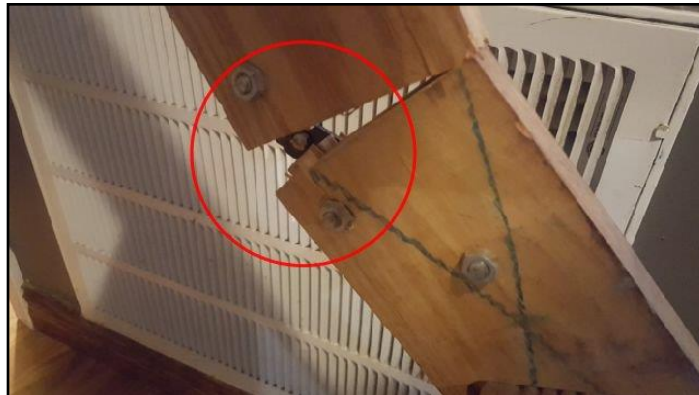
33. Condition: • [Treads loose or broken](#)

Implication(s): Trip or fall hazard

Treads loose or broken

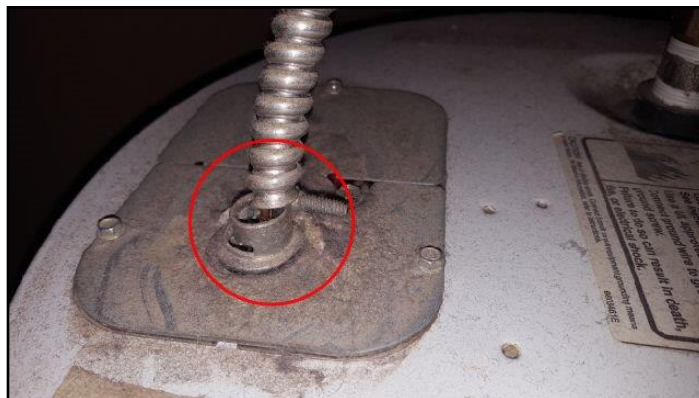
34. Condition: • [Damage](#)

Implication(s): Electric shock | Fire hazard

Damage

Task: Further evaluation by a licensed electrician

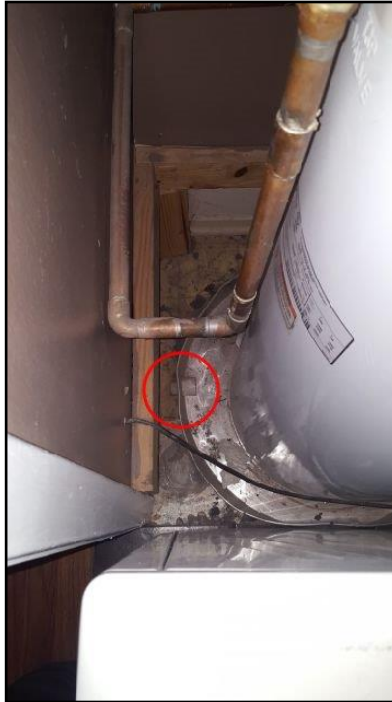
35. Condition: • Missing drain pipe from the catch tray

Implication(s): Water damage to interior

Missing catch pipe

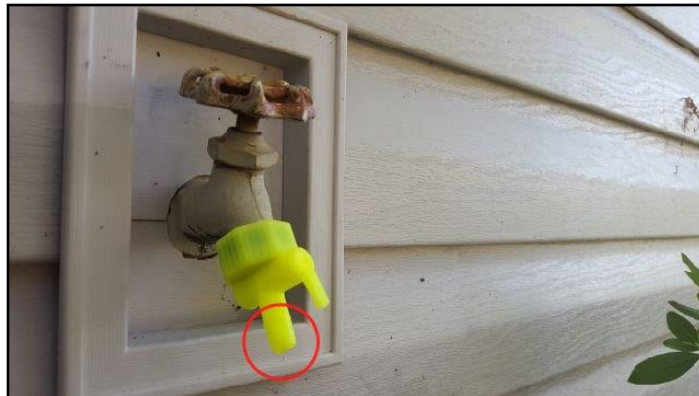
36. Condition: • [Leak or drip](#)

Leak or drip

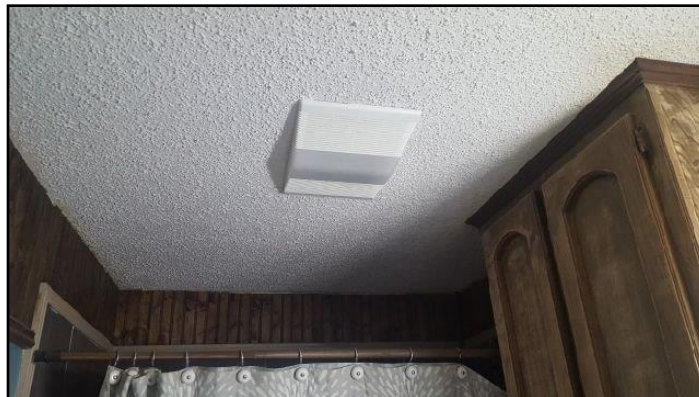
38. **Condition:** • [Not vented to exterior](#)

Implication(s): Chance of condensation damage to finishes and/or structure

Not vented to exterior
