# YOUR INSPECTION REPORT

FOR THE PROPERTY AT:  
22 Glenellen Drive East  
Toronto, ON

INSPECTION DATE:  
Thursday, January 30, 2020

RE: Report No. 2604, v.2  
22 Glenellen Drive East  
Toronto, ON

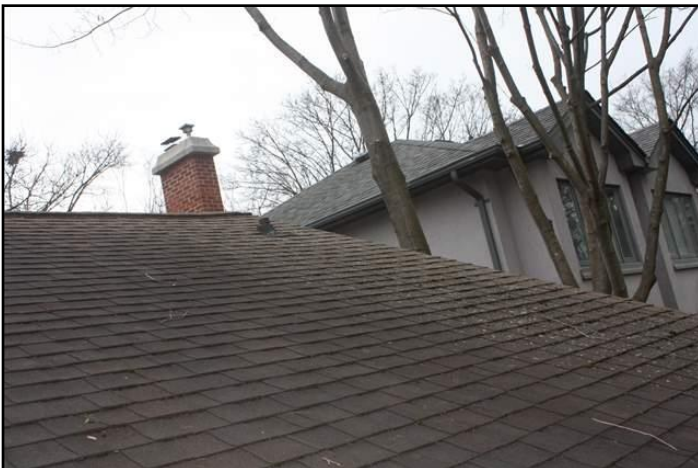
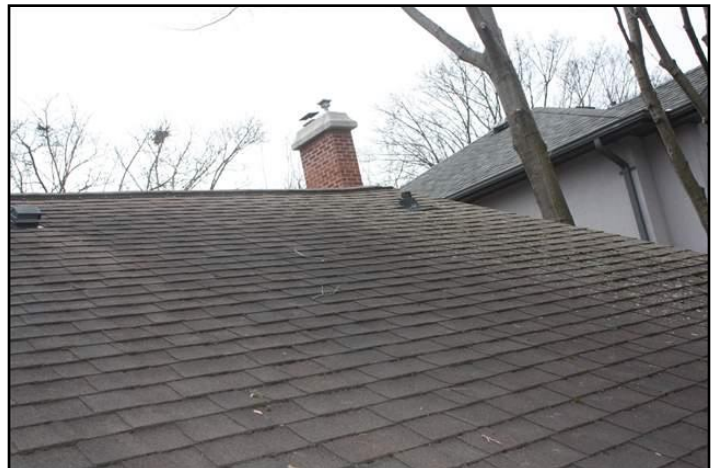
**Condition:** • Debris/moss

1. Debris/moss

2. Debris/moss

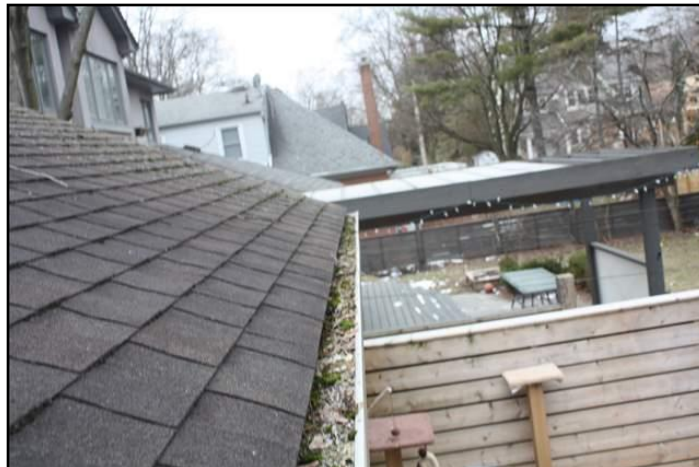
3. example

**Condition:** • Dirty/debris

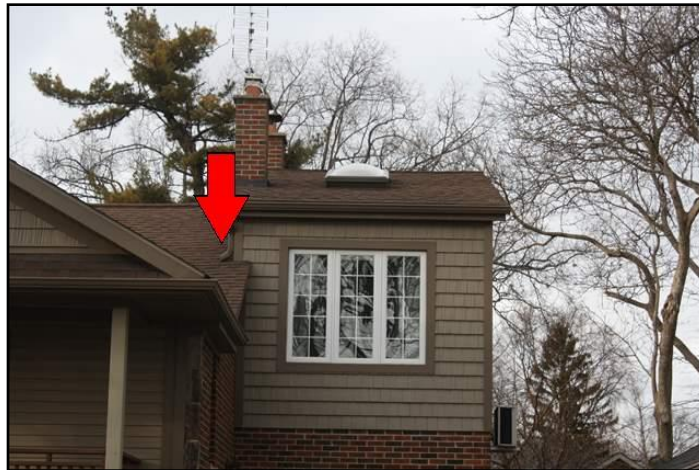
4. Example

**Condition:** • [Discharge onto roofs](#)

Improvement recommendation. Extend Downspouts to lower gutter to protect lower roof from premature wear.

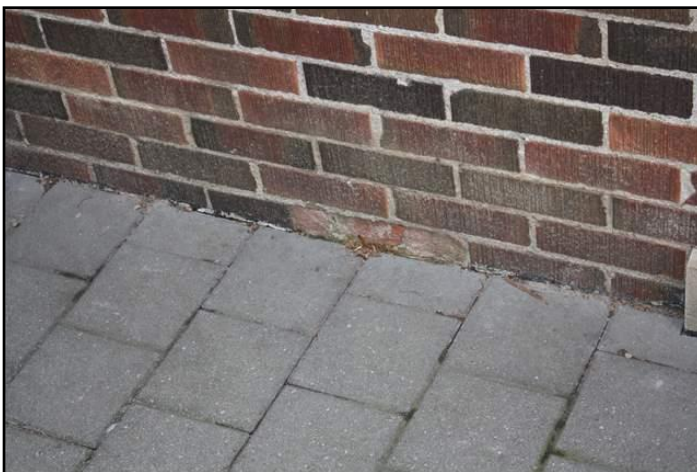
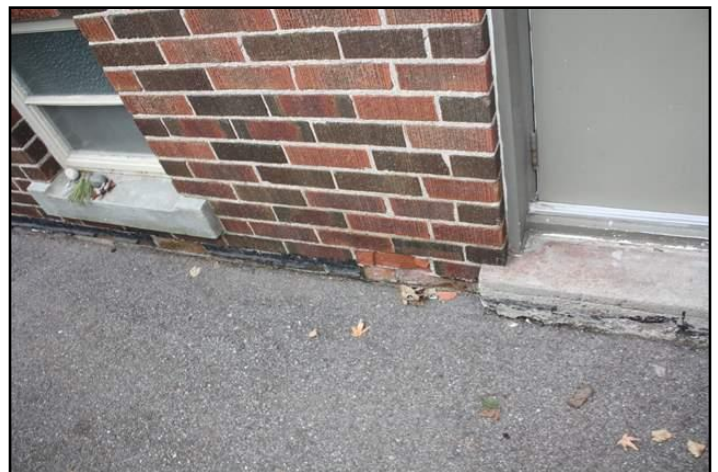
**Condition:** • [Spalling](#)

5. Spalling

6. Spalling

**Task:** Repair

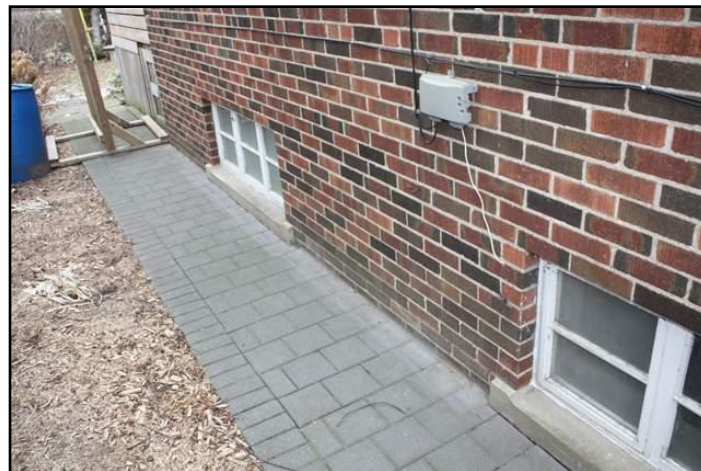
7. example

**Condition:** • [Too close to grade](#)

Some types of brick can be at grade level. Considering the age of the home, the masonry appears in good condition. Continue to monitor. Click blue link to read more information.

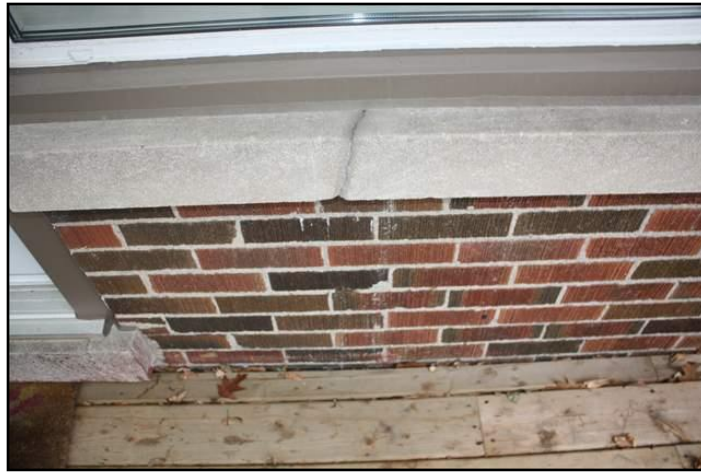
Condition: • [Damage](#)

Patch sill crack

8. Damage

**Task:** Repair

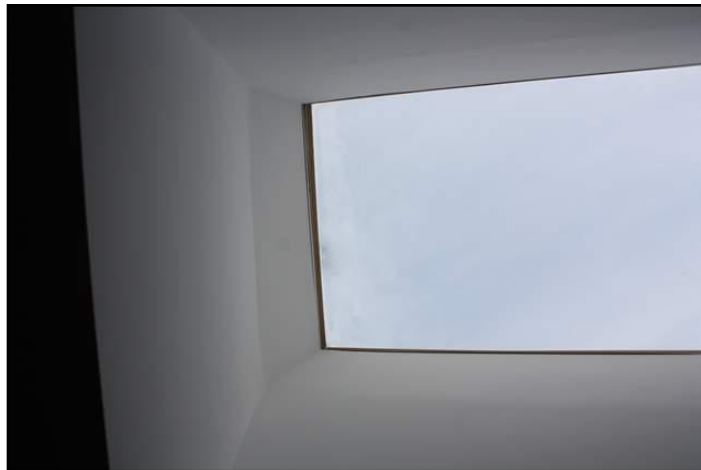
**Condition:** • Lost seal on double or triple glazing

9. Lost seal on double or triple glazing

**Task:** Replace

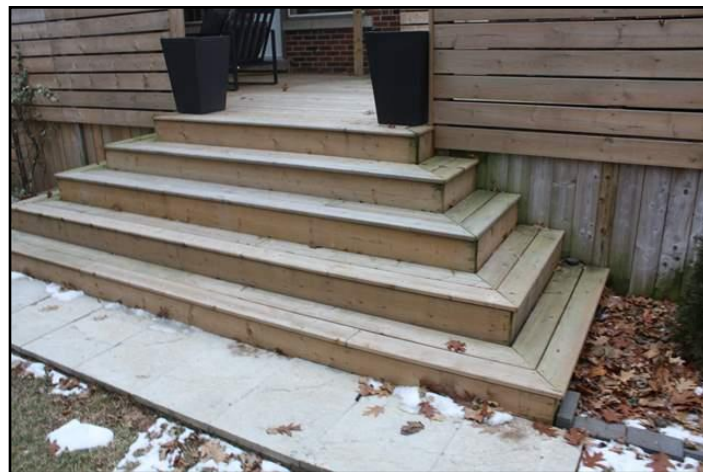
**Condition:** • [Missing](#)

**Implication(s):** Fall hazard

10. Missing

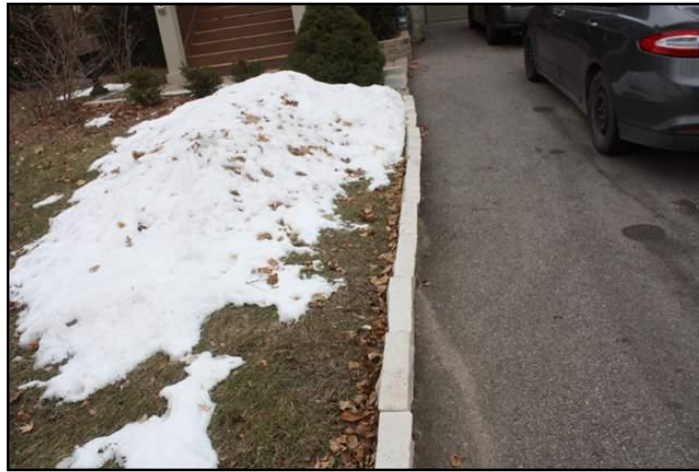
11.

**Condition:** • Lawn retainer leaning/movement.

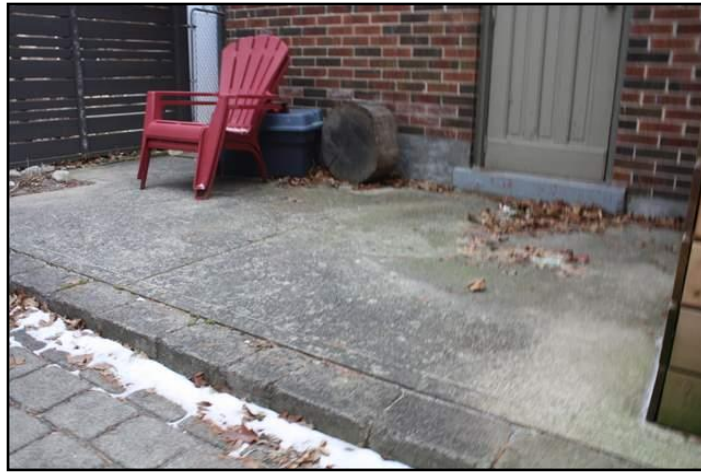
**Condition:** • Low Areas.

12. Low Areas.

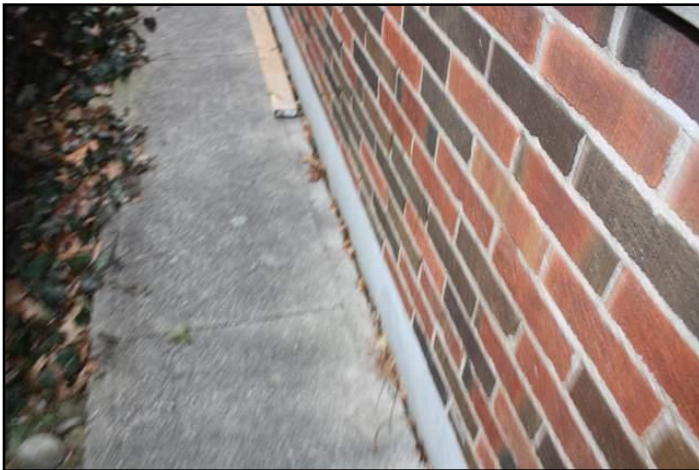
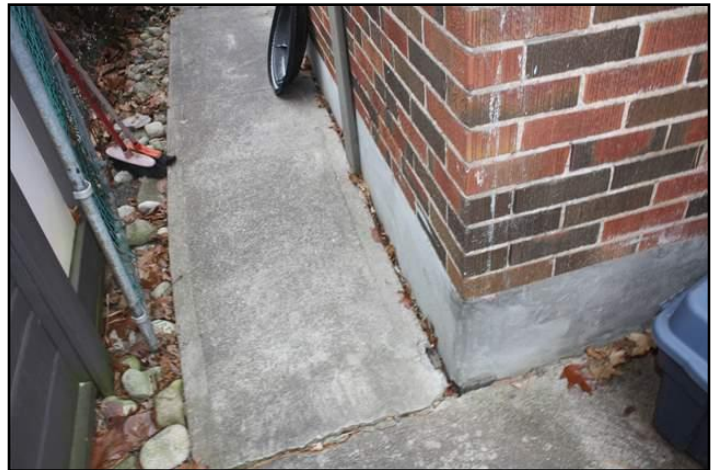
**Condition:** • [Unsealed gap at building](#)

13. Unsealed gap at building

14. Unsealed gap at building

**Task:** Improve

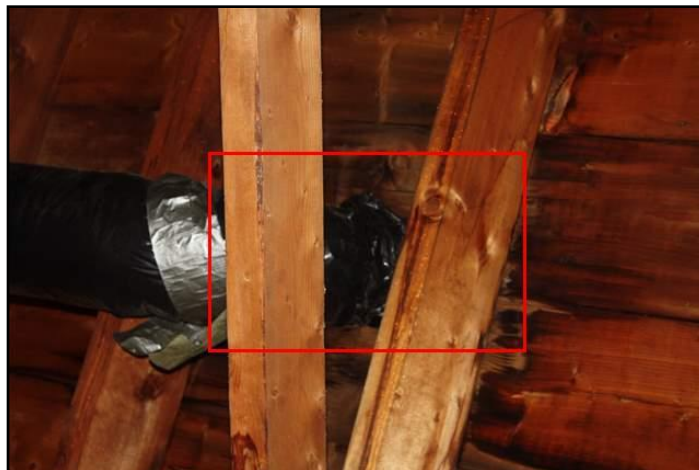
**Condition:** • [Water stains](#)

Water stains noted on attic around exhaust duct penetration through roof. Have roofing contractor repair roof flashing around roof vent.

15. Water stains

**Task:** Repair

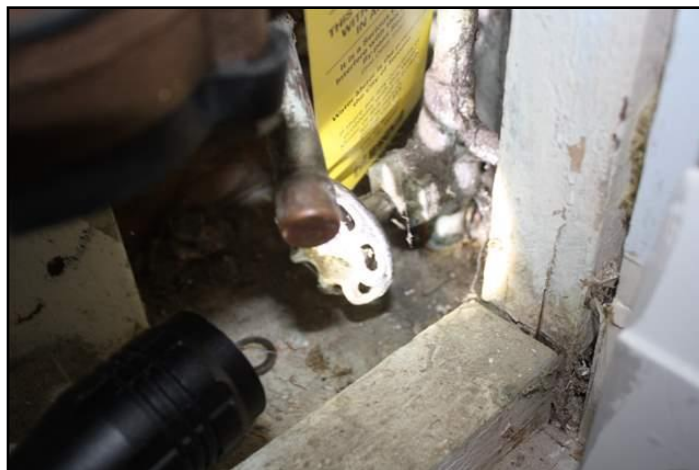
**Condition:** • [Missing](#)

16. Missing

**Task:** Further evaluation / Correct

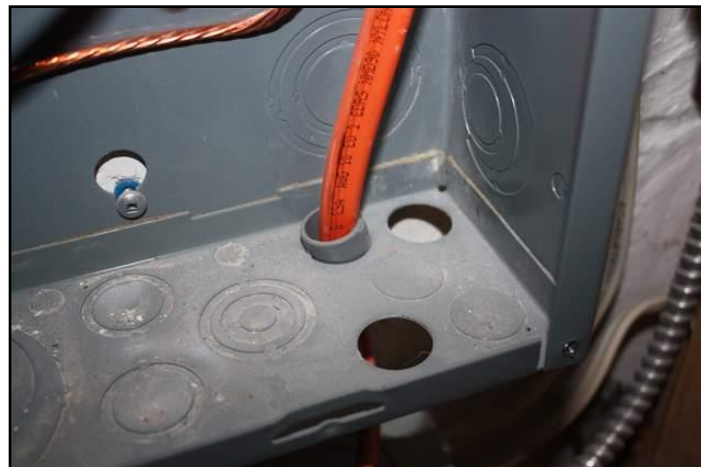
**Condition:** • [Openings in panel](#)

**Implication(s):** Electric shock | Fire hazard

17. Openings in panel

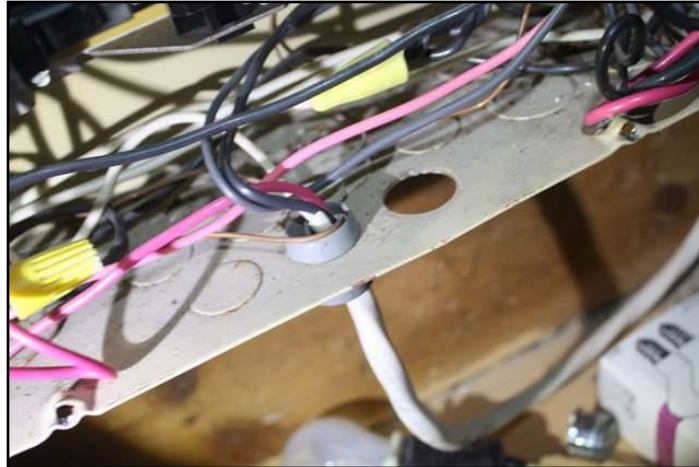
**Condition:** • [Openings in panel](#)

**Implication(s):** Electric shock | Fire hazard

18. Openings in panel

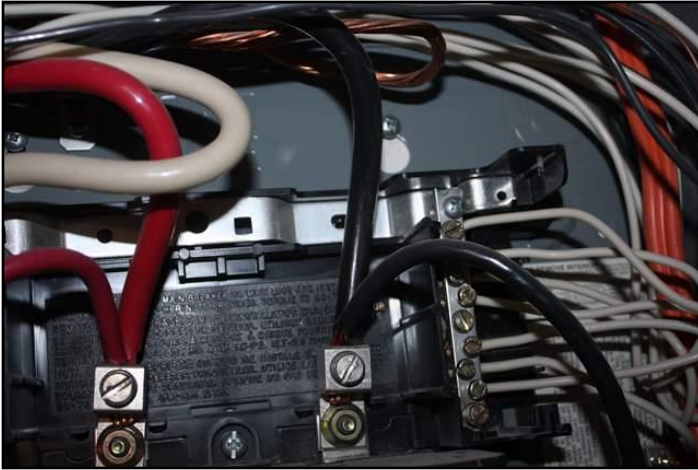
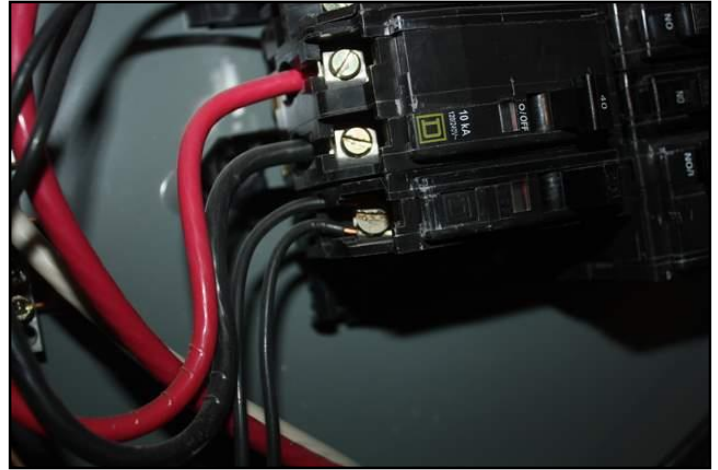
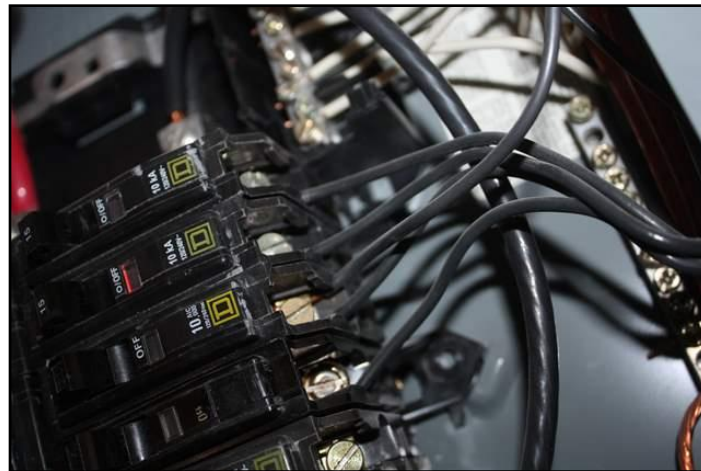
**Condition:** • [Double taps](#)

**Implication(s):** Fire hazard

19. Double taps

20. Double taps

21. Double taps

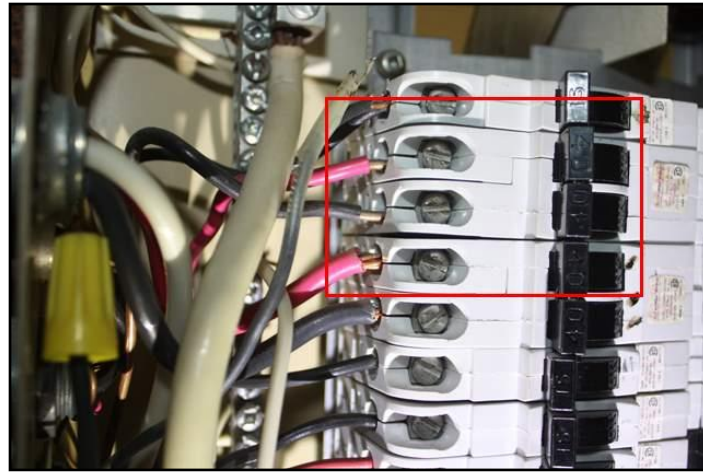
**Condition:** • [Fuses or breakers too big](#)

**Implication(s):** Equipment overheating | Fire hazard

22. breakers too big/wrong size

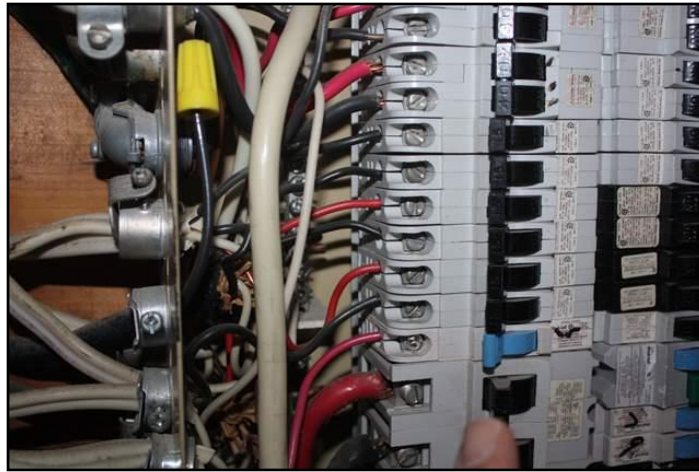
**Condition:** • [No links for multi-wire circuits](#)

23. No links for multi-wire circuits

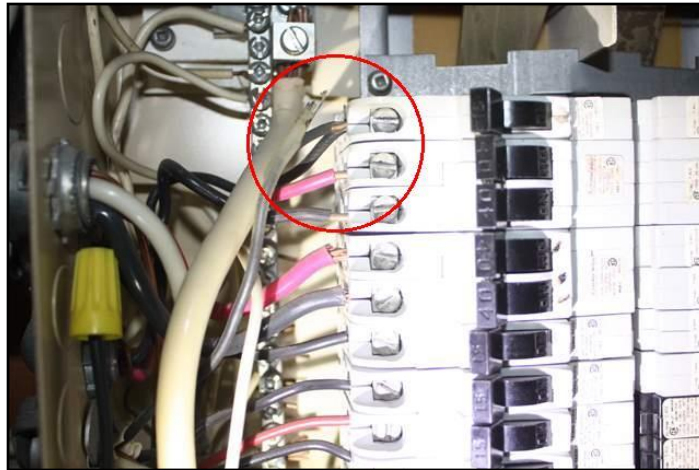
**Condition:** • [Double taps](#)

**Implication(s):** Fire hazard

24. Double taps

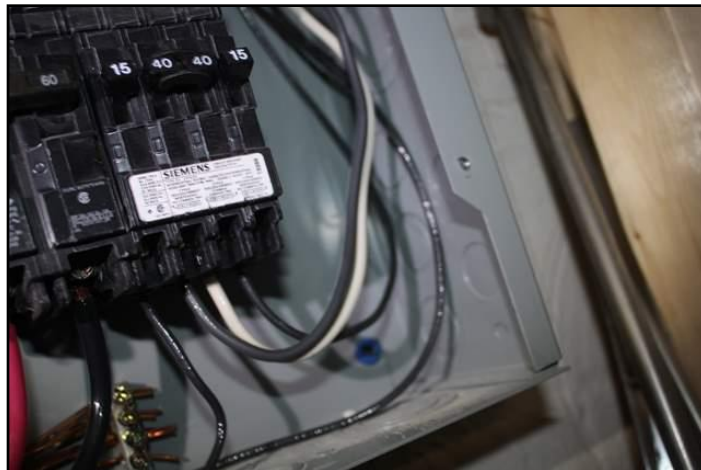
### Condition: • [Improper color coding](#)

White wire used as hot wire - not marked

25. Improper color coding

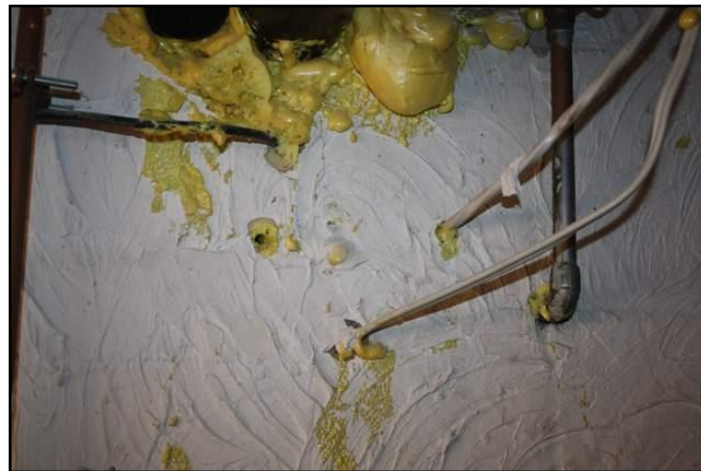
**Condition:** • [Exposed on walls or ceilings](#)

26. Exposed on walls or ceilings

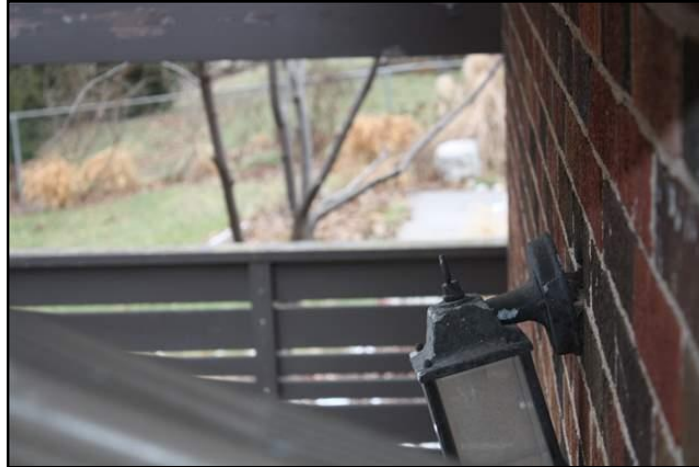
**Condition:** • [Loose](#)

**Implication(s):** Electric shock | Fire hazard

27. Loose

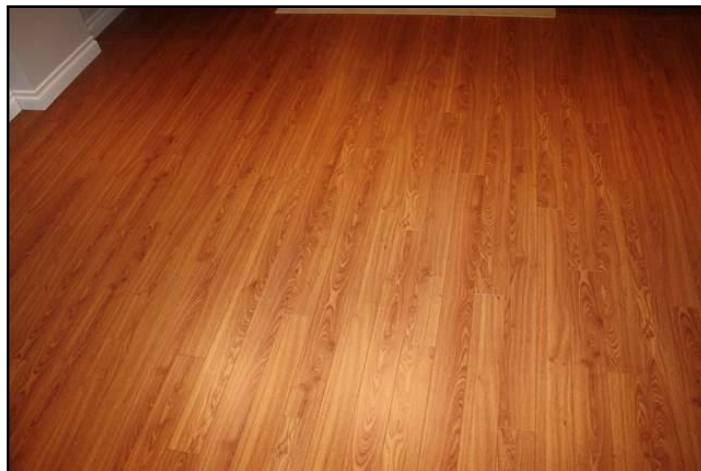
28.

**Floor drain location:** • Seller also noted that there is a floor drain at the rear basement below the raised floor

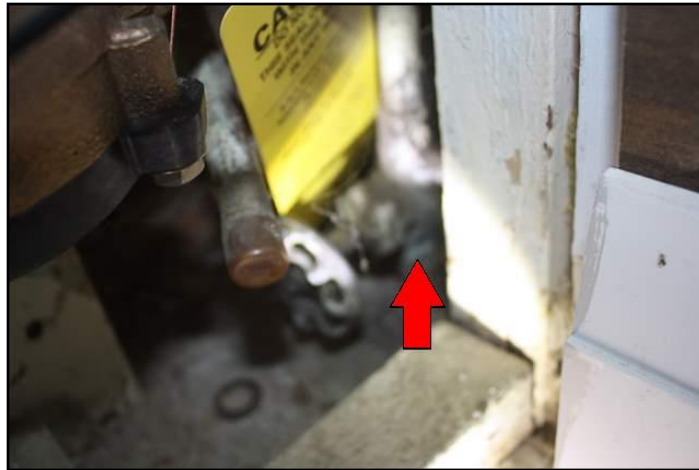
29.

**Condition:** • FYI - The water service pipe material type was not determined. The pipe was painted white. If you would like to learn the material type from street to house, (copper or lead) consult with the city for more information.

**Location:** Front Basement

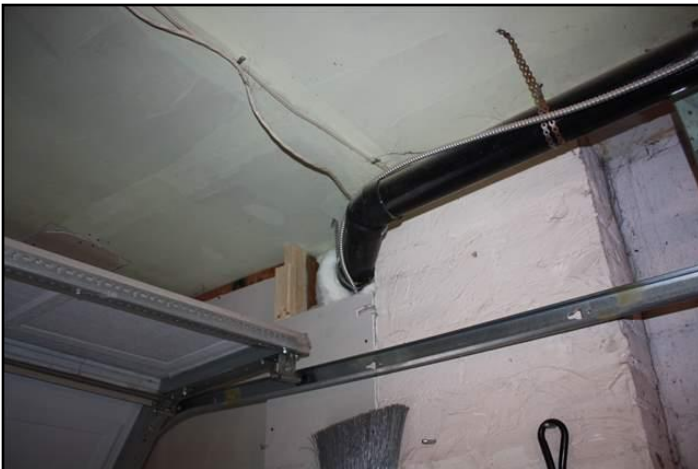
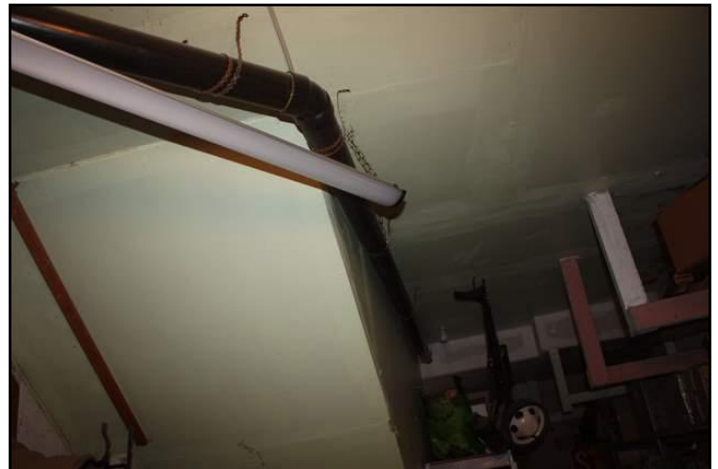
**Condition:** • [Freezing](#)

The waste line from the bathroom runs through the garage and manifolds into another waste line in the wall out of view. It is uncommon for a waste line to pass through the garage. There is a risk of freezing during sub-zero temperatures. Freezing will cause one or more fixtures to clog. (which has occurred in the past) Also there is a risk of the waste line splitting. Since reconfiguring would be invasive consider insulating entire length of waste line and boxing in. Consult contractor.

31. risk of freezing

**Task:** Correct / Improve setup

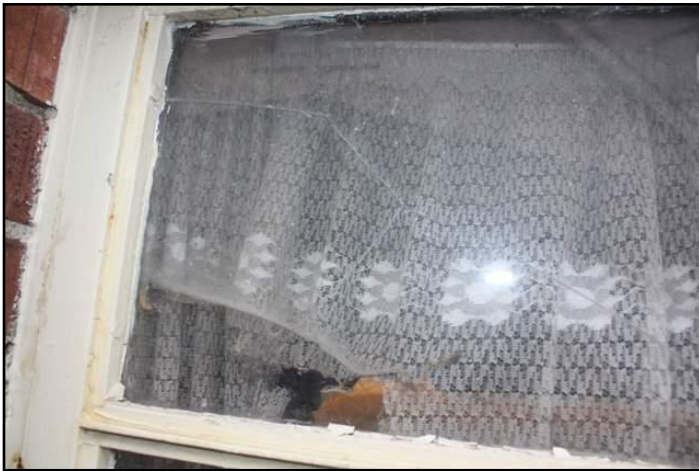
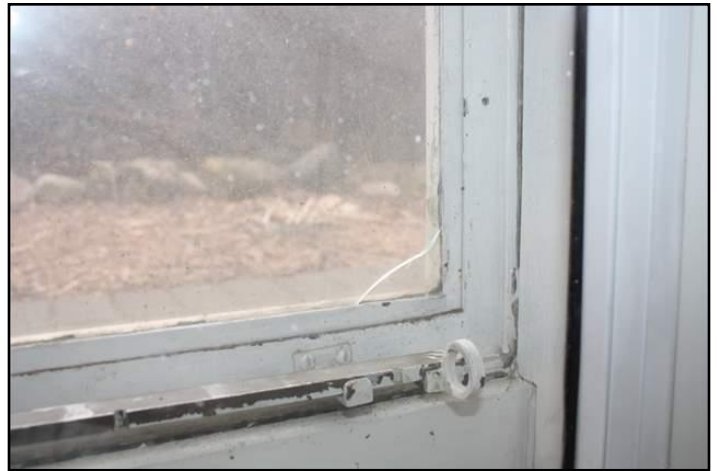
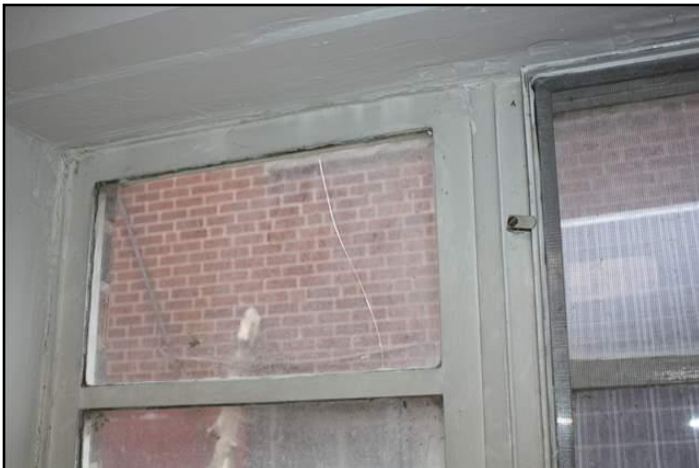
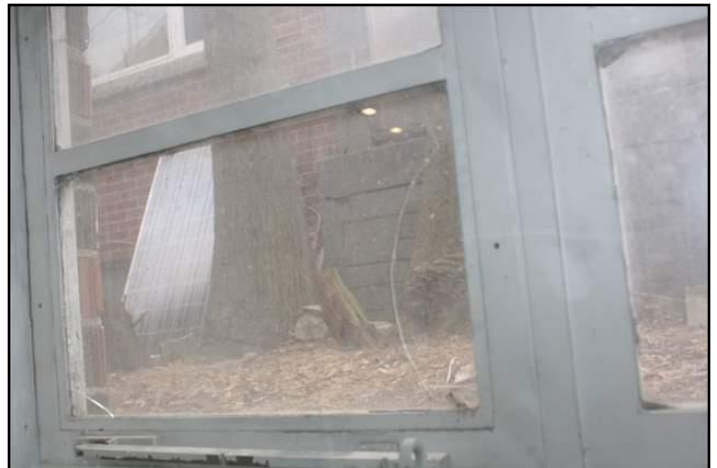
**Condition:** • [Cracked](#)

Old basement windows. Many cracks noted. See note in Windows General

32. Cracked

**Task:** Replace

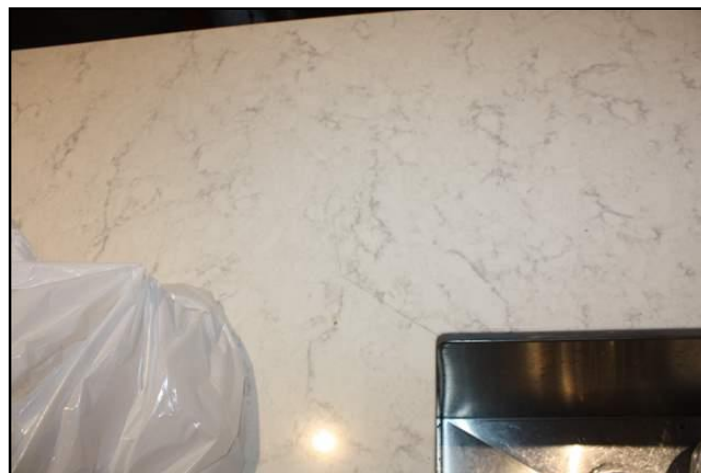
**Condition:** • [Tiles loose, missing, cracked, stained or broken](#)

36. Tiles loose, missing, cracked, stained or...

**Task:** Repair / Replace

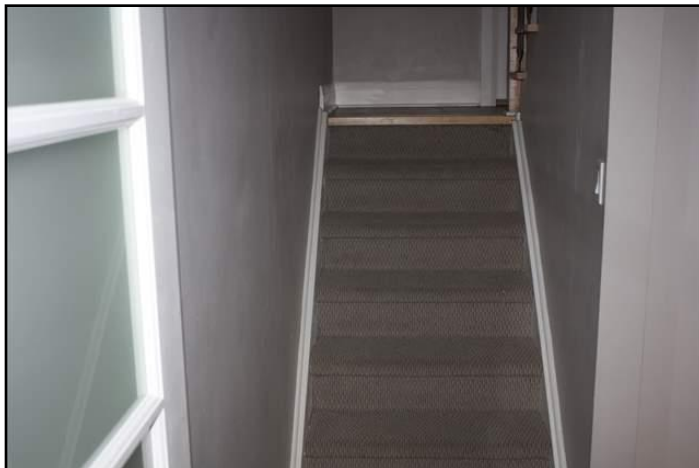
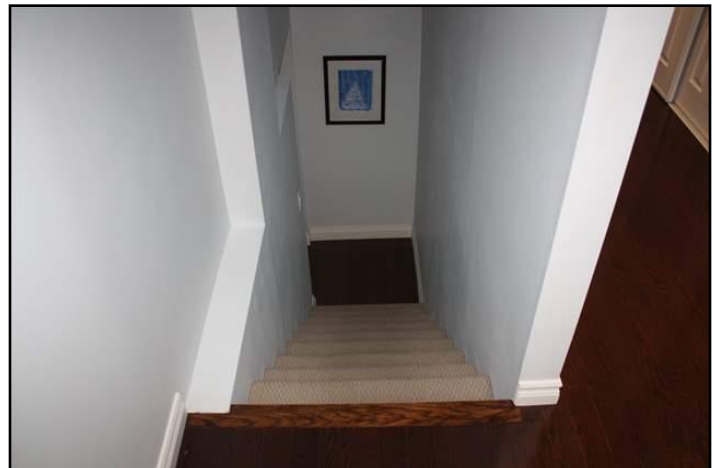
**Condition:** • [Missing](#)

**Implication(s):** Fall hazard

37. Missing

38. Missing

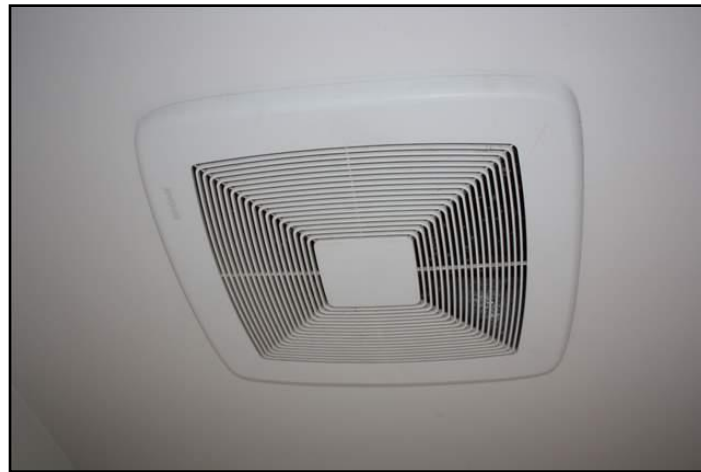
Condition: • [Damage](#)

Implication(s): Chance of condensation damage to finishes and/or structure

39. Damage

Task: Replace

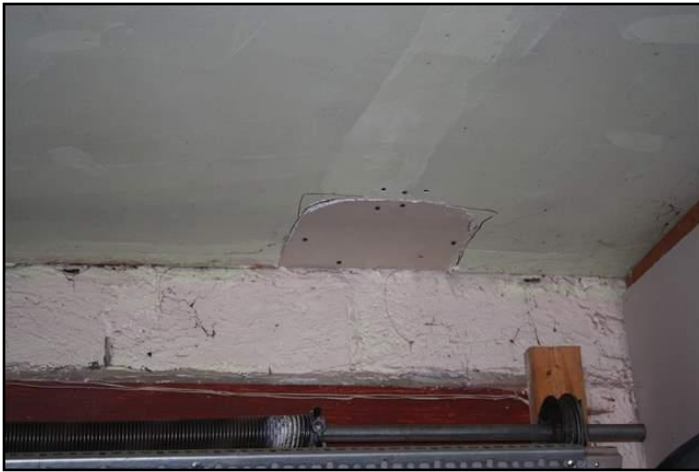
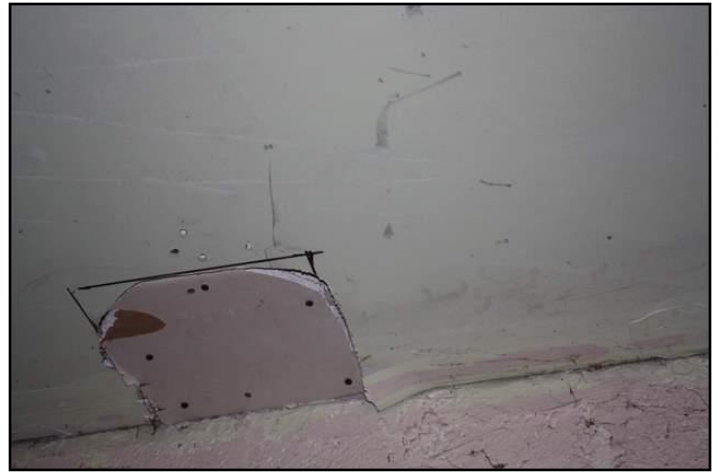
**Condition:** • [Not gastight](#)

**Implication(s):** Hazardous combustion products entering home

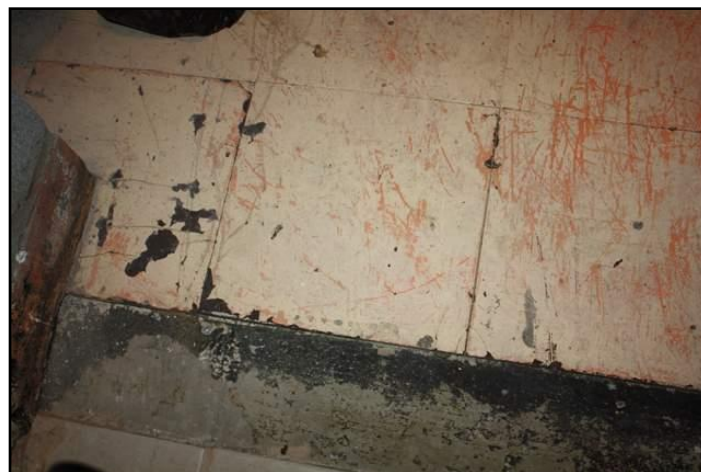
**Condition:** • Possible asbestos containing materials

Old 9"x 9" resilient floor tiles or the mastic glue may contain asbestos. This type of floor tile is commonly found in older homes. Further evaluation is recommended before removing/disturbing these tiles.

42. Possible asbestos containing materials

**Task:** Further evaluation before disturbing / removing
