YOUR INSPECTION REPORT

43 Maher Avenue
Toronto, ON M6P 1S7

Friday, September 17, 2021

RE: Report No. 2947, v.2
43 Maher Avenue
Toronto, ON
M6P 1S7

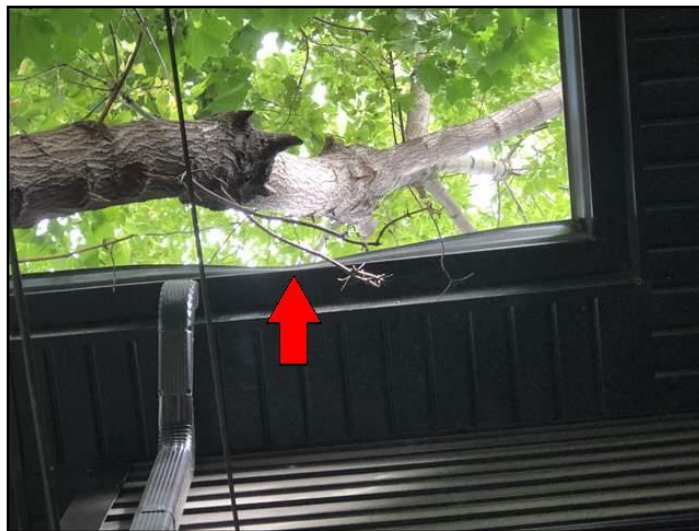
Condition: • Damage

Minor damage likely from tree branch

Location: Rear Right Exterior

2. Damage

Task: Repair / Replace

Time: Less than 1 year

Cost: Minor

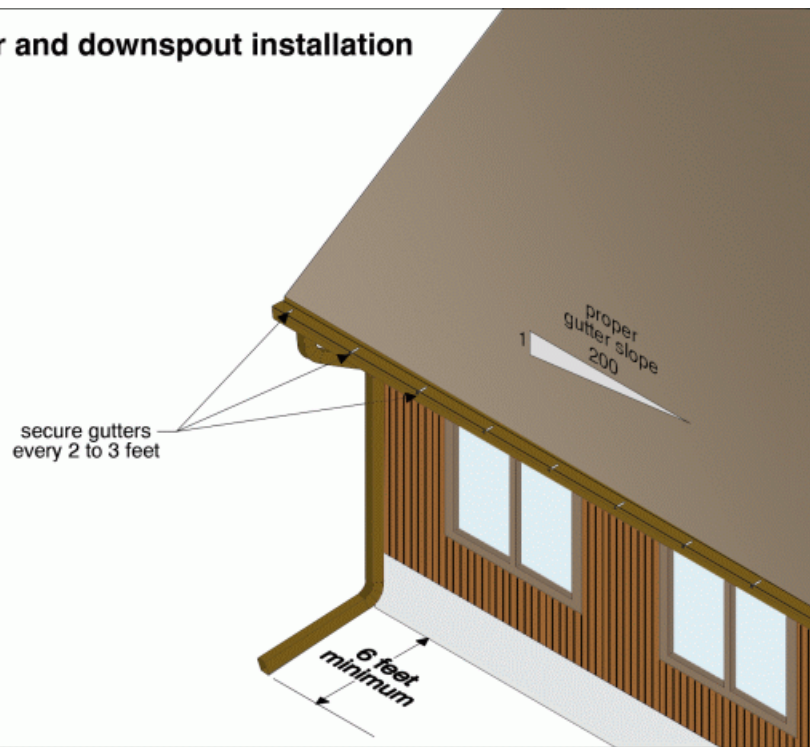
Downspout extension too short

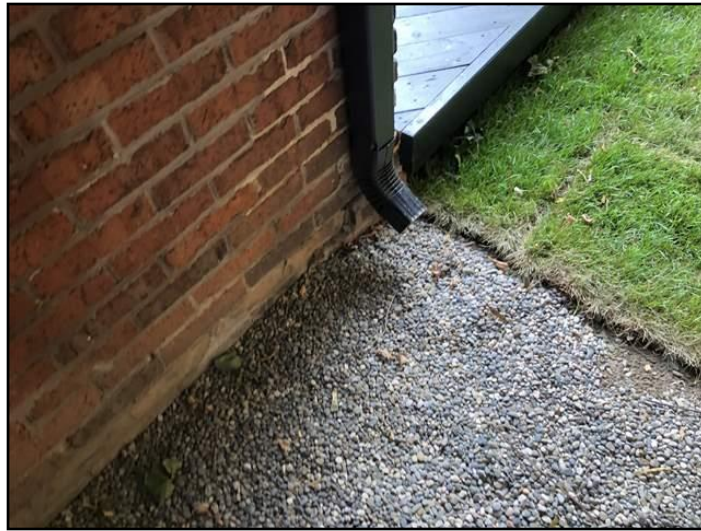
Condition: • [Should discharge 6 feet from building](#)

Location: Left Side Exterior

3. Should discharge 6 feet from building

Task: Improve

Time: Less than 1 year

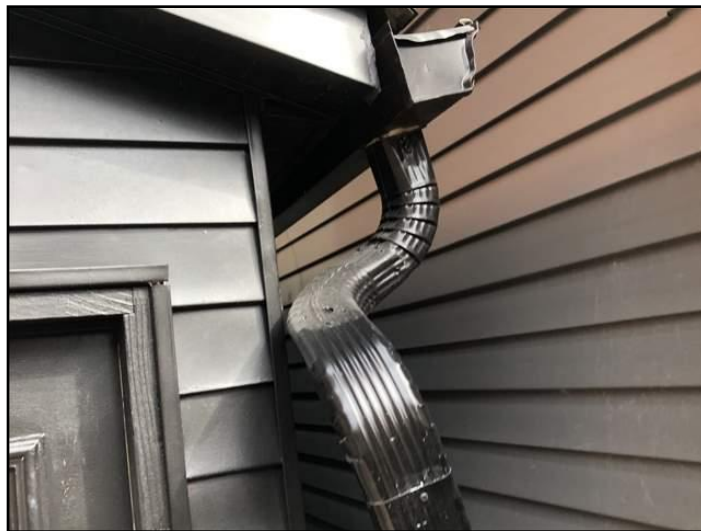
Condition: • [Not well secured](#)

Location: Left Exterior Garage

4. Not well secured

Task: Improve

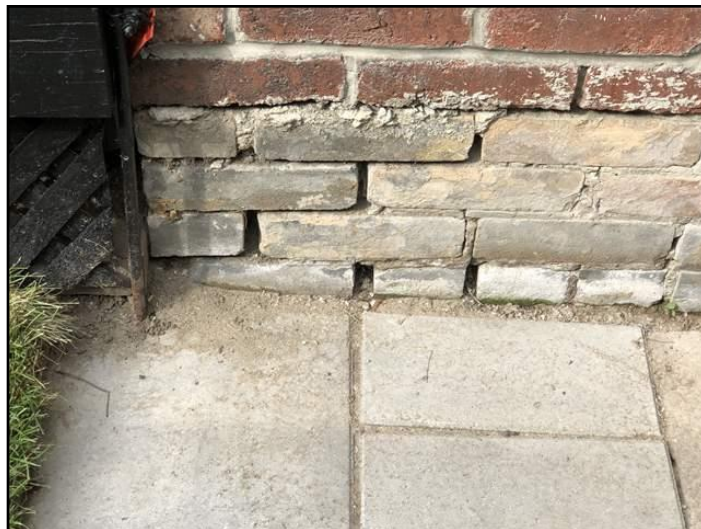
5. example

Condition: • [Mortar deterioration](#)

Provide mortar (Repointing, Tuck pointing) at various areas of the exterior brick and front window sill. This is routine maintenance for homes of this age. Overall the brickwork appears to be in good condition as there have been recent improvements/modifications.

Location: Various Exterior Wall

Task: Provide mortar

Time: Regular maintenance

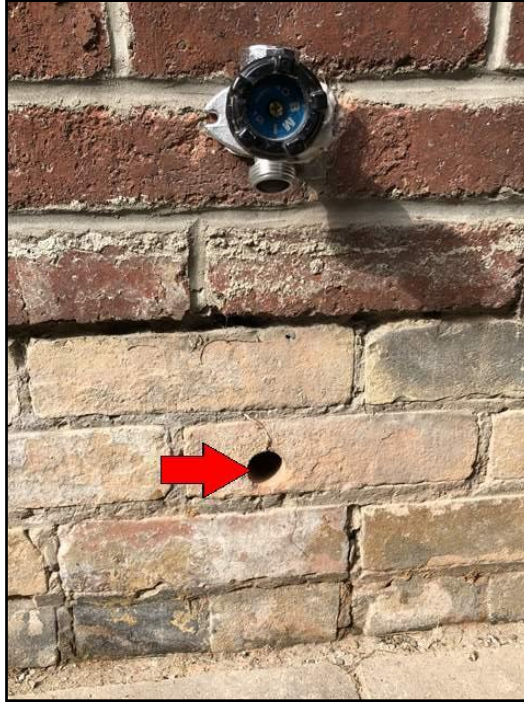
Condition: • Gap at Wall

Location: Left Exterior Wall

6. Gap at Wall

Task: Seal

Time: Less than one year

Cost: Less than \$100

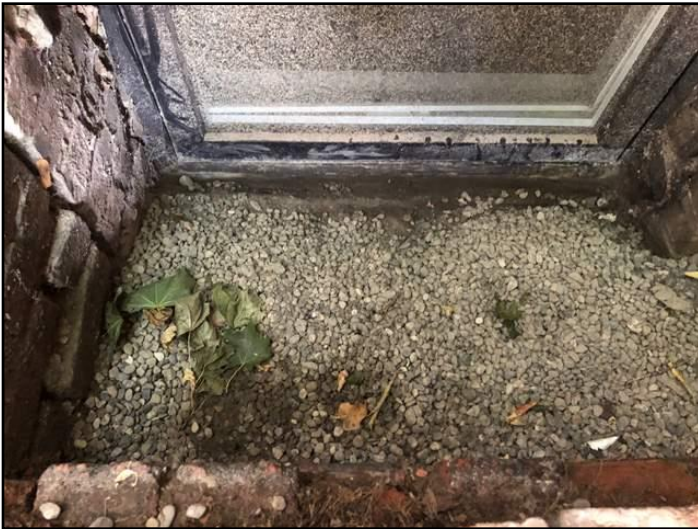
Condition: • [Less than 6 inches below window](#)

7. Less than 6 inches below window

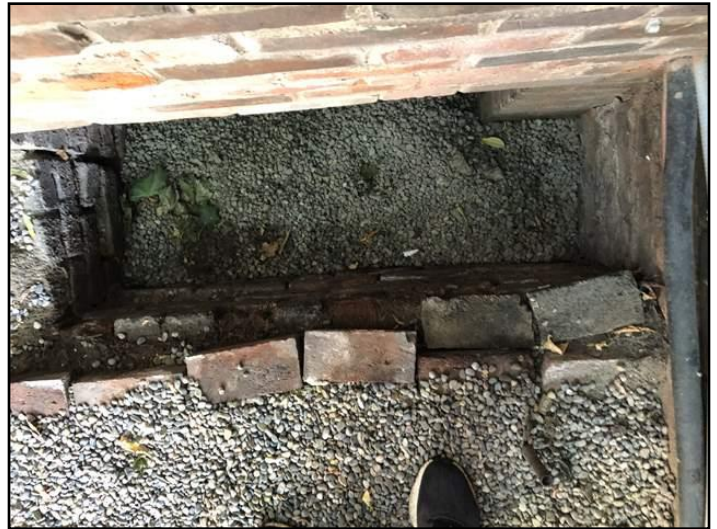
8. Less than 6 inches below window

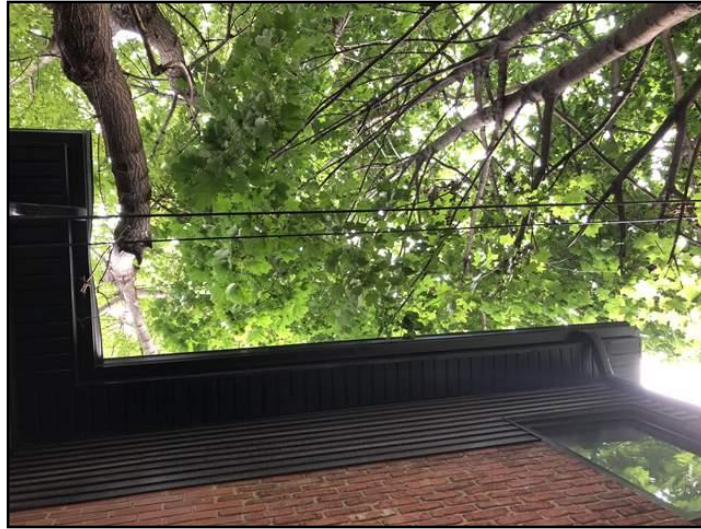
Condition: • Tree Branch Maintenance

9. Tree Branch Maintenance
