# INSPECTION REPORT

For the Property at:  
**2581 SAMPLE WAY**  
NORCROSS, GA 30071

Inspection Date: Thursday, September 3, 2020

RE: Report No. 1019, v.2  
2581 Sample Way  
Norcross, GA  
30071

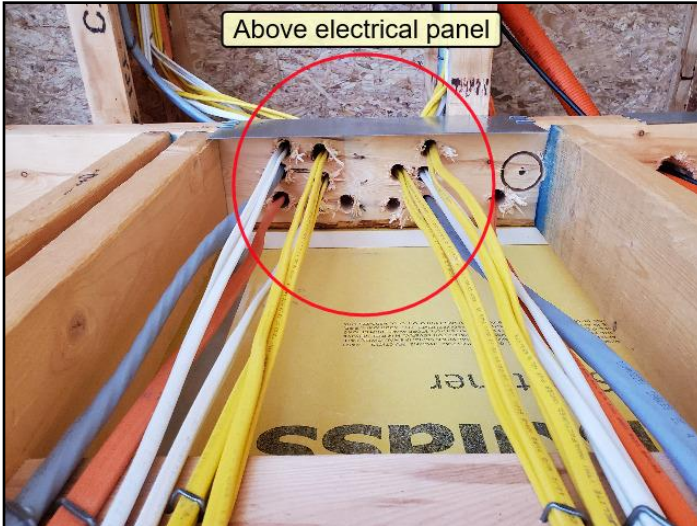
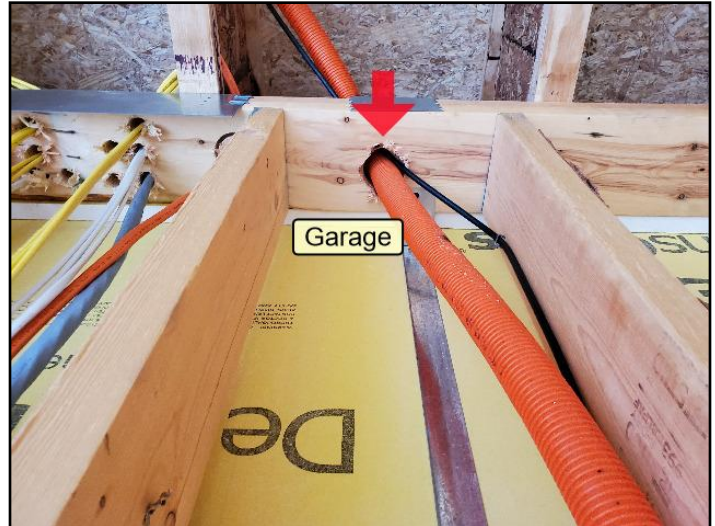
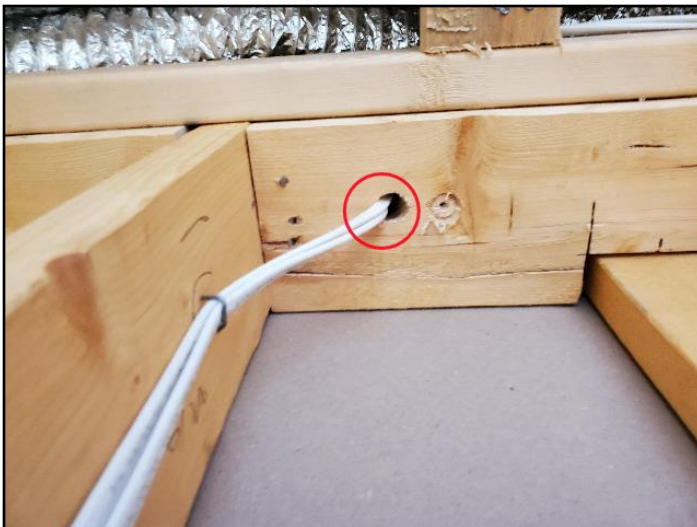
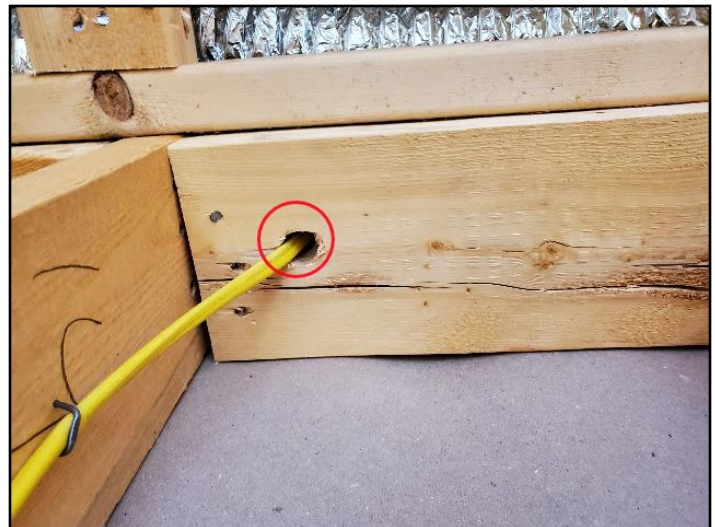
Penetrations through top and bottom plates not fire blocked. Crew was fire blocking at time of inspection. Recommend checking to ensure all top and bottom plates were properly fire blocked.

Penetrations in top and bottom plates

penetrations in top and bottom plates

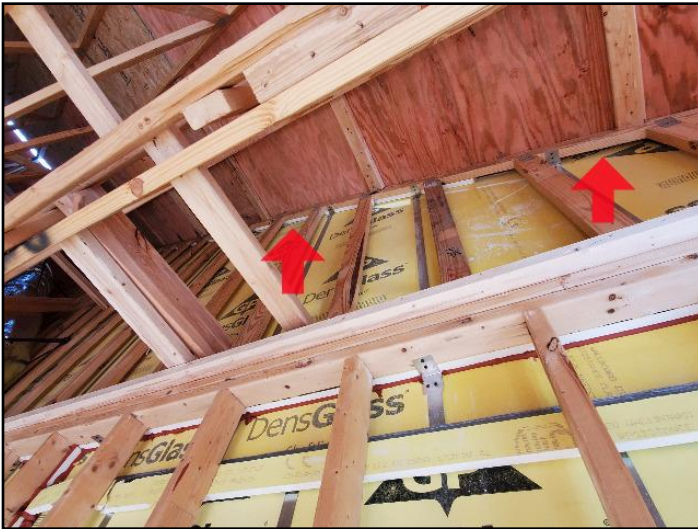
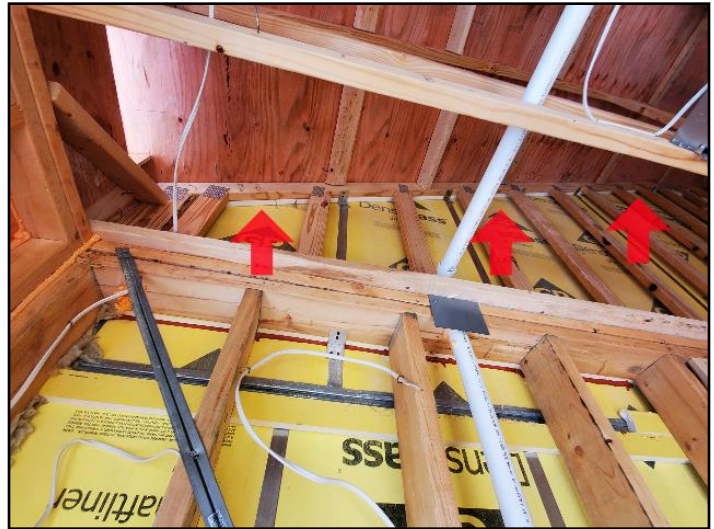
Fire caulk missing at gables. Fireblocking shall be provided in concealed spaces of stud walls and partitions at ceiling and floor levels. Recommend fire caulking at gables to prevent fire from spreading to adjacent units in the event of a fire.

Fire caulk

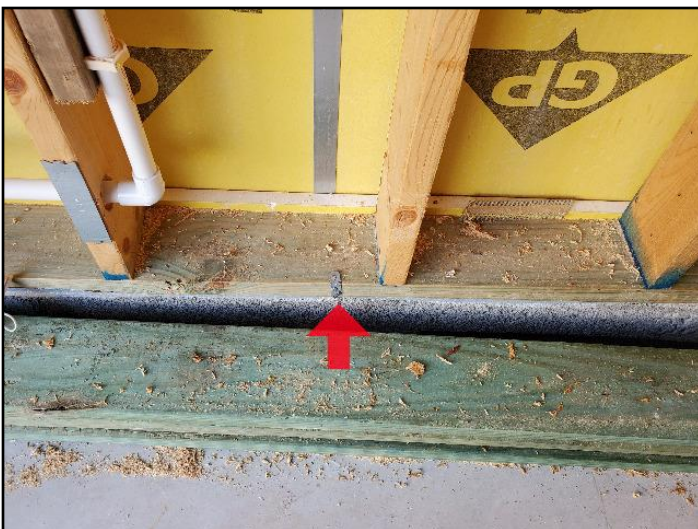
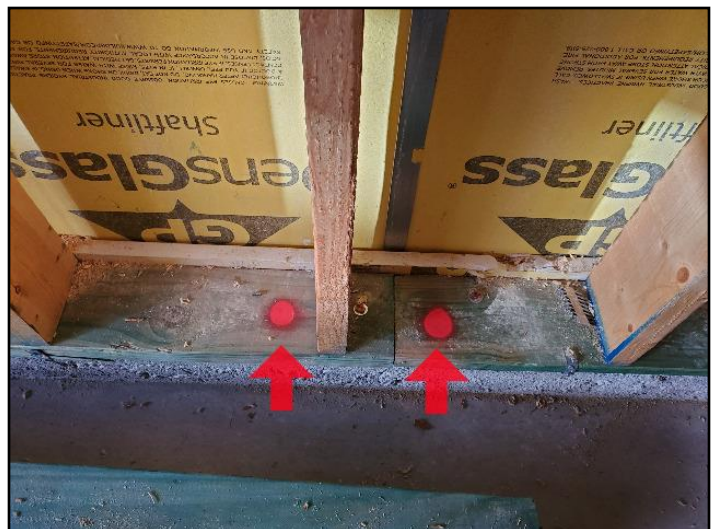
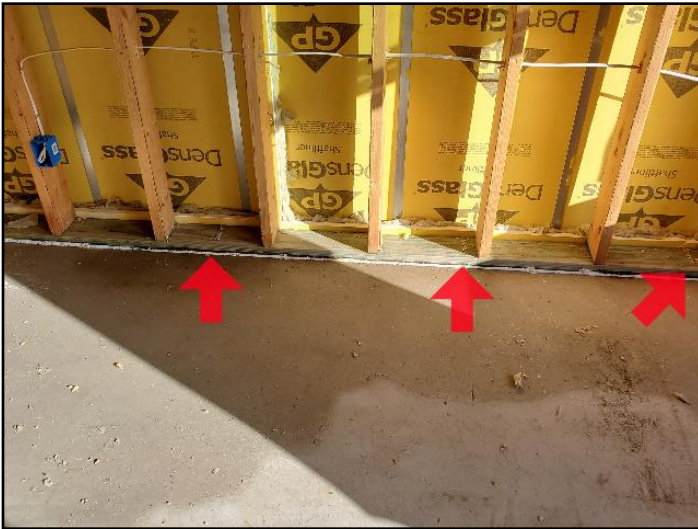
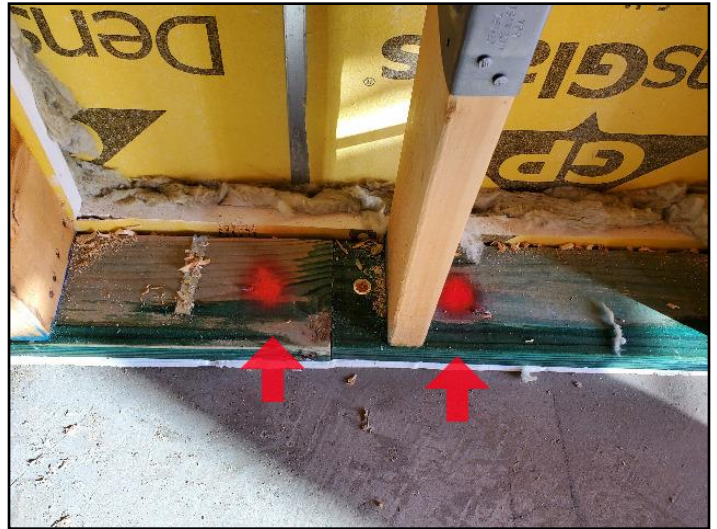
MAB15 straps are required to overlap on both sides of the sill plate and cannot be spaced more than 3'10" apart per the manufacturer. In order to replace the 1/2 inch anchor bolts required by code the straps must be installed per manufacturers instructions. Straps are not installed properly, only overlapping on one side of the sill plate. Wood sill plates shall be anchored with minimum 1/2 inch diameter bolts, embedded not less than 7 inches into the concrete, and spaced not more than 6 feet apart. Bolts shall also be installed within 12 inches of the sill plates ends. Recommend installing proper foundation anchorage on all exterior sill plates.

Anchor bolts missing

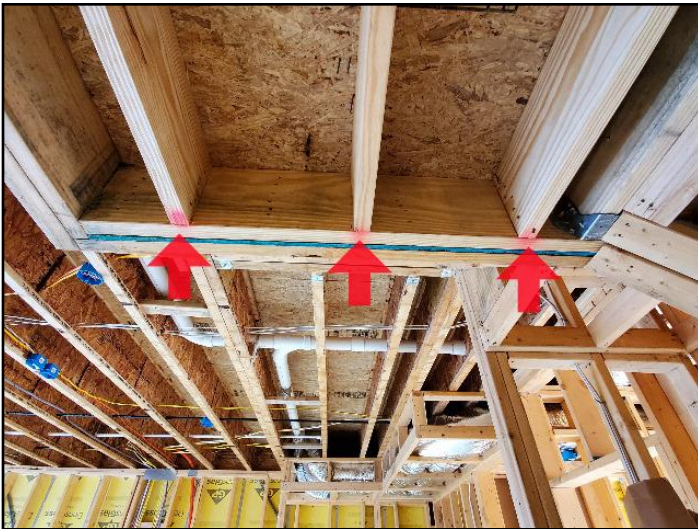
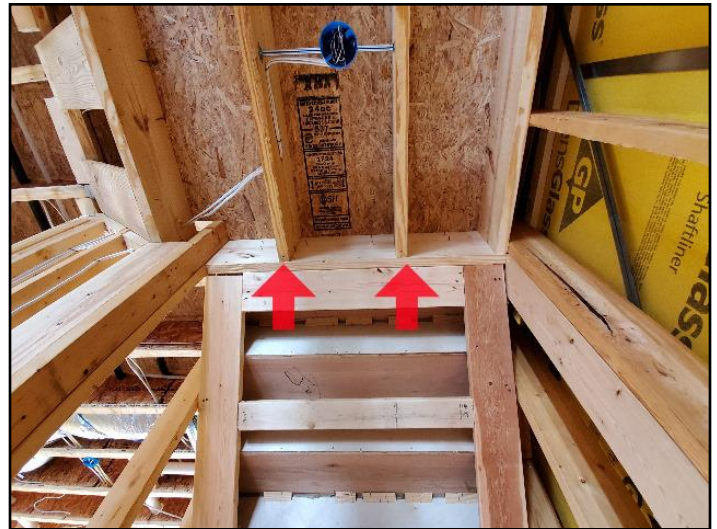
Recommend adding missing joist hangers to joists underneath stair landings to ensure proper support.

Poor end bearing, joist hanger connections

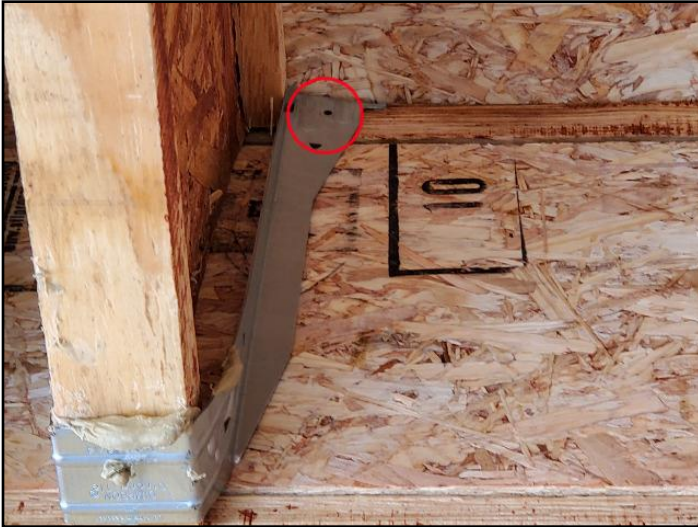
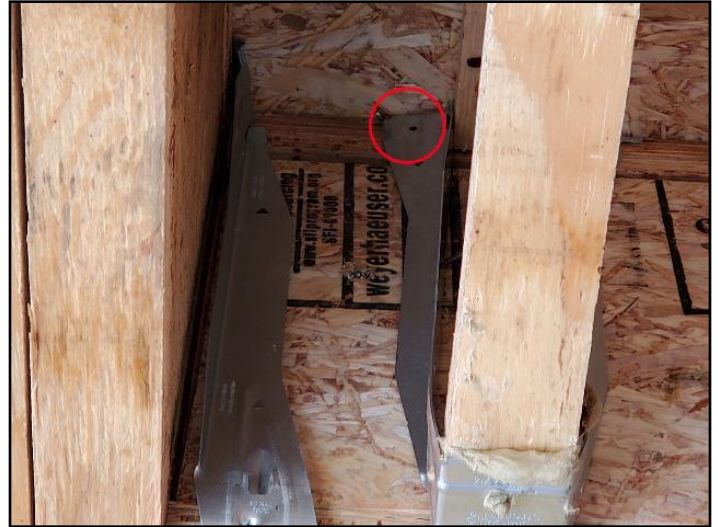
Joist hangers in garage not properly nailed. Recommend nailing all required holes in joist hangers for proper support.

Poor end bearing, joist hanger connections

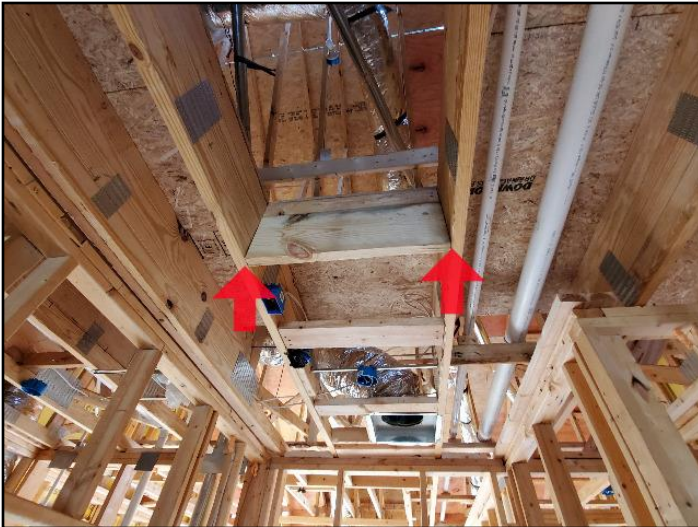
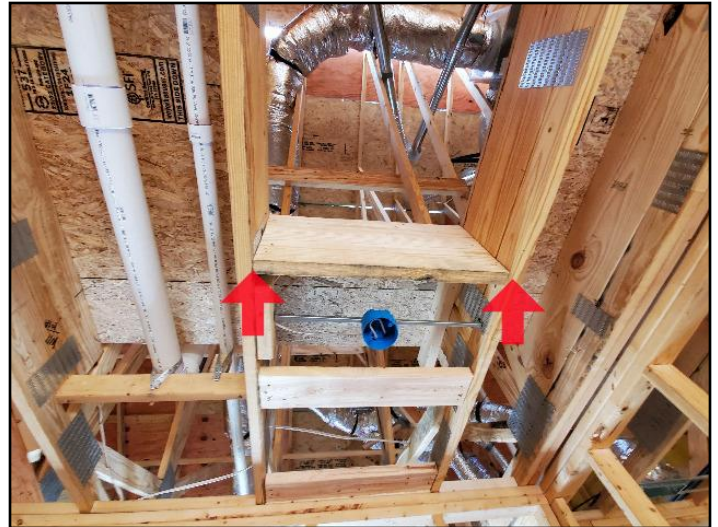
Recommend adding missing joist hangers to attic scuttle to properly support attic stairs.

Poor end bearing, joist hanger connections

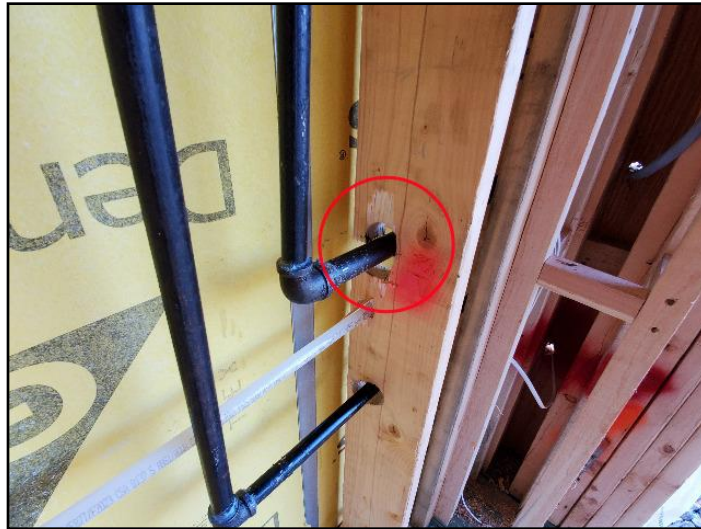
Bored hole for gas line in garage over bored and too close to the edge. Bored holes cannot be within 5/8 inches of the studs face. Recommend adding stud shoe to strengthen stud as it is a load bearing element.

*Notches or holes*

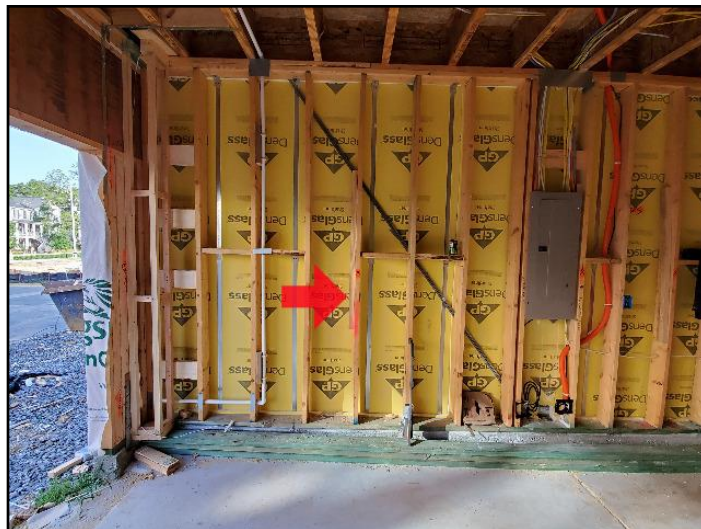
Bowed stud in garage. Studs are not permitted to deflect more than a 1/2 inch. Recommend replacing stud or providing blocking in between studs to straighten.

*Leaning, bowing, buckling*

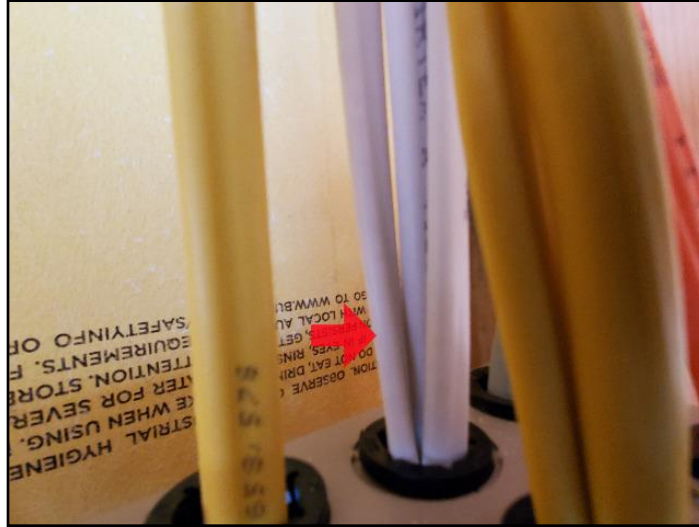
3 wires in knock out (KO) bushing. Manufacturer states KO bushings are designed to house 2 wires. Recommend removing one wire and running it through another knock out.

*3 wires in knock out bushing*

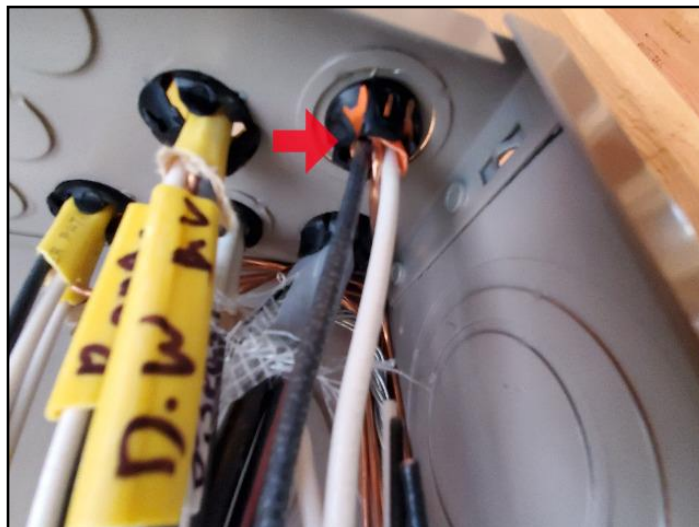
Cable sheath shall extend a minimum of 1/4 inch inside of the panel to protect the wires. Recommend pulling sheath into panel 1/4 inch.

*Sheath into the panel*

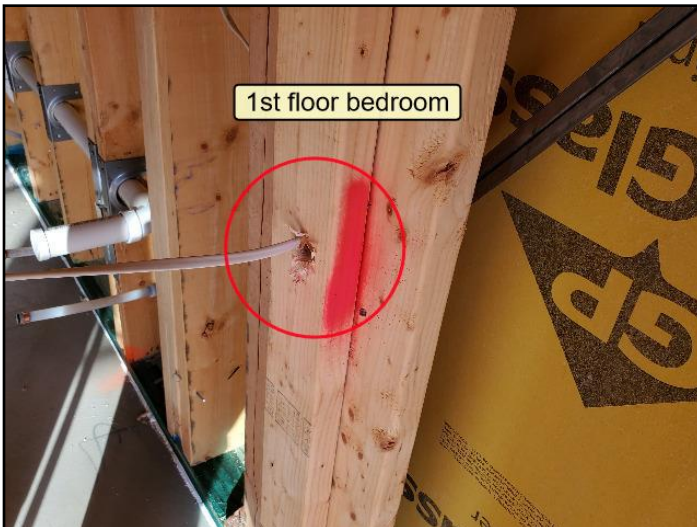
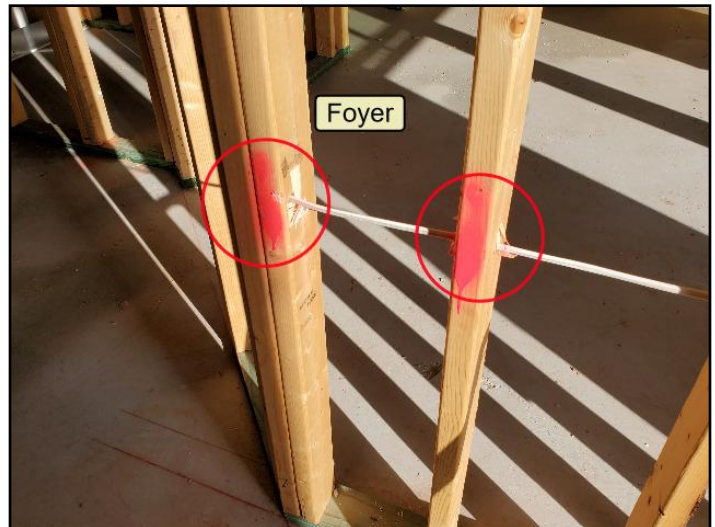
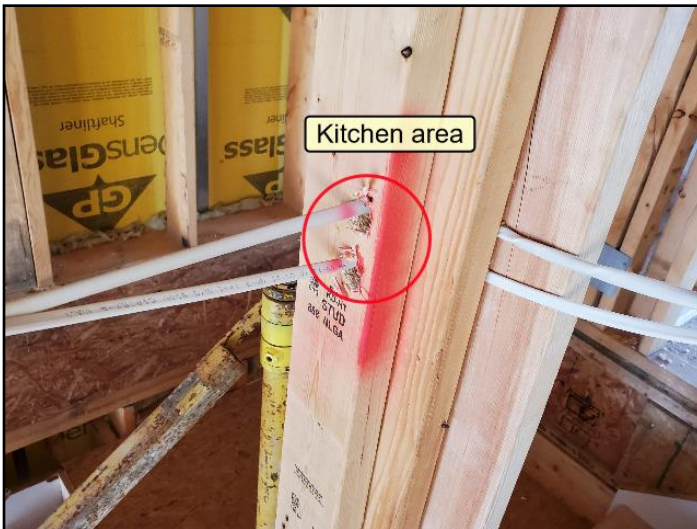
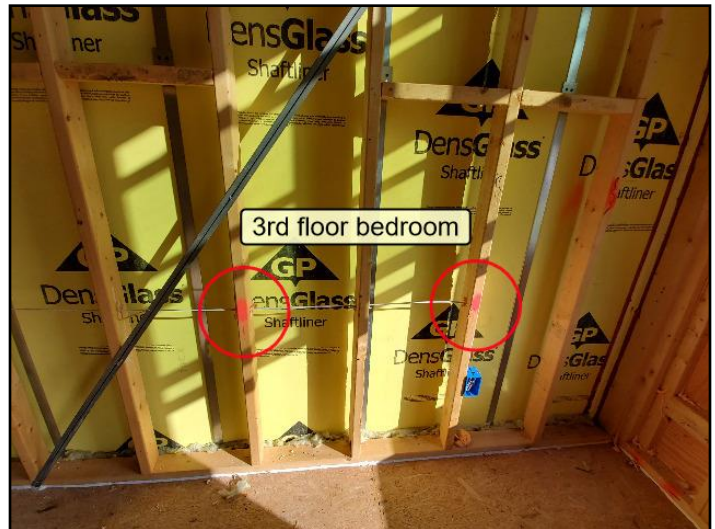
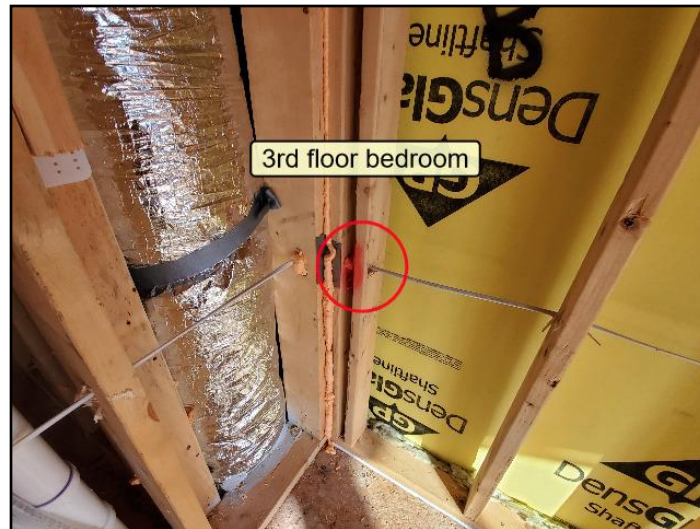
Various nail guards needed on studs where hole is drilled closer than 1 & 1/4 inch from the face of the stud. Recommend adding nail guards to protect electrical wire from nail or screw damage.

*Too close to edge of stud*

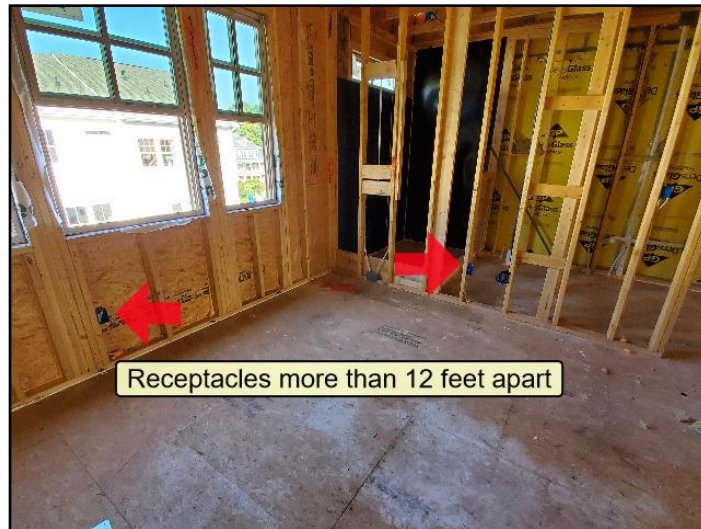
Receptacles in master bedroom more than 12 feet apart. Receptacles shall be installed so that no point measured horizontally along the floor line of any wall space is more than 6 feet, from a receptacle outlet. Recommend installing one receptacle or moving existing receptacles to be within 12 feet of each other.

*Receptacle Spacing*

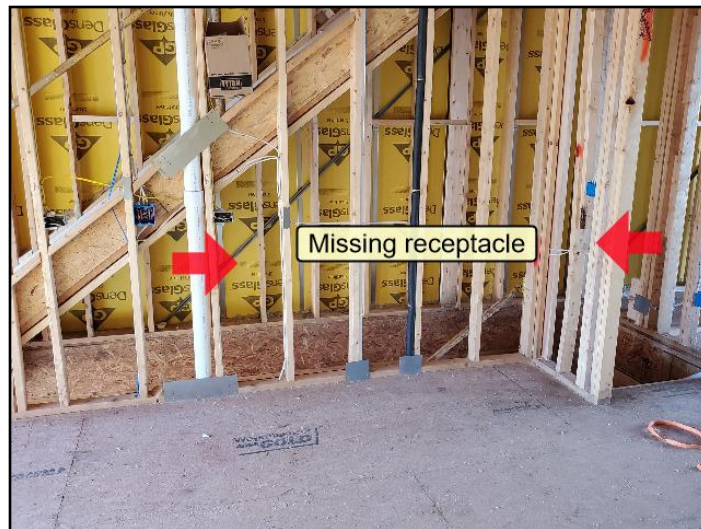
Missing receptacle in kitchen area adjacent to island. If the area is going to be countertop space then the receptacles cannot exceed 4 feet apart and shall be within 2 feet of the edge of the countertop. Otherwise the requirements for wall space installation shall be met. Receptacles shall be installed so that no point measured horizontally along the floor line of any wall space is more than 6 feet, from a receptacle outlet. Recommend installing at least one receptacle in the wall space adjacent to the kitchen island.

*Receptacle Spacing*

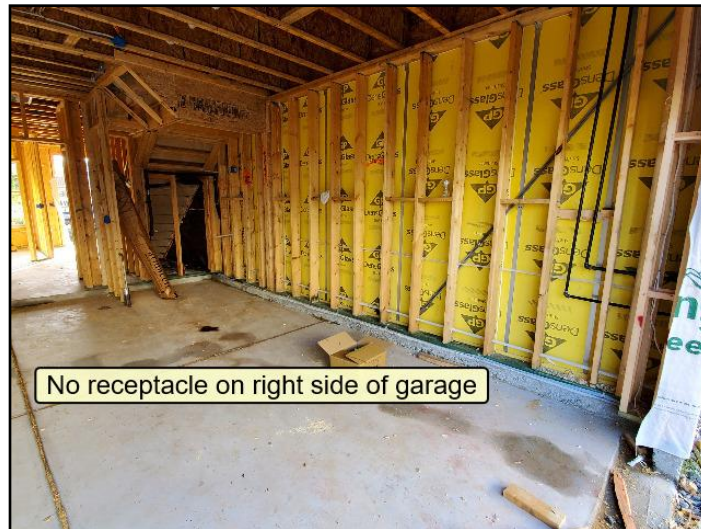
Receptacle missing on right side car space of garage. One receptacle outlet is required in each vehicle bay in attached garages, in addition to to any provided for specific equipment. Recommend installing receptacle on right side of garage.

*Garage Receptacles*

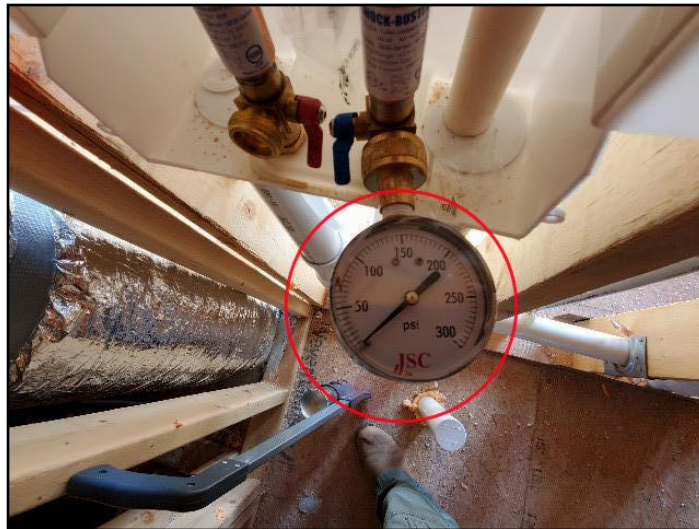
No water pressure. Water-supply system shall be tested and proved tight under a water pressure of not less than the working pressure or by an air test of not less than 50 psi. This pressure shall be held for not less than 15 minutes.

*Water-supply system testing*

Recommend builder test water-supply system and ensure no leaks are present.

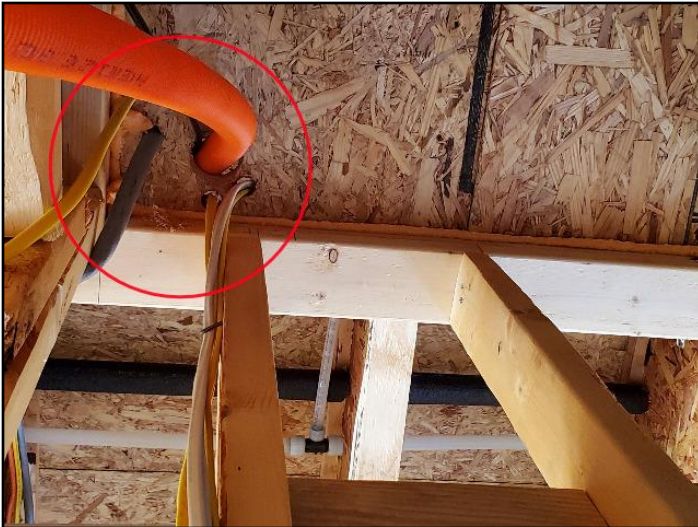
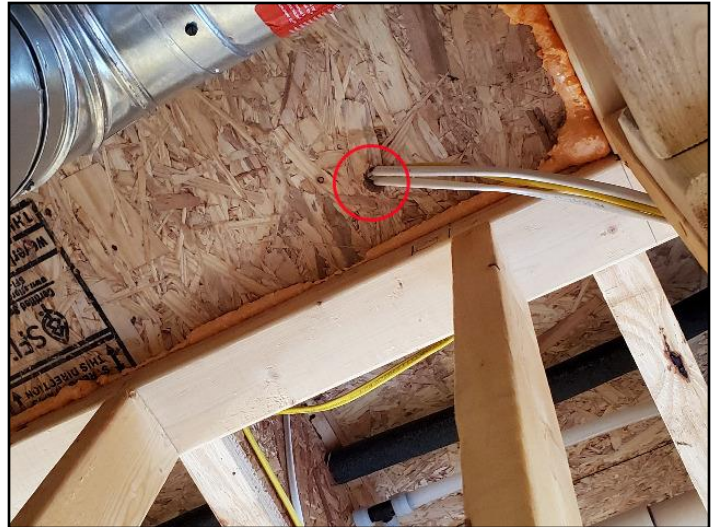
Openings in fireplace chase not fire blocked. All penetrations through the fire place chase must be sealed. Crew was fire caulking and foaming at the time of inspection. Recommend checking to ensure all penetrations in fire place chase were sealed.

Openings in fireplace chase

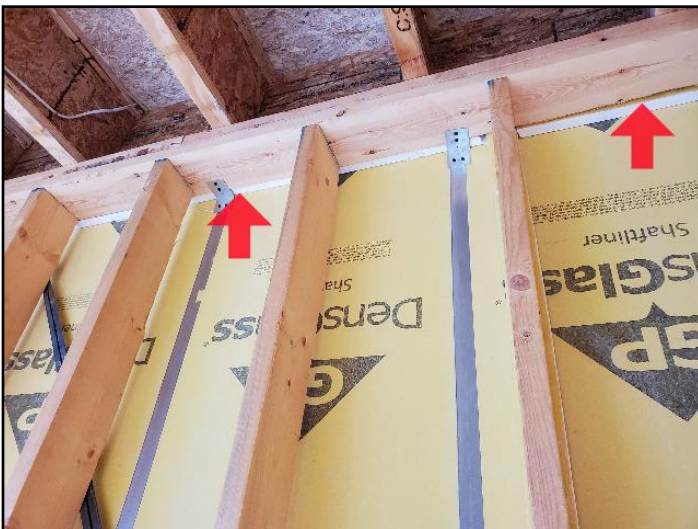
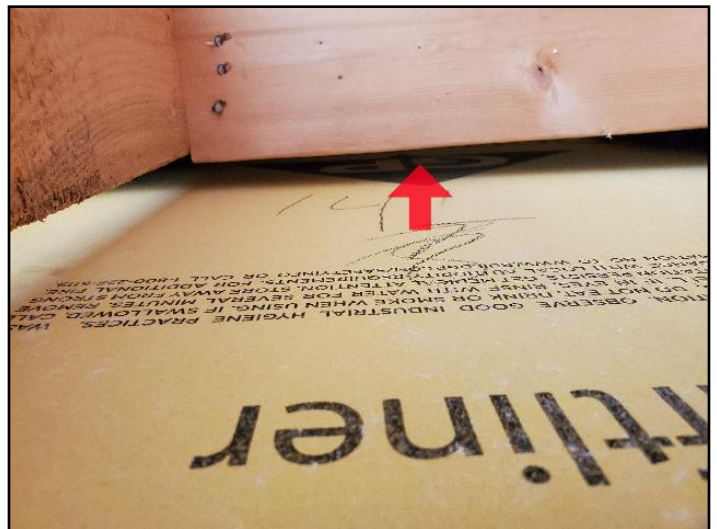
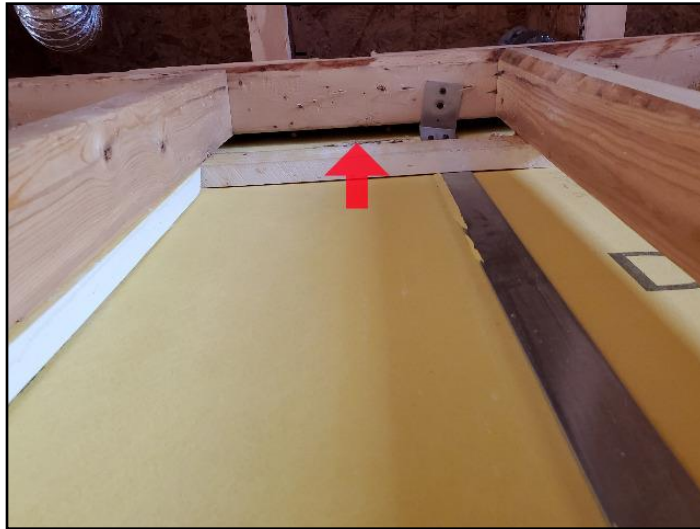
Fire caulk missing at top plates and bottom plates along firewall throughout. Crew was caulking and foaming at time of inspection. Recommend builder provide proof that fire caulking was completed.

Fire Caulk

*Fire Caulk*

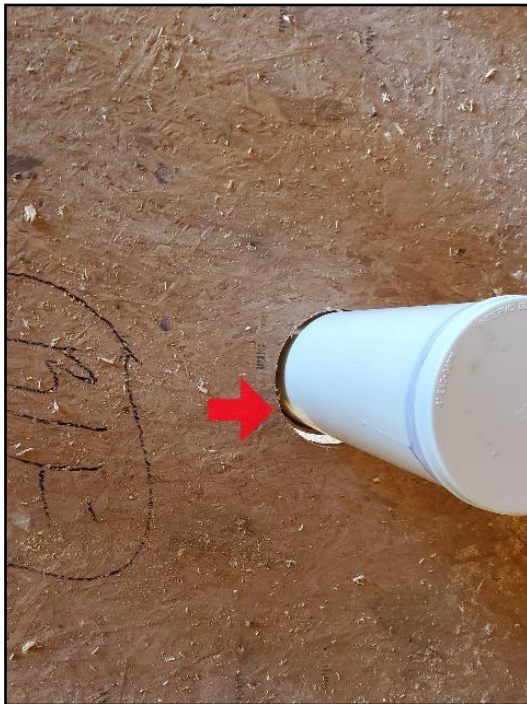
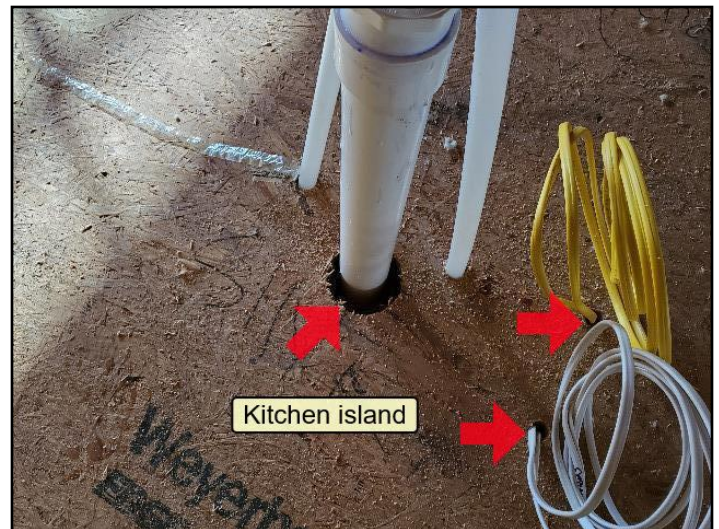
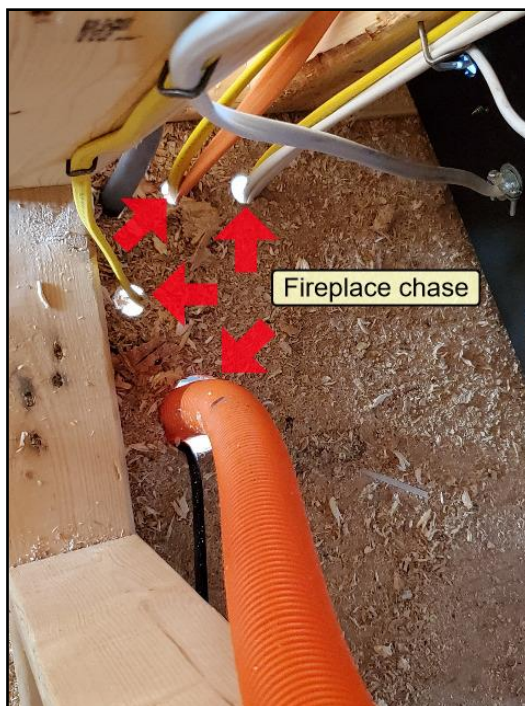
*Floor penetrations*

Recommend sealing all floor penetrations.

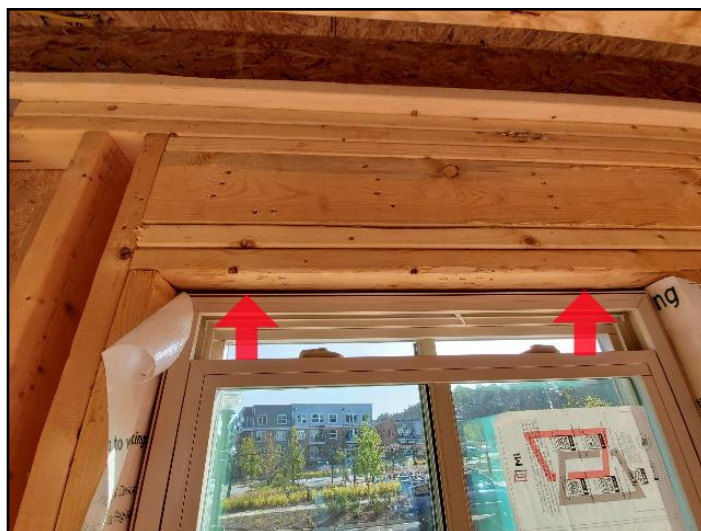
Windows and doors not foamed. All windows and doors shall be foamed for energy code compliance. If foaming is not completed until insulation, recommend builder provide proof that windows and doors were foamed at that time.

*Windows not foamed*

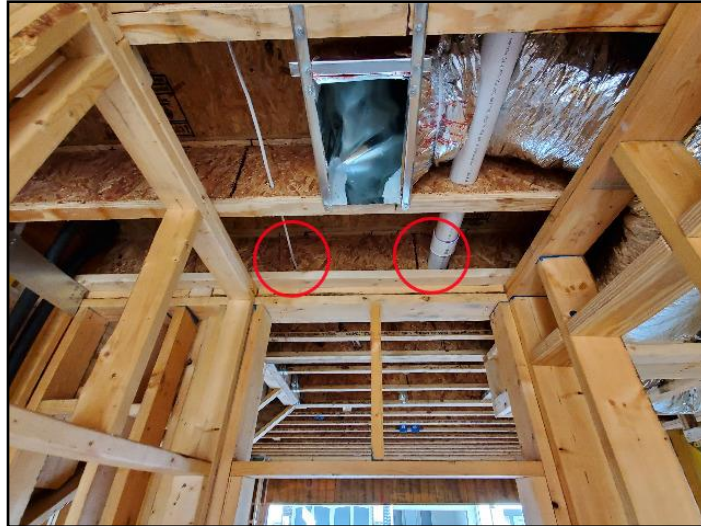
Penetrations from garage to living space not sealed. Recommend fire blocking all penetrations in ceiling from garage to

*Fire separation between garage and living...*

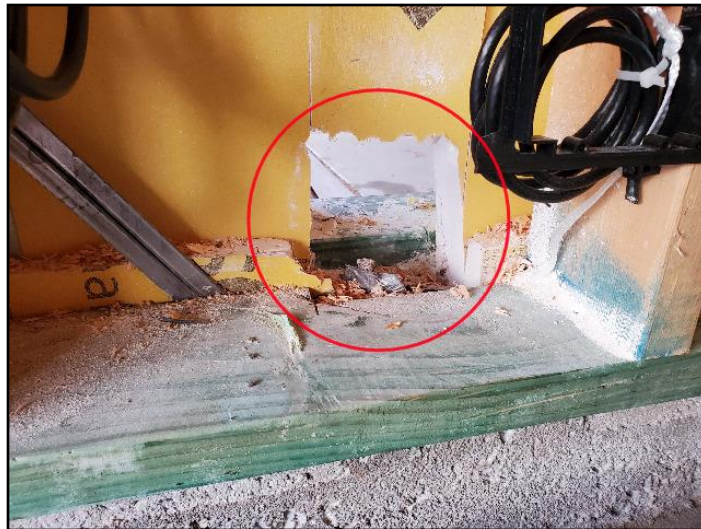
Hole in firewall leading to adjacent unit in garage. Nothing is permitted to penetrate the firewall. Recommend patching the hole in the firewall and sealing with fire caulk.

*Hole in firewall*
