YOUR INSPECTION REPORT

FOR THE PROPERTY AT:
231 Fairview Avenue
Toronto, ON M6P 3A6

INSPECTION DATE:
Thursday, February 26, 2026

RE: Report No. 9054
231 Fairview Avenue
Toronto, ON
M6P 3A6

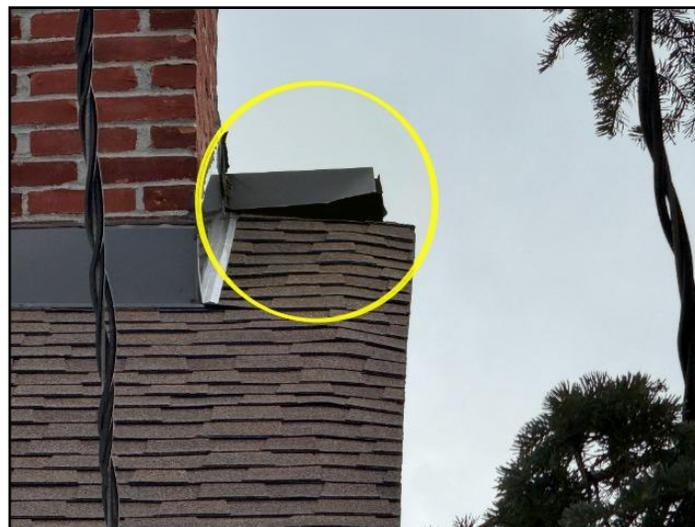
FLAT ROOF FLASHINGS \ Wear or damage

Condition: • [Damage, loose, bent](#)

3. *Damage, loose, bent*

Task: Repair

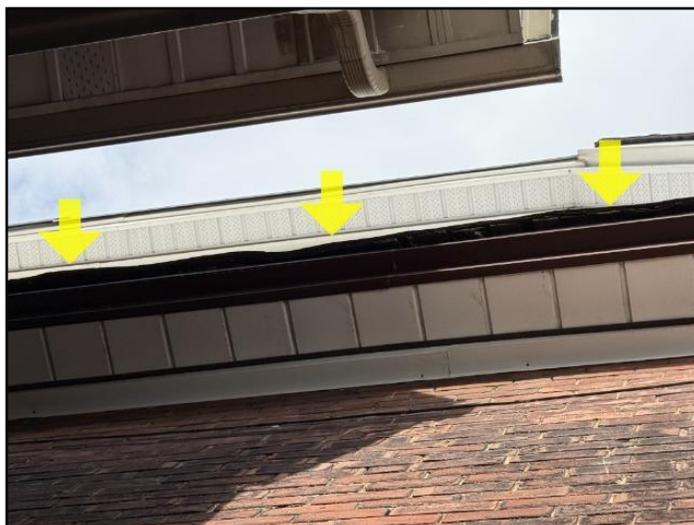
Condition: • [Missing](#)

No gutter is installed along the right side roof overhang. Shingles extend beyond the roof edge and are beginning to sag at the eave. Installation of a gutter is recommended to improve roof edge support and control roof runoff.

4. Missing example

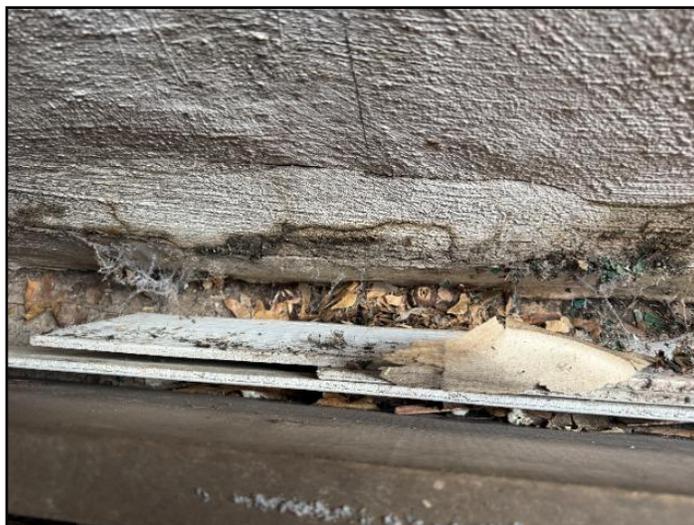
Condition: • [Parging damaged or missing](#)

5. Parging damaged

Task: Repair

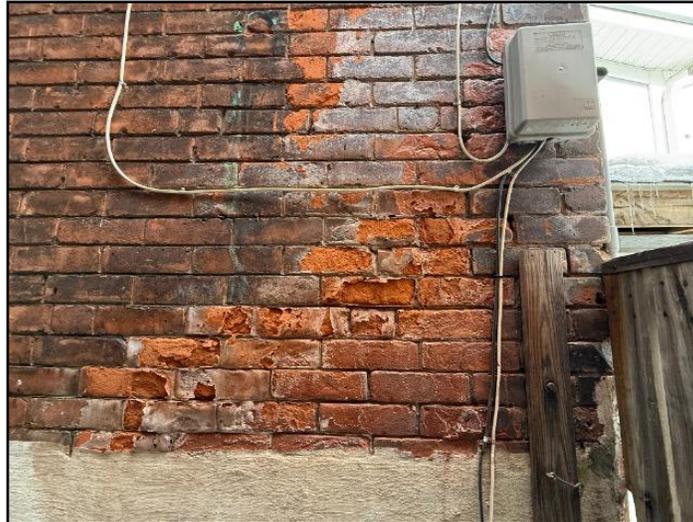
Condition: • Masonry and/or mortar deterioration

6. one example of spalling

Tuckpoint / Repoint mortar and patch/repair spalled masonry. This is typical maintenance for a home of this age.

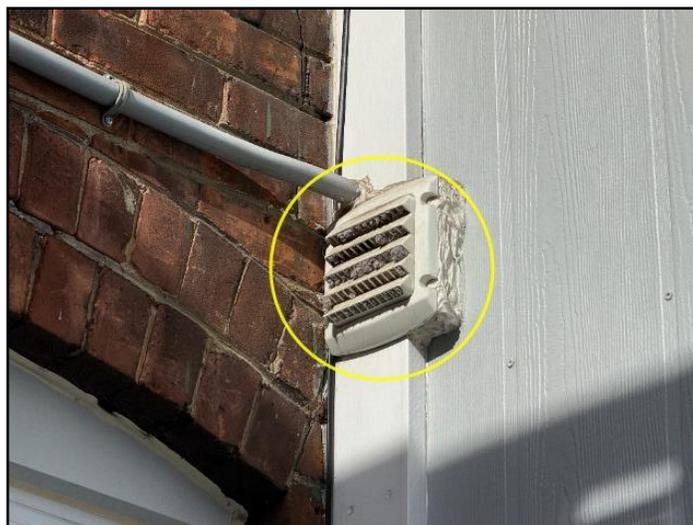
Condition: • Clogged or Obstructed

Implication(s): Reduced performance | Fire hazard

7. Clogged or Obstructed

Task: Clean

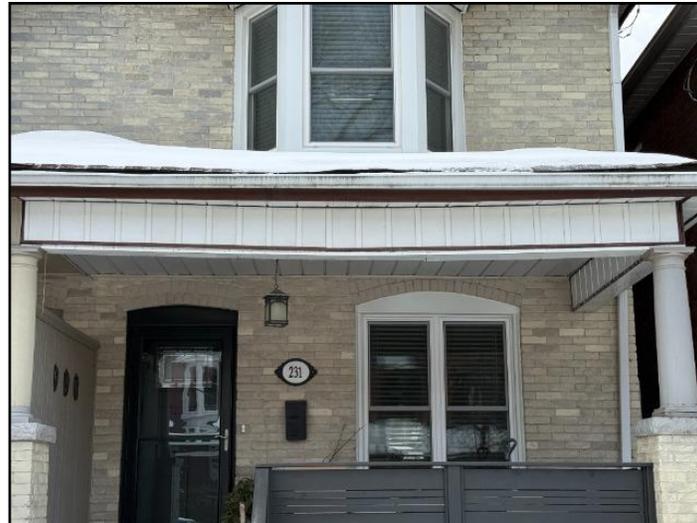
8.

Condition: • Slight sag observed

A slight unevenness was observed along the front porch roof edge. This may be related to trim or metal capping alignment. No active distress or cracking was noted at the time of inspection. Recommend monitoring for changes.

Task: Monitor for movement or activity

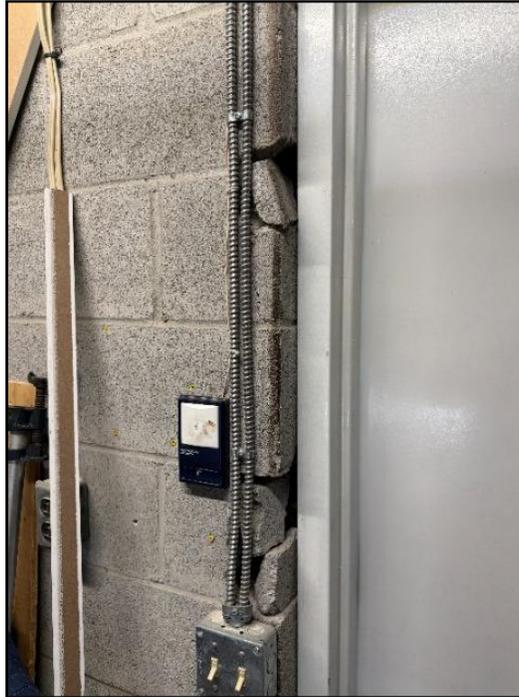
- Step rise too high / not uniform - front top step - Improve as needed.
- Broken concrete block - Garage near doorway - Repair as needed.

9. Garage block damage example

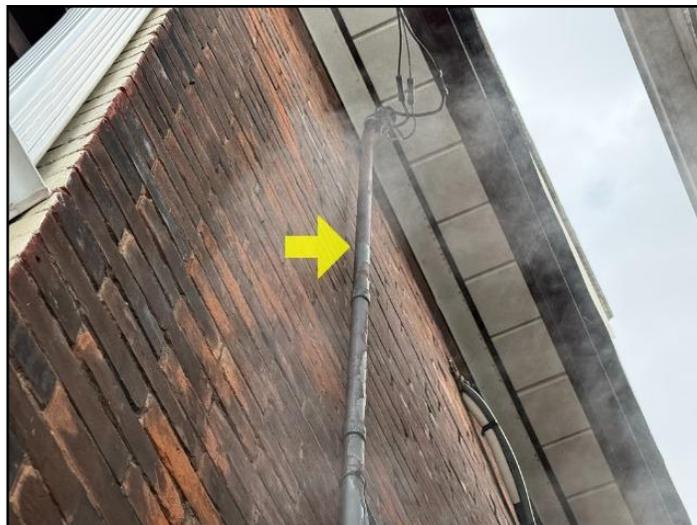
- Condition:** • Mast or Conduit clamp fastener loose or missing
Location: Right Side Exterior
Task: Secure to wall
Time: Less than 1 year
Cost: Minor

12. Mast or Conduit clamp fastener loose or...

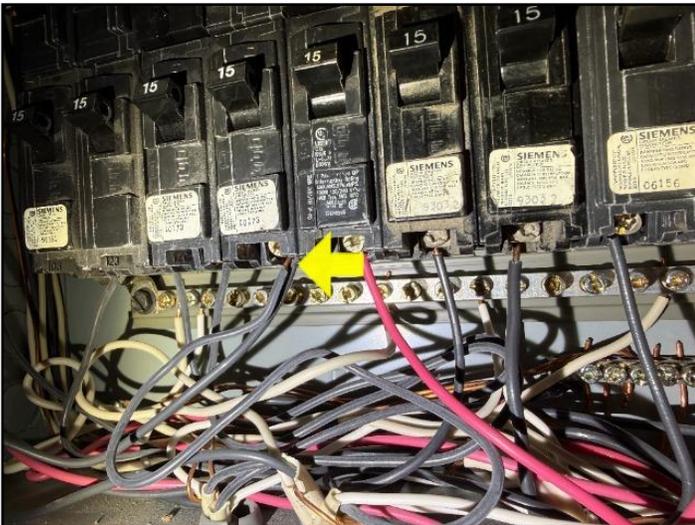
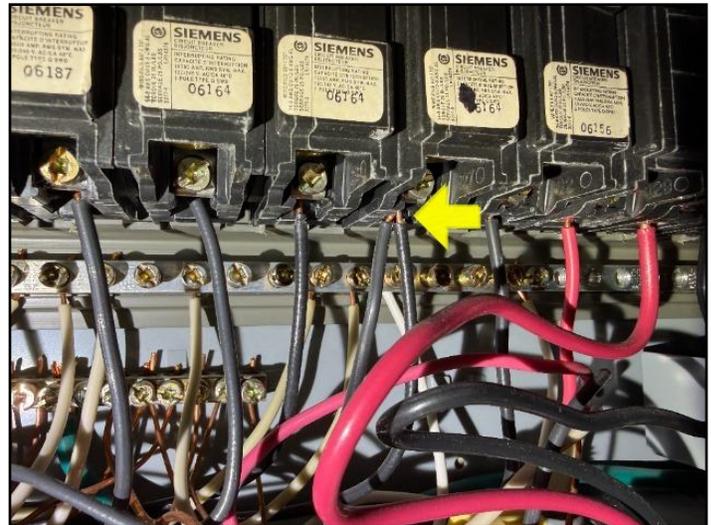
- Condition:** • [Double taps](#)
Implication(s): Fire hazard
Location: Various Basement Panel
Task: Correct
Time: As Soon As Possible
Cost: Minor

13. Double taps

14. Double taps

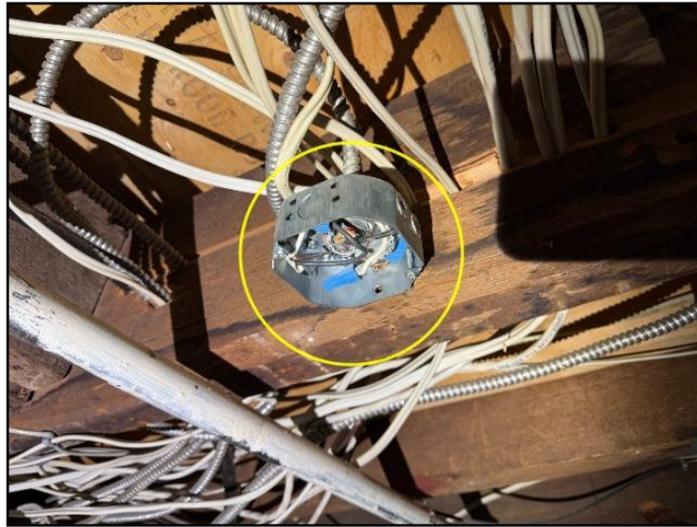
Condition: • Cover missing

15. Cover missing

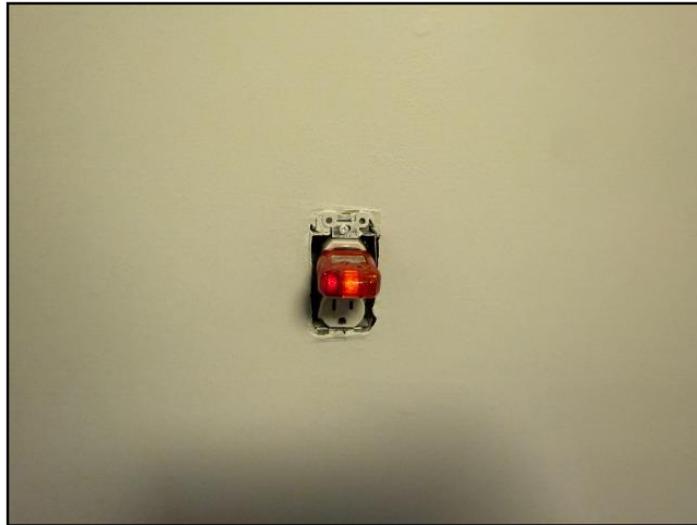
Condition: • [Reversed polarity](#)

16. Reversed polarity

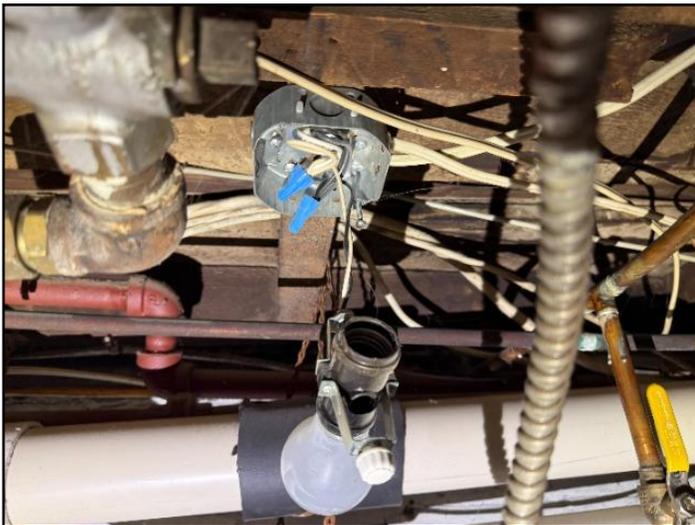
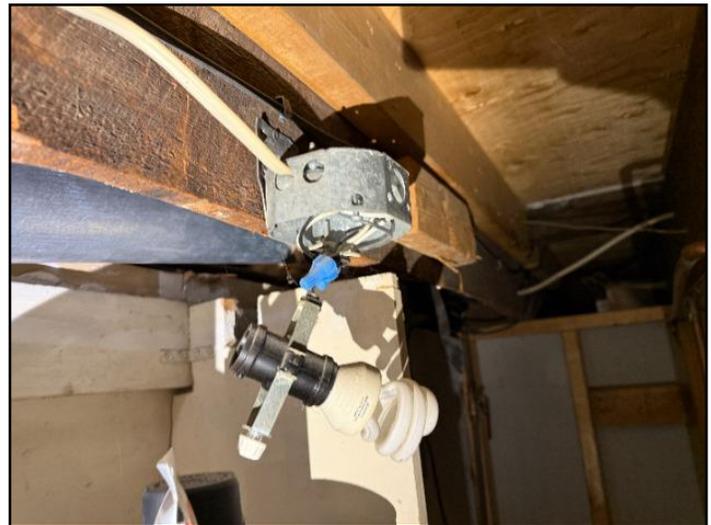
Condition: • [Damage](#)

Implication(s): Electric shock | Fire hazard

17. Damage

18. Damage

Task: Repair / Replace

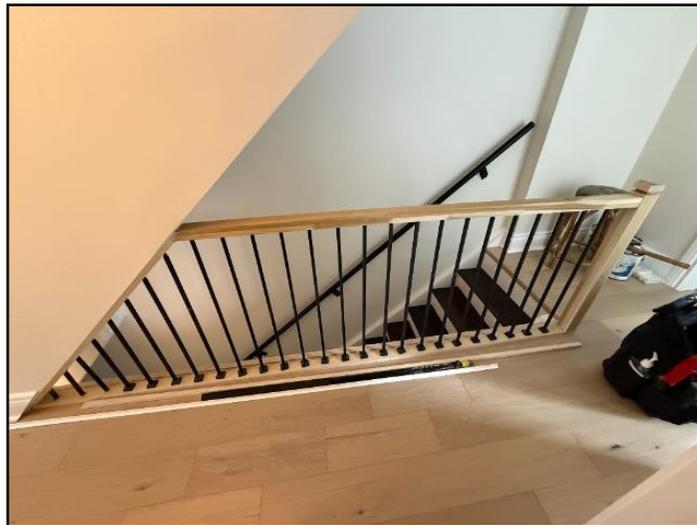
Condition: • [Too low](#)

Implication(s): Fall hazard

20. Too low
