YOUR INSPECTION REPORT

FOR THE PROPERTY AT:
63 Robinson Street
Toronto, ON M6J 1L4

INSPECTION DATE:
Tuesday, April 22, 2025

RE: Report No. 8258, v.3
63 Robinson Street
Toronto, ON
M6J 1L4

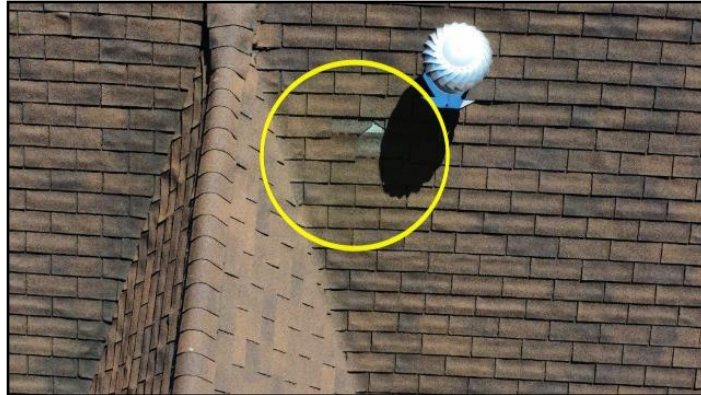
2. Missing, loose or torn

Condition: • [Missing, loose or torn](#)

Task: Repair

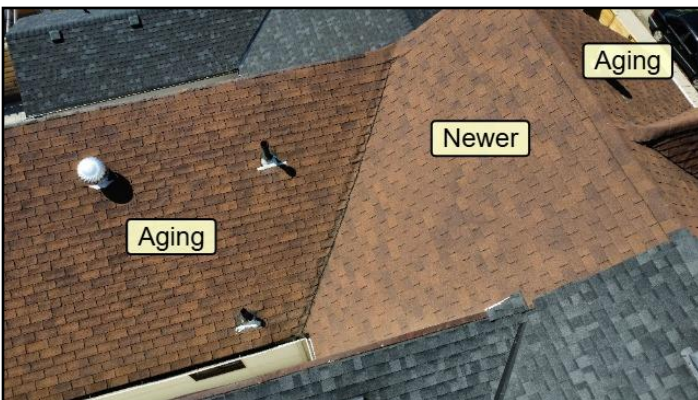
3. Aging

Condition: • Aging

Varying ages of shingles were observed throughout the roof. Some areas are newer and in good condition, while others show signs of aging such as granule loss, cupping, and widened tabs due to shrinkage. Although replacement is not immediately required, replacement of the older sections is likely needed within the next 3 years.

Task: Inspect annually and replace sections as needed coverings

Time: Ongoing / Less than 3 years

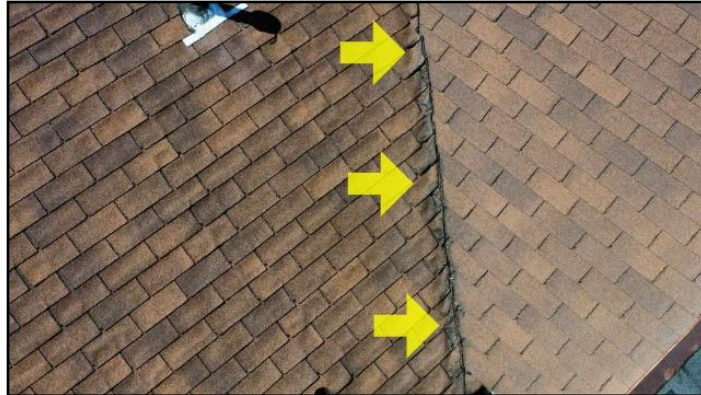
5. Torn, worn

Condition: • [Torn, patched](#)

old/worn

Task: Repair / Replace

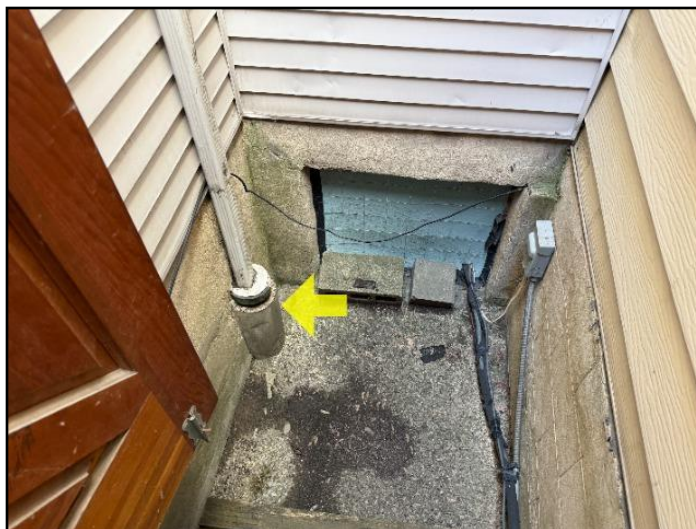
6. Downspouts below grade - Toronto. For more...

Condition: • Downspouts below grade - Toronto.

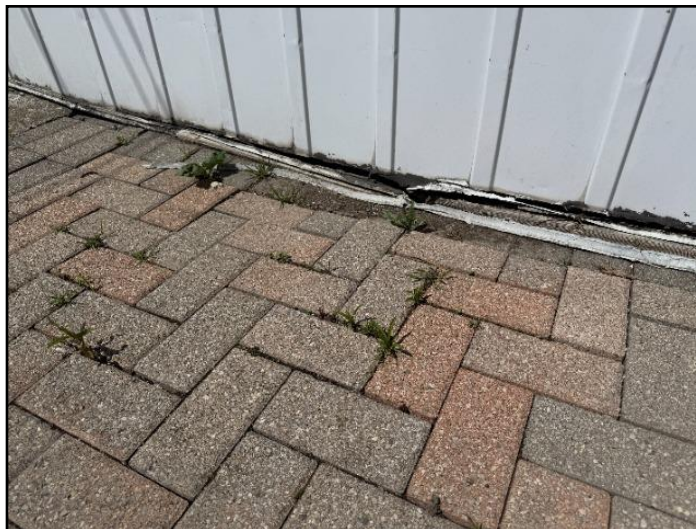
7. Rear patio

Condition: • Settlement -

Areas of the patio near the home have settled, creating low spots and improper slope. Although there is no basement in this area, improving the slope is recommended to help prevent water accumulation.

Task: Correct

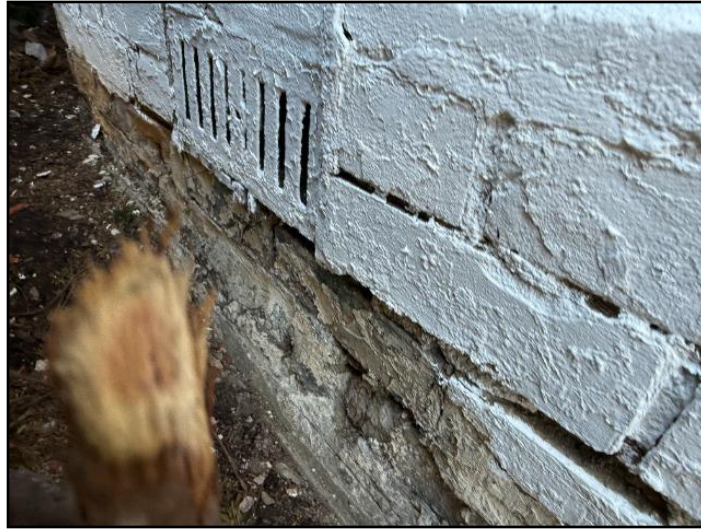
8. one example

Condition: • The following are minor exterior deficiencies and upkeep items noted during the inspection. These are common for the age of the home and should be addressed through routine maintenance to reduce risk of deterioration or moisture intrusion:

- Tuckpoint / Repoint / Patch any mortar deterioration or spalled masonry. This is routine maintenance for a home of this age.
- Aging gutters. Recommend updating gutters soon. When updating, consider replacing with a 5-inch gutter system for improved performance.

Task: Repair/Improve/Monitor

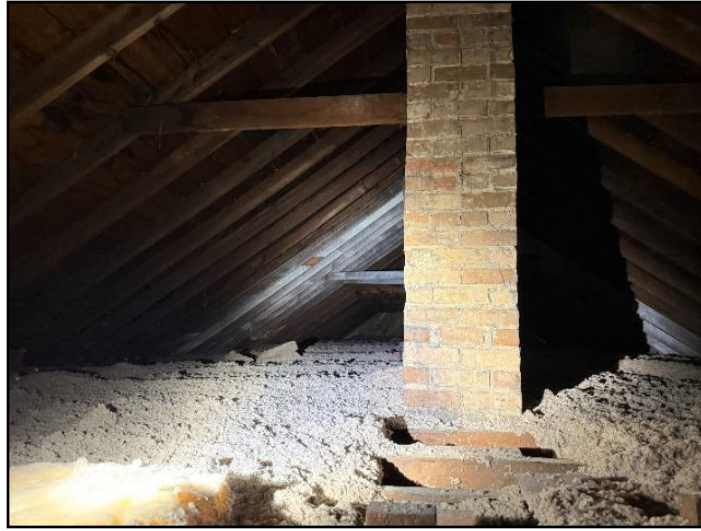
9. Incomplete in attic

Condition: • [Incomplete in attic](#)

Implication(s): Increased fire hazard

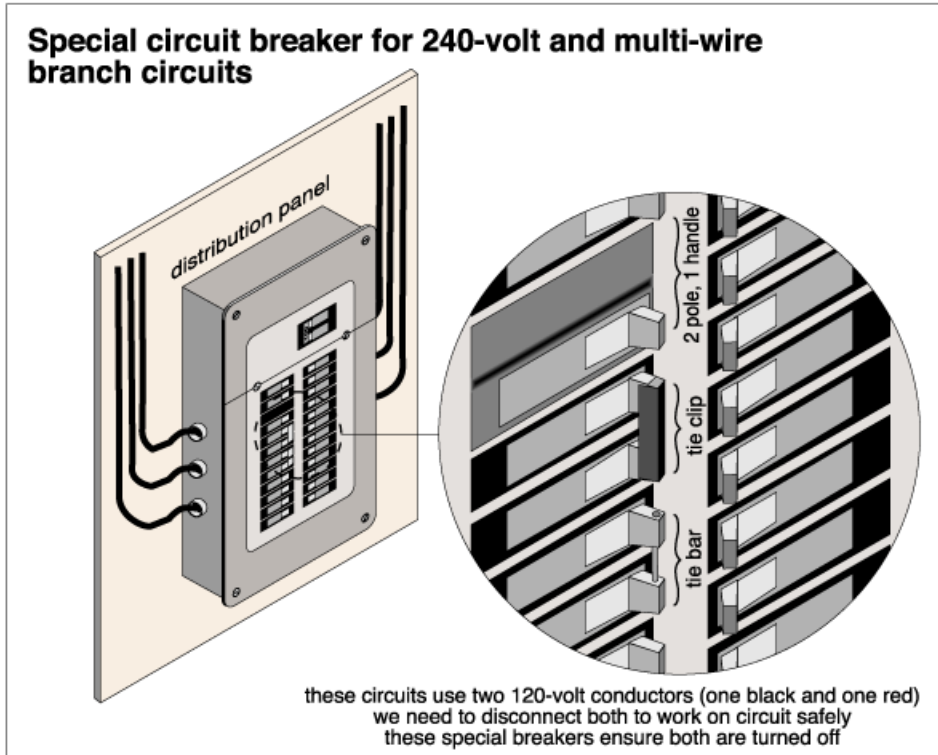
Condition: • [No links for multi-wire circuits](#)

Possible missing links. Have electrician confirm if distribution lines (photos show a sampling) are multi-wire 240V circuits. Provide handle ties if necessary.

Location: Basement Panel
Task: Correct - Provide handle ties
Time: As Soon As Possible
Cost: Minor

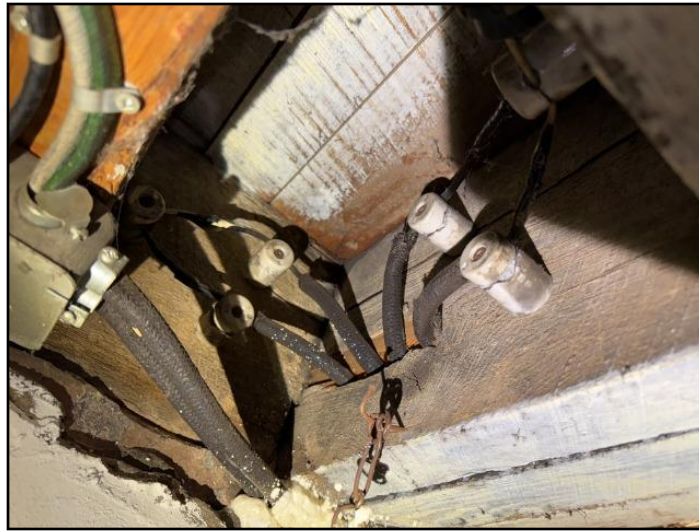
11. one example

Condition: • [Outdated -](#)

A mix of newer wiring and older knob-and-tube wiring was observed in the home.

Knob and Tube wiring was commonly installed in homes built before 1950. The Electrical Safety Authority (ESA) does not deem knob-and-tube wiring unsafe if it is well-maintained and in good condition. However, many insurance providers require this wiring to be replaced or upgraded before issuing policies.

In the interim, installing GFCI outlets in areas with ungrounded wiring is recommended for improved safety until updates are completed.

Time: As Soon As Possible

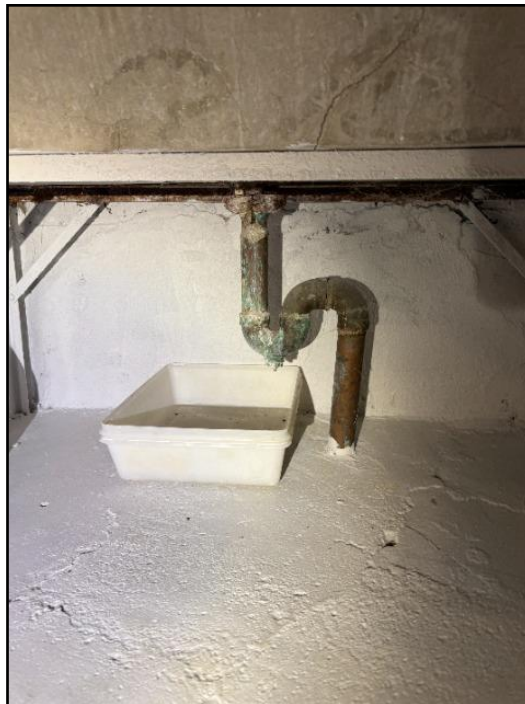
13. Nonstandard shape or material

Condition: • Nonstandard shape or material

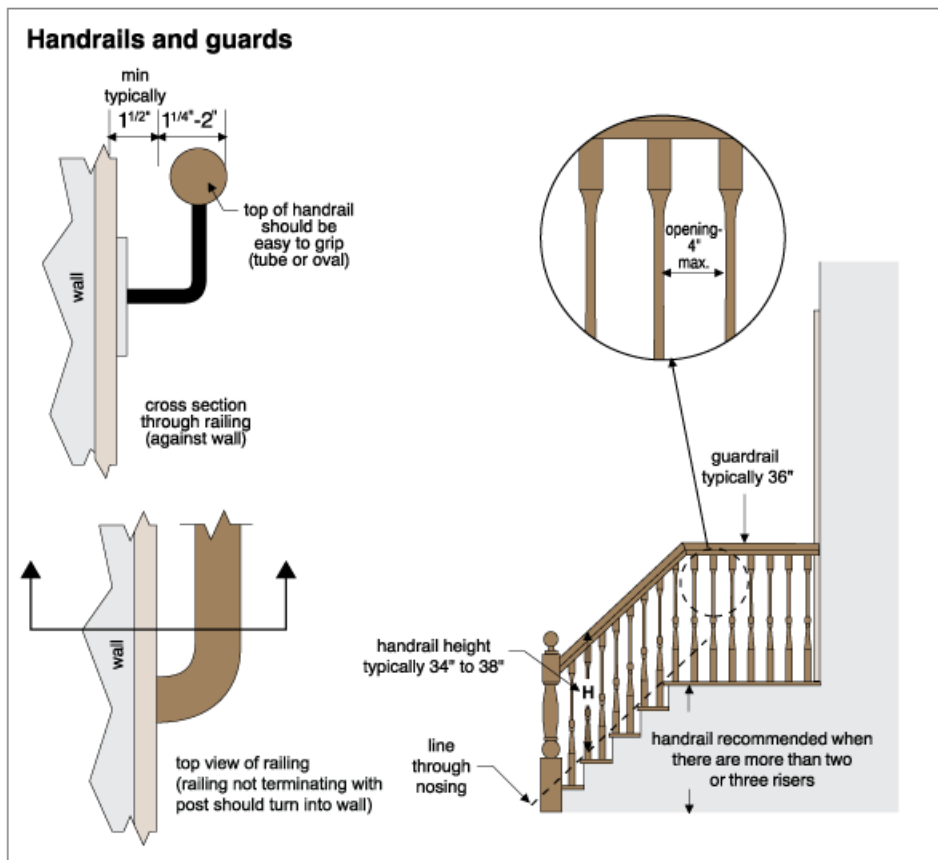
Condition: • [Too low](#)

Implication(s): Fall hazard
Location: Second Floor Hall
Task: Upgrade
Time: As soon as practical
