# YOUR INSPECTION REPORT

FOR THE PROPERTY AT:  
33 White Oak Boulevard  
Toronto, ON M8X 1J1

PREPARED FOR:  
DEANNA ALLEGGRANZA  
TYLER POPE  
INSPECTION DATE:  
Tuesday, May 18, 2021

RE: Report No. 2894  
33 White Oak Boulevard  
Toronto, ON  
M8X 1J1

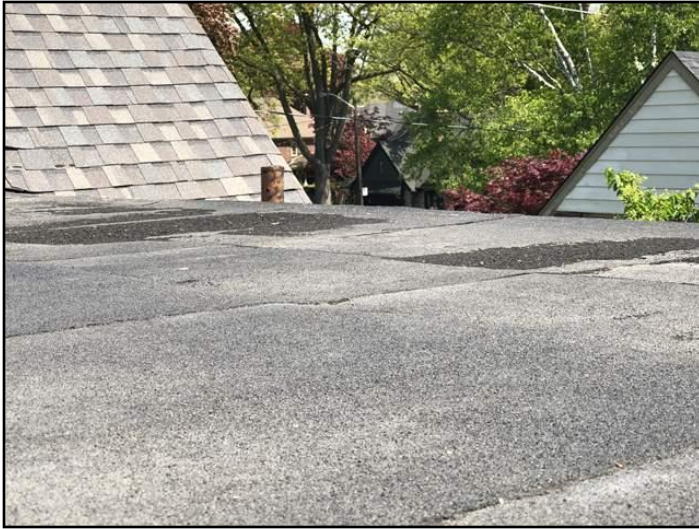
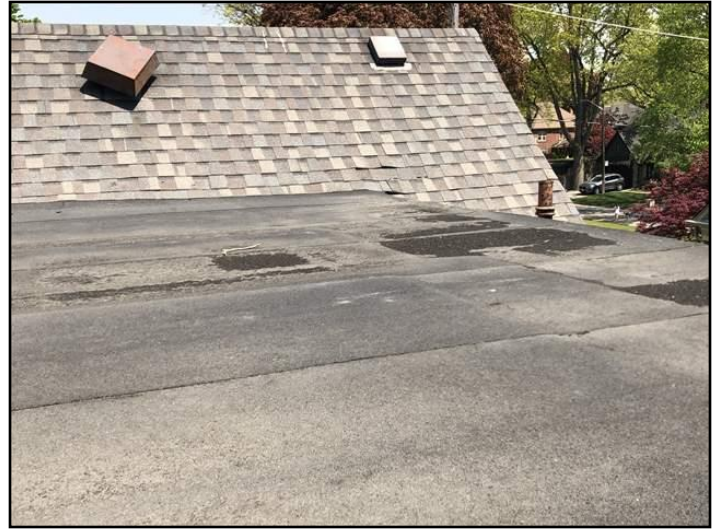
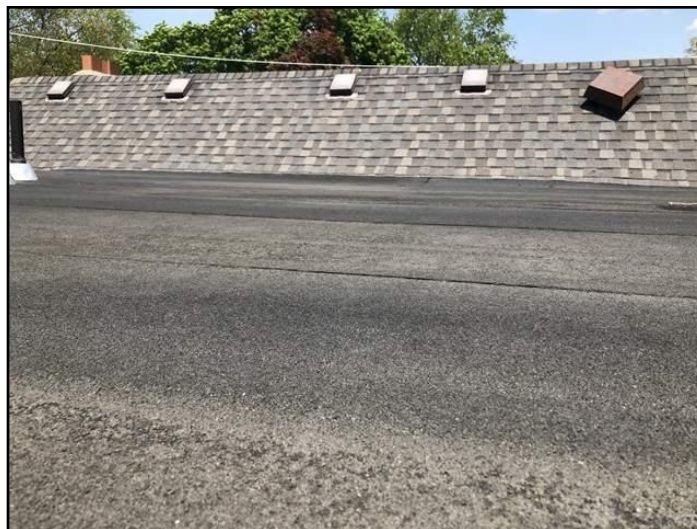
**Condition:** • Aging

Flat roof inspected from ladder at edge of roof. Typical lifespans for modified bitumen roofs are 20-30 years. Surface cracks, low areas and granule loss were noted which occur as roof ages. Covering is nearing end of lifespan. Consult flat roof contractor to evaluate.

2. Aging

**Task:** Patch repair various areas and replace soon

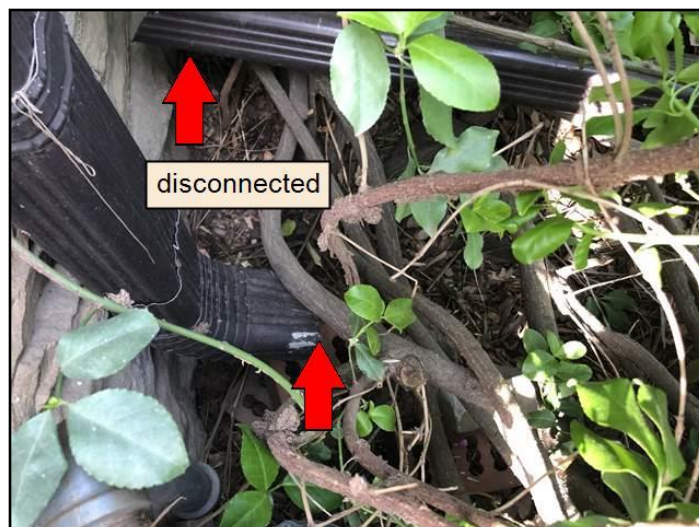
**Condition:** • [Connections loose](#)

5. Connections loose

**Task:** Correct

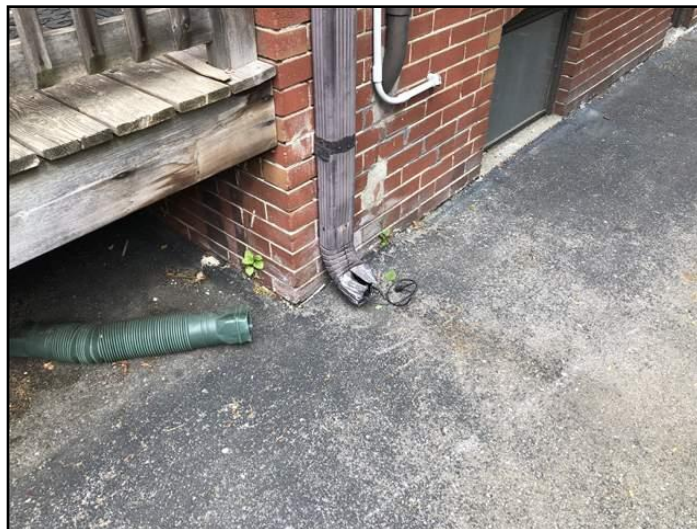
**Condition:** • [Damage](#)

6. Damage

**Task:** Repair / Replace

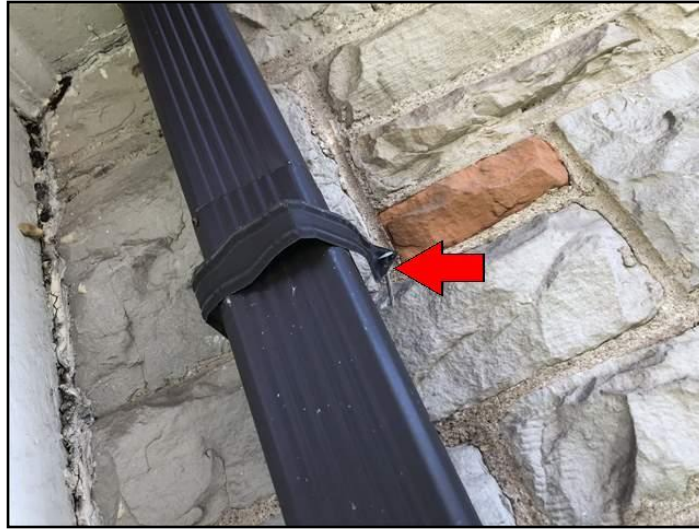
**Condition:** • [Not well secured](#)

7. Not well secured

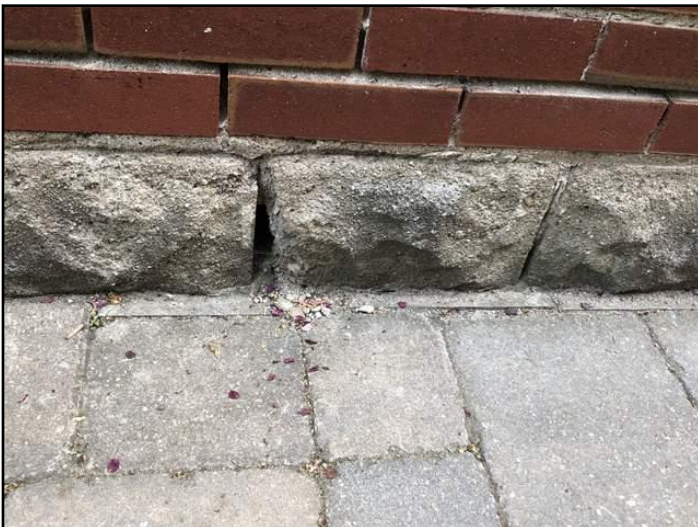
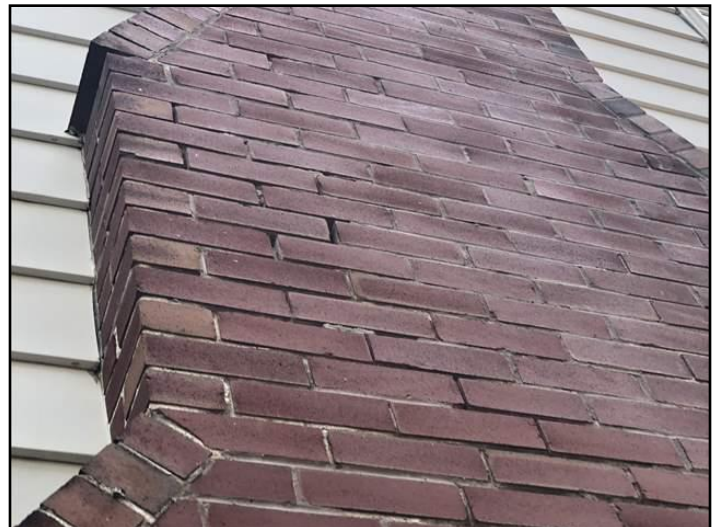
**Condition:** • [Mortar deterioration](#)

Provide mortar (Repointing, Tuck pointing) at various areas of the exterior brick or foundation. This is routine maintenance for homes of this age. Overall the brick and mortar is in good condition. photos show sampling.

**Task:** Repair mortar

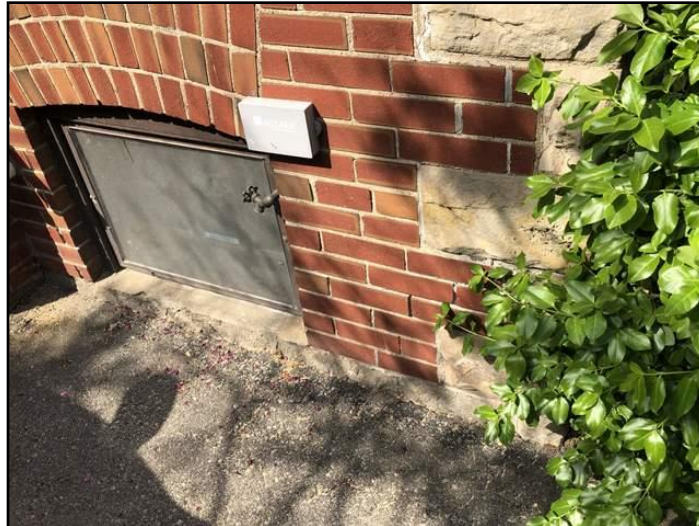
**Condition:** • Sill - Near or at Grade Level

Windows at grade was common on older construction. Modern standards require that bottom of window be above grade by 6-inches or a window well be provided. Window sills at grade are vulnerable to damage and water leakage

10. Sill - Near or at Grade Level example

**Task:** Monitor / Improve

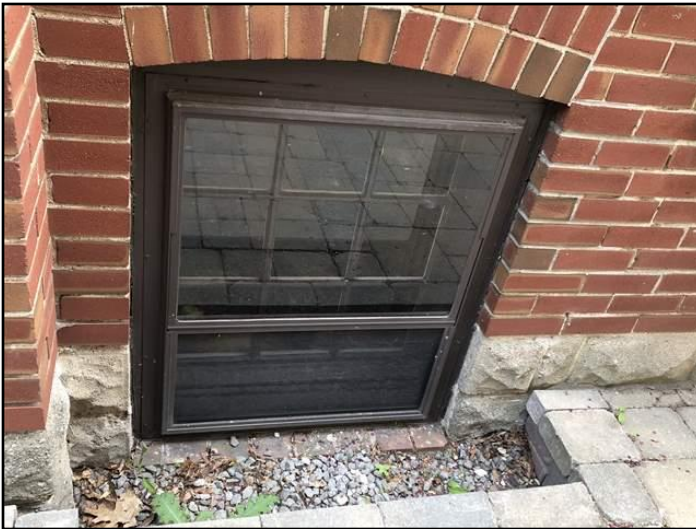
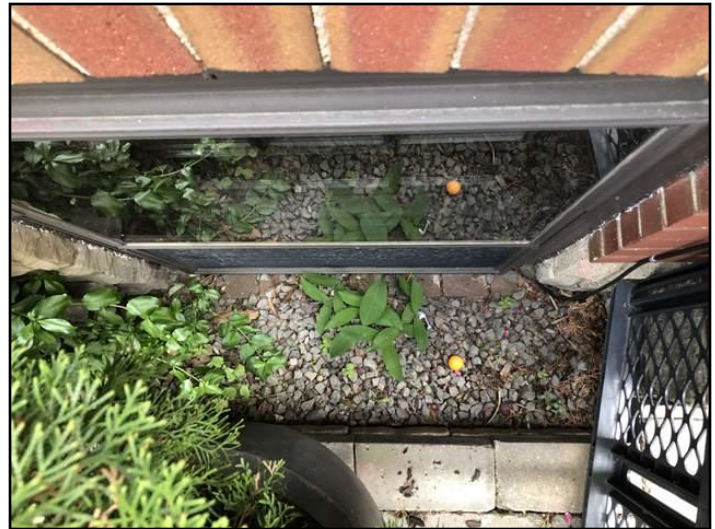
**Condition:** • [Less than 6 inches below window](#)

11. Less than 6 inches below window

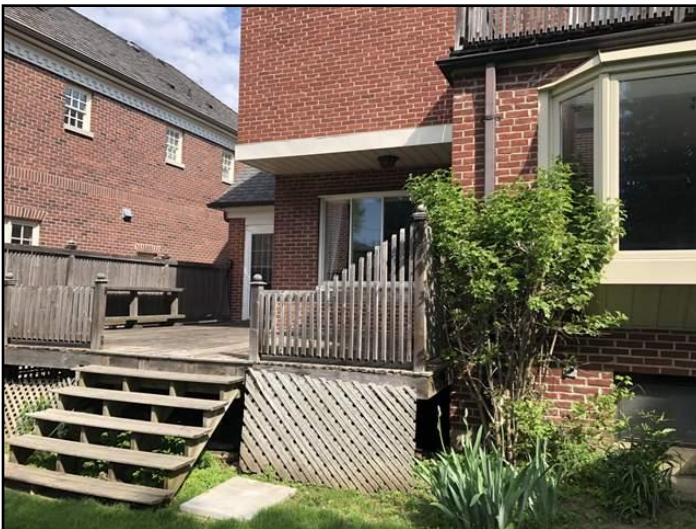
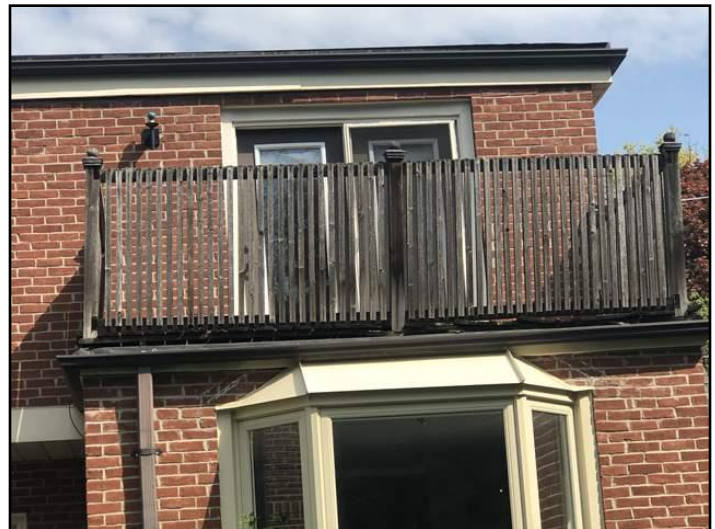
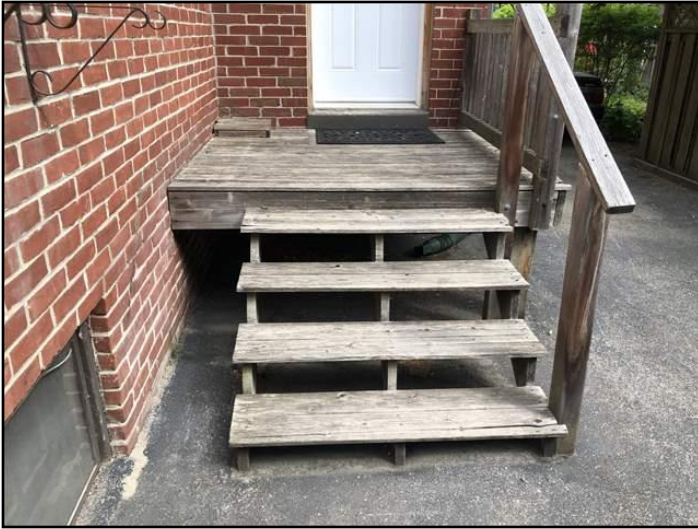
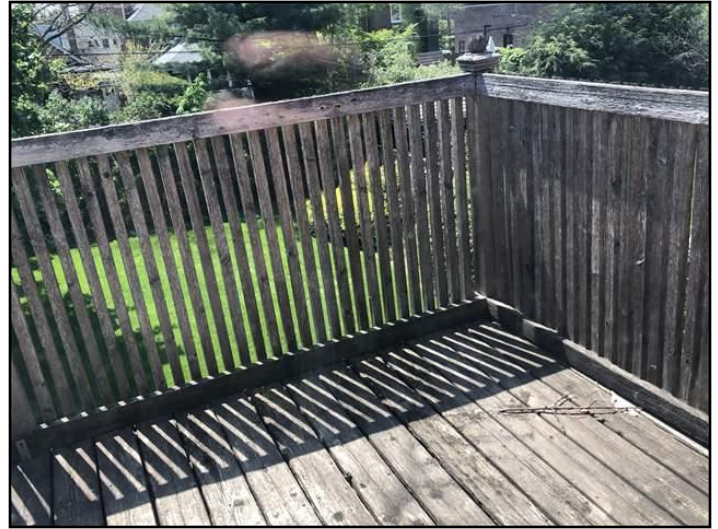
Condition: • Disrepair

End of lifespan and unsafe. Rot, broken boards, loose railings, etc.

13. Disrepair

Task: Replace all decks / railing / stairs

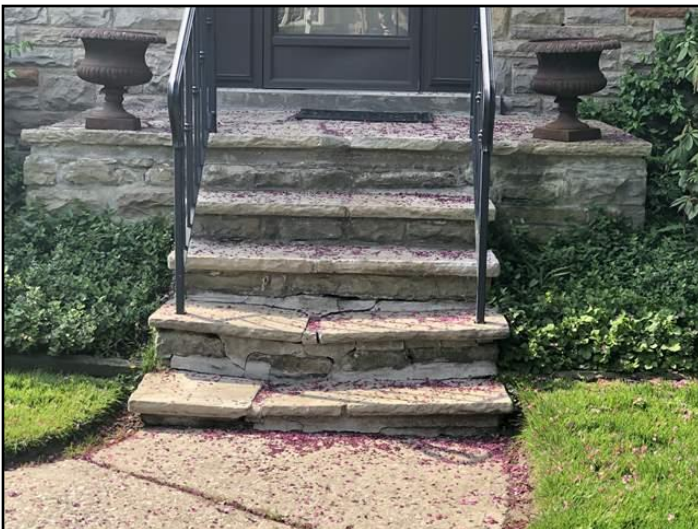
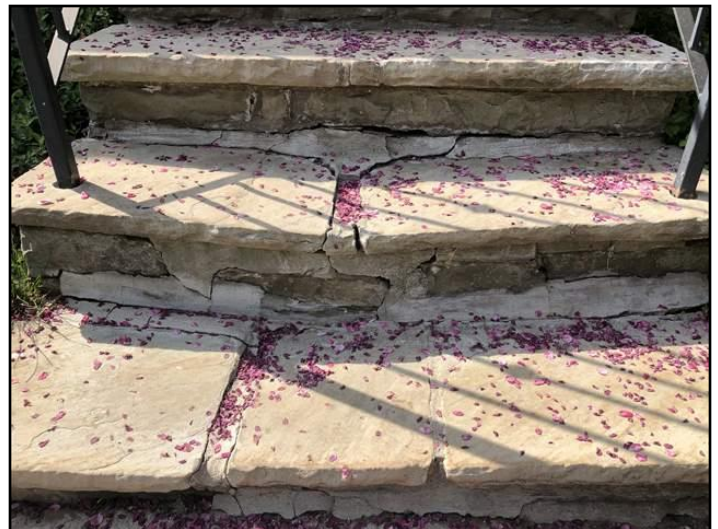
**Condition:** • [Steps or landings settling or heaving](#)

17. Steps or landings settling or heaving

**Task:** Repair or replace

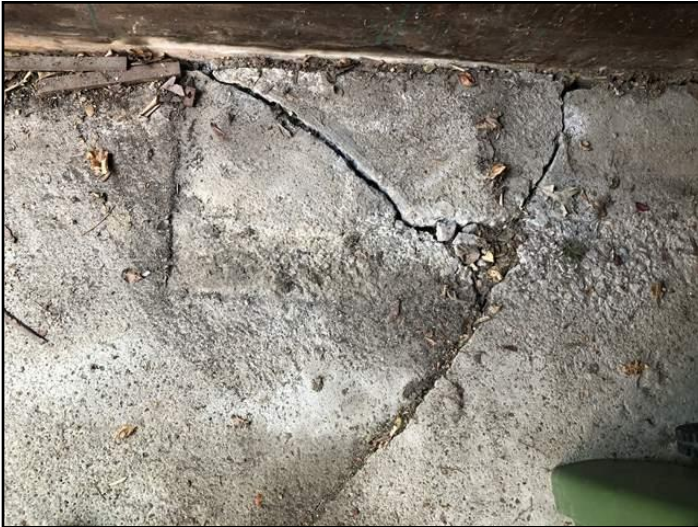
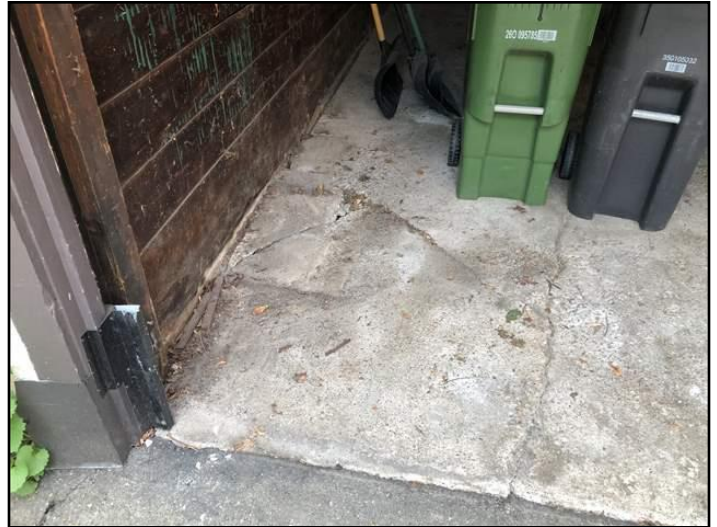
This is a typical old garage commonly found in Toronto. The concrete floor has settled and cracked. Replacement garages are expensive, therefore most people choose to repair garage ongoing as needed.

**Condition:** • [Cracked](#)

19. Cracked and settled

20. Cracked

**Task:** Repair / Replace

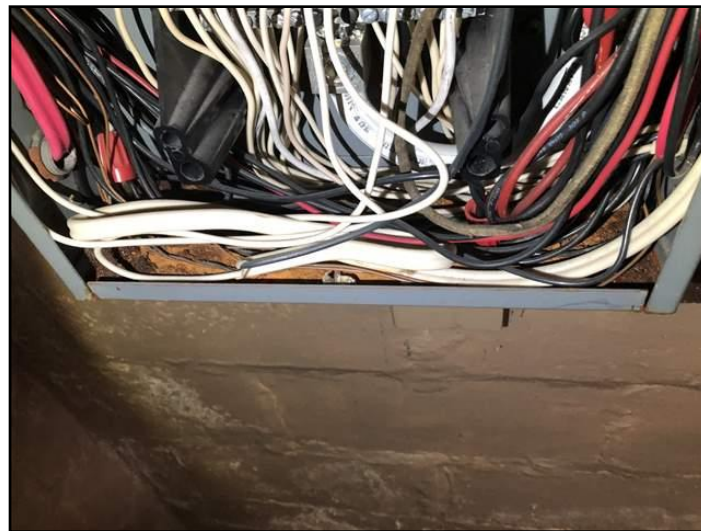
**Condition:** • [Rust or water in panel](#)

21. Rust or water in panel

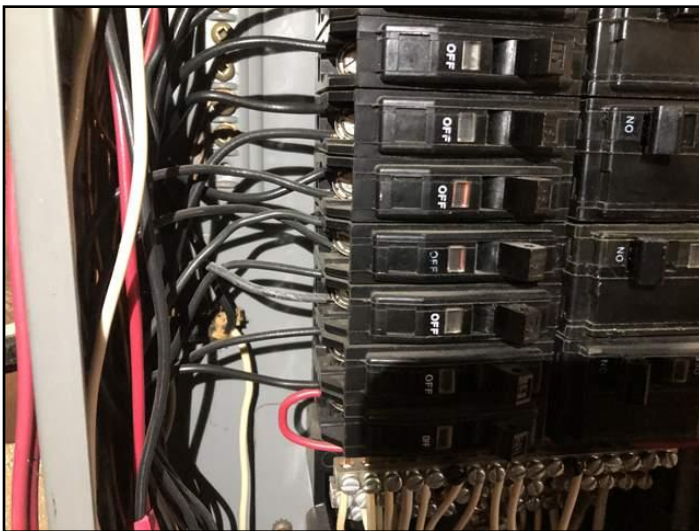
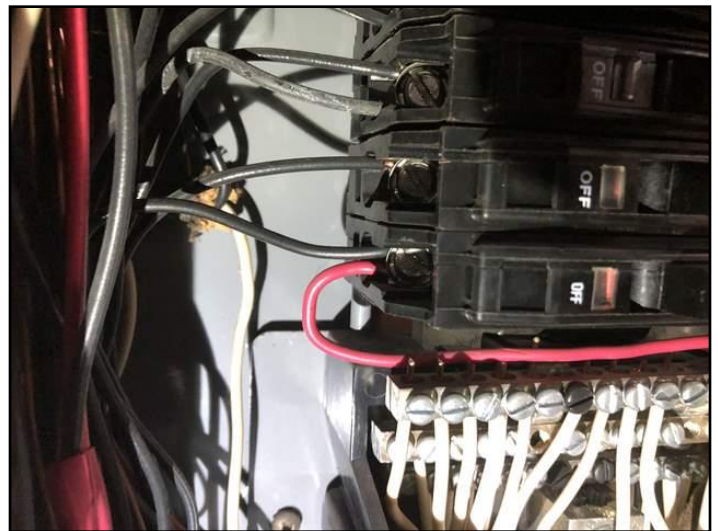
**Condition:** • [Double taps](#)

22. Double taps

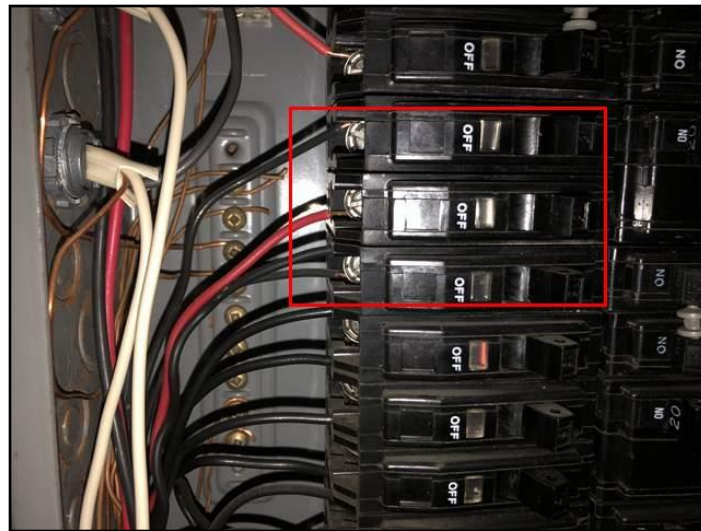
**Condition:** • [Breaker bridge missing](#)

24. Breaker bridge missing

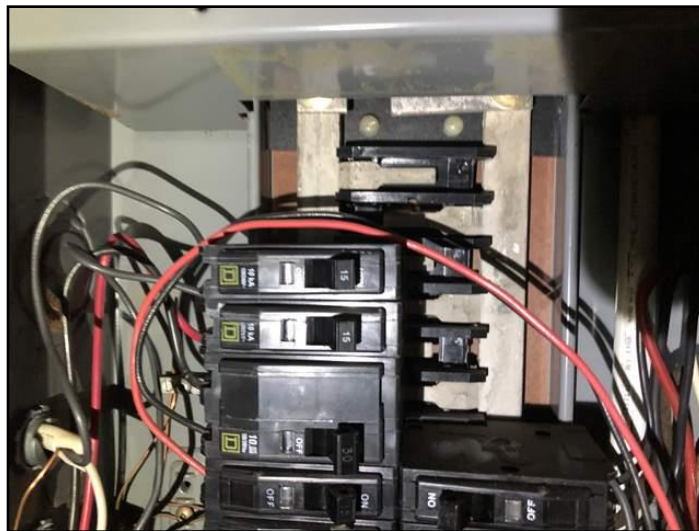
**Condition:** • [Wire crossing bus connections](#)

25. Wire crossing bus connections

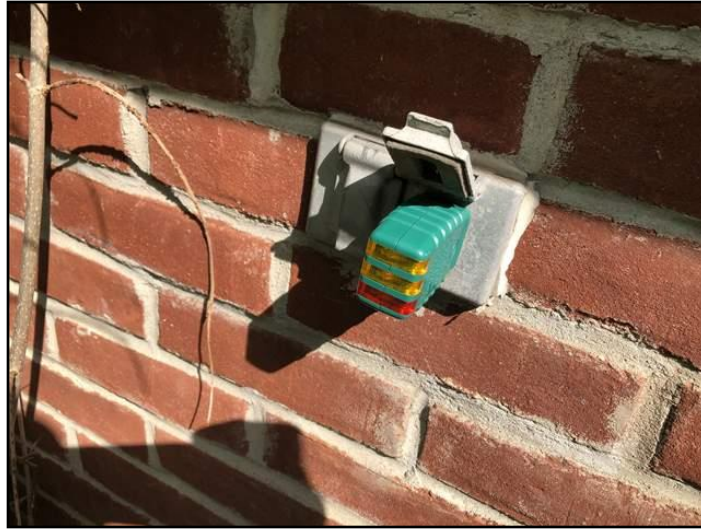
**Condition:** • [GFCI/GFI needed \(Ground Fault Circuit Interrupter\)](#)

26. GFCI/GFI needed (Ground Fault Circuit...

**Task:** Replace

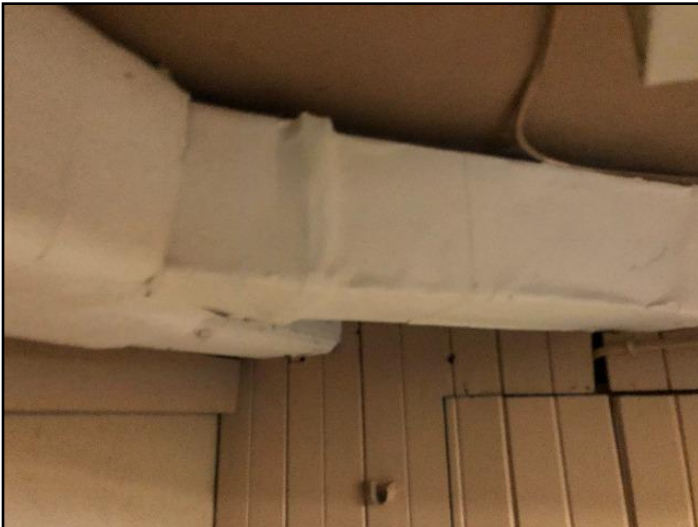
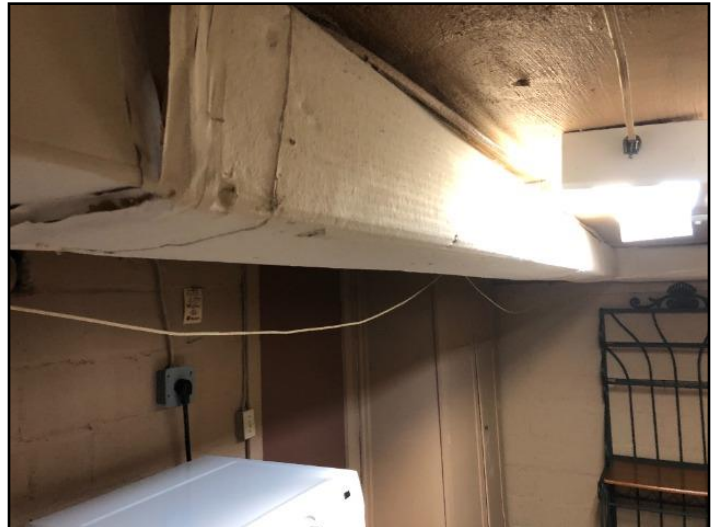
**Condition:** • The insulation on the heating ductwork may contain asbestos. Health Canada recommends the insulation be left in place undisturbed unless there is a risk of asbestos fibers being released into the house air. If this is a concern, a specialist should be consulted. If the insulation is damaged or is to be disturbed, and if it contains asbestos (confirm with Laboratory test), precautions should be taken that asbestos fibers are not released into the house air during the work.

**Task:** Further Evaluation

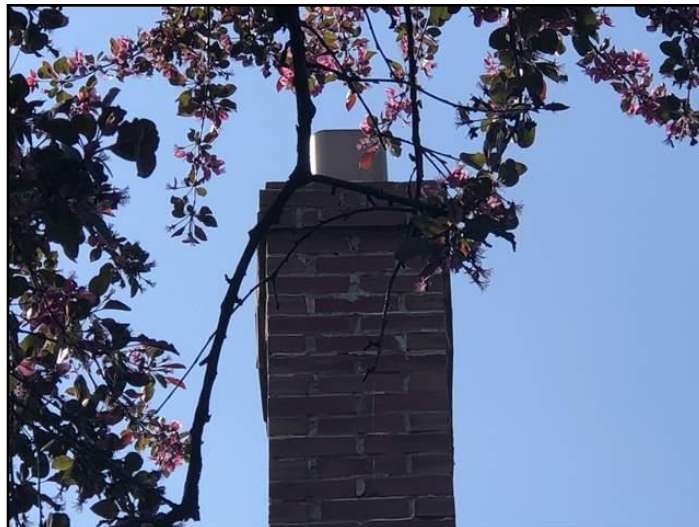
**Condition:** • [Missing](#)

29. Missing

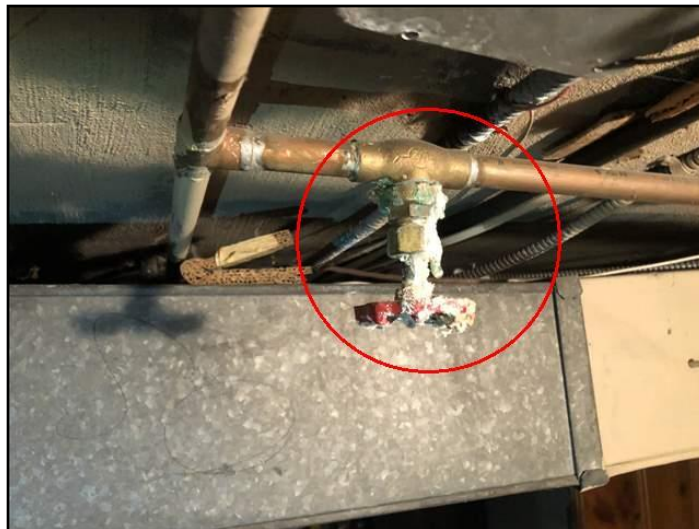
**Condition:** • [Rust](#)

32. corroded valve

**Task:** Replace

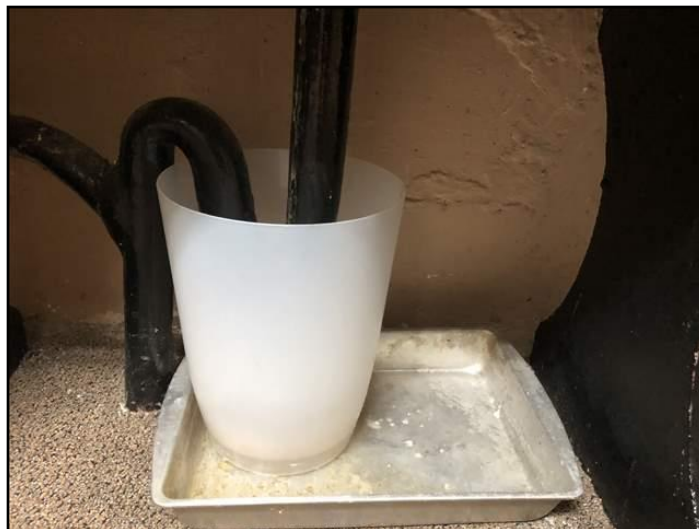
**Condition:** • [Leak](#)

**33. Leak**

**Task:** Replace

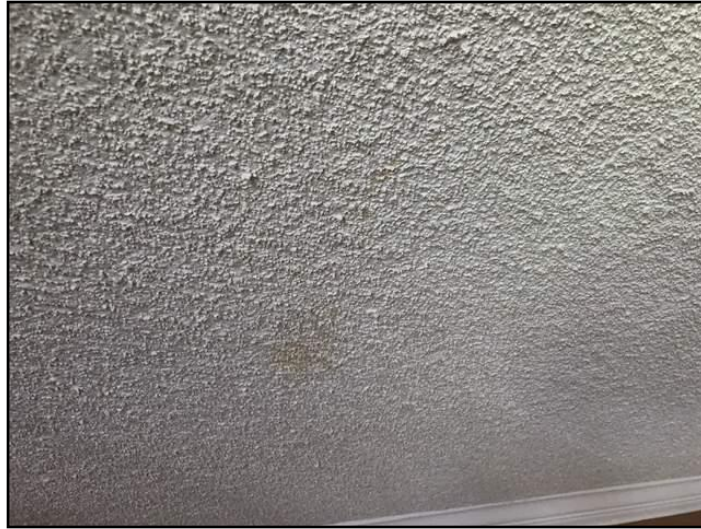
**Condition:** • Stains

Tested with moisture meter. Dry at time of inspection

34. Stains

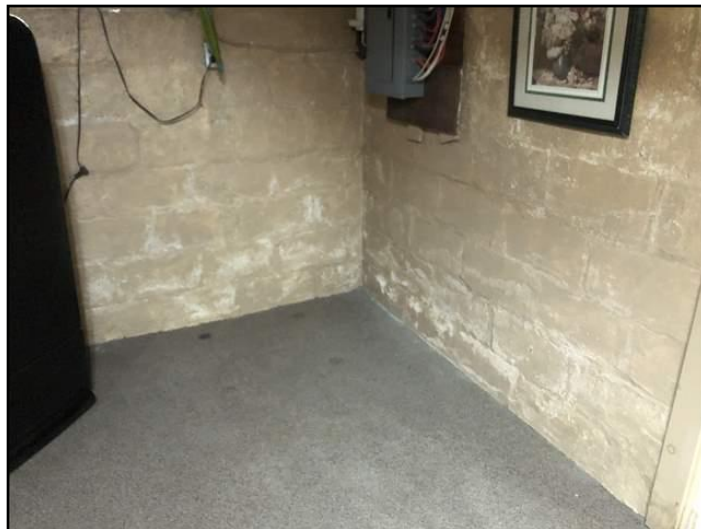
**Condition:** • [Efflorescence](#)

Efflorescence/Stains were noted. This is common with concrete block foundations of homes of this age. They may have been present for many years (decades).
