# YOUR INSPECTION REPORT

139 Gilmour Avenue  
Toronto, ON M6P 3B2

INSPECTION DATE:  
Thursday, March 15, 2018

RE: Report No. 2243  
139 Gilmour Avenue  
Toronto, ON  
M6P 3B2

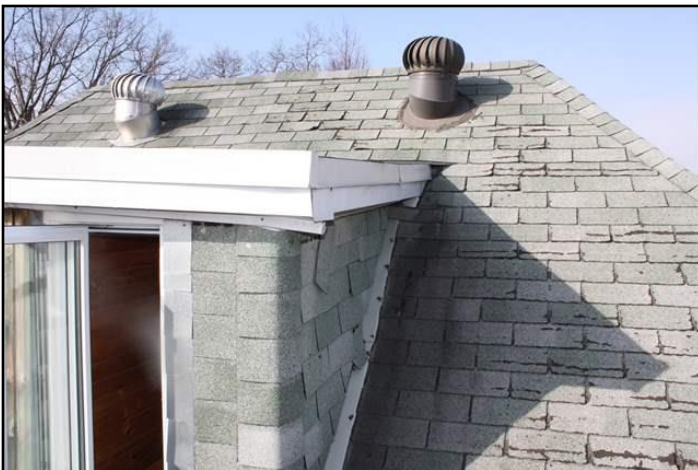
**Condition:** • [Old, worn out](#)

1. Old, worn out

**Task:** Replace

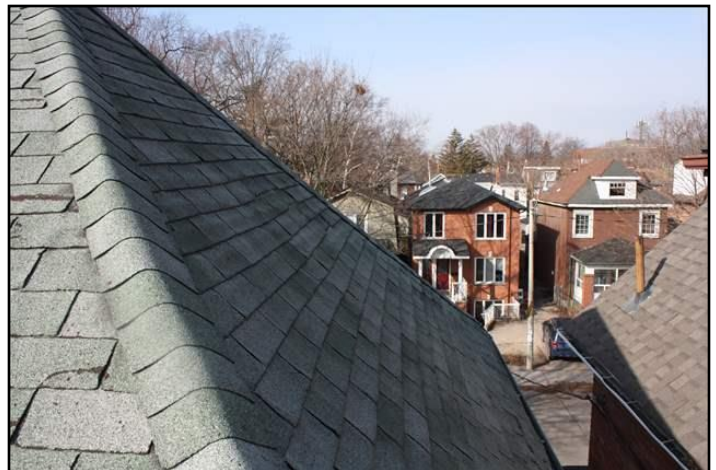
2. Old, worn out

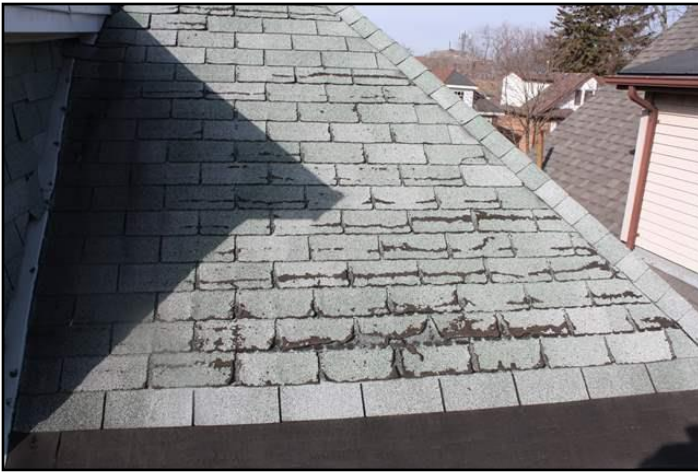
3. Old, worn out

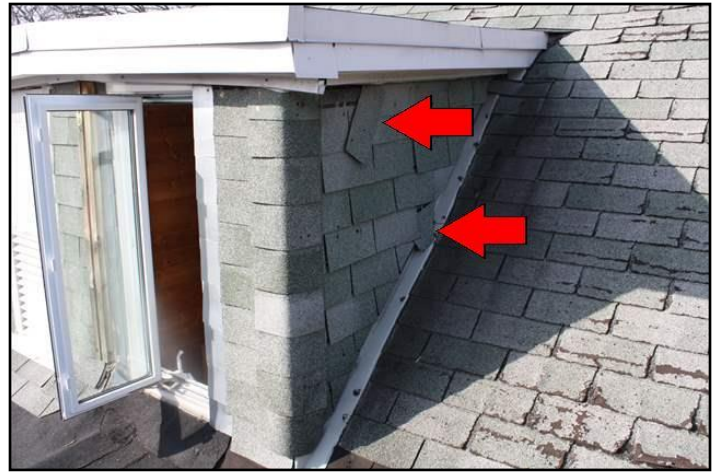
4. Loose shingles

**Condition:** • [Missing, loose or torn](#)

Multiple missing shingles noted. Since we are recommending roof covering replacement, this will be rectified when replaced

**Task:** Repair or replace

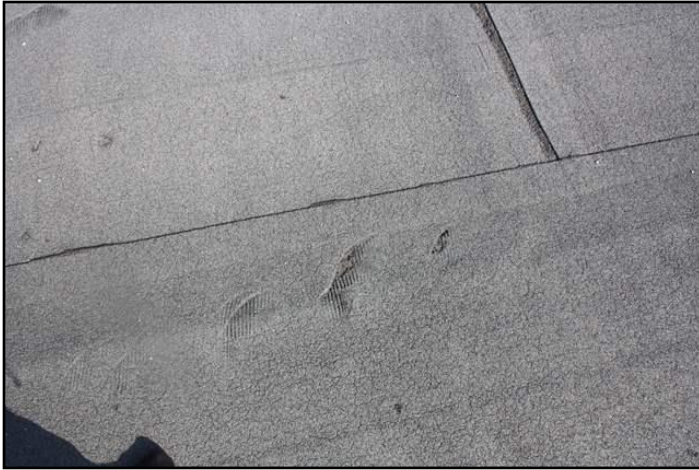
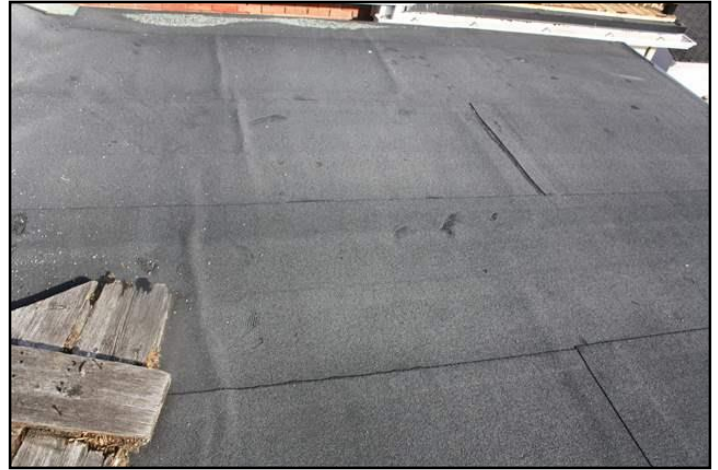
**Condition:** • [Loss of granules](#)

Granule loss is a normal occurrence as roof covering ages. Overall the FLAT ROOF modified bitumen roof covering is in fair condition and does not need replacement at this time. Should have several more years of service.

**Task:** Patch

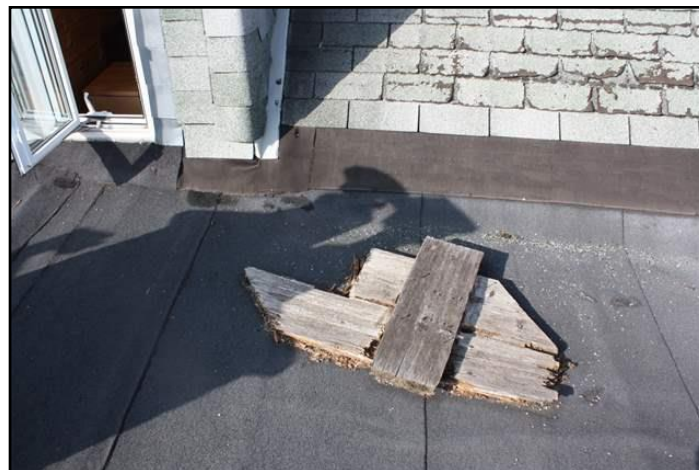
**Condition:** • [Debris on roof](#)

7. Debris on roof

**Task:** Remove

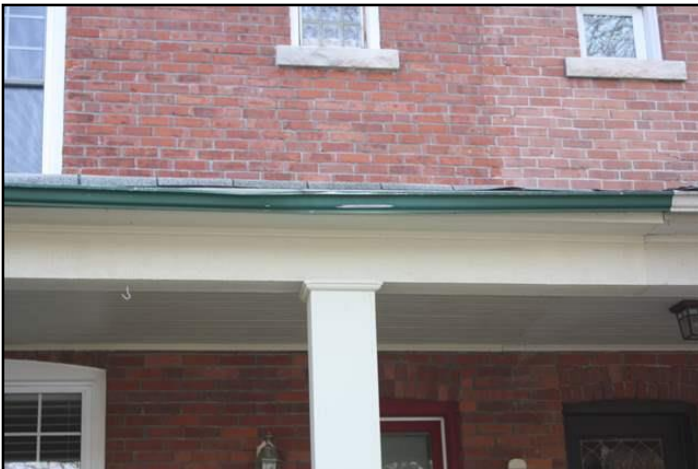
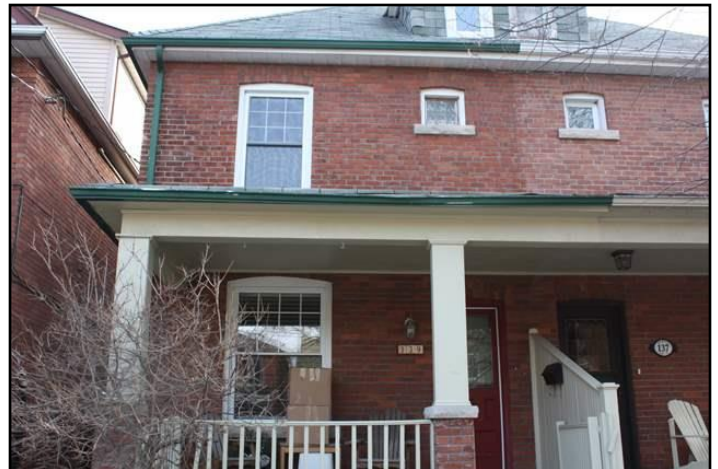
**Condition:** • Damage

9. Damage

**Task:** Repair or replace

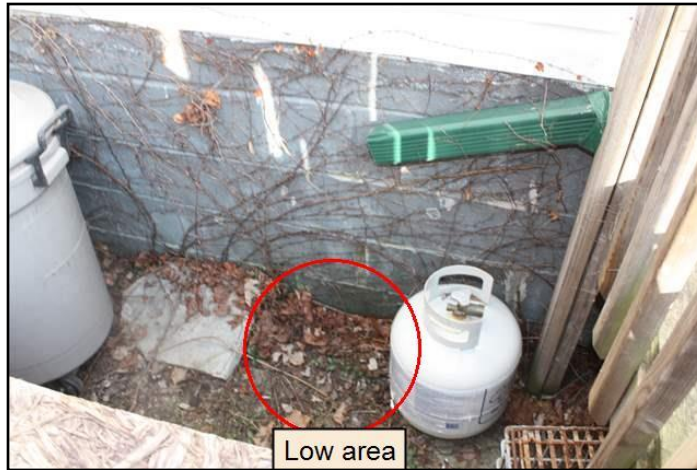
**Condition:** • [Discharge too close to building](#)

Also low area noted where downspout drains water onto soil.

10. Discharge too close to building

**Task:** Improve

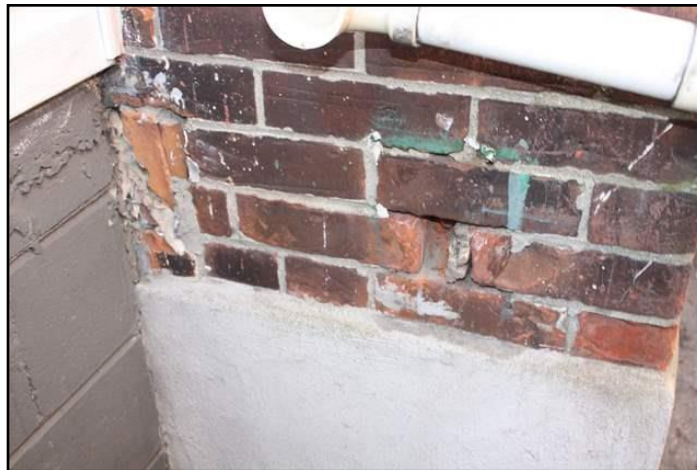
11.

**Condition:** • Gap at wall

**Task:** Patch

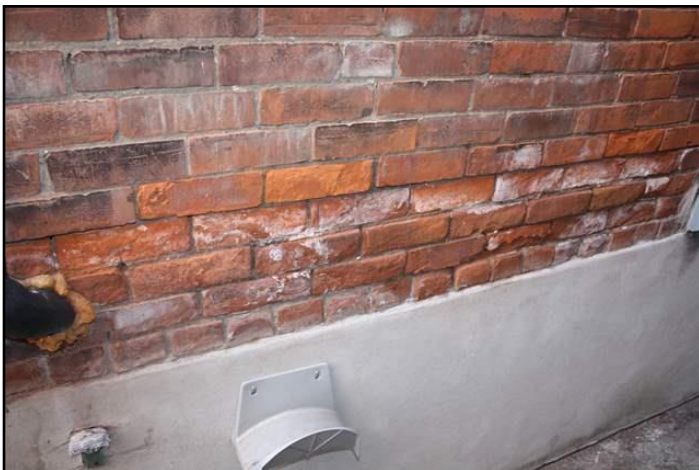
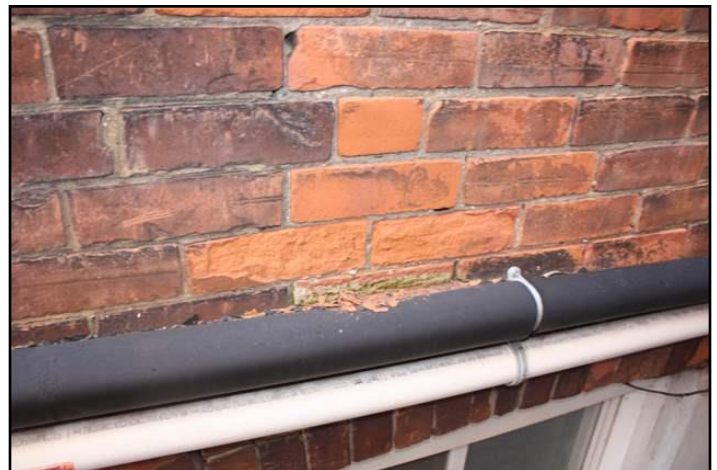
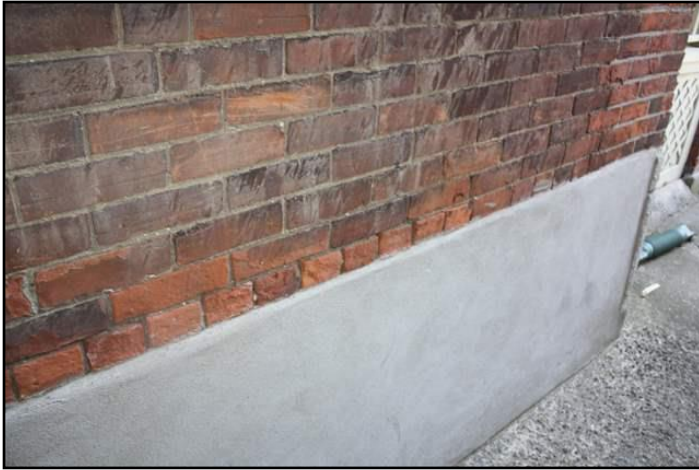
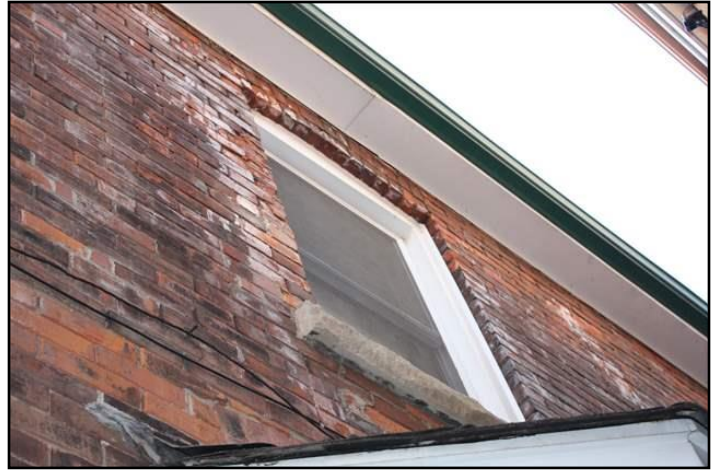
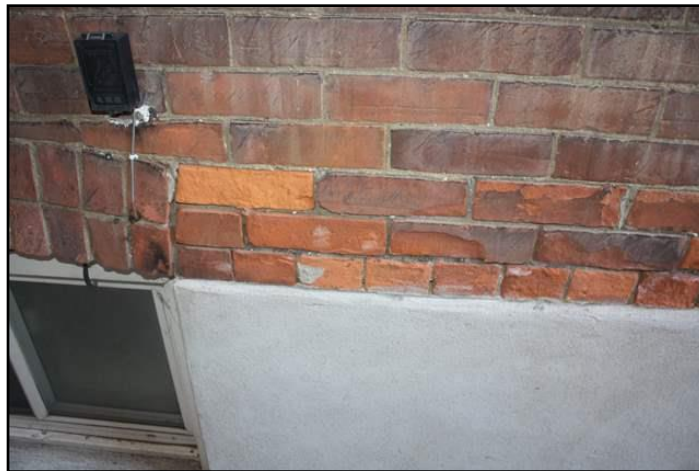
**Condition:** • [Spalling](#)

Spalling/ masonry deterioration noted at various areas. Repair / Replace / Tuck point masonry. This is regular maintenance for a home of this age.

12. Spalling

**Task:** Repair

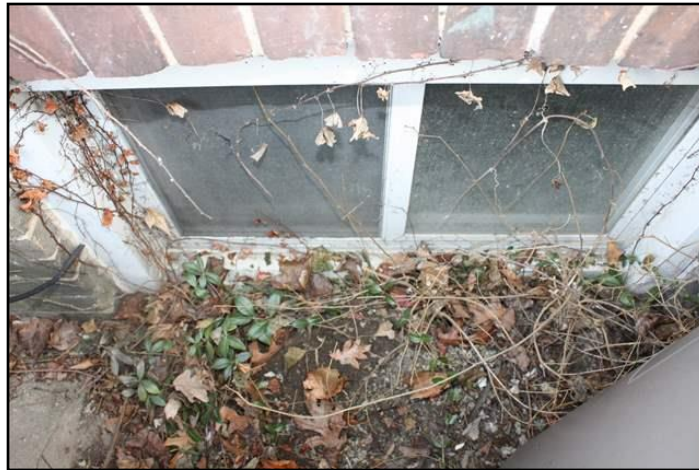
**Condition:** • Sill - Near or at Grade Level

17. Sill - Near or at Grade Level

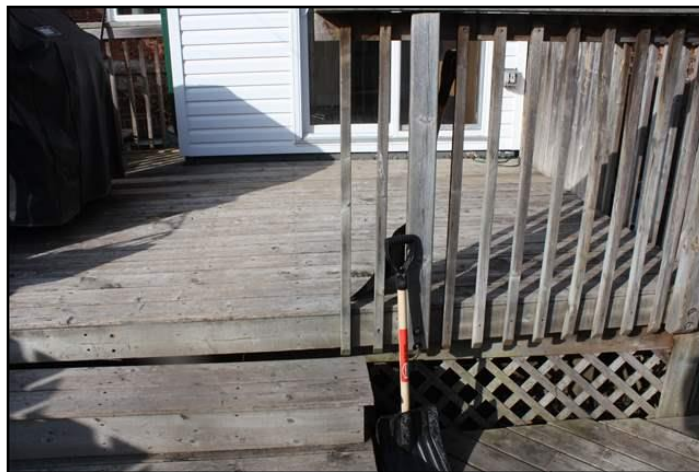
**Condition:** • [Paint or stain needed](#)

18. Paint or stain needed

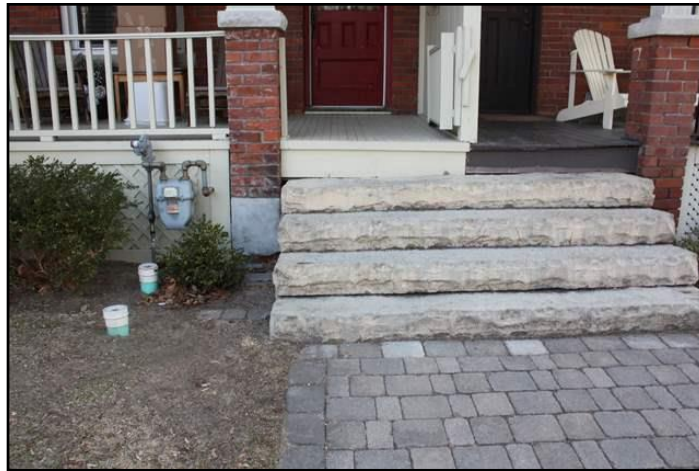
**Condition:** • [Steps or landings settling or heaving](#)

**Implication(s):** Weakened structure | Trip or fall hazard

19. Steps or landings settling or heaving

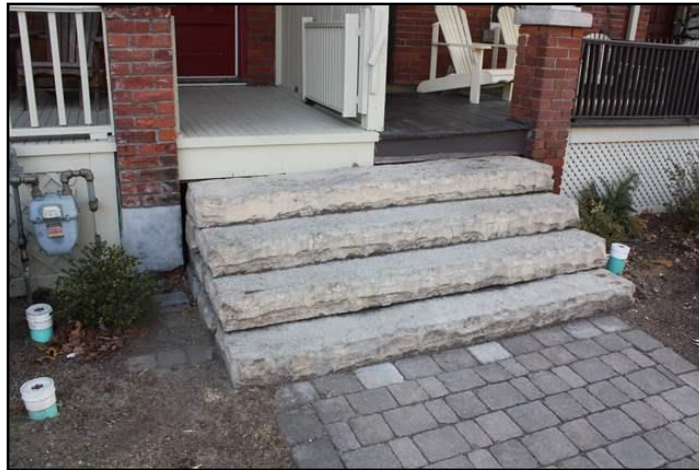
**Condition:** • [Missing](#)

**Implication(s):** Fall hazard

20. Missing Handrail

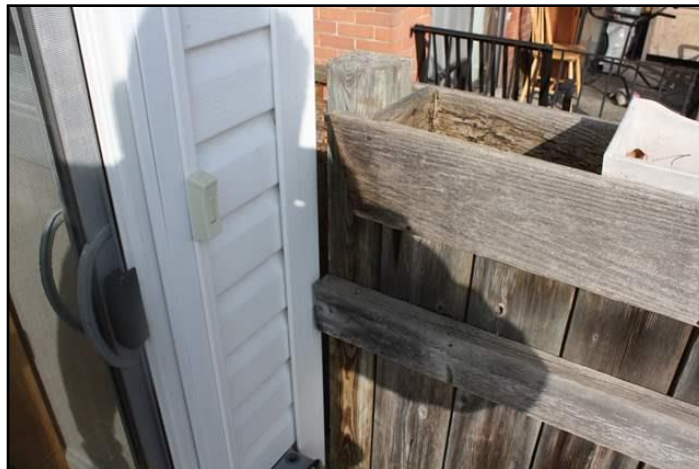
21.

**Condition:** • [Loose](#)

**Implication(s):** Fall hazard

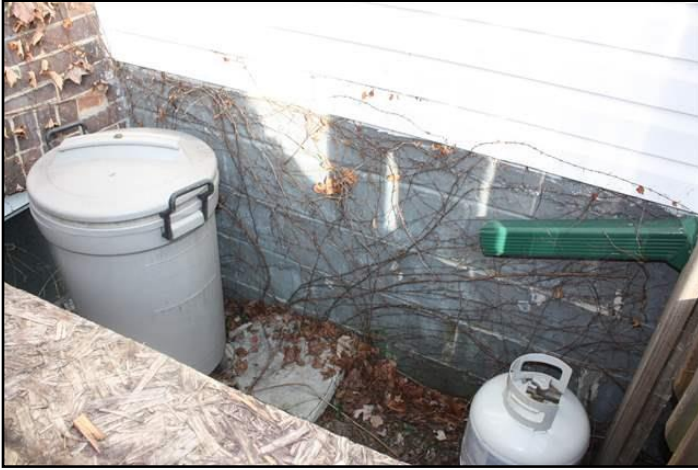
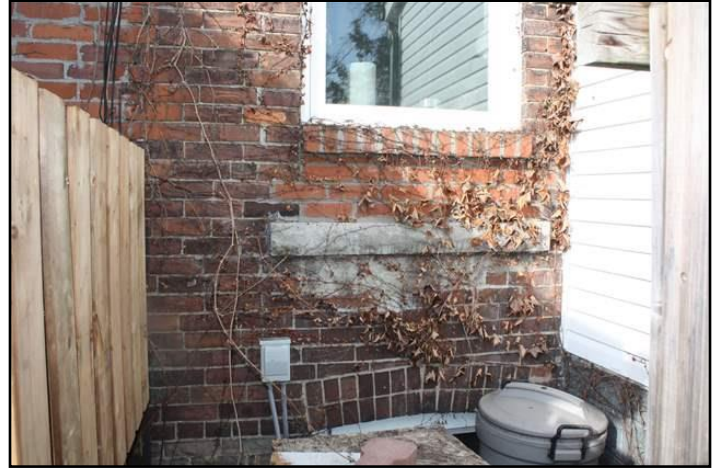
**Condition:** • Vines on building

Vines may damage the home over time. If vines are to remain, and we understand the aesthetic reasons for leaving them, we recommend controlling the growth so vines do not attach to wood surfaces or roofs, and do not clog gutters and downspouts and soffit vents.

22. Vines on building

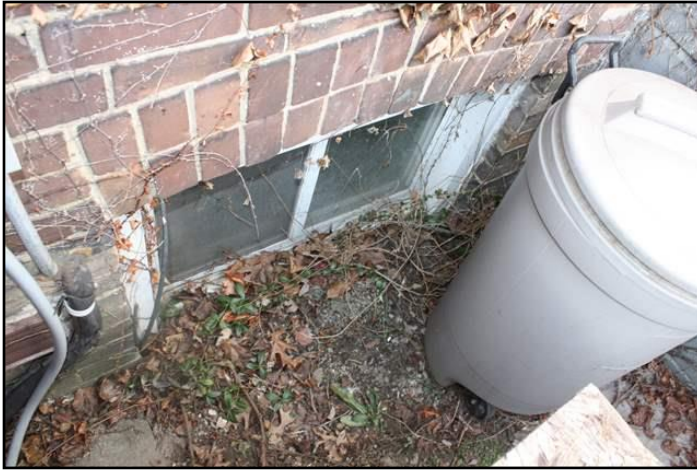
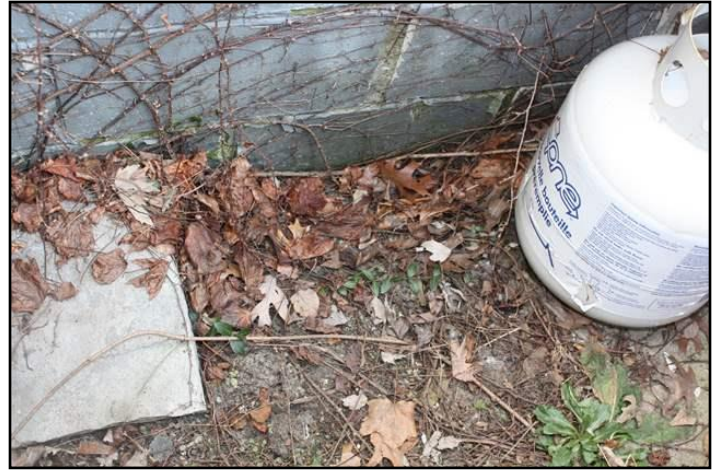
**Condition:** • Low Areas.

24. Low Areas.

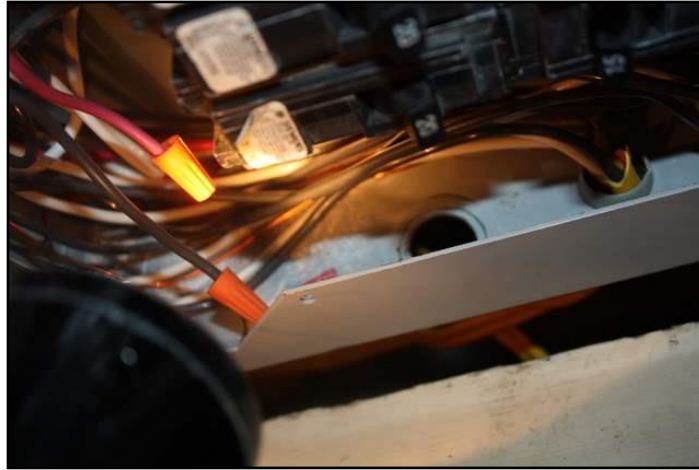
**Condition:** • [Openings in panel](#)

**Implication(s):** Electric shock | Fire hazard

26. Openings in panel

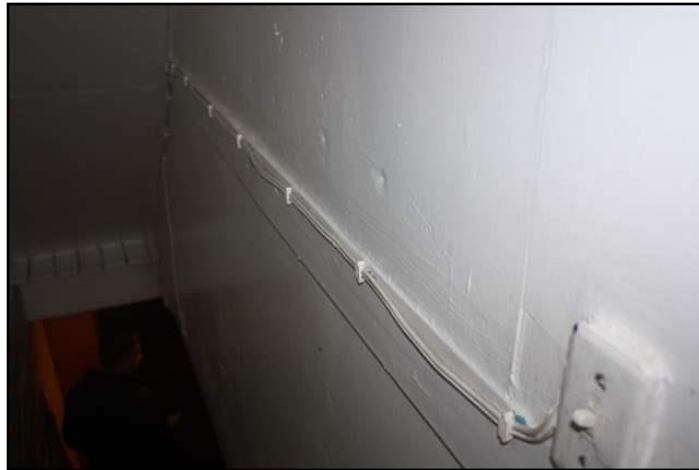
**Condition:** • [Exposed on walls or ceilings](#)

27. Exposed on walls or ceilings

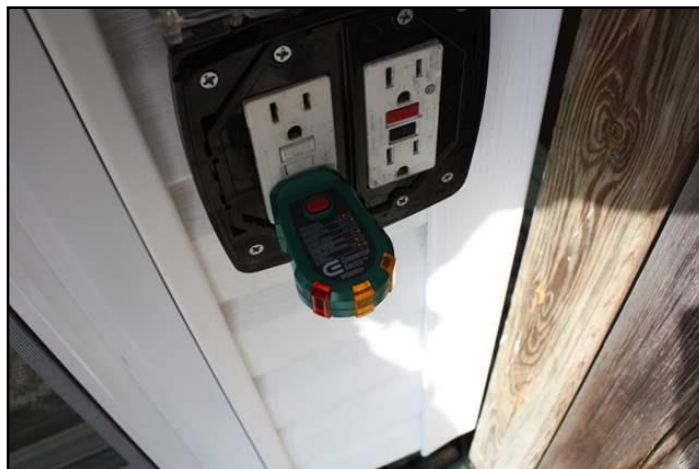
**Condition:** • [Inoperative](#)

28. Inoperative

**Task:** Replace

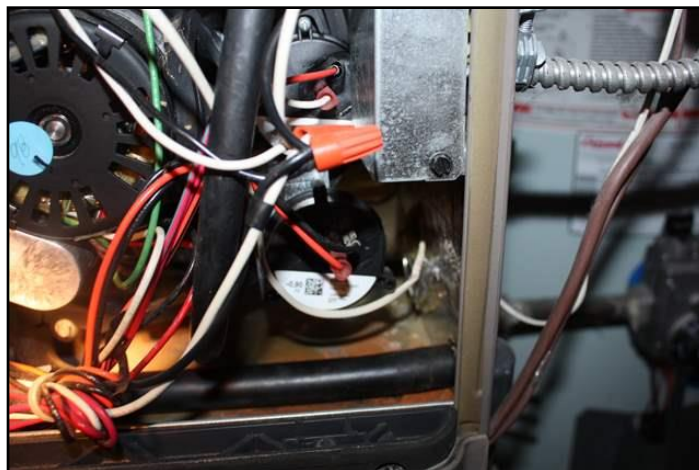
**Condition:** • [Rust](#)

Rust noted inside furnace cabinet. Unknown if condensate leak is still active or intermittent. Dry at time of inspection.

29. Rust

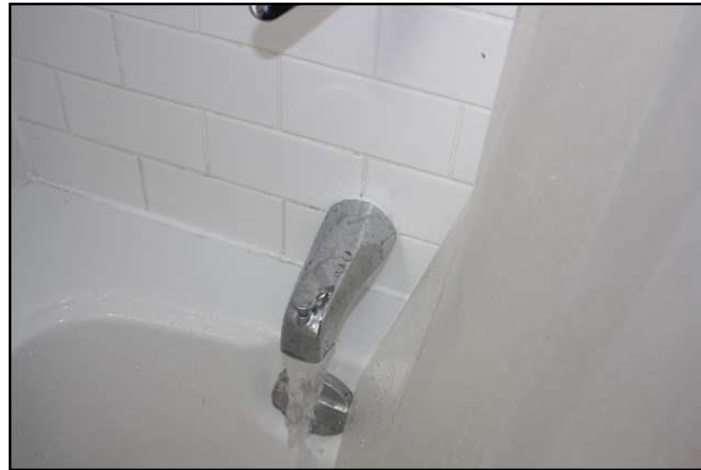
Condition: • [Shower diverter inoperative or defective](#)

31. Shower diverter inoperative or defective

Task: Replace

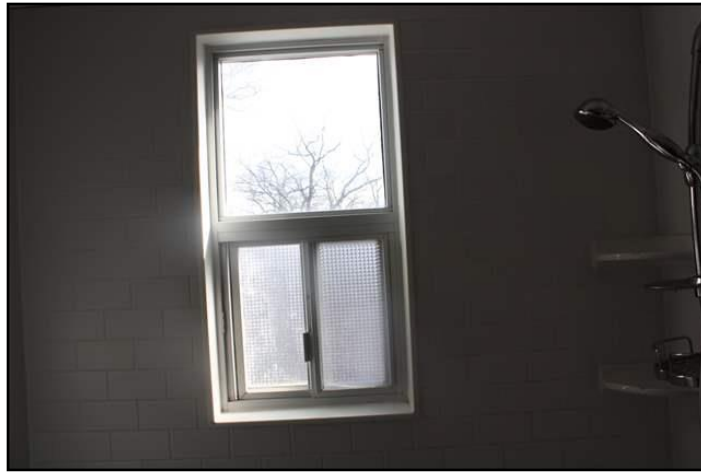
**Condition:** • [Unprotected window](#)

**Implication(s):** Chance of damage to finishes and structure

32. Unprotected window

**Task:** Protect

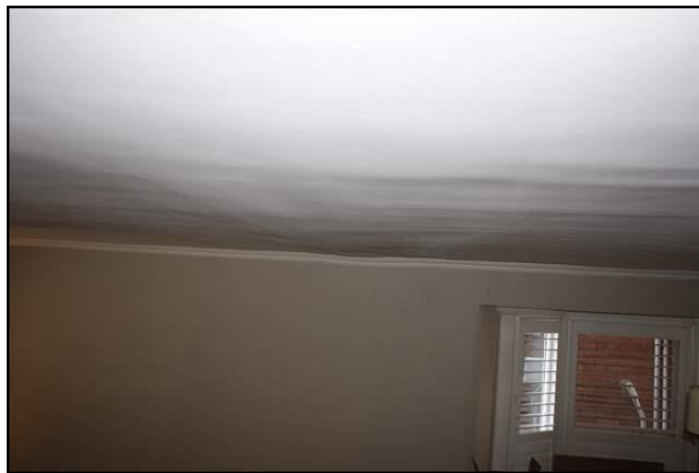
33.

**Condition:** • Typical flaws

Homeowner noted ceiling cosmetic flaw due to wall being removed prior to their ownership (12+years prior)

**Task:** Monitor

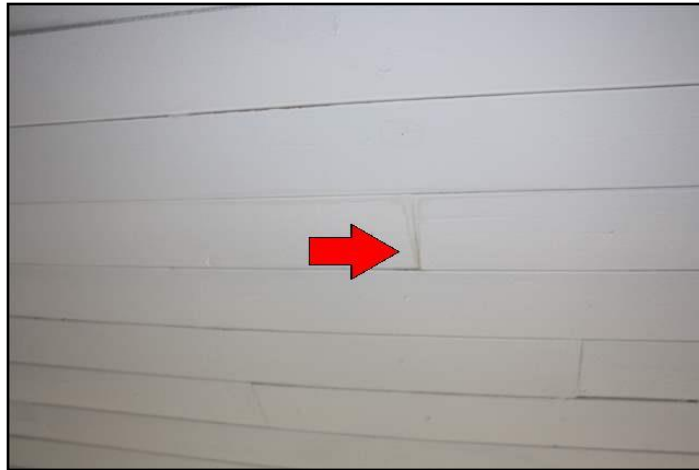
**Condition:** • Stains

Dry at time of home inspection. Old stain

34. Stains

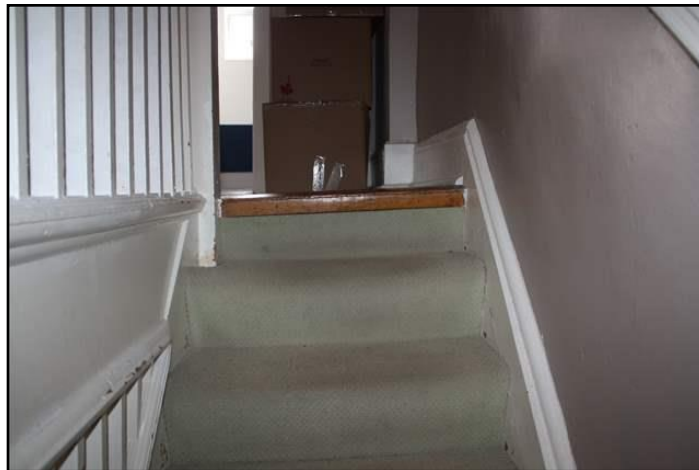
**Condition:** • Slope Noted. Older homes tend to have saggy, sloping floors. If you choose to make repairs to level the floors, repairs can require invasive and extensive work that can cost tens of thousands of dollars.

35. Slope Noted. Older homes tend to have...

**Task:** Improve

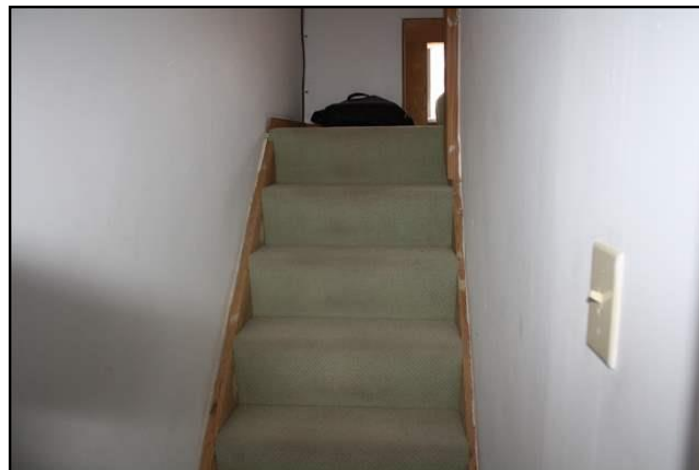
**Condition:** • [Missing](#)

**Implication(s):** Fall hazard

36. Missing

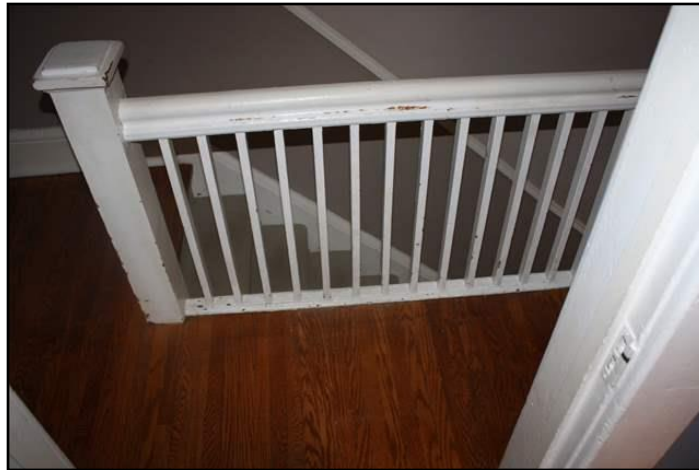
Condition: • [Too low](#)

37. Too low

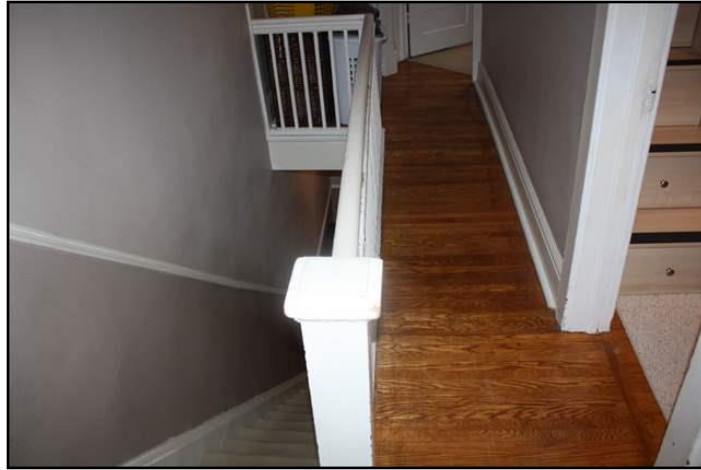
**Condition:** • [Loose](#)

38. Loose

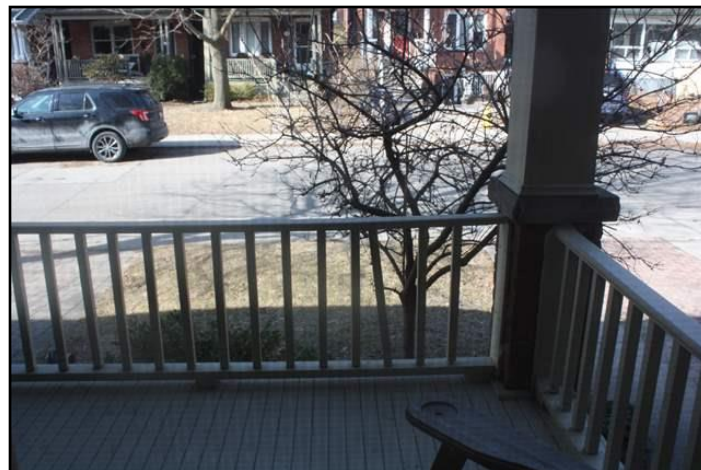
**Condition:** • [Damage](#)

39. Damage

**Task:** Repair or replace
