# HOME INSPECTION REPORT

PREPARED FOR:  
TOM LATHROP

INSPECTION DATE:  
Wednesday, March 3, 2021

RE: Report No. 1080  
4147 Cedar Hill Road  
Victoria, BC  
V8N 3C2

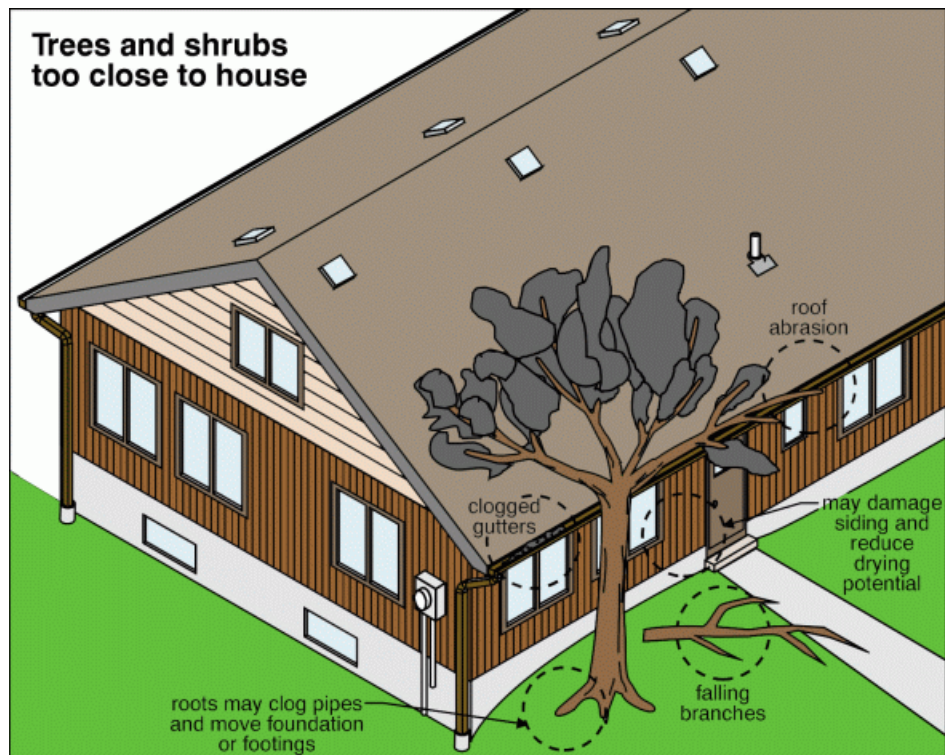
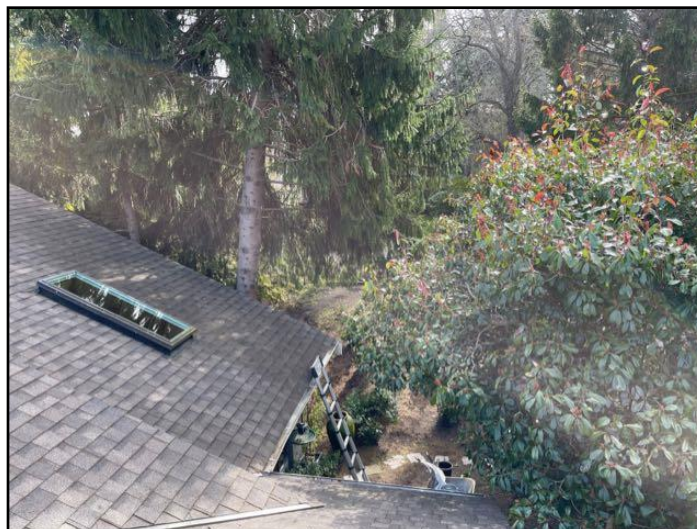
**Condition:** • Tree branches touching roof

**Implication(s):** Shortened life expectancy of material

*Tree branches touching roof*

Keep the trees trimmed away from the roof line.

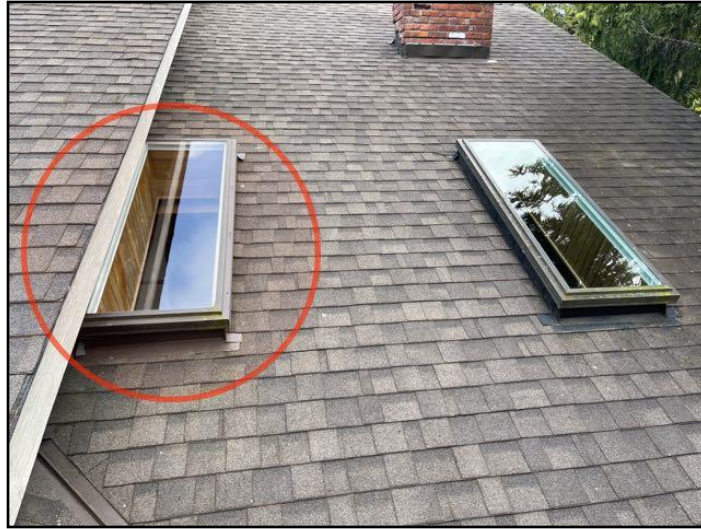
**Condition:** • [Skylight not well secured](#)

The skylight over the entryway is not secure.

**Implication(s):** Chance of water damage to structure, finishes and contents

*Skylight not well secured*

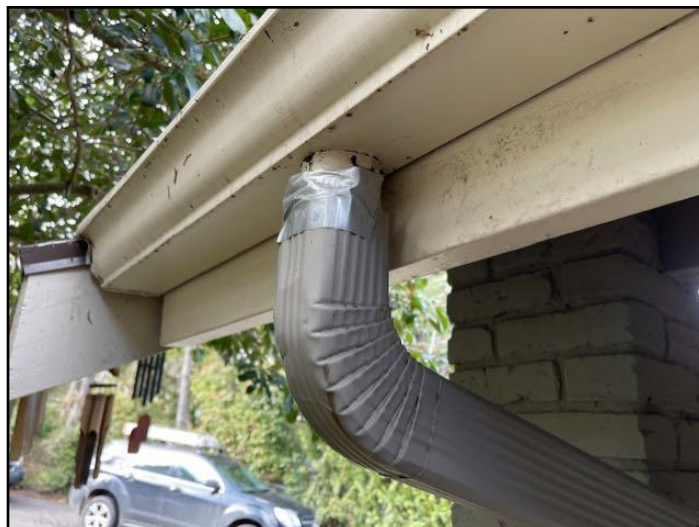
**Condition:** • Loose

*Loose*

Secure the downspout to the gutter at the south west corner of the house

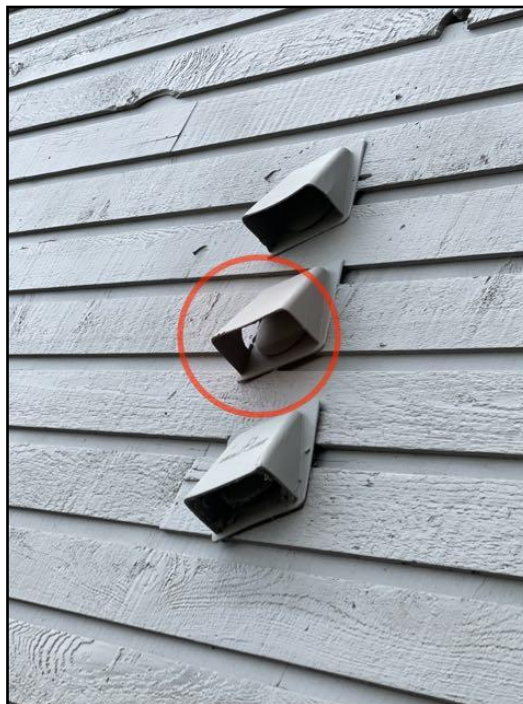
**Condition:** • Cover damaged

One of the exterior wood vents on the north side of the house is cracked. Recommend future replacement. Ensure the edges of the vents are well sealed.

*Cover damaged*

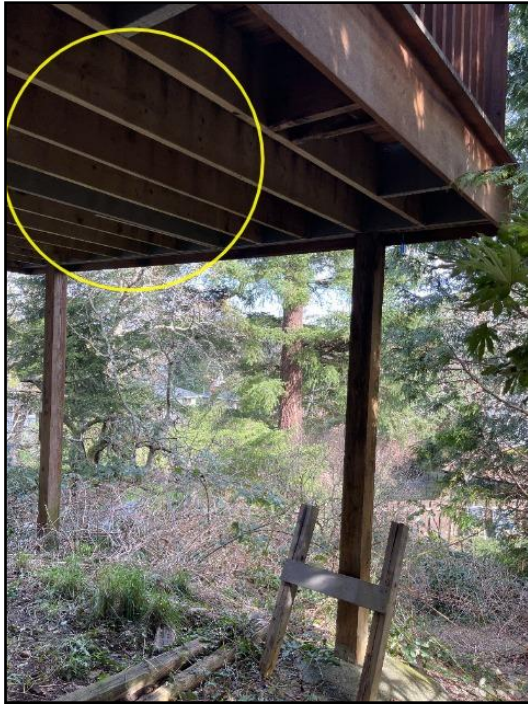
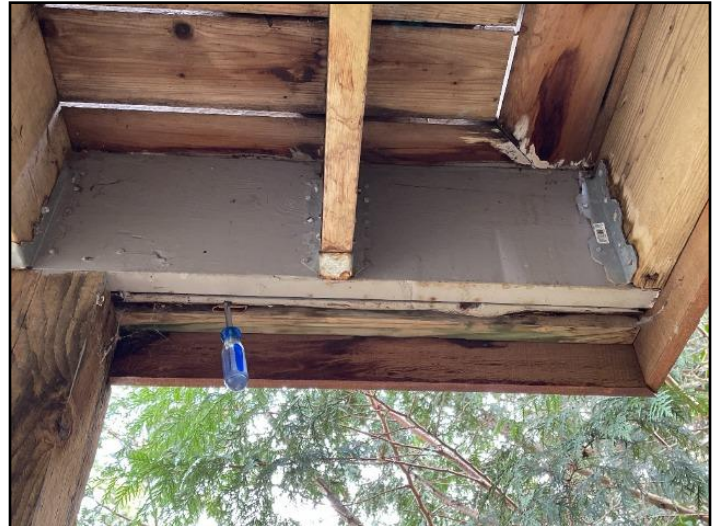
**Condition:** • [Rot](#)

There is rot damage in the east deck support beam and floor joists.

**Implication(s):** Weakened structure | Chance of movement

*Rot*

Consult a contractor for further evaluation of the future repairs/upgrades that will be needed.

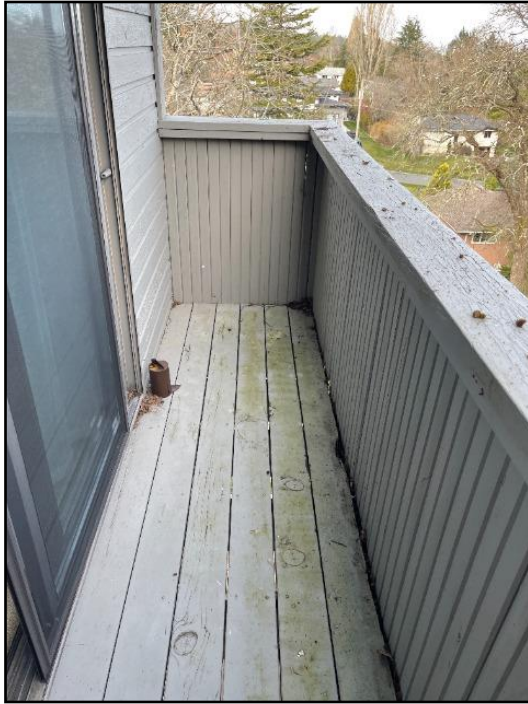
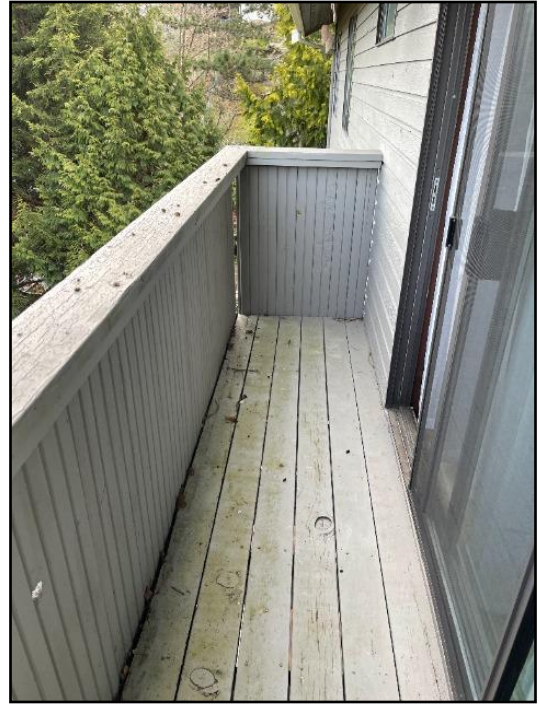
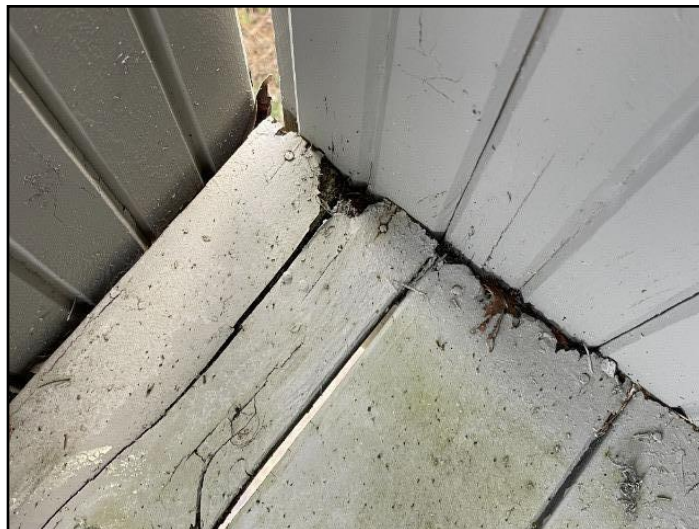
**Condition:** • [Rot](#)

There is rot damage in the upper N/E deck framing / railings.

**Implication(s):** Weakened structure | Chance of movement

*Rot*

Future repairs will be needed. Consult a contractor for further evaluation.

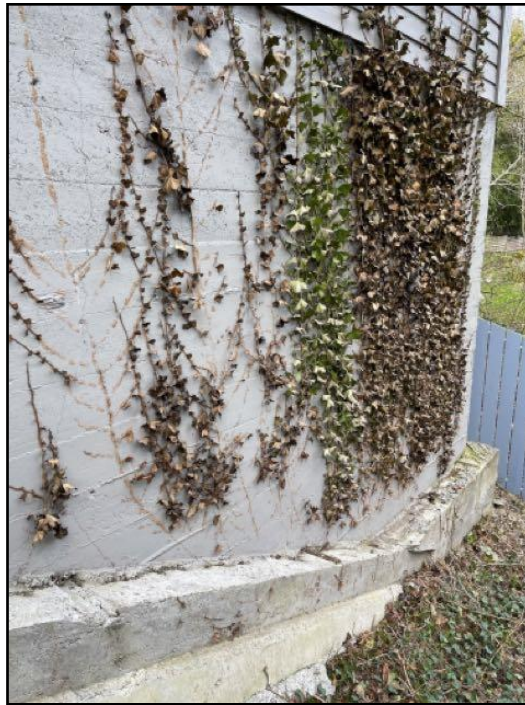
**Condition:** • [Vines](#)

**Implication(s):** Chance of damage to finishes

*Vines*

Keep the ivy/vegetation off of the building.

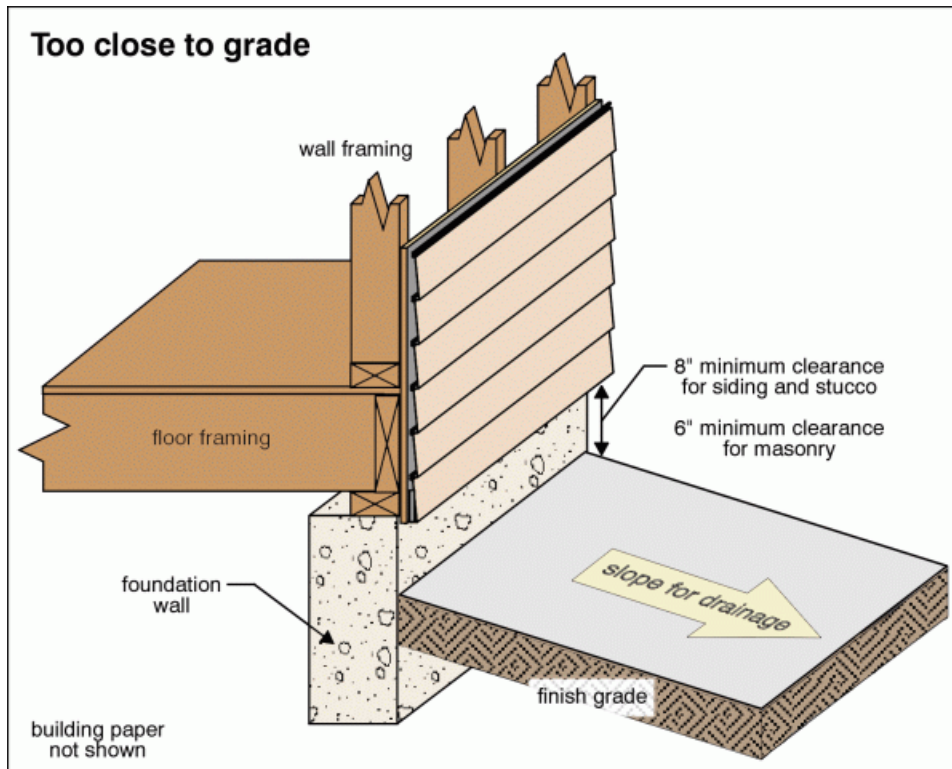
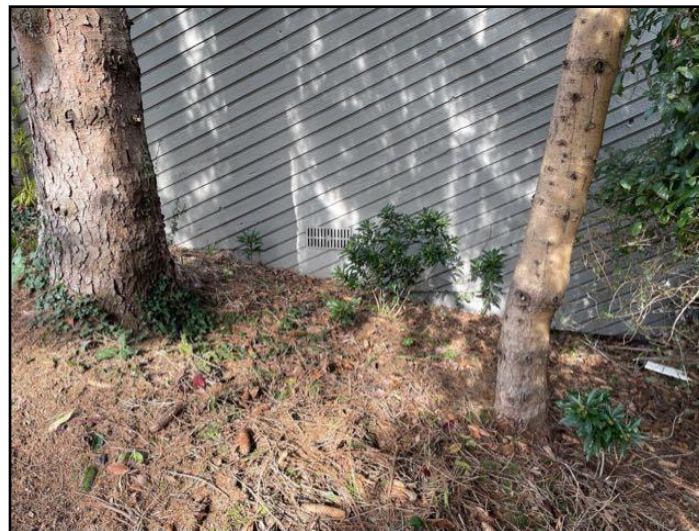
**Condition:** • [Siding too close to grade](#)

**Implication(s):** Chance of water entering building | Weakened structure | Rot | Insect damage

*Siding too close to grade*

Improve the siding / ground clearance along the south side of the house.

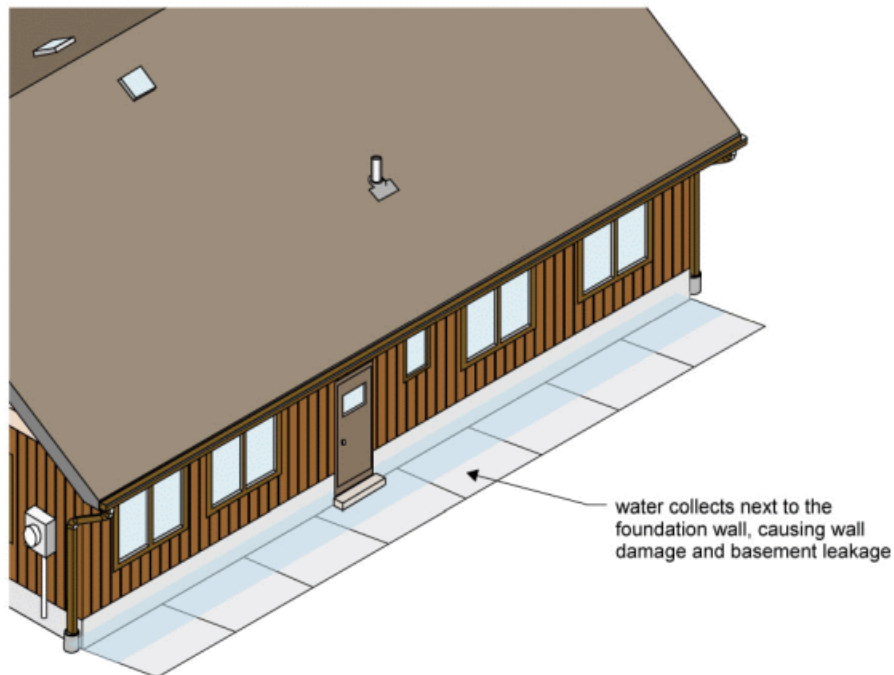
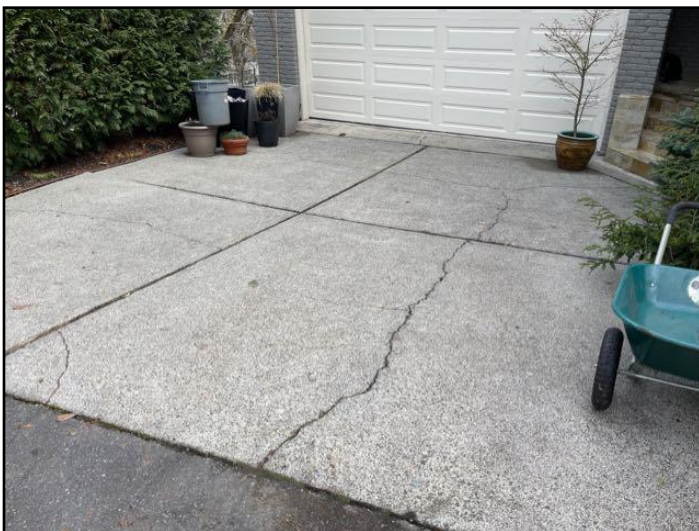
## Condition: • [Improper slope or drainage](#)

Driveway slopes towards the house. Monitor the water drainage.

**Implication(s):** Chance of water damage to structure, finishes and contents

Walk/patio sloping towards house

Driveway slopes towards house

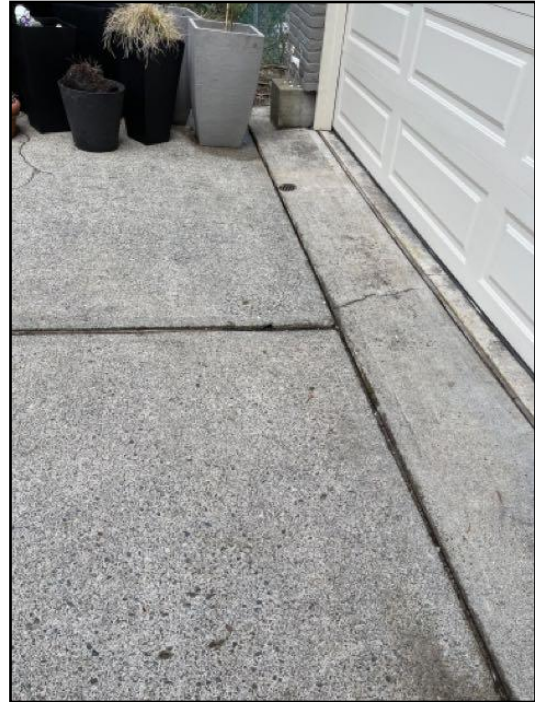
*Keep drainage clean / clear*

Keep the drain in front of the garage door clean/clear.

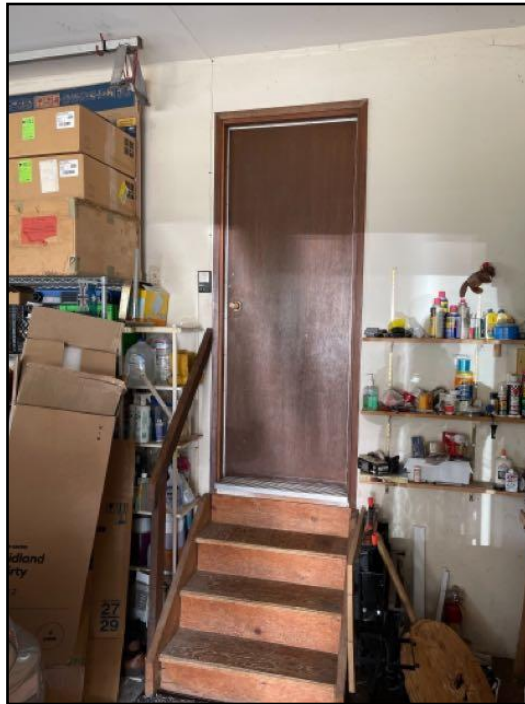
**Condition:** • Adjust the auto closer on the garage / house door so it will close by itself every time.

*Adjust self-closer*

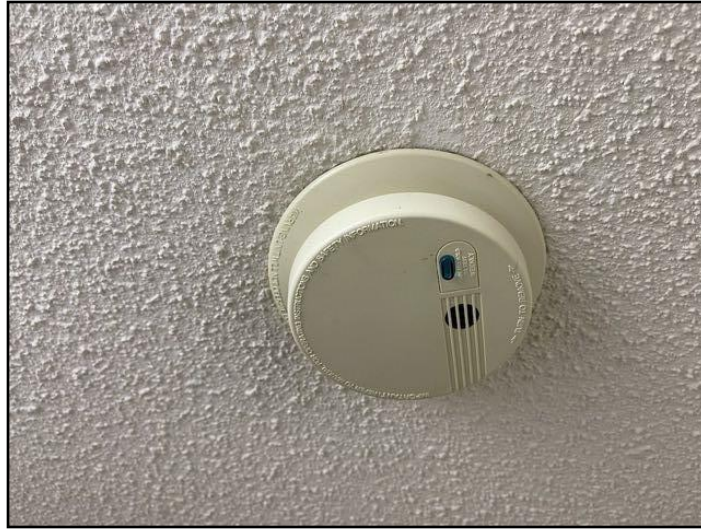
**Condition:** • Past life expectancy

**Implication(s):** Life safety hazard

*Past life expectancy*

Install new smoke alarms in the house.

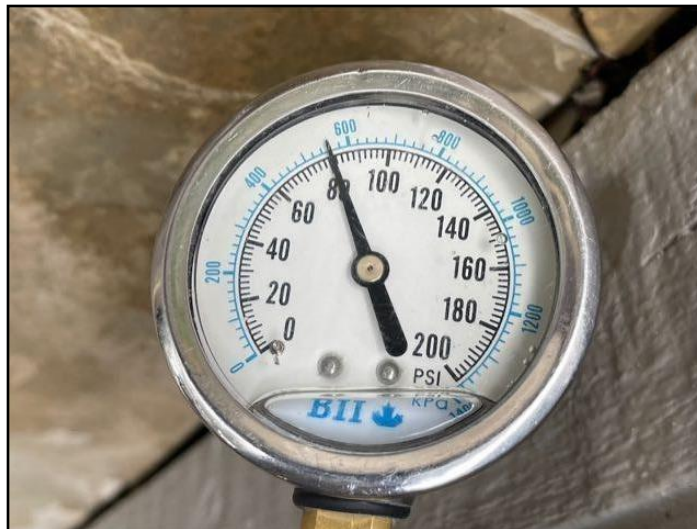
**Condition:** • Static water pressure should not exceed 80 psi

**Implication(s):** Chance of water damage to structure, finishes and contents | Damage to equipment

*Static water pressure should not exceed 80...*

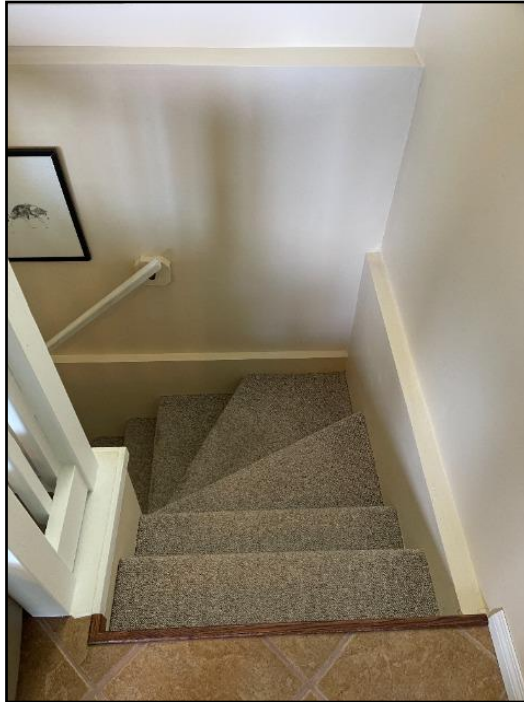
*Tapered stairs*

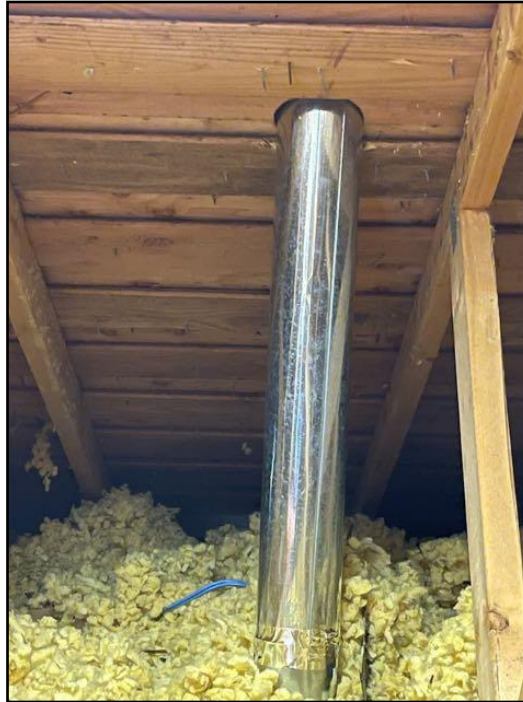
**Condition:** • [Not insulated in unconditioned space](#)

**Implication(s):** Chance of condensation damage to finishes and/or structure

*Not insulated in unconditioned space*

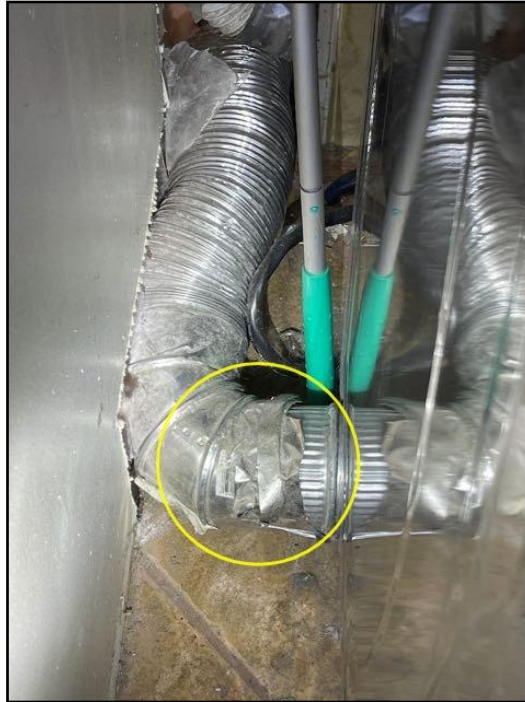
**Condition:** • Vent disconnected or damaged

**Implication(s):** Fire hazard

*Vent disconnected or damaged*
