# YOUR INSPECTION REPORT

6 Burlington Crescent  
Toronto, ON M6H 2L4

INSPECTION DATE:  
Monday, March 22, 2021

RE: Report No. 2855, v.2  
6 Burlington Crescent  
Toronto, ON  
M6H 2L4

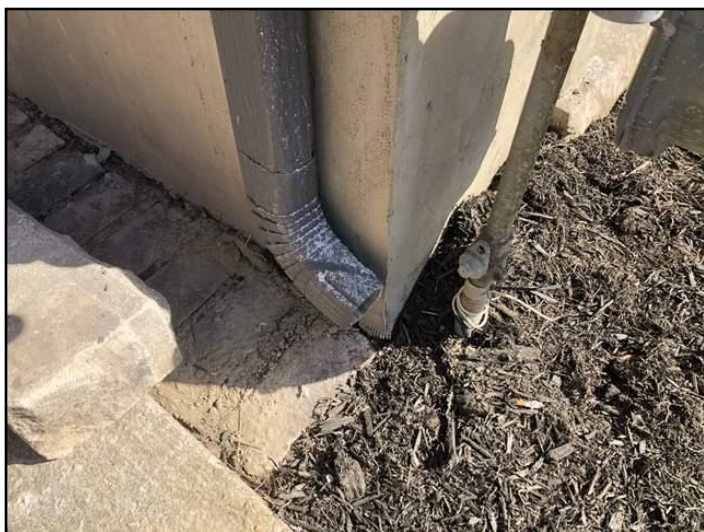
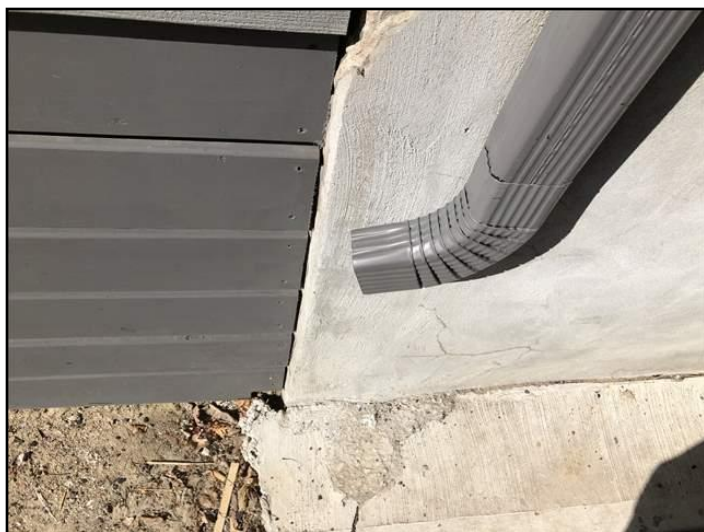
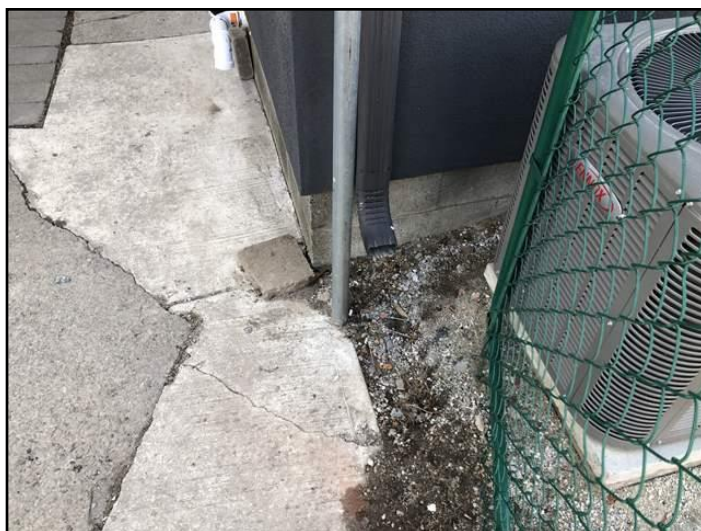
**Condition:** • [Discharge too close to building](#)

1. Discharge too close to building

2. Discharge too close to building

3. Discharge too close to building

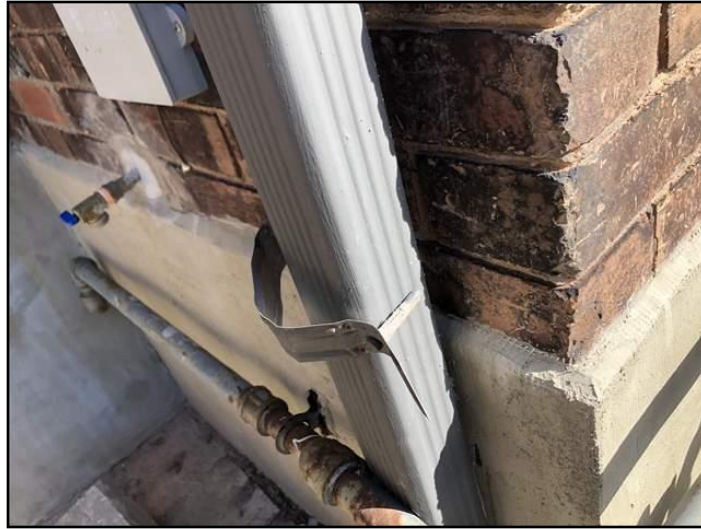
**Condition:** • [Not well secured](#)

4. Not well secured

**Task:** Repair

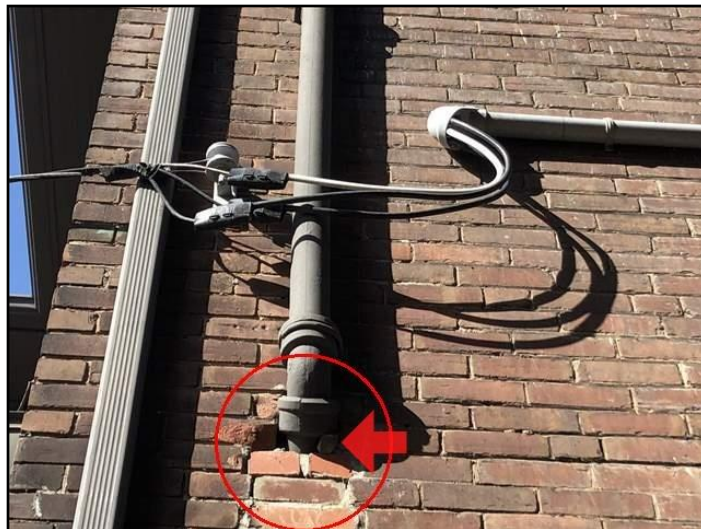
Condition: • [Caulking missing or ineffective](#)

5. Caulking missing or ineffective

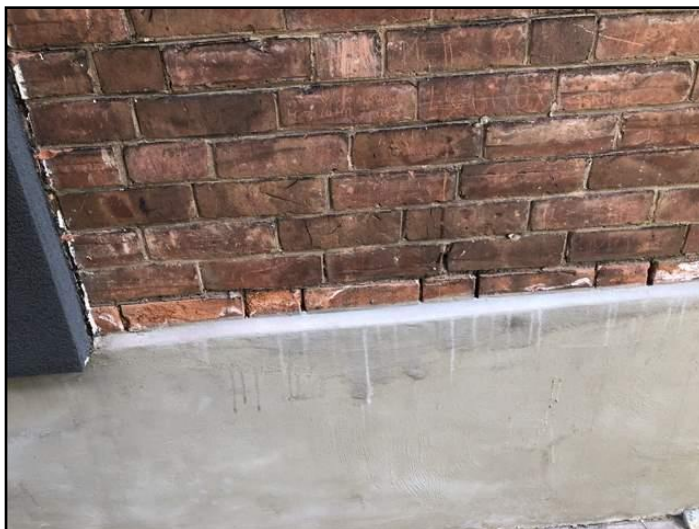
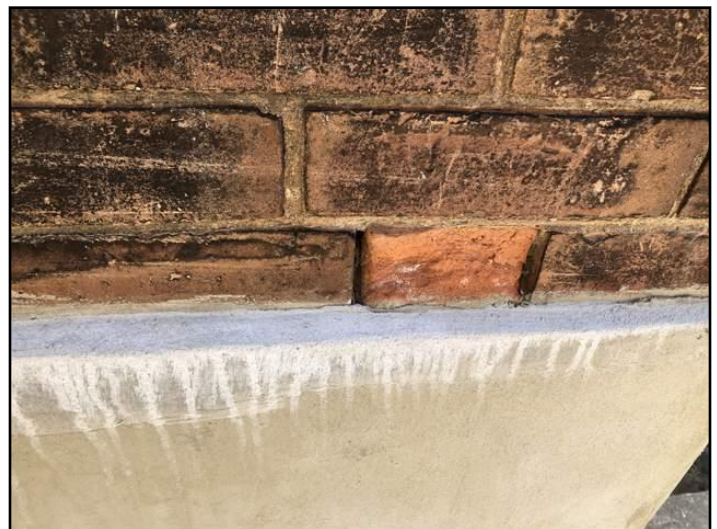
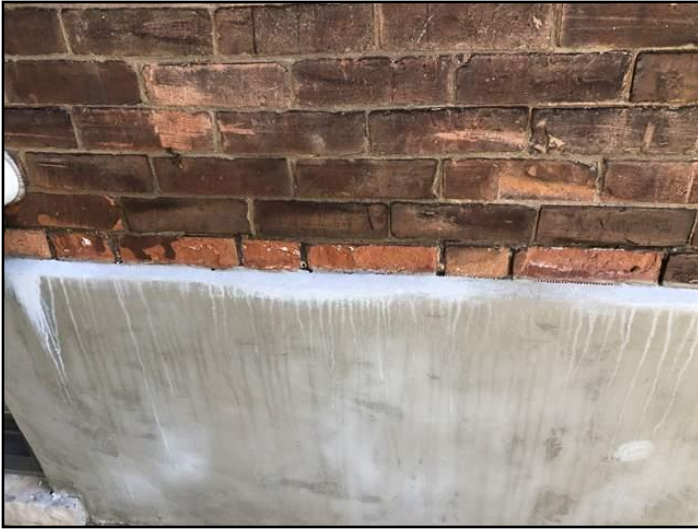
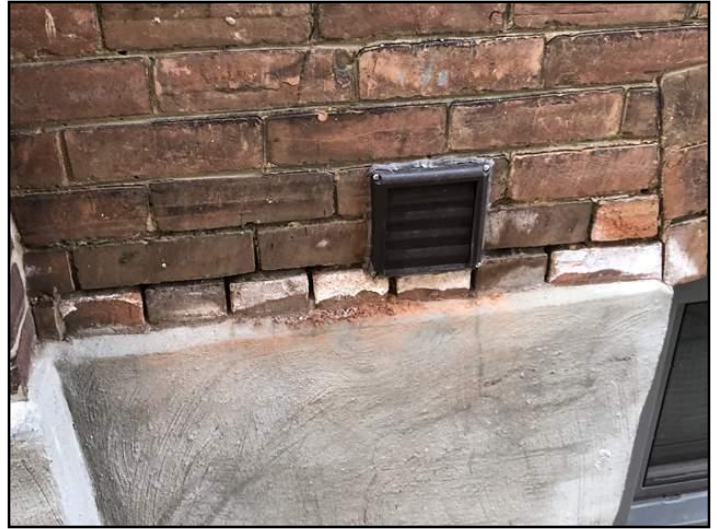
Condition: • [Spalling](#)

Spalling and mortar deterioration at various areas of brick. Repair / Replace / Tuck point masonry. This is regular maintenance for a home of this age. photos show a sampling. Overall the exterior walls are in good condition.

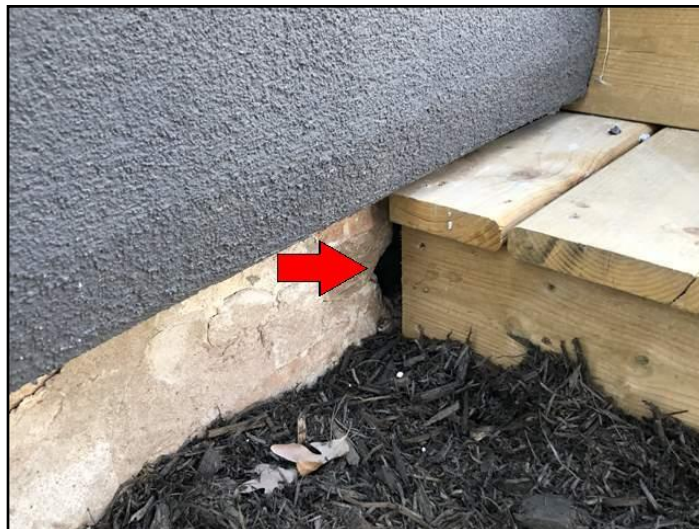
**Condition:** • Gap at Wall

10. Gap at Wall

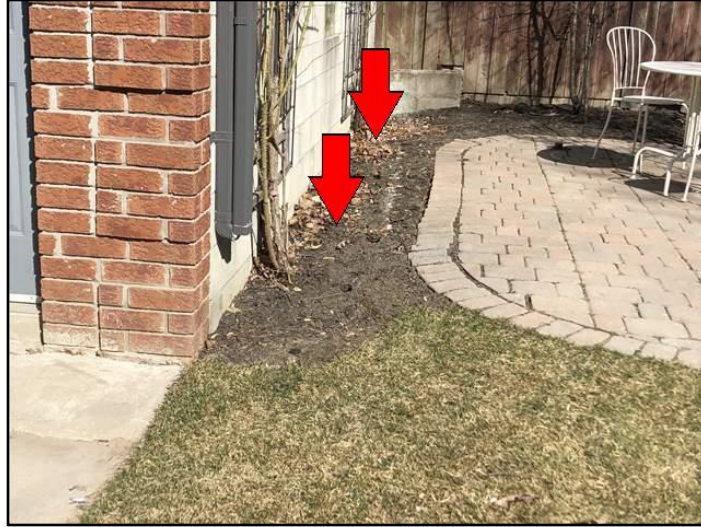
**Condition:** • Low Areas.

11. Low Areas

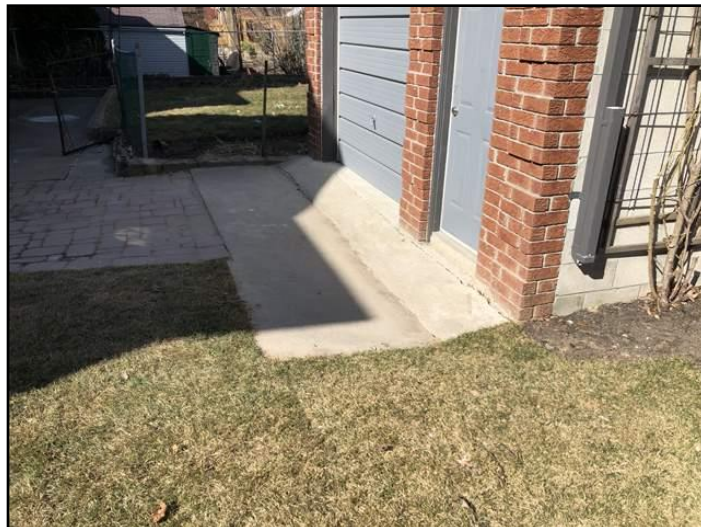
**Condition:** • [Improper slope or drainage](#)

12. Improper slope or drainage

**Task:** Monitor / Improve

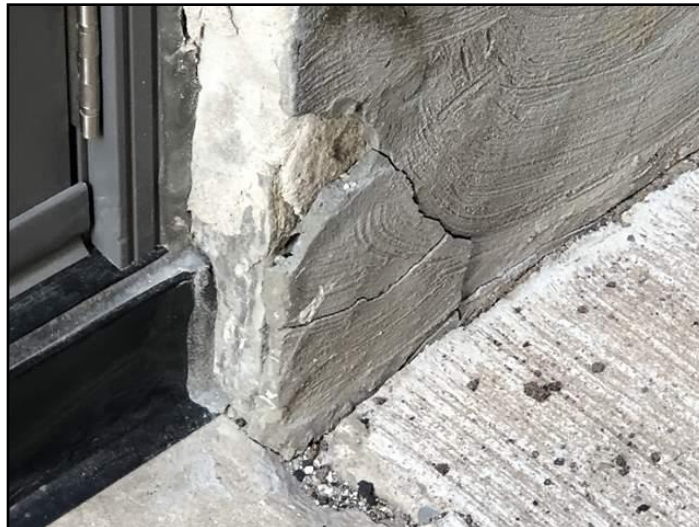
**Condition:** • [Parging damaged or missing](#)

13. Parging damaged or missing

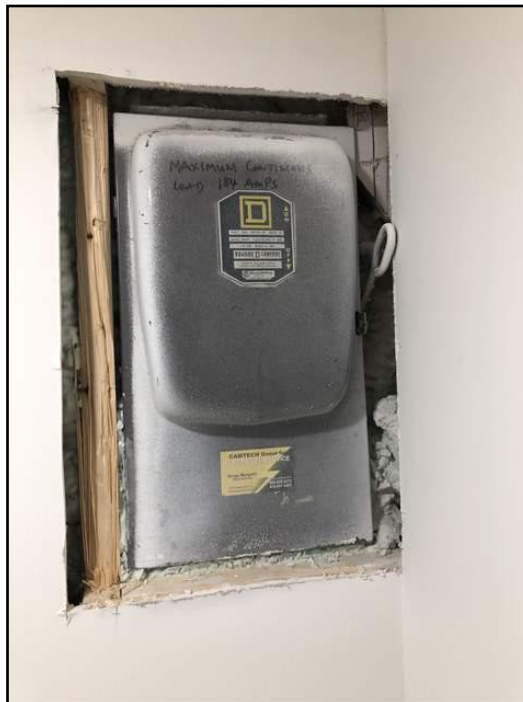
14. Fuses - basement

Fuse box could not be opened to view the inside.

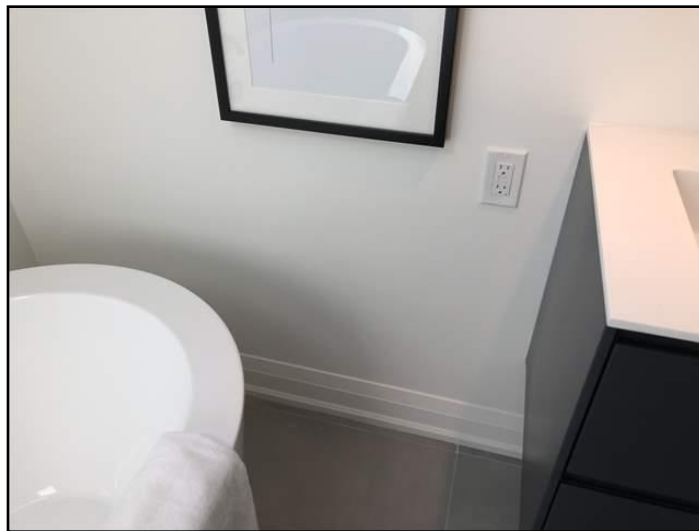
**Condition:** • [Too close to bathtub or shower](#)

**16.** Too close to bathtub or shower

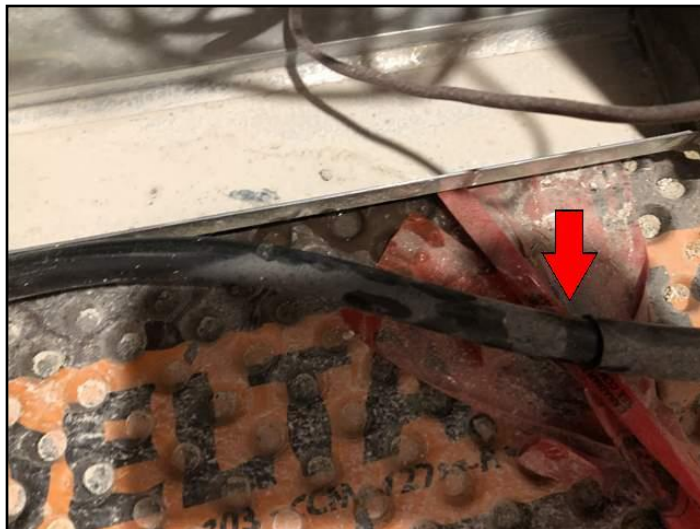
**Condition:** • [Condensate leak](#)

Minor leak at condensate drain line connection. Adjust drain line. Seller notified and will repair

17. Condensate leak

**Task:** Adjust / Repair

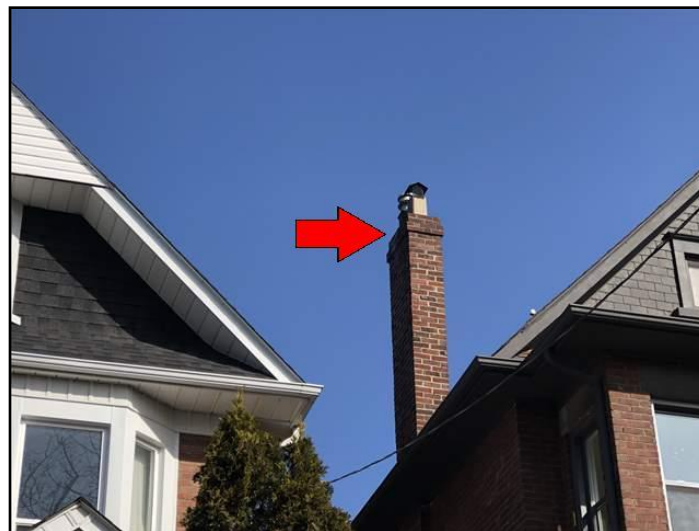
**Condition:** • [No drip edge on cap \(crown\)](#)

18. No drip edge on cap (crown)
