# **Your Inspection Report**

# 254 Windermere Ave Etobicoke, ON

**INSPECTION DATE:** Friday, April 21, 2017

RE: Report No. 57777, v.5 254 Windermere Ave Etobicoke, ON

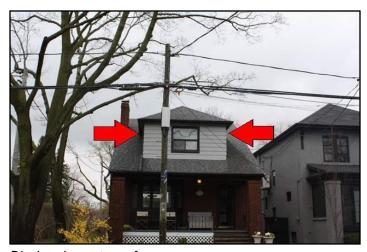
Condition: • Discharging onto roof

Discharging onto roof

Improvement recommendation. Provide downspout from upper gutter to lower gutter. This will help prevent premature wear to the shingles in these areas.

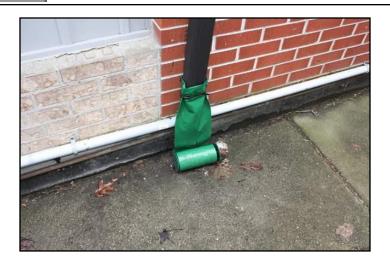
**Condition:** • Damage

Minor damage noted. Also, the downspout configuration from dormer to lower gutters should be improved.

Implication(s): Chance of water damage to contents, finishes and/or structure

**Location**: Exterior **Task**: Replace

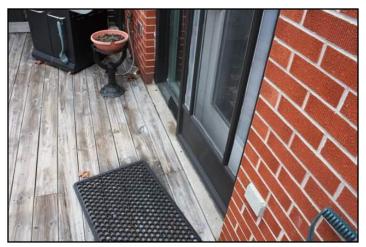
Threshold - too low

Condition: • Threshold - too low Location: Exterior South Side Task: Monitor / Improve

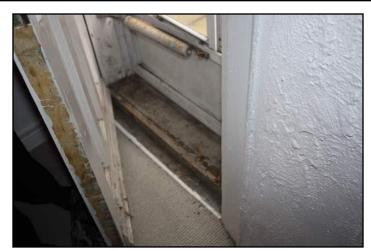
Interior view

Threshold - too low

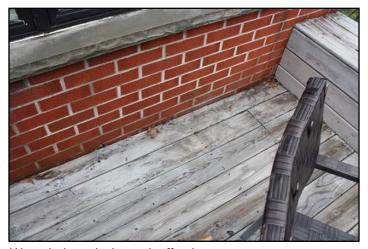
Condition: • Weep holes missing or ineffective

Implication(s): Chance of damage to structure

Weep holes missing or ineffective

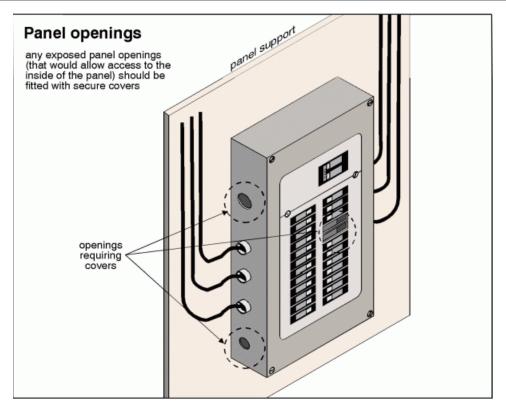
Condition: • Openings in panel

Implication(s): Electric shock | Fire hazard

Openings in panel

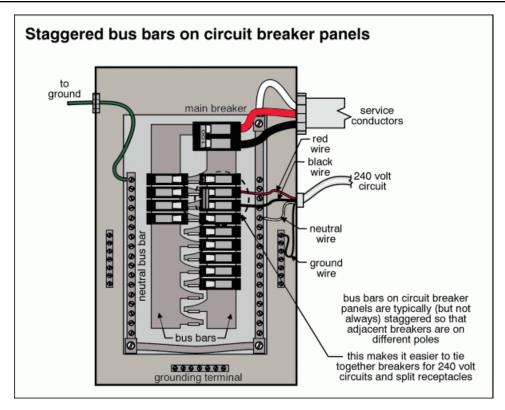
Condition: • No links for multi-wire circuits

No links for multi-wire circuits

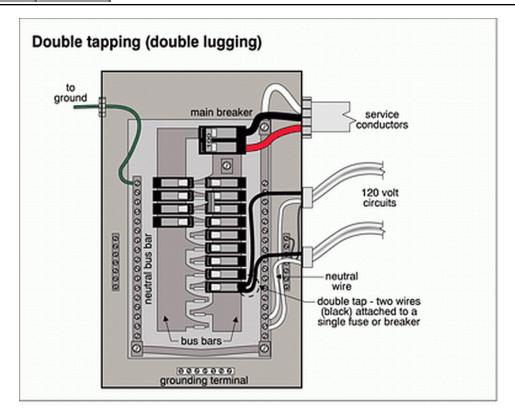
Condition: • <u>Double taps</u>
Implication(s): Fire hazard
Location: Basement Sub Panel

Double taps

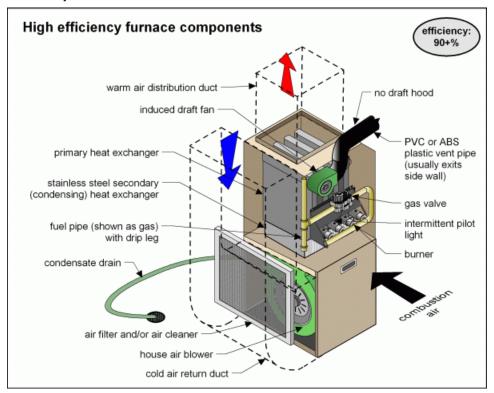
• The furnace is working properly and airflow was noted at all accessible registers. It is common to feel the airflow stronger at some registers, depending on the length of the ductwork and the number of turns required to get there. Different preferences and seasons often necessitate different setups (balancing).

A service agreement that covers parts and labour (for heating and cooling equipment) is typically advised. Furnace cabinet is in good, clean condition

Task: Inspect/service annually

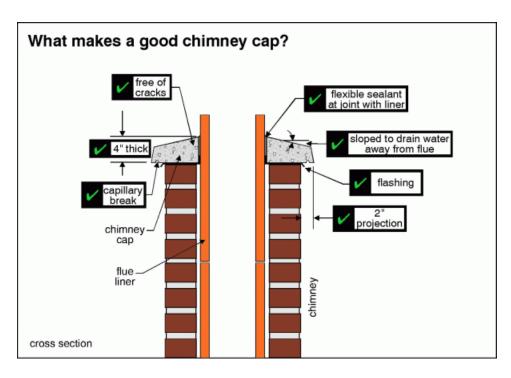
Condition: • Chimney cap missing

Ideally, a concrete or stone cap would be installed to protect the brickwork at the top of the chimney. This would reduce the wear and ultimately the maintenance on the chimney.

**Task**: Provide cap **Time**: If desired

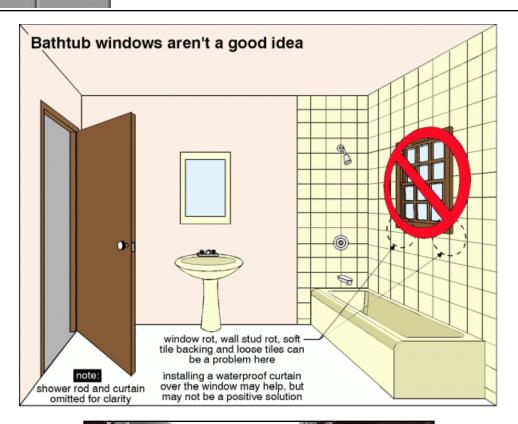
Condition: • Unprotected window

Implication(s): Chance of damage to finishes and structure

Unprotected window

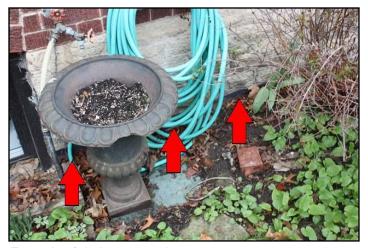
Condition: • <u>Drainage membrane</u> Location: Exterior South Wall

Example of drainage membrane

Task: Monitor / Click link to read more information
