your INSPECTION REPORT

888 Volcano Drive
Oahu, HI

RAM Inspections

RE: Report No. 1002, v.2
888 Volcano Drive
Oahu, HI

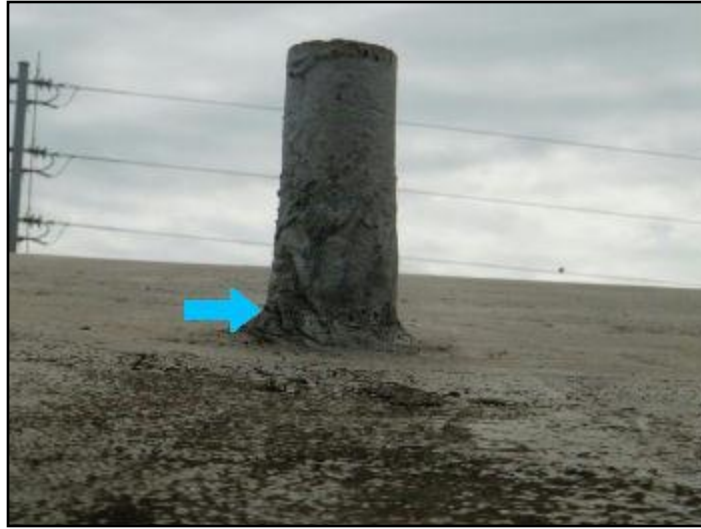
2. **Condition:** • [Openings at seams or flashings](#)

Open seams around vent pipe flashings have opened and are splitting. Seams should be sealed to prevent leakage.

Openings at seams or flashings

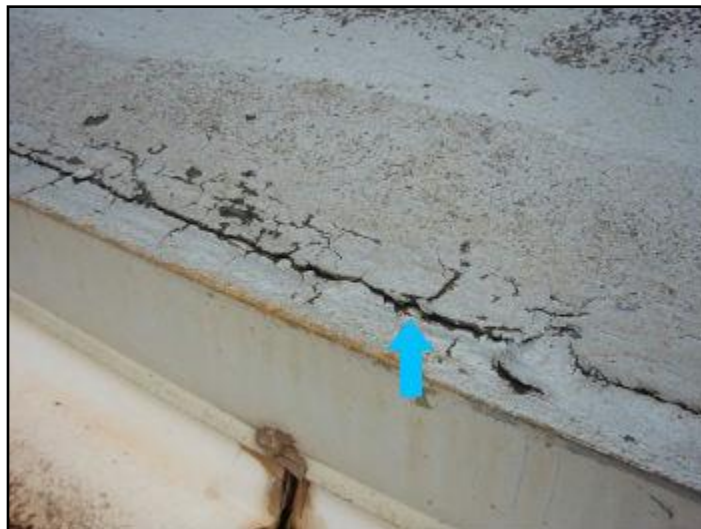
3. Condition: • [Surface cracks, splitting](#)

Roofing material is heavily deteriorated and cracked especially around edges. Cracks should be sealed to prevent leakage.

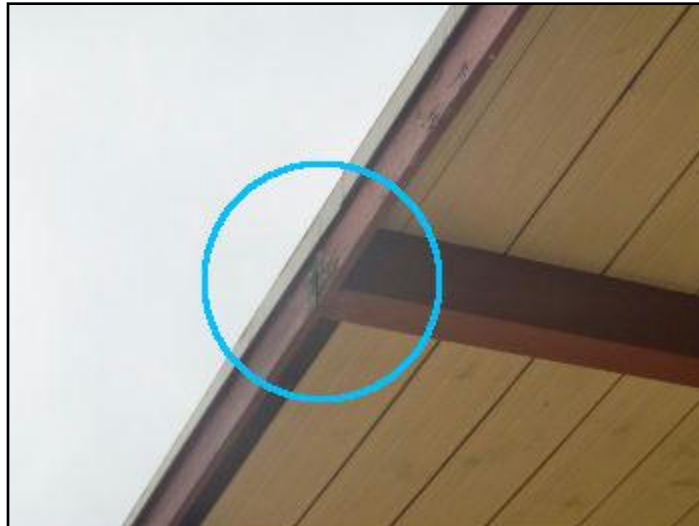
Areas of dry rot on fascia boards should be repaired or replaced to avoid further damage.

Rot or insect damage

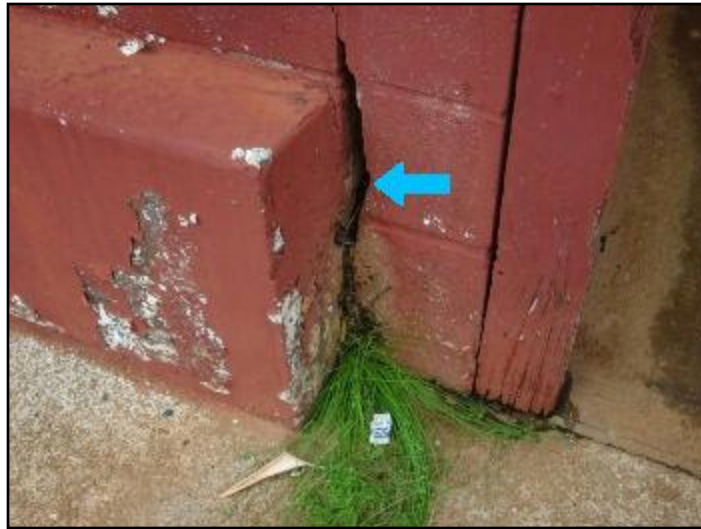
5. Condition: • [Cracked](#)

Damaged wall should be repaired and then monitored for future movement.

Cracked

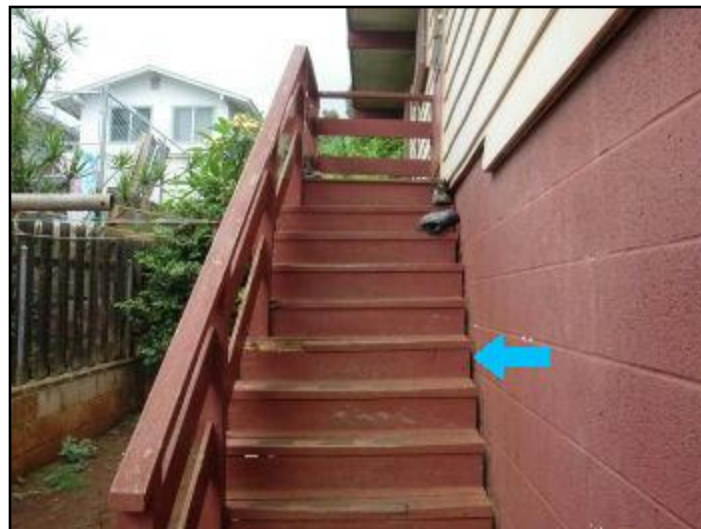
7. Condition: • [Steps or landings settling or heaving](#)

Steps or landings settling or heaving

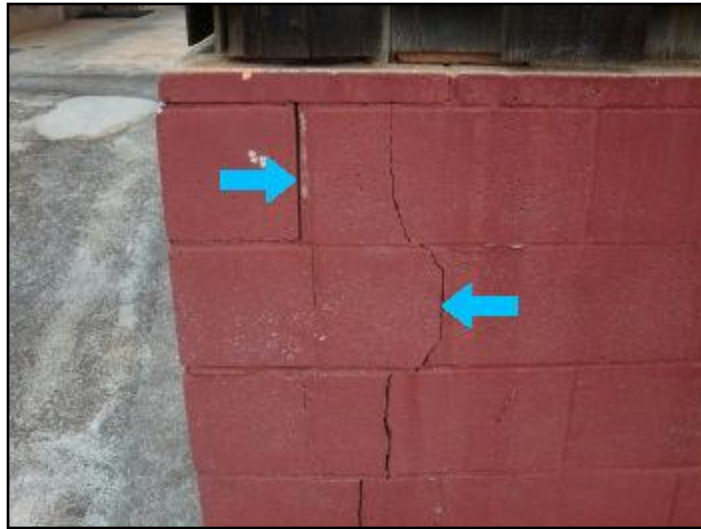
10. Condition: • [Cracked](#)

Large crack noted in retaining wall. Crack has been repaired and should be monitored for further movement.

Cracked

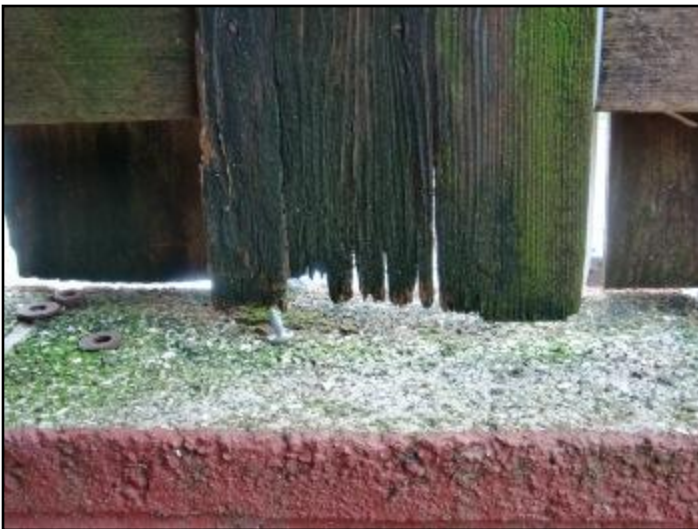
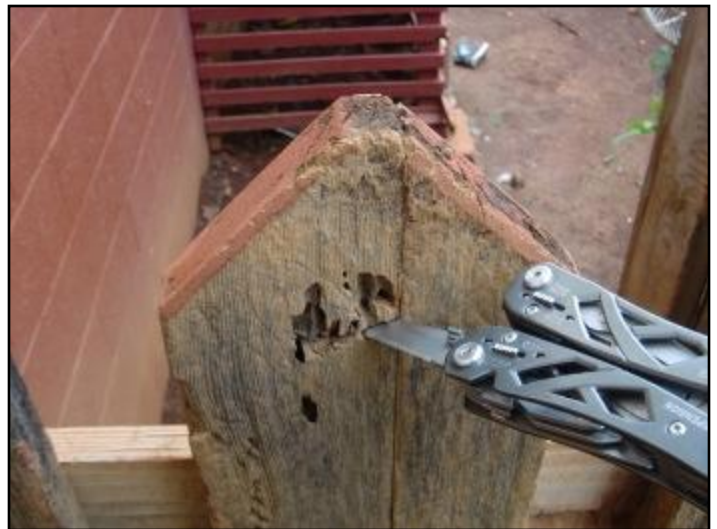
Some boards in fence are heavily moisture damaged, some termite damaged. Damaged boards should be repaired or replaced.

Rot or insect damage

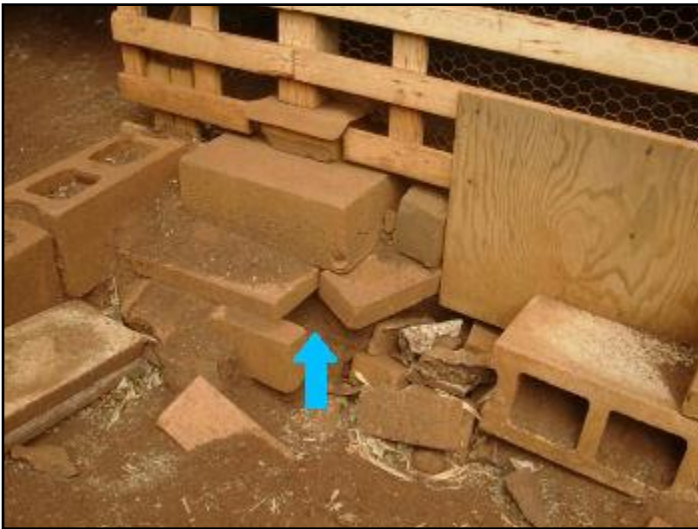
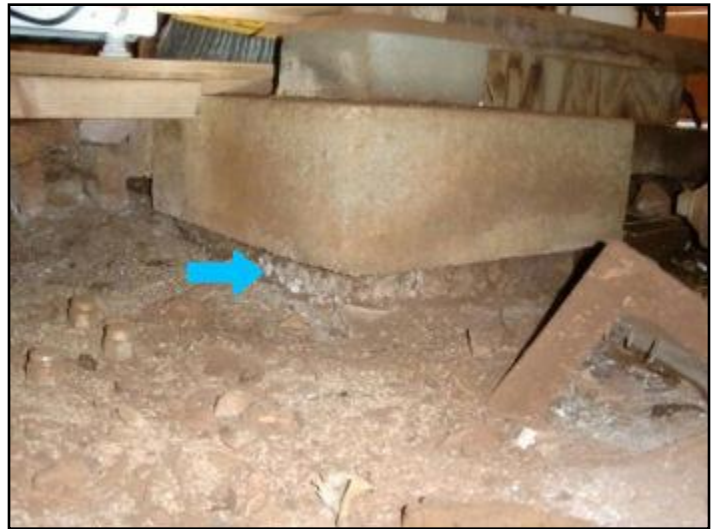
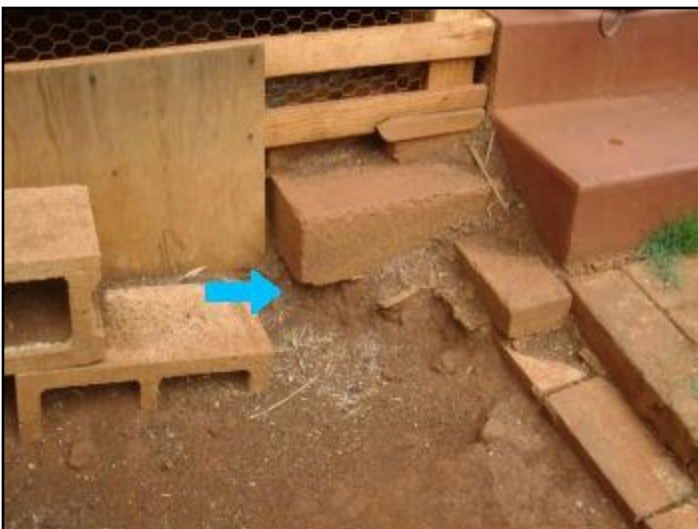
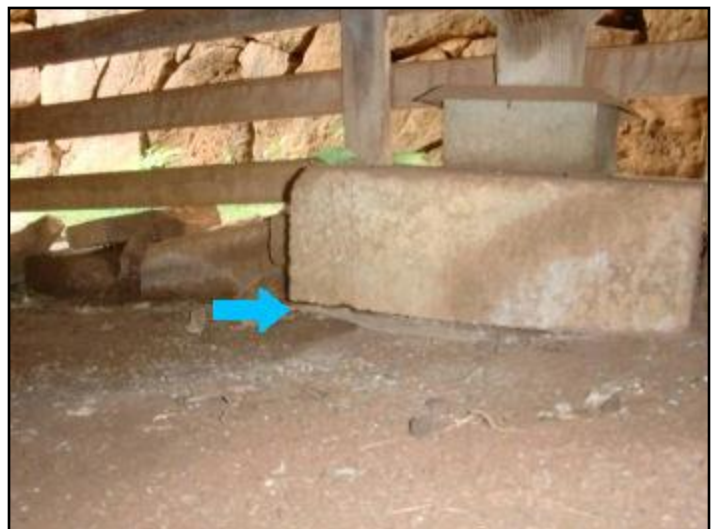
15. Condition: • Erosion below footings. Soil should be built back up and flow of water diverted away from entering crawlspace.

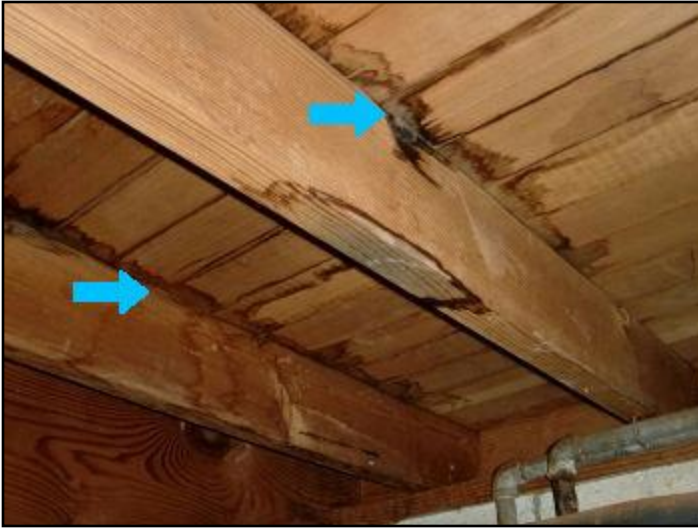
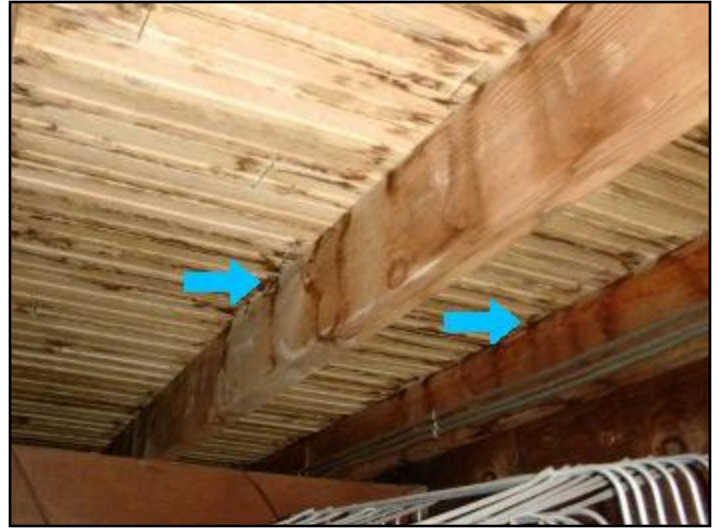
16. Condition: • Moisture stains noted on sub flooring and beams. No moisture present at time of inspection.

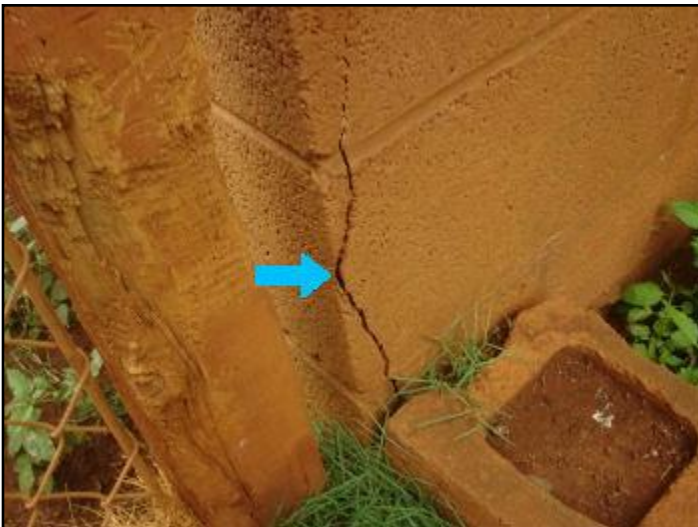
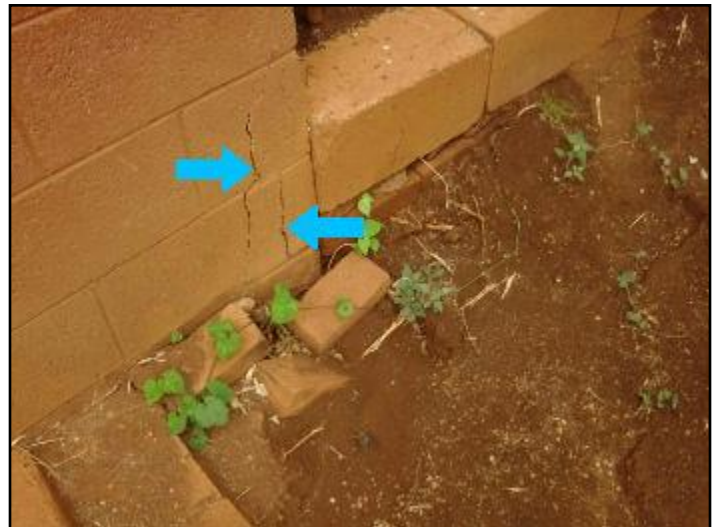
Cracks in masonry wall should be sealed and monitored for further movement.

Cracked

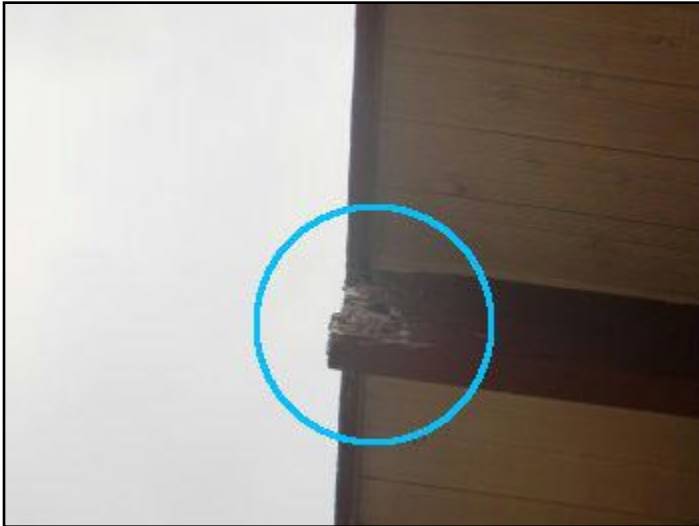
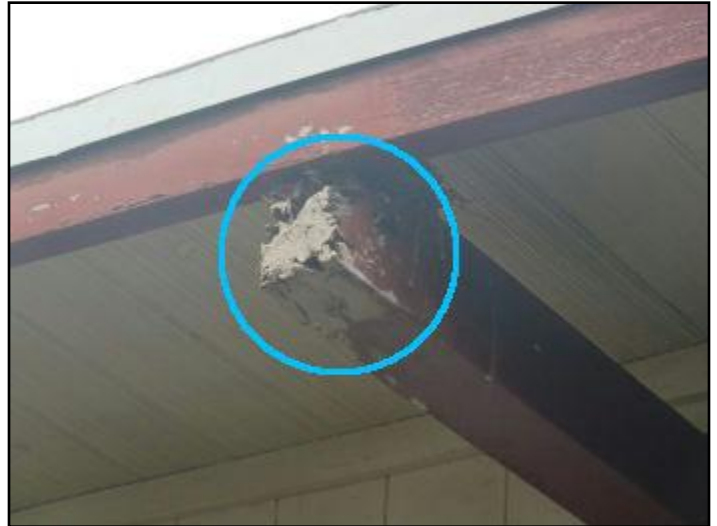
Heavy dry rot noted in ends of rafters. Ends should be repaired or replaced and flashings added to prevent future moisture damage.

Rot

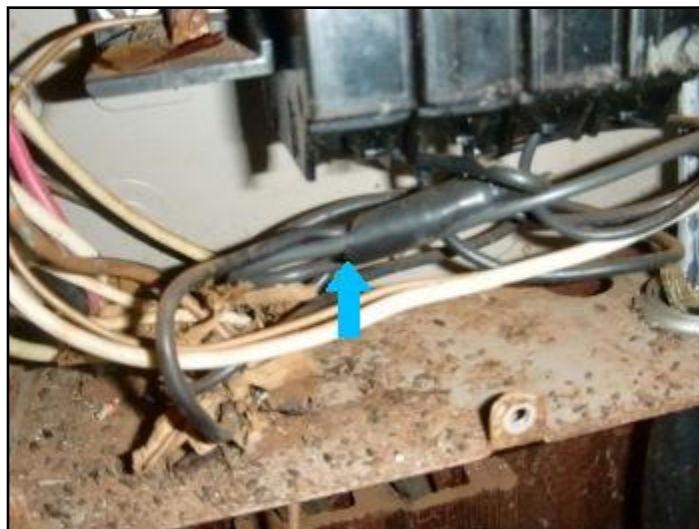
Double tap on branch wiring noted in main distribution panel. Tap can easily be corrected with the installation of an additional breaker.

Double taps

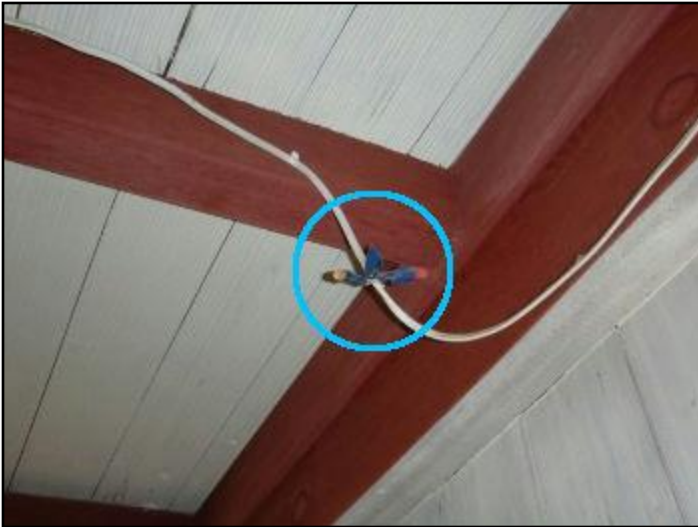
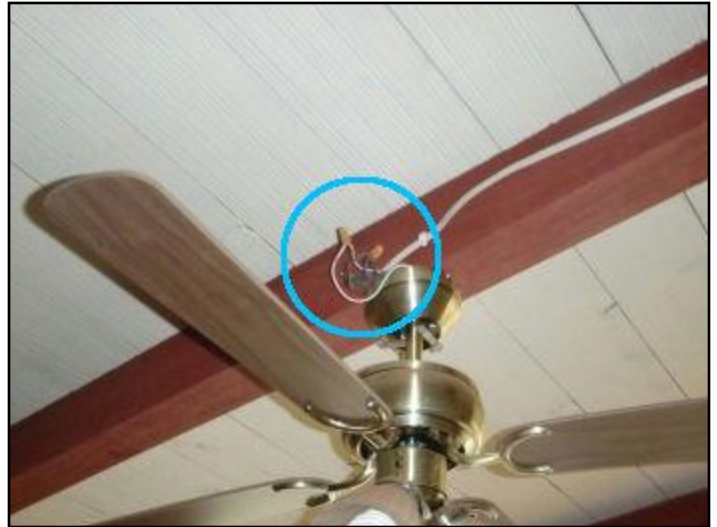
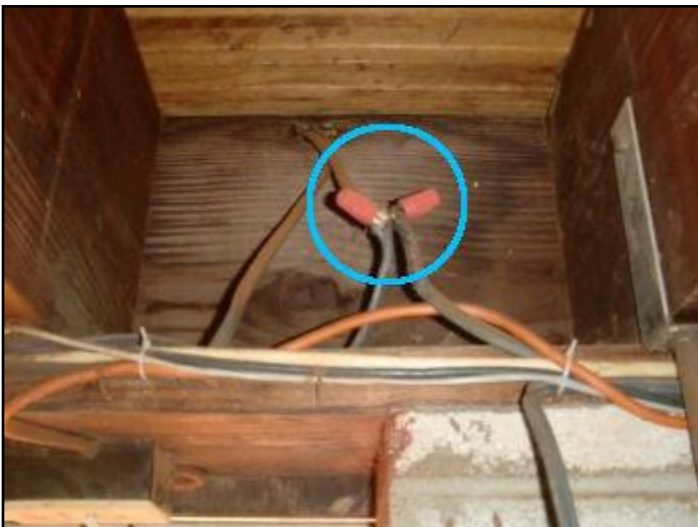
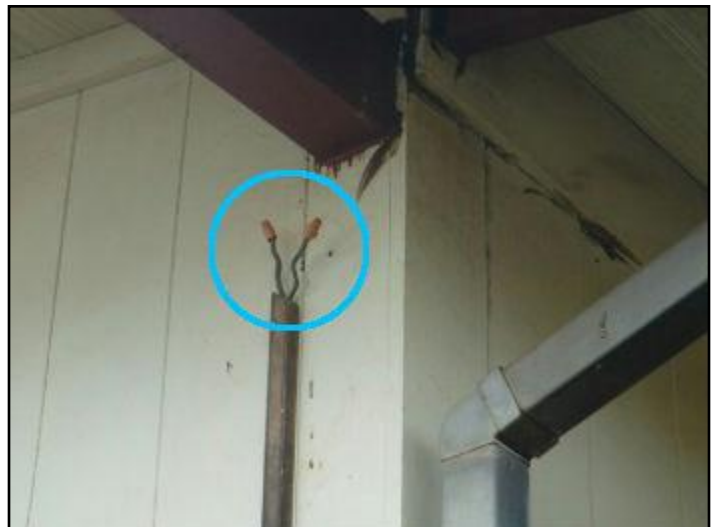
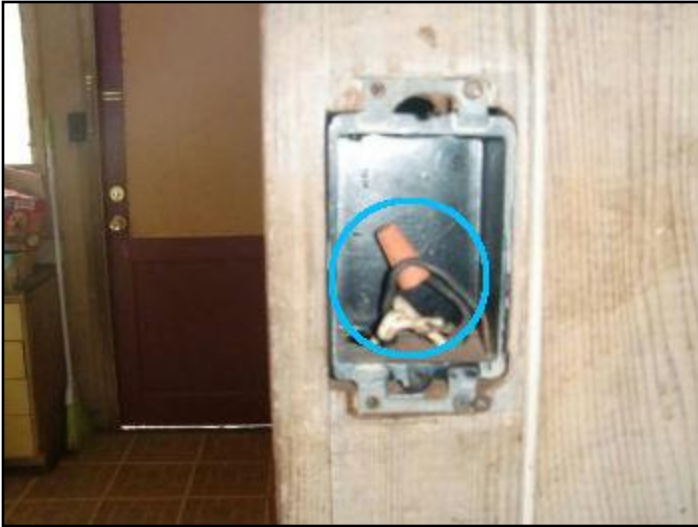
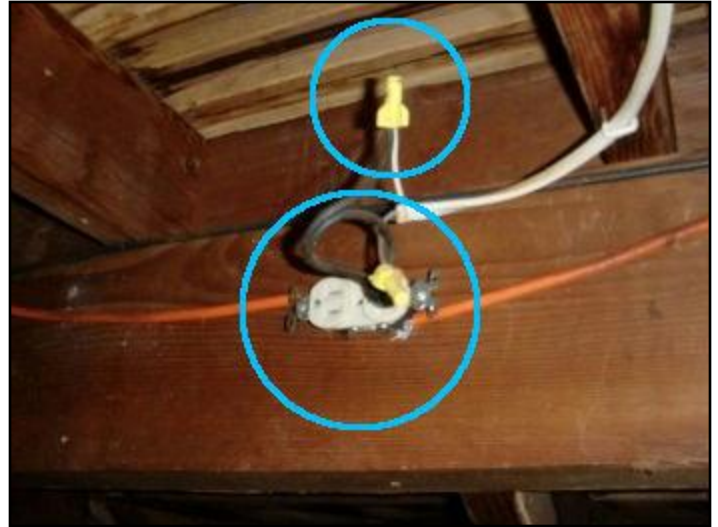
21. Condition: • [Exposed on walls or ceilings](#)

Exposed on walls or ceilings

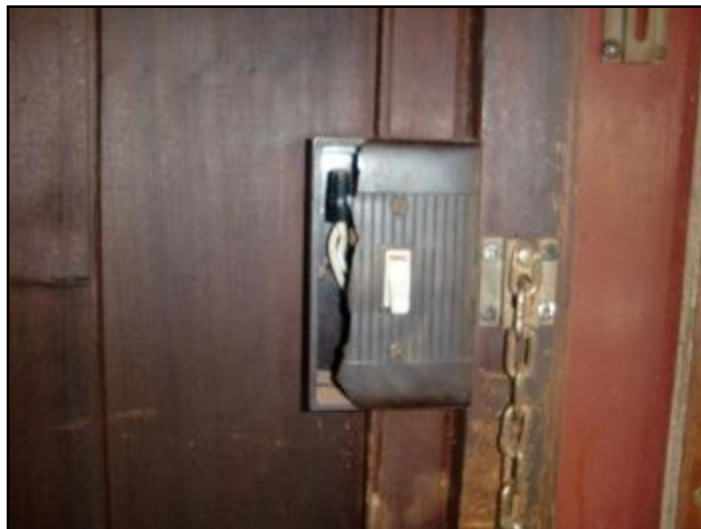
Light switch cover is damaged. New cover should be installed to prevent electrical shock hazard.

Damage

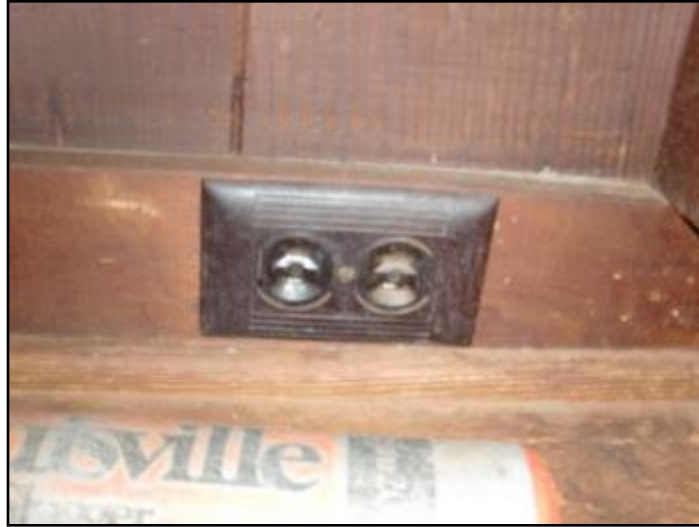
Outlets are obsolete ungrounded two-prong. Recommend upgrading to grounded three-prong outlets.

Ungrounded

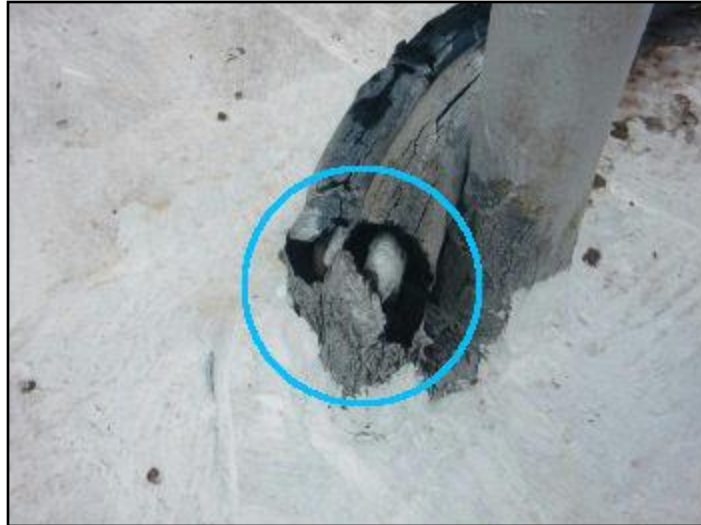
24. Condition: • Deteriorated insulation on supply lines

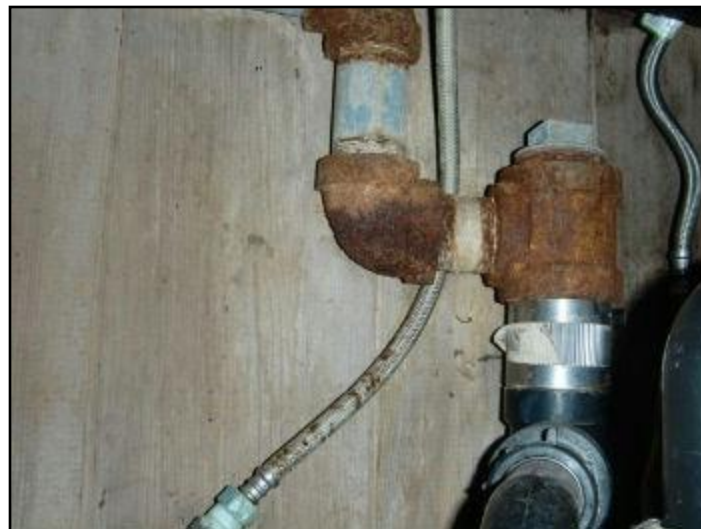
Drain lines heavily corroded at joints. No active leak noted at time of inspection.

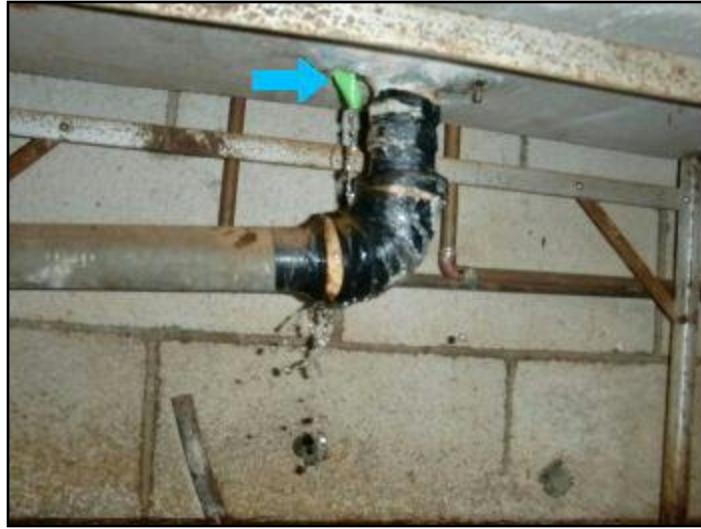
Drain below laundry sink leaks heavily when in use.

Leak

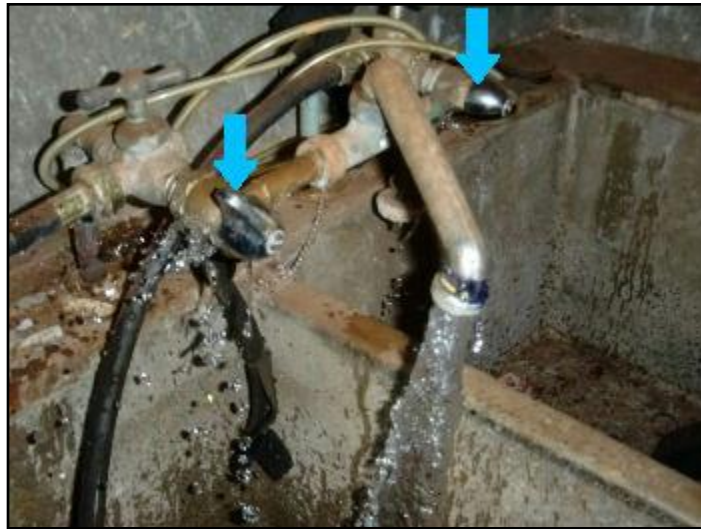
Hot and cold fixtures in laundry tub leak when in use.

Leak

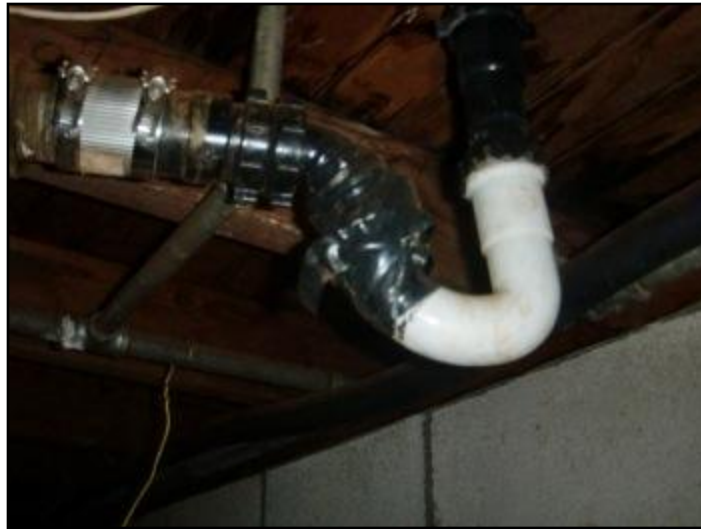
Drain line in crawlspace is taped heavily, appears to have leaked in the past but currently is not.

Leak

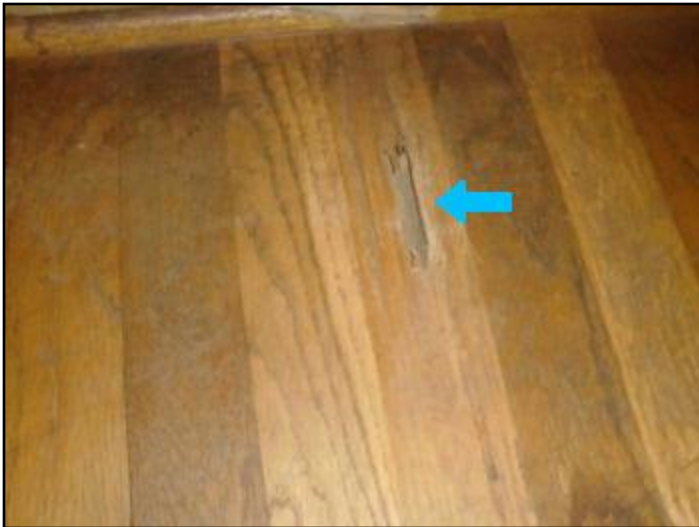
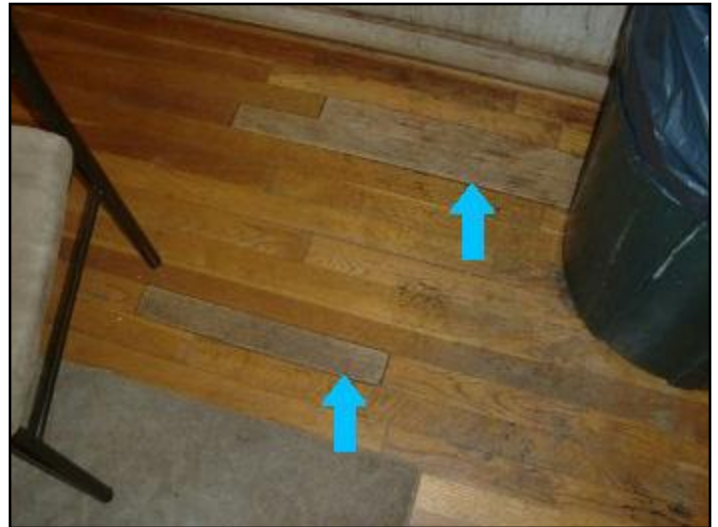
29. Condition: • Insect damage

30. Condition: • Boards in dining room are slightly damaged and previous repairs noted.

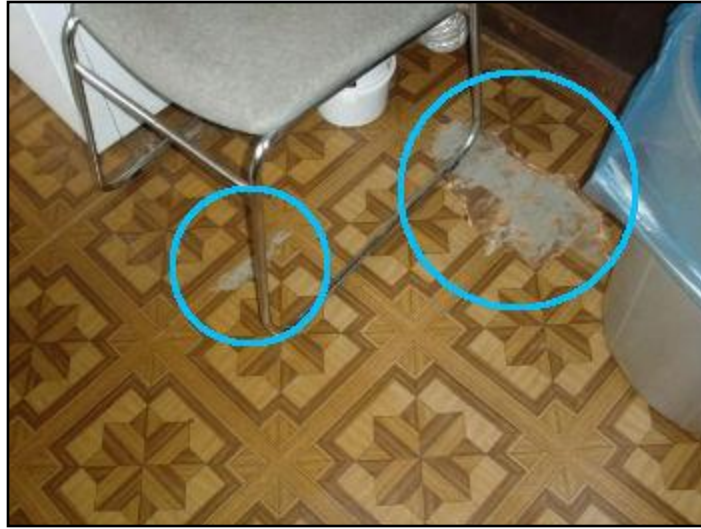
Flooring in back house dining area is damaged.

Damage

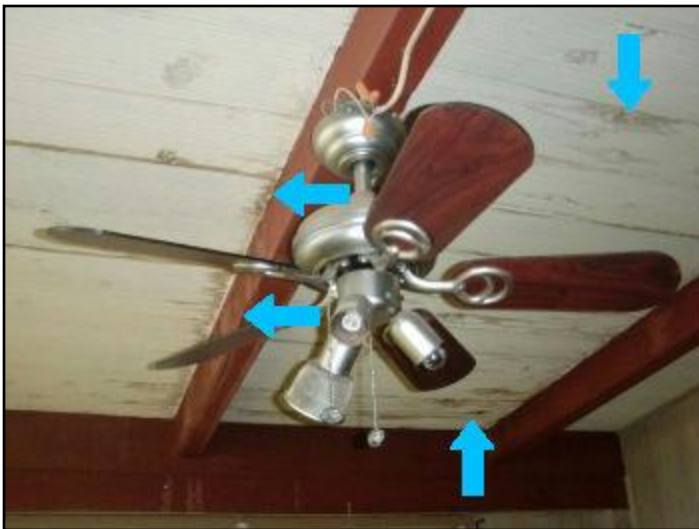
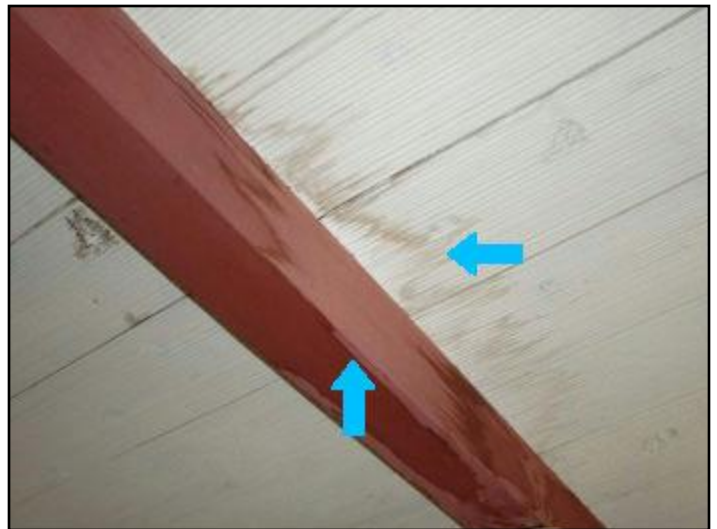
33. Condition: • Heavy stains noted in areas of ceiling. No moisture present at time of the inspection

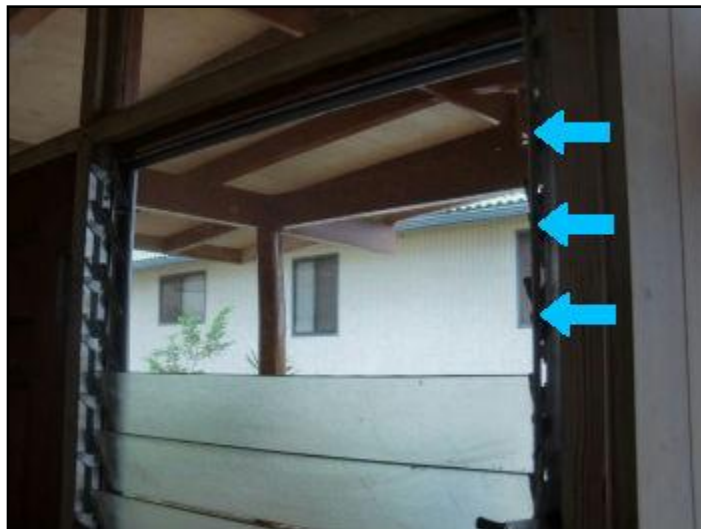
Jalousies missing.

Missing

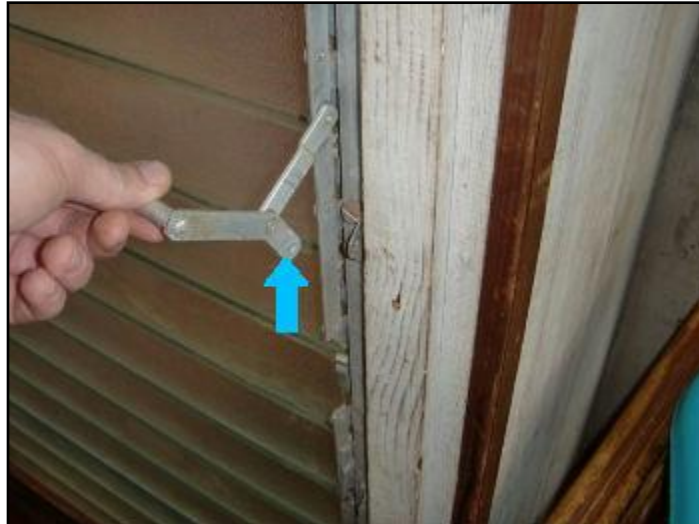
35. Condition: • [Inoperable](#)

Inoperable

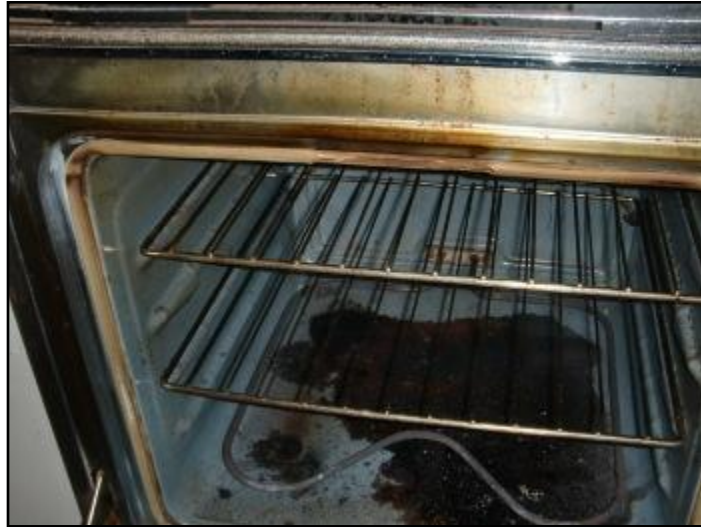
36. Condition: • Door gasket frayed/ damaged
Door seal damaged and should be repaired or replaced.

Door gasket frayed/ damaged

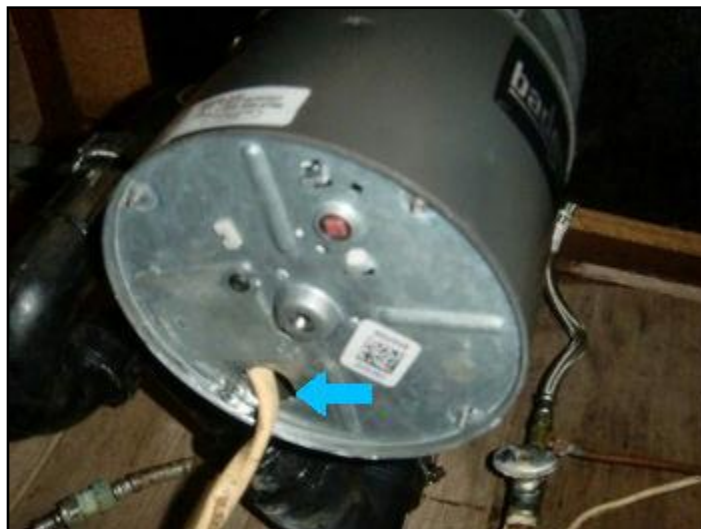
37. Condition: • Loose/ Missing wire clamp
Clamp missing. Without the clamp, over time, the vibrations can damage the insulation on the wires.

Wiring exposed or loose

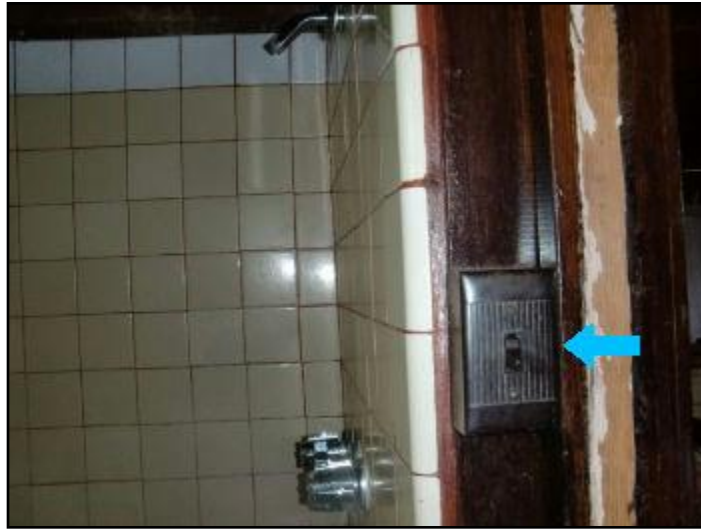
39. Condition: • Wall switch is too close to shower.

Implication(s): Electric Shock Hazard

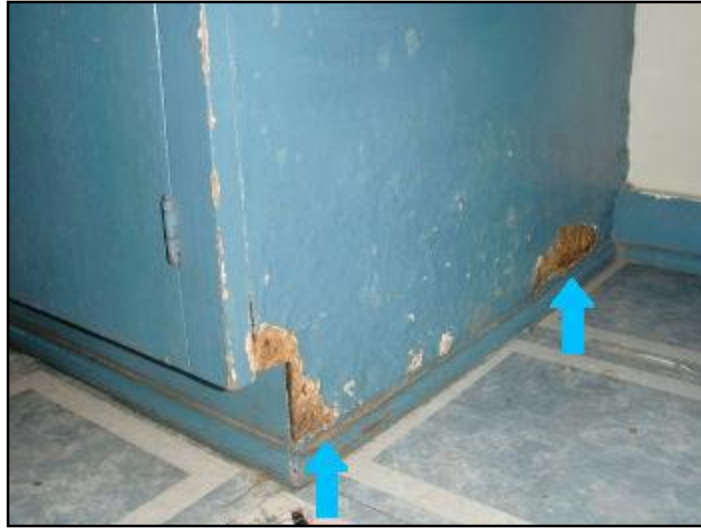
40. Condition: • Moisture damage on bottom edges of vanity noted. Repair/Replace as necessary.
