## Horizon Home Inspectors Sample Report Hilton Head Island, SC 29928

**INSPECTION DATE:**  
Wednesday, January 2, 2019

RE: Report No. 5190, v.3  
Horizon Home Inspectors Sample Report  
Hilton Head Island, SC  
29928

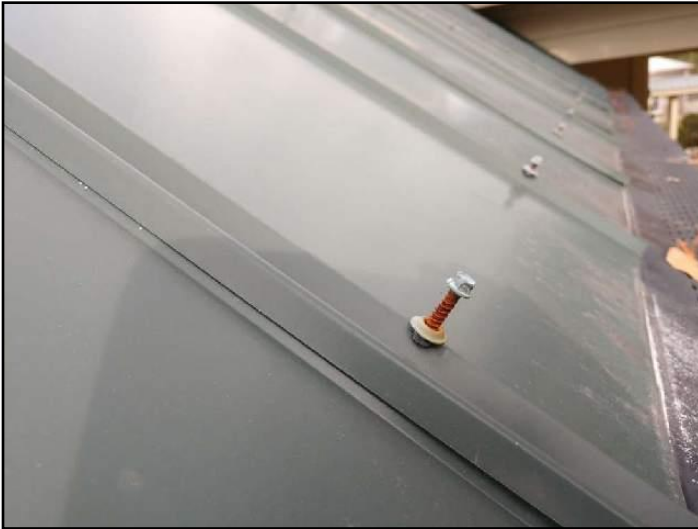
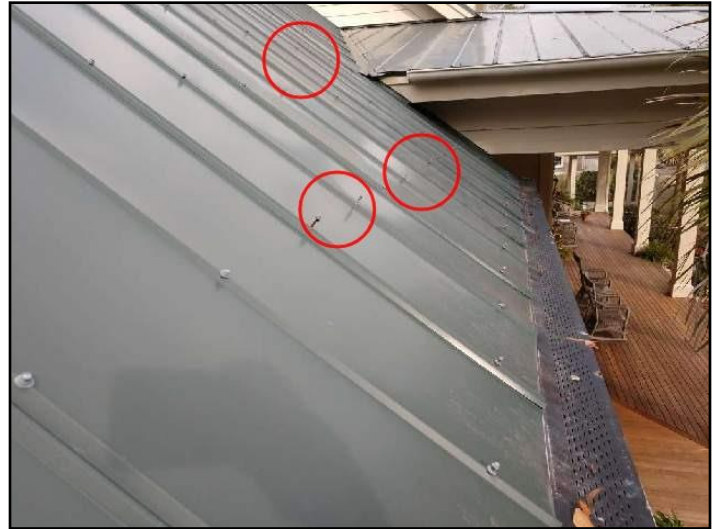
**Condition:** • [Failed fasteners](#)

**Implication(s):** Chance of water damage to contents, finishes and/or structure

2. Failed fasteners

**Task:** Repair recommended

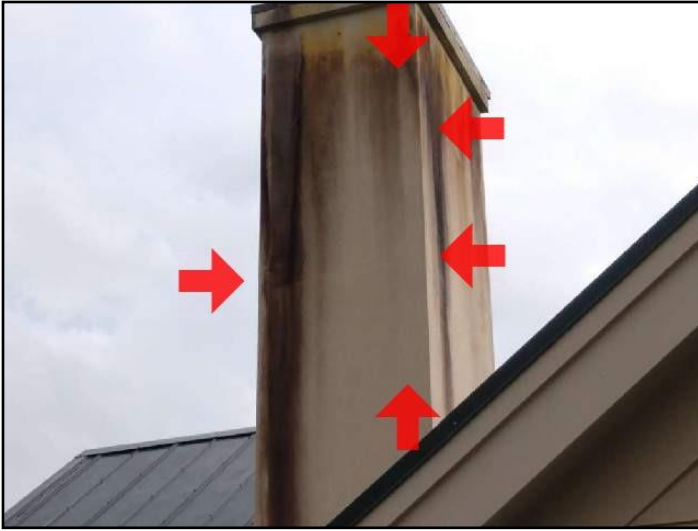
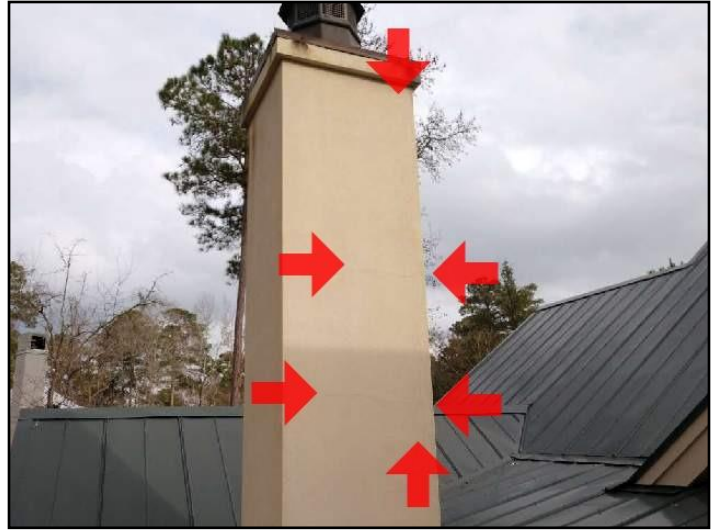
**Condition:** • There are visible cracks in the stucco. Although it is not uncommon for cracks to develop in rigid materials like stucco, I advise that you request further observation by a qualified contractor prior to closing to determine whether the visible cracking represents a deficiency.

**Implication(s):** Water damage

3. Cracks in stucco

4. Cracks in stucco

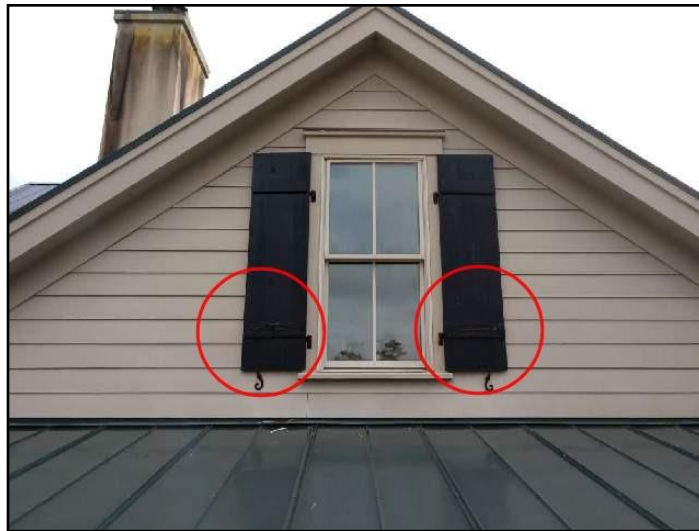
Condition: • [Rot](#)

5. Rot on shutters

Task: Repair recommended

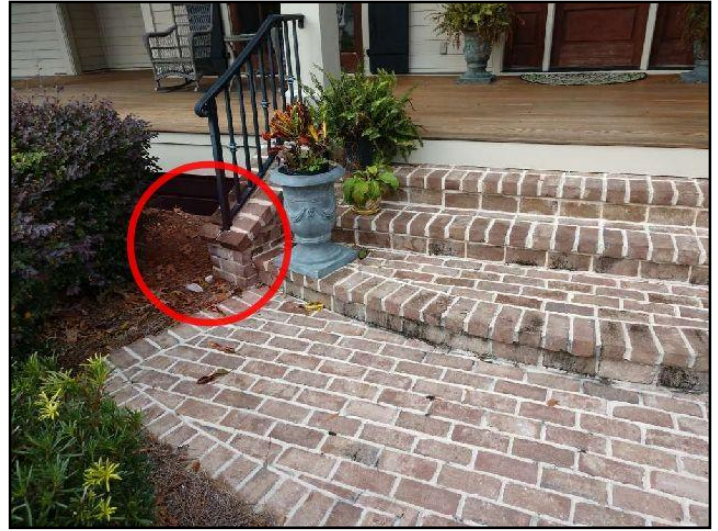
Condition: • [Masonry or concrete cracking](#)

7. Masonry or concrete cracking

Task: Repair recommended

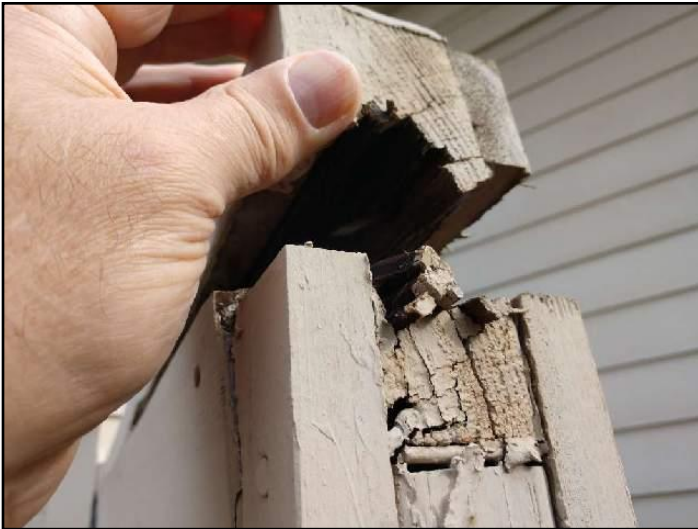
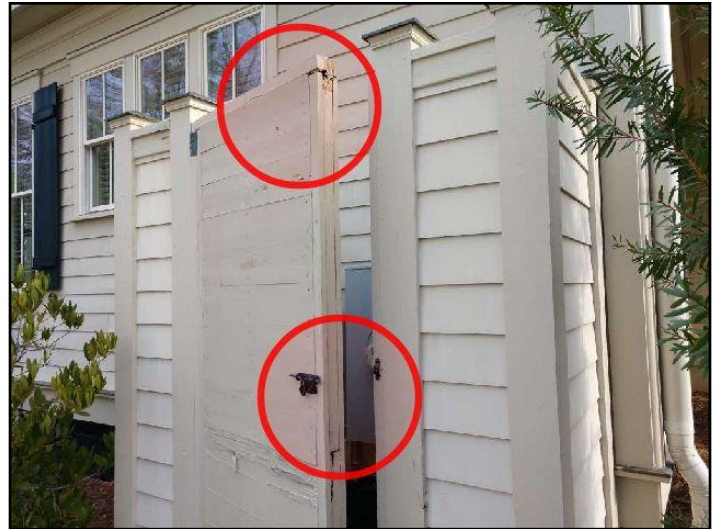
**Condition:** • Boards damaged

**Task:** Repair recommended

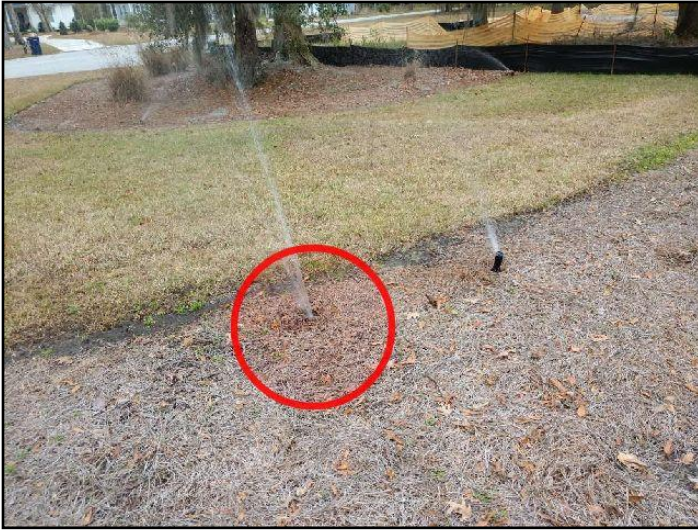
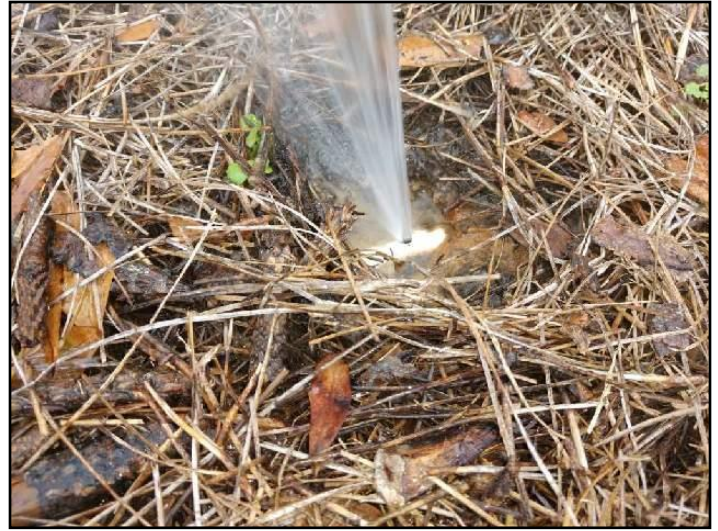
**Condition:** • Leak

10. Leak

**Task:** Repair recommended

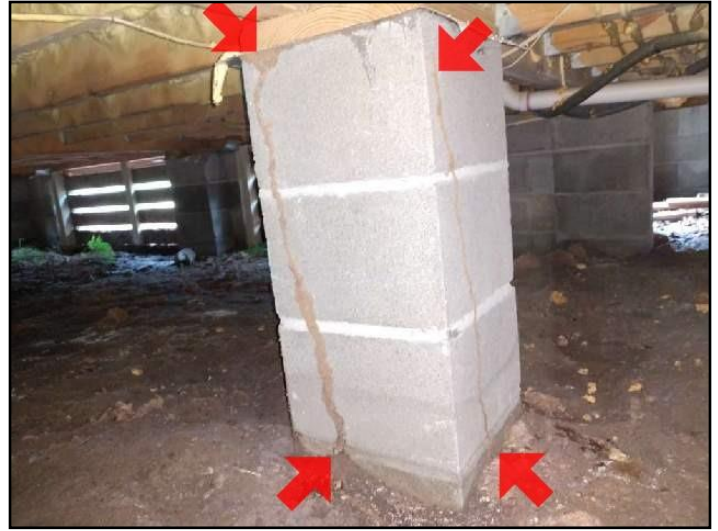
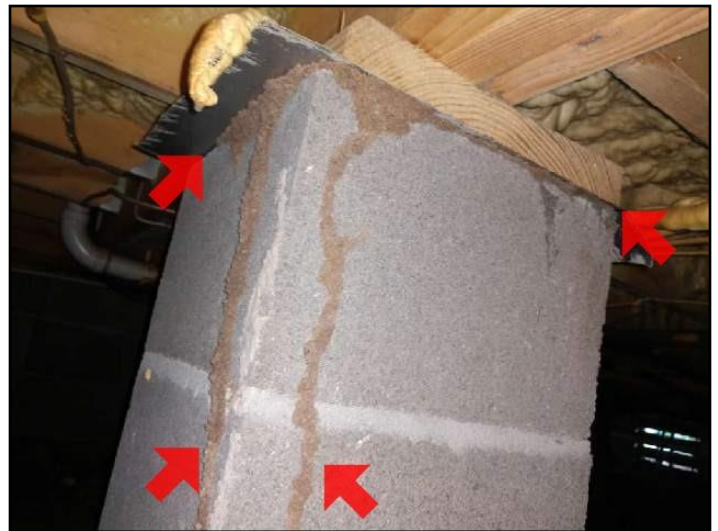
**Condition:** • [Evidence of wood destroying insects.](#)

**Implication(s):** Insect penetration/Damage/Weakened structure

13. Evidence of wood destroying insects

15. Evidence of wood destroying insects

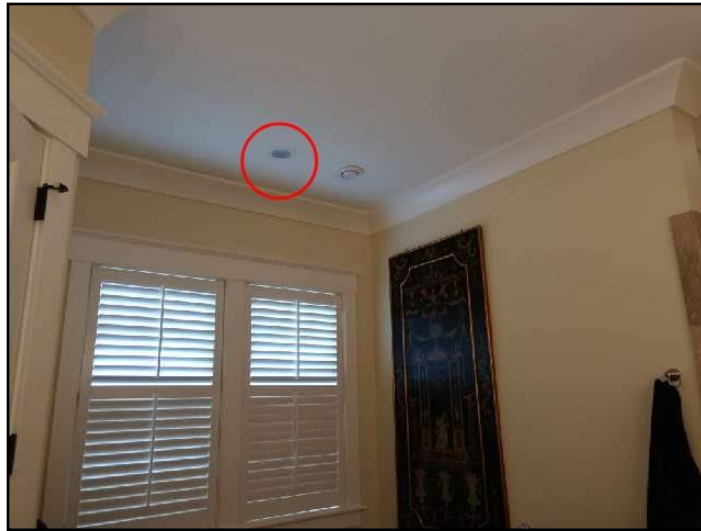
**Condition:** • [Inoperative](#)

**Implication(s):** Inadequate lighting

16. Inoperative

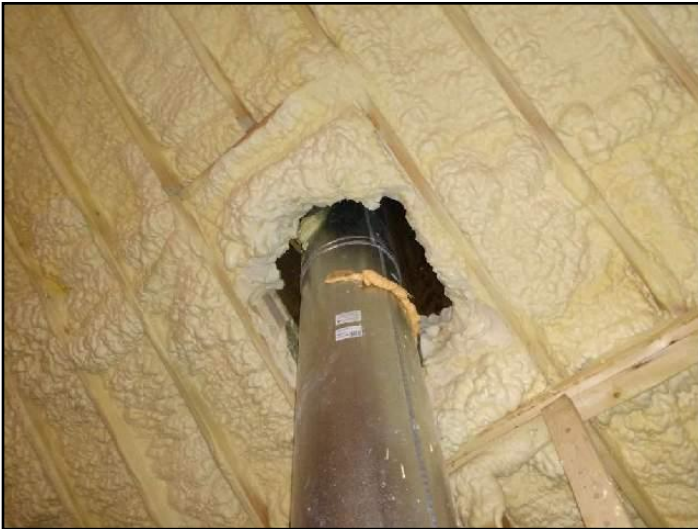
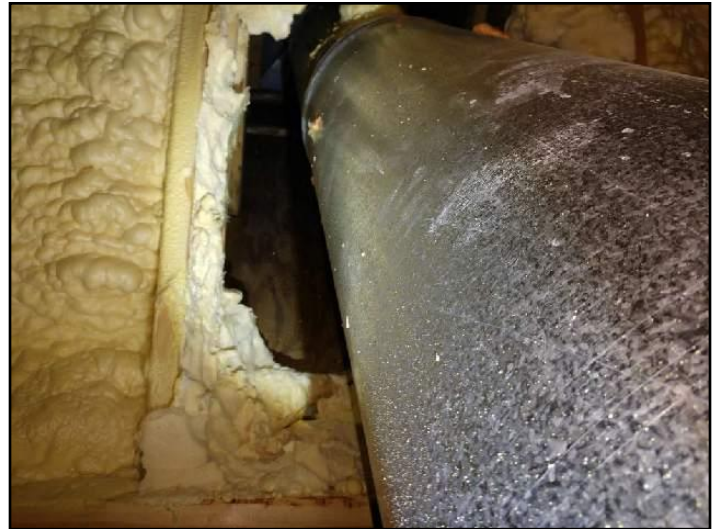
**Condition:** • [Gaps or voids](#)

17. Gaps and voids

**Task:** Correction recommended

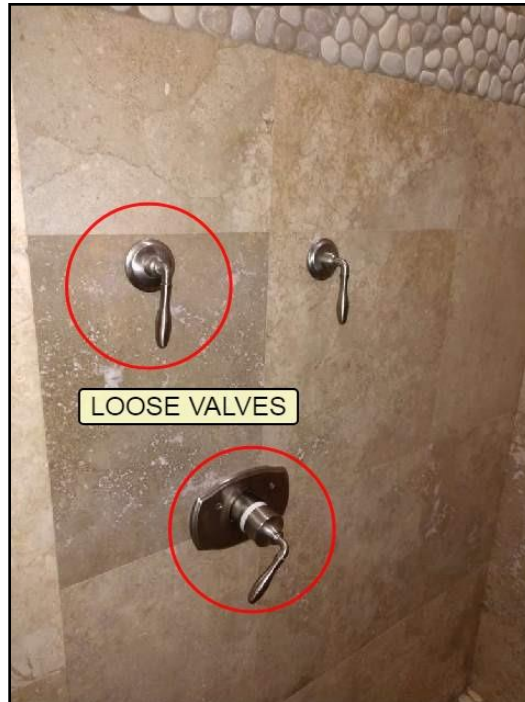
**Condition:** • Valves are loose on the shower wall

**Implication(s):** Water damage

19. Valves are loose on the shower wall

**Task:** Repair recommended

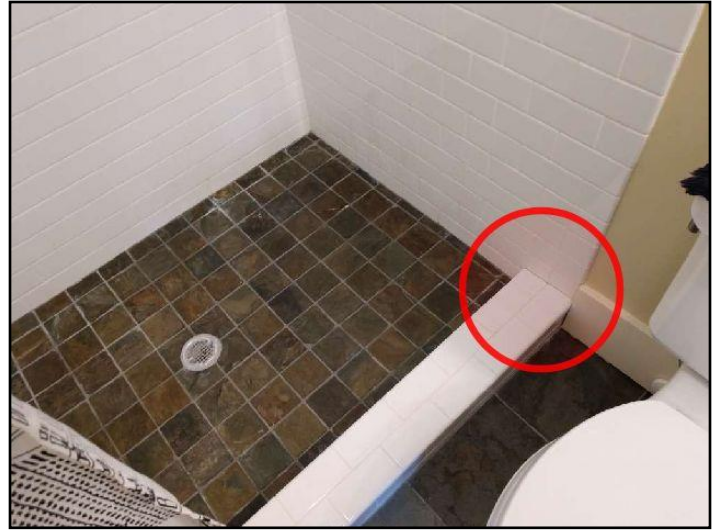
**Condition:** • [Grout loose, missing or deteriorated](#)

21. Grout loose, missing or deteriorated

**Task:** Correction recommended

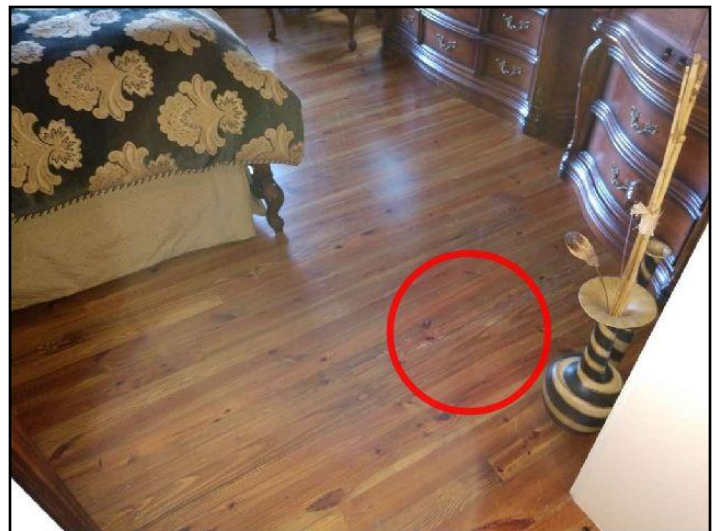
**Condition:** • Insect damage to Floor boards. This damage is near and above the insect activity noted in the crawlspace

**Implication(s):** Insect penetration/Damage

23. Insect damage to Floor boards

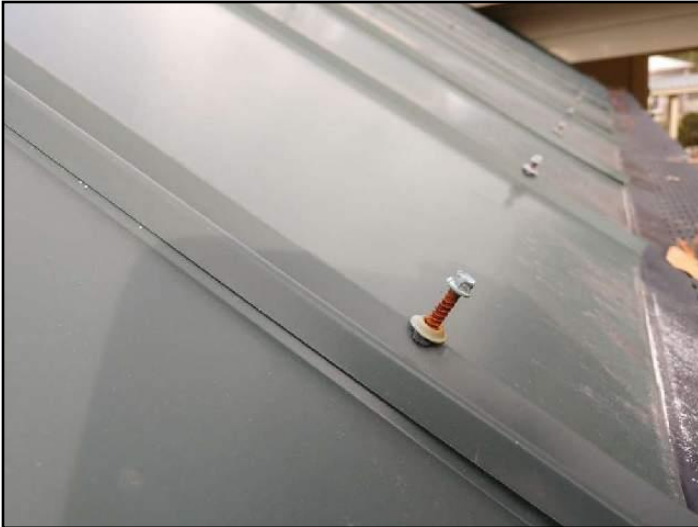
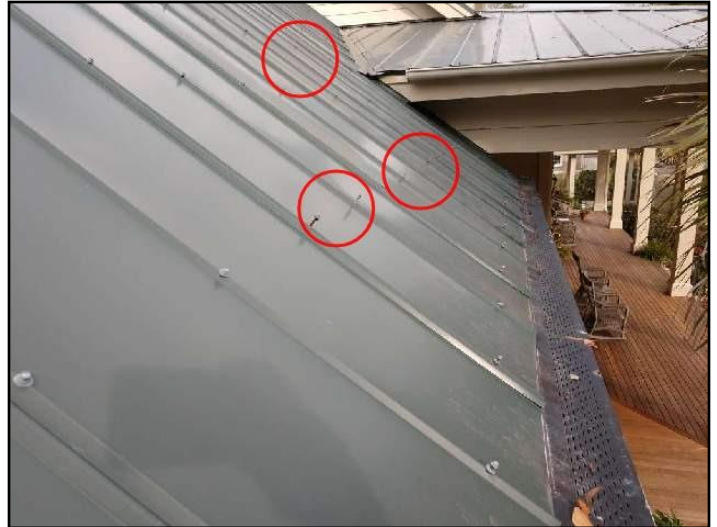
**2. Condition:** • [Failed fasteners](#)

**Implication(s):** Chance of water damage to contents, finishes and/or structure

25. Failed fasteners

**Task:** Repair recommended

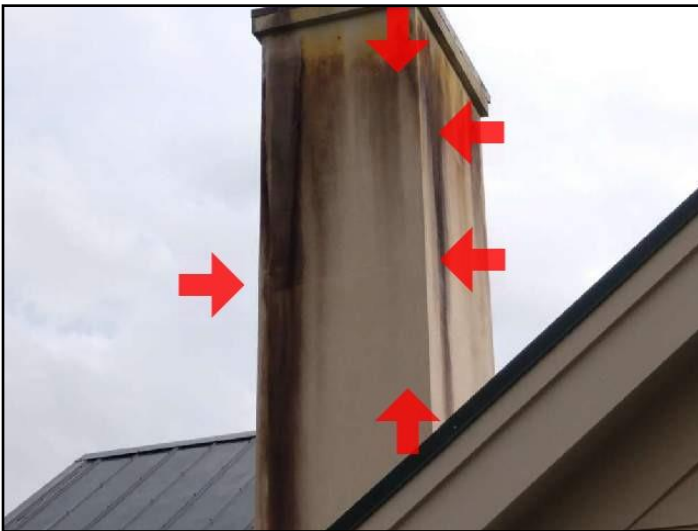
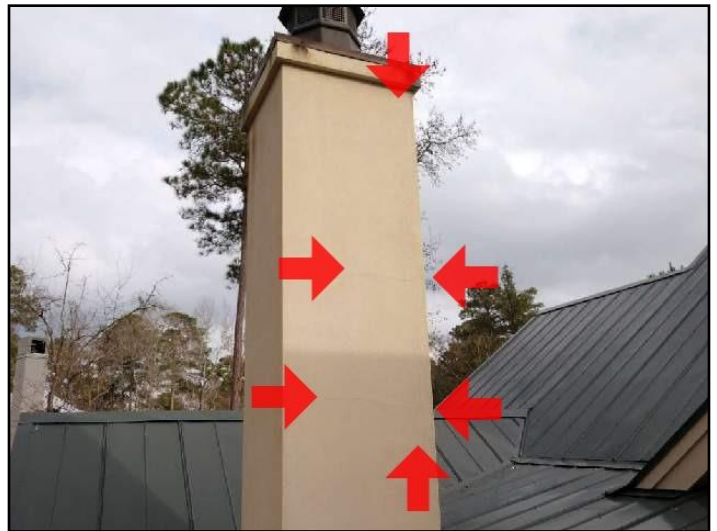
**4. Condition:** • There are visible cracks in the stucco. Although it is not uncommon for cracks to develop in rigid materials like stucco, I advise that you request further observation by a qualified contractor prior to closing to determine whether the visible cracking represents a deficiency.

**Implication(s):** Water damage

30. Cracks in stucco

31. Cracks in stucco

**Task:** Evaluation by a qualified technician or contractor.

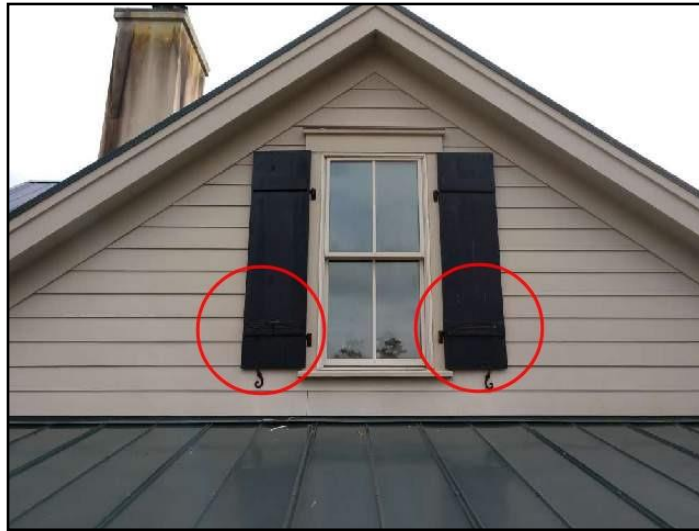
**5. Condition:** • [Rot](#)

32. Rot on shutters

**Task:** Repair recommended

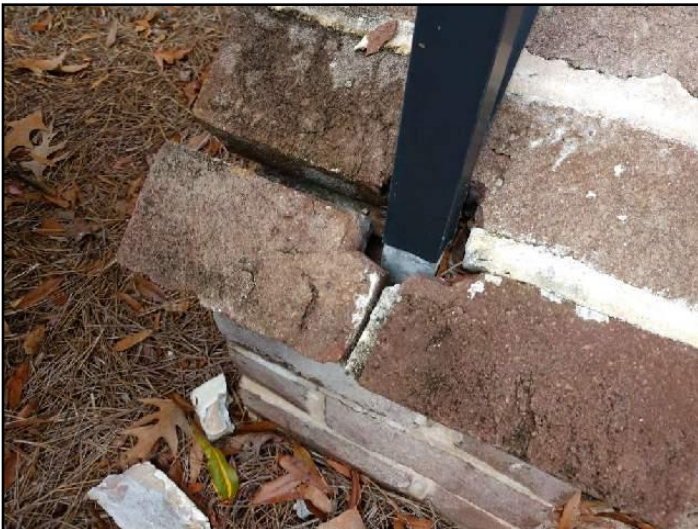
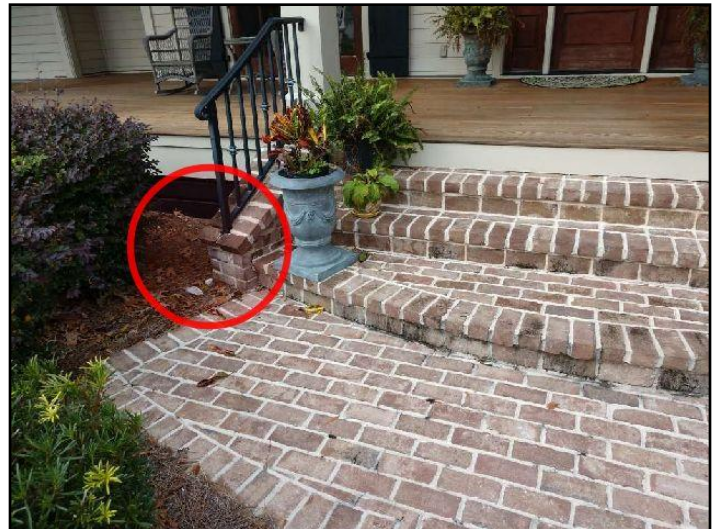
6. Condition: • [Masonry or concrete cracking](#)

34. Masonry or concrete cracking

Task: Repair recommended

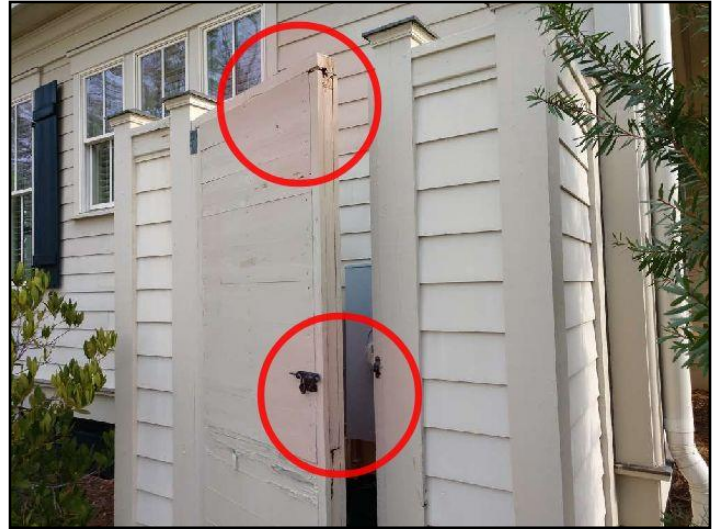
7. Condition: • Boards damaged

Task: Repair recommended

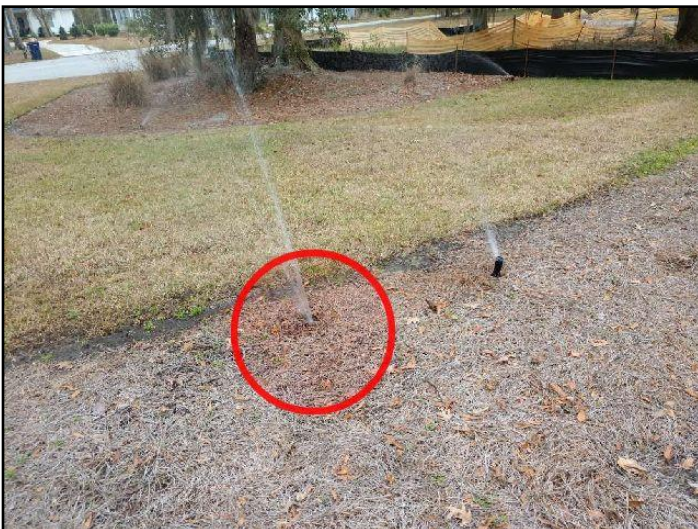
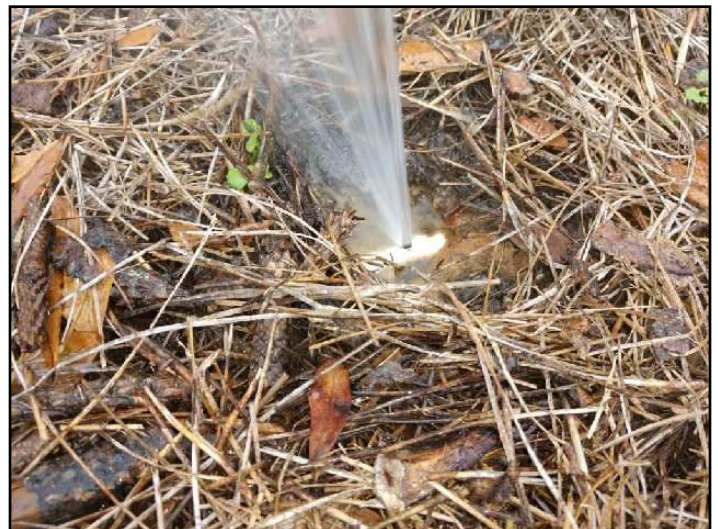
8. Condition: • Leak

37. Leak

Task: Repair recommended

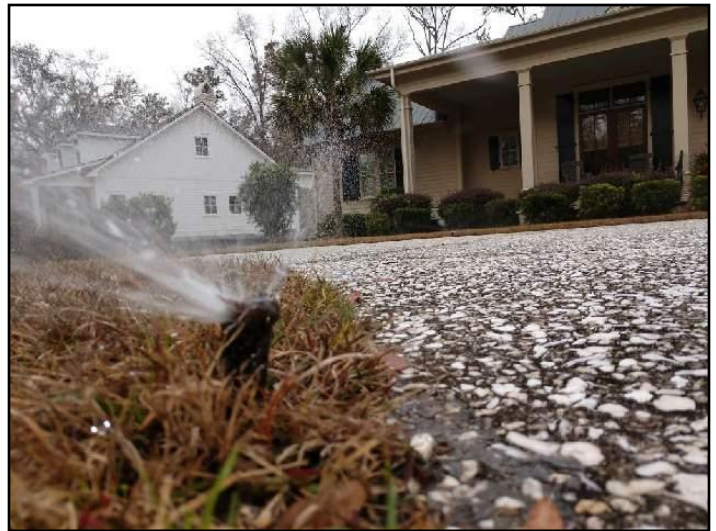
40. Irrigation appears operative, but with issues

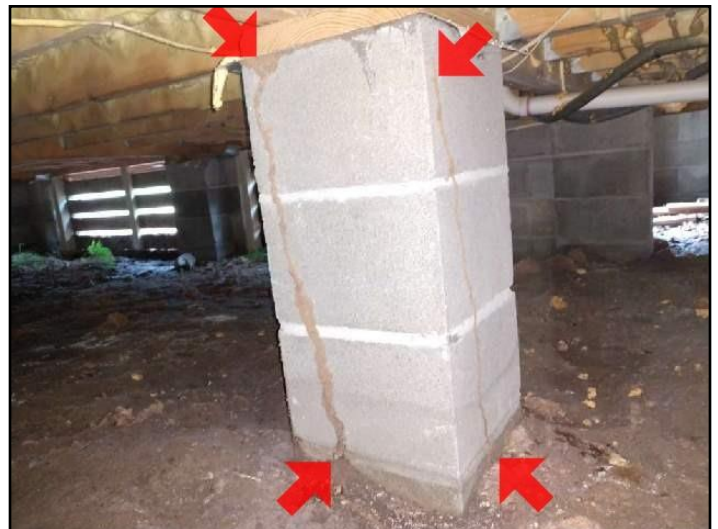
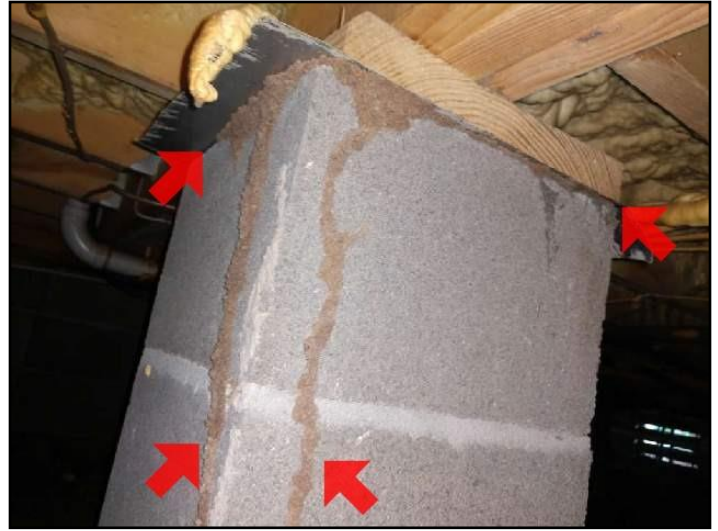
**10. Condition:** • [Evidence of wood destroying insects.](#)

**Implication(s):** Insect penetration/Damage/Weakened structure

42. Evidence of wood destroying insects

44. Evidence of wood destroying insects

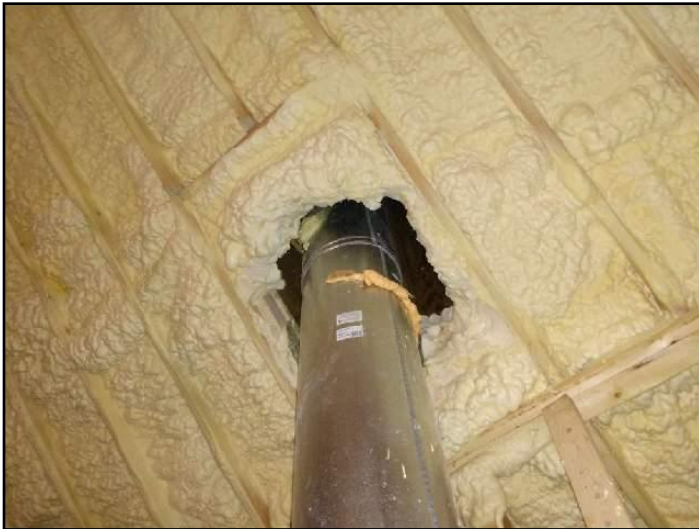
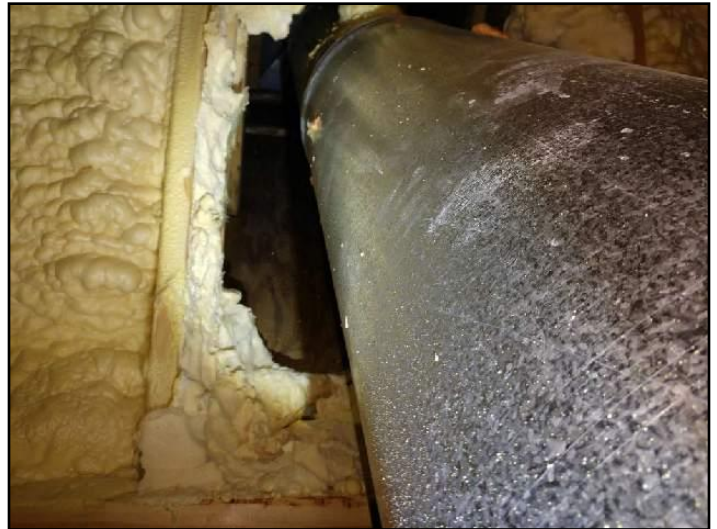
#### 14. Condition: • [Gaps or voids](#)

79. Gaps and voids

**Task:** Correction recommended

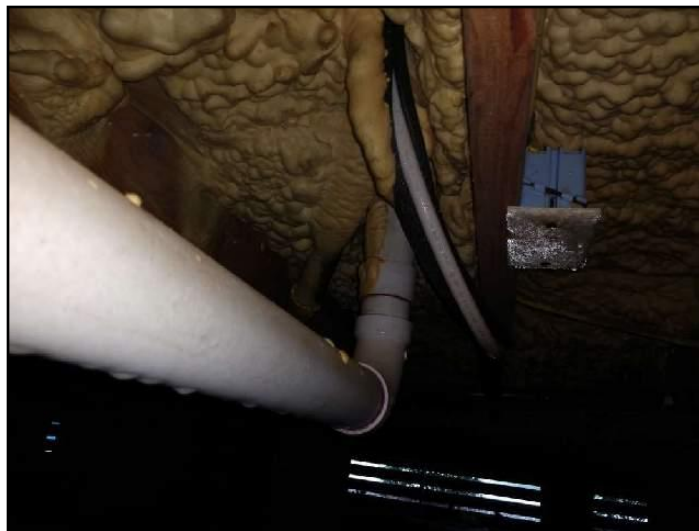
**Crawlspace inspection performed:** • Foam insulation on the underside of the floor structure limited observation and the extent of the inspection

89. Foam obstruction - crawlspace

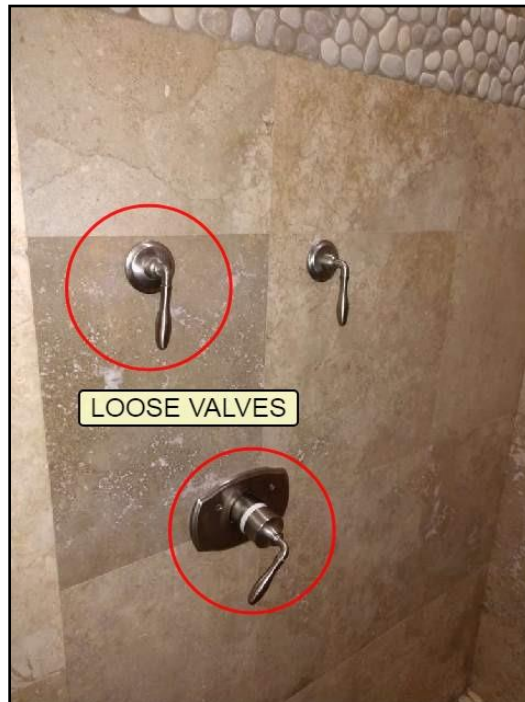
**16. Condition:** • Valves are loose on the shower wall

**Implication(s):** Water damage

90. Valves are loose on the shower wall

**Task:** Repair recommended

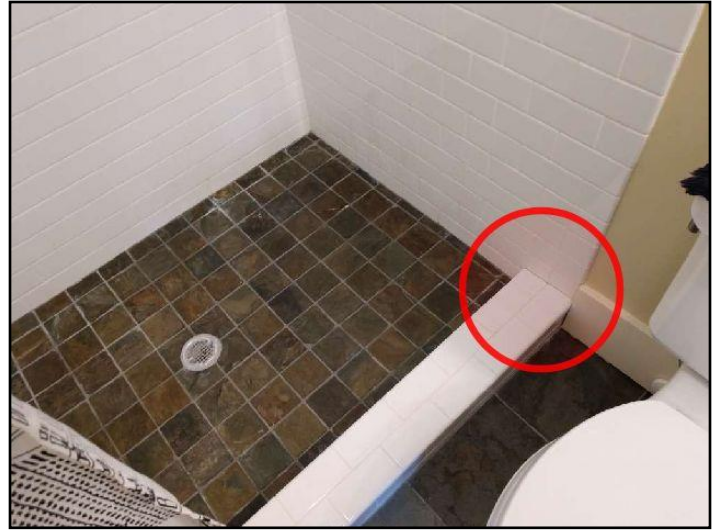
92. Grout loose, missing or deteriorated

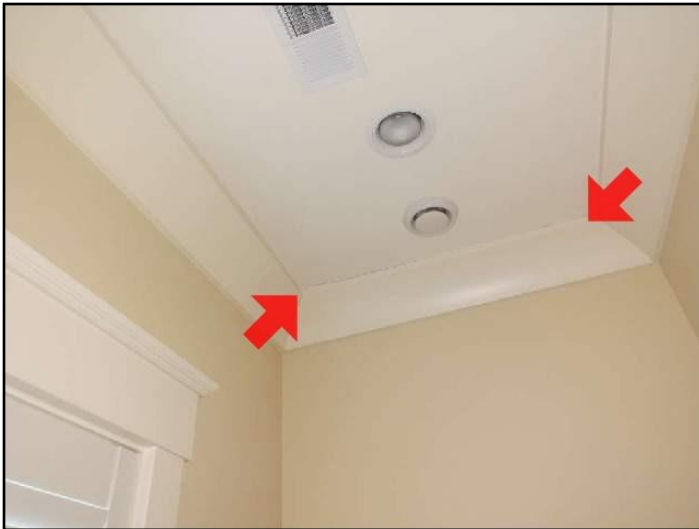
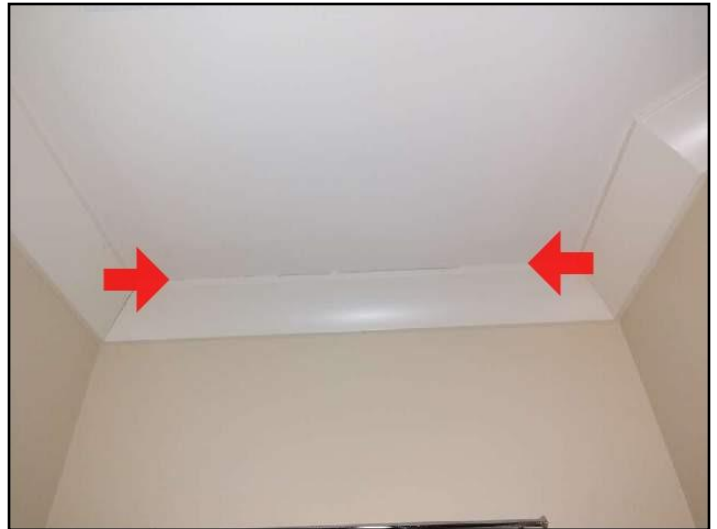
100. Typical flaws

101. Typical flaws

**Task:** Repair recommended

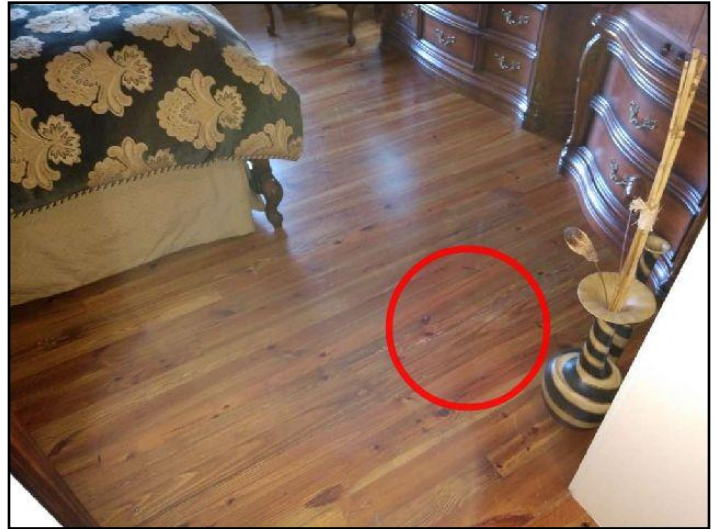
104. Insect damage to Floor boards
