Your Inspection Report

51 Skylark Rd
Toronto, ON M6S 4M5

INSPECTION DATE:
Tuesday, April 7, 2026

RE: Report No. 96754, v.2
51 Skylark Rd
Toronto, ON
M6S 4M5

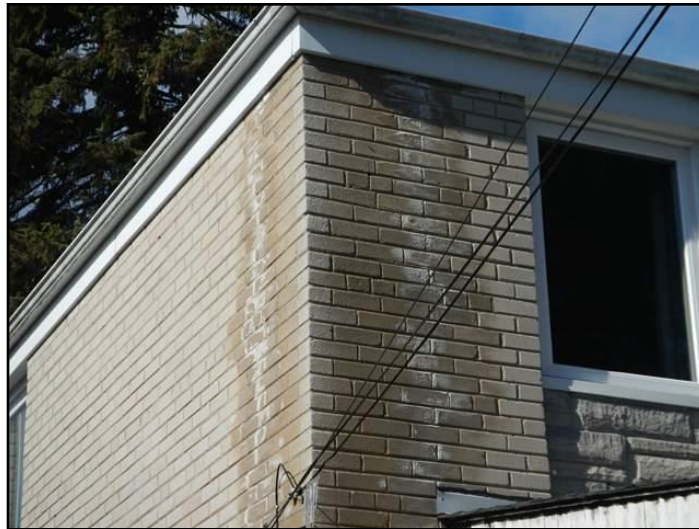
Condition: • [Efflorescence](#)

Efflorescence

Task: Improve

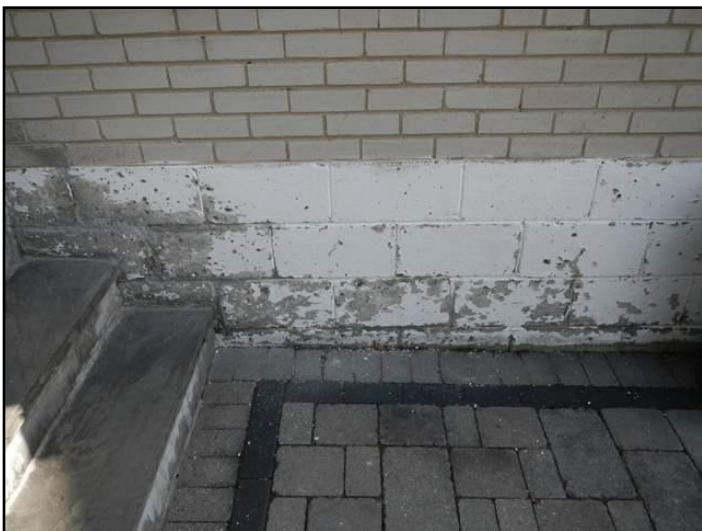
Condition: • [Spalling](#)

Spalling

Task: Improve

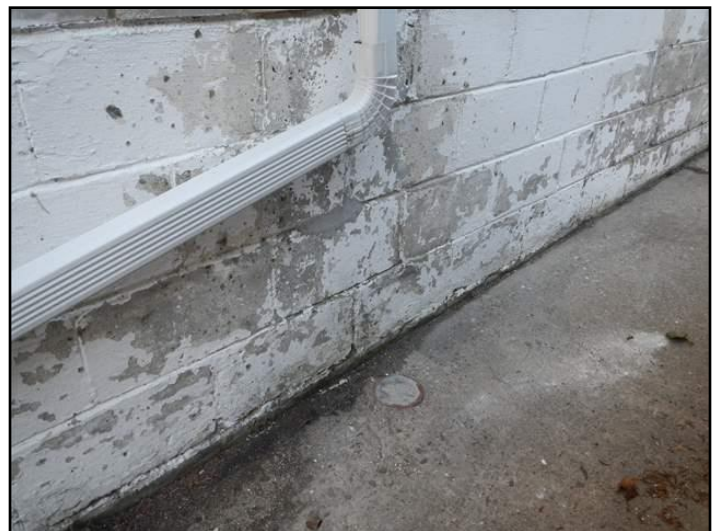
Spalling

Condition: • [Spalling](#)

Task: Improve

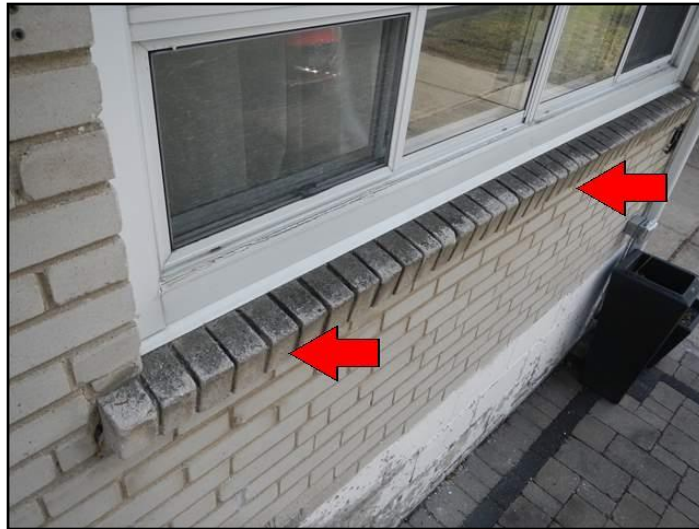
Spalling

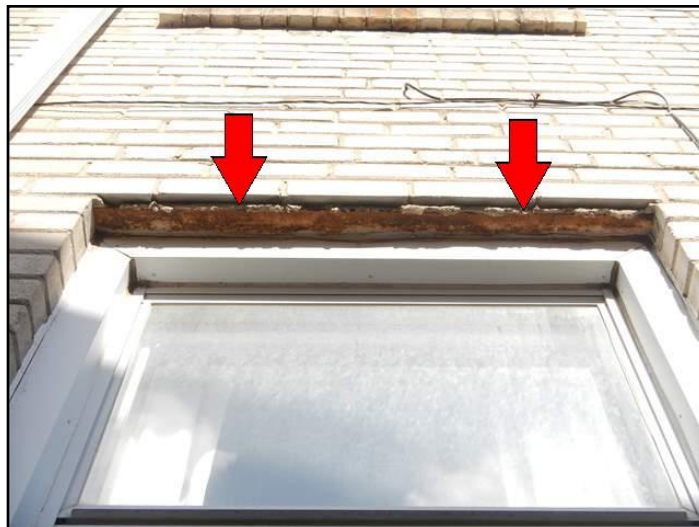
Condition: • Rusty lintel.

Task: Improve

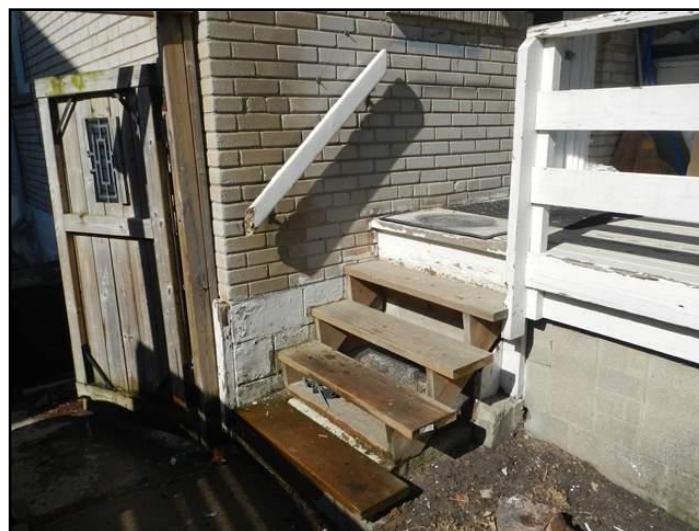
Condition: • [Missing](#)

Missing on one side.

Missing

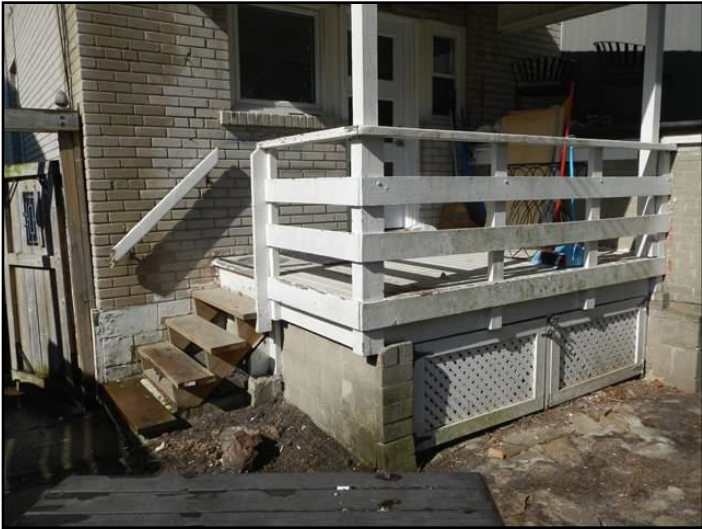
Location: Rear Porch

Condition: • [Spindles \(balusters\) climbable](#)

Spindles (balusters) climbable

Task: Improve
Time: As required
Cost: Minor

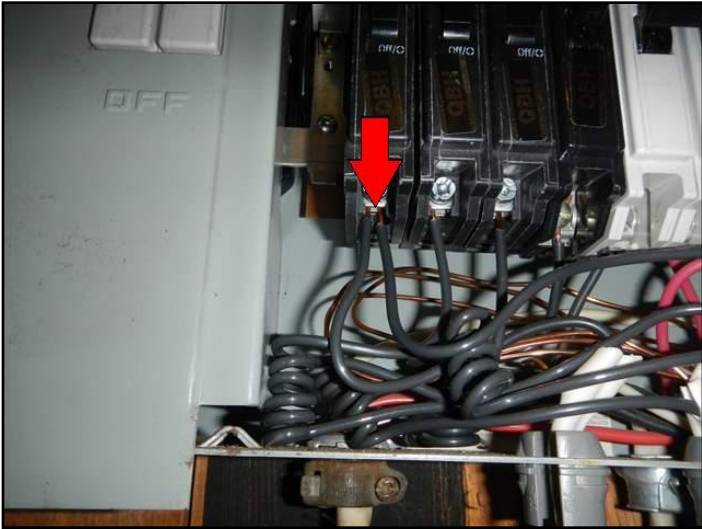
Condition: • [Double taps](#)

Double tap

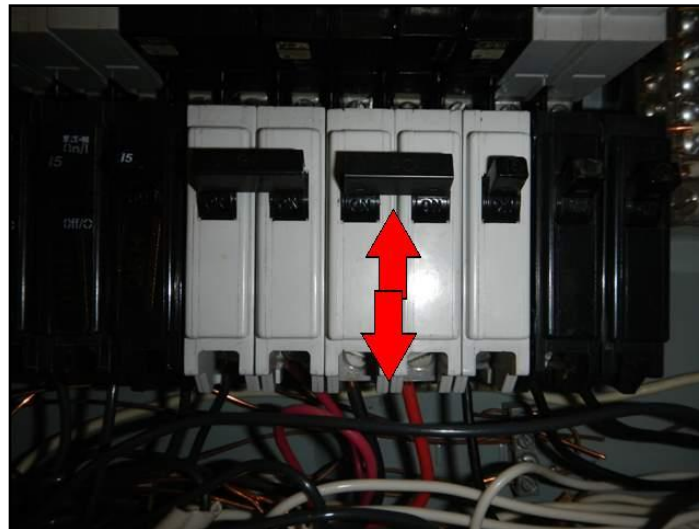
Condition: • [Fuses or breakers too big](#)

Breaker too big

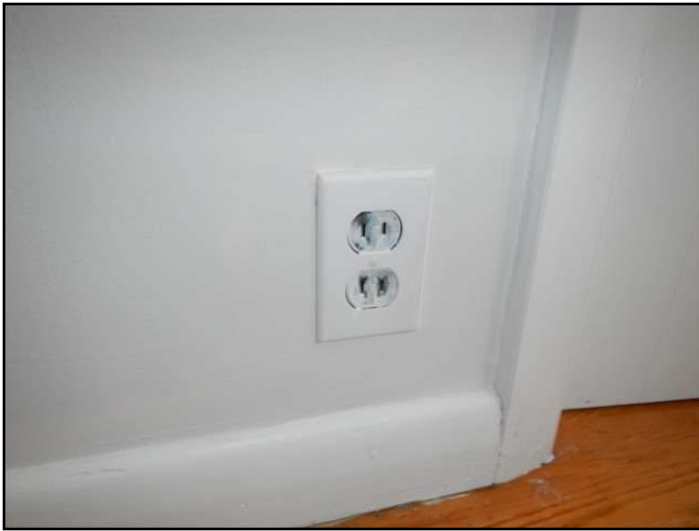
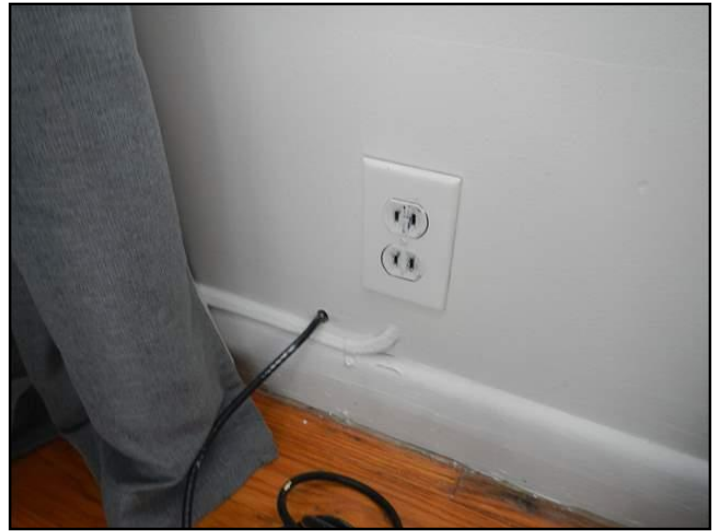
Condition: • [Ungrounded](#)

Ungrounded

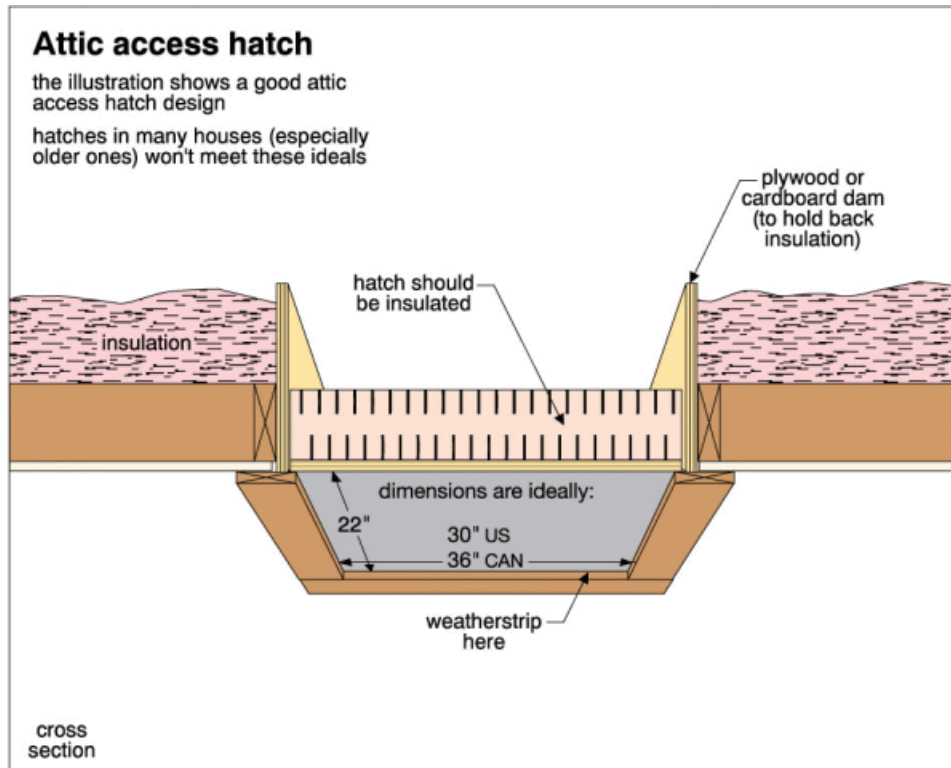
Condition: • [Not insulated and not weatherstripped](#)

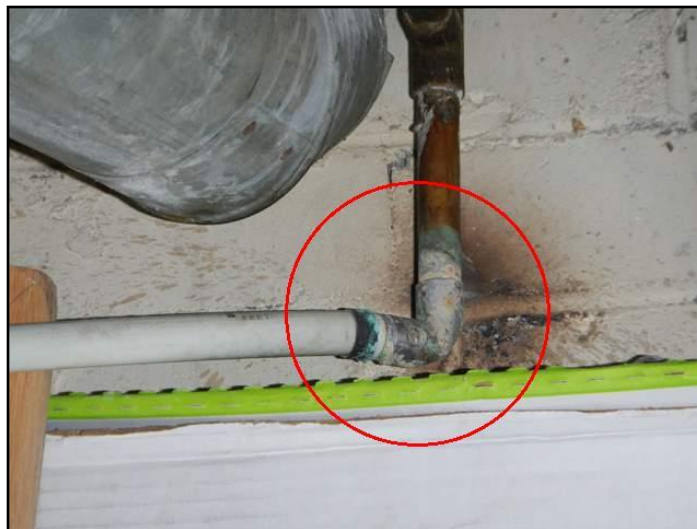
Condition: • Corrosion

Corrosion

Task: Repair

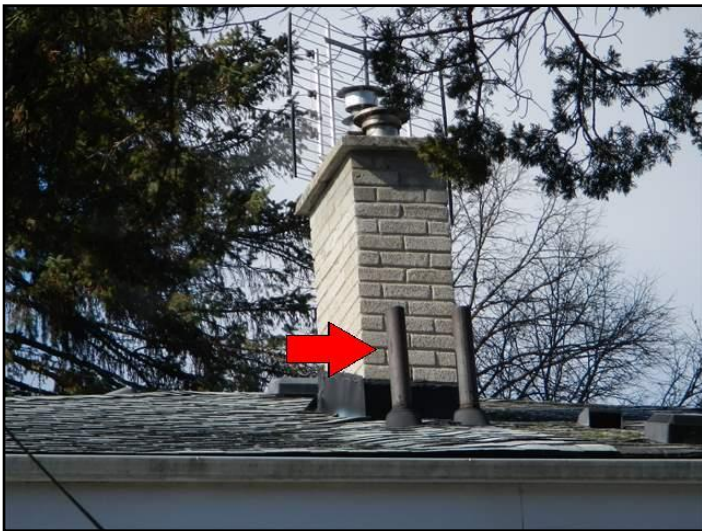
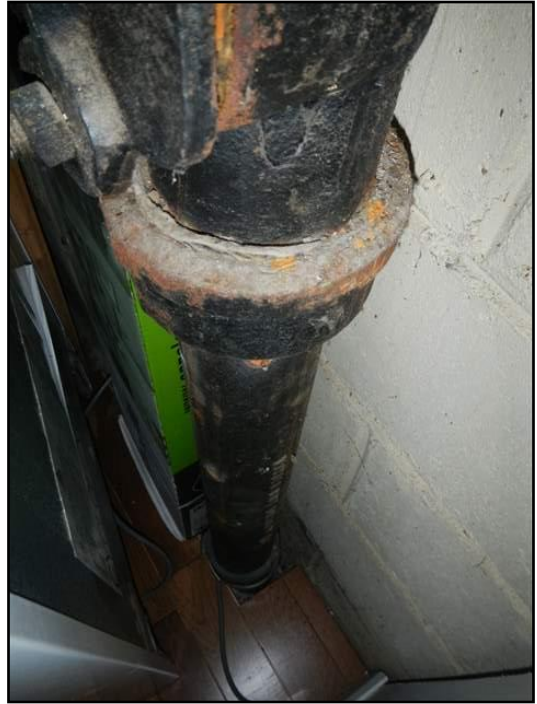
Condition: • The cast iron waste piping is near the end of its normal life expectancy and is prone to rusting through or splitting. Replacement may be required in the near future.

Cast iron old -

Task: Replace

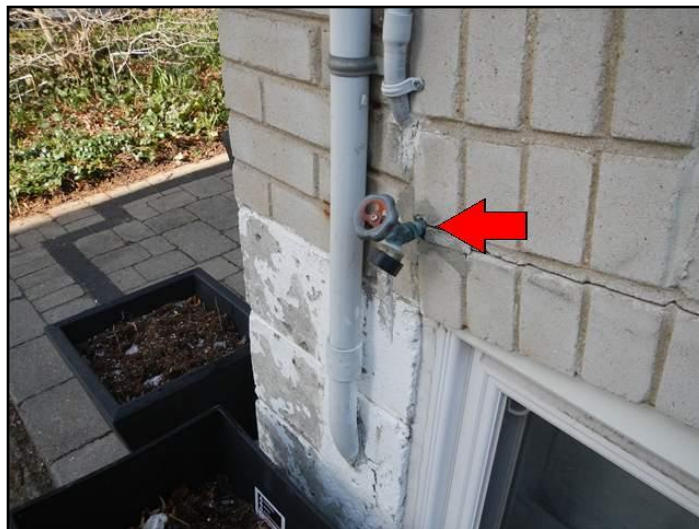
Condition: • [Not frost free](#)

Not frost free

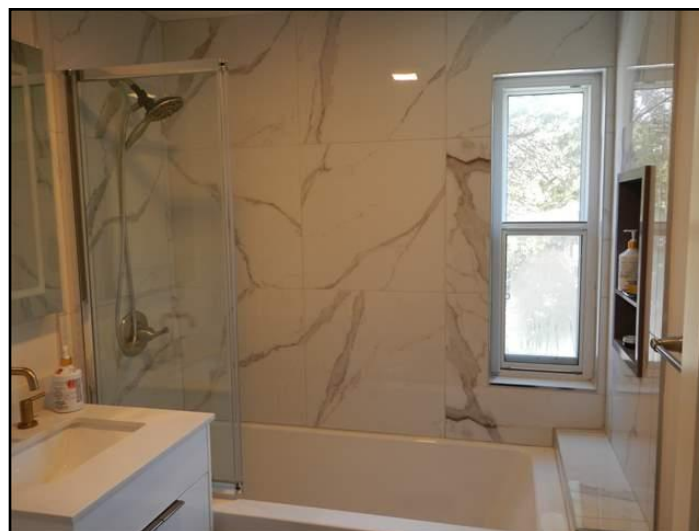
Condition: • Window - vulnerable area for leaks

Shower - Window vulnerable -

Task: Improve

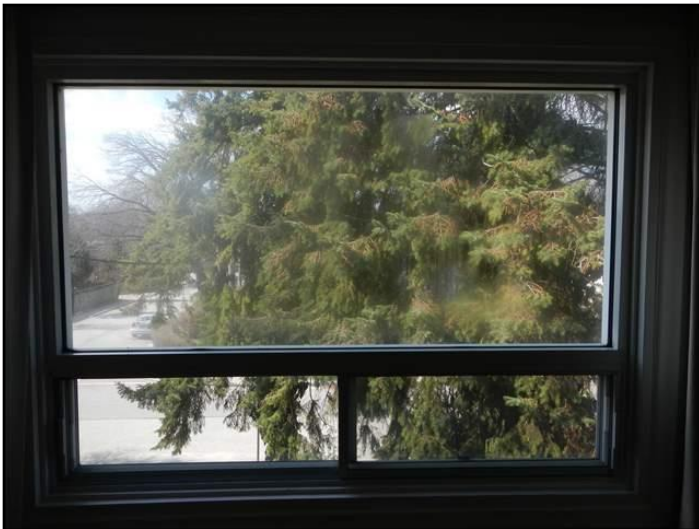
Front bedroom

Condition: • [Lost seal on double or triple glazing](#)

Task: Replace

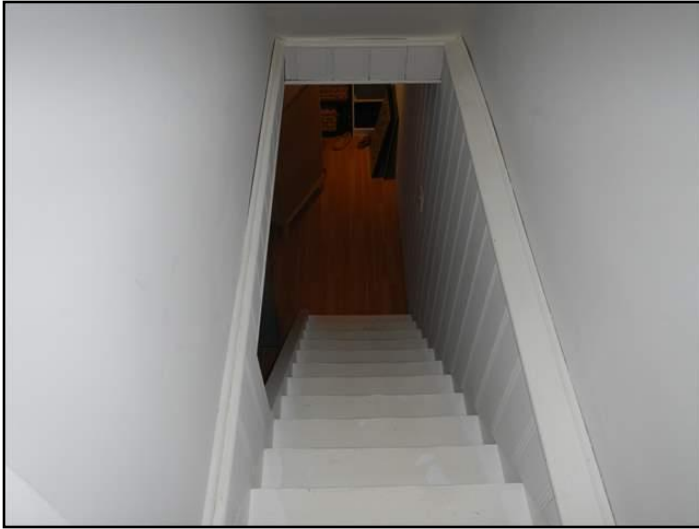
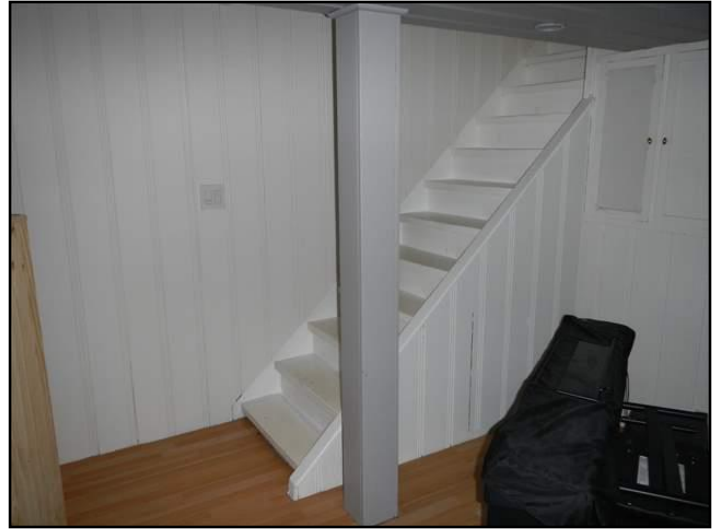
Condition: • [Missing](#)

This is a serious fall arrest issue.

Missing

Task: Provide

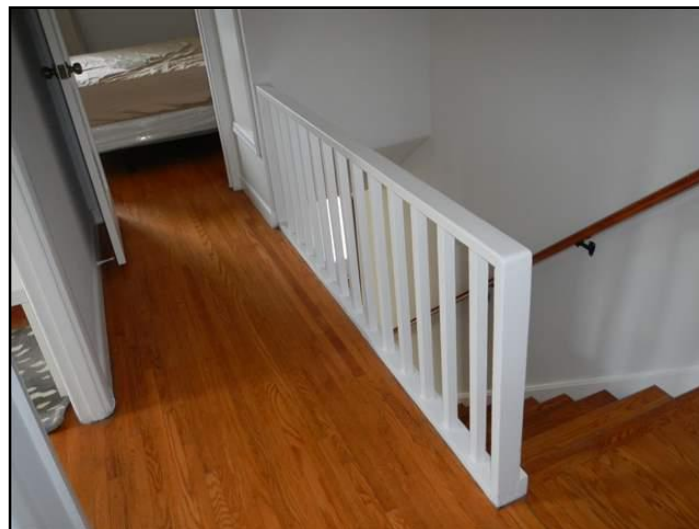
Condition: • [Too low](#)

Too low

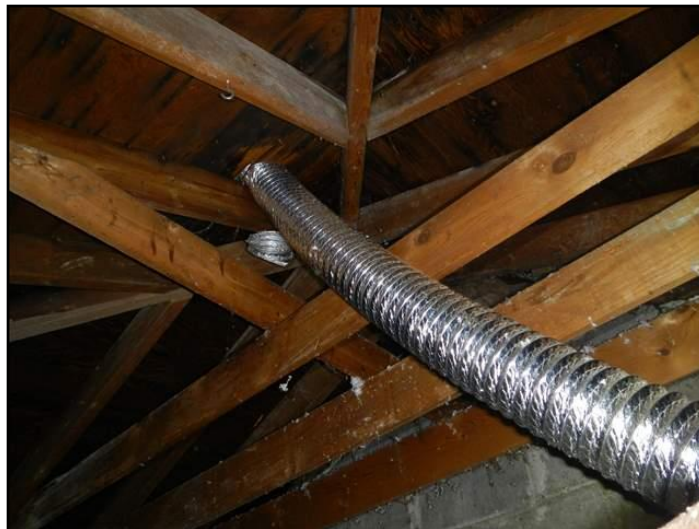
Condition: • Ductwork not insulated in Attic
Task: Improve
Time: As required
Cost: Minor

Ductwork not insulated in Attic
