# YOUR INSPECTION REPORT

67 Westholme Avenue  
Toronto, ON M6P 3B9

INSPECTION DATE:  
Friday, January 11, 2019

RE: Report No. 2390, v.2  
67 Westholme Avenue  
Toronto, ON  
M6P 3B9

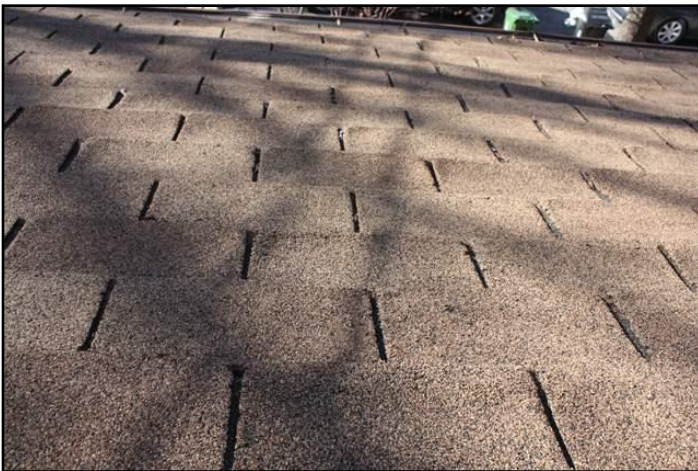
**Condition:** • Aging

Typical lifespan for this type of roof covering is 15-17 years. The current roof covering is reported to be 14 years old and is aging with typical wear - granule loss.

1. Aging

**Task:** Replace

**Time:** Less than 3 years

**Cost:** \$4,000 - \$6,500

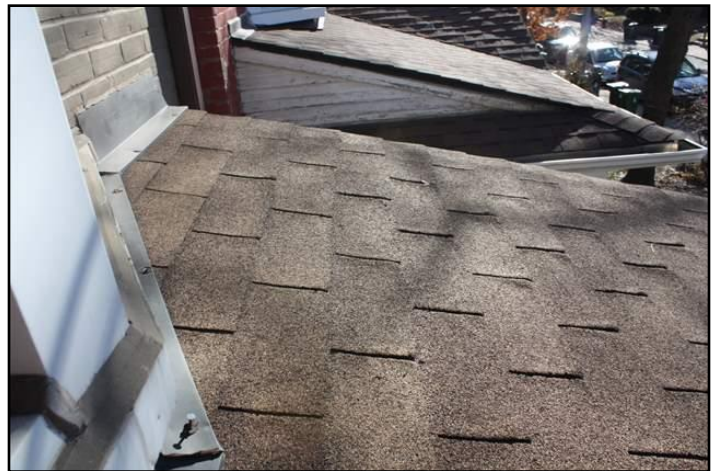
2. Aging

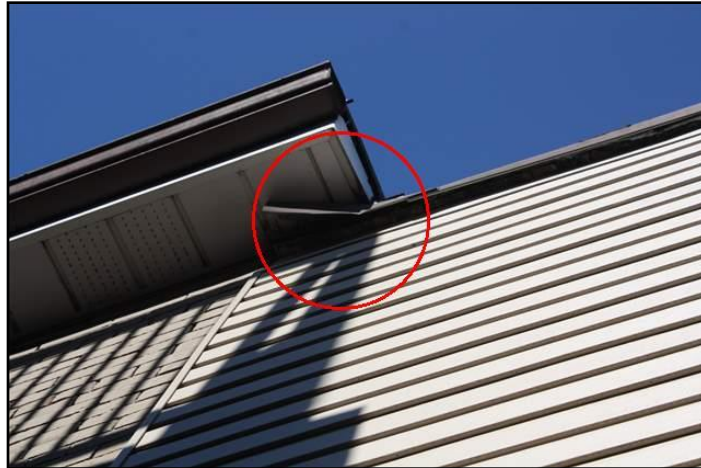
**Condition:** • [Damage, loose, bent](#)

**Implication(s):** Chance of water damage to contents, finishes and/or structure

3. Damage, loose, bent

**Task:** Repair

**Time:** Less than 1 year

**Cost:** Minor Regular maintenance item

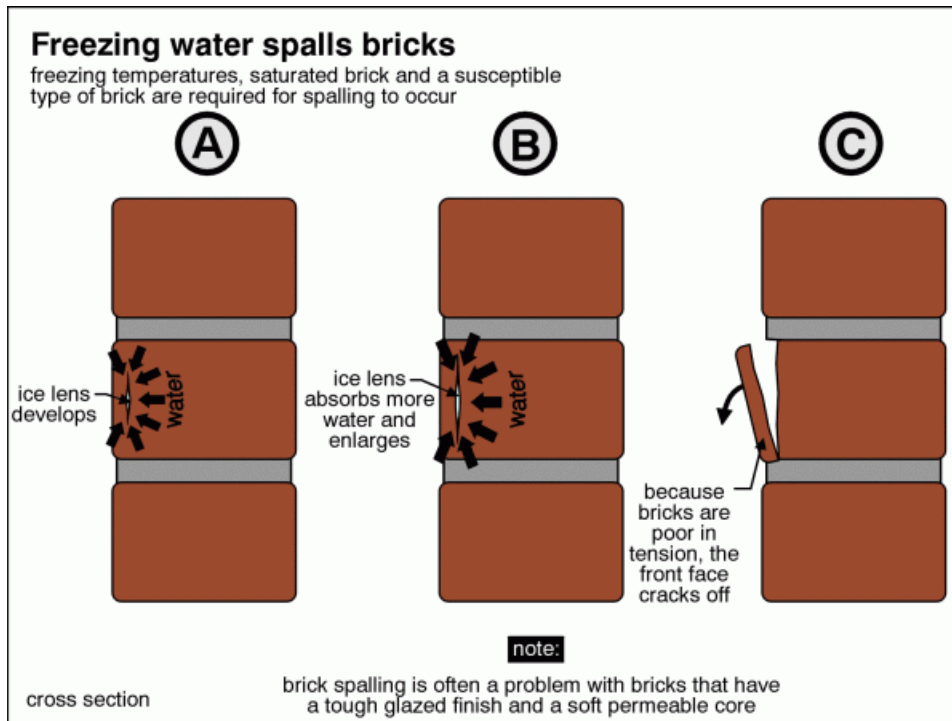
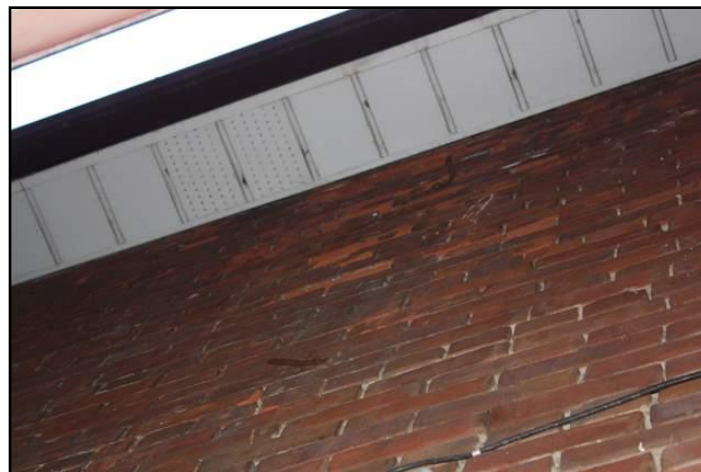
4. Example

**Condition:** • [Spalling](#)

Minor Spalling/ masonry deterioration noted at various areas. Repair / Replace / Tuck point masonry. This is regular maintenance for a home of this age.

**Implication(s):** Chance of structural movement | Weakened structure

**Task:** Repair / Replace

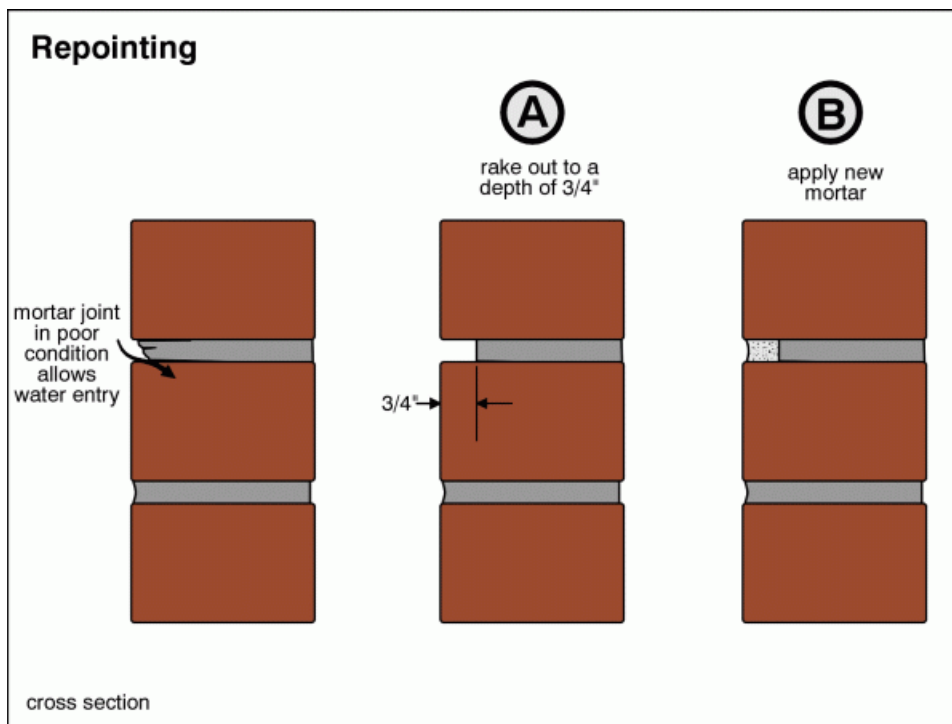
**Condition:** • [Mortar deterioration](#)

Tuck Pointing (Re-pointing) is a common maintenance item with all older brick and concrete properties.

**Implication(s):** Chance of structural movement | Weakened structure | Chance of water entering building

Provide mortar (Repointing, Tuck pointing) at various wall locations.

**Task:** Improve

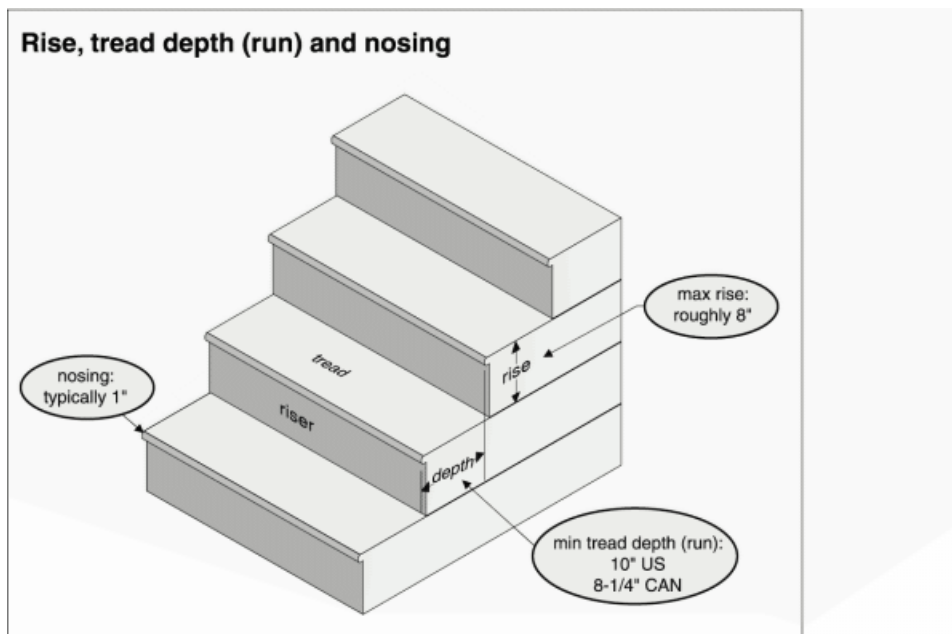
**Condition:** • [Stair rise too big or not uniform](#)

**Implication(s):** Trip or fall hazard

**Task:** Improve

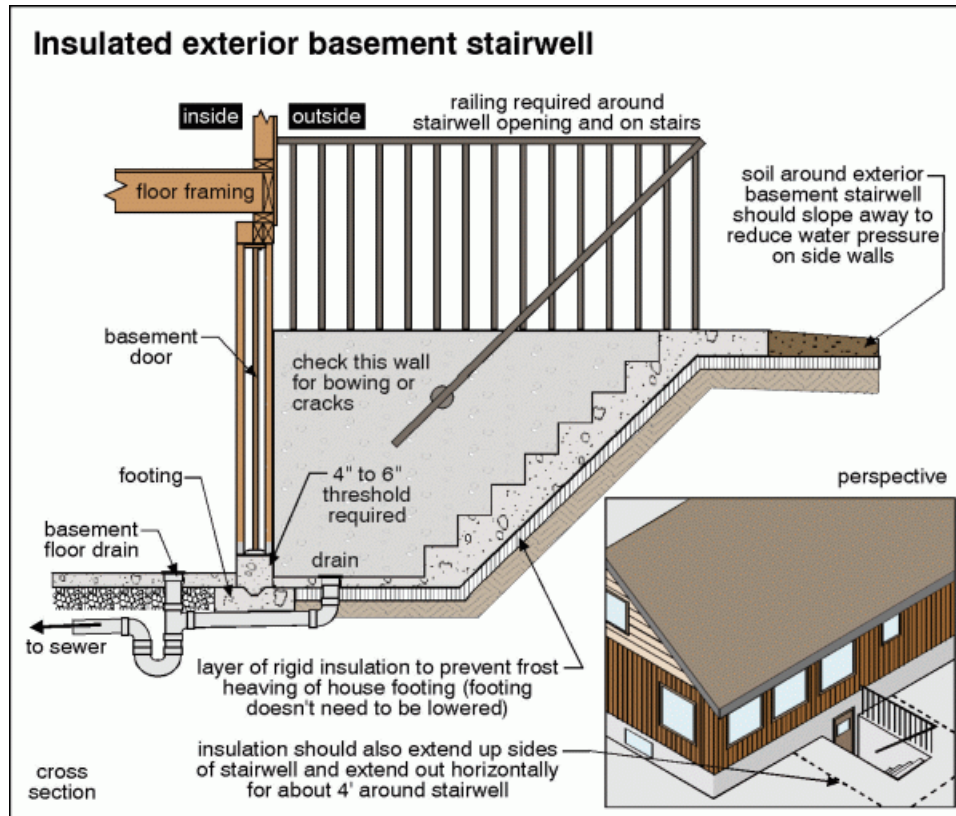
**Condition:** • [Guard and handrail problems](#)

**Implication(s):** Fall hazard

**Task:** Provide Handrail

**Time:** Less than 1 year

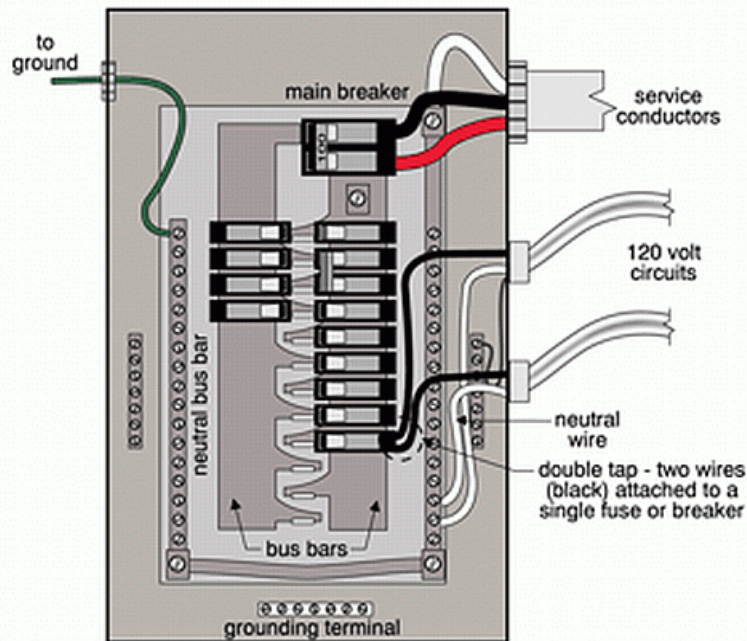
## Double tapping (double lugging)

**Condition:** • [Double taps](#)

**Implication(s):** Fire hazard

**Cost:** Less than - \$200

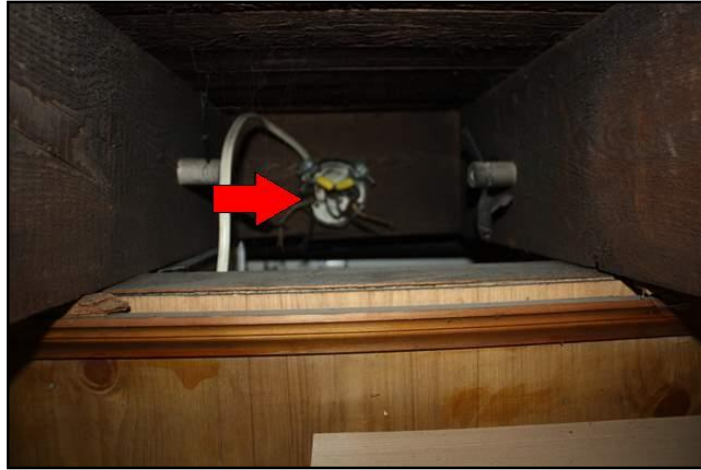
**Condition:** • [Cover loose or missing](#)

**Implication(s):** Fire hazard | Electric shock

5. Cover loose or missing

**Time:** Immediate

**Cost:** Minor

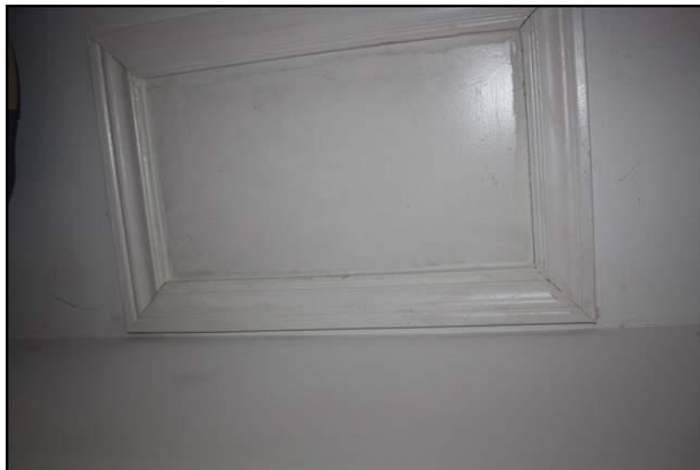
**Condition:** • [Inaccessible](#)

The attic hatch is sealed shut, therefore we could not observe the attic space. Provide larger access and inspect attic for issues with structure, insulation, water damage, vermiculite asbestos, and mold.

6. *Inaccessible*

**Task:** Provide access and inspect

**Time:** Less than 1 year

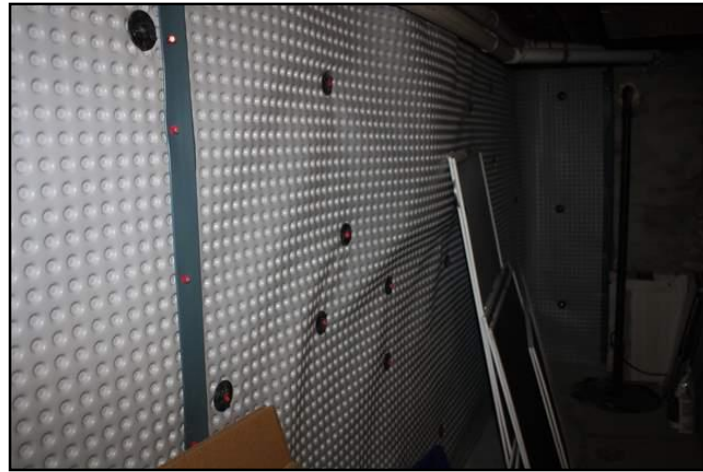
**Condition:** • [Drainage membrane](#)

For Your Information - drainage membrane was observed at part of the foundation wall. This is a common method used to help manage moisture on stone foundations.

7. Drainage membrane

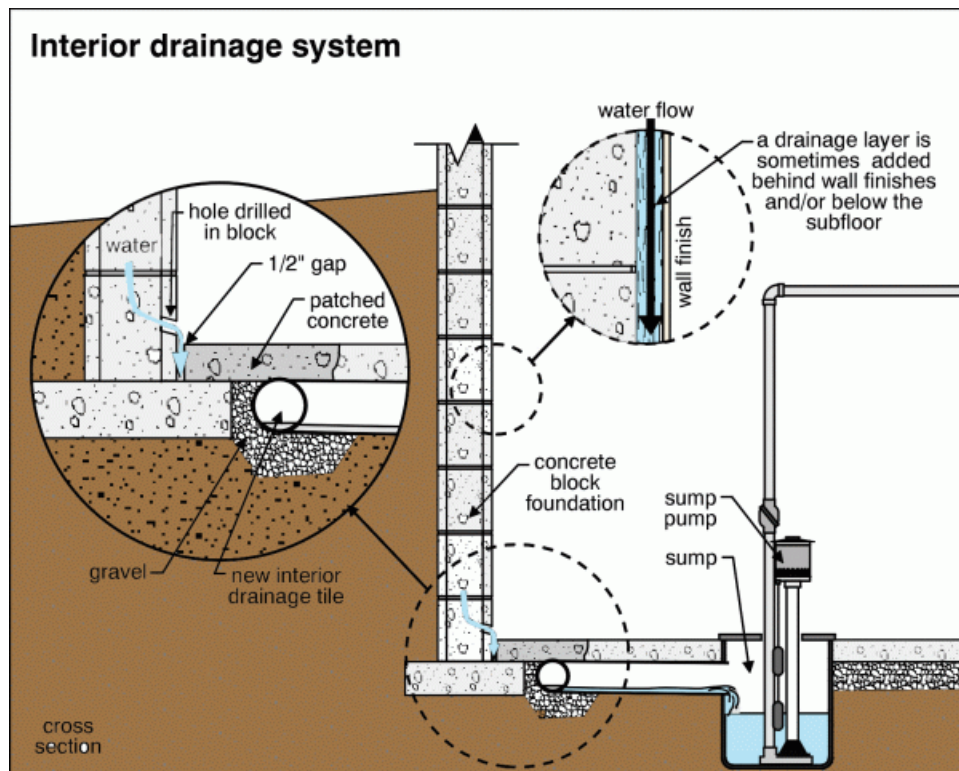
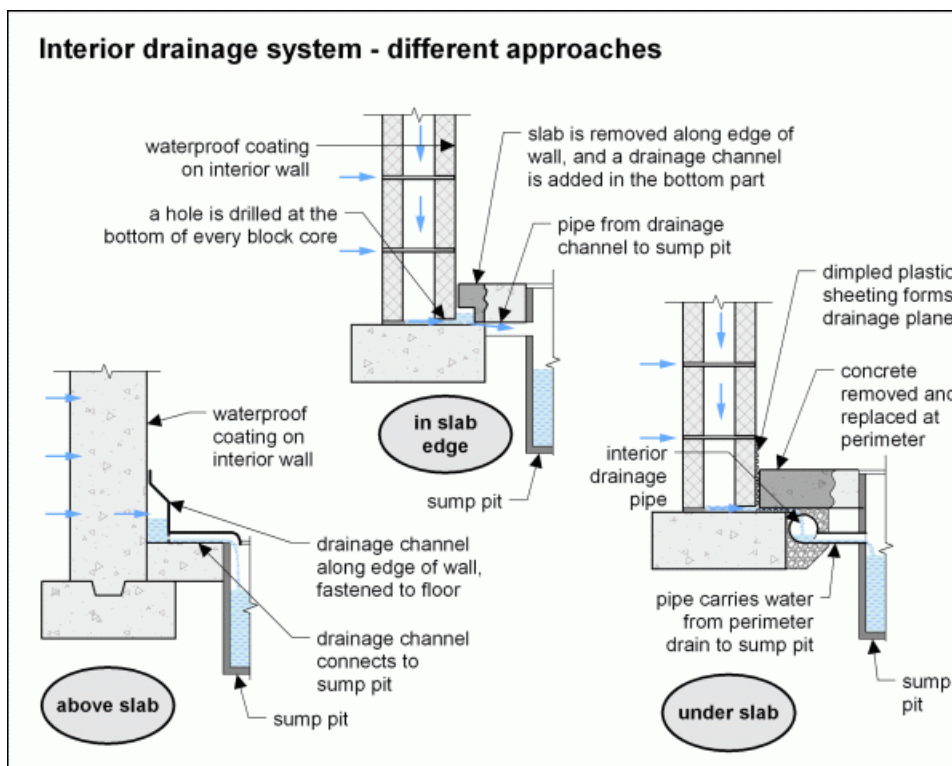
**Condition:** • [Floor patched around perimeter](#)

**Implication(s):** Chance of water damage to contents, finishes and/or structure

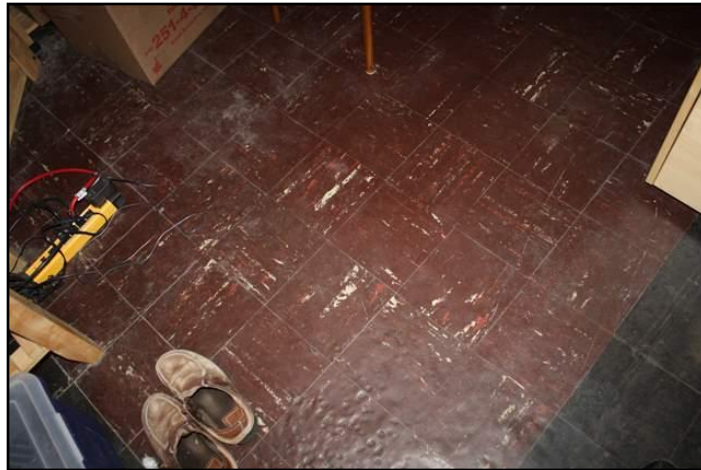
**Condition:** • Possible asbestos containing materials

Old 9 x 9 Floor tiles or mastic glue may contain asbestos. This type of floor tile is commonly found in older homes. If you plan to remove / disturb the floor tiles, it is recommended that lab testing be performed prior to doing so.

**Implication(s):** Health hazard

8. Possible asbestos containing materials

**Time:** Prior to removal / disturbing.

**Cost:** \$400-\$600 for testing. \$15-\$20 per sq ft for removal
