YOUR INSPECTION REPORT

54 Albani St.
Etobicoke, ON

INSPECTION DATE:
Tuesday, August 15, 2017

RE: Report No. 2150
54 Albani St.
Etobicoke, ON

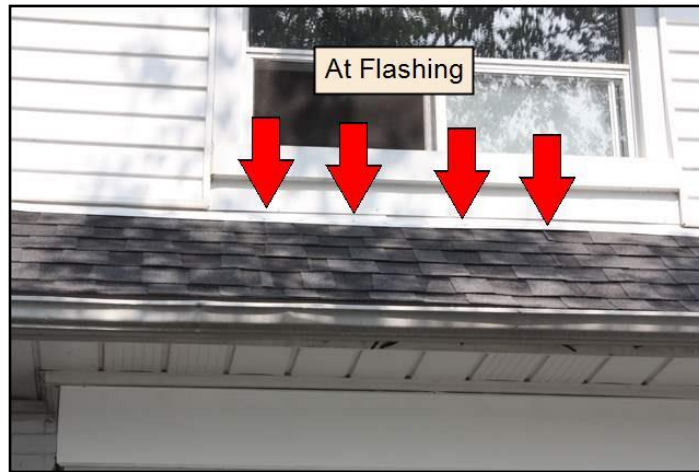
Condition: • [Exposed fasteners](#)

Implication(s): Chance of water damage to contents, finishes and/or structure

1. *Exposed fasteners*

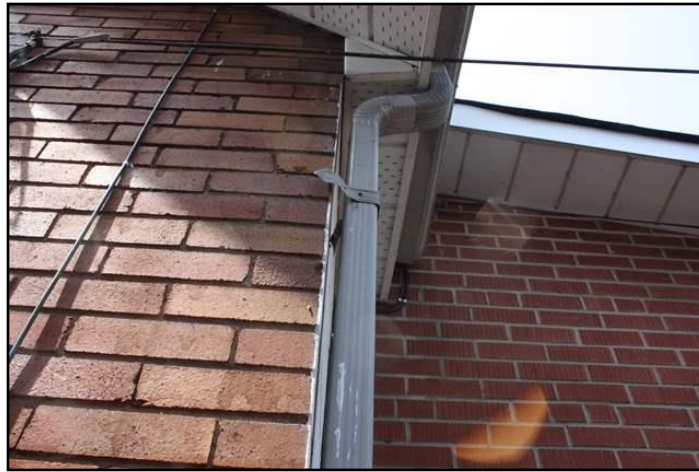
Condition: • [Not well secured](#)

Implication(s): Leakage

3. Not well secured

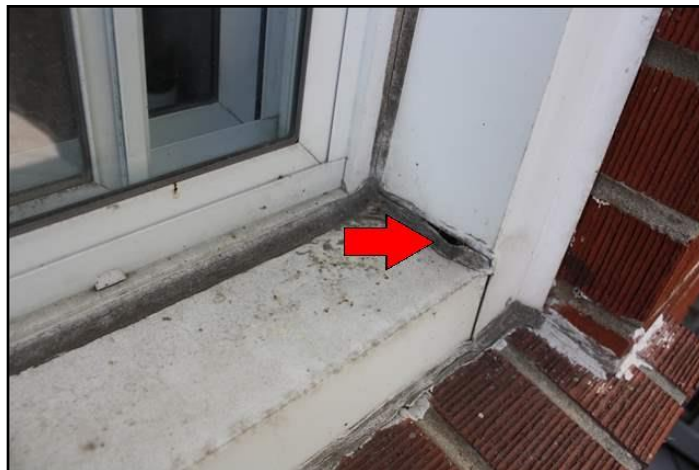
Condition: • [Caulking missing or ineffective](#)

Implication(s): Chance of water damage to contents, finishes and/or structure

4. *Caulking missing or ineffective*

Task: Improve

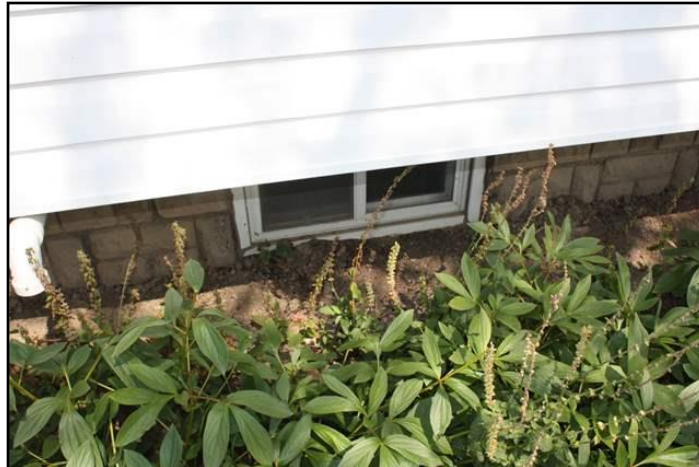
Condition: • Sill - Near or at Grade Level

Vulnerable area for leakage.

5. Sill - Near or at Grade Level

Task: Monitor / Improve

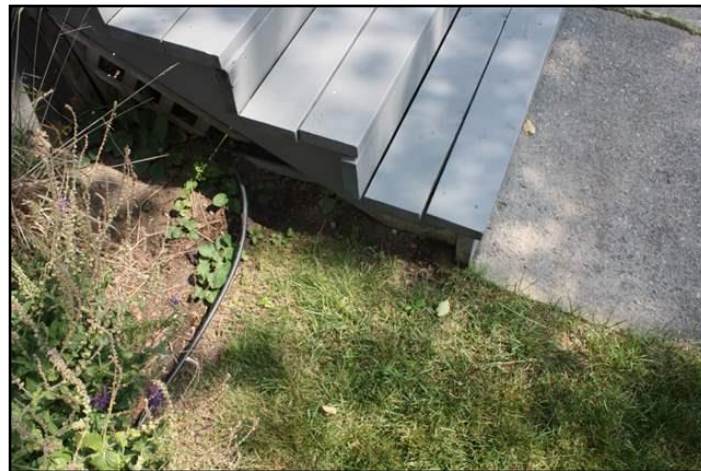
Condition: • [Steps springy, loose or sagging](#)

Implication(s): Trip or fall hazard

6. Steps springy

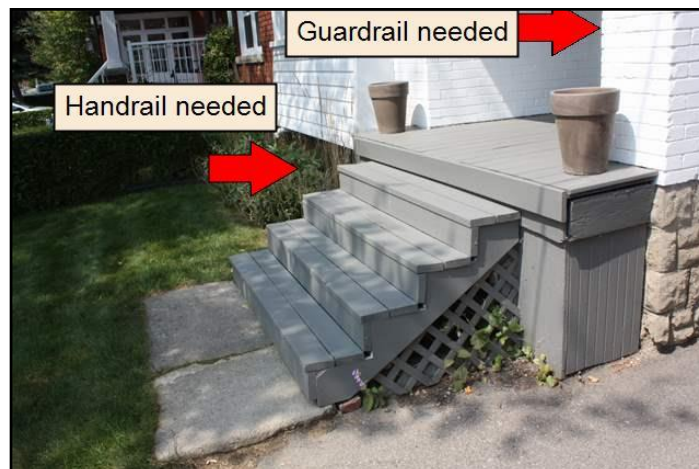
Condition: • [Missing](#)

Implication(s): Fall hazard

7. Missing Hand and Guardrail

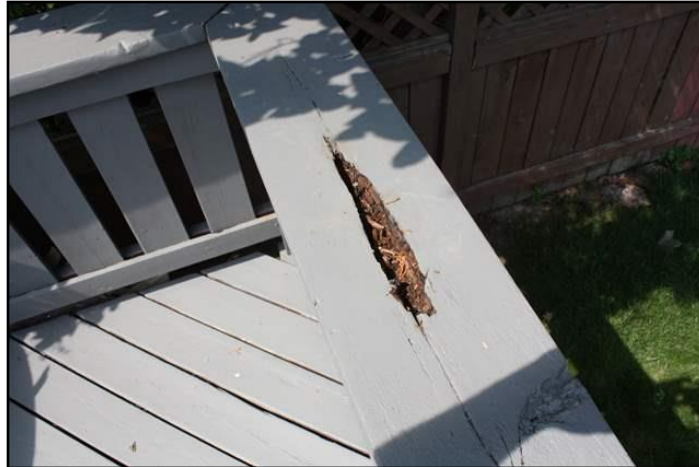
Condition: • Rot

Implication(s): Fall hazard

8. Example of Rot

Task: Replace

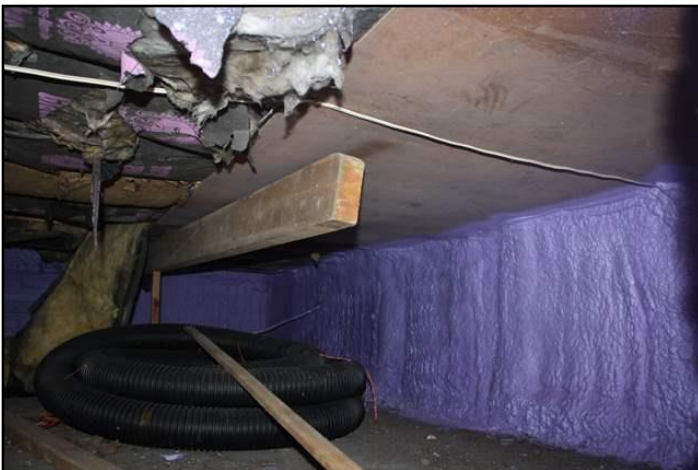
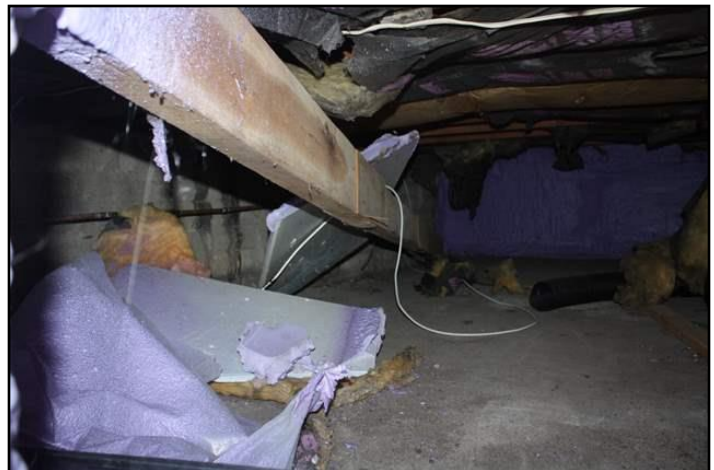
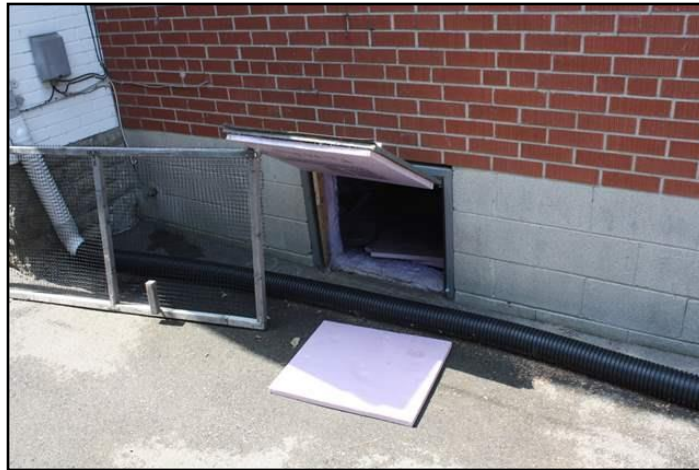
Condition: • Missing

Upon viewing the crawlspace we noted a beam that was not attached. We could not determine if this beam was intended to be structural or was originally there to support and keep the insulation in place. Regardless of its use, due to the span of joist under the Addition, we recommend that a contractor analyze and provide support beams and posts if necessary.

Implication(s): Chance of structural movement**Location:** Crawl Space**Task:** As soon as possible / Repair**Time:** Less than 1 year**Cost:** Consult with Contractor

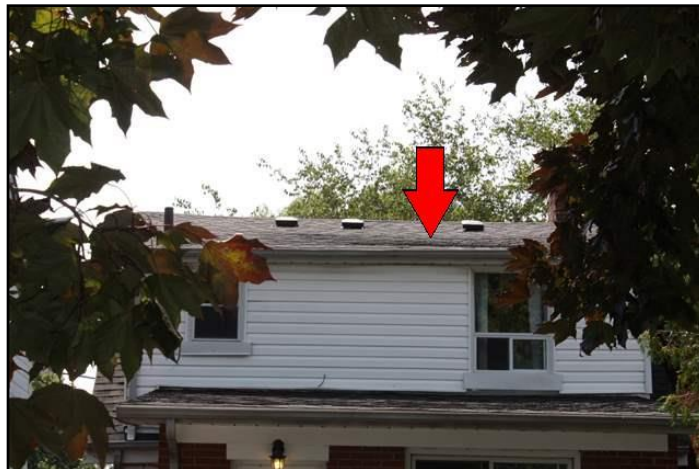
Condition: • [Sagging](#)

12. Minor Sag

Task: Replace sheathing in this area

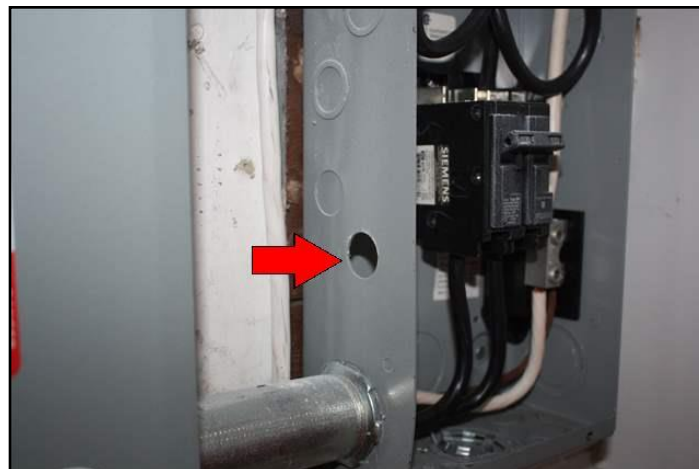
Condition: • [Unprotected openings](#)

14. Unprotected openings

any exposed panel openings (that would allow access to the inside of the panel) should be fitted with secure covers

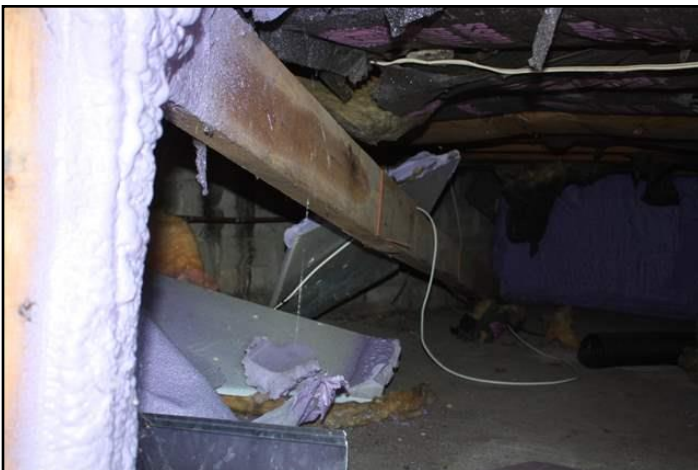
Condition: • [Not well secured](#)

Implication(s): Fire hazard | Electric shock

15. Not well secured

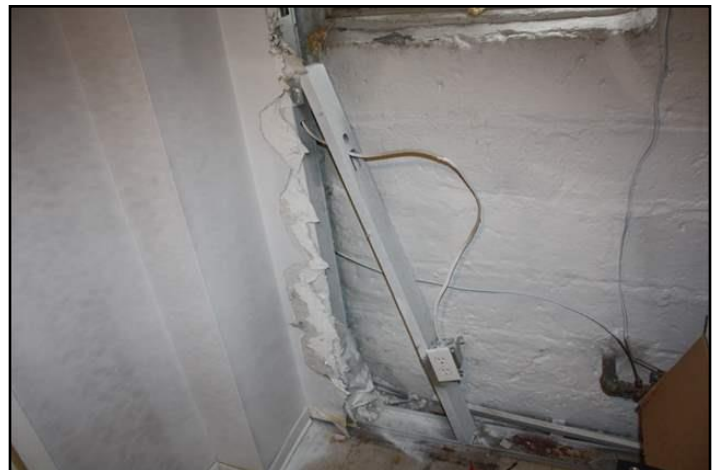
16. Not well secured

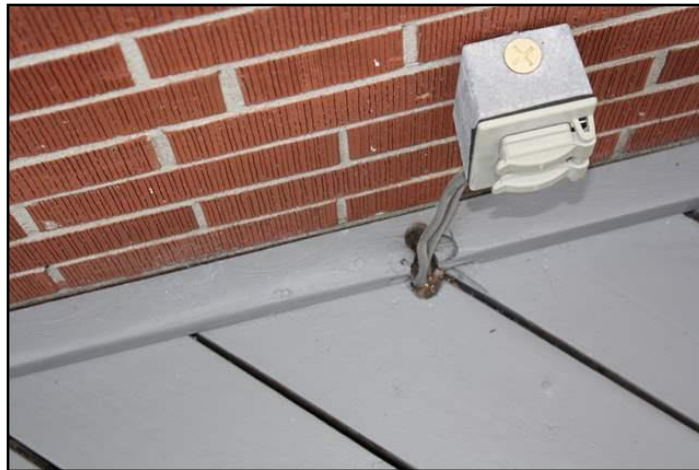
Condition: • [Flexible conduit needed](#)

17. Flexible conduit needed

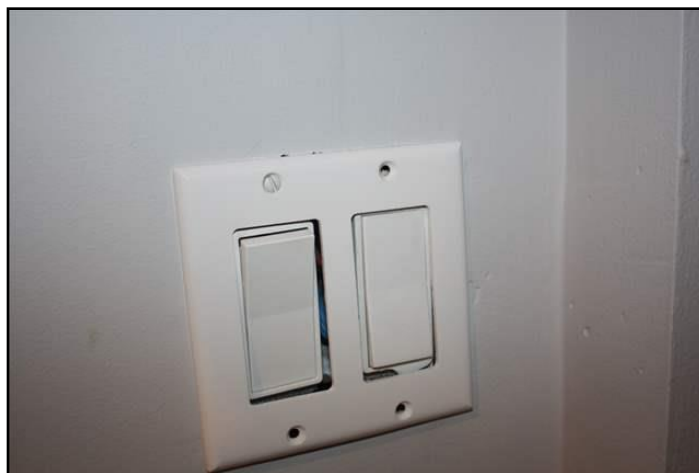
Condition: • [Loose](#)

18. Loose

Task: Repair or replace

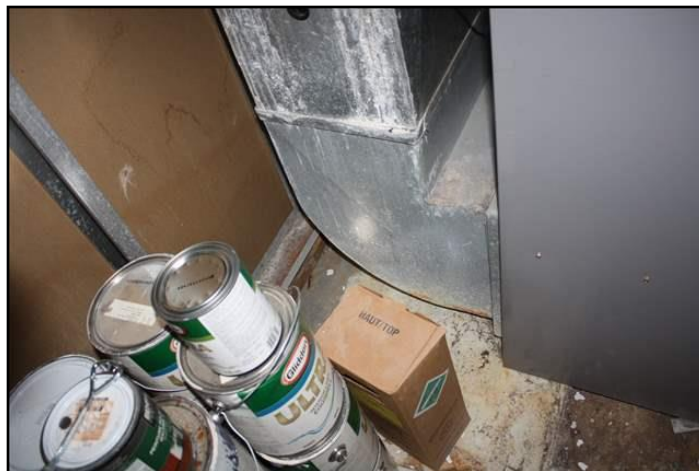
19.

Condition: • Rust noted at furnace ducting . Likely caused by a prior humidifier leak.

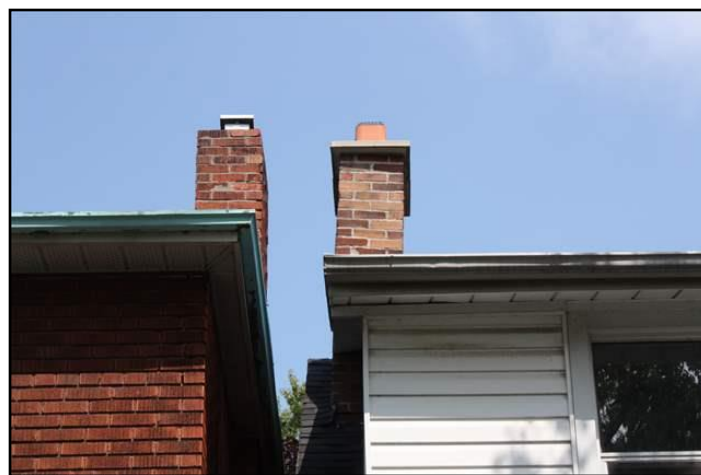
Condition: • [Settling or leaning](#)

Minor lean of chimney noted. Have Chimney specialist evaluate.

Implication(s): Hazardous combustion products entering home | Chance of chimney movement | Chance of water damage to contents, finishes and/or structure

20. leaning

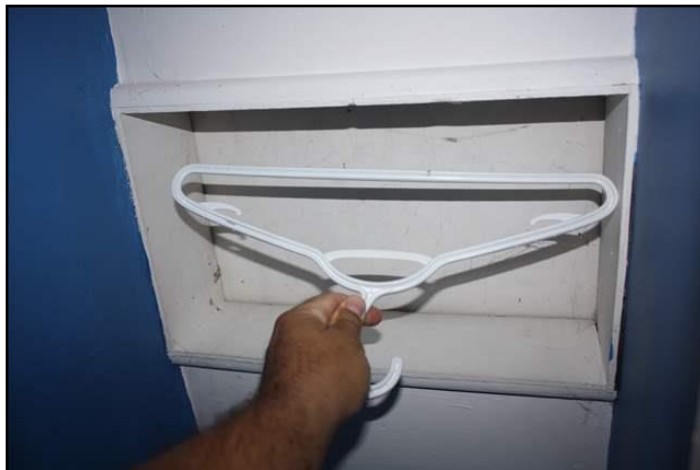
Condition: • [Inaccessible](#)

The attic hatch opening was too small, therefore we could not observe the attic. Attics are important areas. Provide larger access and inspect attic for issues with structure, insulation, water damage, vermiculite asbestos, and mold.

21. Small hatch

Task: Increase hatch opening and inspect

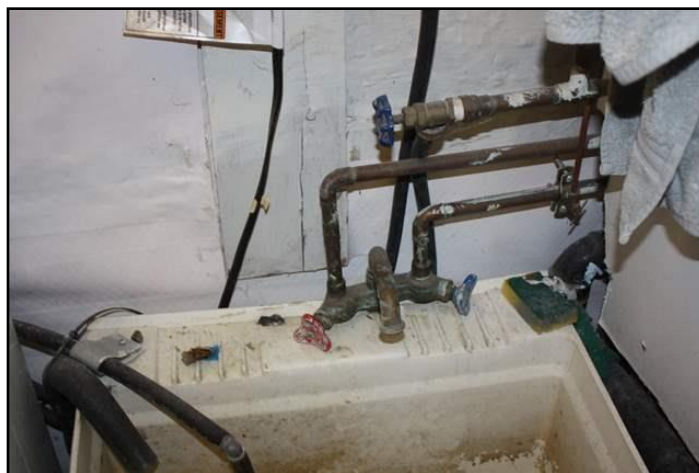
Condition: • [Poor support](#)

Implication(s): Leakage | Chance of water damage to contents, finishes and/or structure

22. Poor support

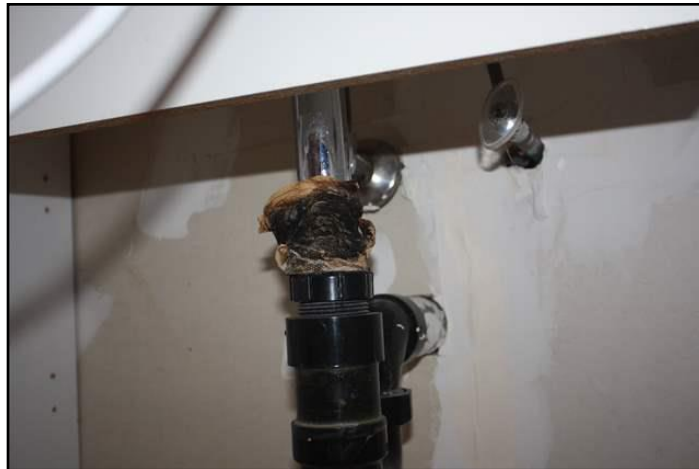
Condition: • [Nonstandard shape or material](#)

23. *Nonstandard material*

Task: Repair

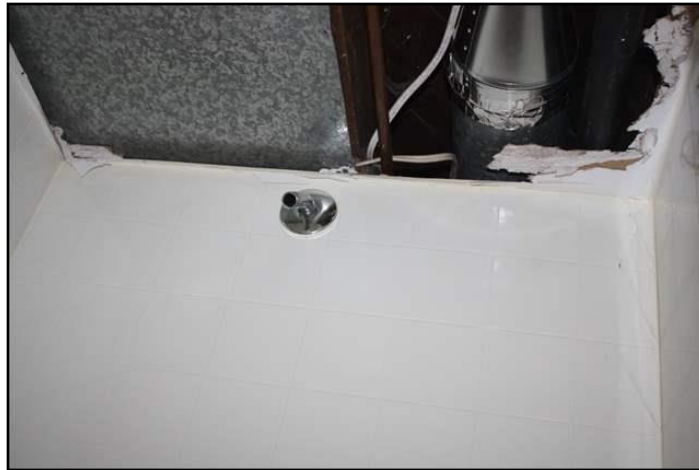
24.

Condition: • Missing

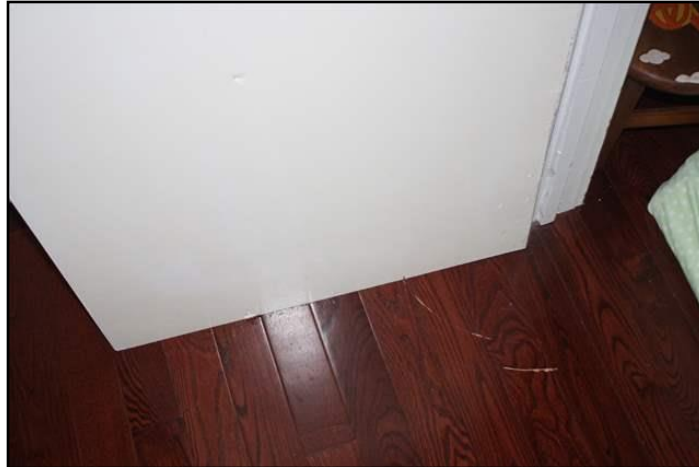
Condition: • [Loose or poor fit](#)

Implication(s): Chance of damage to finishes and structure

25. Door rubs floor

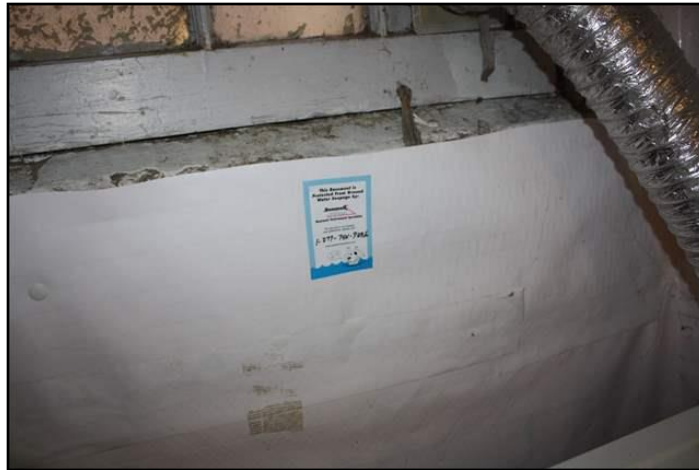
Condition: • [New dampproofing material](#)

Implication(s): Chance of water damage to contents, finishes and/or structure

26. New dampproofing material

Task: Monitor / Click link to read more information
