YOUR INSPECTION REPORT

631 Hudson Ave
Albany, NY

Wednesday, May 2, 2018

RE: Report No. 1001, v.7
631 Hudson Ave
Albany, NY

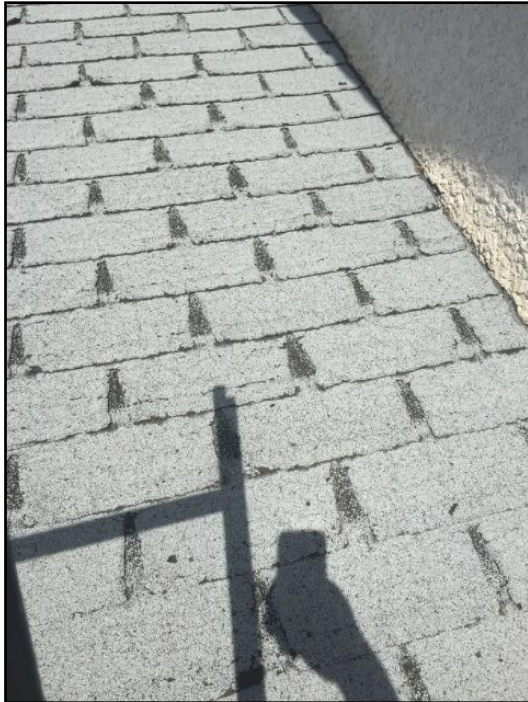
1. Condition: • [Near end of life expectancy](#)

Implication(s): Chance of water damage to structure, finishes and contents

2. Near end of life expectancy

Time: Less than 2 years

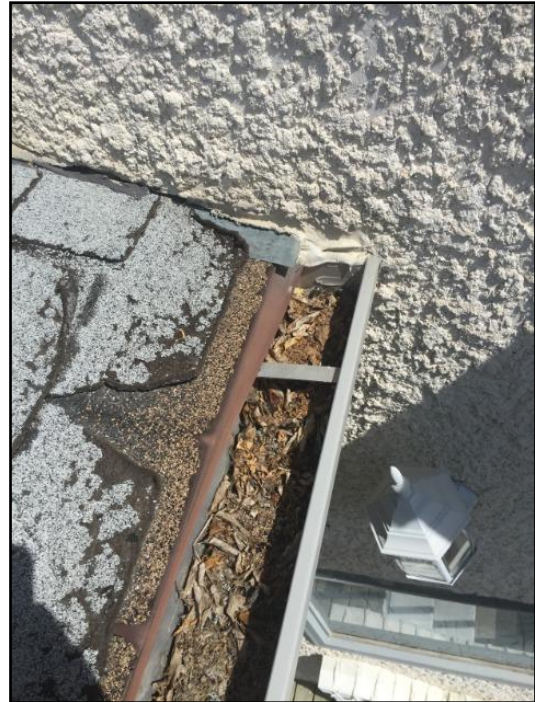
3. Near end of life expectancy

2. Condition: • [Near end of life expectancy](#)

Shingles are curling and cupping replace roofing in the next few years, to do just over the garage would be \$500 to \$1000

Task: Repair or replace

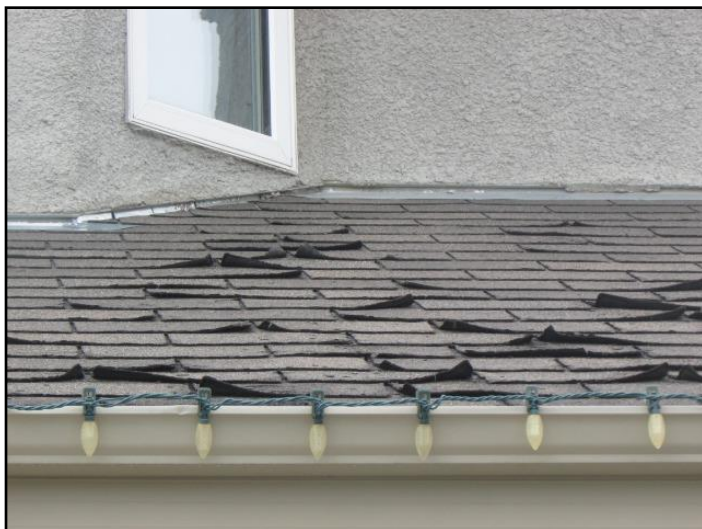
4. Near end of life expectancy

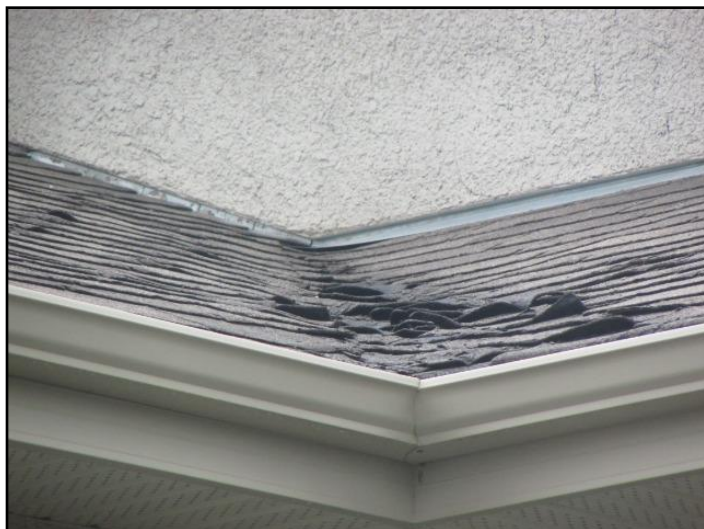
5. Near end of life expectancy

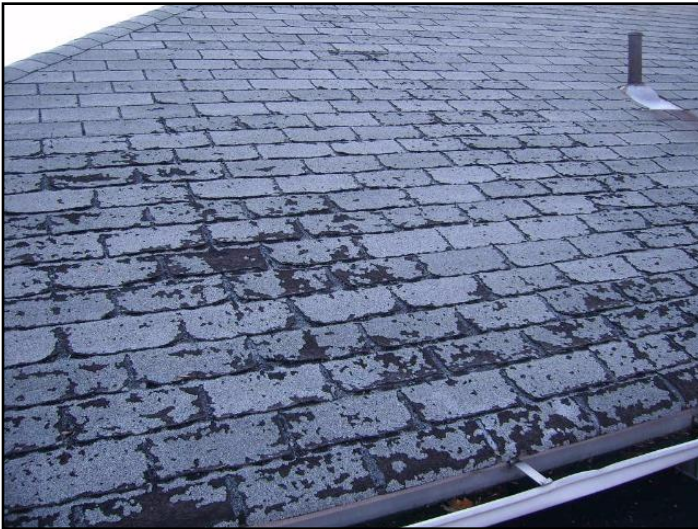
3. Condition: • [Granule loss](#)

Implication(s): Chance of water damage to structure, finishes and contents

6. Granule loss

Task: Replace

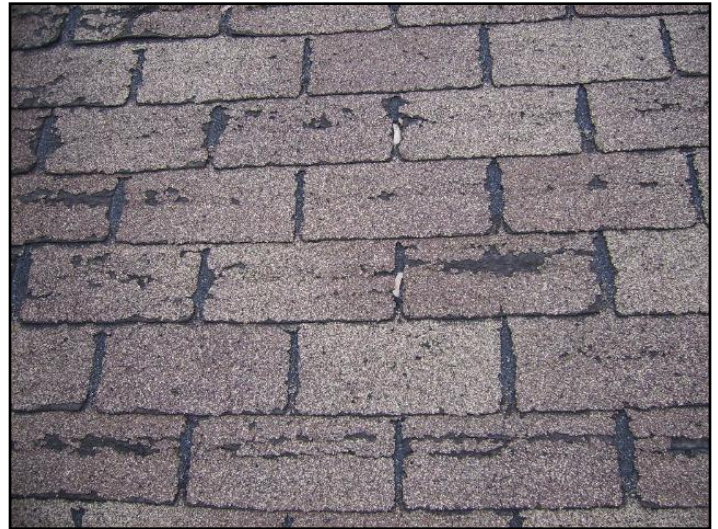
7. Granule loss

4. Condition: • [Granule loss](#)

Implication(s): Chance of water damage to structure, finishes and contents

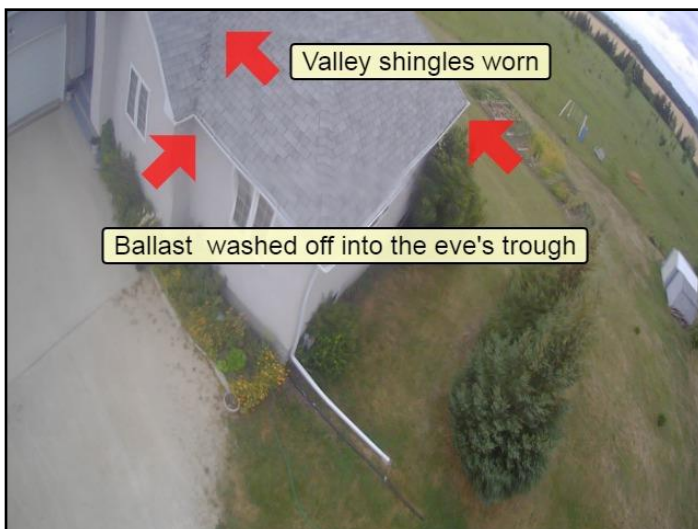
7. Condition: • [Vulnerable areas](#)

Implication(s): Chance of water damage to structure, finishes and contents

8. Vulnerable areas

Task: Repair or replace

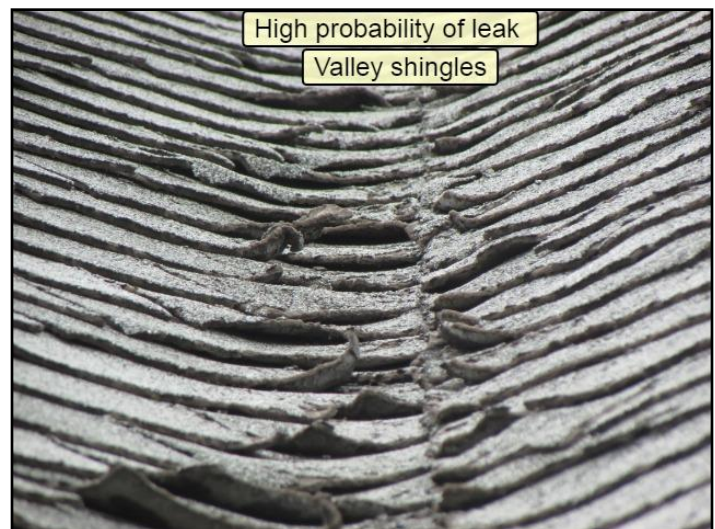
9. Vulnerable areas

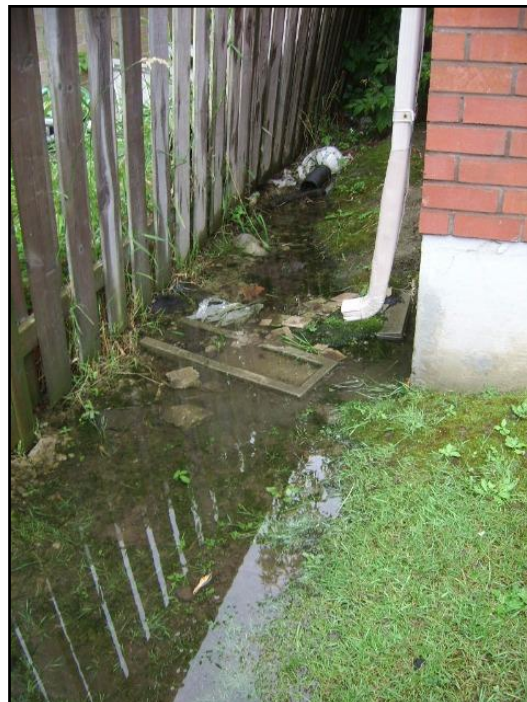
11. Condition: • [Discharge too close to building](#)

Implication(s): Chance of water damage to structure, finishes and contents

10. Downspouts end too close to building

Task: Improve

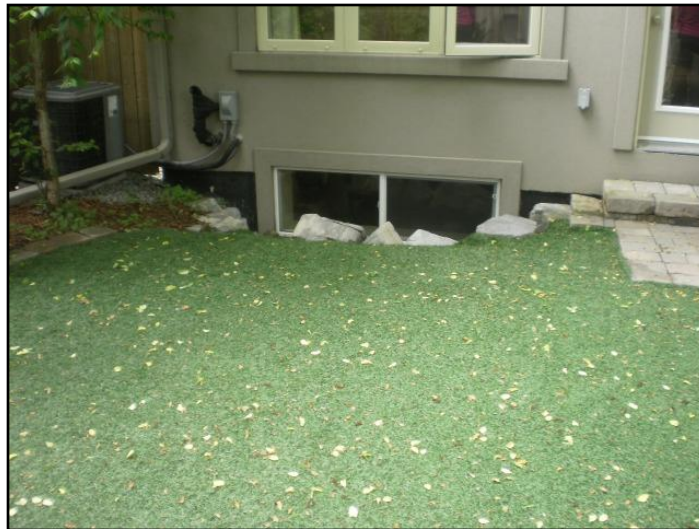
13. Condition: • [Improper slope or drainage](#)

Implication(s): Chance of water damage to structure, finishes and contents

12. Improper slope

Task: Improve

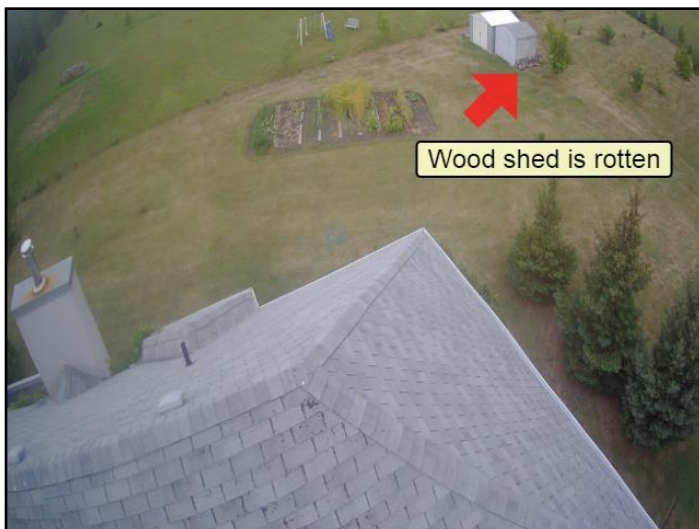
14. Condition: • [No swale](#)

When looking at my drone footage the lot slope looked good

13. No swale

Task: Further evaluation

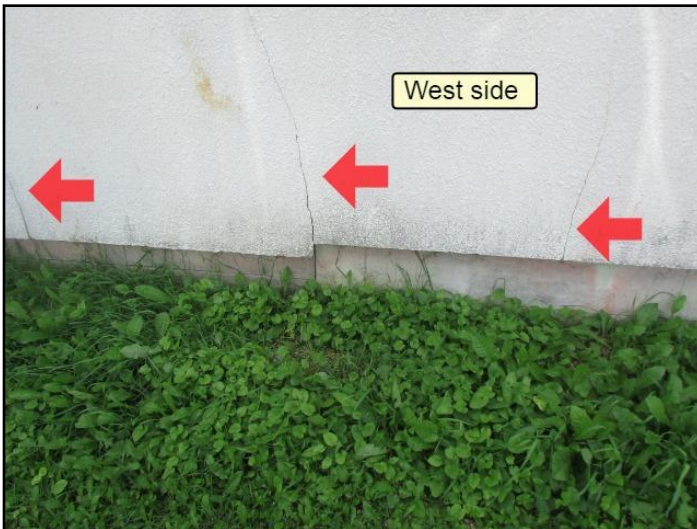
15. Condition: • Typical minor cracks

16. Typical minor cracks

Keep the water away from the foundation by extending the down spouts. Patch and monitor all cracks.

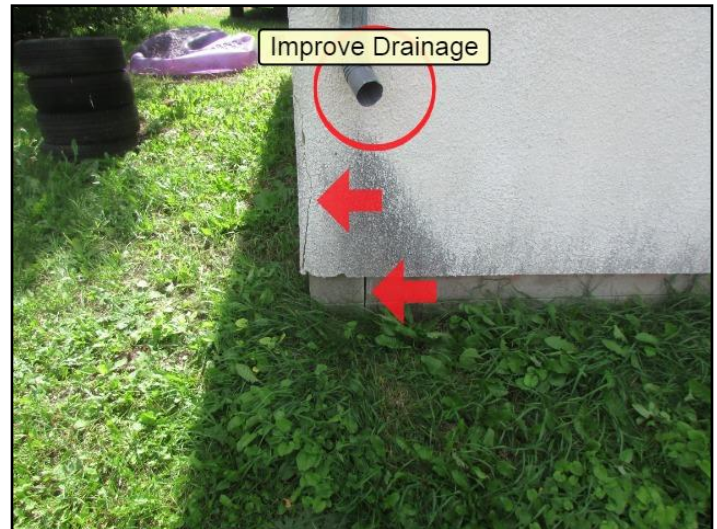
17. Typical minor cracks

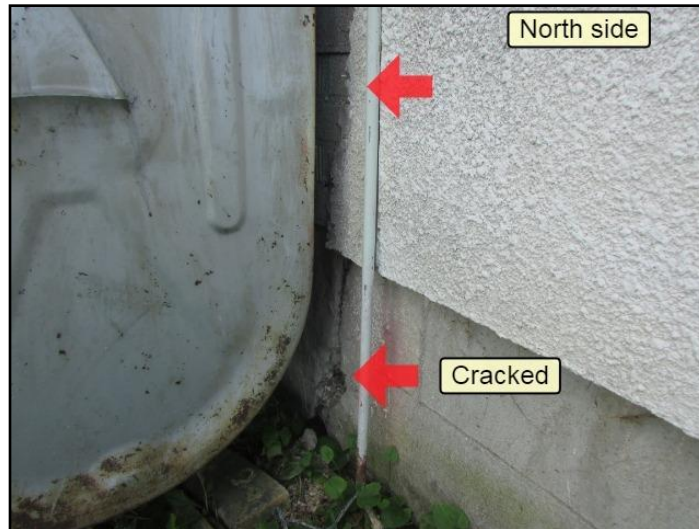
16. Condition: • [Cracked](#)

Implication(s): Chance of water damage to structure, finishes and contents | Weakened structure

18. Cracked

Task: Further evaluation

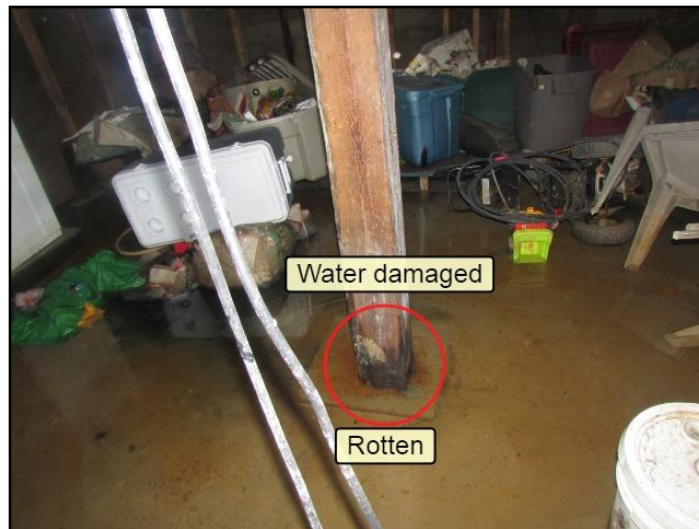
17. Condition: • [Rot or insect damage](#)

Sump pit failed and support post is water soaked and rotten. Recommend replace with new telly post.

Implication(s): Weakened structure | Chance of structural movement

19. Rot or insect damage

Task: Repair or replace

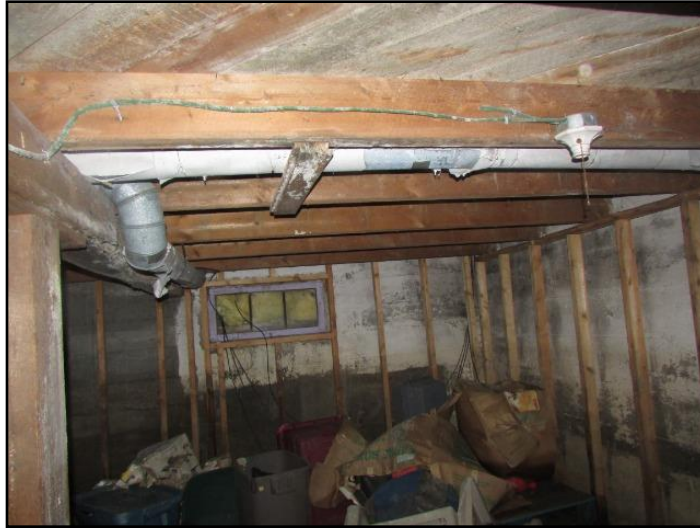
18. Condition: • [Heaved](#)

Implication(s): Weakened structure | Chance of structural movement

20. Heaved

Task: Further evaluation

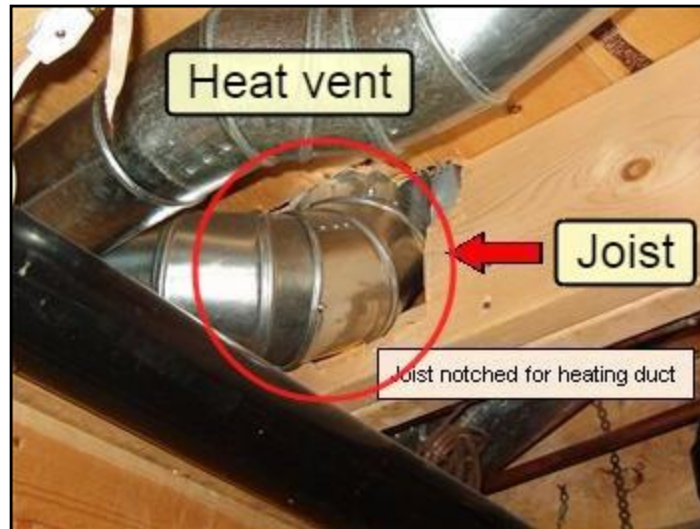
21. Damaged joist

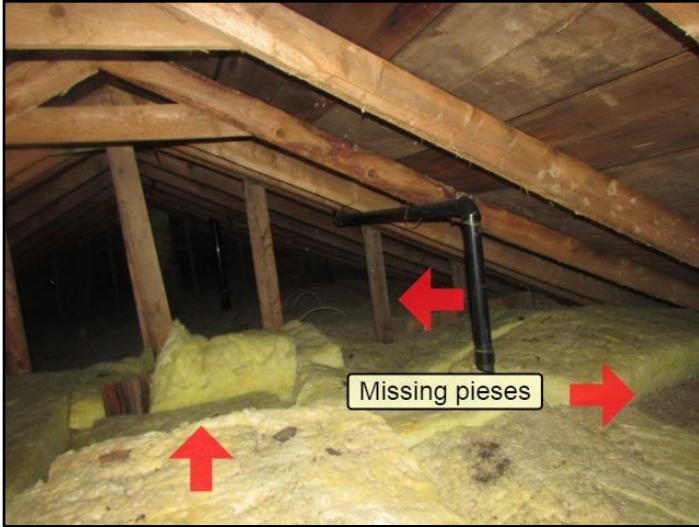
19. Condition: • [Gaps or voids](#)

Attic insulation is inconsistent, some missing and some gaps.

24. Gaps or voids

Task: Improve

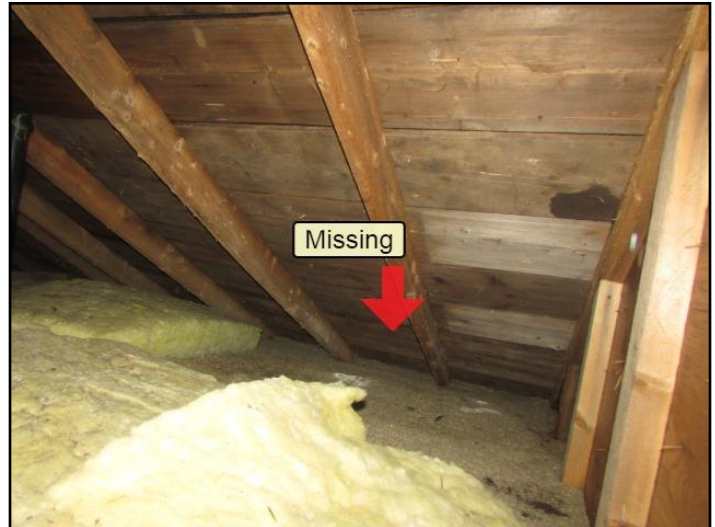
25. Gaps or voids

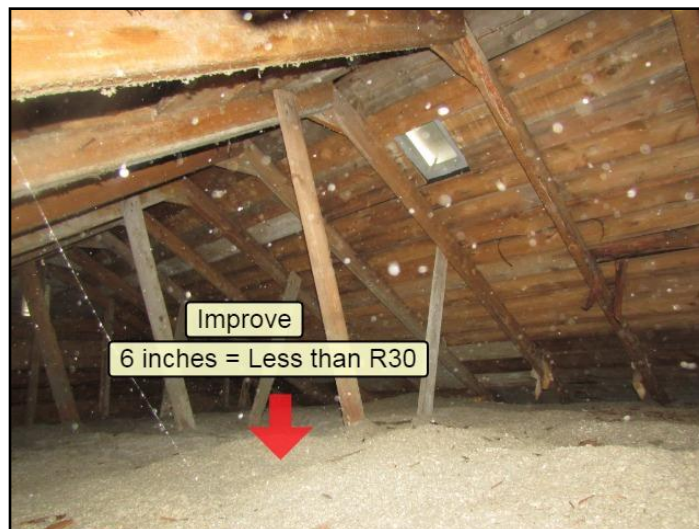
26. Gaps or voids

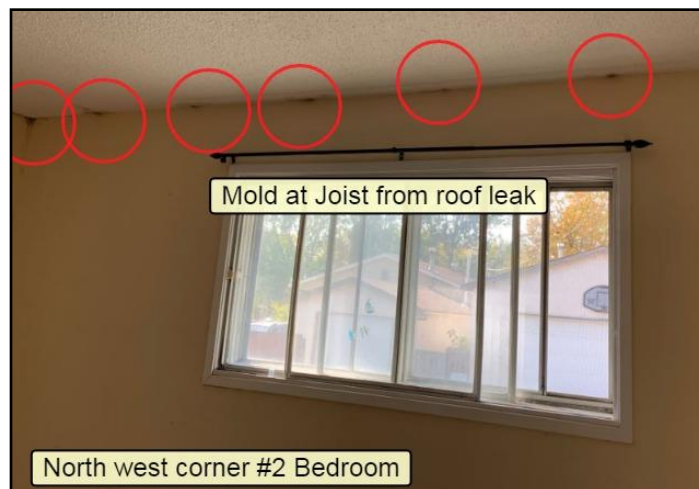
20. Condition: • [Shadow effect](#)

27. Shadow effect

Air quality test recommended

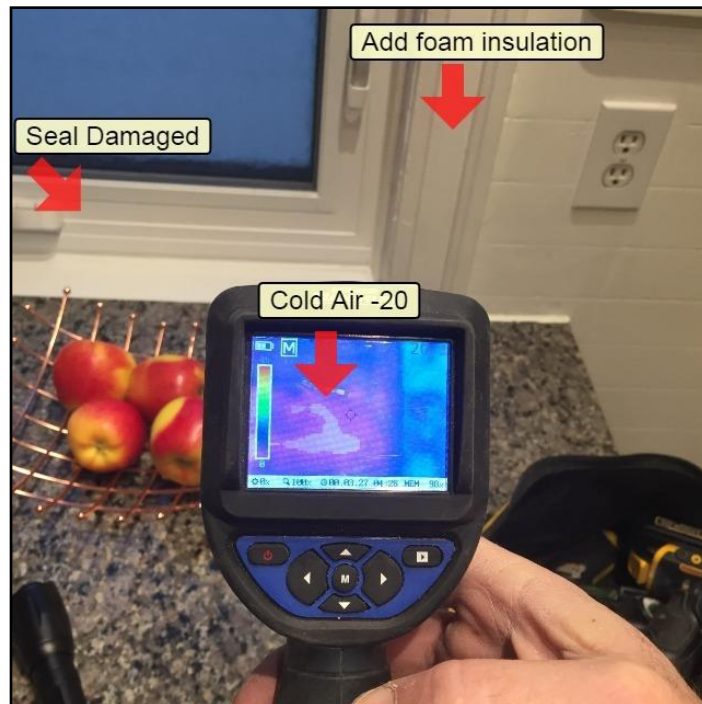
28.

21. Condition: • Re-Insulation around the frame, check and replace seal
