# INSPECTION REPORT

1234 Sample Street, Calgary  
AB S1M P1E

**Dettexx Enterprises**

October 18, 2019

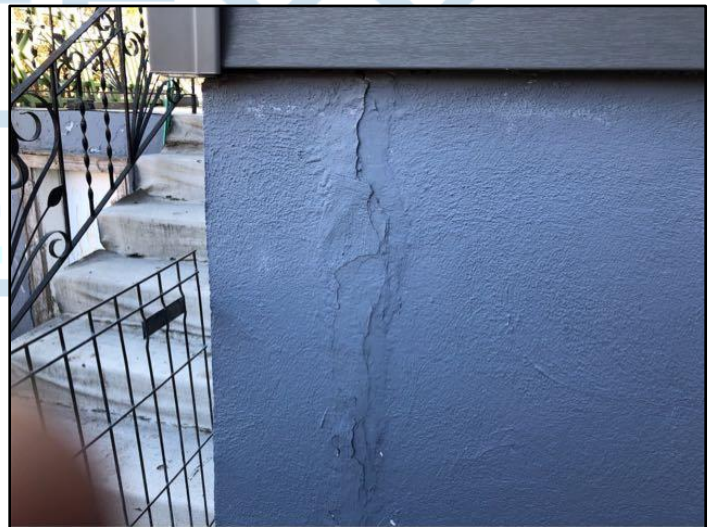
### Walls\Masonry (brick, stone) and concrete

Cracked

**Task:** Correction by qualified contractor

**Time:** Discretionary

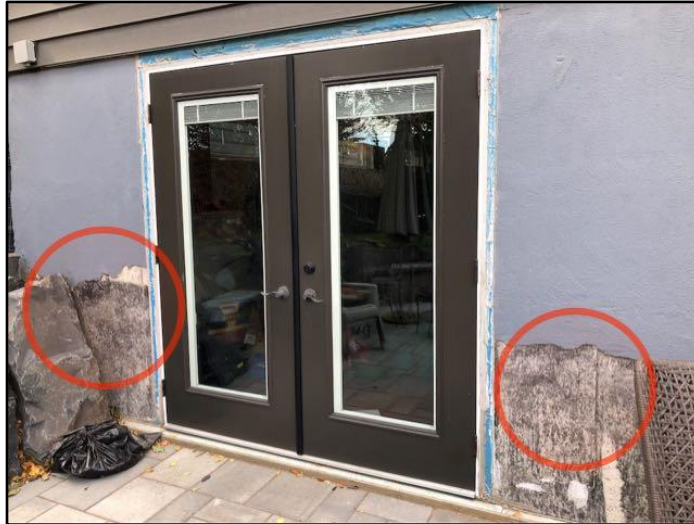
Parging damaged or missing**Implications:** Chance of damage to structure | Shortened life expectancy of material**Location:** East Second Floor**Task:** Correction by qualified contractor**Time:** Discretionary

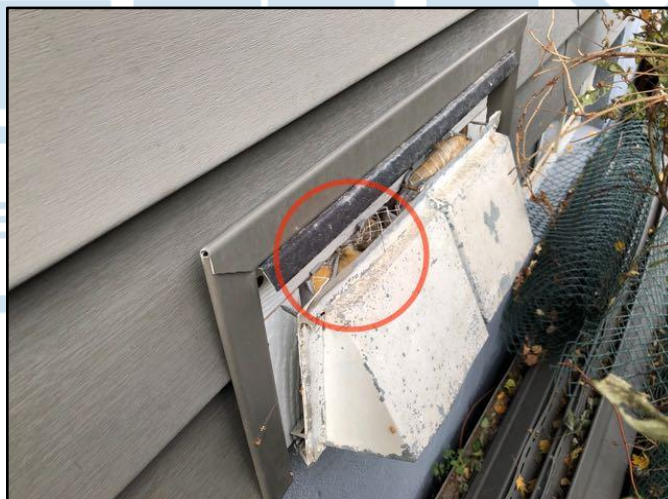
**WallsVent (fan, clothes dryer, etc.)**

Cover does not close properly

**Notes:** Trim material not complete - moisture intrusion- possible damage to building materials**Implications:** Chance of pests entering building | Increased heating and cooling costs**Location:** East Basement**Task:** Repair by a qualified contractor**Time:** Immediate

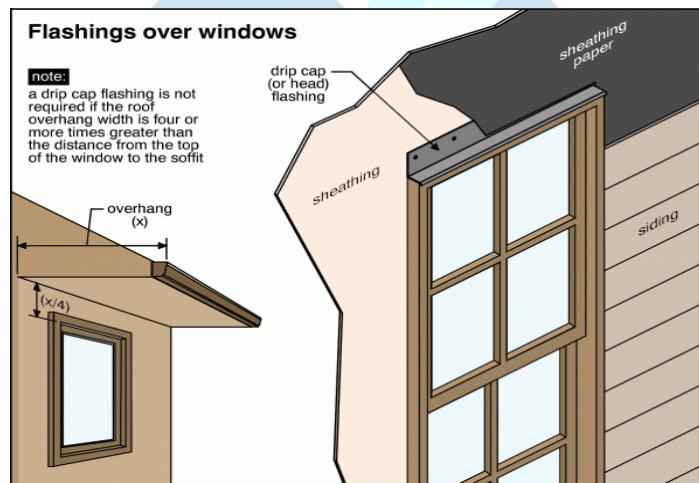
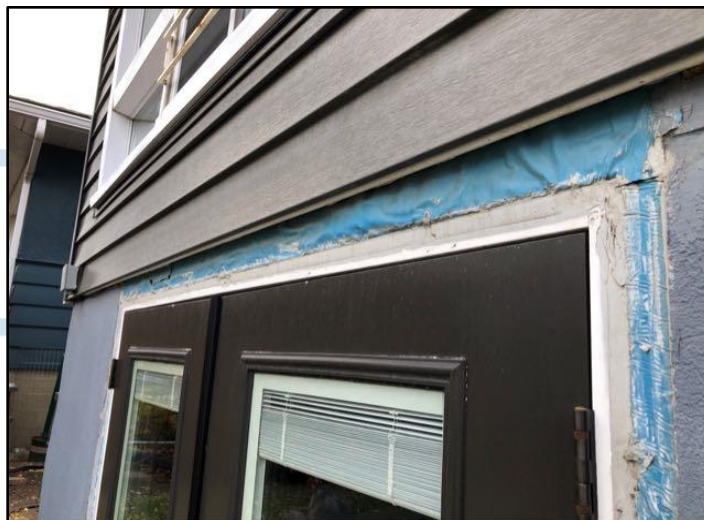
**Exterior glass/windows\Frames**[Rot or insect damage](#)**Implications:** Chance of water damage to contents, finishes and/or structure | Material deterioration**Location:** South Basement**Task:** Replace by a qualified contractor**Time:** Less than 1 year**Exterior glass/windows\Exterior drip caps/Drip cap flashing/Head flashing**[Missing](#)**Implications:** Chance of water damage to contents, finishes and/or structure**Location:** Basement East**Task:** Provide**Time:** Immediate

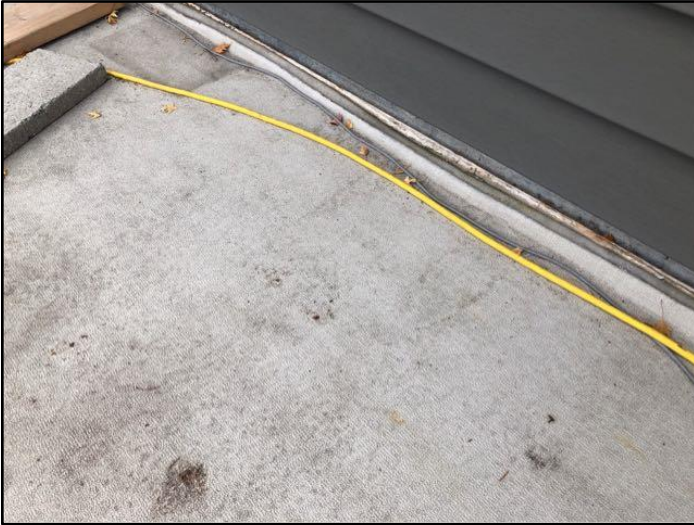
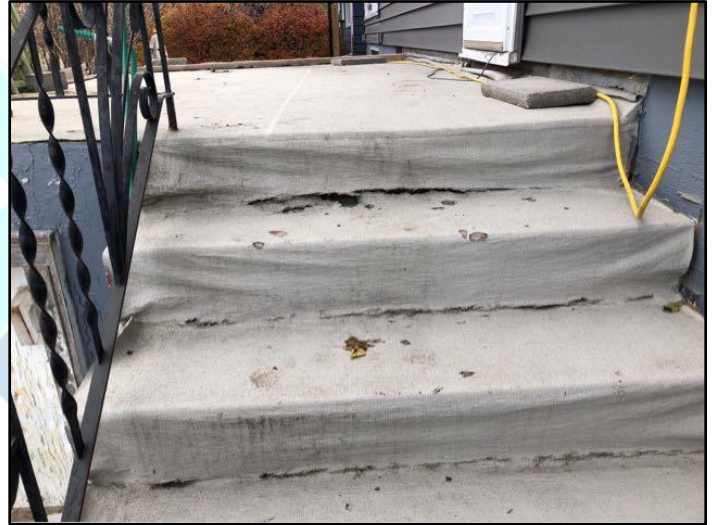
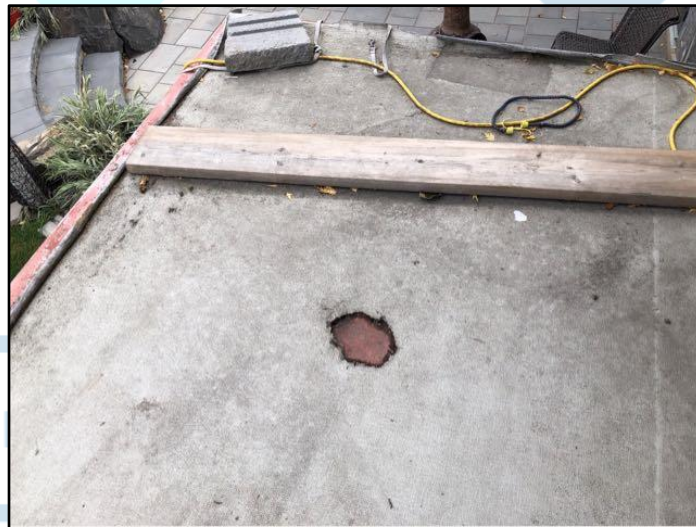
**Porches, decks, stairs, patios and balconies\Floors****Damage****Notes:** Vinyl deck covering is deteriorated, exposing the concrete structure below - Trip hazard**Implications:** Weakened structure | Chance of movement**Location:** East First Floor Exterior Deck**Task:** Replace by a qualified contractor**Time:** less than a year

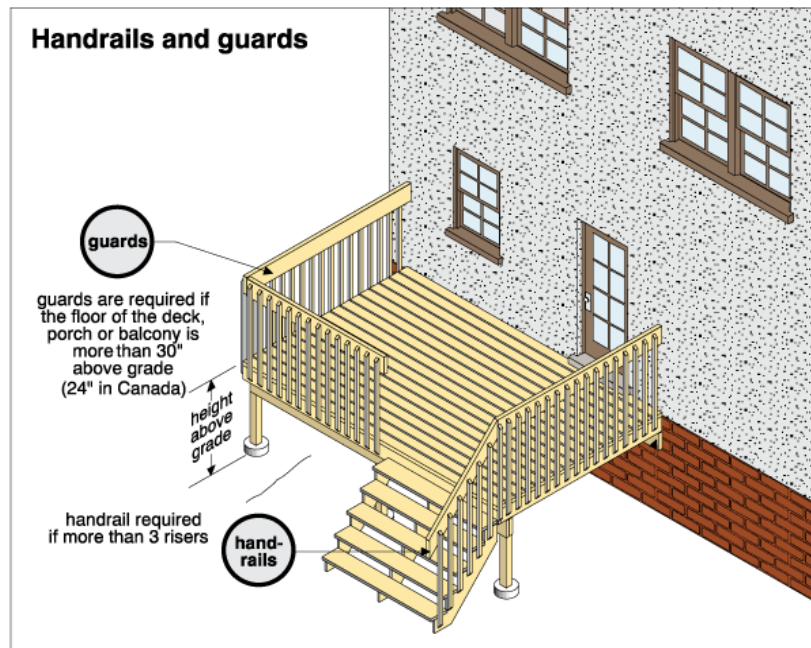
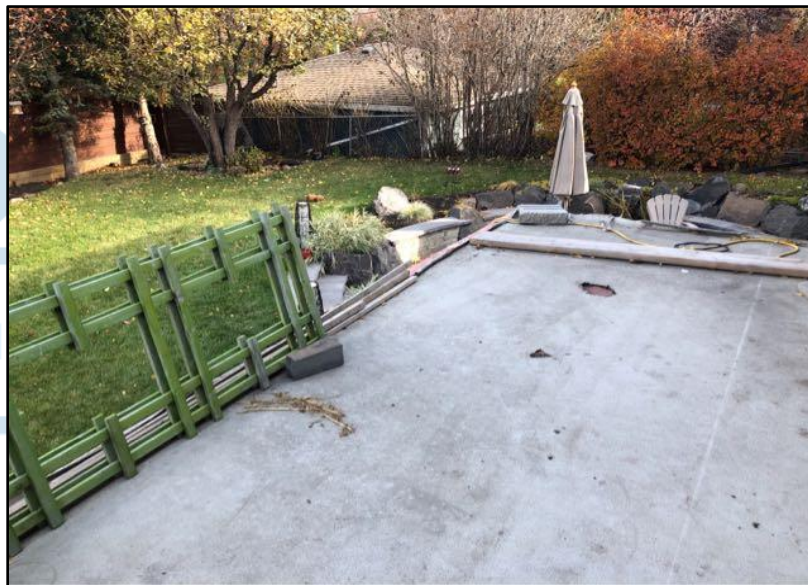
**Porches, decks, stairs, patios and balconies\Handrails and guards**[Missing](#)**Implications:** Fall hazard**Location:** East First Floor Deck**Task:** Provide**Time:** Immediate

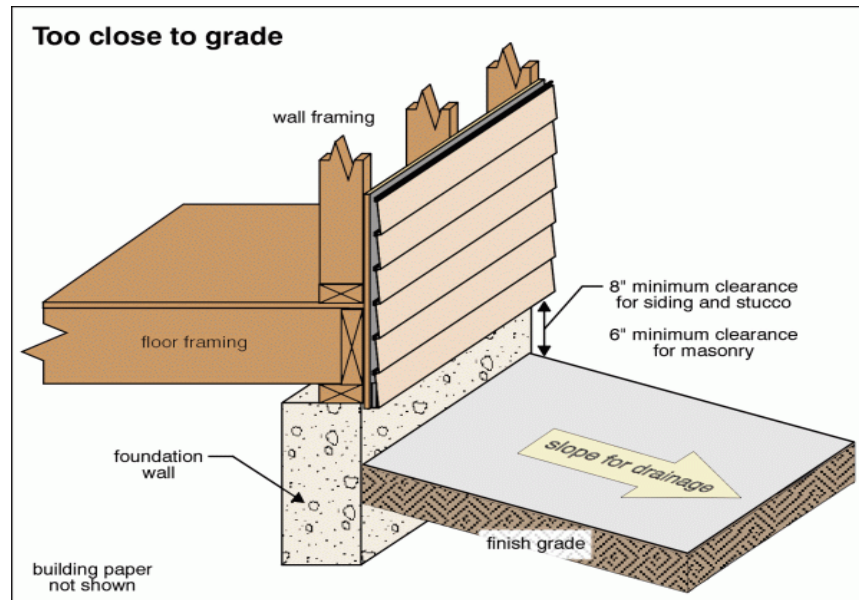
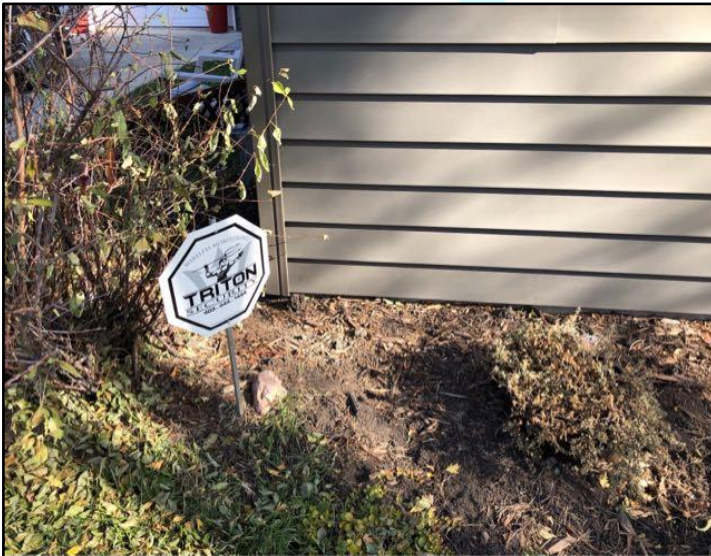
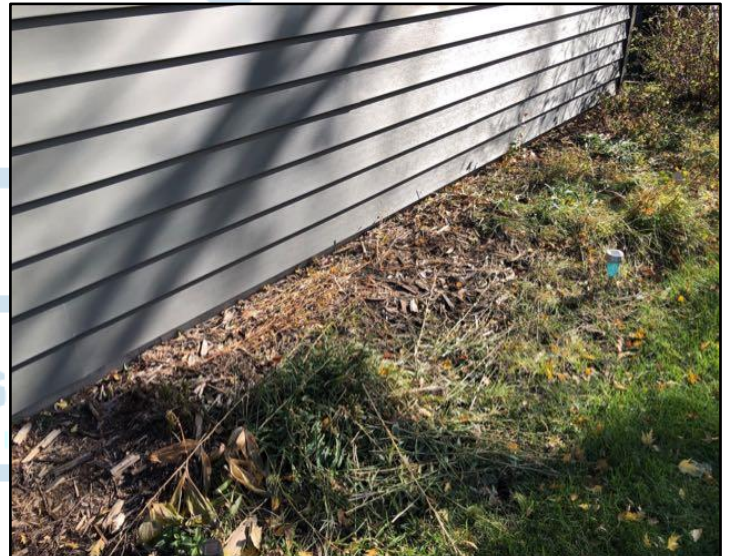
**Implications:** Chance of water entering building | Weakened structure | Rot | Insect damage

**Task:** Correction by qualified contractor

**Time:** Less than 1 year

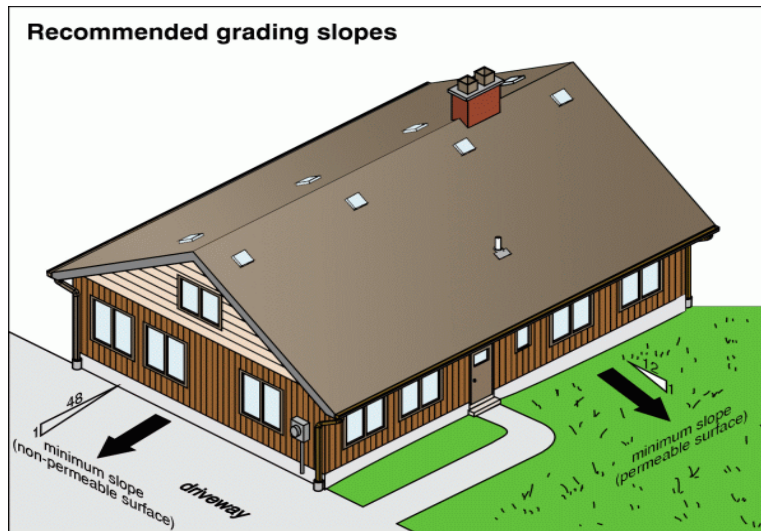
### [Improper slope or drainage](#)

**Implications:** Chance of water damage to contents, finishes and/or structure

**Task:** Correction by qualified contractor

**Time:** Less than 1 year

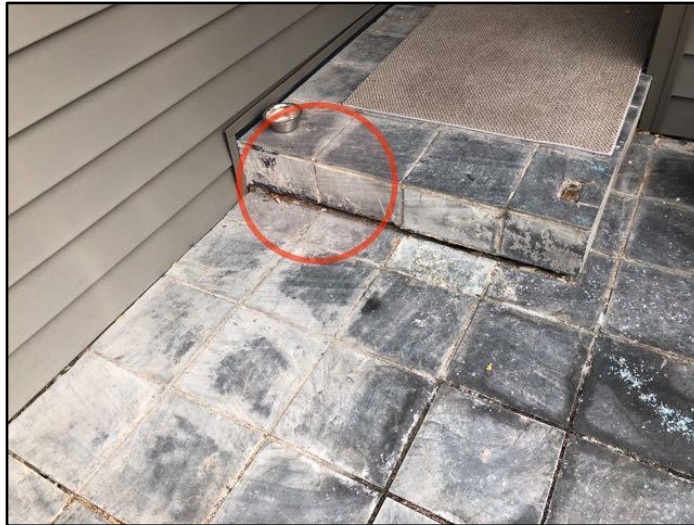
Settlement

**Location:** West Exterior**Task:** Repair by a qualified contractor**Time:** Discretionary

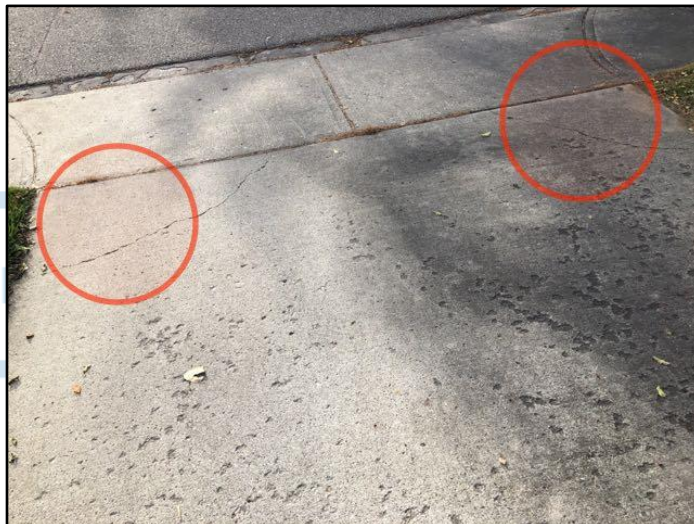
**Landscaping\Driveway**[Cracked or damaged surfaces](#)**Implications:** Trip or fall hazard**Location:** Various**Task:** Monitor

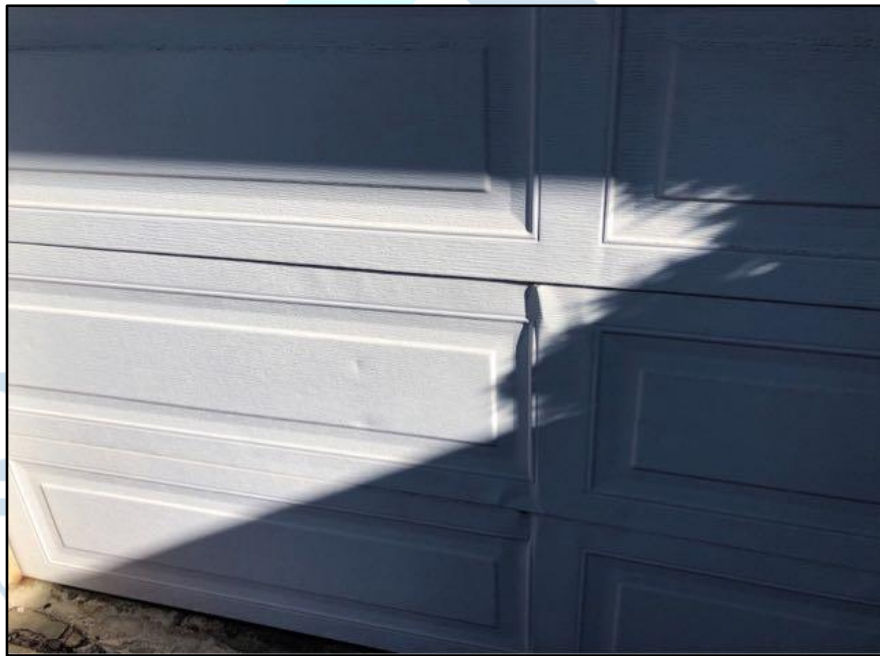
**Garage\Door into garage / Man-door**[No self-closer](#)**Implications:** Hazardous combustion products entering home | Increased fire hazard**Location:** First Floor Kitchen Garage**Task:** Provide**Time:** Less than 1 year[Weatherstripping missing or ineffective](#)**Implications:** Hazardous combustion products entering home**Location:** Kitchen Garage**Task:** Correct**Time:** Less than 1 year**Garage\Vehicle doors**

Damage

**Location:** Middle**Task:** Repair or replace by a qualified contractor**Time:** Discretionary

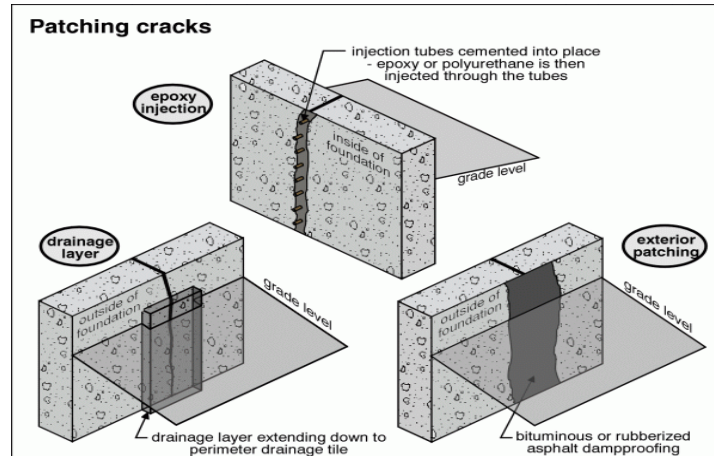
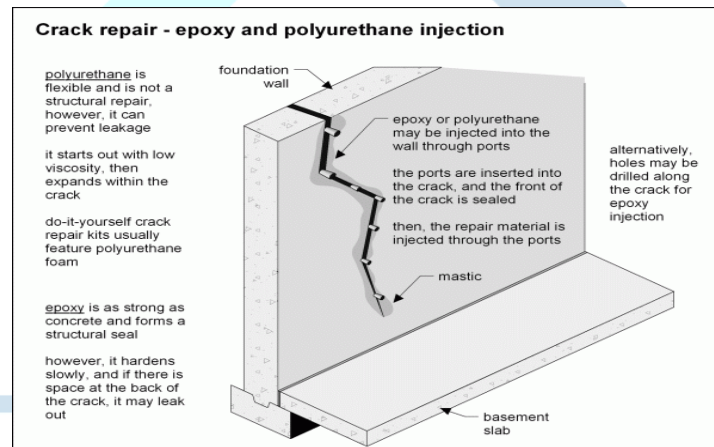
### Foundations\General

Typical minor cracks

**Implications:** Chance of water entering building

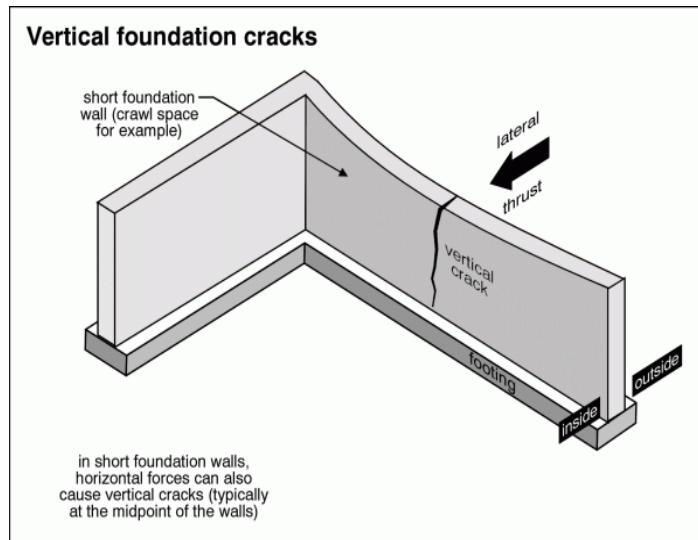
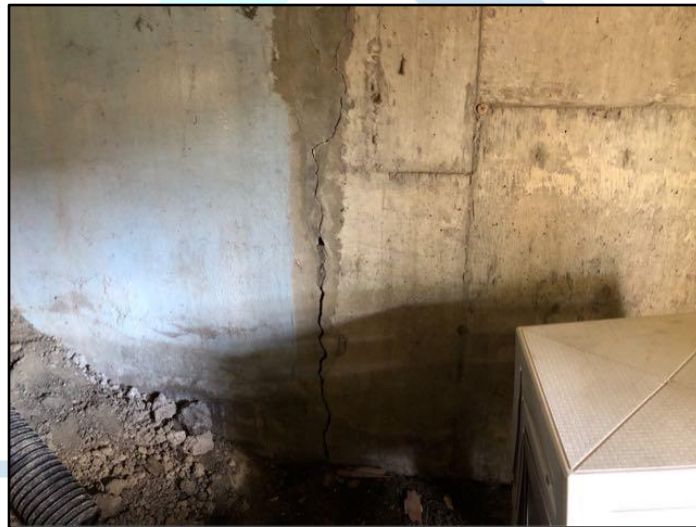
### Cracked

**Implications:** Chance of water damage to contents, finishes and/or structure | Weakened structure

**Location:** Basement Exterior Wall

**Task:** Monitor Inspect annually

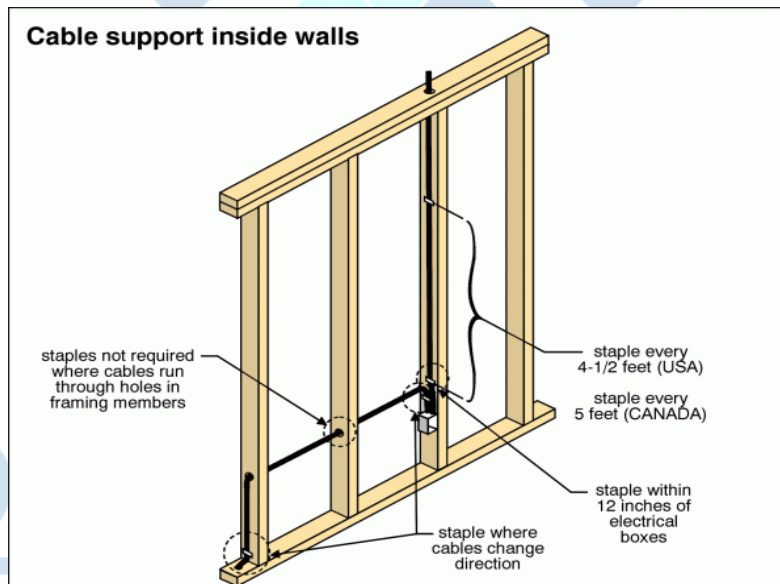
#### [Not well secured](#)

**Implications:** Electric shock | Fire hazard

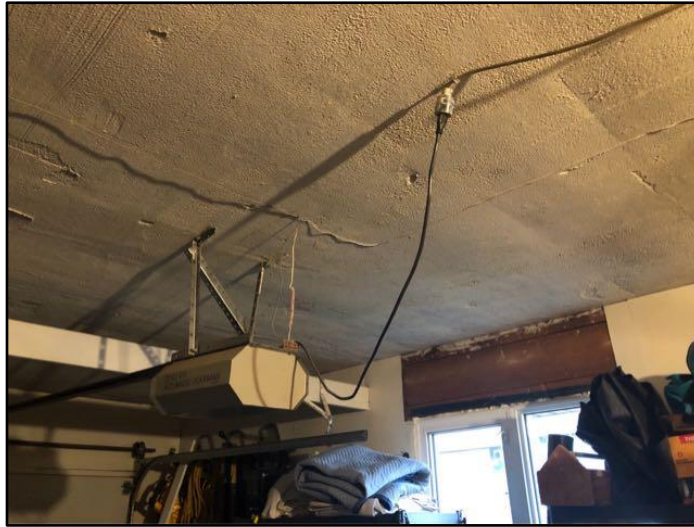
**Distribution system\Outdoor wiring**[Extension cord for garage door opener](#)**Implications:** Fire hazard**Location:** First Floor Garage**Task:** Repair by a qualified contractor**Time:** within a year

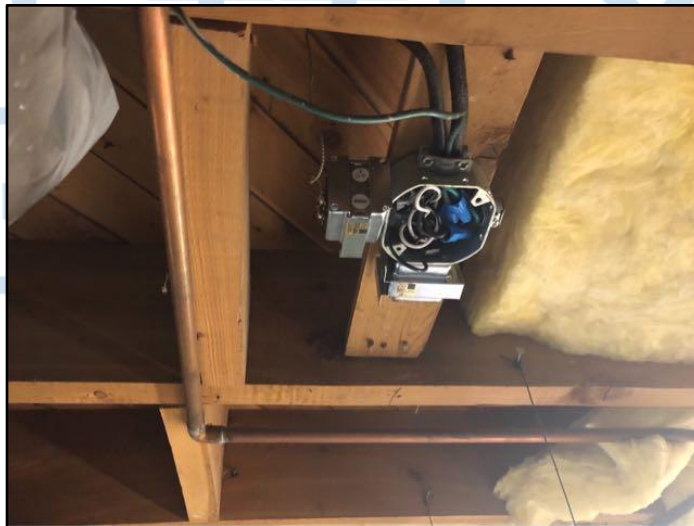
**Distribution system\Junction boxes**[Cover loose or missing](#)**Implications:** Electric shock | Fire hazard**Location:** Basement Laundry Area**Task:** Correction by qualified contractor**Time:** Immediate

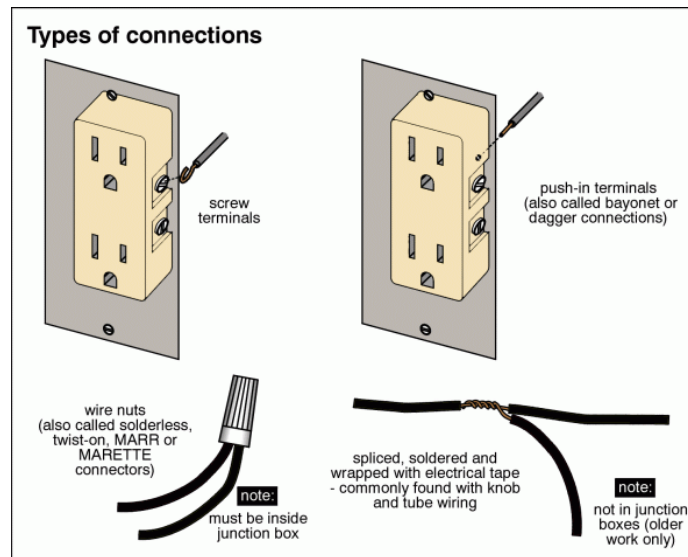
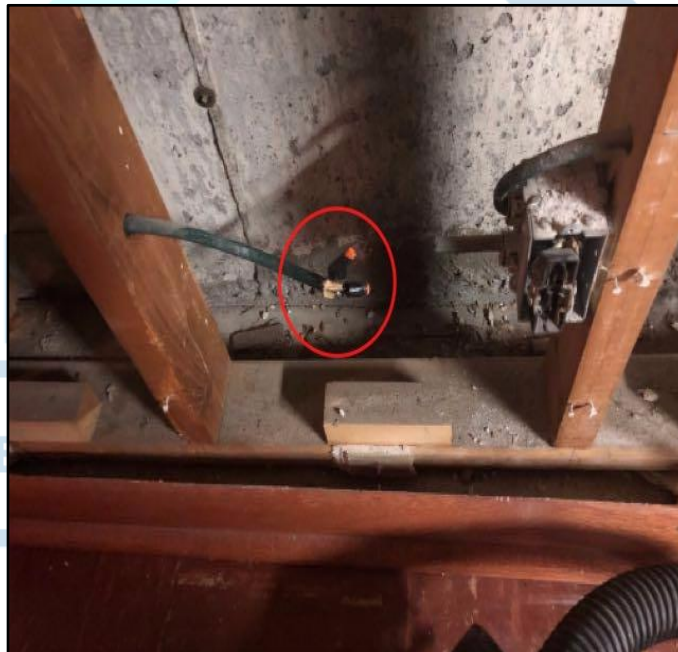
**Missing****Notes:** Missing junction box**Implications:** Electric shock | Fire hazard**Location:** Basement Family Room**Task:** Correction by qualified contractor**Time:** Immediate

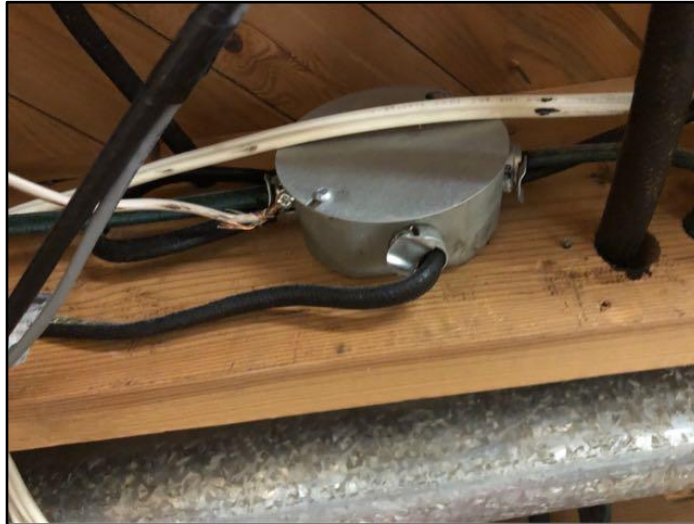
Overcrowded**Implications:** Electric shock | Fire hazard**Location:** Basement Utility Room**Task:** Correction by qualified contractor

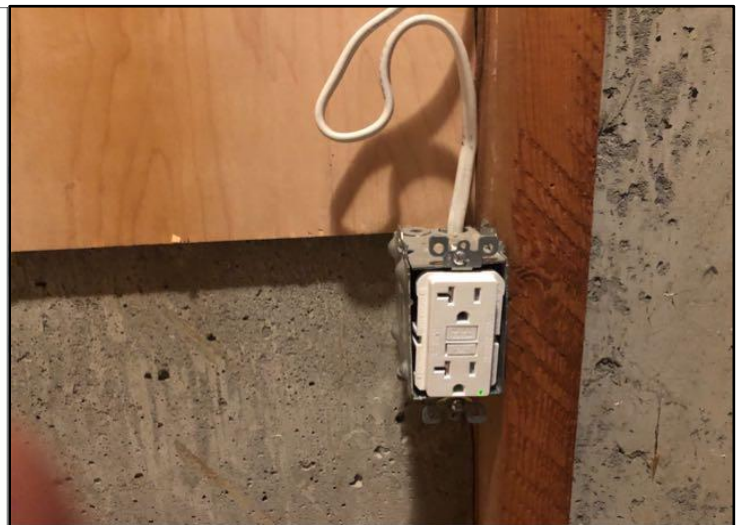
**Distribution system\Outlets (receptacles)**Wrong type**Notes:** 20 amp outlet on a 15 amp circuit**Implications:** Electric shock | Fire hazard**Location:** East Basement Panel**Task:** Correction by qualified contractor**Time:** Immediate**Wrong type receptacle**

20 amp receptacles shouldn't be installed  
on 15 amp circuits  
when you see 20 amp receptacles, check  
that they are attached to 12 gauge wire

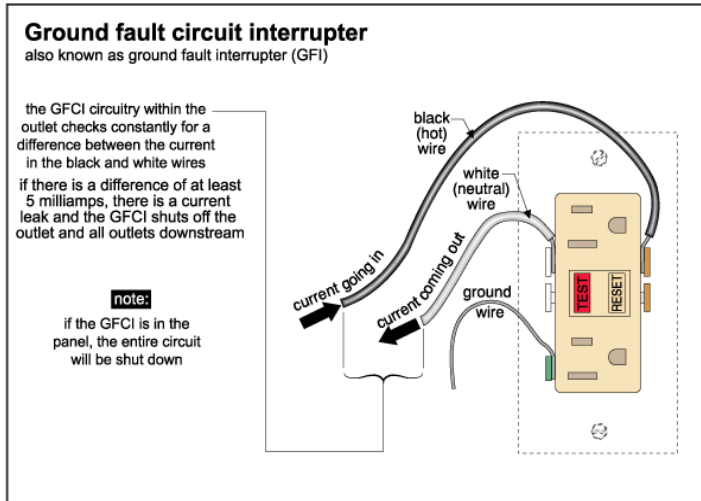
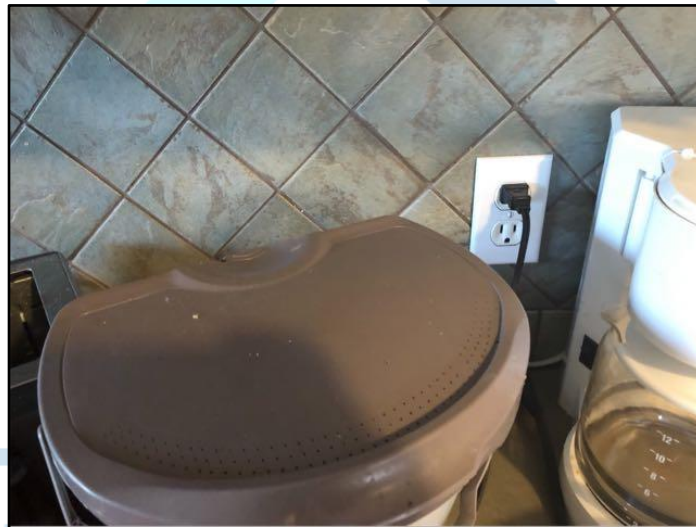
No GFCI/GFI (Ground Fault Circuit Interrupter)**Implications:** Electric shock**Location:** First Floor Kitchen**Task:** Provide**Time:** Less than 1 year

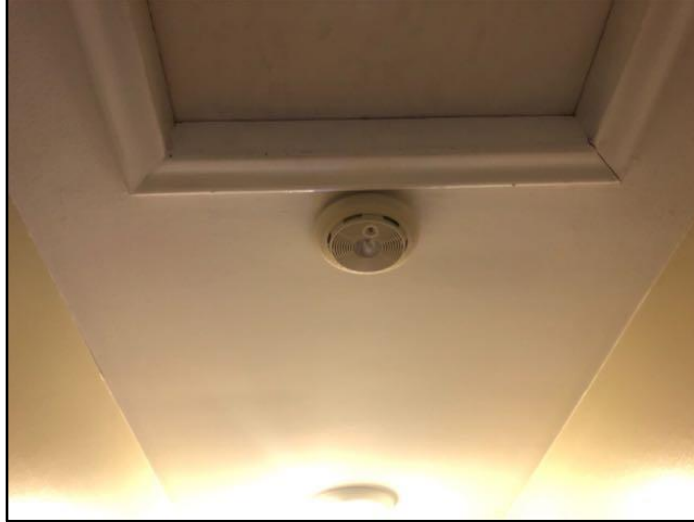
**Smoke alarms (detectors)**[Present](#)**Notes:** Not tested recommend replacement

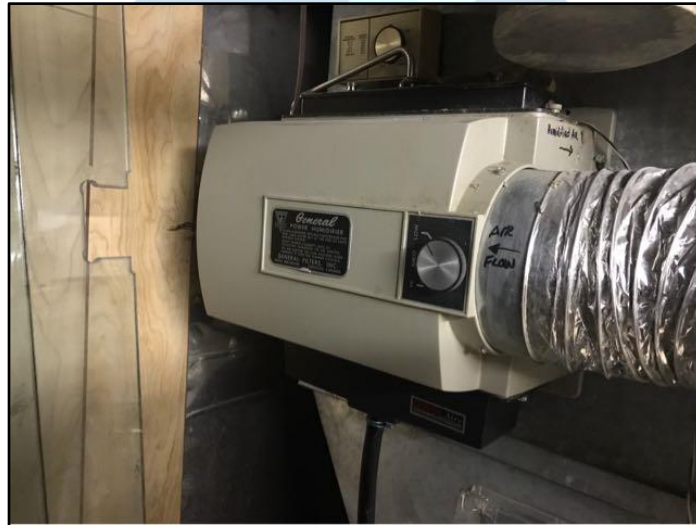
**Furnace\Humidifier**

Water supply turned off to humidifier / possible issue with supply line - water stains on framing

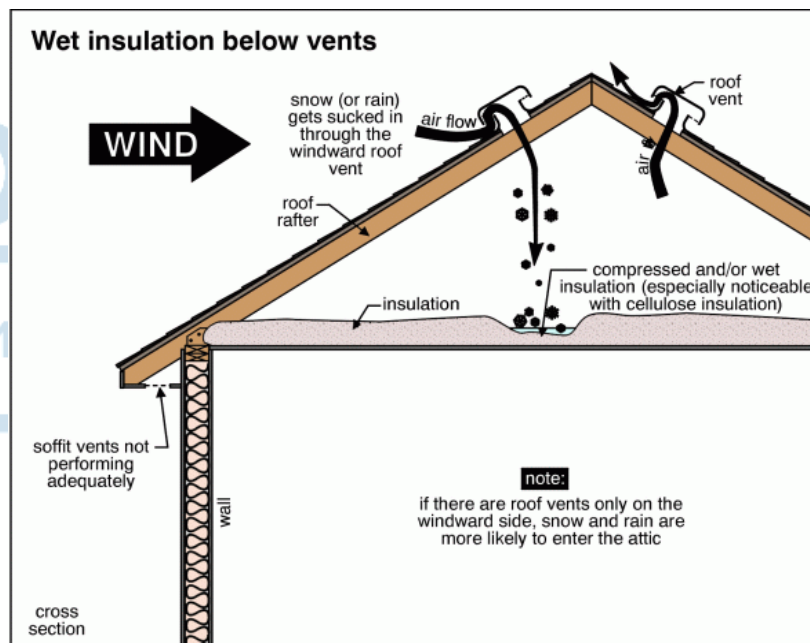
Compressed

**Implications:** Increased heating and cooling costs | Reduced comfort

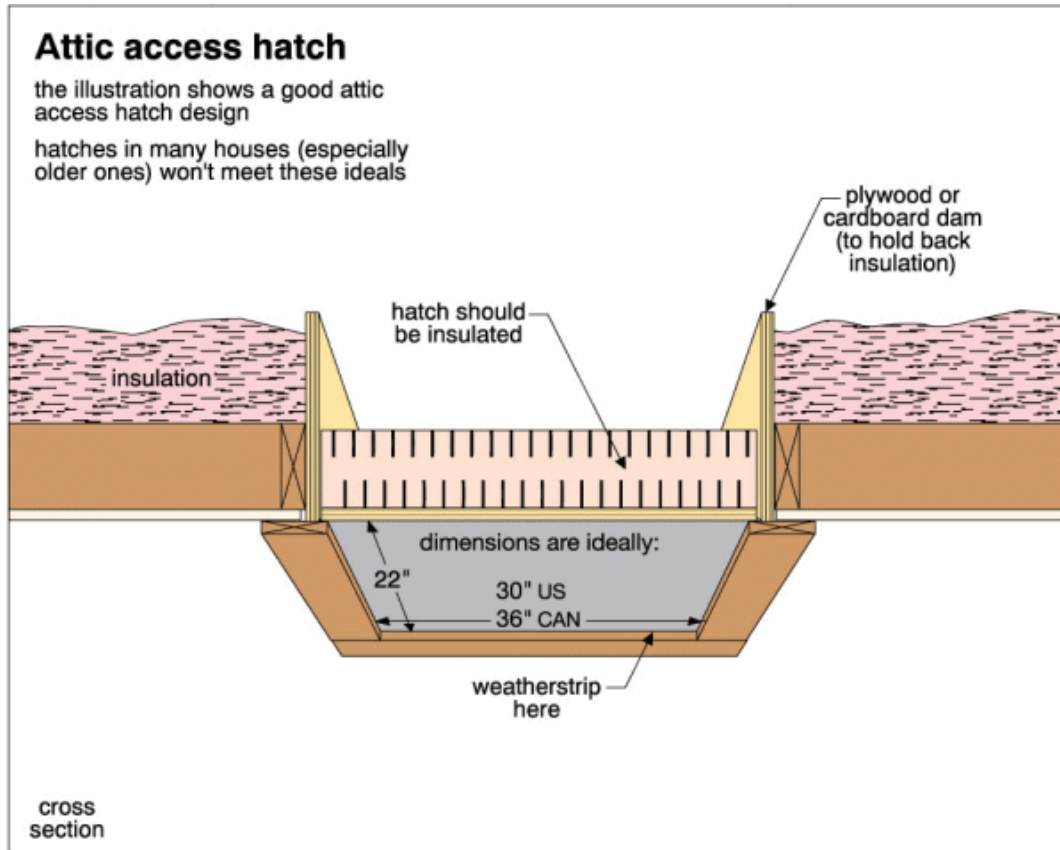
**Attic/roof/Hatch/Door**[Not weatherstripped](#)

**Implications:** Chance of condensation damage to finishes and/or structure | Increased heating and cooling costs

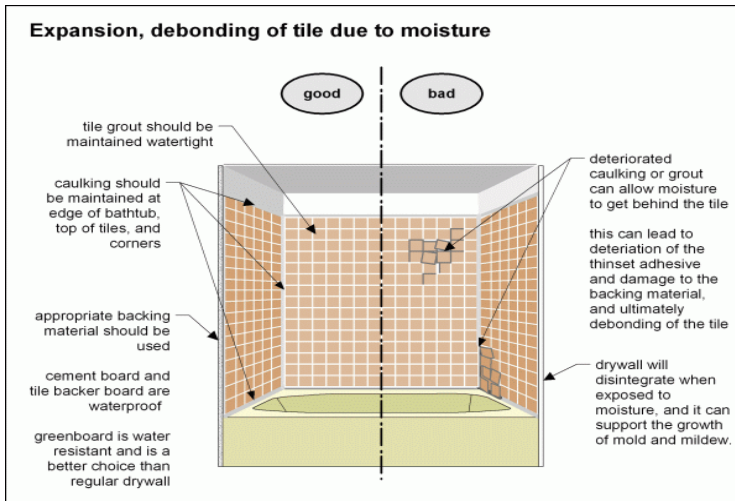
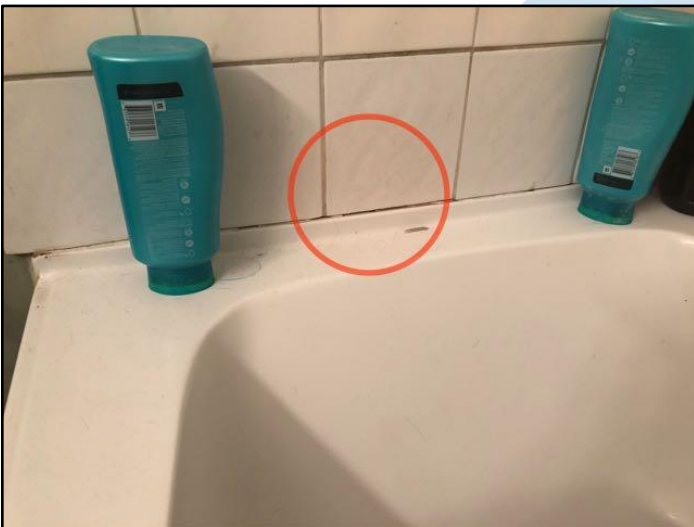
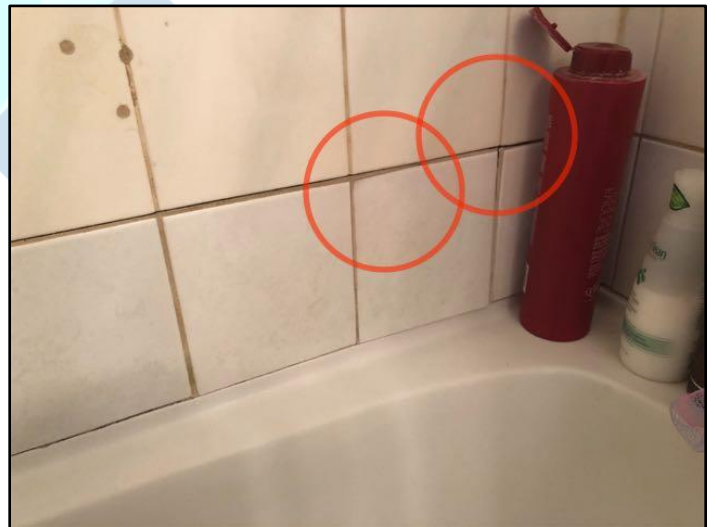
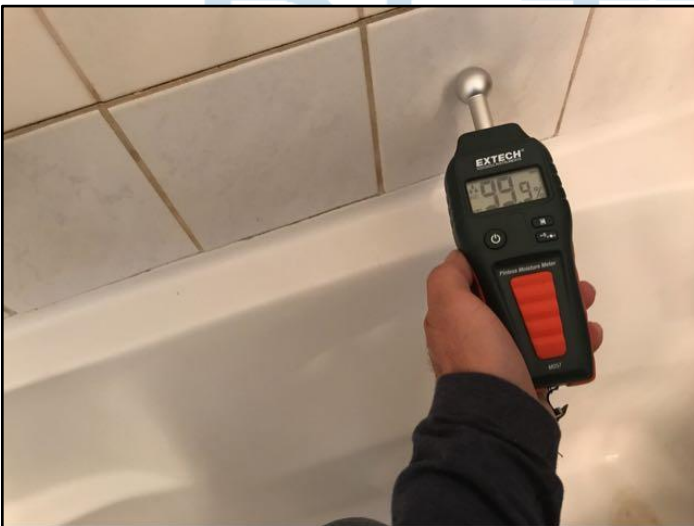
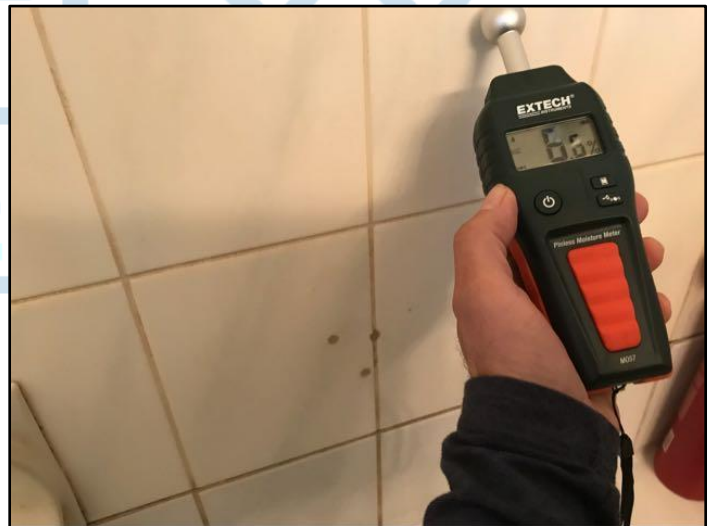
### Fixtures and faucets\Bathtub enclosure

[Caulking loose, missing or deteriorated](#)**Implications:** Chance of water damage to contents, finishes and/or structure[Grout loose, missing or deteriorated](#)**Implications:** Chance of water damage to contents, finishes and/or structure[Tile loose, broken or missing](#)**Notes:** High moisture reading at tiles just above the tub**Implications:** Chance of water damage to contents, finishes and/or structure**Location:** Bathroom First Floor**Task:** Repair or replace by a qualified contractor**Time:** Immediate

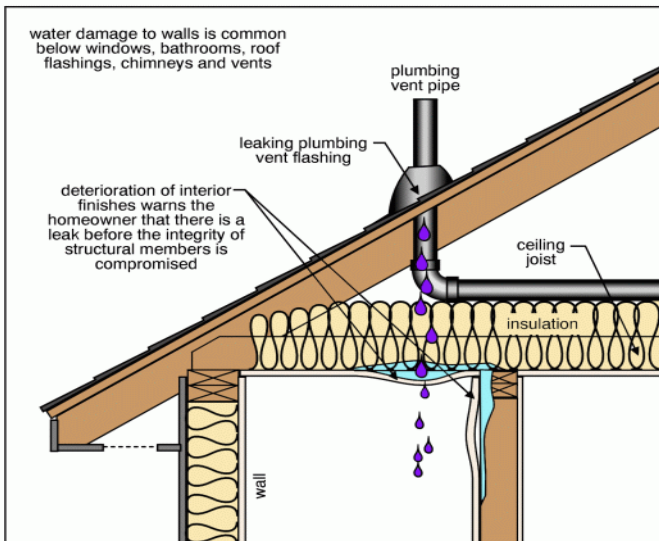
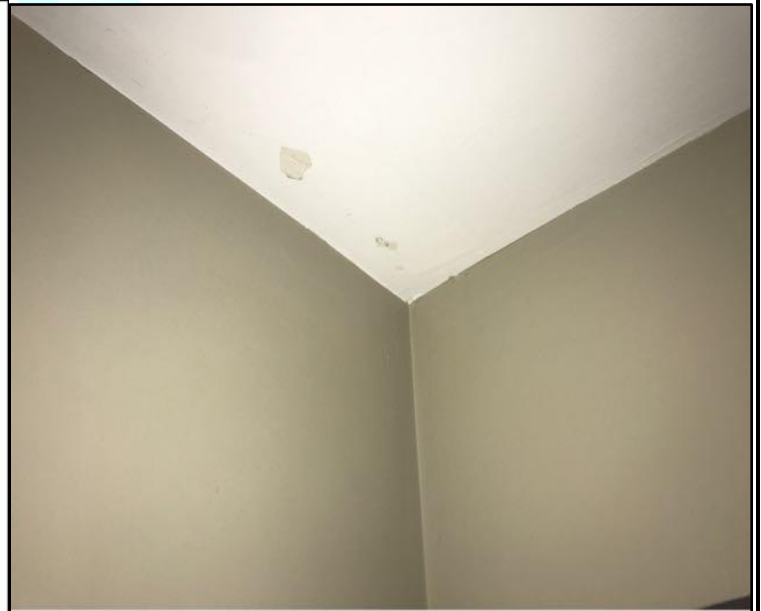
[Water damage](#)

**Implications:** Chance of movement | Rot | Leakage

**Task:** Repair by a qualified contractor

**Time:** Less than 1 year

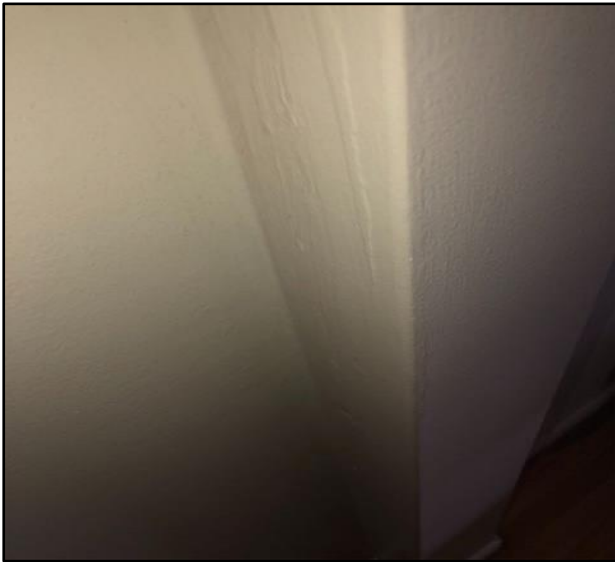
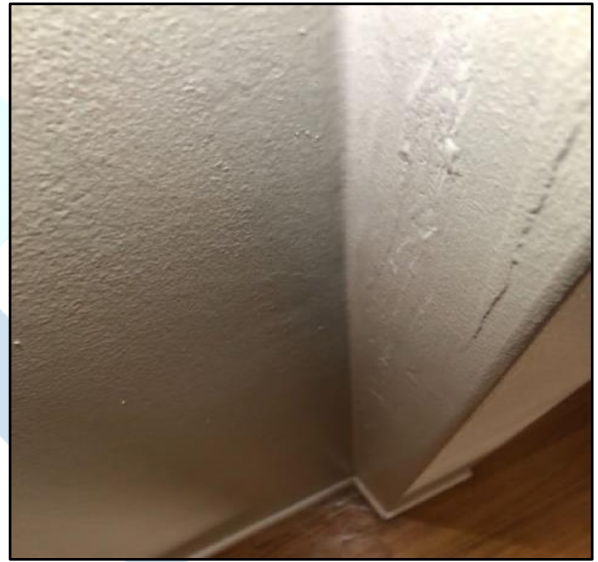
Finish coat cracked and or peeling, usually cosmetic and could be the result of wind or seismic activity, expansion and contraction caused by humidity and temperature changes, and poor material fastening and finishing.

**Notes:** Evidence of previous moisture intrusion

**Task:** Monitor

**Time:** Ongoing

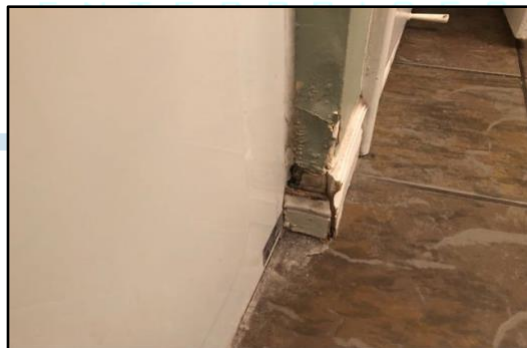
**Walls\Plaster or drywall**

[Water damage](#)

**Task:** Repair by a qualified contractor

**Time:** Less than 1 year

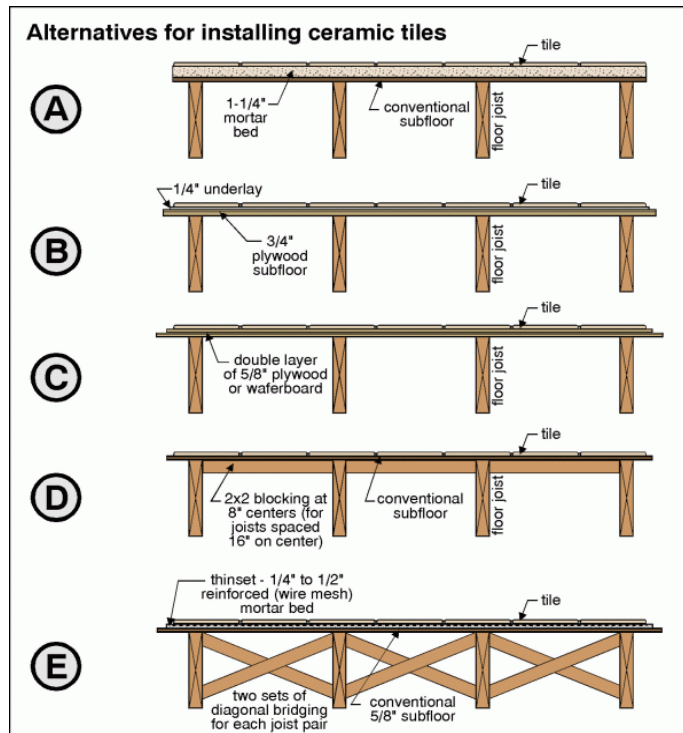
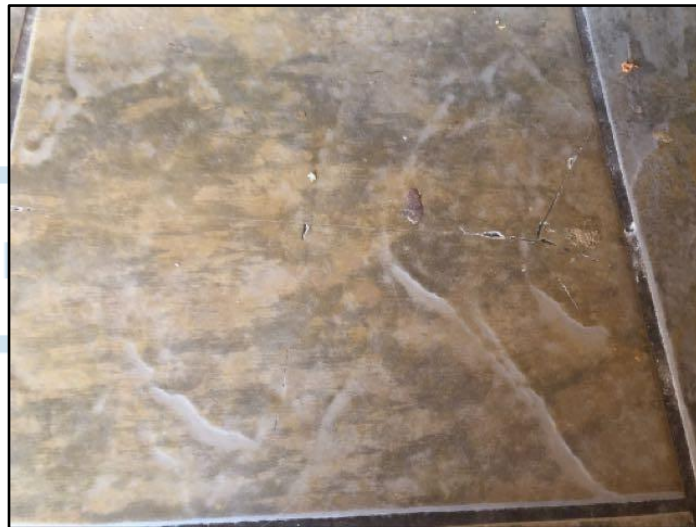
**Floors\Ceramic tile, stone, marble, etc**[Tiles cracked](#)**Implications:** Trip or fall hazard**Location:** First Floor Kitchen**Task:** Replace by a qualified contractor**Time:** Discretionary

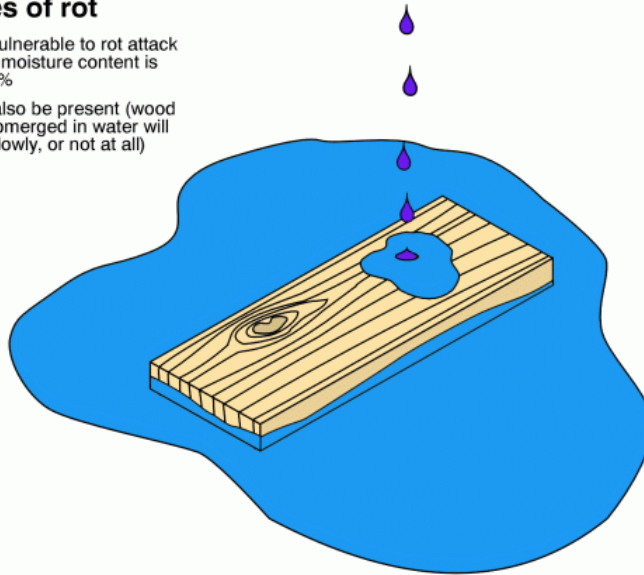
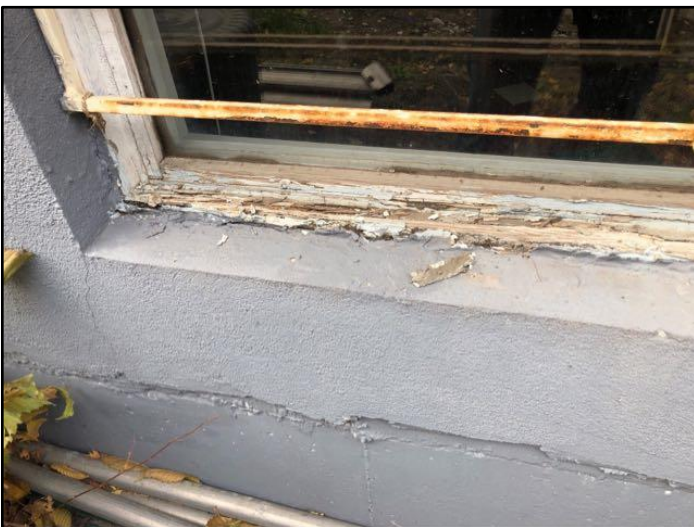
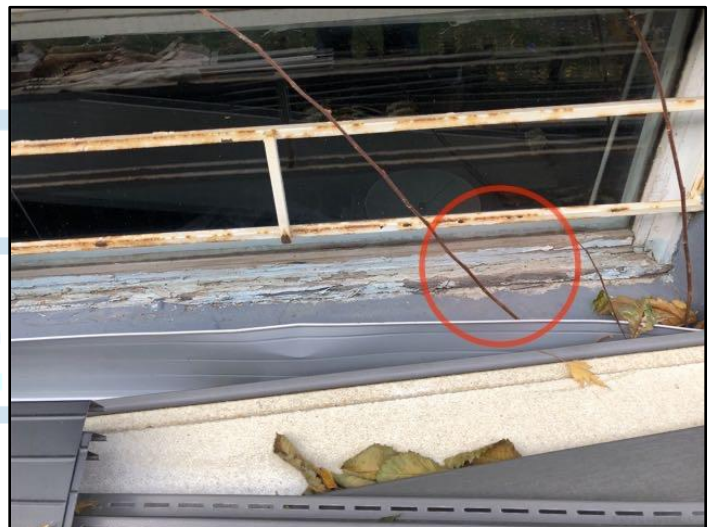
## Windows\Frames

### Rot

**Implications:** Chance of damage to structure | Material deterioration

**Task:** Replace by a qualified contractor

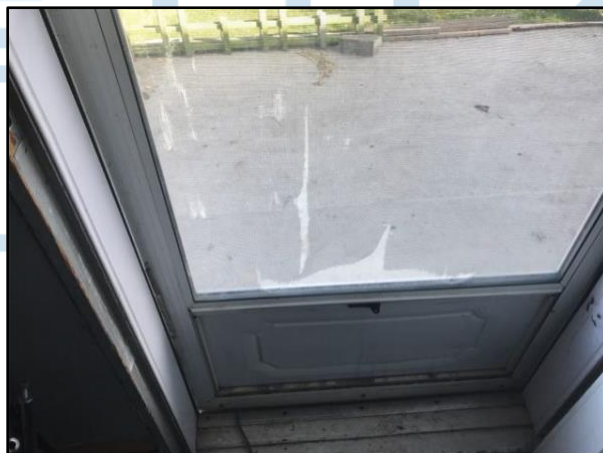
## Doors\Storms and screens

### Torn

**Task:** Repair by a qualified contractor

**Time:** Discretionary

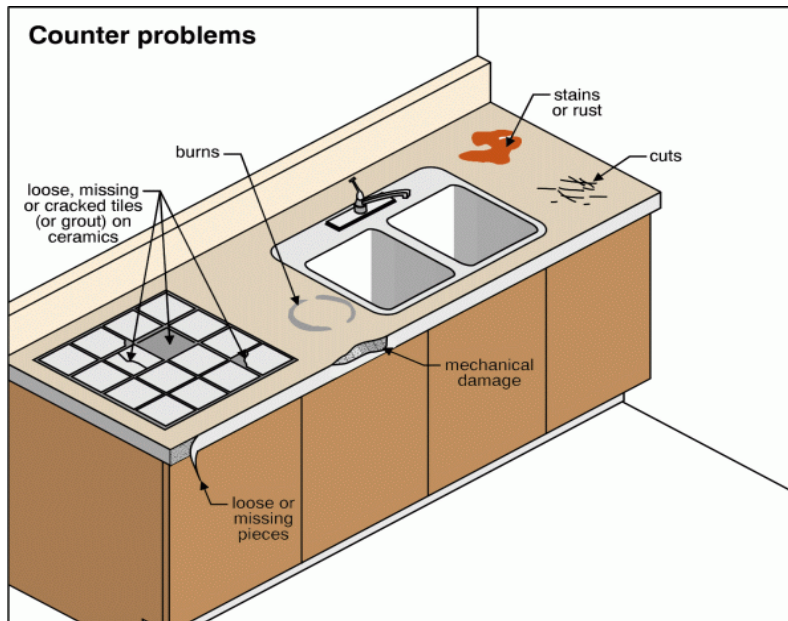
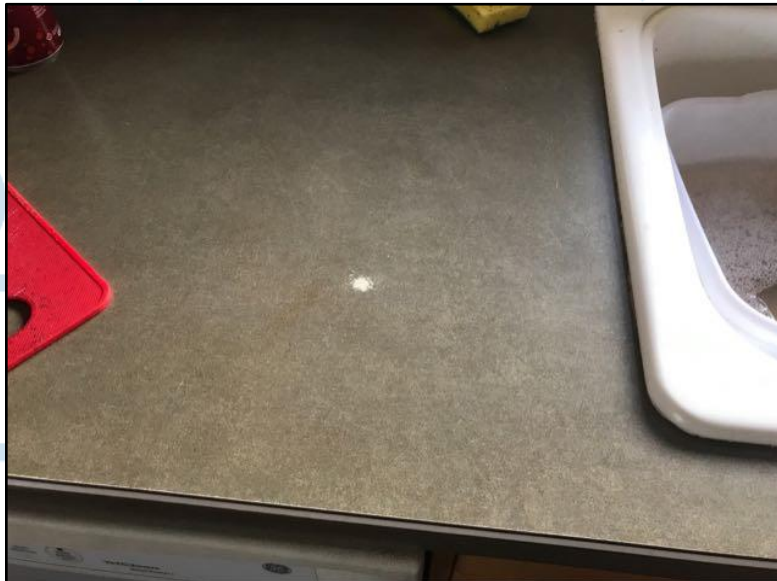
Burned, cut or worn

**Task:** Repair or replace by a qualified contractor

**Time:** When remodelling
