# INSPECTION REPORT

1234 Sample Street, Calgary  
AB S1M P1E

**Dettexx Enterprises**

October 18, 2019

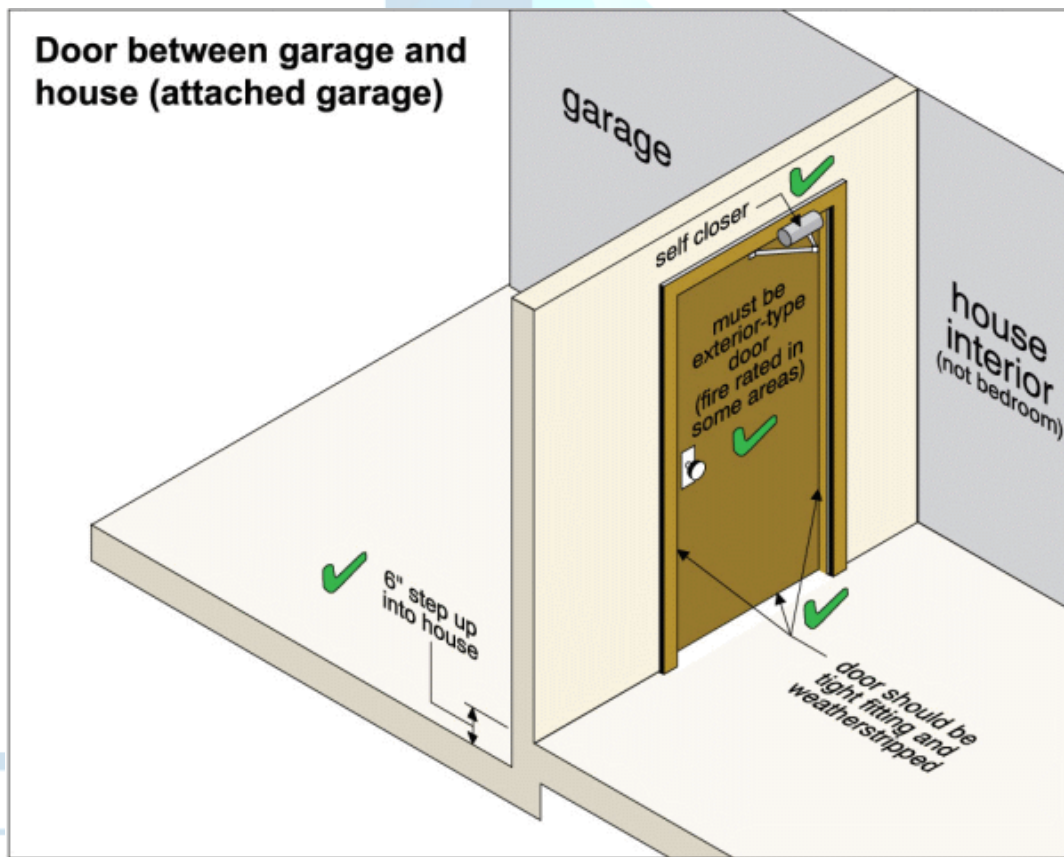
Not vented to exterior

**Implications:** Chance of condensation damage to finishes and/or structure**Garage\Door between garage and living space**[No self closer](#)**Notes:** Not at current standards - consider installing closure when renovating**Implications:** Hazardous combustion products entering home**Location:** Kitchen Garage**Task:** Provide**Time:** Discretionary

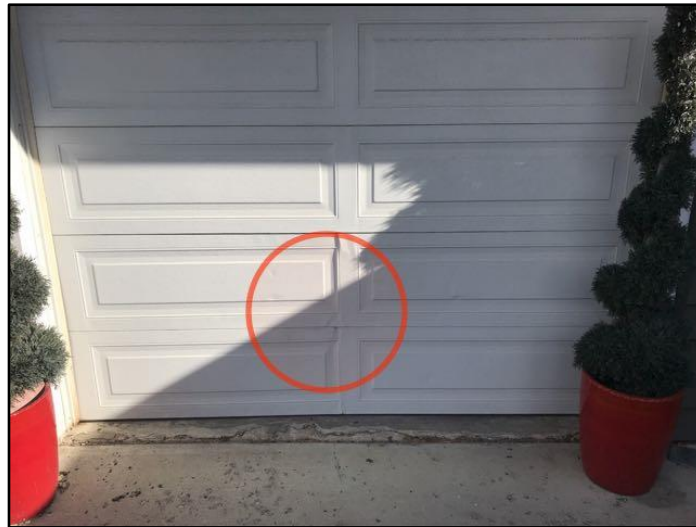
## Garage\Vehicle doors

[Rusted or dented](#)**Implications:** Material deterioration**Location:** Garage**Task:** Replace by a qualified contractor**Time:** Discretionary

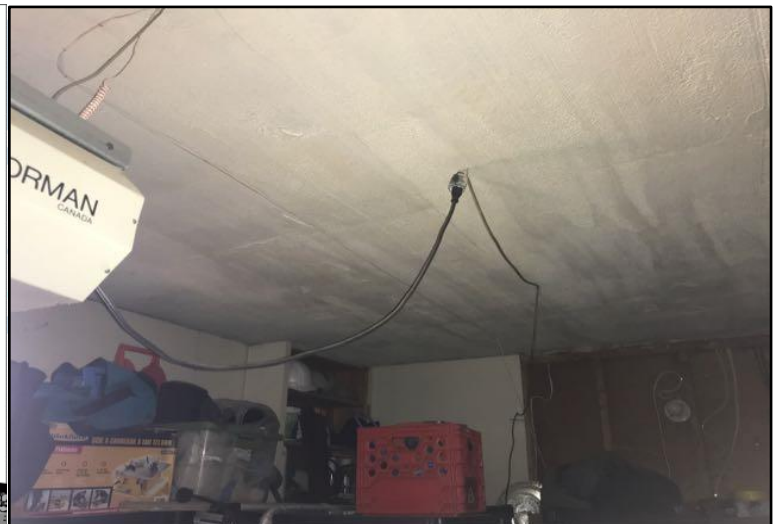
## Garage\Vehicle door operators

[Extension cord for opener](#)**Implications:** Electric shock**Location:** Garage**Task:** Correction by qualified contractor
