Your Inspection Report

86 Joymar Dr, Suite 80
Mississauga, ON L5M 7Z6

INSPECTION DATE:
Tuesday, February 13, 2018

RE: Report No. 60998, v.2
86 Joymar Dr, 80
Mississauga, ON
L5M 7Z6

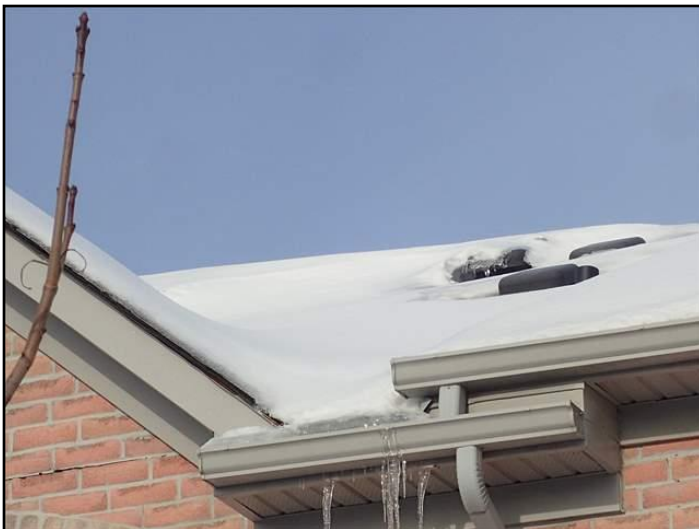
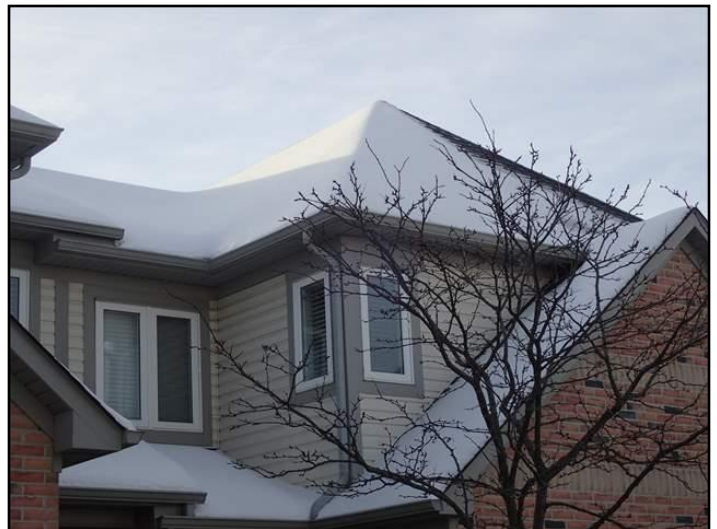
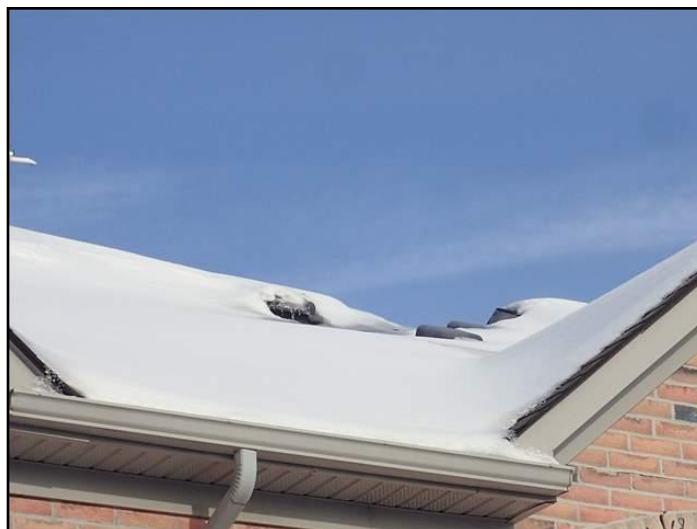
- Because of the snow/ice, the roof surface was not visible.

Snow-covered roof

A complete look at the roof should be made after the snow has melted.

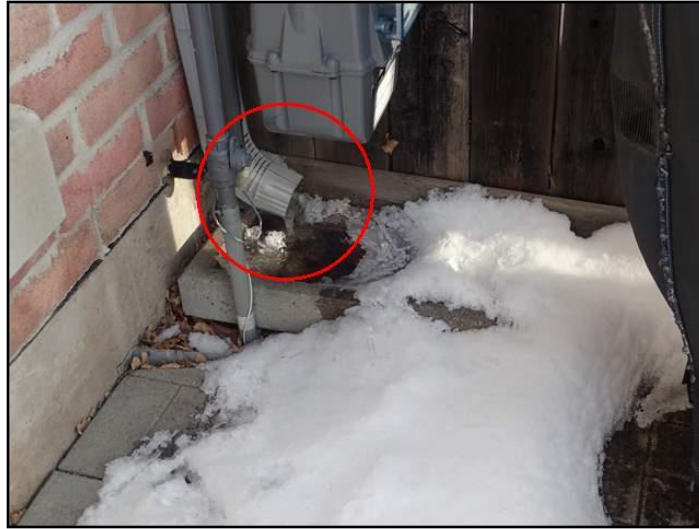
Condition: • [Discharge too close to building](#)

Discharge too close to building

When or where possible, it is best to extend the downspouts as far away from the house as practical.

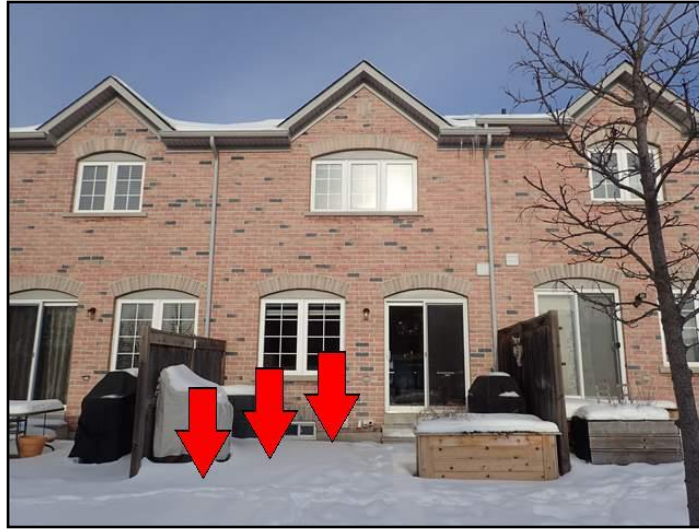
Condition: • Lot grading

With the snow, it was difficult to judge the grading at the back of the house.

Implication(s): When trying to minimize basement leakage, it is always best to be proactive and slope the grades away from the house.

Maintain slope away from house

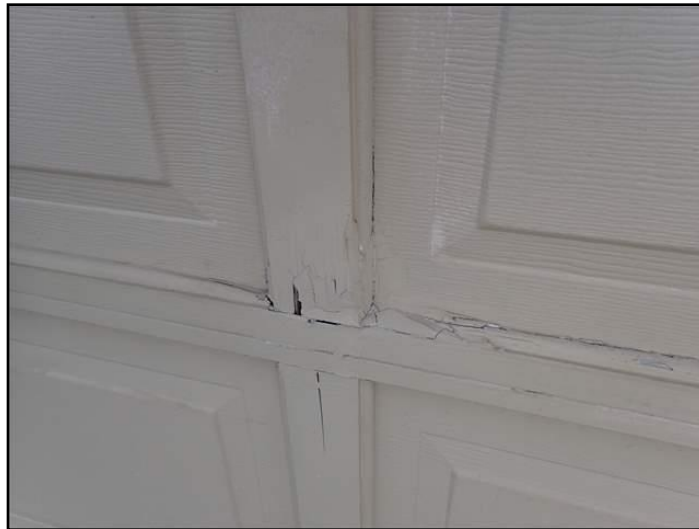
Condition: • Rot

Rot noted on Garage door

Task: Repair / Replace

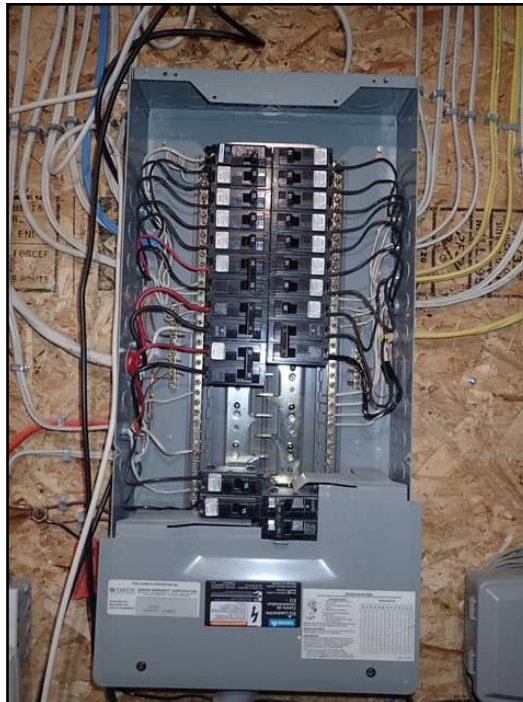
- The panel and the panel wires look professionally organized and well put together.
- Any other visible work looks well installed.
- All plugs and switches tested were in good working order.

Panel and wiring are in good condition

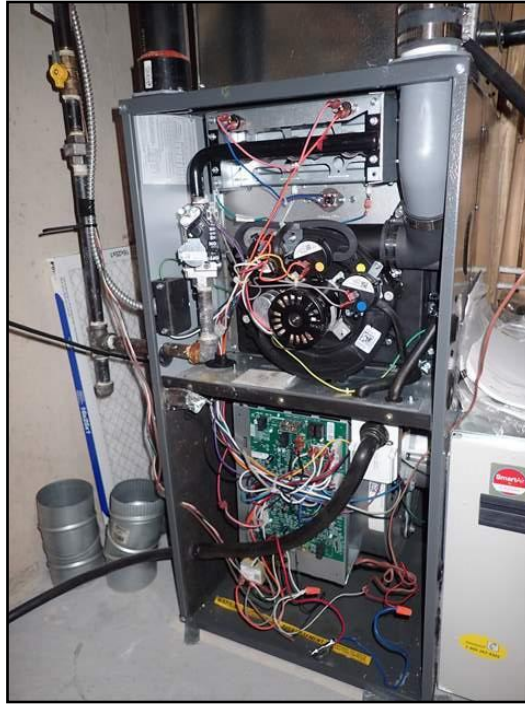
Furnace cabinet is in good condition

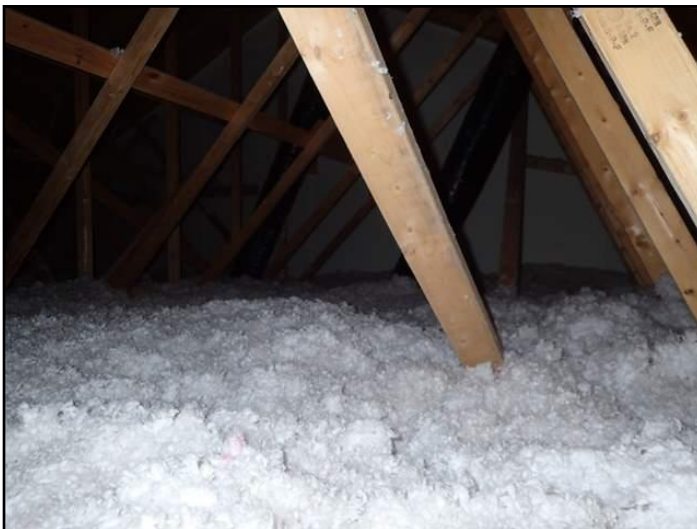
Insulation is evenly distributed

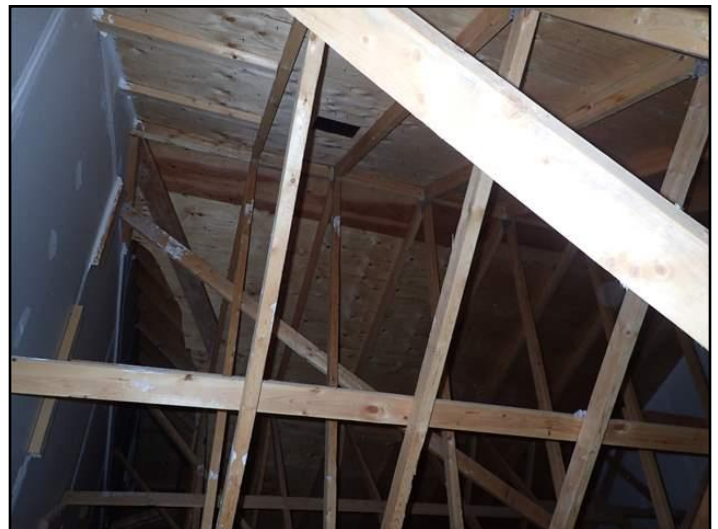
Roof sheathing is clean

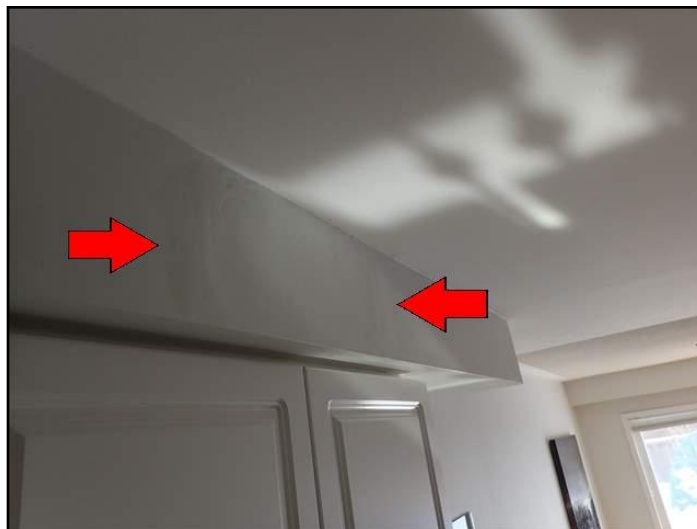
Condition: • Patched

Other times they are from repairs/renovations.

The ceiling felt solid and tested dry with the moisture meter at the time of inspection.

Patched ceiling/bulkhead below Bathroom

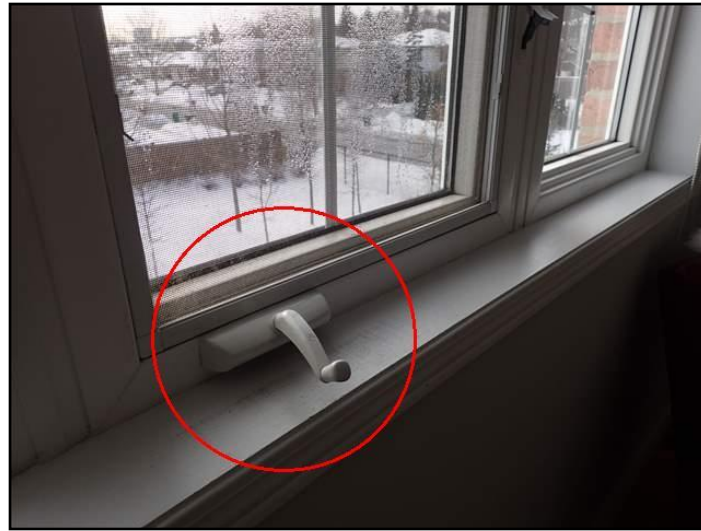
Condition: • [Inoperative](#)

Inoperative window crank

Task: Repair / Replace

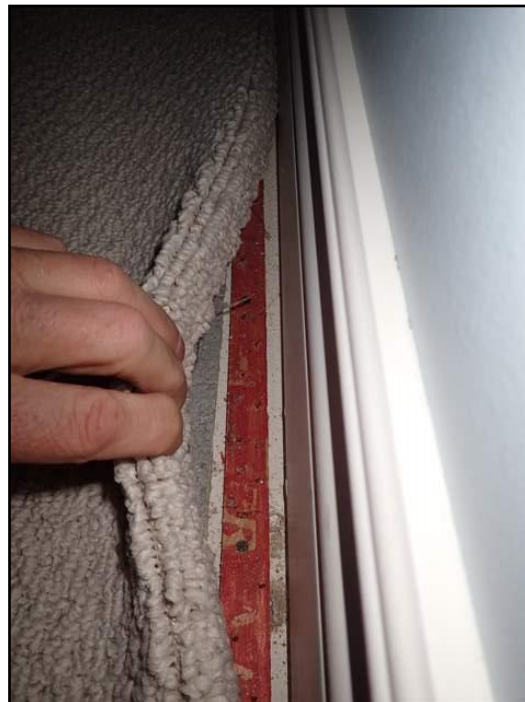
Condition: • There was no evidence to suggest any kind of ongoing problem; there was no musty smell, peeling paint, water stained or damaged drywall, etc.

Clean carpet tack strip and baseboard

A dehumidifier is also advised (especially for the summer).
