YOUR INSPECTION REPORT

FOR THE PROPERTY AT:
490 Windermere Avenue
Toronto, ON M6S 3L6

INSPECTION DATE:
Monday, September 22, 2025

RE: Report No. 8592, v.2
490 Windermere Avenue
Toronto, ON
M6S 3L6

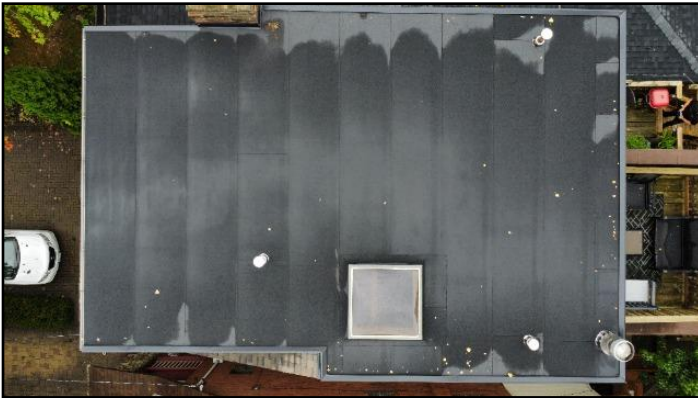
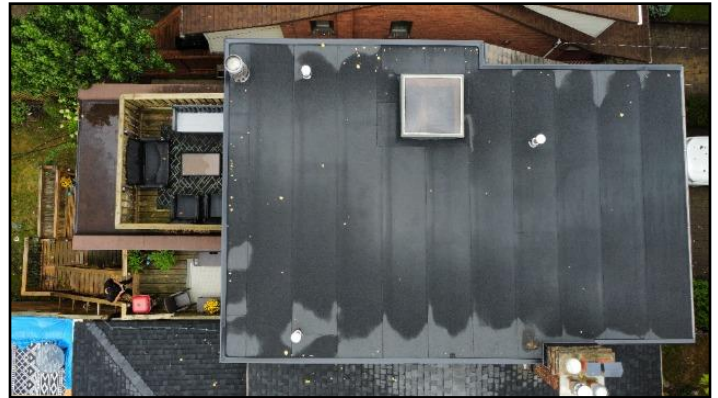
Upper flat roof is in good condition overall

1. Modified bitumen membrane

2. Modified bitumen membrane

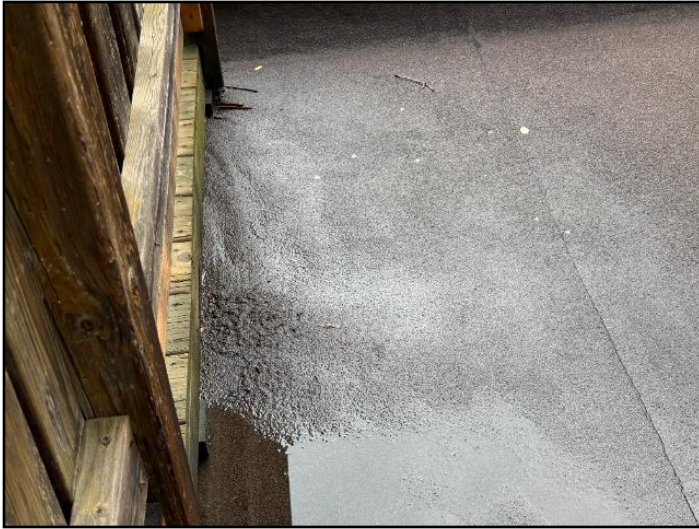
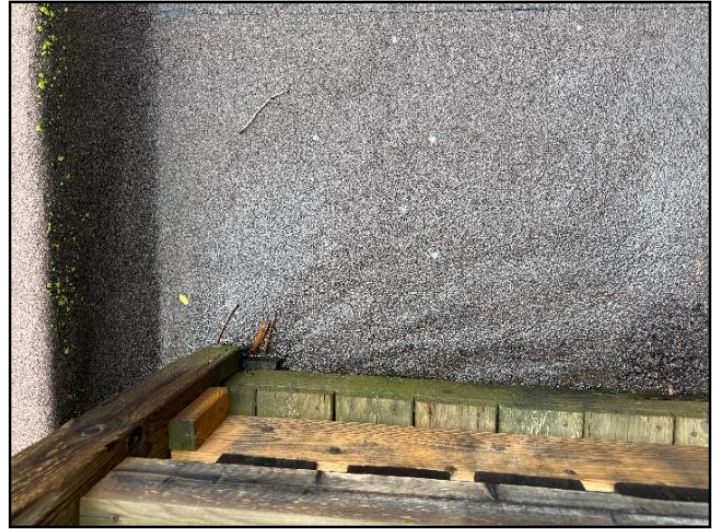
Areas of the rear roof (at deck) that are visible show signs of aging - granule loss, wear. Consult flat roof contractor to evaluate timeline for replacement.

The majority of this roof area is below the deck and full condition was not determined.

3. Aging

4. Aging

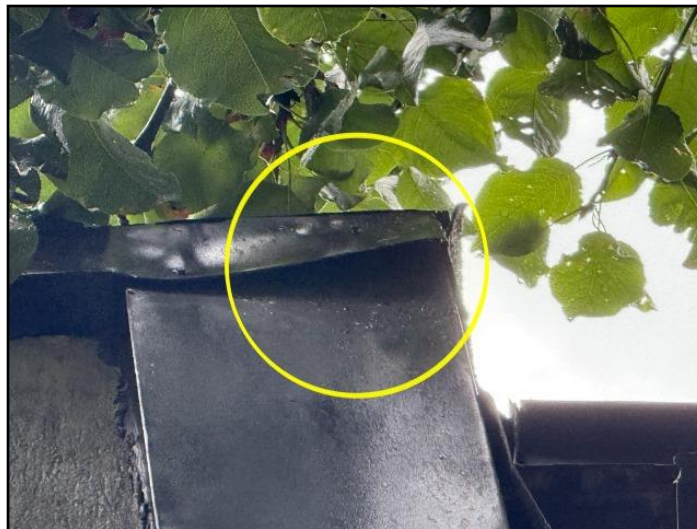
Condition: • [Open at seams or ends](#)

5. Open at seams or ends

Task: Repair

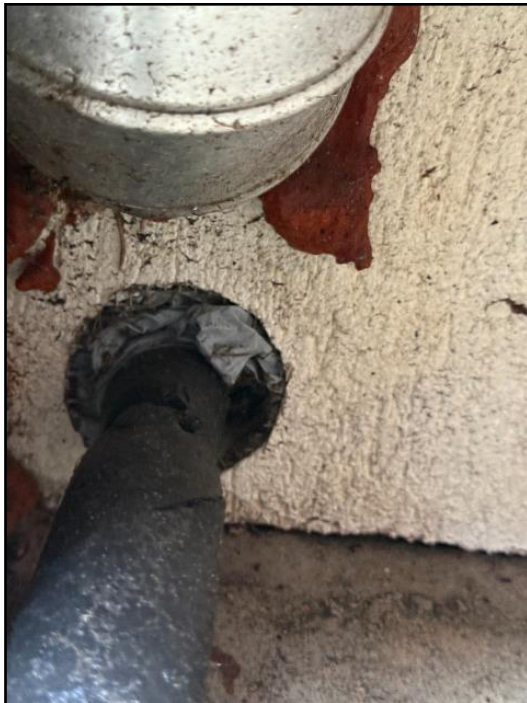
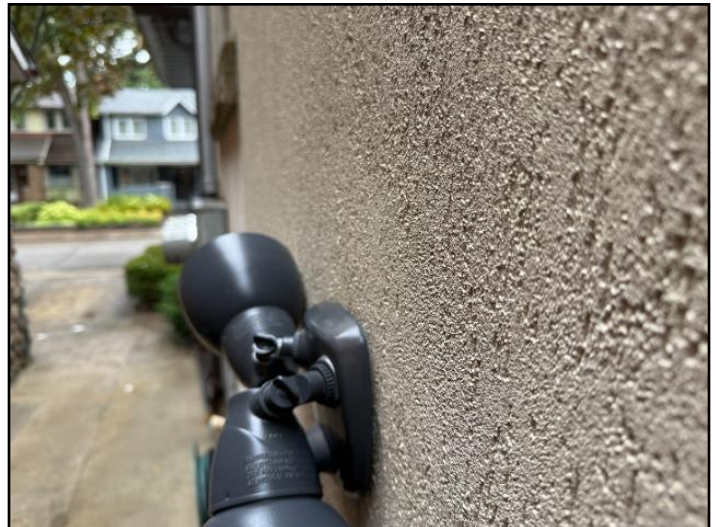
Condition: • FOR ALL HOMES - Caulking around windows, doors, and wall penetrations should be inspected regularly and improved as needed to prevent moisture entry and air leakage.

6. example at a/c refrigerant lines

7. example at light fixture

Task: Seal

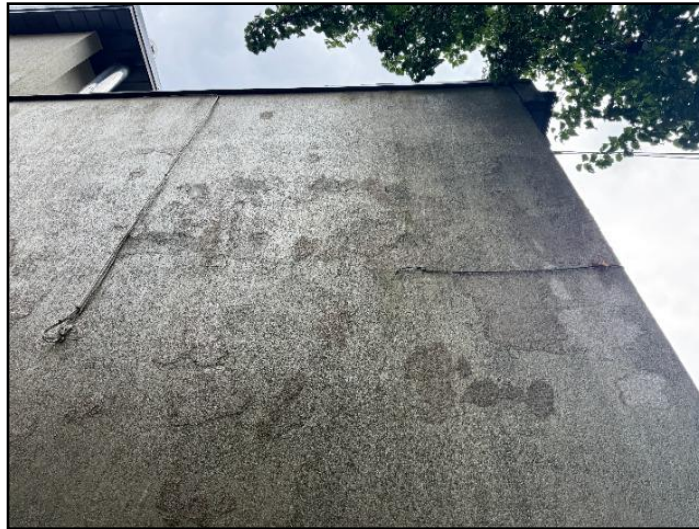
Condition: • [Patched](#)

8. Patched

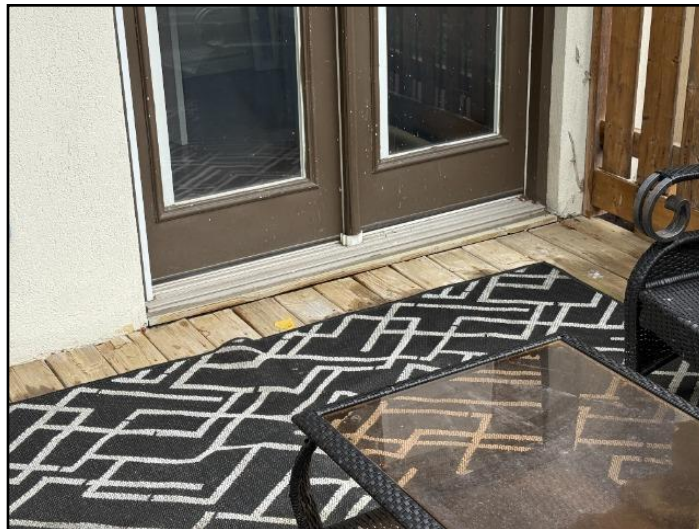
Condition: • Threshold too low

Having a minimal step makes the inside/outside transition easier. On the other hand, it also makes it more prone to snow buildup/leakage.

11. Threshold too low

While it is probably not practical to improve the current situation, it will be important to keep any weatherstripping/caulking in good condition.

Task: Monitor for moisture intrusion / Improve

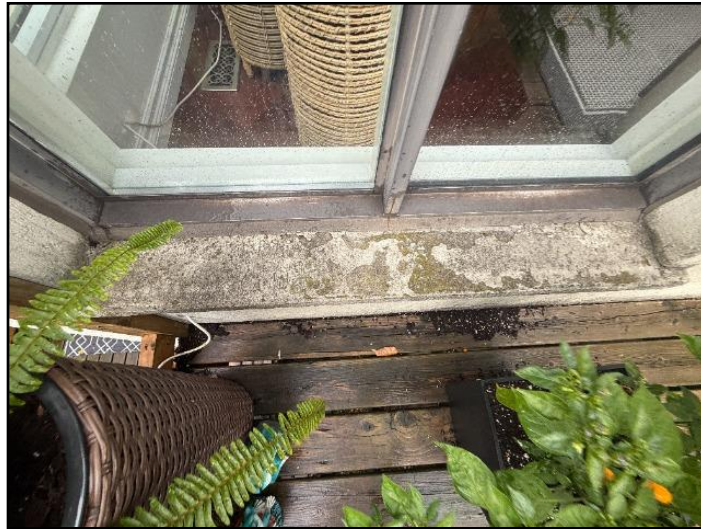
Condition: • [Damaged, cracked or loose](#)

12. *Damaged, cracked or loose*

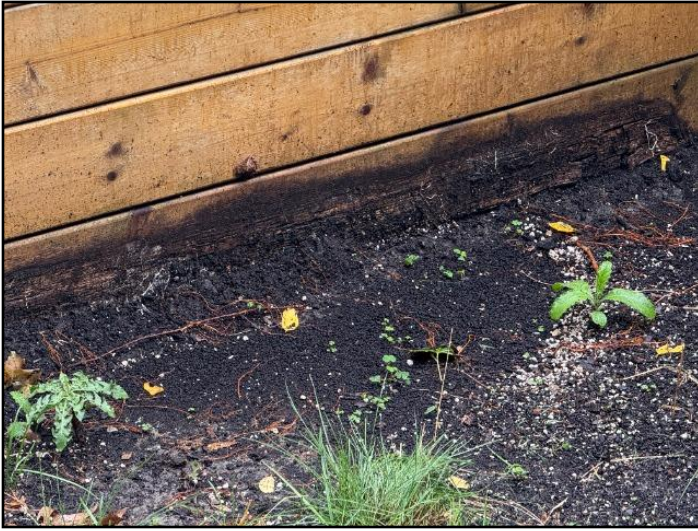
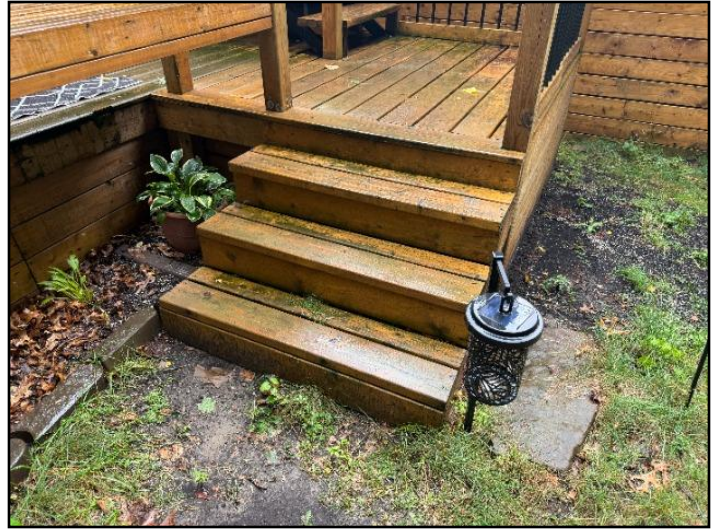
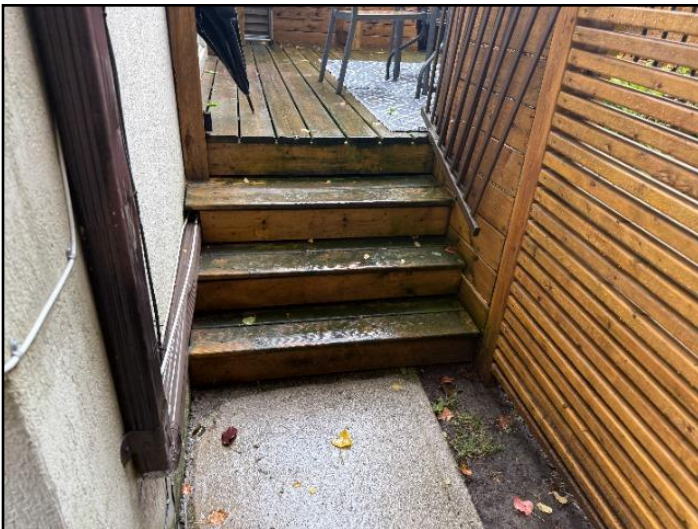
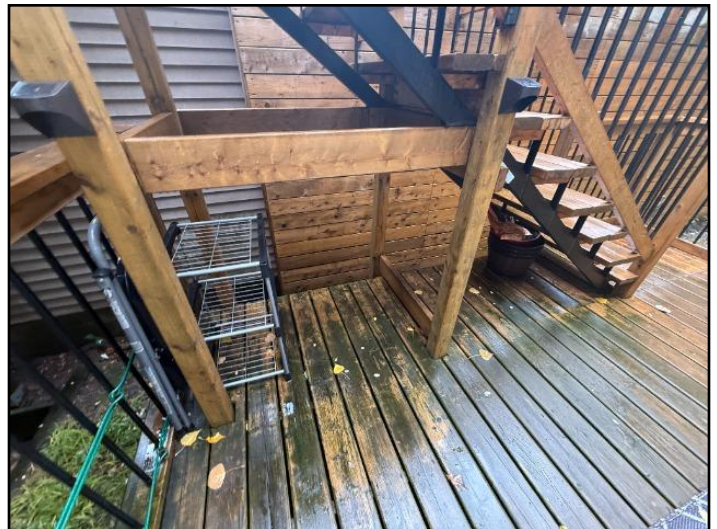
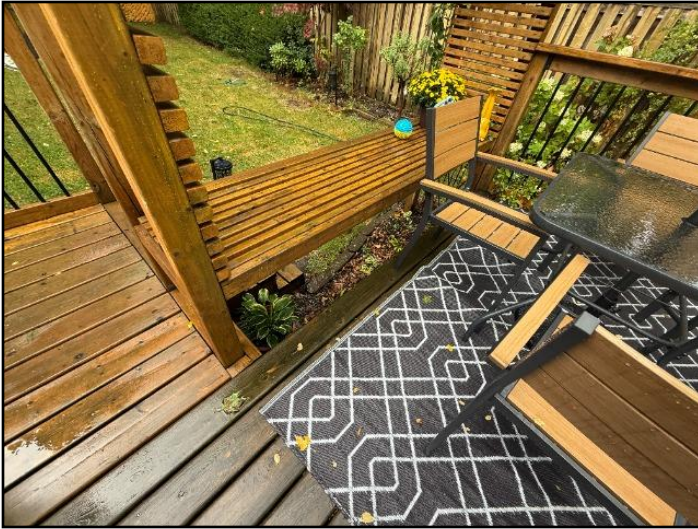
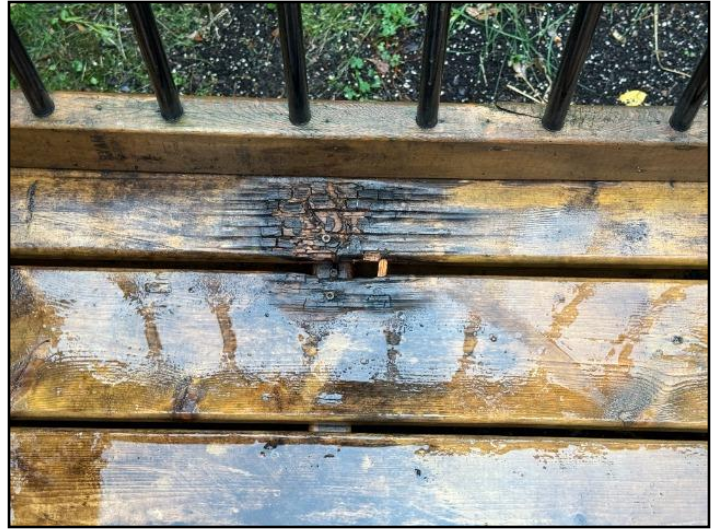
Condition: • Various deck, handrail / guardrail recommendations:

- Handrails missing at steps
- Wood/soil contact at rear deck rotting bottom skirting
- Various guardrails missing
- Damaged deck board

13. wood/soil contact at skirting

14. Missing handrail

15. Missing handrail

16. Missing guards

17. Missing guards

18. Damaged deck board

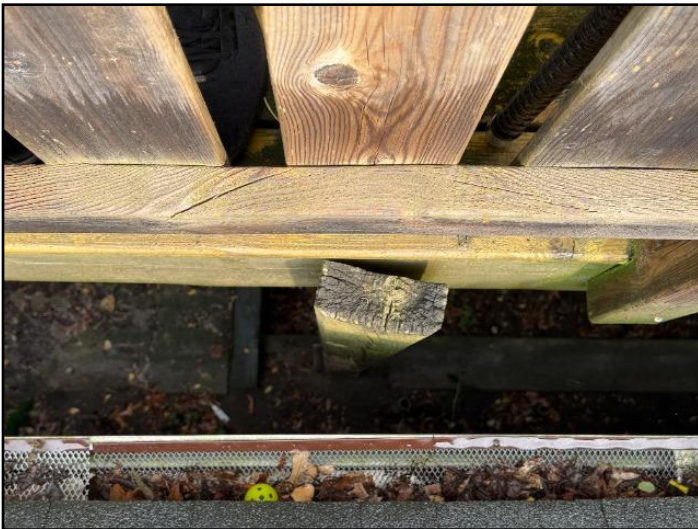
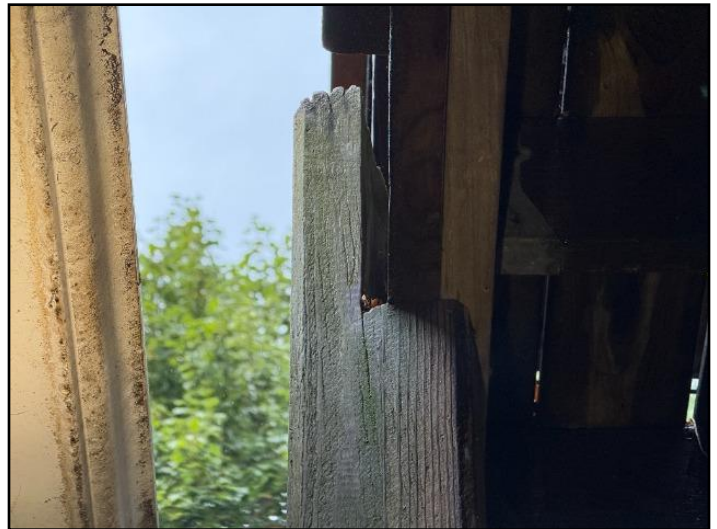
Condition: • [Damage](#)

19. Damage/Twisted

20. Twisted / not fastened to deck

Task: Secure to deck or evaluate for possible post replacement

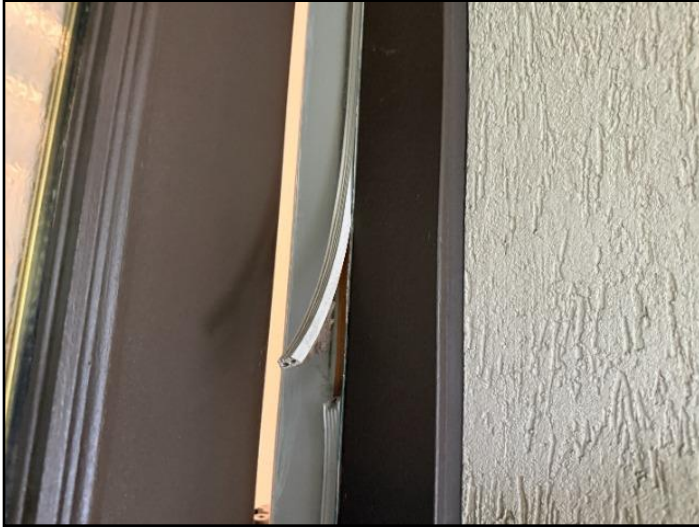
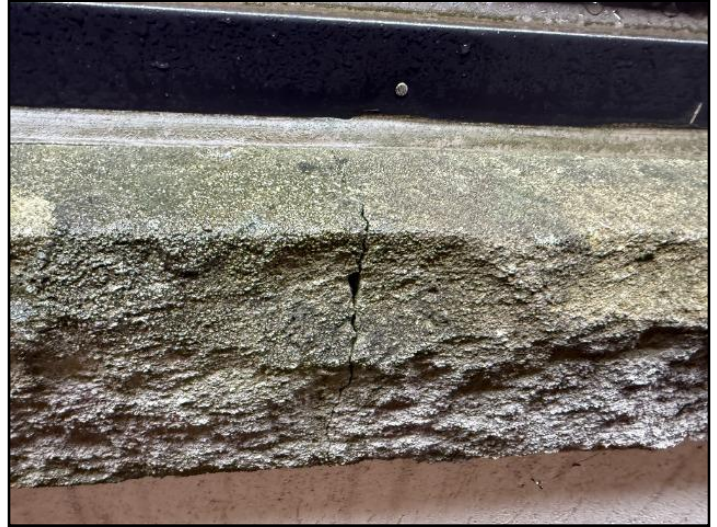
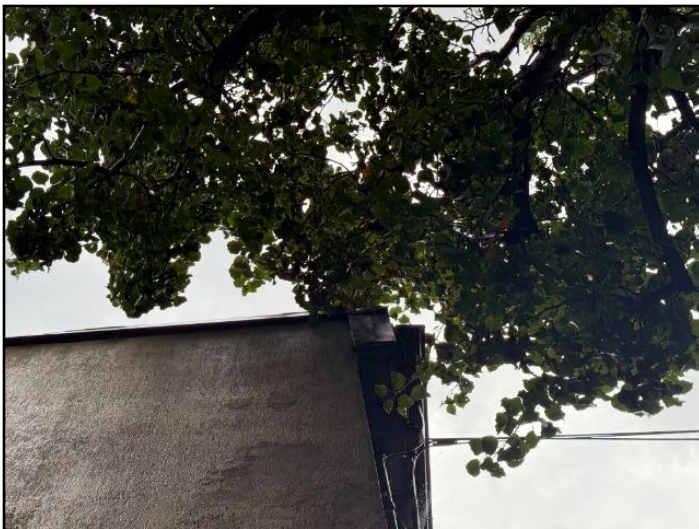
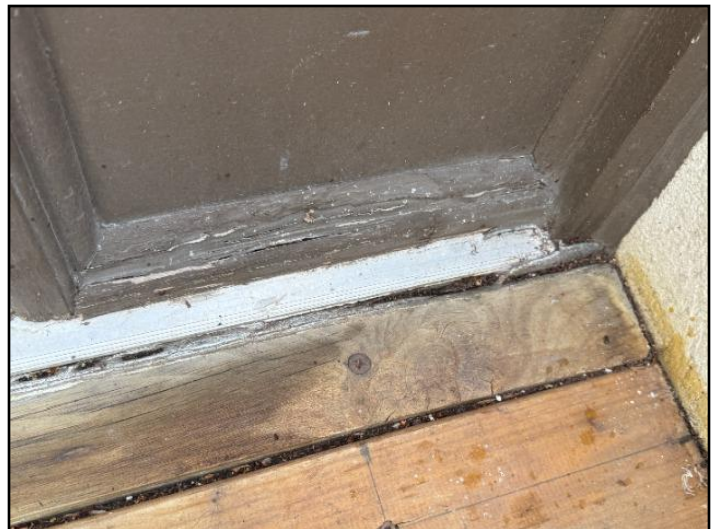
Condition: • The following are minor exterior deficiencies and upkeep items noted during the inspection. These are common for the age of the home and should be addressed through routine maintenance to reduce risk of deterioration or moisture intrusion:

- Weatherstripping loose/damaged - exterior front door
- Minor cracks at window sill - patch

- Keep tree branches trimmed back 3 feet from roof line - ongoing routine maintenance.
- Rear trim exhibits rot

21. example weatherstripping

22. example minor typical cracks

23. tree maintenance

24. rotted trim

Task: Repair or Replace or Improve or Monitor

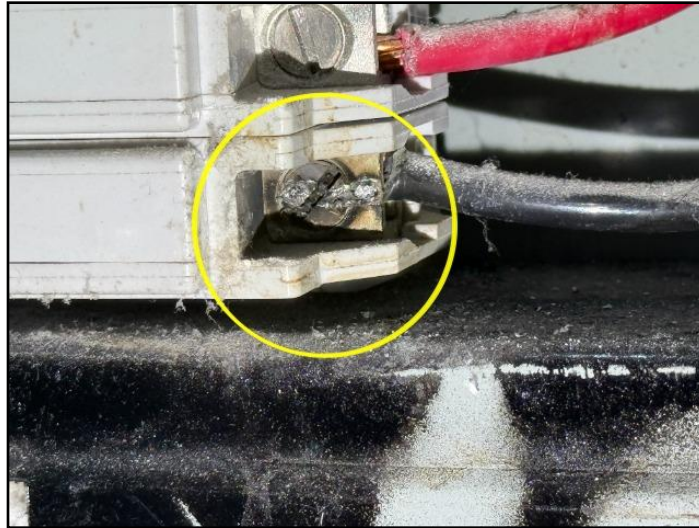
Condition: • [Overheating](#)

Implication(s): Fire hazard

26. Overheating

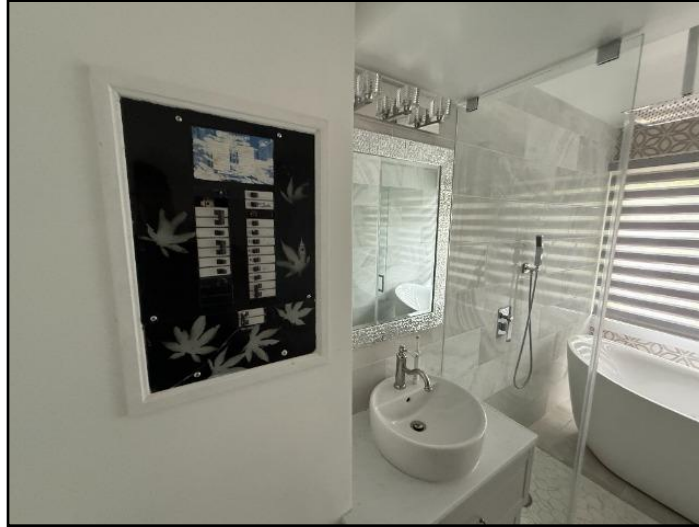
Condition: • [Poor location](#)

The electrical sub panel is located in a bathroom with a shower, which is typically not permitted due to the risk of moisture exposure. Moisture and condensation can lead to corrosion, electrical faults, and potential fire hazards. Special provisions or exemptions may be required, and consultation with a licensed electrician is strongly recommended to assess compliance and determine corrective measures. Relocation may be necessary.

27. Poor location

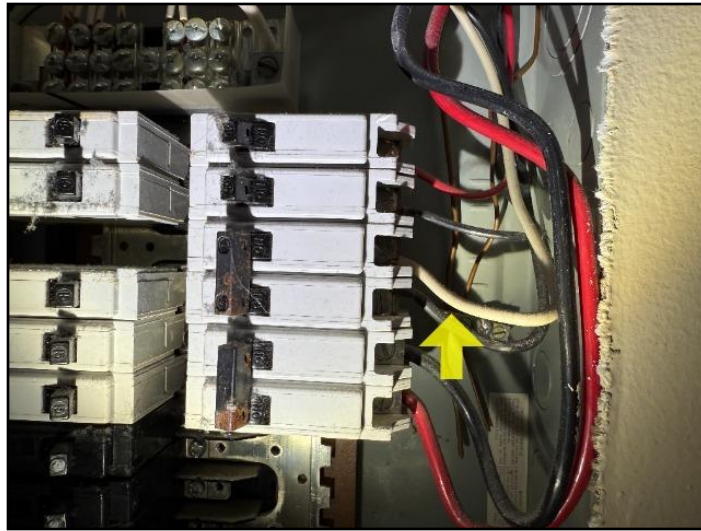
Condition: • White wires connected to breakers not identified as hot/live/ungrounded
White wire used as hot wire not marked

28. White wires connected to breakers not...

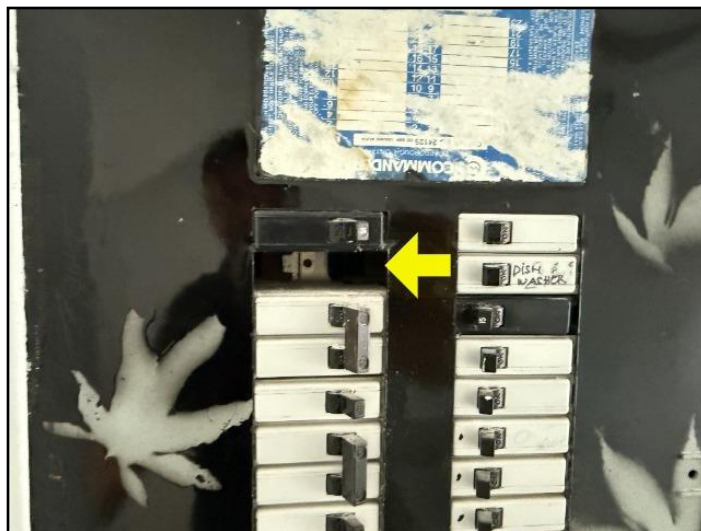
Condition: • Unprotected Opening(s)

29. Unprotected Opening(s)

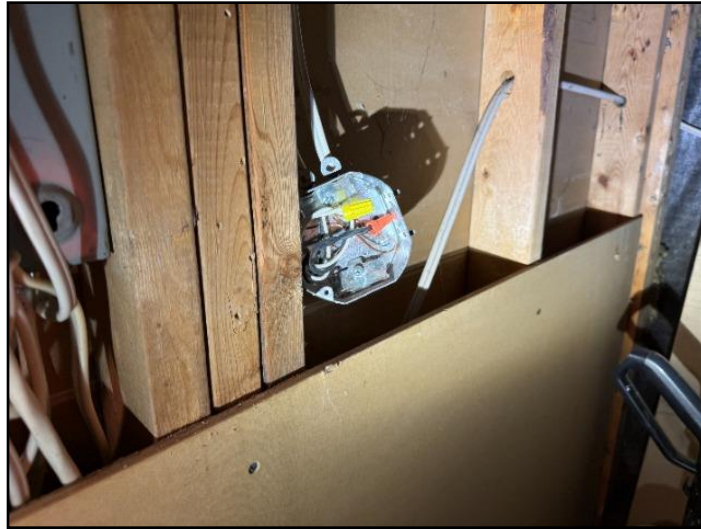
Condition: • Cover missing

Implication(s): Electric shock, Fire hazard

30. Cover missing

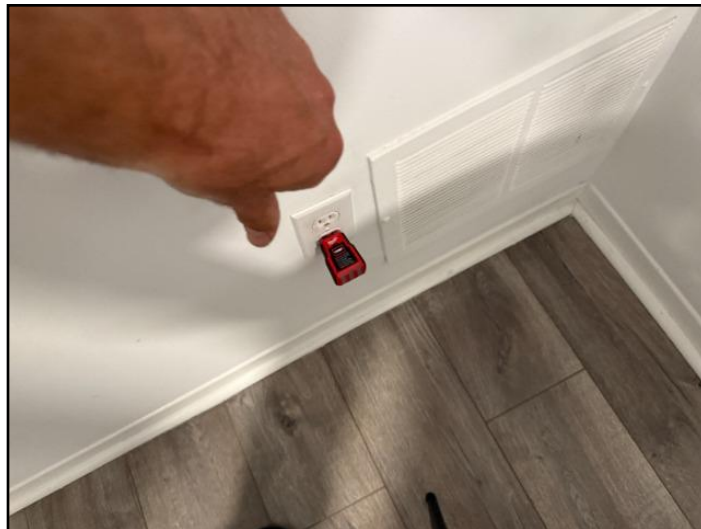
Condition: • [Inoperative](#)

Additionally outlet is loose.

31. Inoperative

Task: Replace

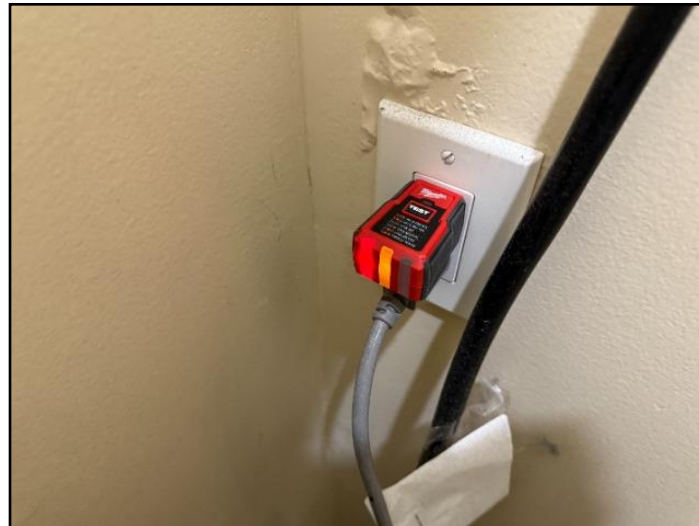
Condition: • [Reversed polarity](#)

32. Reversed polarity

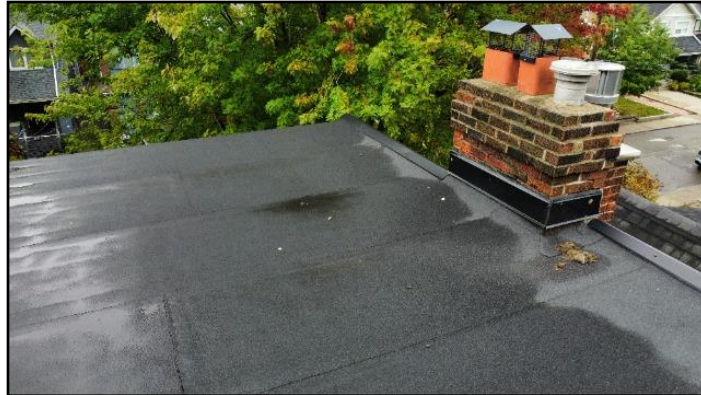
Condition: • [No drip edge on cap \(crown\)](#)

Implication(s): Chance of water damage to structure, finishes and contents | Shortened life expectancy of material |

33. No drip edge on cap (crown)

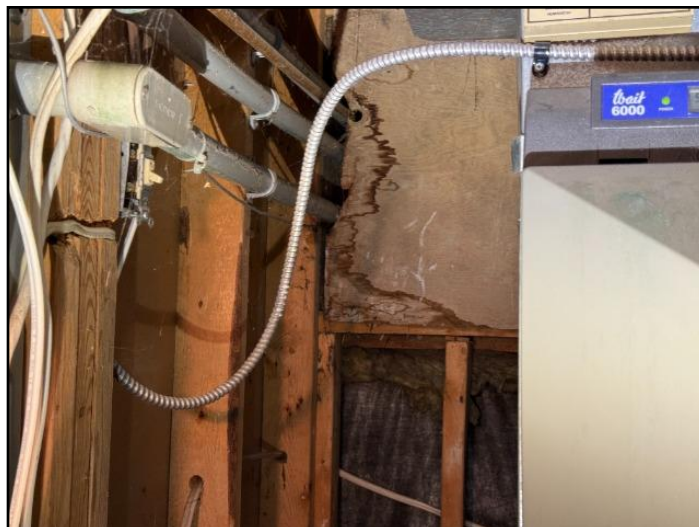
Condition: • Water stains

Water marks/stains tested dry at time of inspection. It is common to find water stains in basements of this vintage.

35. one example

Task: Monitor for moisture / water intrusion

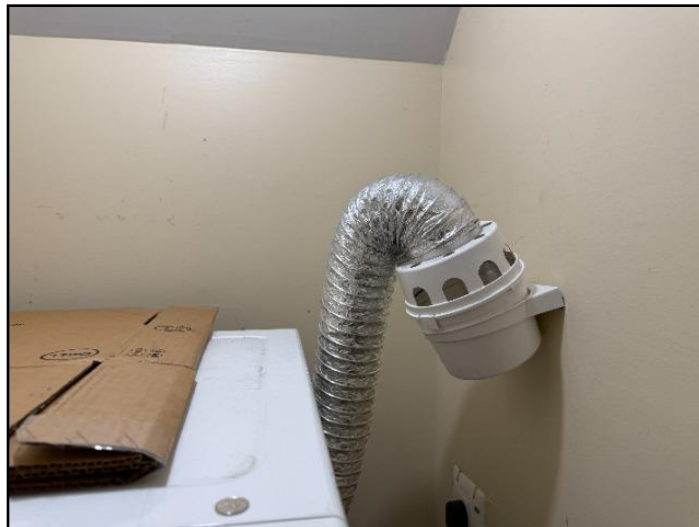
Condition: • Not vented to exterior

37. example at first floor laundry area
