INSPECTION REPORT

XXXXXXXXXX
ANYWHERE, OK

Inspection Date: Tuesday, June 26, 2018

RE: Report No. 1004, v.4

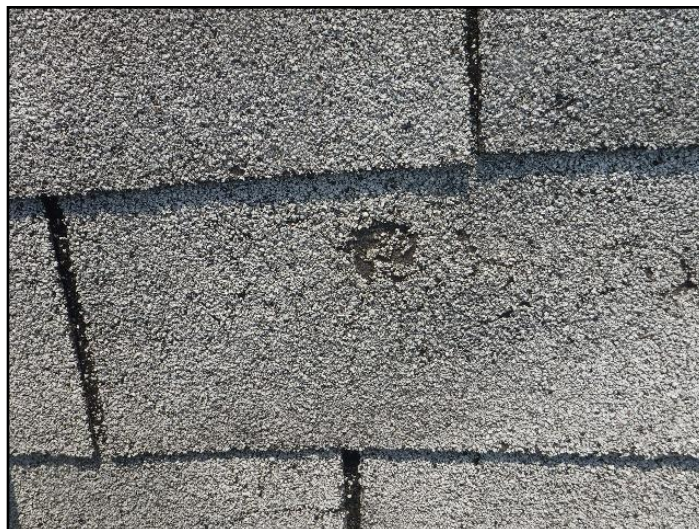
4. **Condition:** • [Damage](#)

Asphalt shingles are showing minor blemishes.

Task: Monitor Repair and Replace as needed

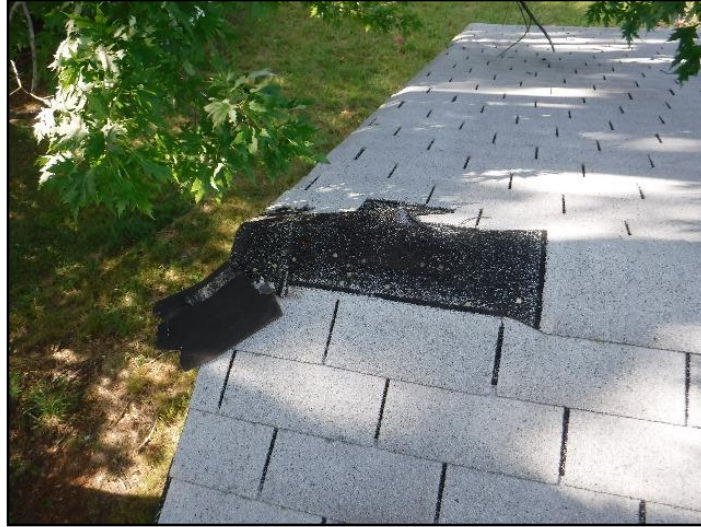
5. Condition: • [Missing, loose or torn](#)

East side of the roof covering had loose or missing shingles. (Roof cap)

Task: Repair and install

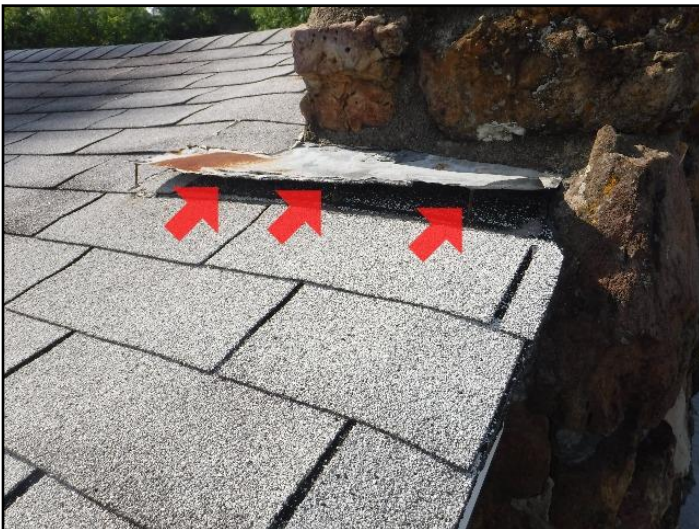
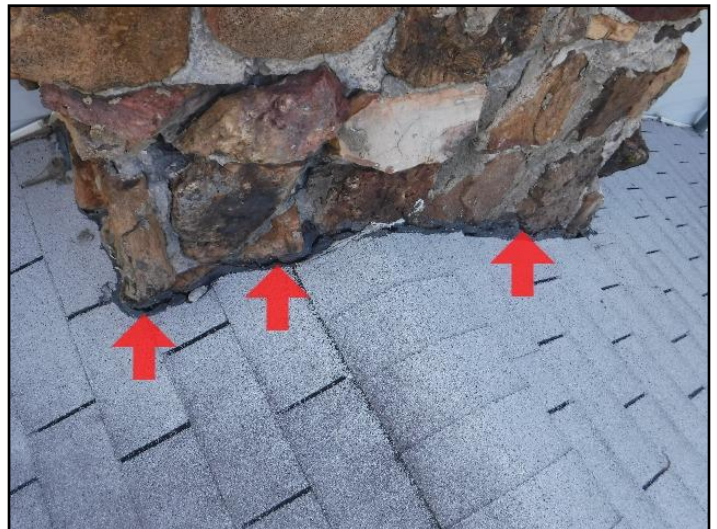
7. Condition: • [Damage, loose, open seams, patched](#)

Main roof near chimney has loose flashing. Carport roof near chimney has flashing missing.

Task: Repair and replace

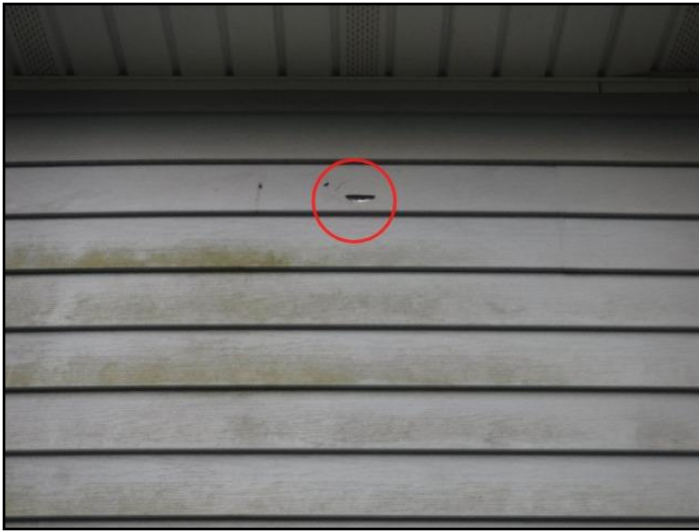
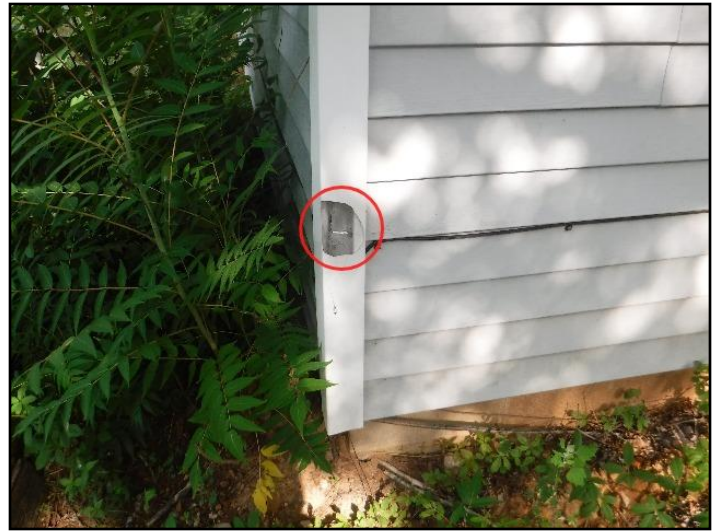
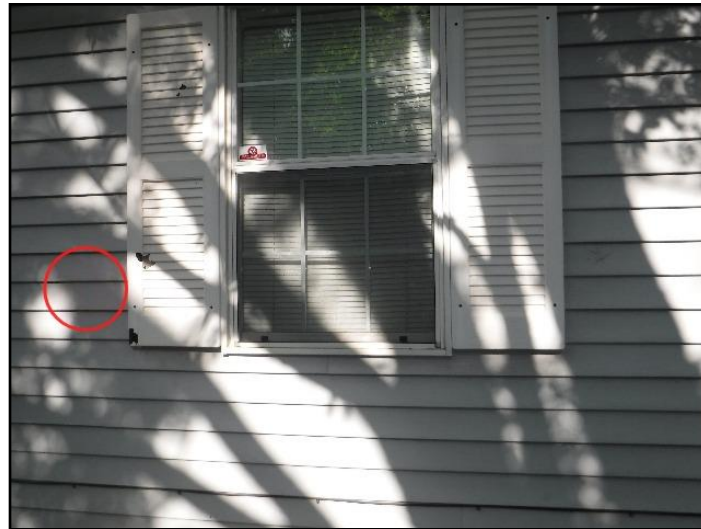
8. Condition: • The vinyl siding has various areas with minor damage.

Task: Repair and seal.

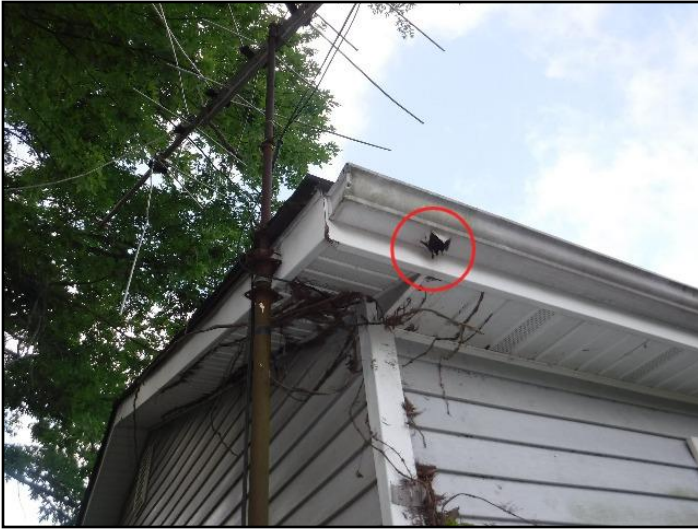
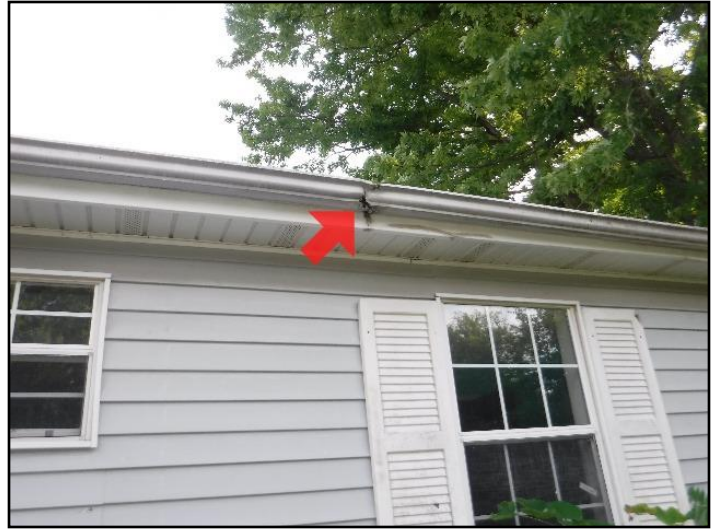
9. Condition: • Damage

North East side of home has clogged gutters and one of the down spouts has fallen off. South East side has damage to the gutter system(appears to be functional)

Task: Repair and clean out gutters

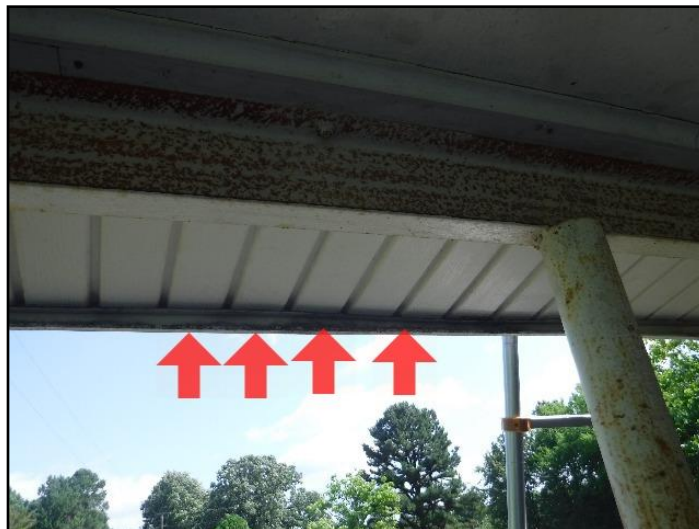
Location: North side of carport

10. Condition: • [Loose or missing pieces](#)

Task: Repair and install

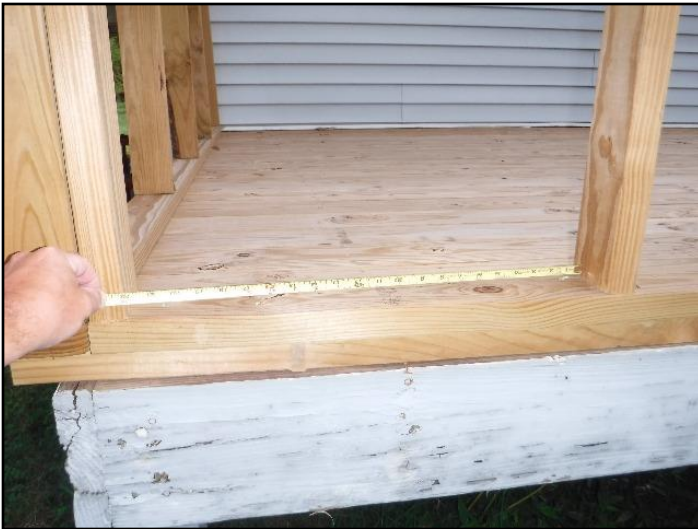
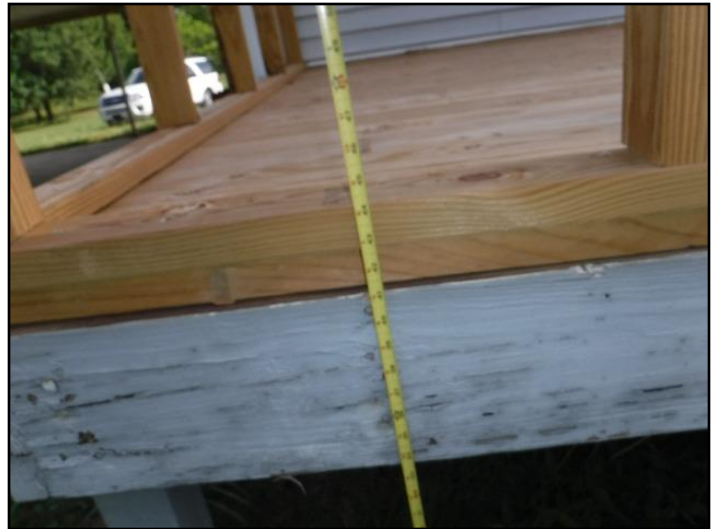
15. Condition: • [Openings between spindles \(balusters\) too large](#)

Task: Repair and install

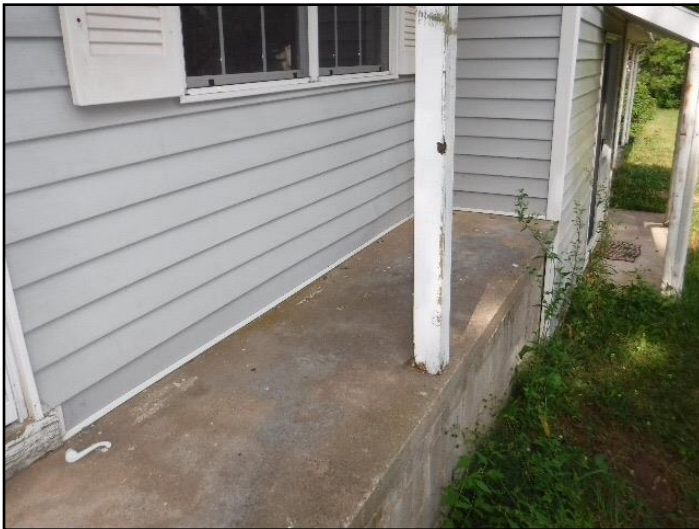
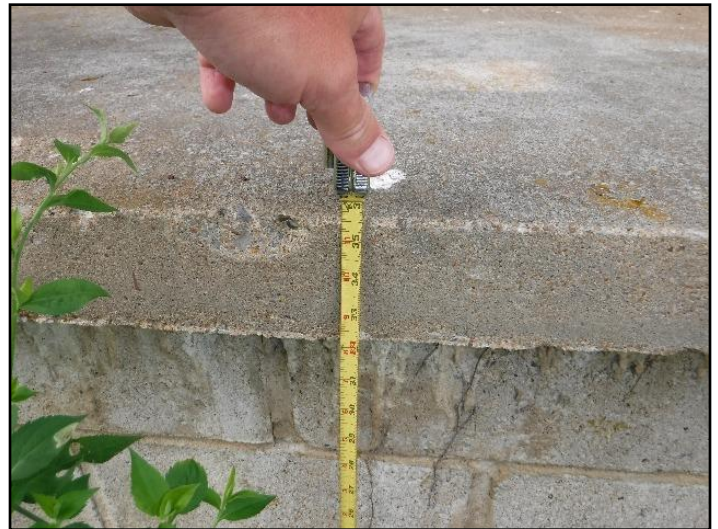
16. Condition: • [Spindles \(balusters\) missing](#)

Front porch which is has a elevation above 30 inches of the surface below is required to have balusters/ Guardrail installed. Balusters need to be close enough a 4 inch sphere cannot pass between them.

Spindles (balusters) missing

Task: Repair and install

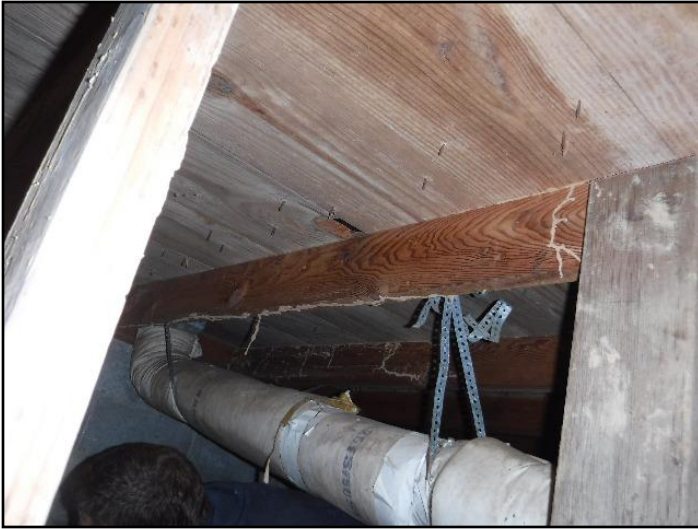
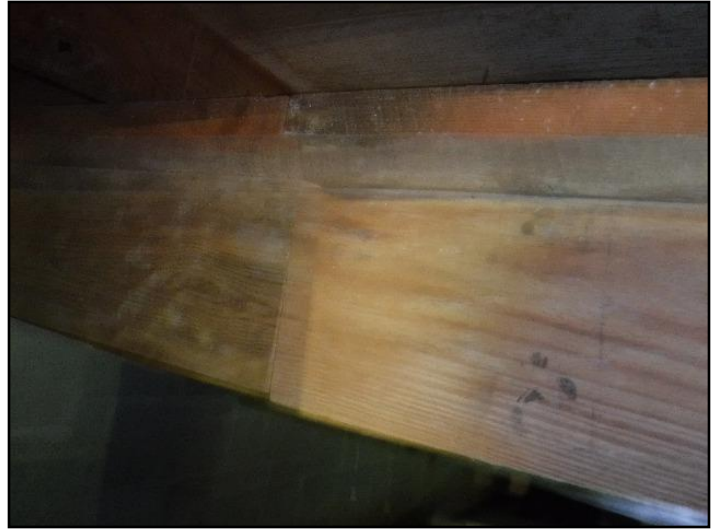
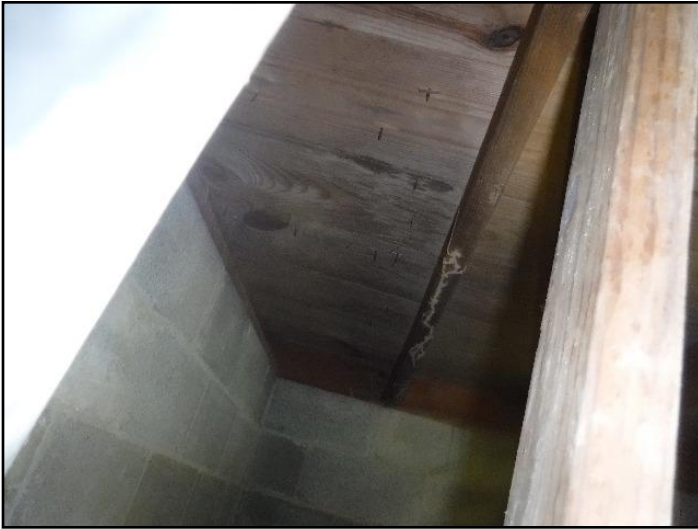
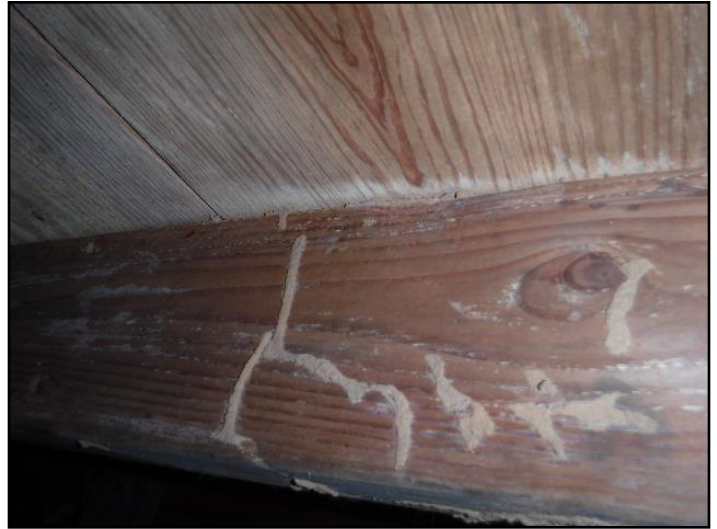
18. Condition: • [Rot, insect or fire damage](#)

West side of living room area has 4 joists which are weakened by possible insect damage.

Task: Recommend further evaluation by licensed termite inspector.

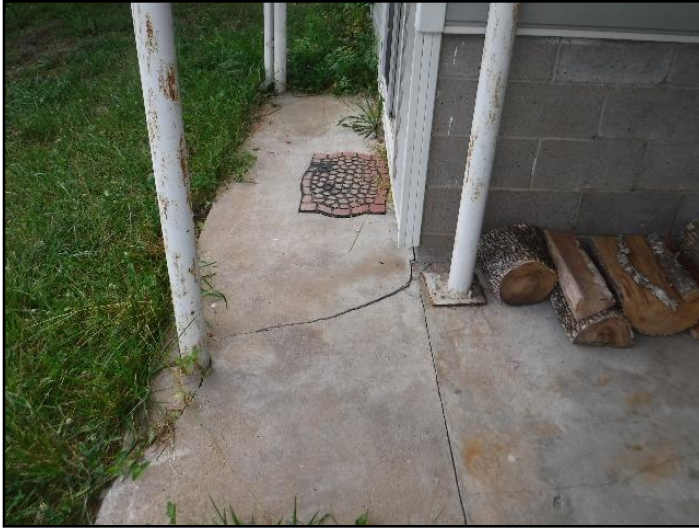
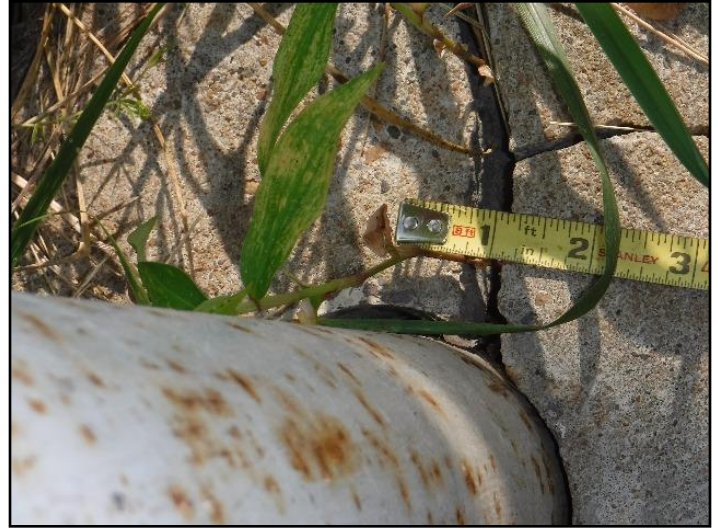
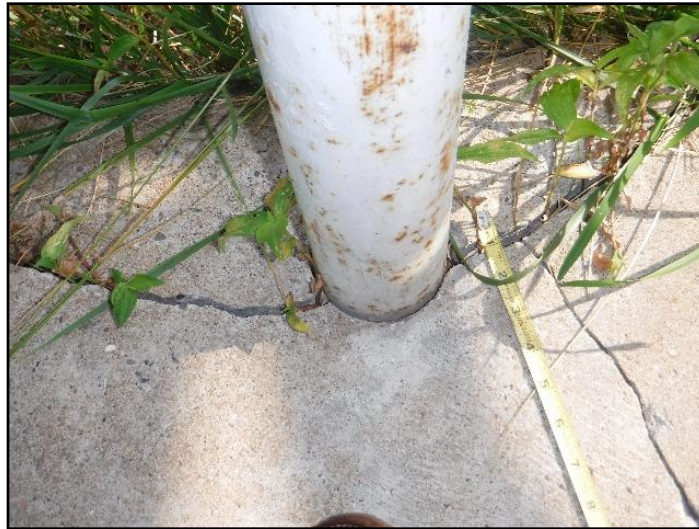
20. Condition: • [Cracked](#)

Concrete slab has minor cracks.

Task: Monitor and repair as needed

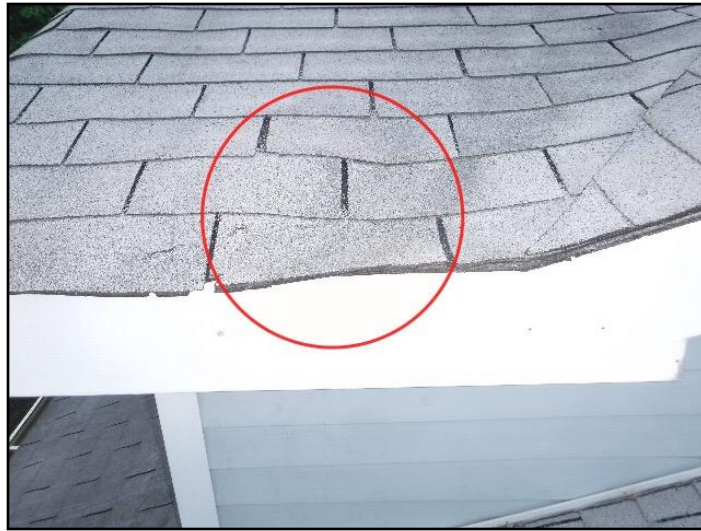
21. Condition: • [Rot, fire or insect damage](#)

Sheathing appears to be rotten or weakened from moisture.

Task: Repair and replace

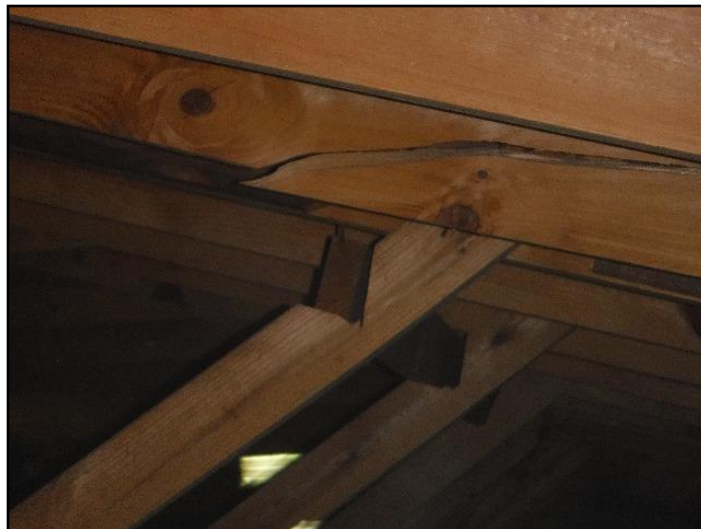
22. Condition: • [Split](#)

South west side of roof area has a split truss.

Task: Repair

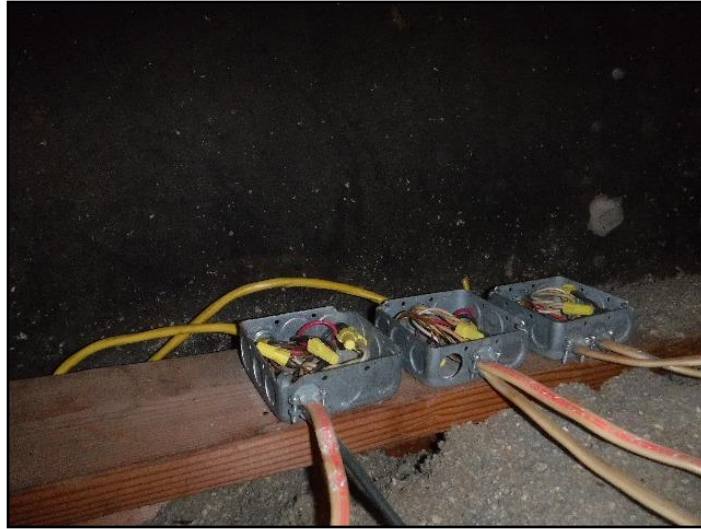
27. Condition: • [Cover loose or missing](#)

Junction boxes in attic do not have cover plate installed.

Task: Repair and install

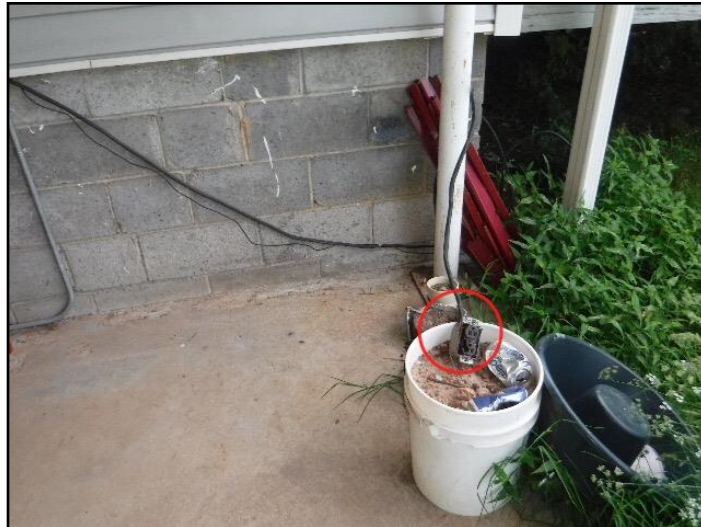
28. Condition: • [Damage](#)

One receptacle in the carport area is damaged, not attached to structure and live.

Damage

Task: Repair and replace

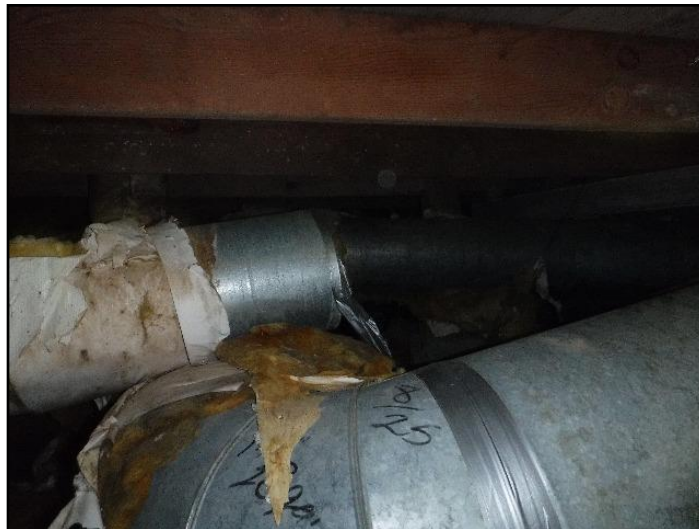
38. Condition: • [Disconnected ducts](#)

Various ducts are disconnected

Task: Repair and replace

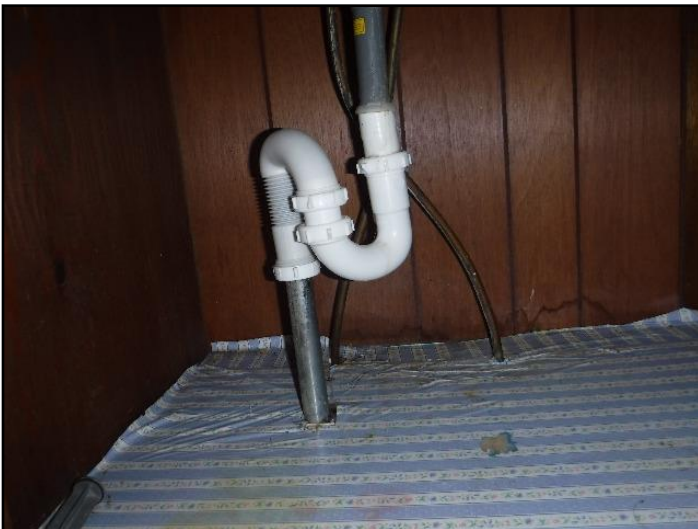
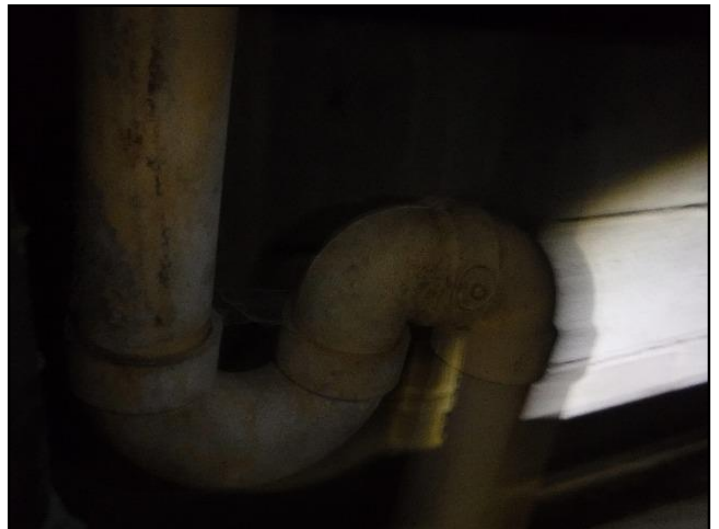
50. Condition: • All traps in home are S traps and the bath tub is draining slowly.

Task: Monitor (Repair and replace as needed)
