# YOUR INSPECTION REPORT

FOR THE PROPERTY AT:  
719 Saint Clarens Avenue  
Toronto, ON M6H 3X2

INSPECTION DATE:  
Thursday, April 24, 2025

RE: Report No. 8266  
719 Saint Clarens Avenue  
Toronto, ON  
M6H 3X2

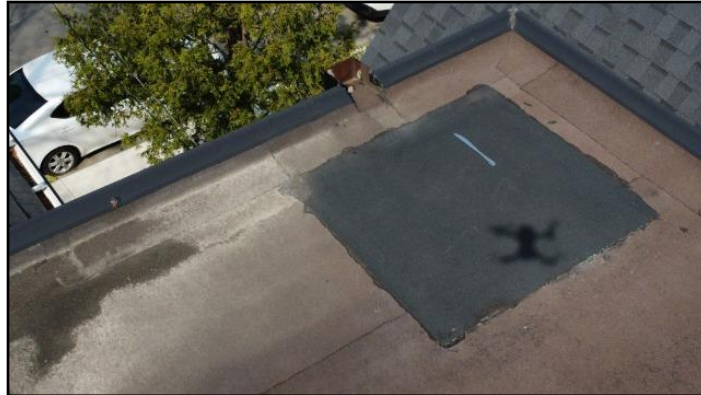
4. Patched

**Condition:** • [Patched](#)

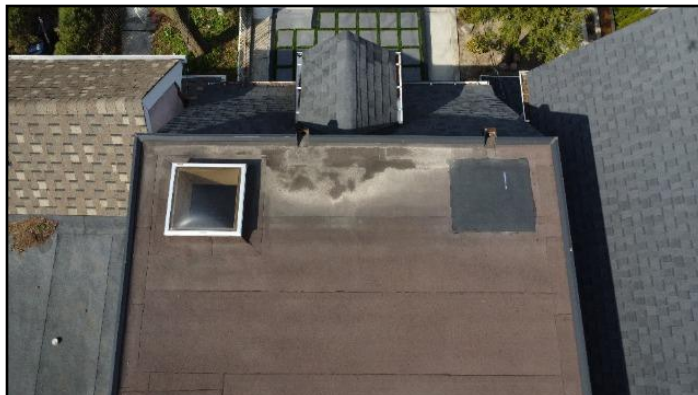
5. Prior ponding

**Condition:** • [Ponding](#)

Staining and discoloration observed at the front flat roof suggest a low area where water may have previously accumulated near the drain. Ponding is defined as water that remains on a roof for more than 48 hours after rainfall. No active ponding was present at the time of inspection, but the area should be monitored during rainy conditions and improved if standing water is observed.

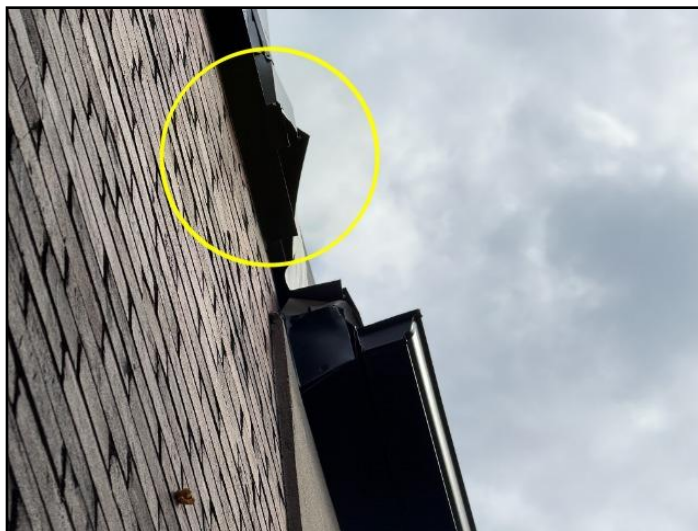
6. Flashings incomplete or ineffective

**Condition:** • [Flashings incomplete or ineffective](#)

**Task:** Repair

**Time:** Less than 1 year

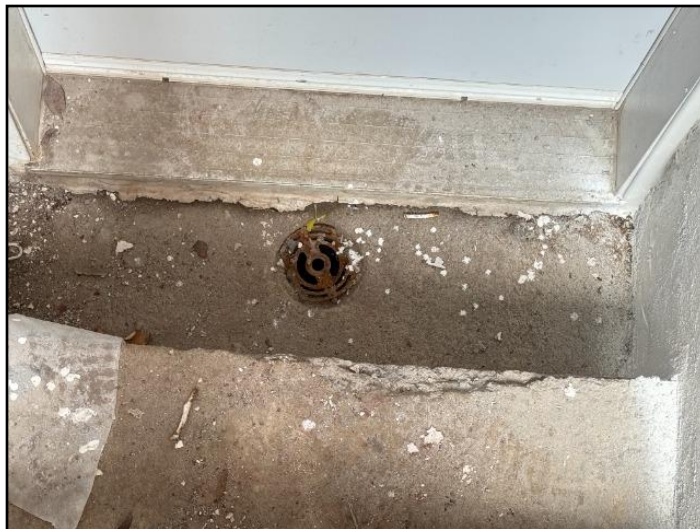
7. Door threshold missing, too low, not...

**Condition:** • [Door threshold missing, too low, not watertight](#)

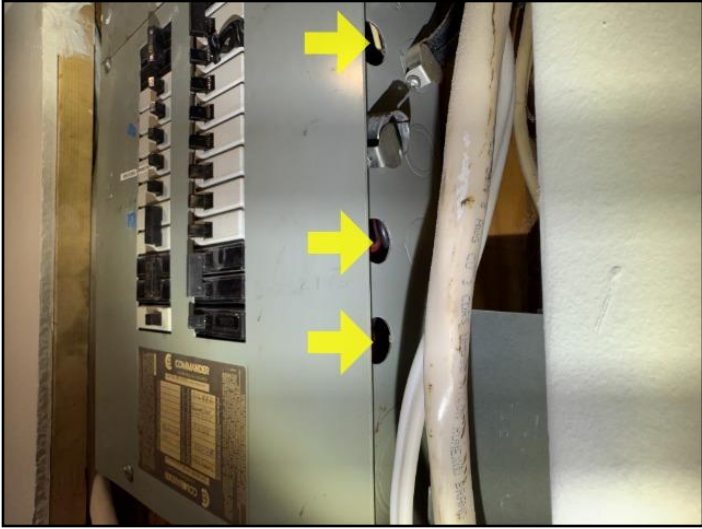
10. Openings in panel

**Condition:** • [Openings in panel](#)

**Implication(s):** Electric shock | Fire hazard

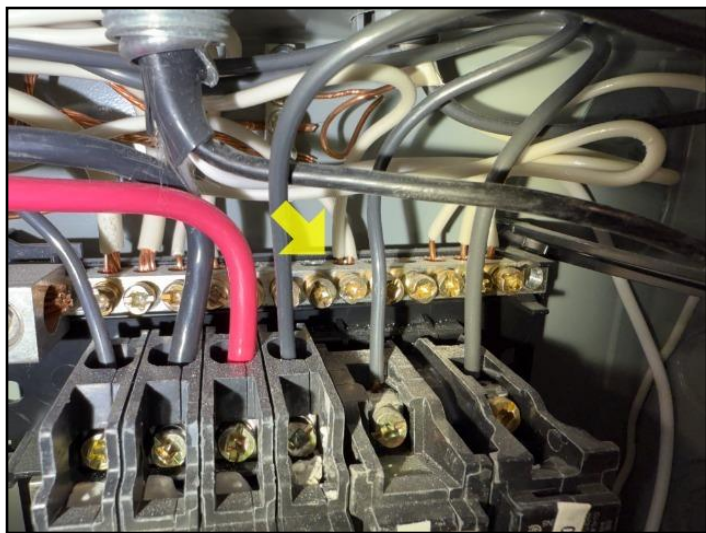
11. Double taps

**Condition:** • [Double taps](#)

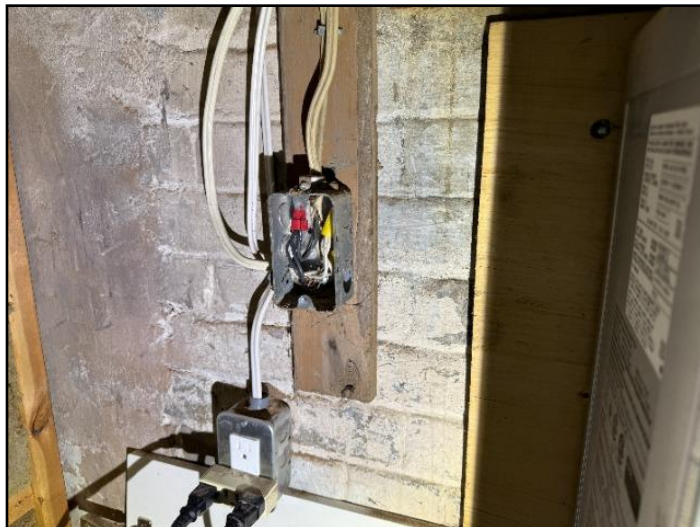
12. Cover missing

**Condition:** • Cover missing

**Implication(s):** Electric shock, Fire hazard

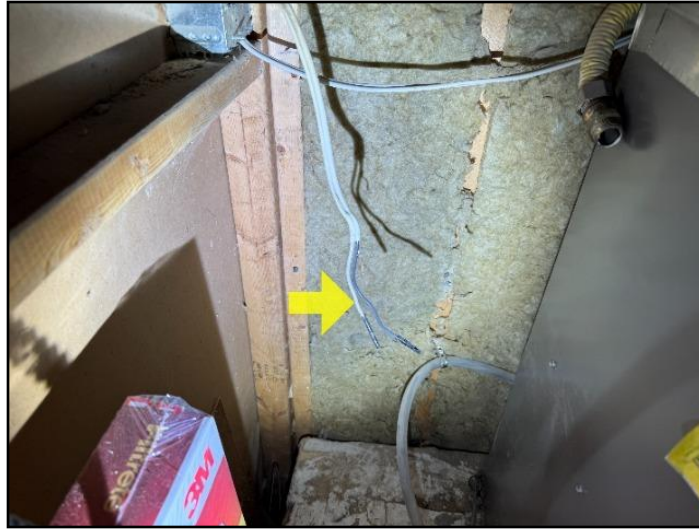
13. Wire not in use

**Condition:** • Electrical maintenance items noted below are generally straightforward to address but should still be treated as safety-related. These types of issues are common in many homes and may be corrected as part of routine electrical maintenance:

- Abandoned wire noted in furnace room - not in use and not live - provide proper junction box or remove.
- Loose GFCI outlet near basement kitchen sink - secure.

**Implication(s):** Fire and/or shock hazards
