# INSPECTION REPORT

For the Property at:  
**1234 MAIN ST.**  
KELOWNA, BC

Inspection Date: Friday, June 12, 2015

RE: Report No. 1574, v.2  
1234 Main St.  
Kelowna, BC

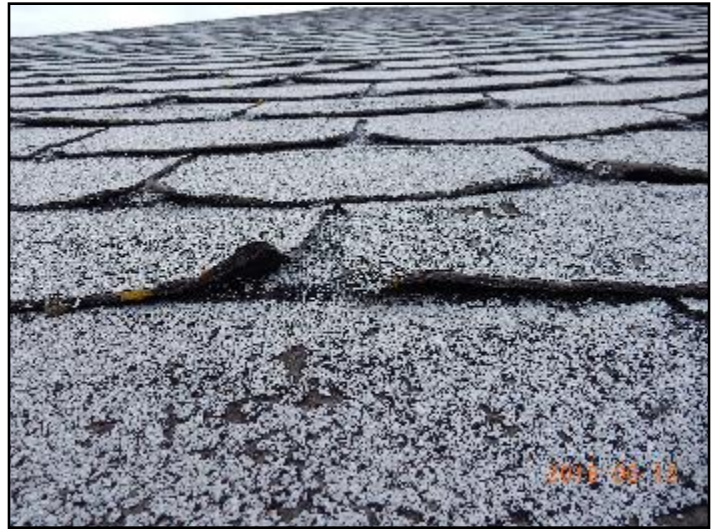
7.

**1. Condition:** • [Old, worn out](#)

The asphalt roof shingles are old and showing signs of deterioration including granule loss, widened slots as well as cupping and curling. Recommend replacement within 2 years

**Task:** Replace

**Time:** Less than 2 years

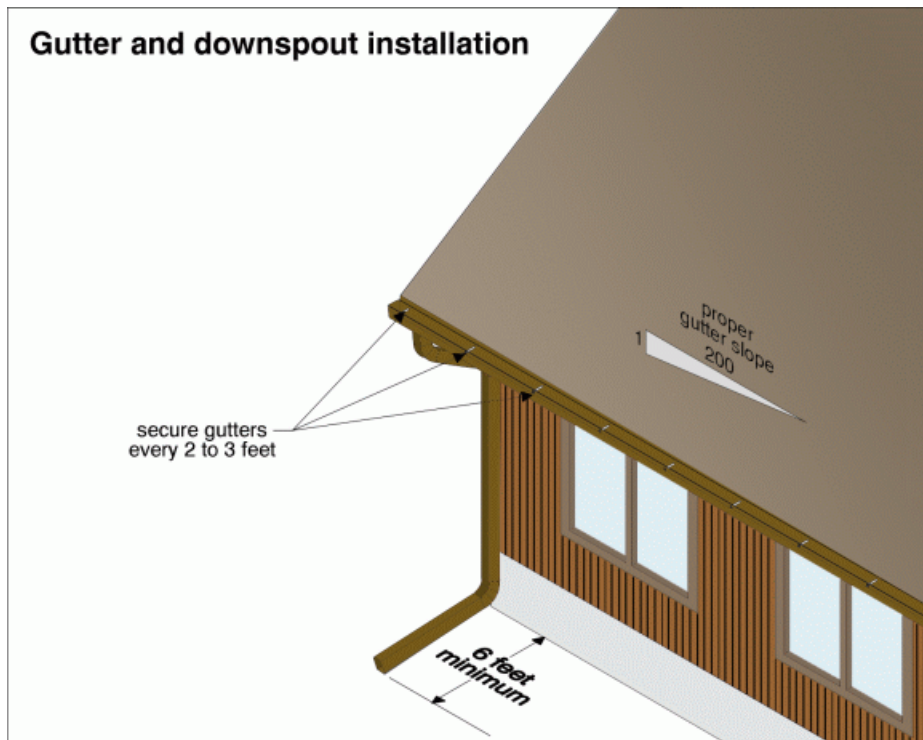
### 3. Condition: • [Downspouts end too close to building](#)

The downspout should discharge approx 6 feet from the building. Downspouts that drain water against the foundation can damage exterior finishes, erode the structure, and increase the risk of water damage. Recommend improvement of any downspouts that end too close to the structure.

**Task:** Improve

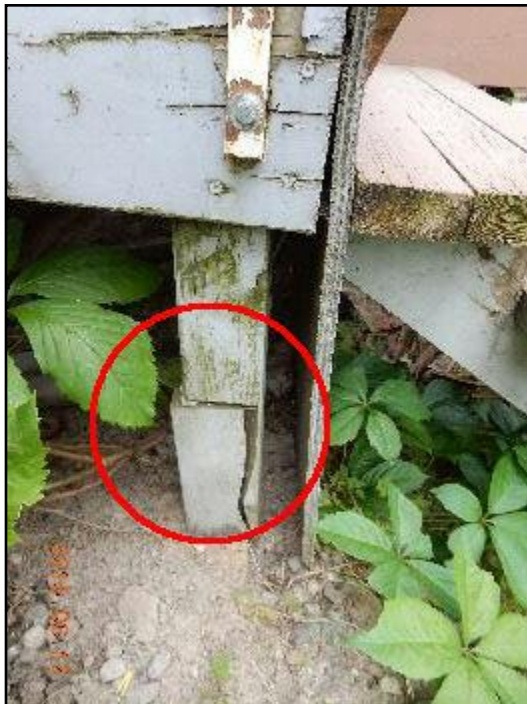
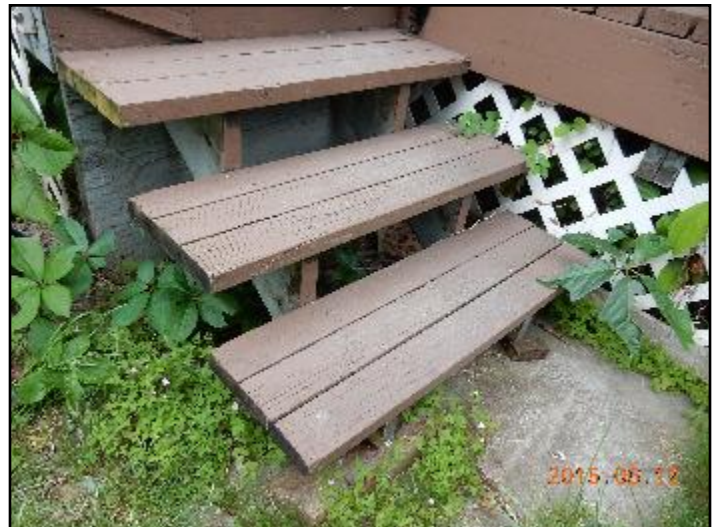
**6. Condition:** • The rear exterior small set of stairs is poorly fastened to the deck and is weak. The post supporting the steps is split, and in contact with the soil. There is movement noted when used. repair is recommended immediately.

**Task:** Repair

**Time:** Immediate

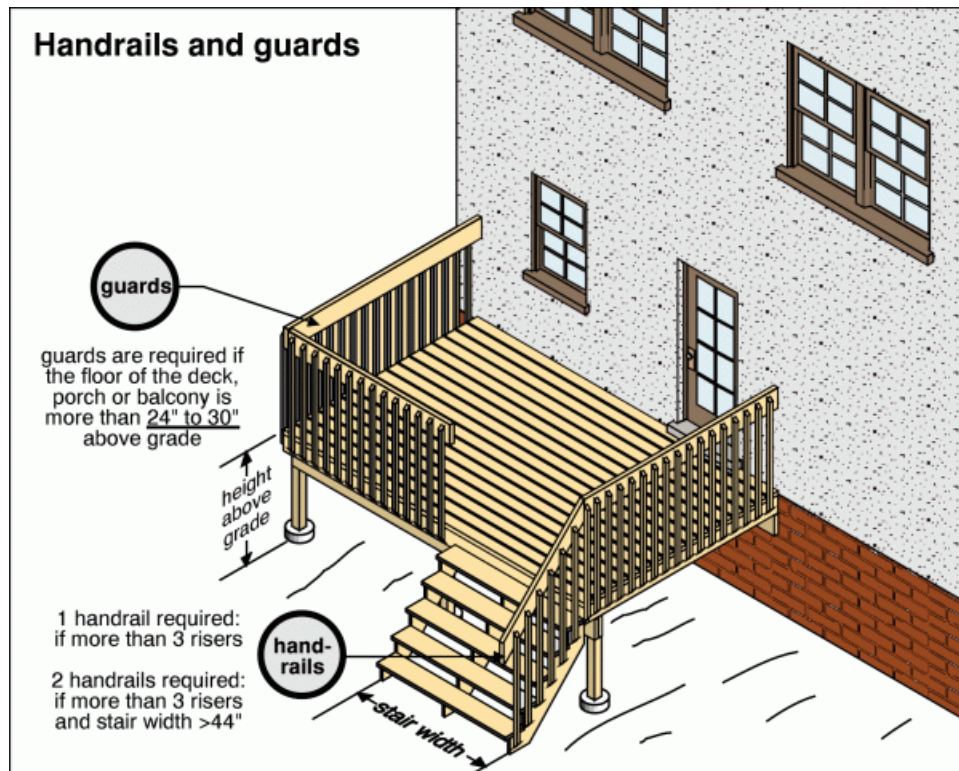
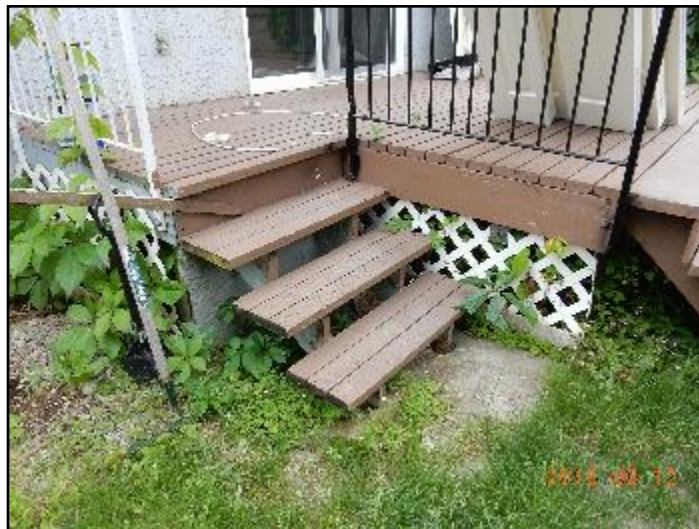
36.

**7. Condition:** • [Missing](#)

There are missing handrails and guard rails on the rear stairs. Stairs with 3 or more stairs require a handrail and guardrail on both sides.

**Task:** Provide

**Time:** Immediate

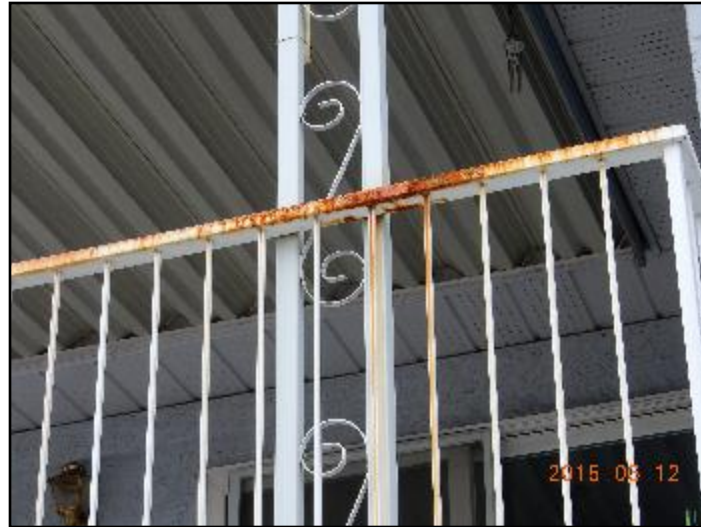
37.

**8. Condition:** • [Rust](#)

The structure of the rail does not appear to be affected. Rust will deteriorate the materials over time. Repair or replace as needed.

**Task:** Repair or replace

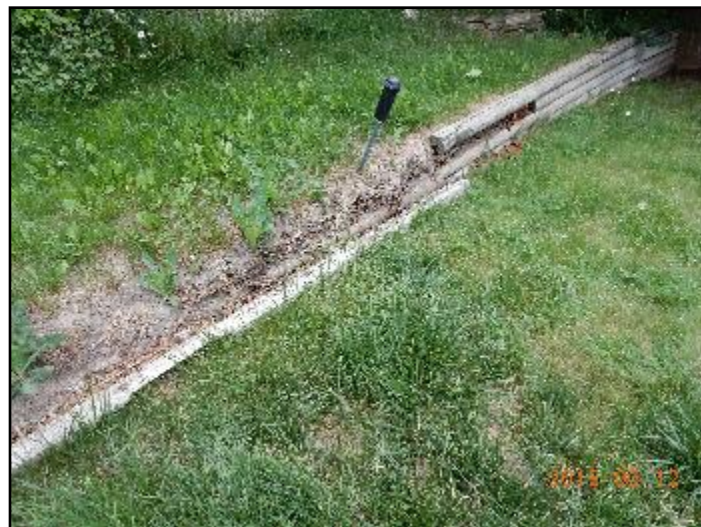
38.

**9. Condition:** • [Rot](#)

The small wood retaining wall in the back yard is rotten and damaged. Repair or replace at your discretion.

**Task:** Repair or replace

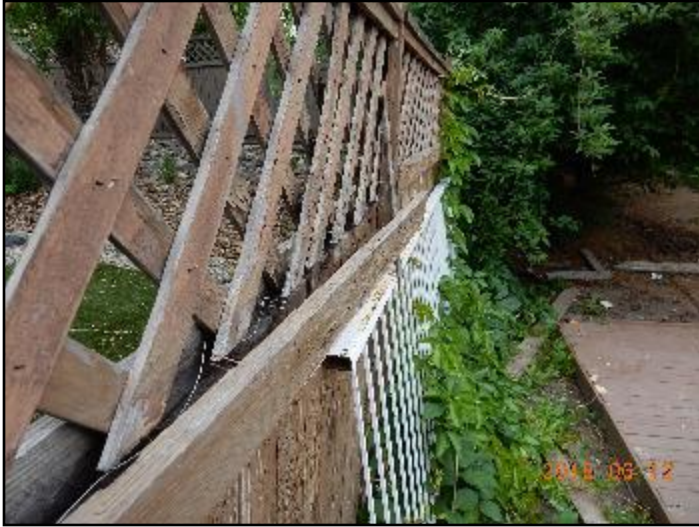
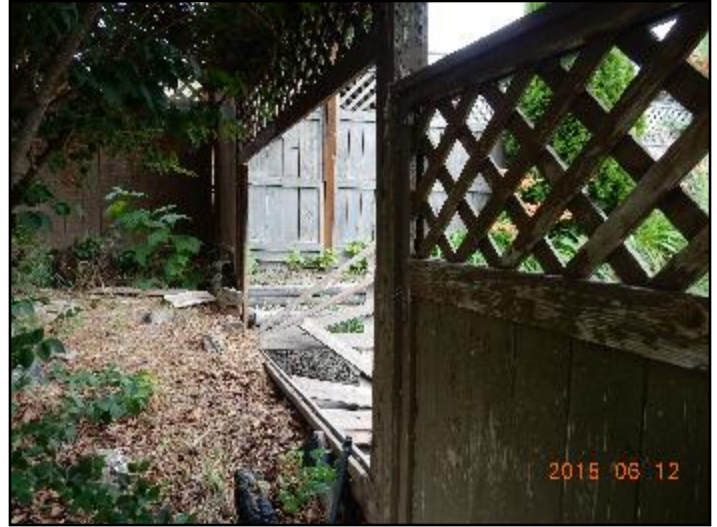
**10. Condition:** • Deteriorated

The back yard fence is deteriorated, broken, leaning and damaged throughout. Repair or replace as part of regular house maintenance.

**Task:** Repair or replace

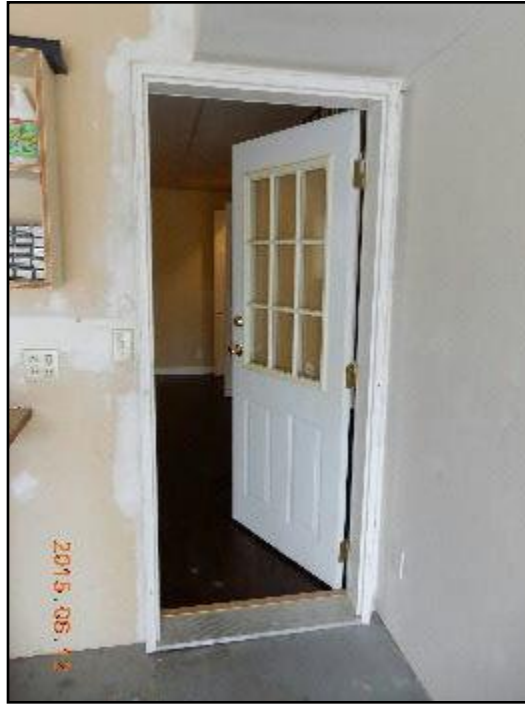
42.

**11. Condition:** • [No self-closer](#)

The rear garage man-door has no self closer. The door is also not fire rated (window). Replacement is recommended as well as adding self closing hinges.

**Task:** Replace

**Time:** Immediate

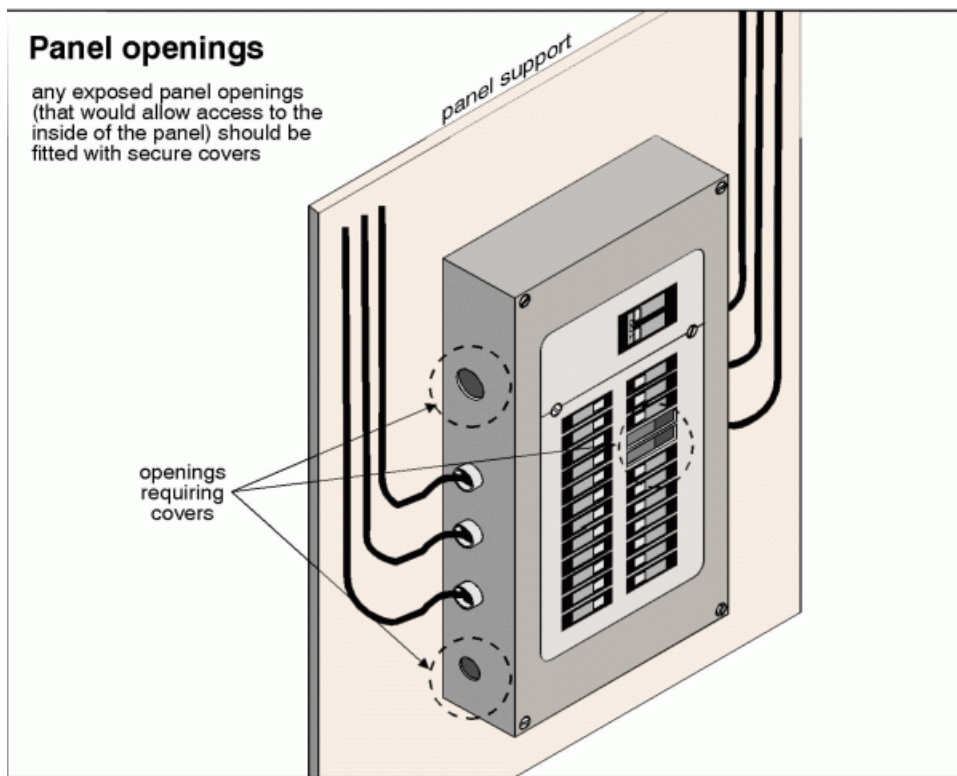
55.

**13. Condition:** • [Openings in panel](#)

There is a portion of the electrical panel where the cut-outs (block off plates) are missing. This is a safety item, and should be protected immediately. Block off plates are inexpensive and easy to install.

**Task:** Protect

**Time:** Immediate

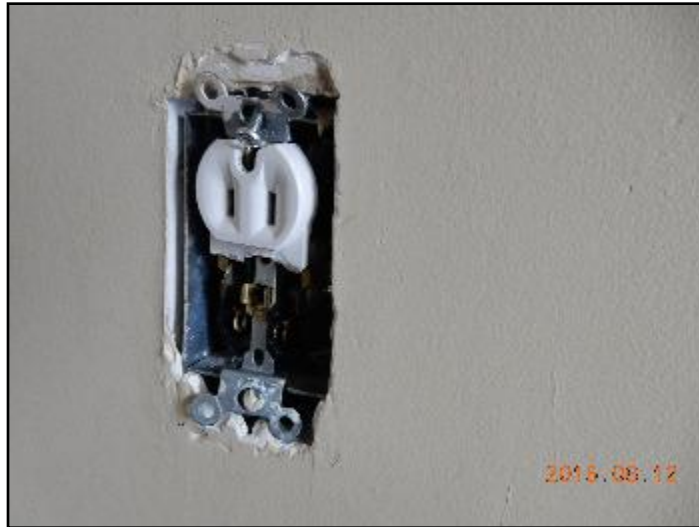
56.

### 14. Condition: • [Damage](#)

There are broken and damaged outlets noted. Replace immediately.

**Task:** Replace

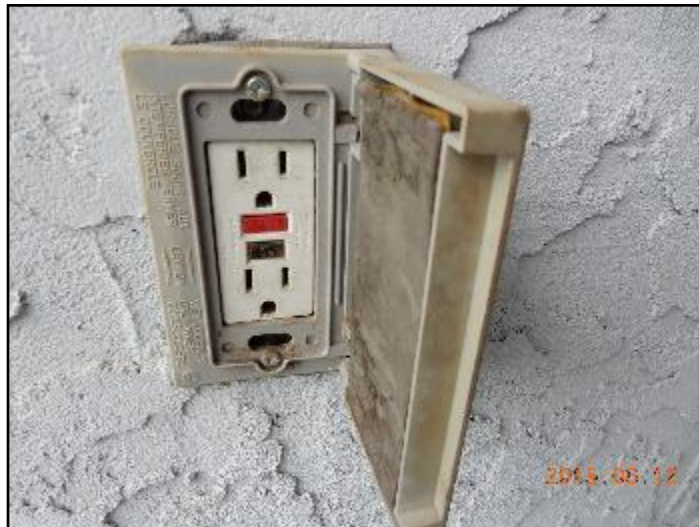
57.

**15. Condition:** • [Test faulty on Ground Fault Circuit Interrupter \(GFCI\)](#)

The GFCI at the front of the home tested faulty and would not trip. This is typical for mechanical devices to fail over time. Replacement is recommended.

**Task:** Replace

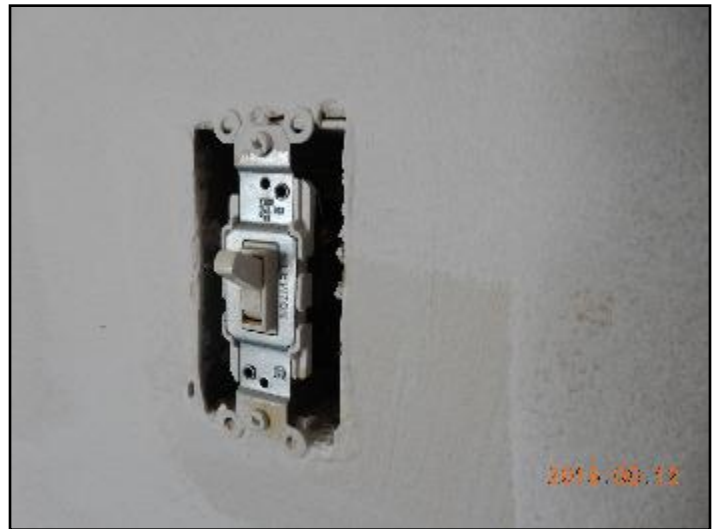
59.

**16. Condition:** • [Missing](#)

There are various areas where outlets and switches are missing covers. This is a safety concern and covers should be provided immediately.

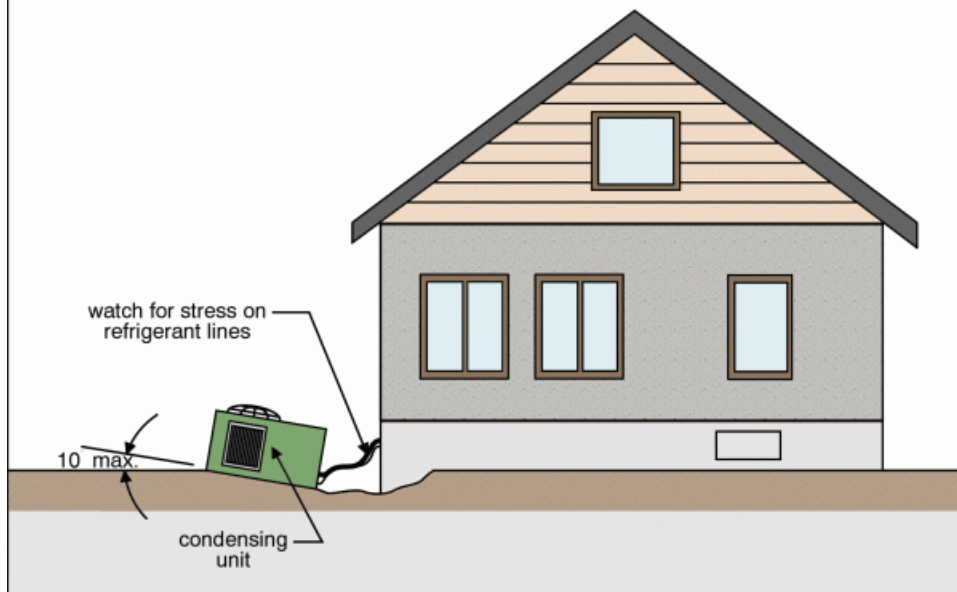
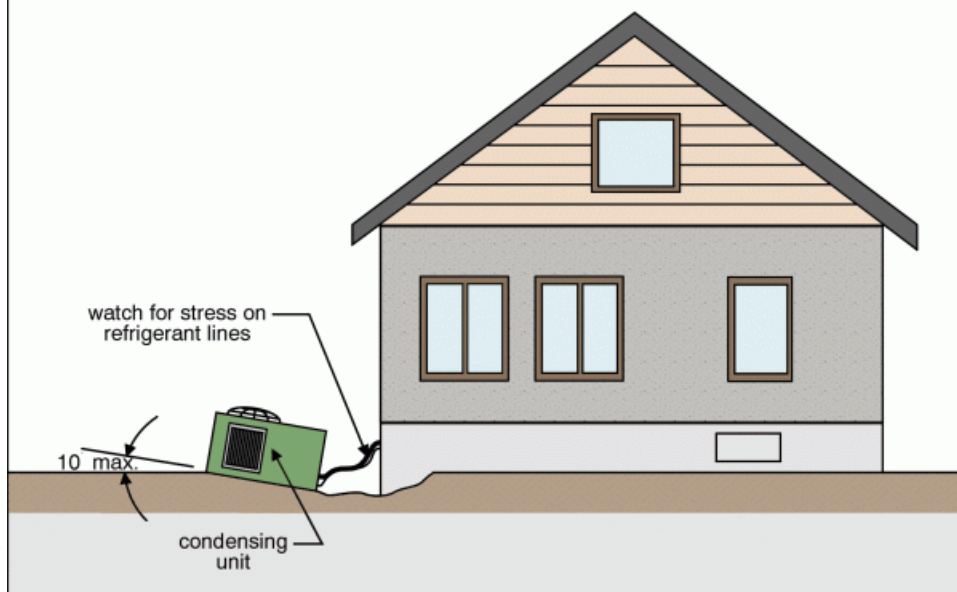
### 20. Condition: • Out of level

The air conditioner has settled and is no longer level. This can stress refrigerant lines and shorten life expectancy of the equipment. The refrigerant lines appear to have no added stress or damage at the time of the inspection. The settlement is minor. Monitor for further movement and improve as needed.

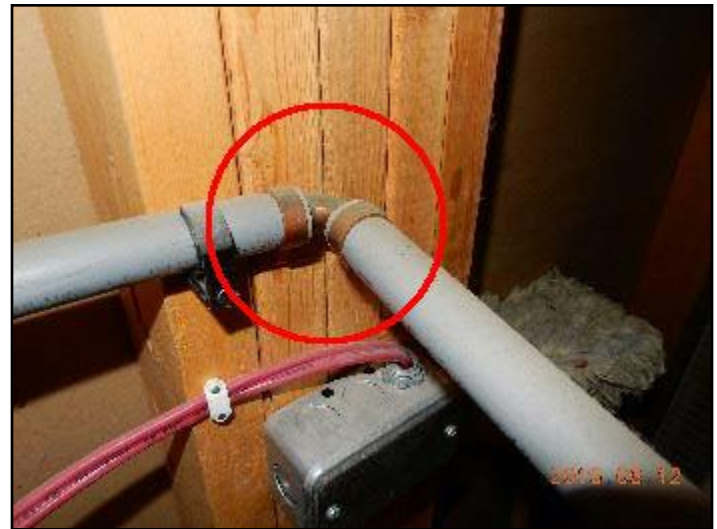
91.

#### 22. Condition: • [Polybutylene](#)

There is Poly B supply piping throughout the home. This is a common plumbing material found in homes built in and around the 1990's. There have been issues with plastic fittings. Copper fittings (t's and 90's) noted in visible areas.

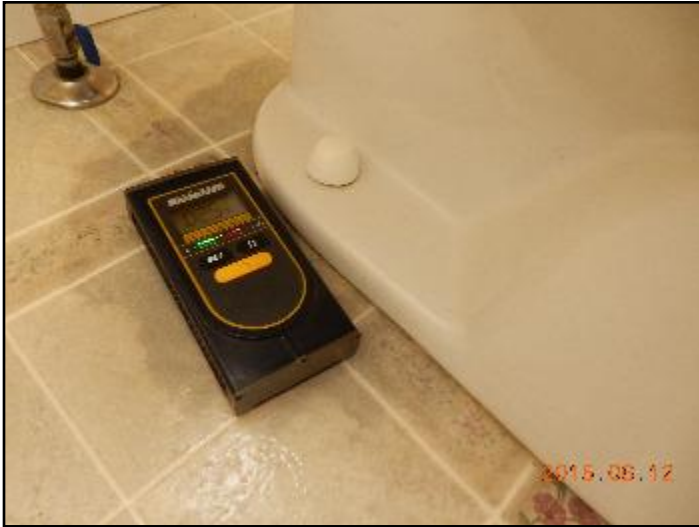
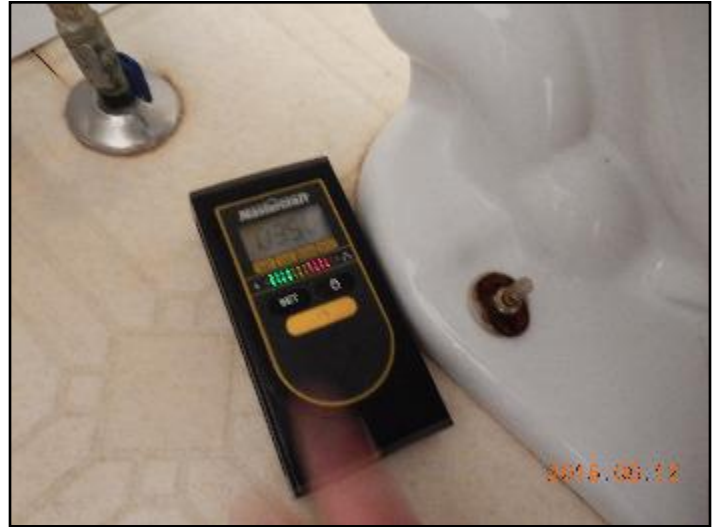
**25. Condition:** • Suspect wax seal leak. Moisture present around base of toilet.

The master bathroom toilet as well as the hallway bathroom toilet have moisture present in the floor when tested with a moisture meter. It is likely that the wax seal is leaking. Repair is recommended immediately. Concealed damage of the floor may exist.

**Task:** Repair

**Time:** Immediate

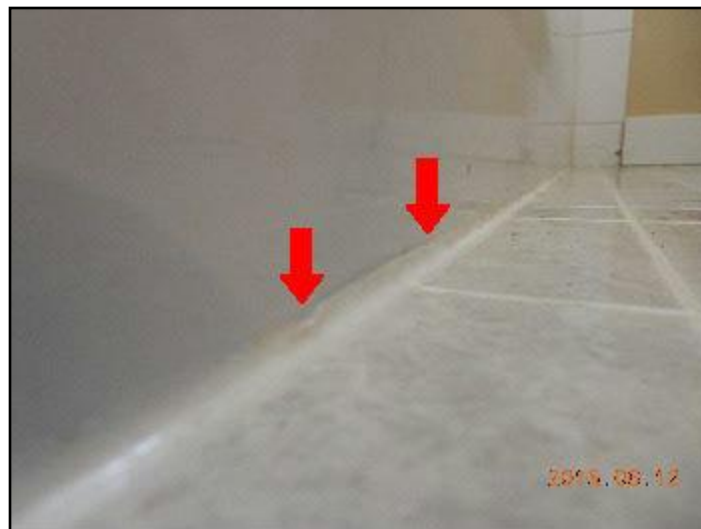
95.

**26. Condition:** • [Caulking loose, missing or deteriorated](#)

The master bathroom has areas around the tub/floor intersection with deteriorated or missing caulking. This is typical for a home this age. These areas need to be protected as part of regular maintenance with new caulking to ensure no moisture penetration.

**Task:** Repair

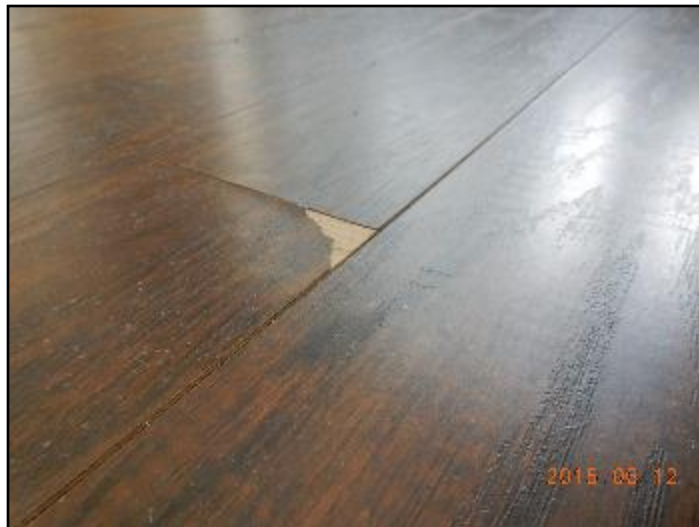
122.

**28. Condition:** • Damage

There are areas of the laminate floor that are damaged and worn. There are also areas that have paint drips. This is a cosmetic issue.

**Task:** Repair or replace

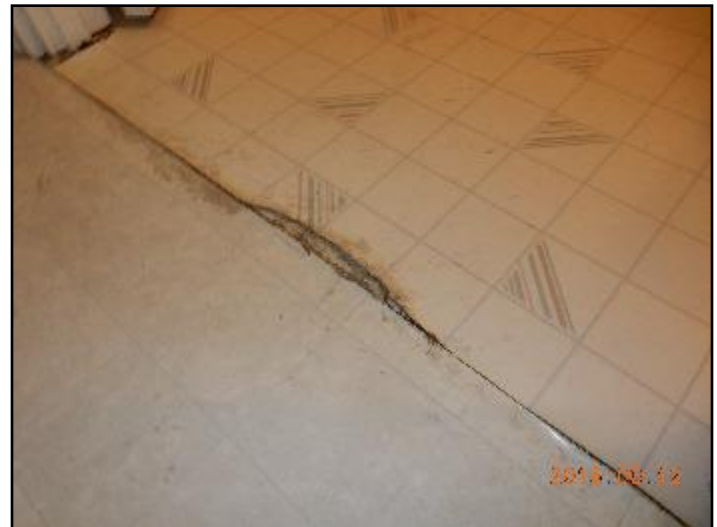
124.

**29. Condition:** • [Damage](#)

There are areas of the resilient floor that are torn or damaged. Repair or replace as needed.

**Task:** Repair or replace

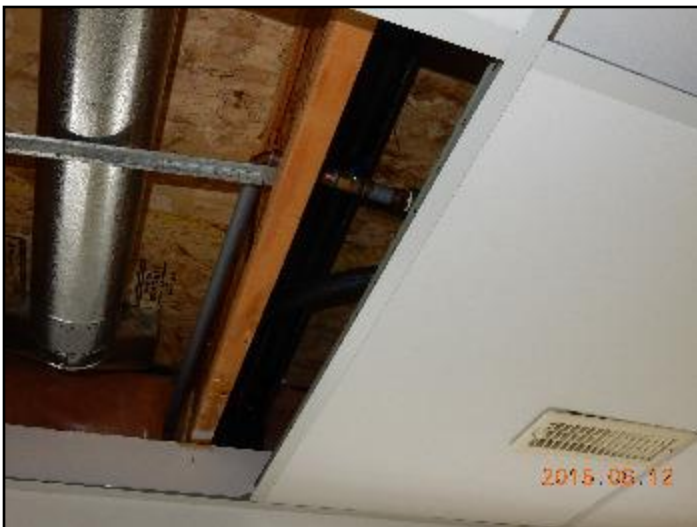
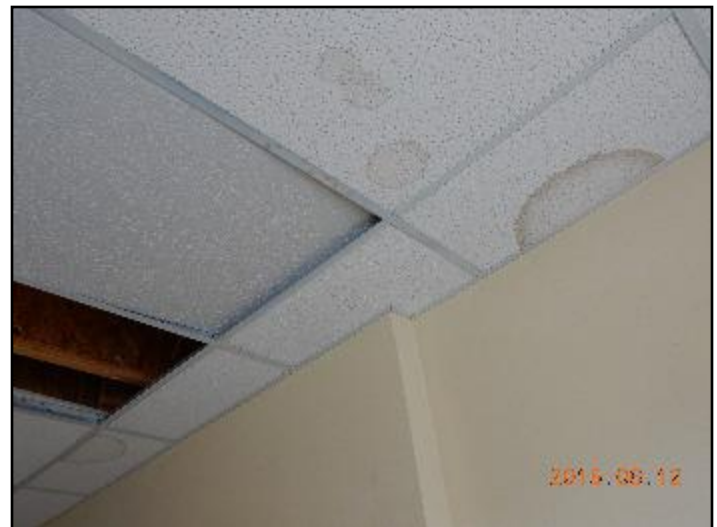
### **30. Condition:** • Stains

There are areas of the drop down ceiling in the basement with water stains. Paneling was removed in each area to determine the cause. There are no visible signs of moisture damage, nor are there sources of water noted with leaks. Repair or replace panels at your discretion.

**Task:** Repair or replace

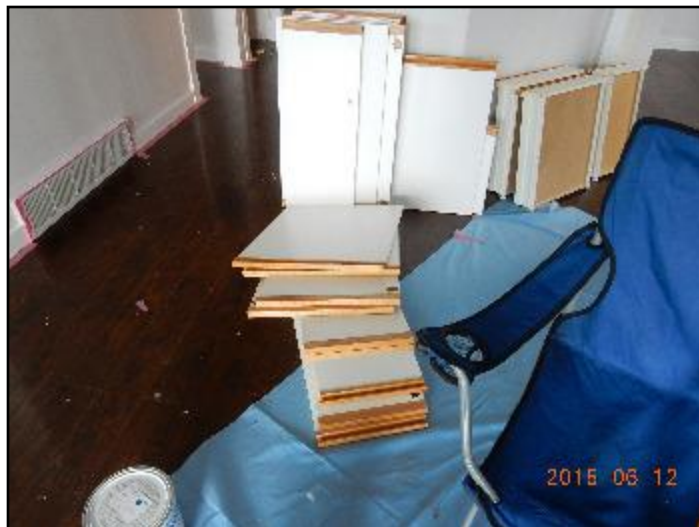
128.

**32. Condition:** • [Doors or drawers missing or loose](#)

All of the kitchen cabinet doors have been removed. Repair may be necessary. Replacement is recommended.

**Task:** Repair or replace

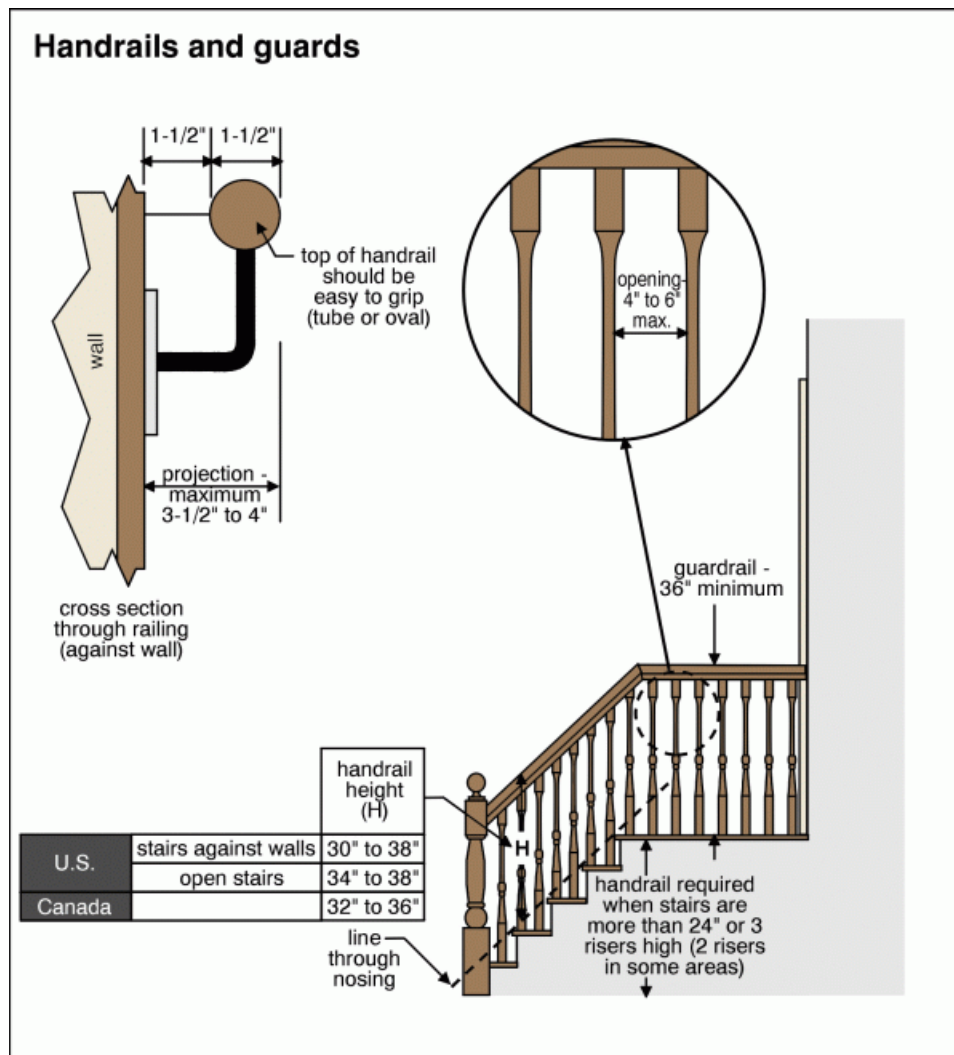
129.

### 33. Condition: • [Missing](#)

**Task:** Provide

**Time:** Immediate
