# INSPECTION REPORT

For the Property at:  
**123 YOUR STREET**  
NEW ORLEANS, LA

Prepared for: SAMPLE REPORT  
Inspection Date: Tuesday, April 25, 2023  
Prepared by: Turk Schexnayder LHI Lic.10679

RE: Report No. 2508, v.4  
123 Your Street  
New Orleans, LA

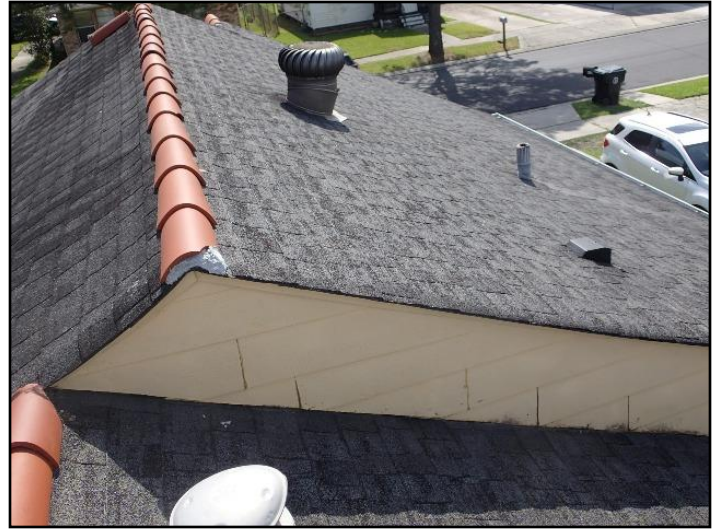
6. Installed at incorrect angle

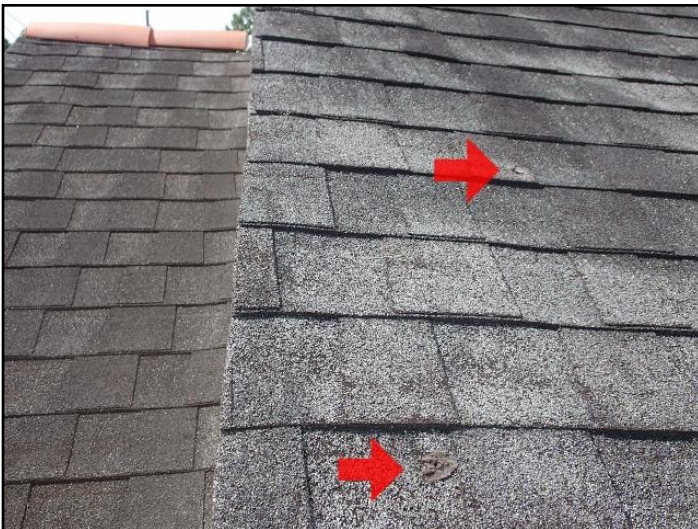
11. Curling

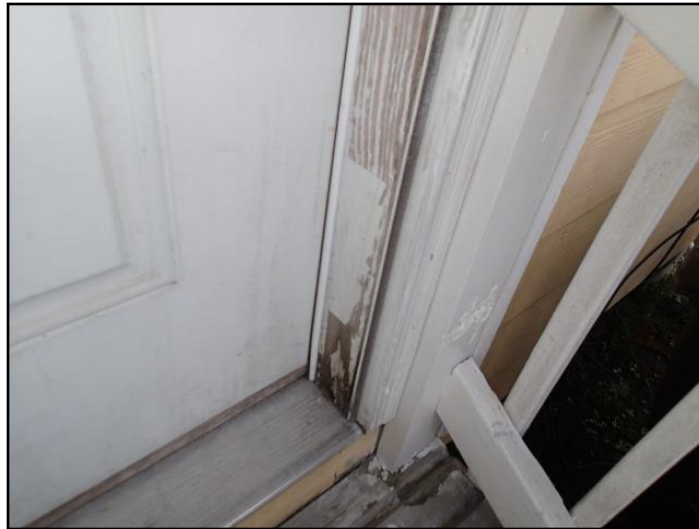
**3. Condition:** • Peeling paint, or stain needed on exterior exterior wood surfaces. Including, but not limited to, windows, trim, shutters, soffit, fascia, and weather boards.

Peeling paint noted on rear door frame.

**15.** *Peeling paint, or stain needed on exterior...*

**Task:** Paint as needed.

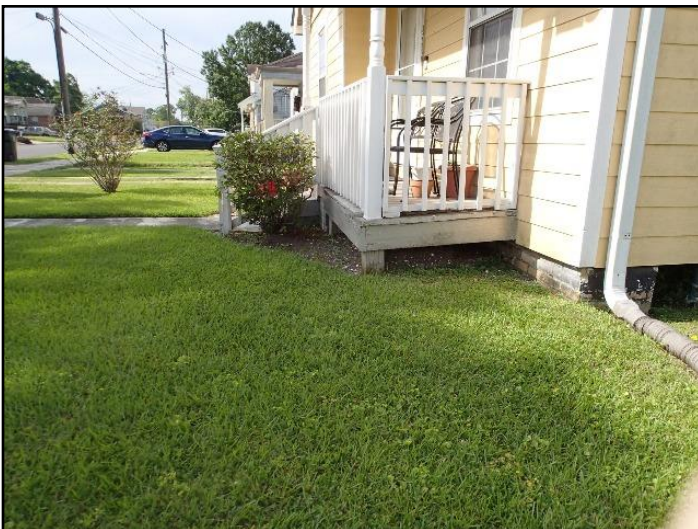
**4. Condition:** • The front porch appears to be sinking on right side. Cracked concrete over wood frame on front porch. Ledger board below porch was not properly secured to house. It appears concrete was poured over a wooden porch. The concrete over the wood has cracked with some concrete removed. Peeling paint was also noted.

**16.** *Sinking or low spot.*

**Task:** Include in evaluation with structural repairs.

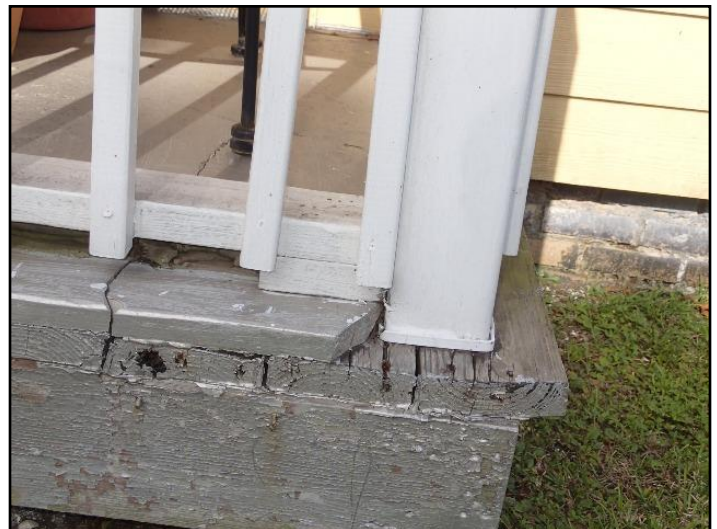
**17.** *Cracked concrete over wood frame*

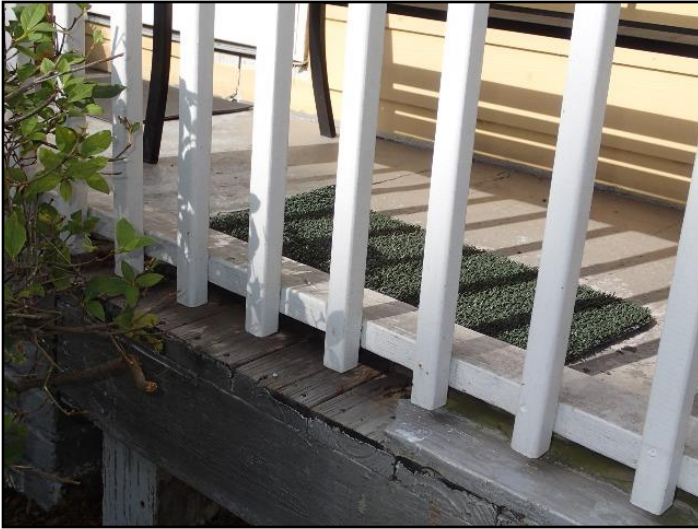
18. Cracked concrete over wood frame

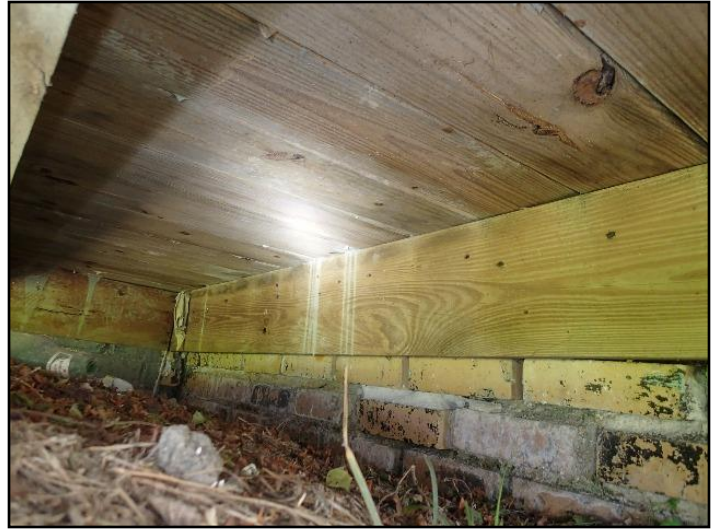
19. Ledger board not properly secured to home

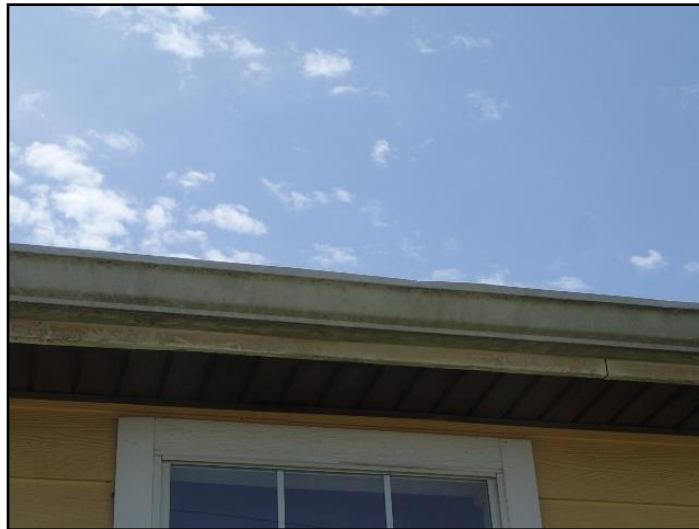
### 5. Condition: • [Improper slope, ponding](#)

**Implication(s):** Chance of water damage to structure, finishes and contents

20. Improper slope, ponding

**Task:** Adjust gutters for proper slope.

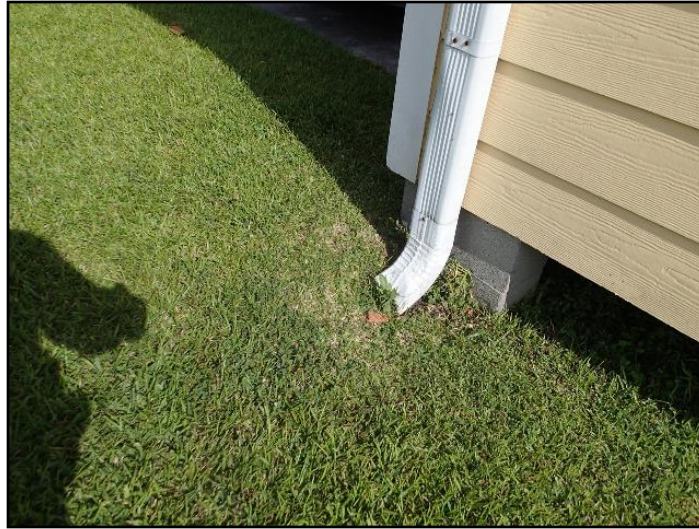
Damaged diverter at end of downspout on left corner.

21. Damage

**Task:** Replace diverter

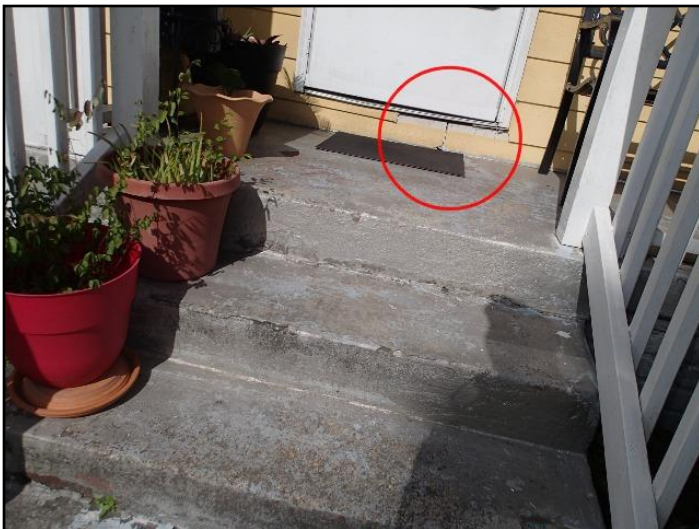
22. Opening/damaged siding

**Task:** Seal openings where needed.

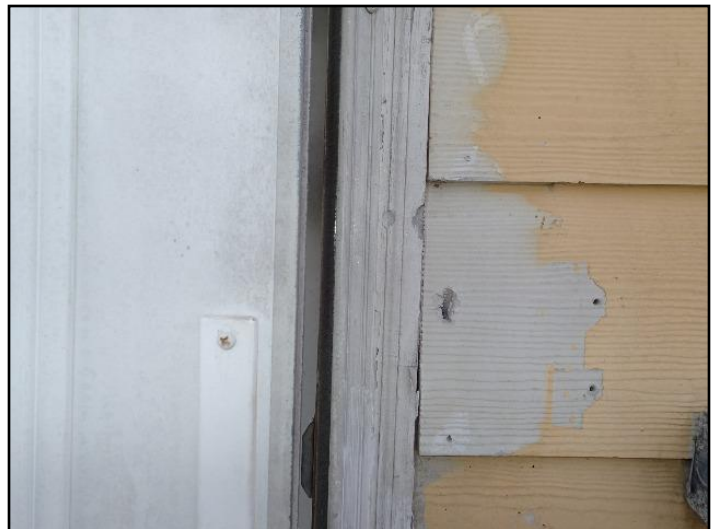
**7. Condition:** • Open seams in siding

23. Open seams in siding

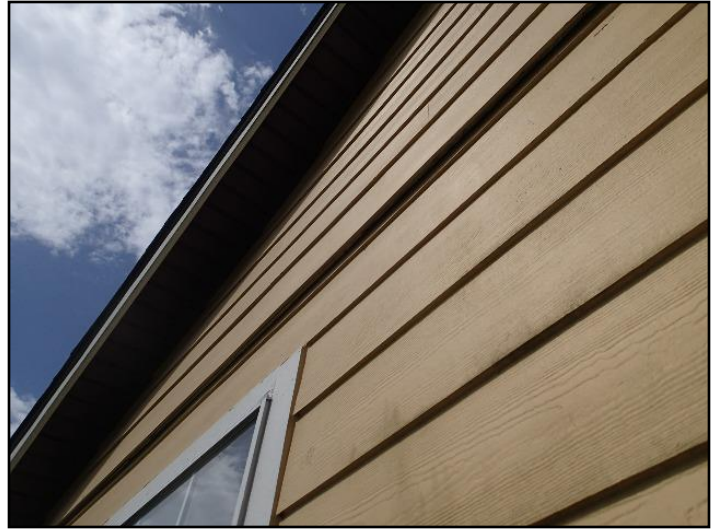
25. Loose siding on front wall

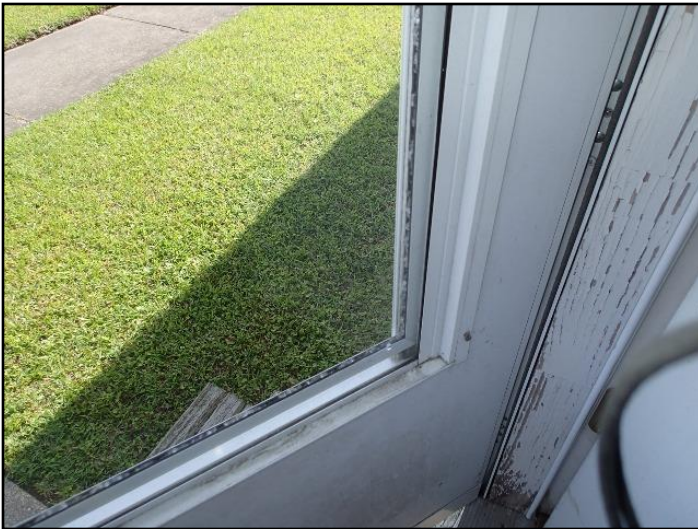
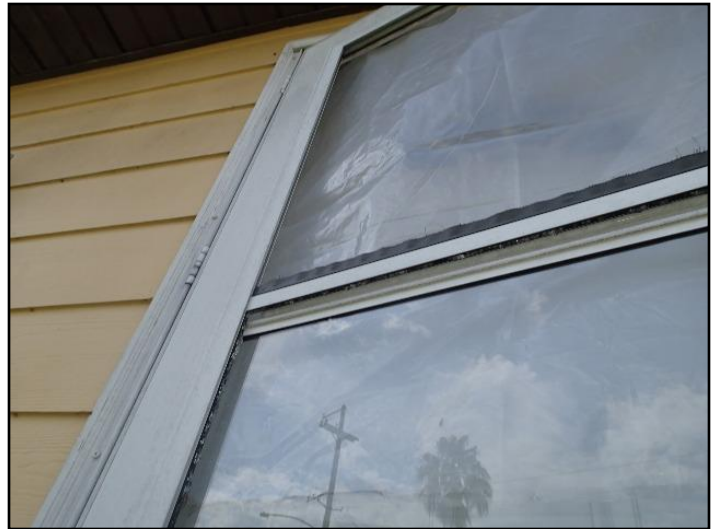
8. **Condition:** • Broken glass on rear storm door.

26. Broken glass

**Task:** Replace as needed.

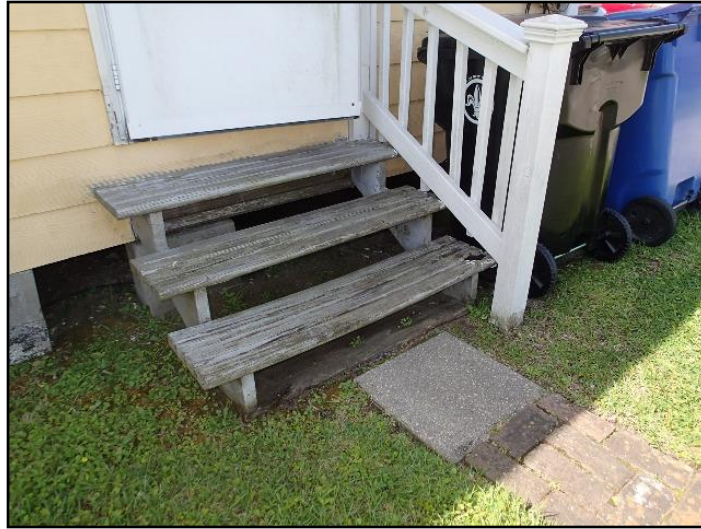
Damage noted to lower step. Steps were installed directly on the ground.

**Implication(s):** Trip / Fall hazard

28. Damaged steps.

**Task:** Repair / Improve

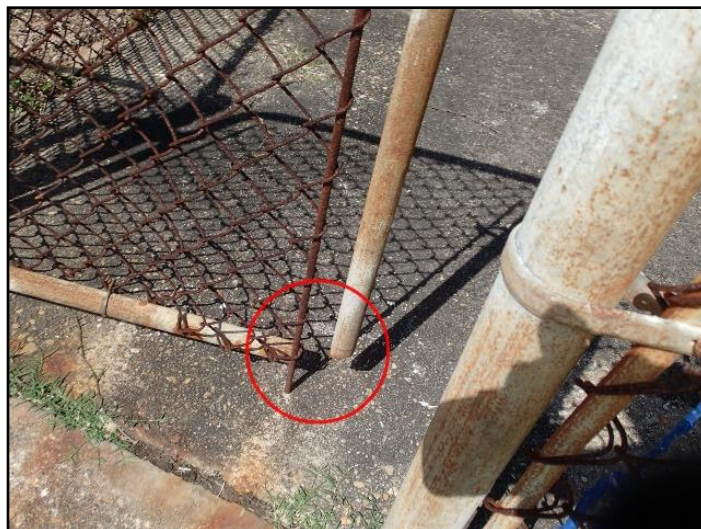
Bottom corner of gate was missing.

29. Gate damaged

**Task:** Repair or replace as needed.

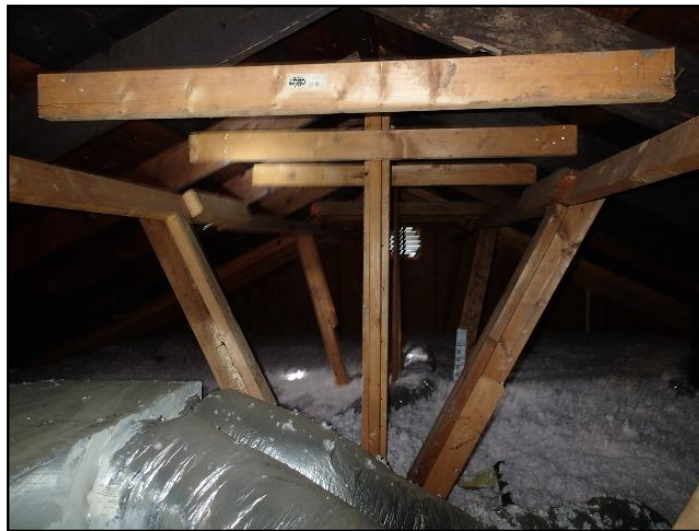
Safe attic access stopped just past the furnace. No flooring, insulation covering joists and attic framing prevented further safe access.

**30.** Entered but access was limited

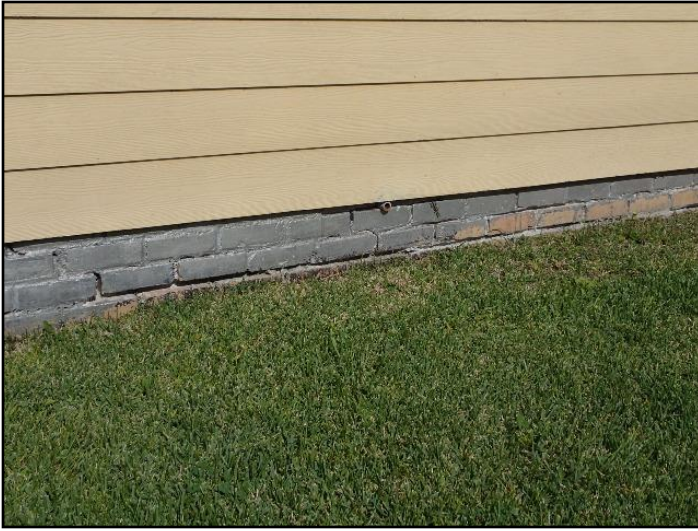
32. Missing mortar

**Task:** Further evaluation is recommended. Evaluation should include a scope of work and cost estimates.

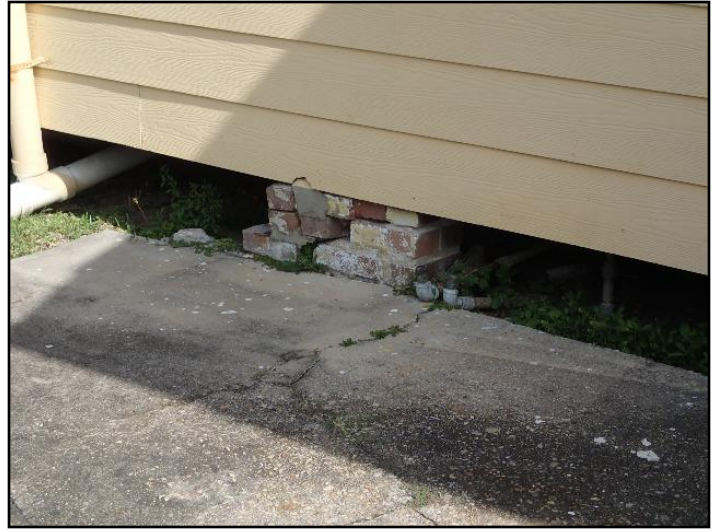
33. Damaged pier

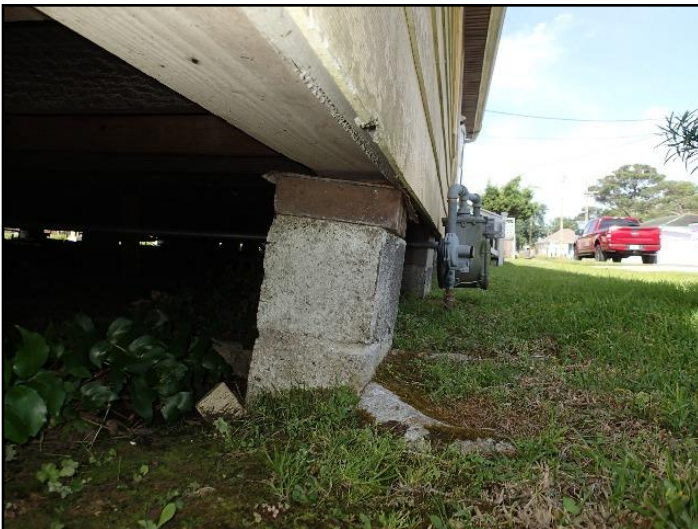
34. Leaning pier with poor support

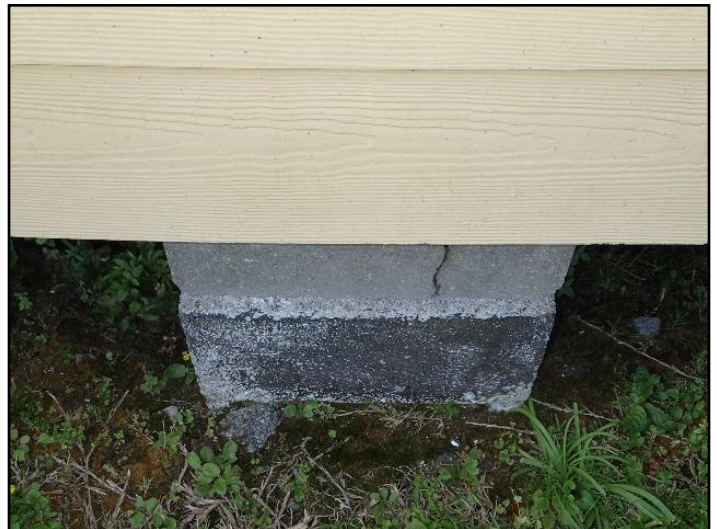
35. Crack in CMU block pier

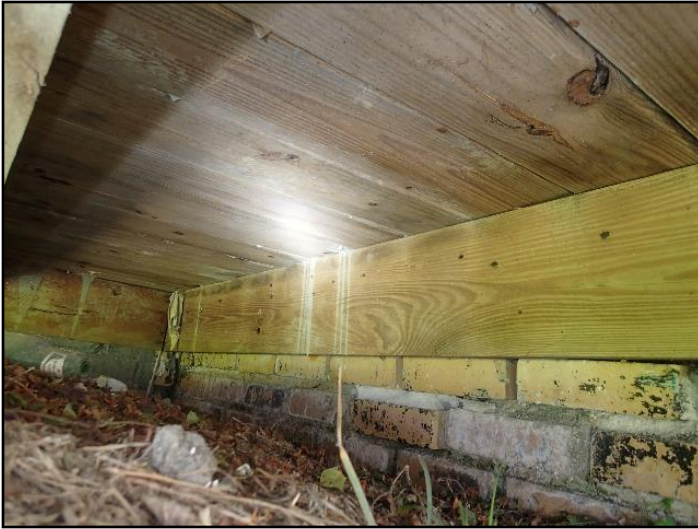
36. Ledger board not connected properly

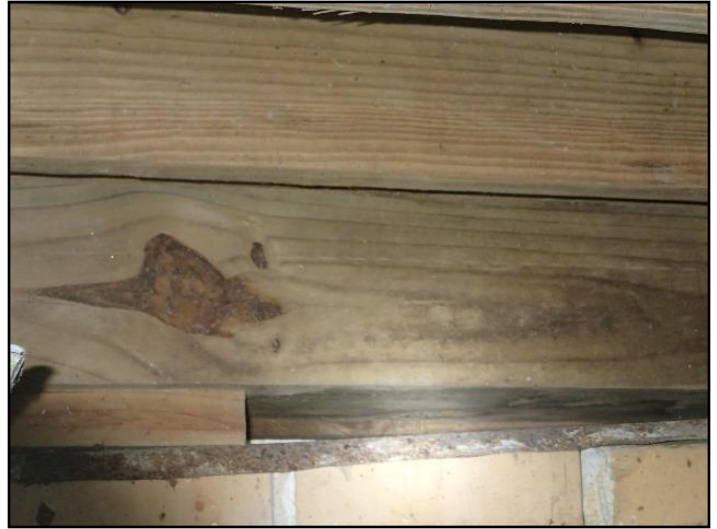
37. Twisted with poor bearing

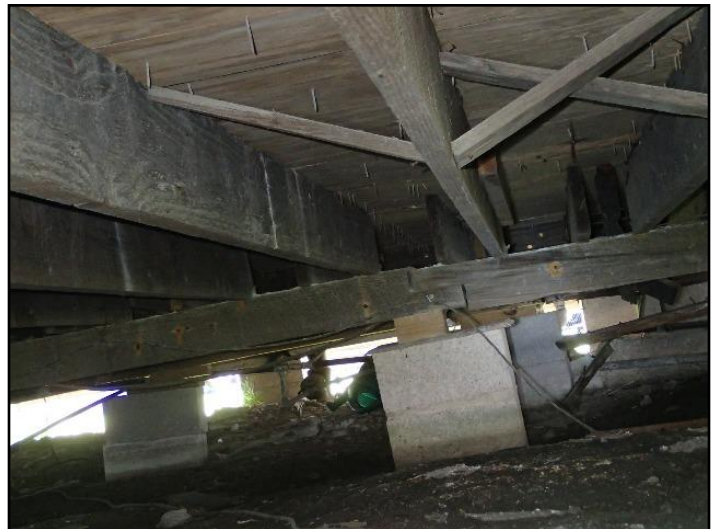
39. Poor bearing below joint

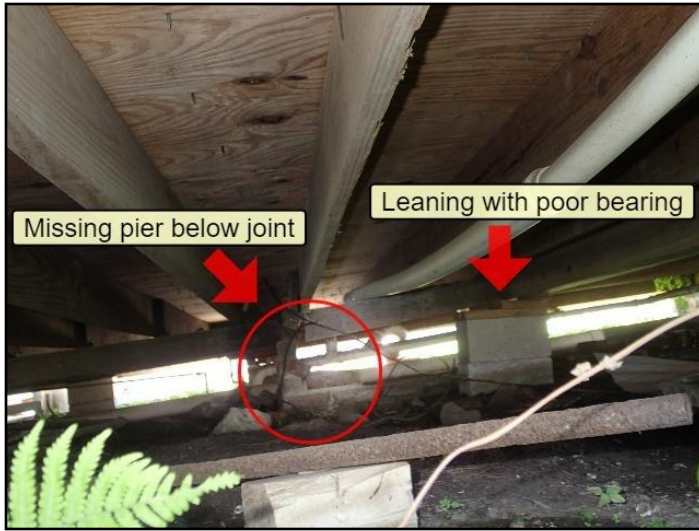
40. Missing pier & leaning pier with poor support

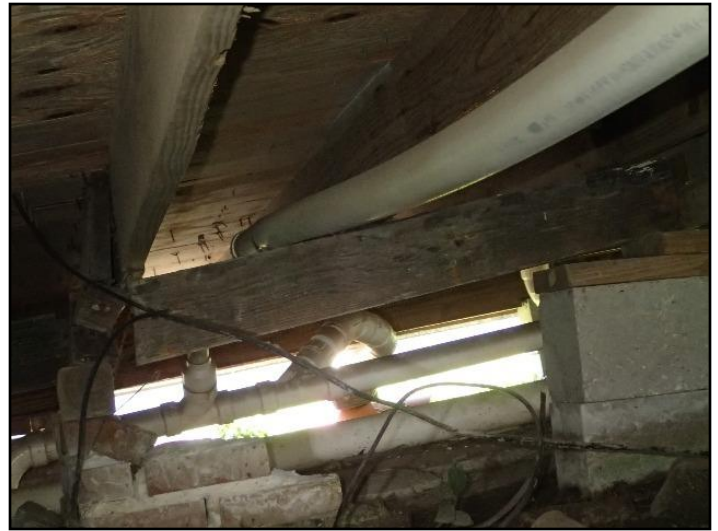
41. Missing pier close up

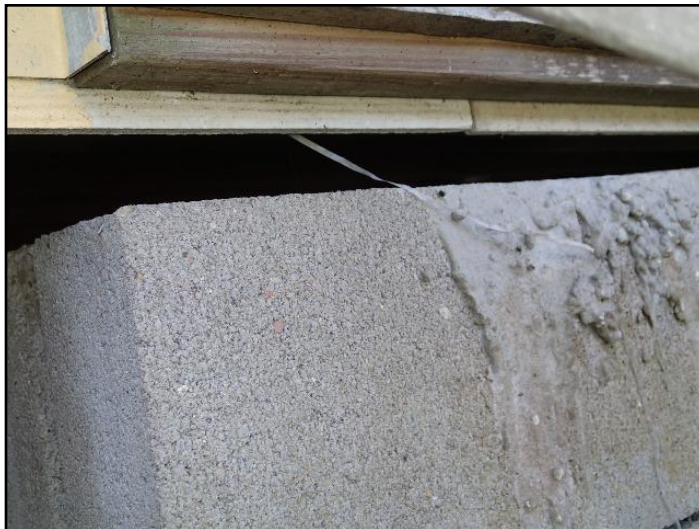
42. No bearing below door

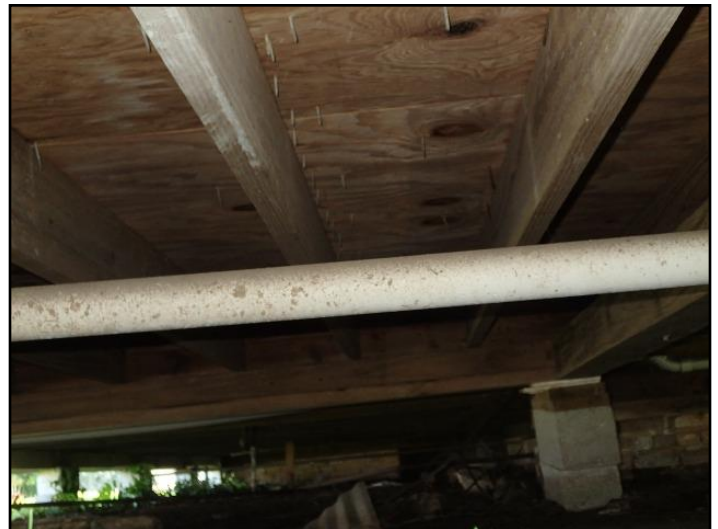
43. Leaning pier

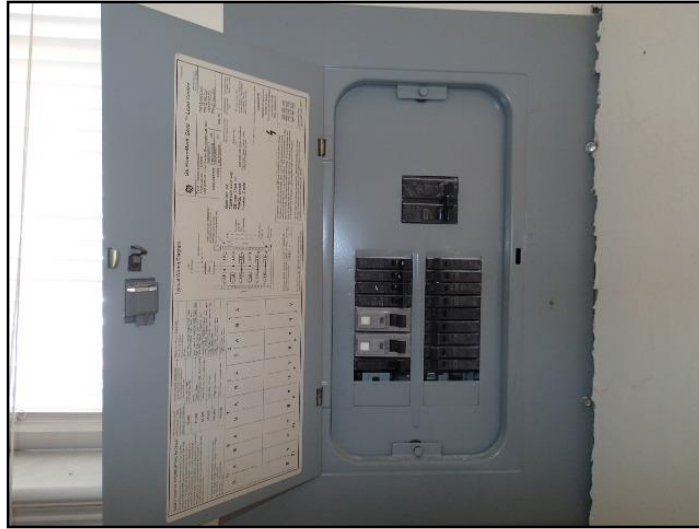
- The circuits are not labeled at the panel

50. Not labeled.

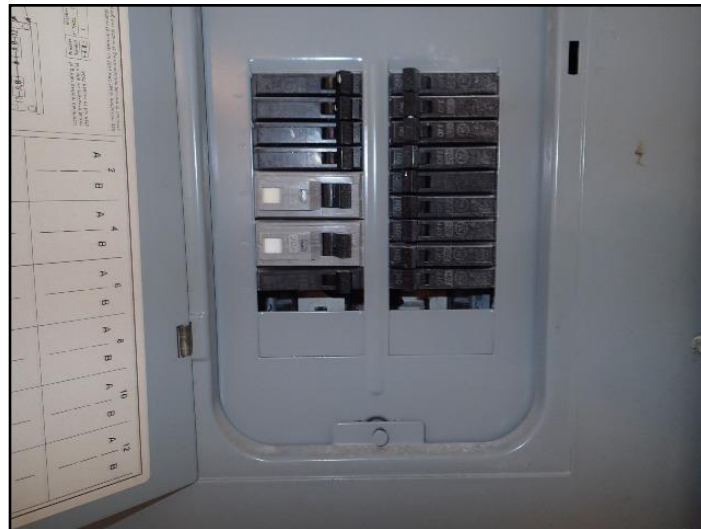
Extra knock outs were missing or removed. Unprotected openings in panel should be covered with the appropriate inserts.

51. Open knock-outs

**Task:** Repair / Correct

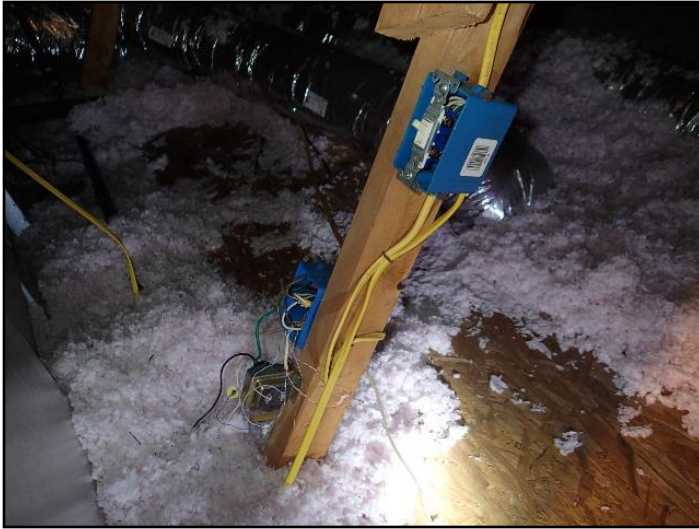
Cover loose or missing on junction boxes and switches in attic and/or crawl space. Electrical connections should be in closed junction boxes. All open junction box locations or switches may not be pictured.

**Implication(s):** Fire hazard | Electric shock

52. Missing covers

**Task:** Correct / Repair

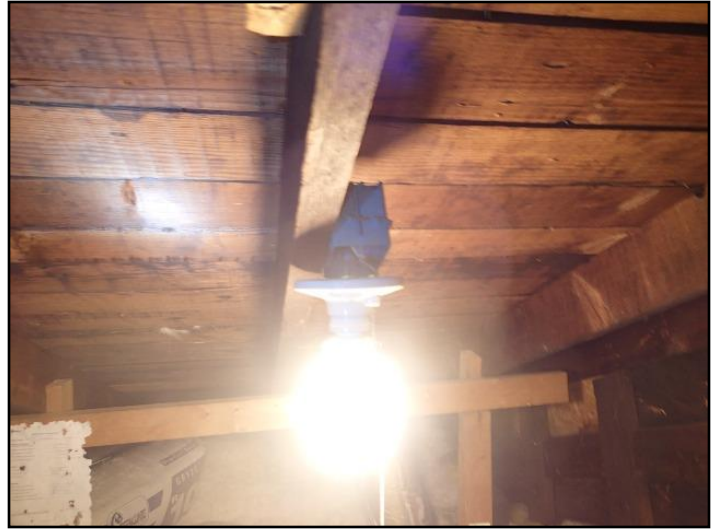
53. Loose cover

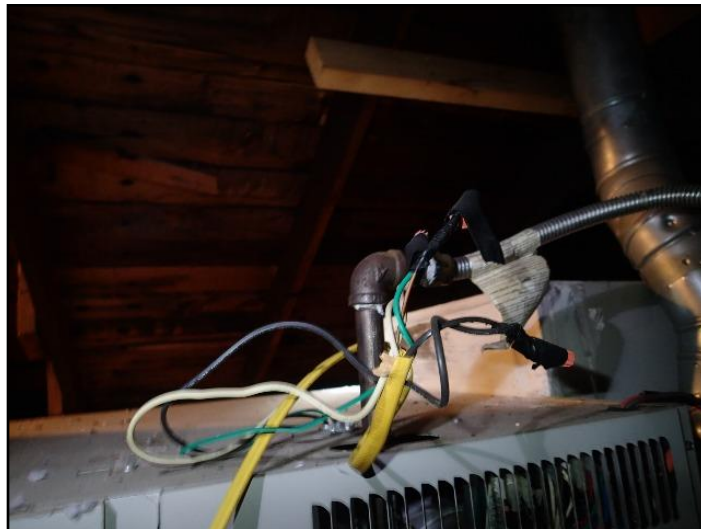
54. No junction box on connection

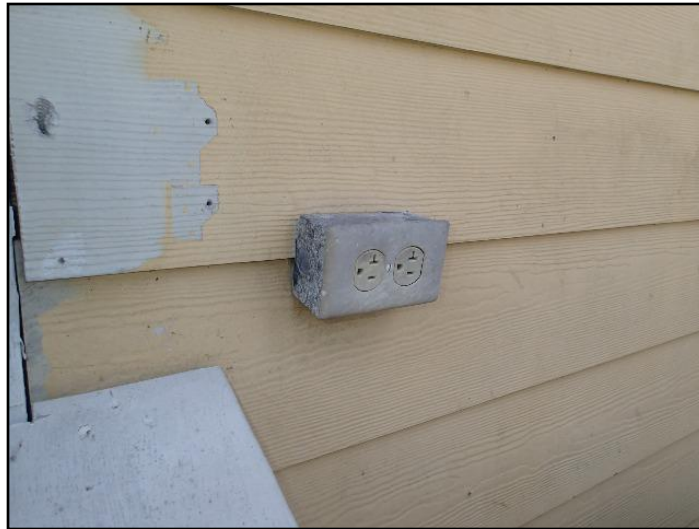
**16. Condition:** • Weather proof covers on exterior outlets were damaged or missing.

55. Weather proof covers missing

**Task:** Improve

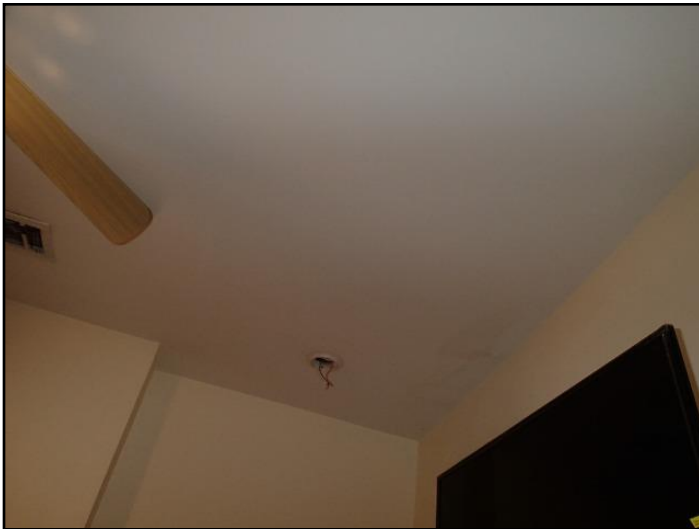
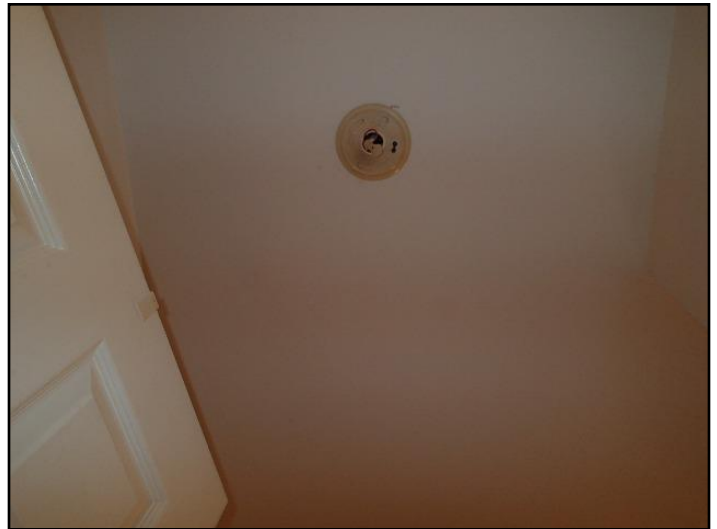
Bedrooms had empty smoke alarm brackets in place. These should be replaced.

57. Empty bracket

**Task:** Replace alarms where needed.

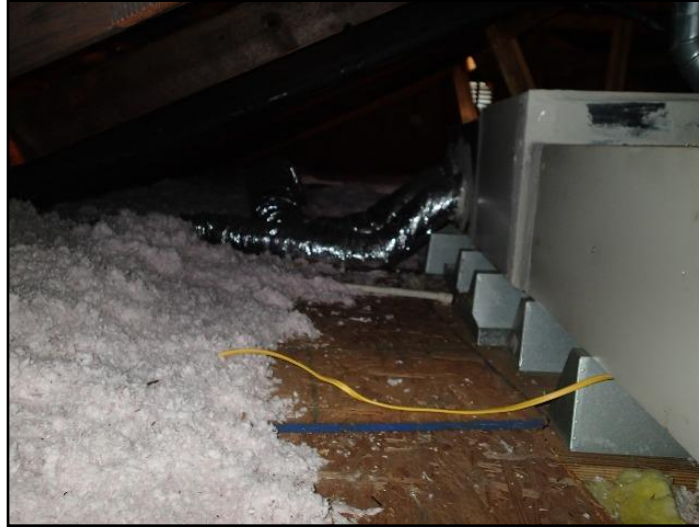
**25. Condition:** • Discharge point not visible

66. Discharge point not visible

**Task:** Further evaluation is recommended.

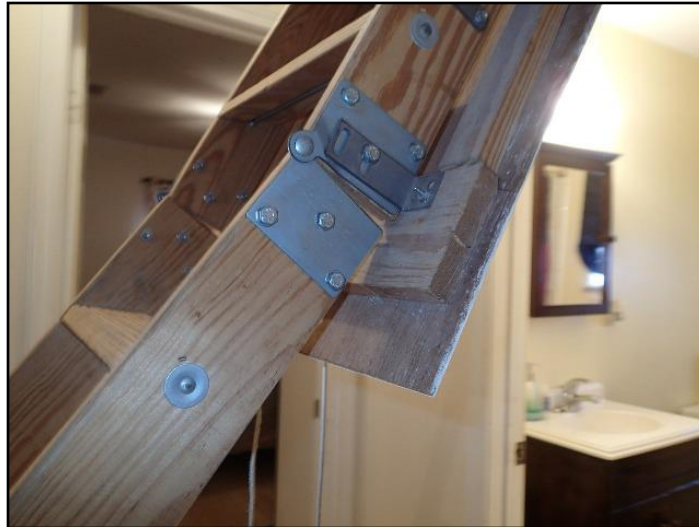
**28. Condition:** • Not properly trimmed to height. Attic stair lower section did not sit flush to upper section which can cause stress on hinges causing failure. For safety stairs should be trimmed to proper height.

69. Not cut to proper height

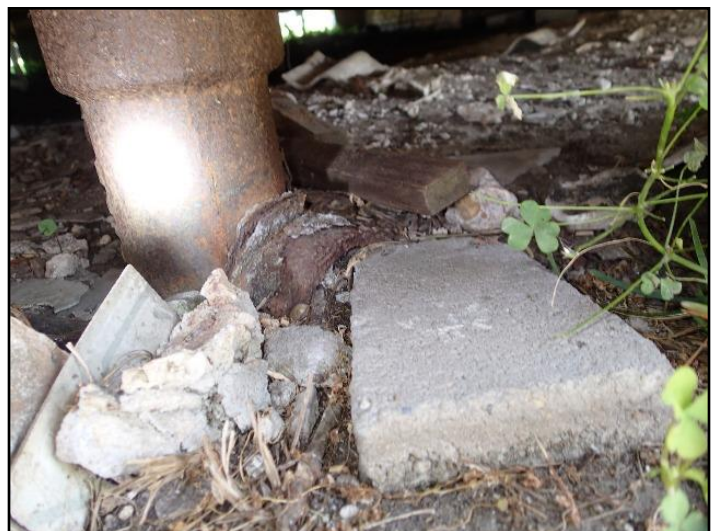
Wet area at connection of plastic waste line into what appears to be terra cotta. Rust and splits in cast iron waste lines also noted.

74. Rust and split in pipe

**30. Condition:** • Consider a complete evaluation of the system by a licensed professional plumber. It is recommended that a licensed, professional plumber be engaged to verify and quantify the total of these issues, as well as a more detailed evaluation of the entire system. This should include recommendations and cost estimates.

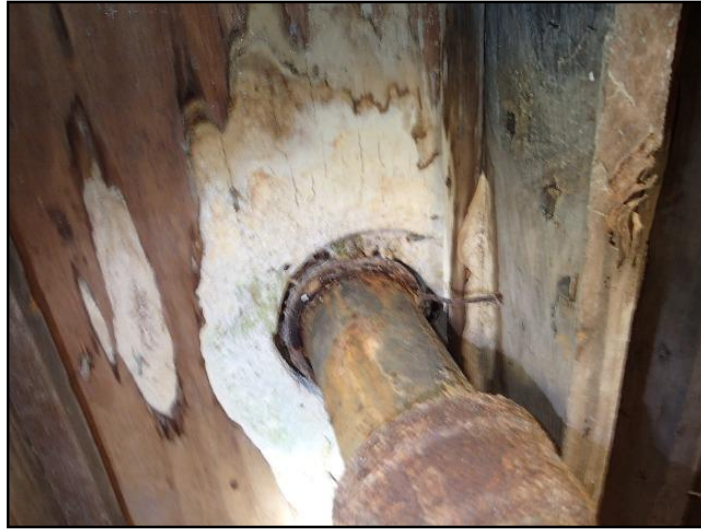
75. Rust at connection and possible split

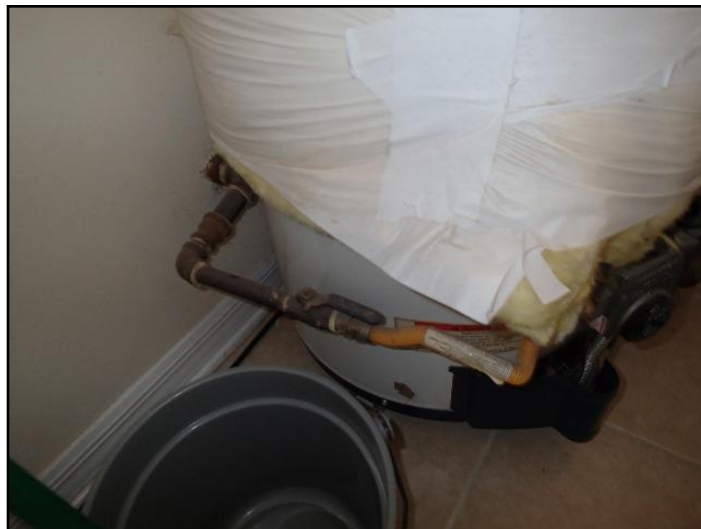
**31. Condition:** • Possible wrong shut off valve for gas supply. It was not verified whether this valve was designed for gas or water.

76. Possible wrong type of shut off valve

**Task:** Verify or replace while conducting other repairs.

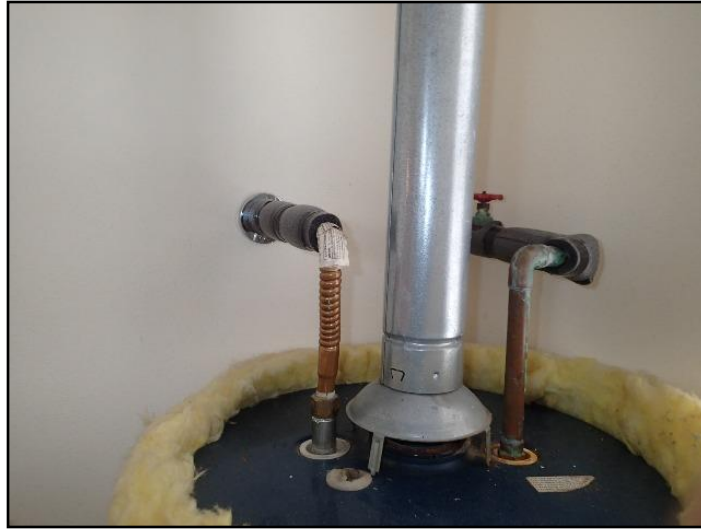
**32. Condition:** • [Inadequate](#)

**Implication(s):** Fire hazard

77. Inadequate clearance

**Task:** Remove insulation from vent hood area.

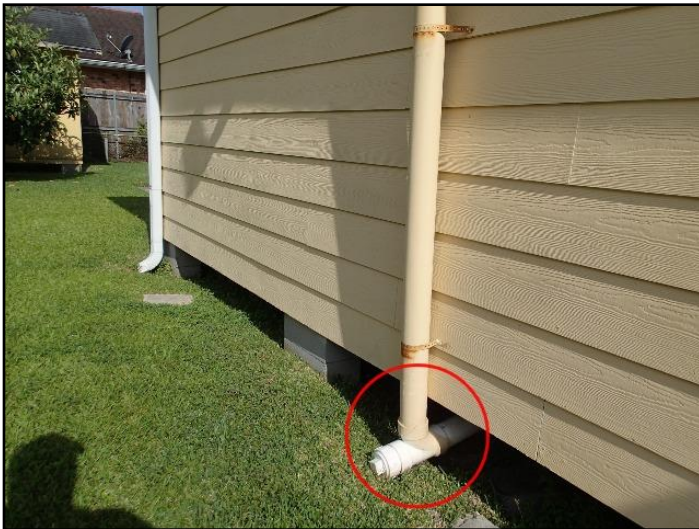
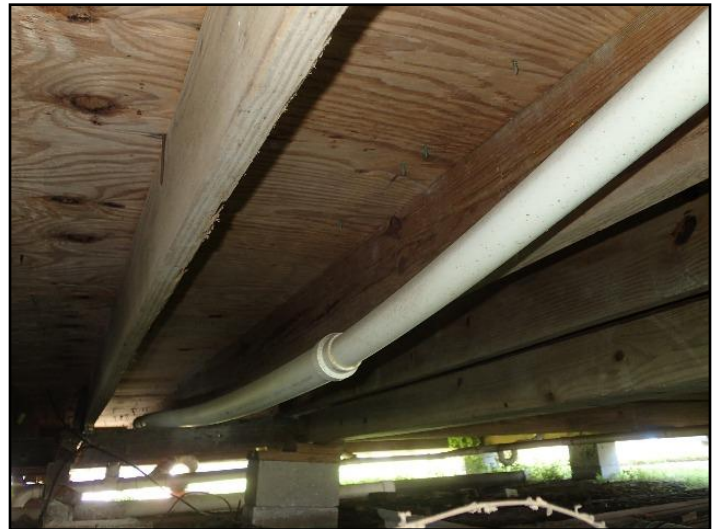
### 33. Condition: • [Poor support](#)

**Implication(s):** Sewage entering the building | Chance of water damage to structure, finishes and contents

78. Poor support

**Task:** Repair by a licensed plumber

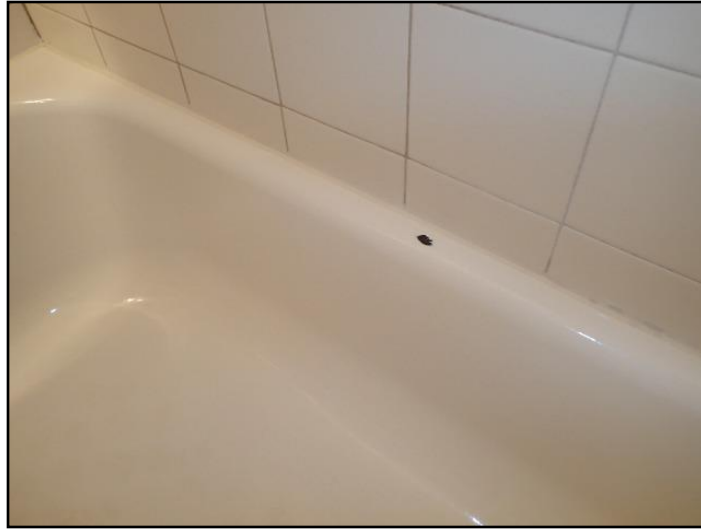
### 34. Condition: • [Surface defects](#)

80. Surface defects

**Task:** Repair

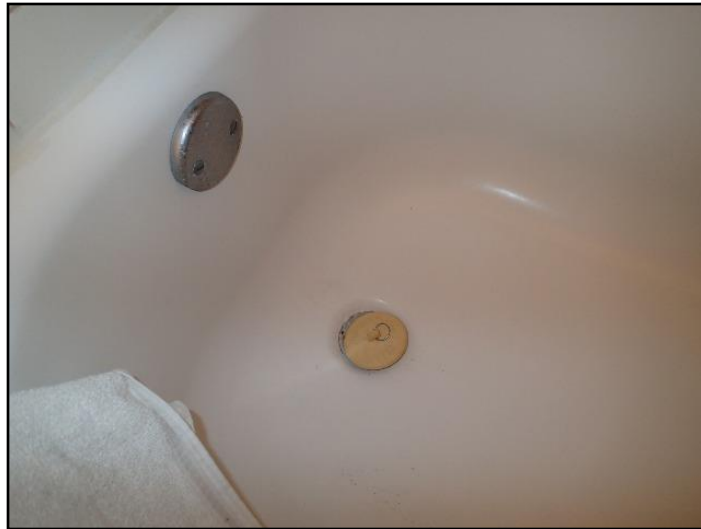
**35. Condition:** • Drain stop missing

81. Drain stop missing

**Task:** Repair by a licensed plumber

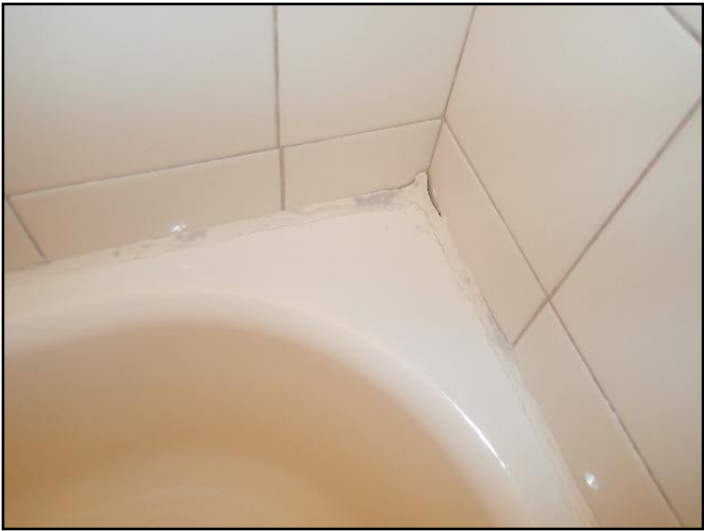
**36. Condition:** • [Caulking loose, missing or deteriorated](#)

82. *Caulking loose*

**Task:** Repair / Improve

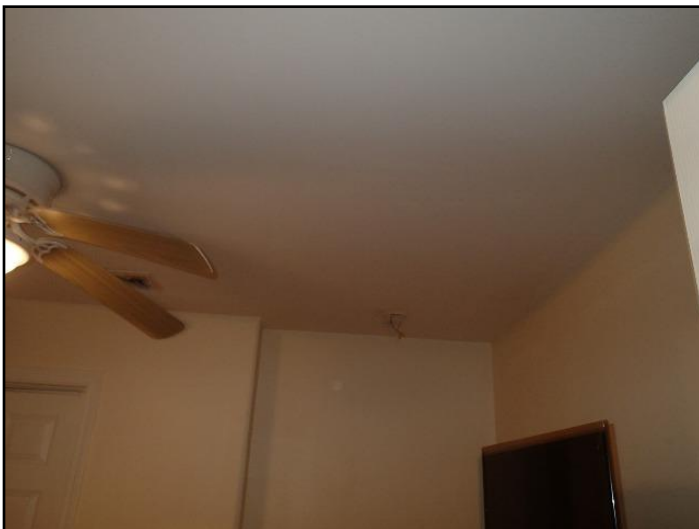
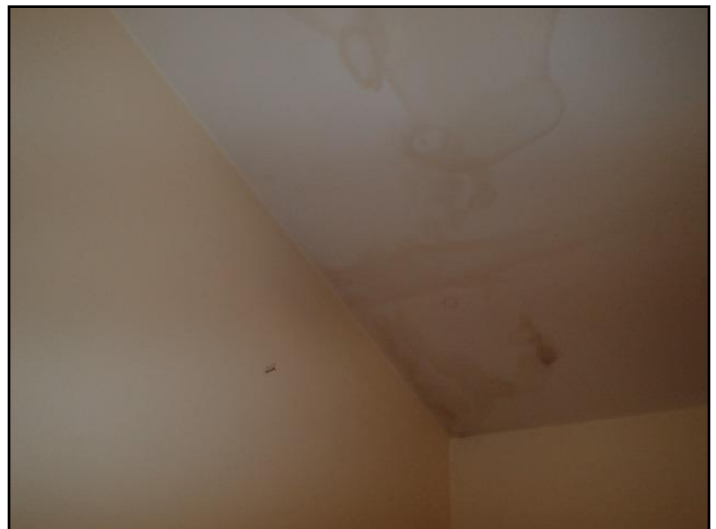
Ceiling stains noted in front room and middle bedroom. See roof section for more details.

83. Water stains

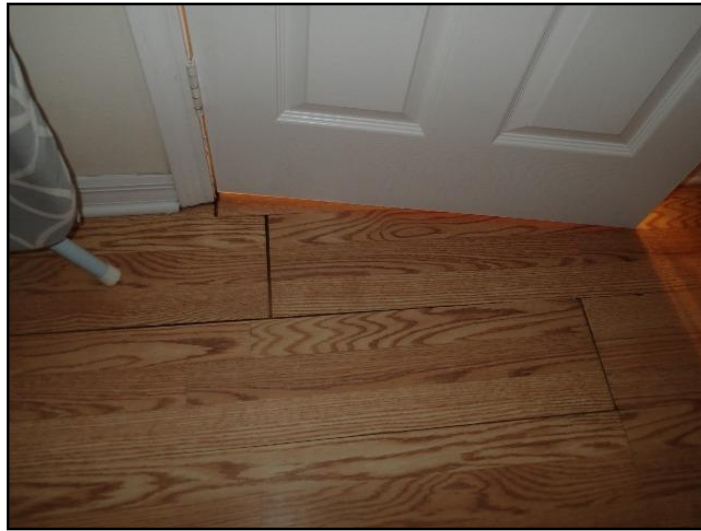
**38. Condition:** • [Loose or missing sections](#)

85. Loose or missing sections

**Task:** Repair

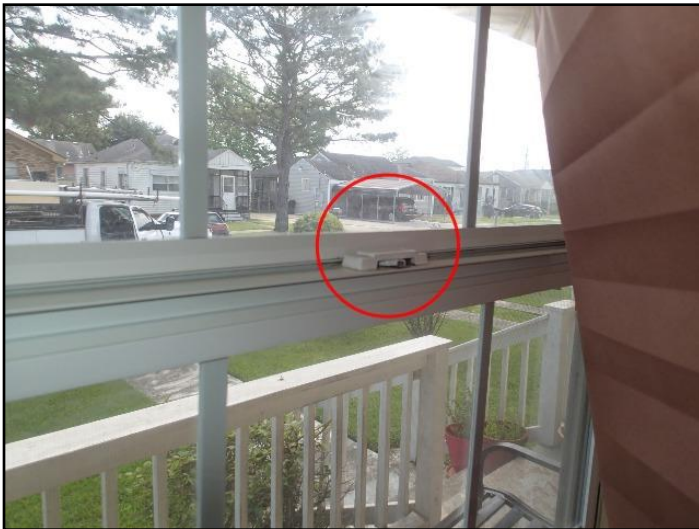
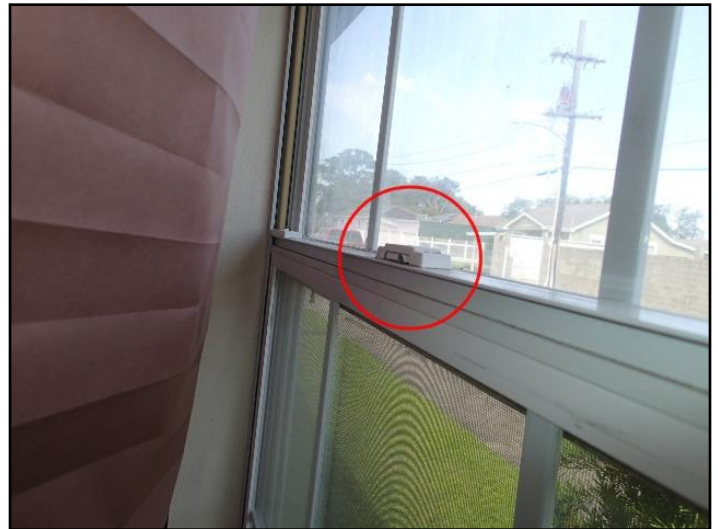
Of the accessible windows tested most, if not all of the locking hardware was broken. Only two are pictured as examples.

86. Broken

**Task:** Repair

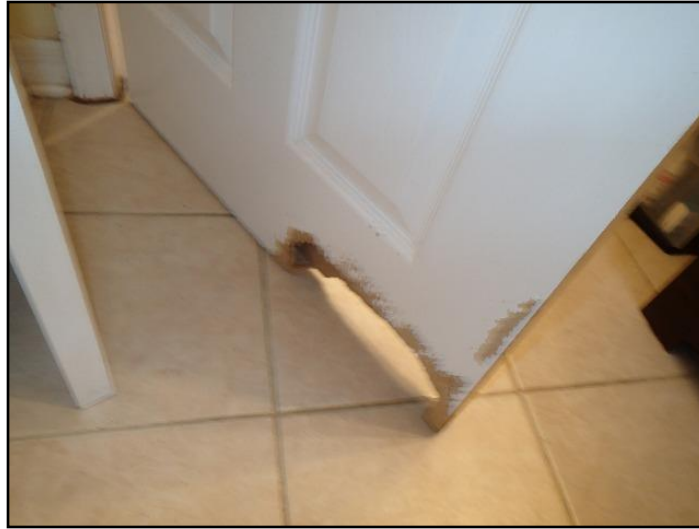
40. Condition: • [Damage](#)

88. *Damaged*

**Task:** Replace

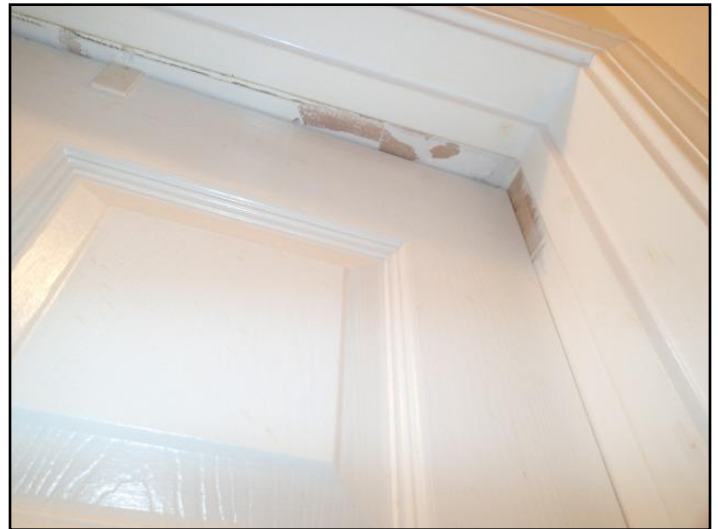
## 41. Condition: • Binds

90. *Binds*
