YOUR INSPECTION REPORT

FOR THE PROPERTY AT:
417 Prince Edward Drive North
Toronto, ON

INSPECTION DATE:
Wednesday, July 18, 2018

RE: Report No. 2304, v.3
417 Prince Edward Drive North
Toronto, ON

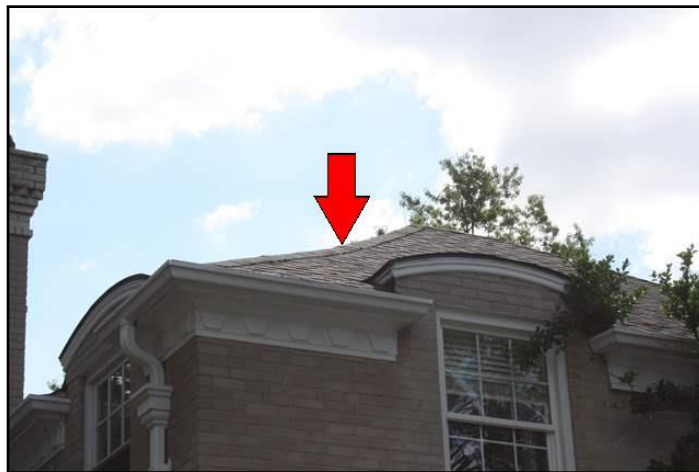
Condition: • [Exposed fasteners](#)

Implication(s): Chance of water damage to contents, finishes and/or structure

Location: Various Front Exterior Roof

3. Exposed fasteners example

Task: Seal top of fasteners (sealant)

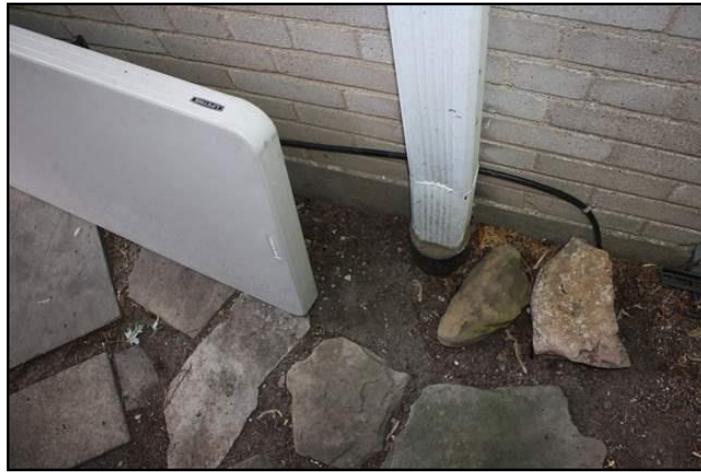
Condition: • [Discharge below grade](#)

Implication(s): Chance of water damage to contents, finishes and/or structure

Location: Throughout Exterior

4. one example

Task: Monitor / Improve

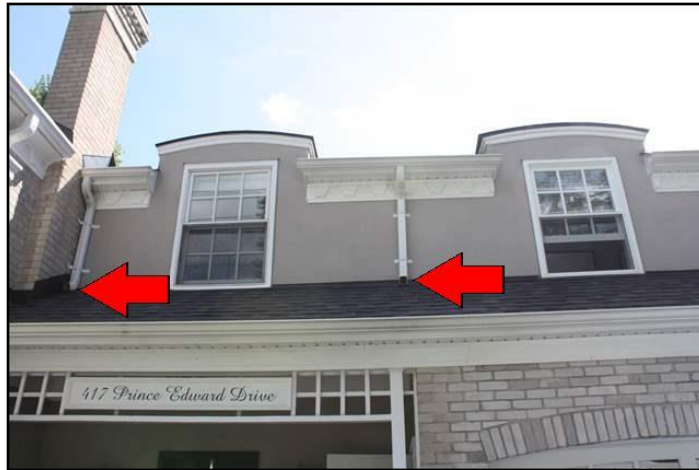
Condition: • [Discharge onto roofs](#)

Improvement recommendation. Extend Downspouts to lower gutter to protect lower roof from premature wear.

Implication(s): Chance of water damage to contents, finishes and/or structure

Location: Front Exterior Roof

5. Example

Task: Improve

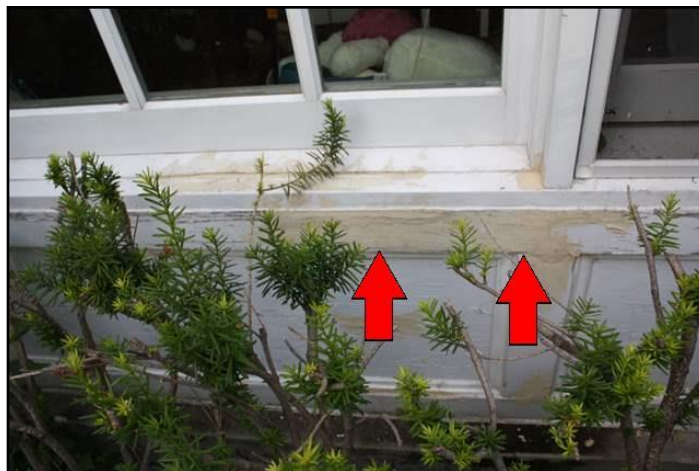
Condition: • Rot

Some areas of wood below window are soft due to rot. Prior patchwork noted. Repair/replace as required. This is common in areas where tree/vegetation are in contact with wood materials

Implication(s): Material deterioration | Chance of water damage to contents, finishes and/or structure

6. Prior patches

Task: Monitor / Improve

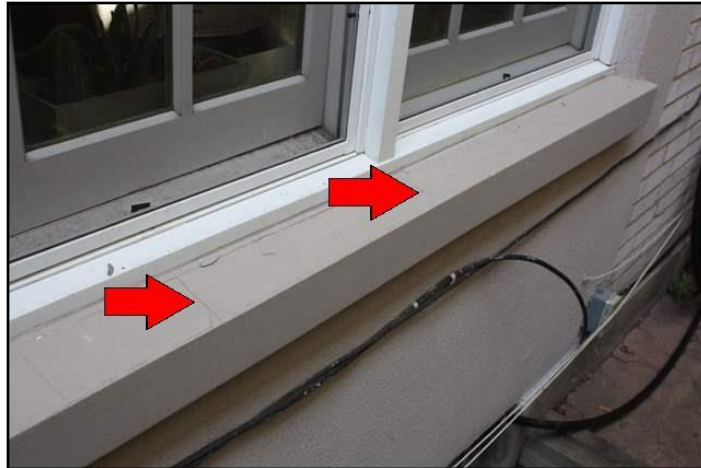
Condition: • [Damage](#)

Normal maintenance

7. small cracks on trim

Task: Improve

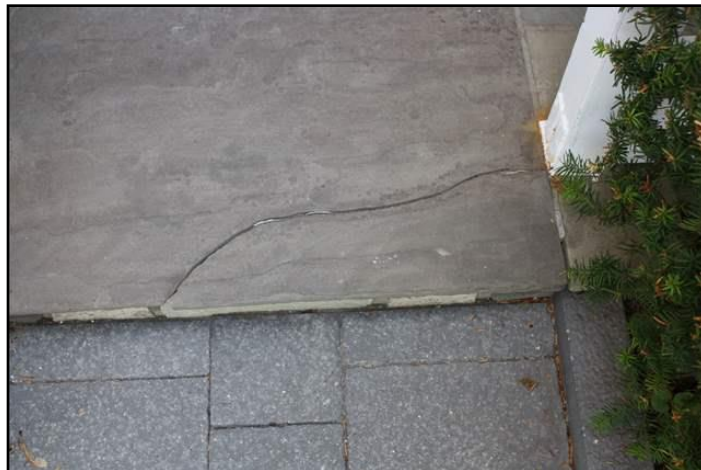
Condition: • [Concrete cracked](#)

Implication(s): Trip or fall hazard | Material deterioration | Chance of damage to structure

Location: Front Exterior

8. Concrete cracked

Task: Repair / Replace

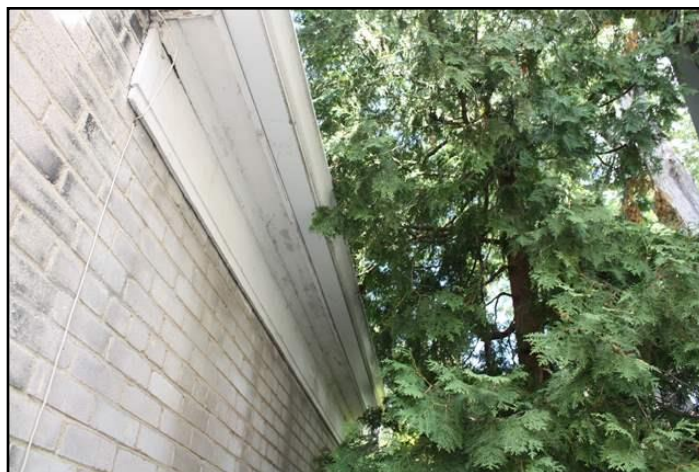
Condition: • [Trees or shrubs too close to building](#)

Keep tree branches trimmed back 3 feet from roof line.

9. Trees or shrubs too close to building

Task: Improve

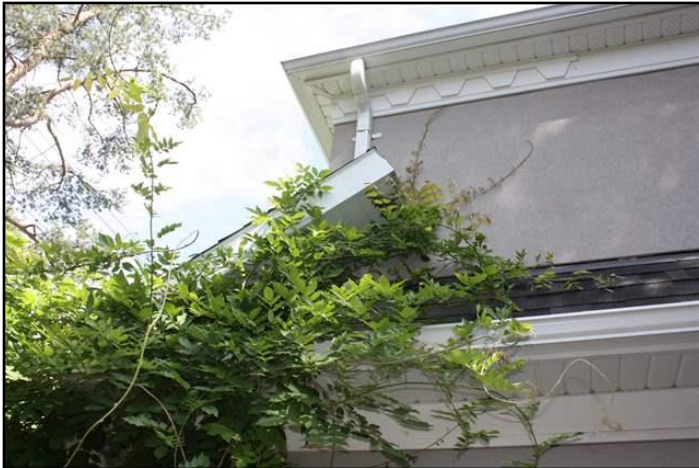
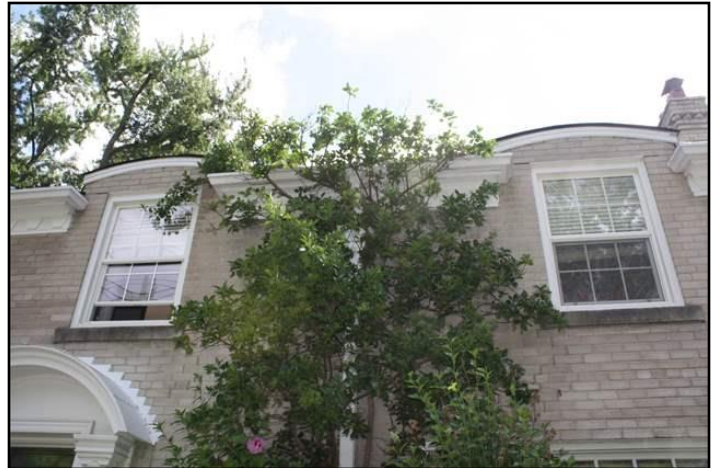
Condition: • Vines on building

Vines may damage the home over time. If vines are to remain, and we understand the aesthetic reasons for leaving

them, we recommend controlling the growth so vines do not attach to wood surfaces or roofs, and do not clog gutters and downspouts and soffit vents.

10. Vines on building

11. Example

Task: Remove

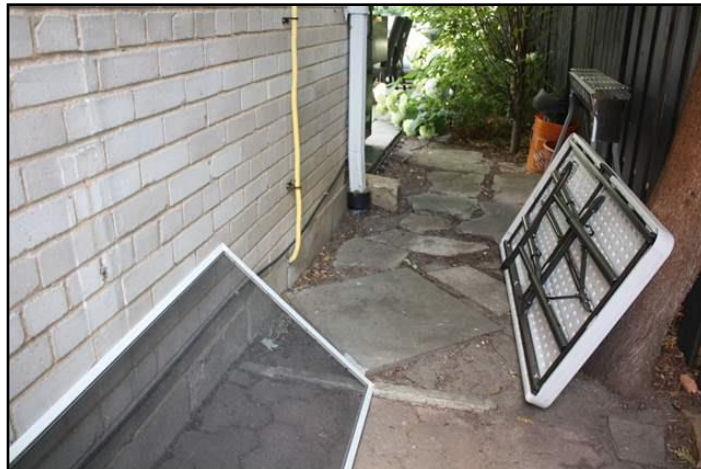
Condition: • Low Areas.

Ensure grading (ground) promotes drainage away from home

12. Low Areas.

Task: Improve

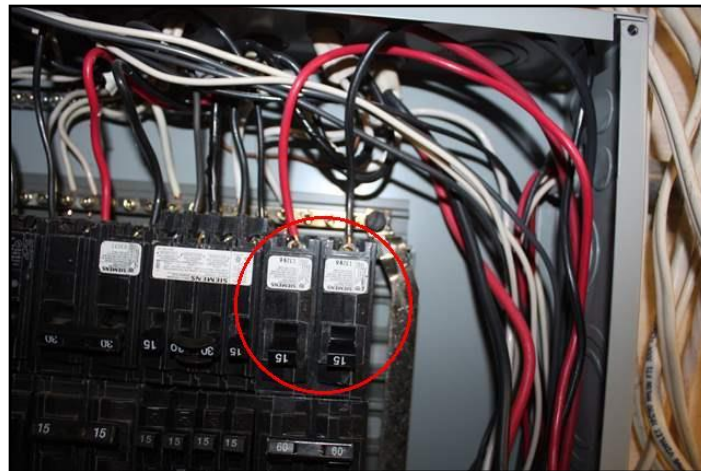
Condition: • [No links for multi-wire circuits](#)

we noted one only.

16. No links for multi-wire circuit

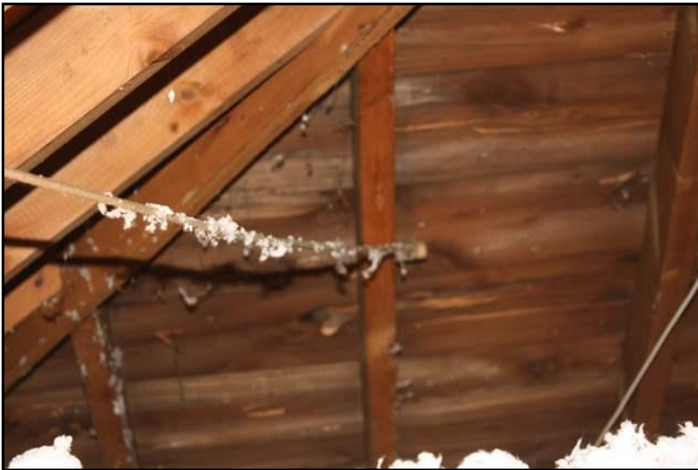
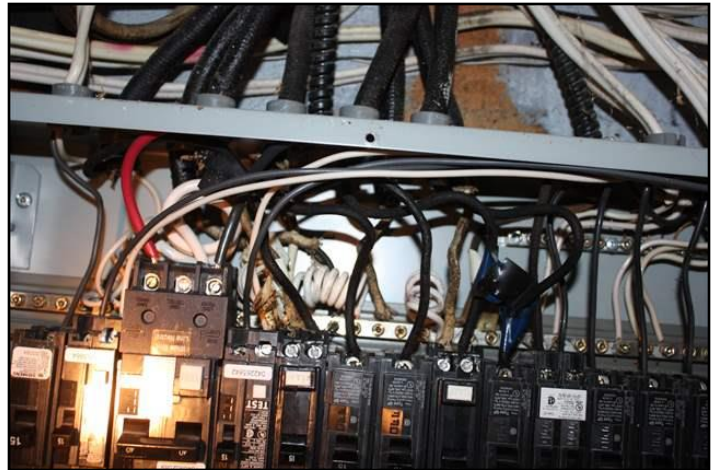
Condition: • **BACKGROUND** This pre-1955 wiring system is good quality and although it does not include the safety enhancement of a ground wire that is found in modern wiring, it can be serviceable if in good repair. Knob-and-tube wiring is often discovered when renovating or accessing areas that are not visible during a home inspection.

17. BACKGROUND This pre-1955 wiring system is...

18. BACKGROUND This pre-1955 wiring system is...

Condition: • [Outdated](#)

There is a mix of mostly new wiring with some older wiring remaining in the original home. The electrical panel contains a mix of mostly modern wiring with approximately 6 distribution lines of older wiring.. We noted some ungrounded outlets in the original portion of the house. Knob and tube wiring was installed pre-1950 in all homes. Most of the wiring in the home is behind walls and ceilings and not observed.

The ESA authority does not consider this wiring unsafe. However, Knob and tube wiring is an insurance issue as many insurers require that this wiring be upgraded. Some insurers will require an audit to estimate the percentage of knob and tube wiring still present. Consult with your insurance company for their requirements and/or acceptable limits

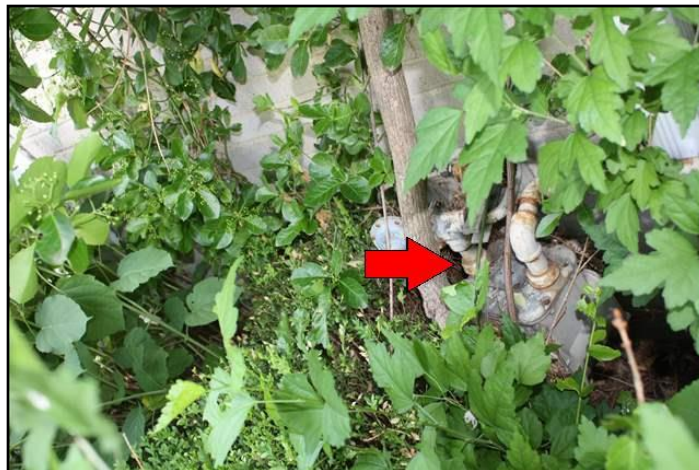
Condition: • [Poor access](#)

19. *Poor access*

Task: Keep vegetation trimmed back
