YOUR INSPECTION REPORT

FOR THE PROPERTY AT:
486 St John's Rd.
Toronto, ON

INSPECTION DATE:
Monday, July 17, 2017

RE: Report No. 2138
486 St John's Rd.
Toronto, ON

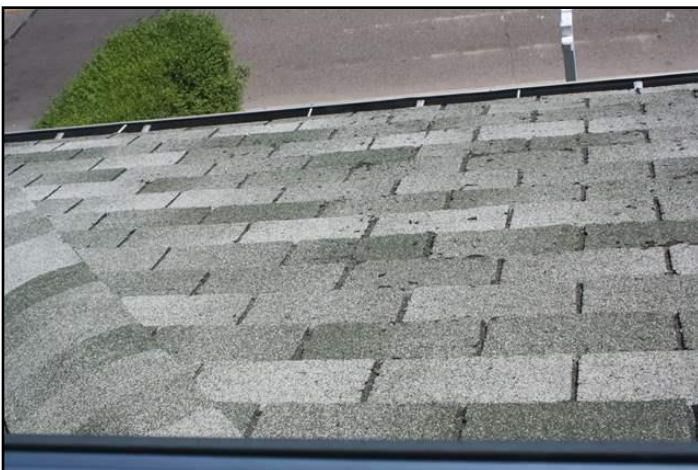
Condition: • [Old, worn out](#)

Typical life expectancy for this type of roof covering is 13-17 years. The current roof covering is old / worn.

Implication(s): Chance of water damage to contents, finishes and/or structure

1. Old, worn out

Task: Replace

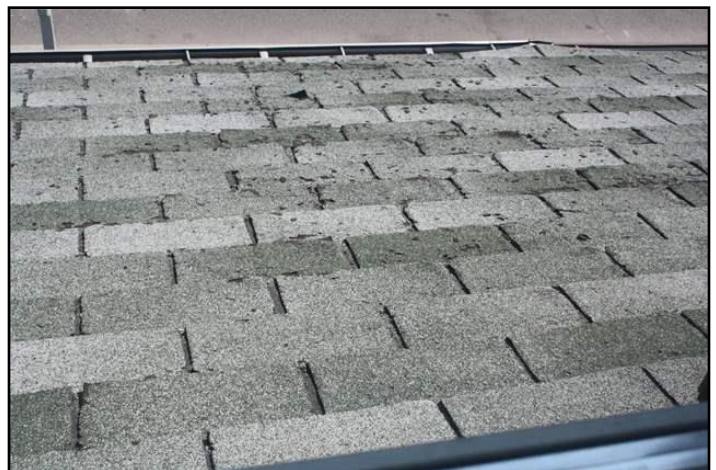
2. Old, worn out

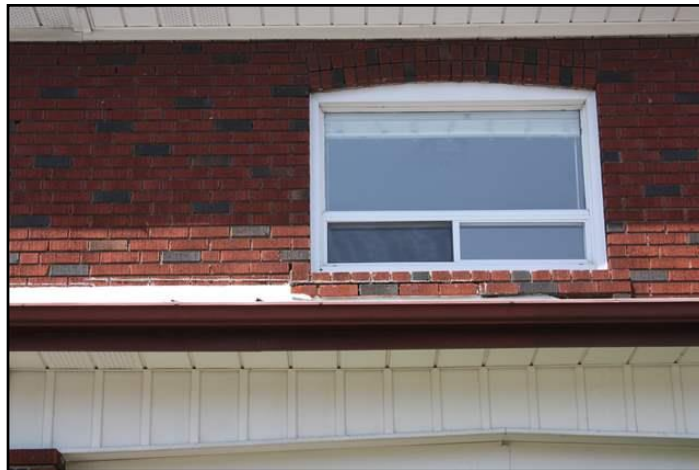
Condition: • [Too short](#)

Implication(s): Chance of water damage to contents, finishes and/or structure

3. Too short

Task: Further evaluation / Improve

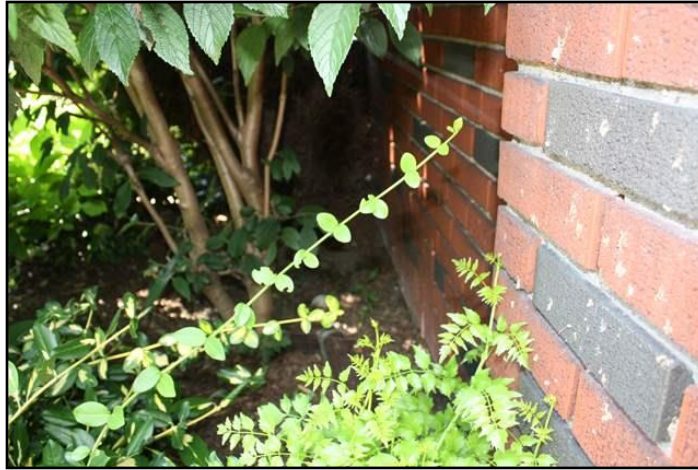
Condition: • [Downspouts end too close to building](#)

Implication(s): Chance of water damage to contents, finishes and/or structure

4. Downspouts end too close to building

Task: Improve

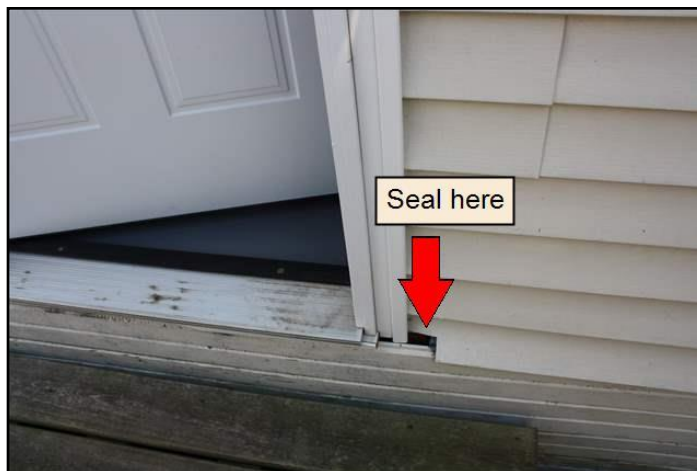
Condition: • [Loose or missing pieces](#)

Implication(s): Chance of water damage to contents, finishes and/or structure

5. Loose or missing pieces

Task: Improve

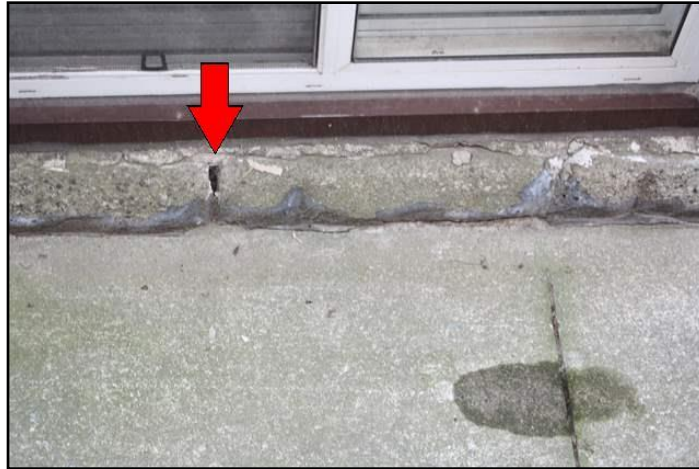
6. Example

Condition: • Gaps at wall

Task: Patch

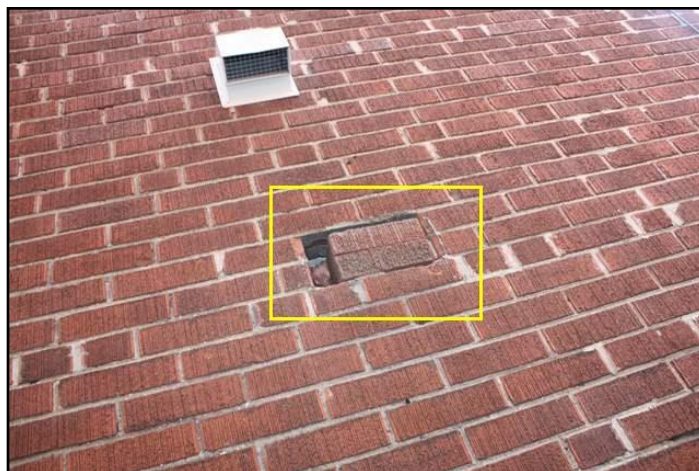
Condition: • [Mechanical damage](#)

Homeowner noted that this was from a vent that was moved. Homeowner will repair.

Implication(s): Chance of water entering building | Weakened structure

7. Mechanical damage

Task: Repair

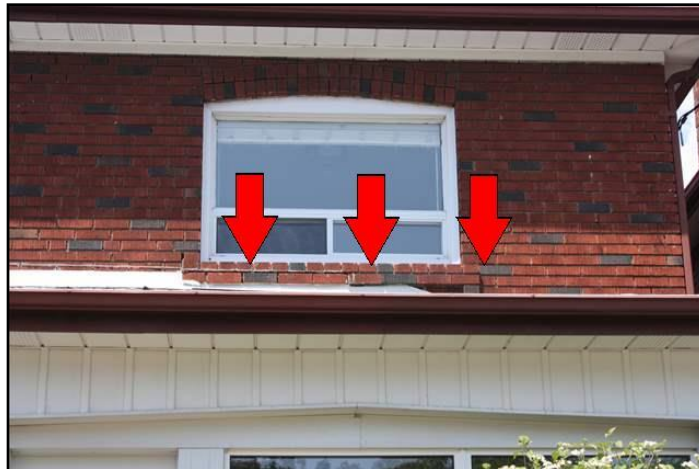
8. Example

Condition: • [Mortar deterioration](#)

Tuck Pointing (Re-pointing) is a common maintenance item with all older brick homes.

Implication(s): Chance of water entering building | Weakened structure | Chance of structural movement

Provide mortar (Repointing, Tuck pointing) at various wall locations.

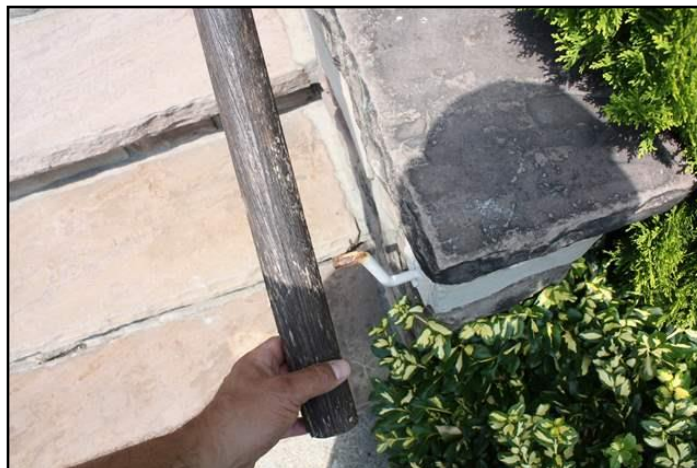
Condition: • [Ineffective](#)

Implication(s): Fall hazard

9. Ineffective

Task: Repair or replace

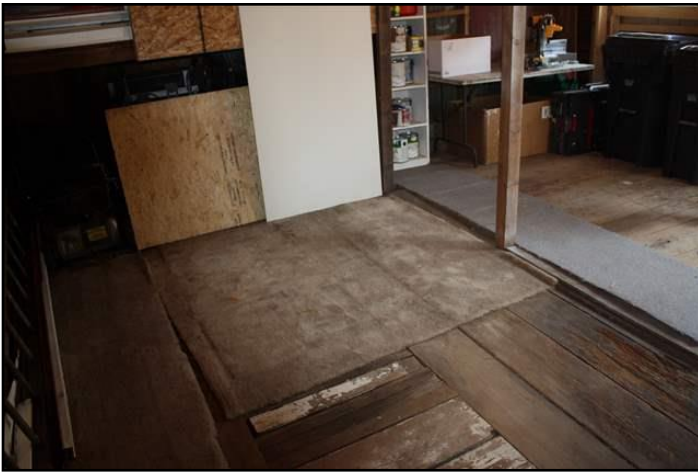
Condition: • Typical low quality structure

This is your standard older style Toronto Garage. Improvements have been made to the cladding and the homeowner has recently replaced the roof structure and sheathing and shingles. The floor is unfinished. Repairs ongoing as needed

10. Typical low quality structure

Task: Repair

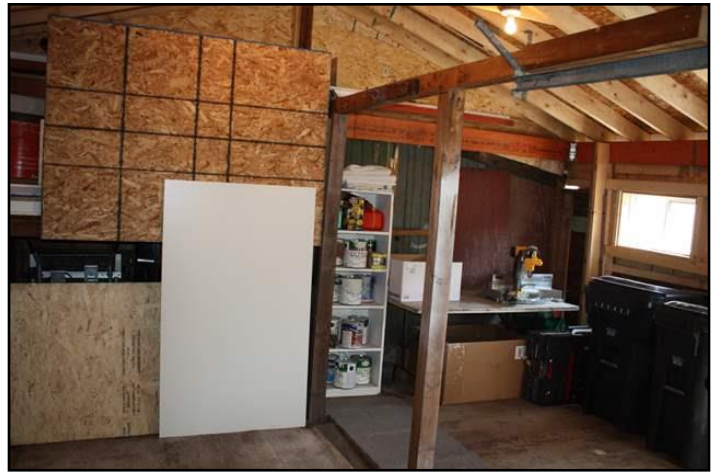
11. Typical low quality structure

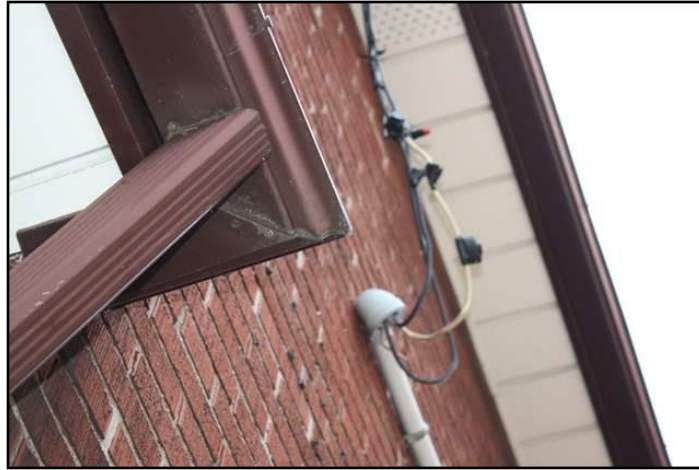
Condition: • [Poor connection to service conductors](#)

Implication(s): Electric shock | Interruption of electrical service

12. Poor connection to service conductors

Task: Further evaluation / Improve

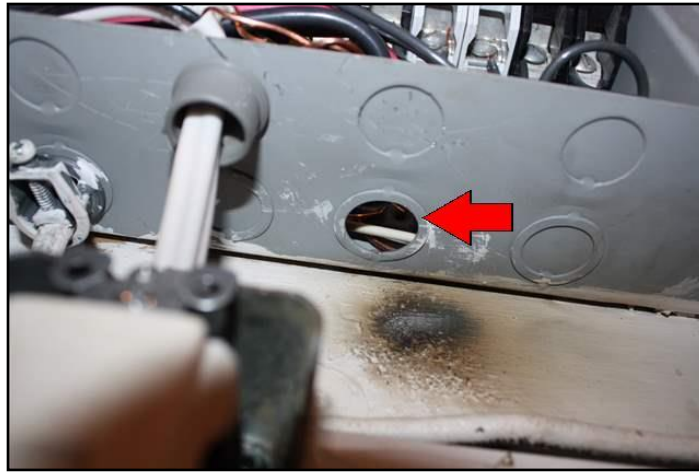
Condition: • [Openings in panel](#)

Implication(s): Electric shock | Fire hazard

13. Openings in panel

Task: Correct

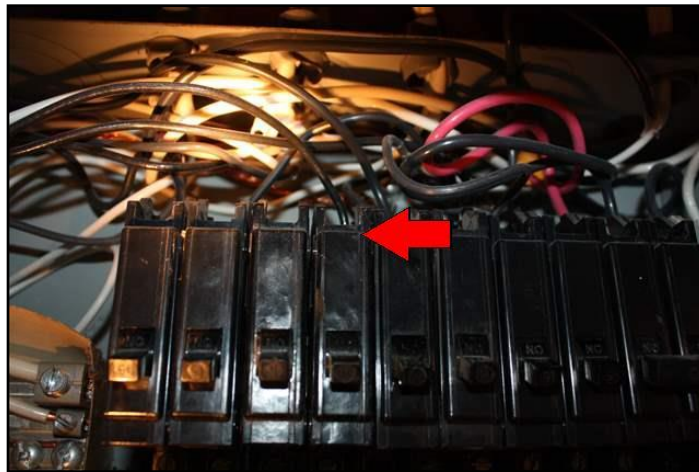
Condition: • [Fuses or breakers too big](#)

Implication(s): Equipment overheating | Fire hazard

14. breakers too big

Task: Correct

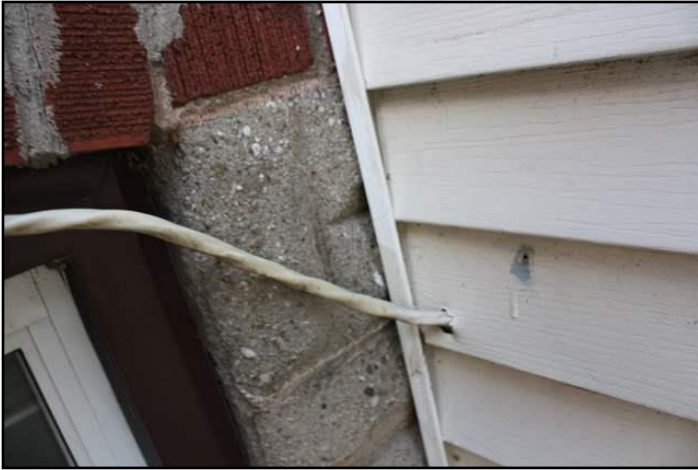
Condition: • [Flexible conduit needed](#)

15. Flexible conduit needed

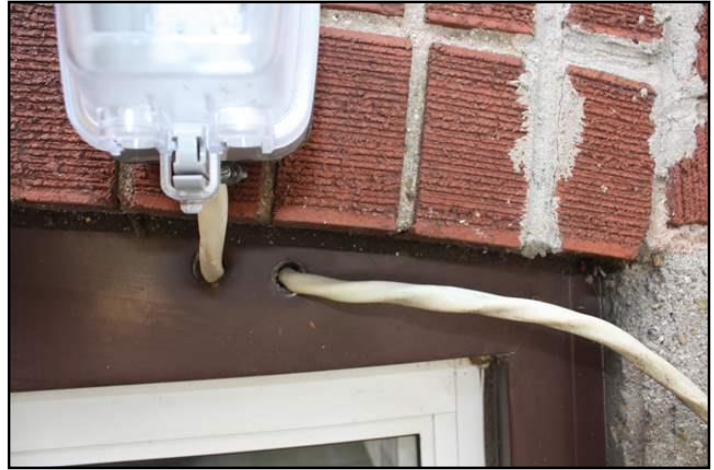
16. Flexible conduit needed

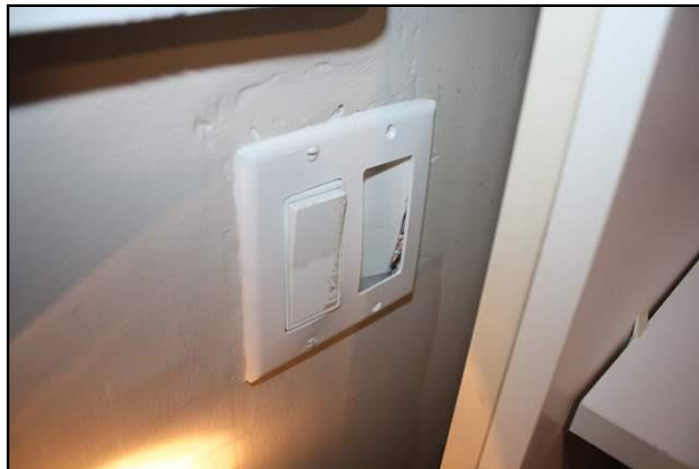
Condition: • [Damage](#)

Implication(s): Electric shock | Fire hazard

17. Damage

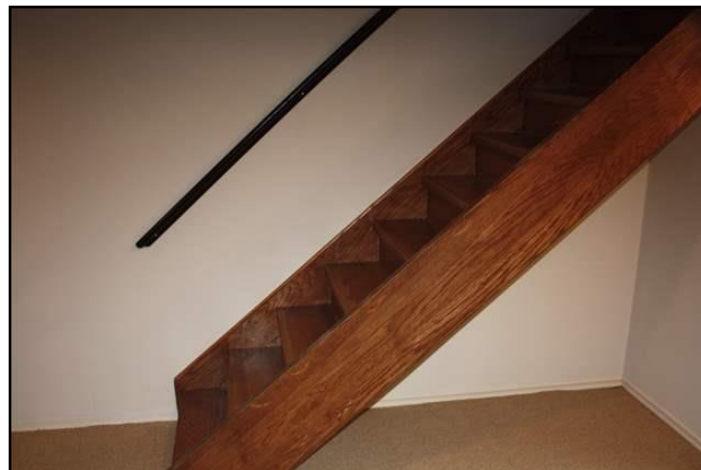
Condition: • [Missing](#)

Implication(s): Fall hazard

18. Missing handrail on open side
