YOUR INSPECTION REPORT

45 Kennedy Park Road
Toronto, ON M6P 3H2

INSPECTION DATE:
Tuesday, April 22, 2025

RE: Report No. 8257
45 Kennedy Park Road
Toronto, ON
M6P 3H2

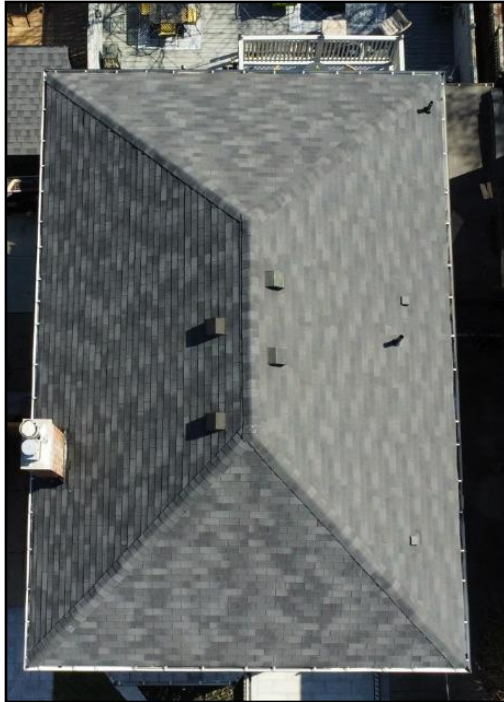
1. Asphalt shingles

Reported to be 5 years old.

Good condition overall.

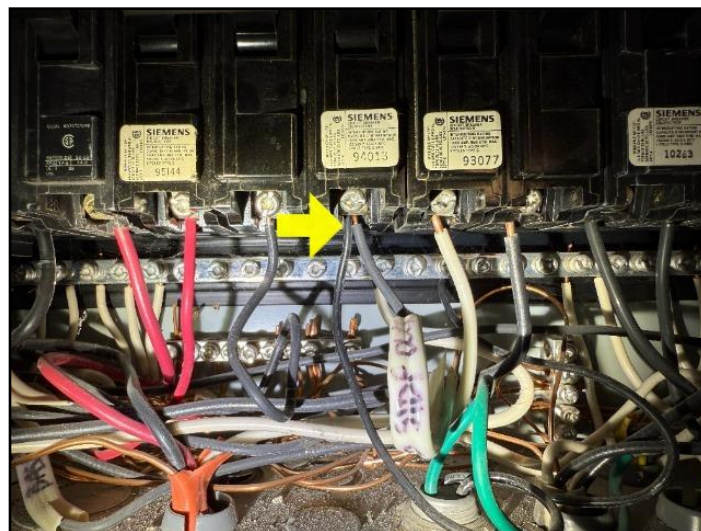
7. Double taps

Condition: • [Double taps](#)

Double tap noted at low voltage wire connection to breaker. Although we see this frequently, it is not permitted. Pigtail

recommended.

Implication(s): Fire hazard

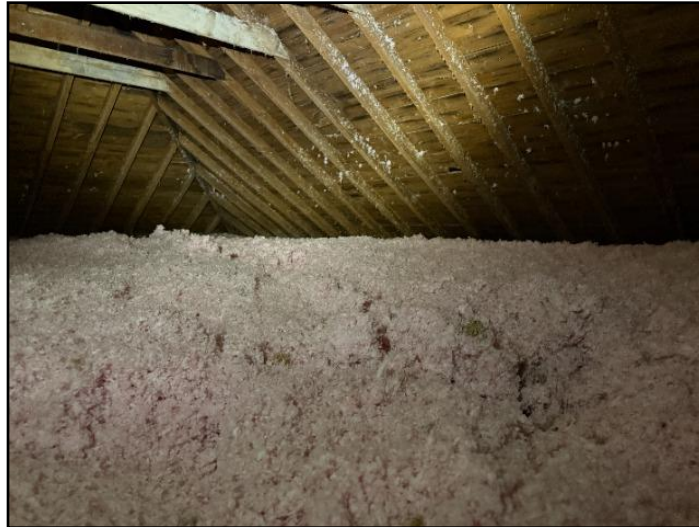
8. Glass fiber

Fiberglass over cellulose fiber in visible areas

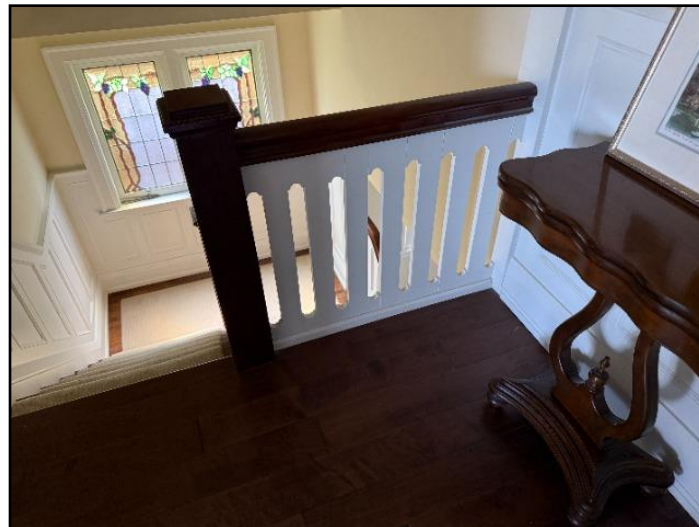
10. Too low

Condition: • [Too low](#)

Implication(s): Fall hazard
