# YOUR INSPECTION REPORT

446 Armadale Avenue  
Toronto, ON M6S 3X9

INSPECTION DATE:  
Friday, March 23, 2018

RE: Report No. 2245  
446 Armadale Avenue  
Toronto, ON  
M6S 3X9

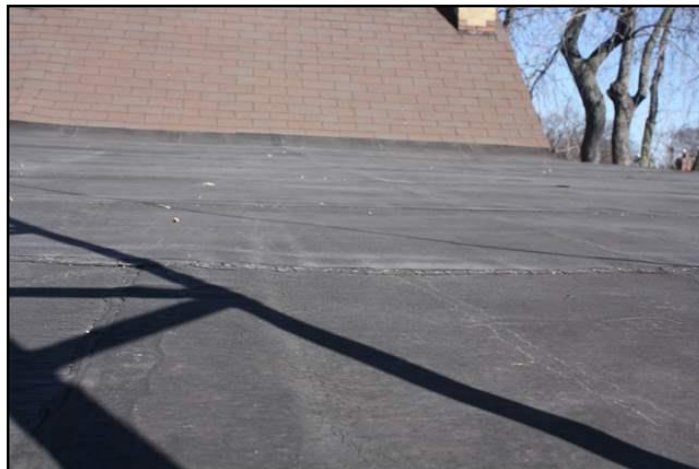
1. Aging

**Condition:** • Aging

Signs of aging roof noted - Cracking surfaces, opening seams. Inspect annually and plan to replace in 2-4 years

**Task:** Monitor annually and replace in less than 4 years

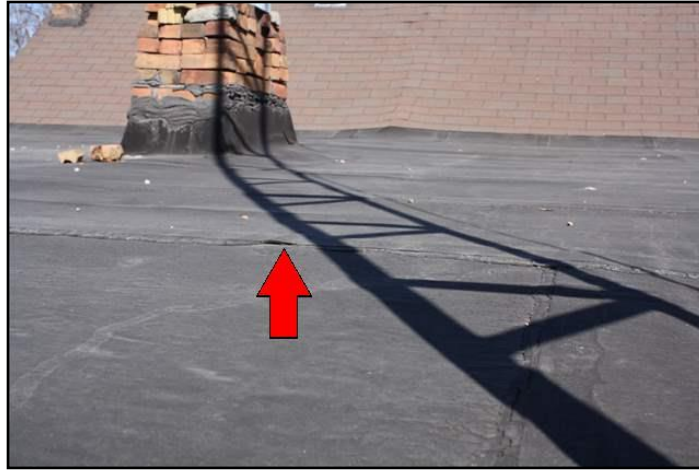
2. Openings at seams or flashings

**Condition:** • [Openings at seams or flashings](#)

**Implication(s):** Chance of water damage to contents, finishes and/or structure

**Task:** Repair

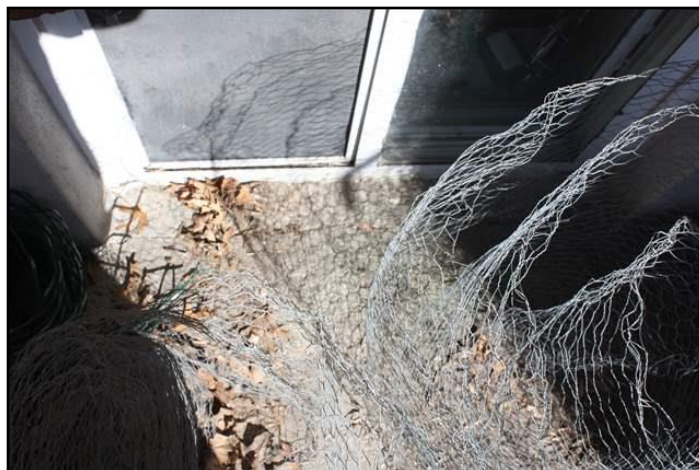
3. Rear window

**Condition:** • [Missing](#)

Window wells help manage the water in areas where windows are at or below grade. A properly installed window well will help prevent water entry / damage to windows and structure. THIS IS SOMETHING TO MONITOR FOR NOW, especially through the Spring rainy season. In the meantime, you may consider adding clear window covers to manage the water in this area.

**Implication(s):** Chance of water damage to contents, finishes and/or structure | Material deterioration

**Task:** Provide window well

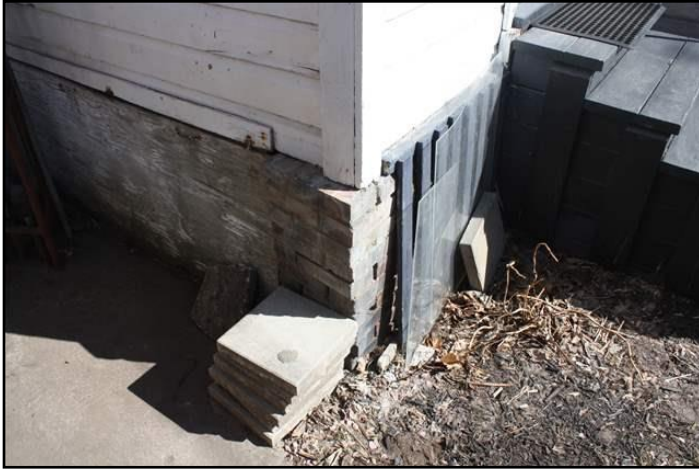
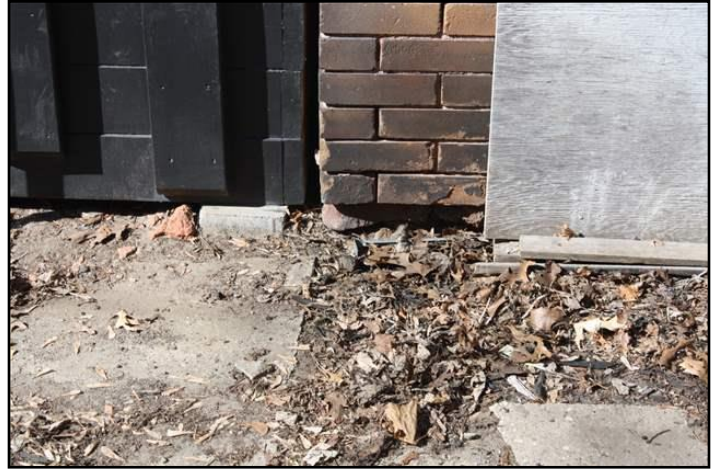
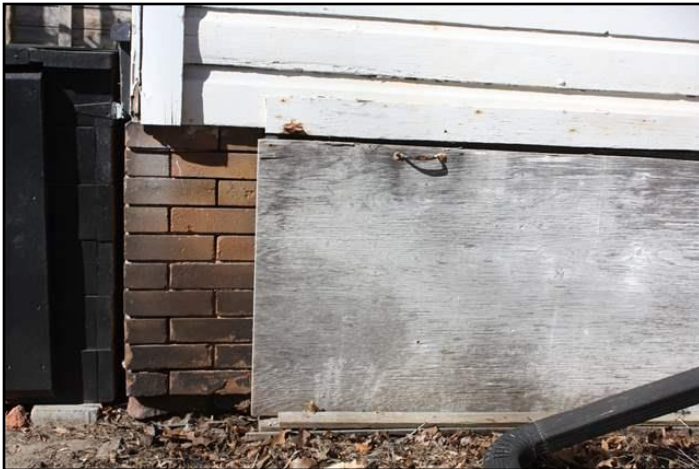
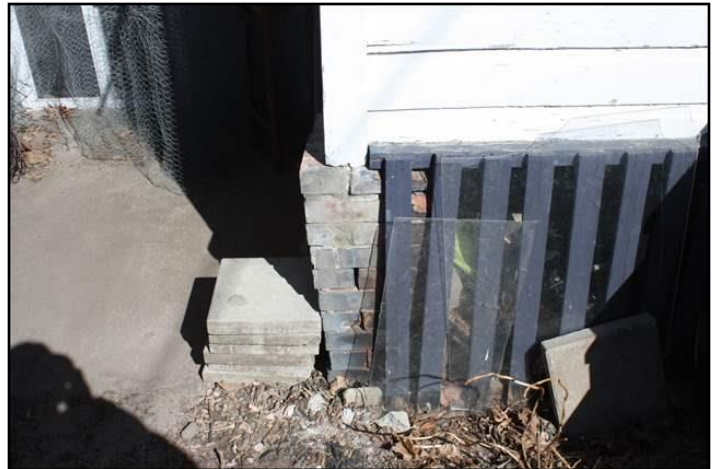
**Condition:** • [Damage](#)

4. Damage

**Task:** Repair or Replace columns

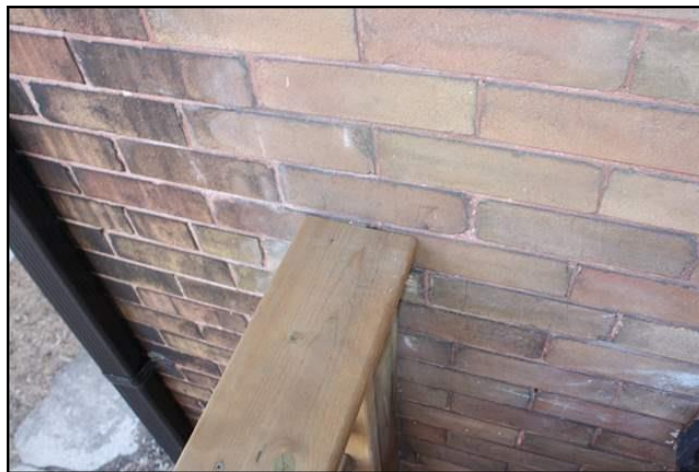
**Condition:** • [Loose](#)

**Implication(s):** Fall hazard

9. Guardrail not secured

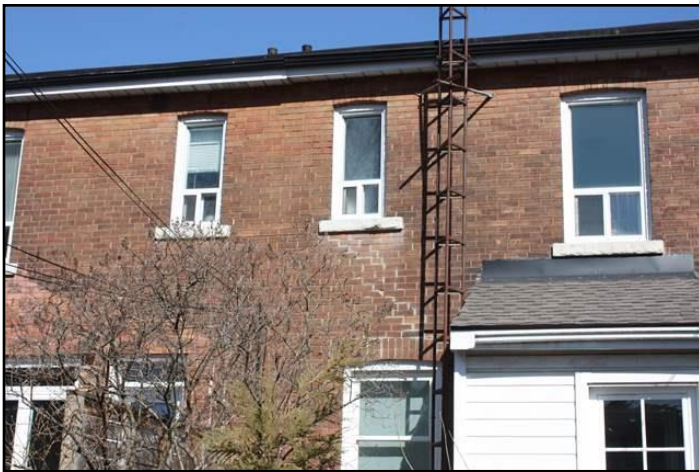
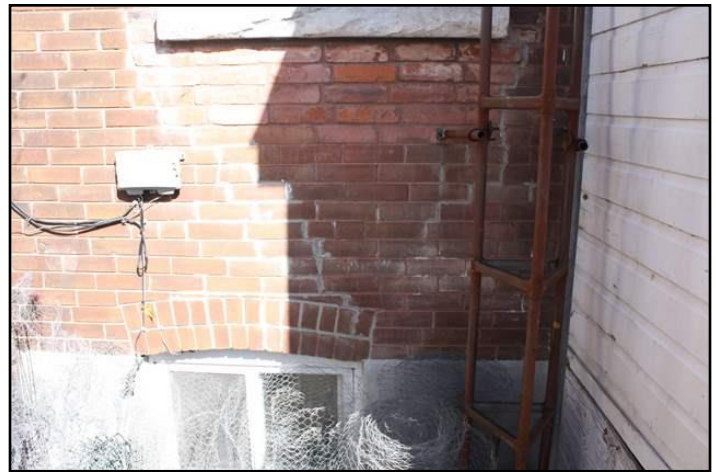
**Condition:** • [Prior repairs](#)**Implication(s):** Weakened structure**Location:** Rear Exterior Wall**Task:** Monitor**Time:** Ongoing

10. Prior repairs example

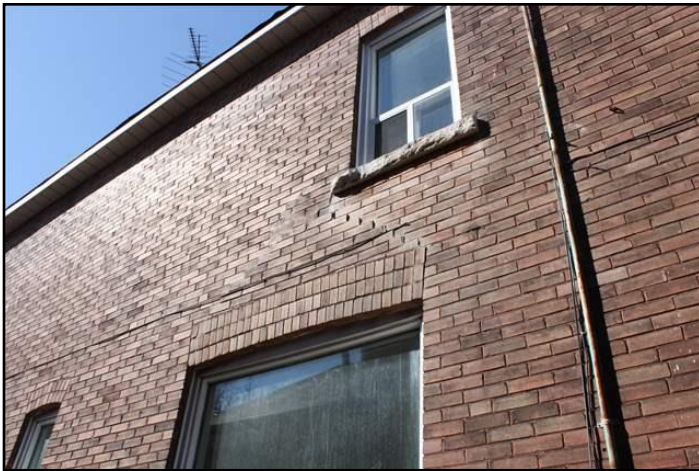
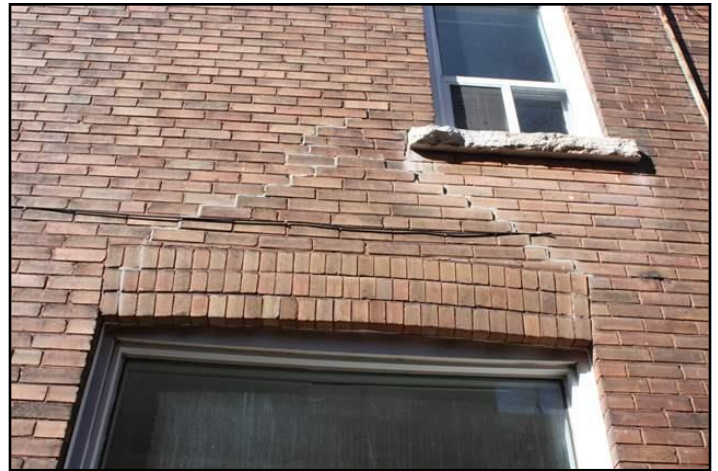
**Condition:** • [Dropped, rotating or leaning](#)

Cracking and lateral movement noted.

**Implication(s):** Weakened structure | Chance of structural movement**Location:** Left Side Exterior Wall**Task:** Repair**Time:** Less than 1 year

12. *Dropped, rotating or leaning*

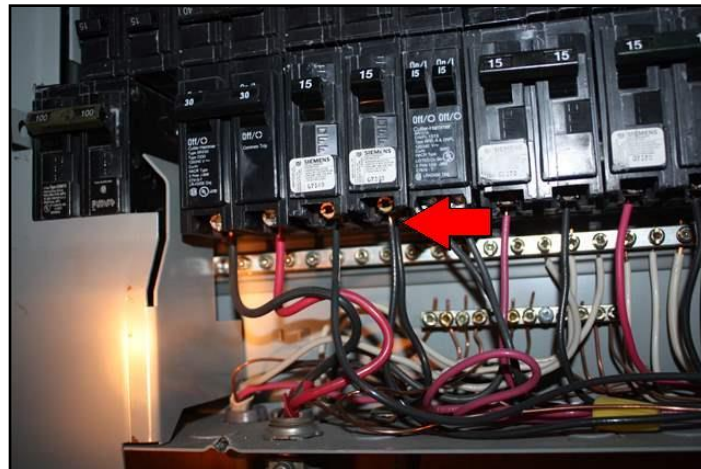
**Condition:** • [Double taps](#)

**Implication(s):** Fire hazard

15. Double taps

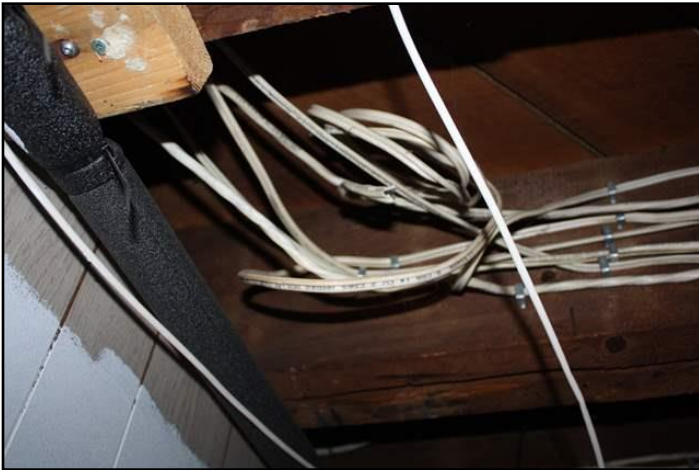
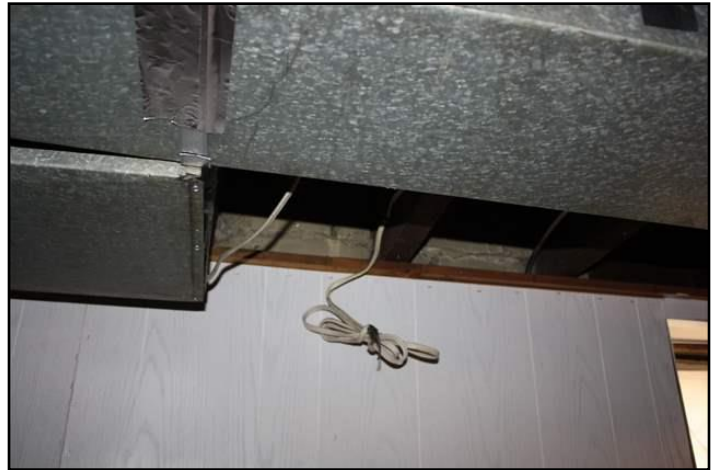
**Condition:** • [Abandoned wire](#)

16. Abandoned wire

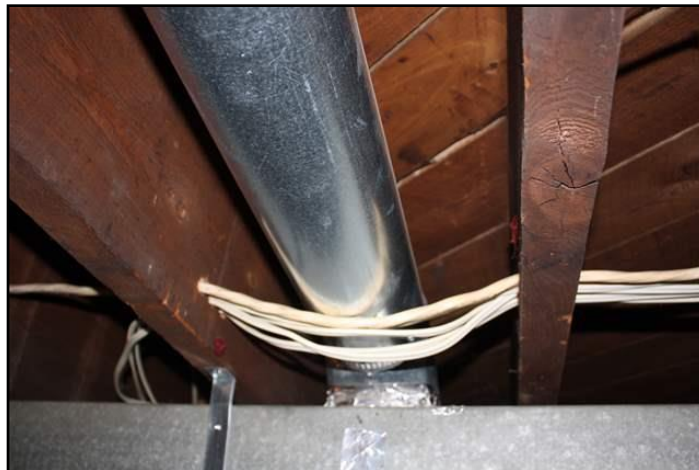
**Condition:** • [Too close to duct, pipe, vent or chimney](#)

**Implication(s):** Electric shock | Fire hazard

18. Too close to duct, pipe, vent or chimney

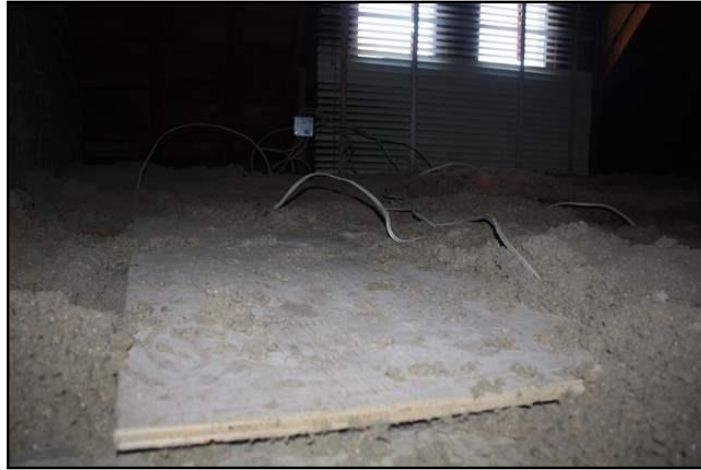
**Condition:** • [Exposed in attics](#)

19. Exposed in attics

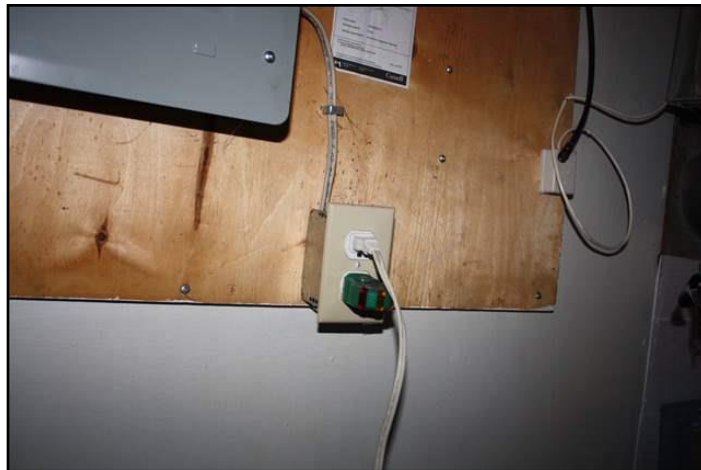
**Condition:** • [Inoperative](#)

20. Inoperative

**Task:** Correct

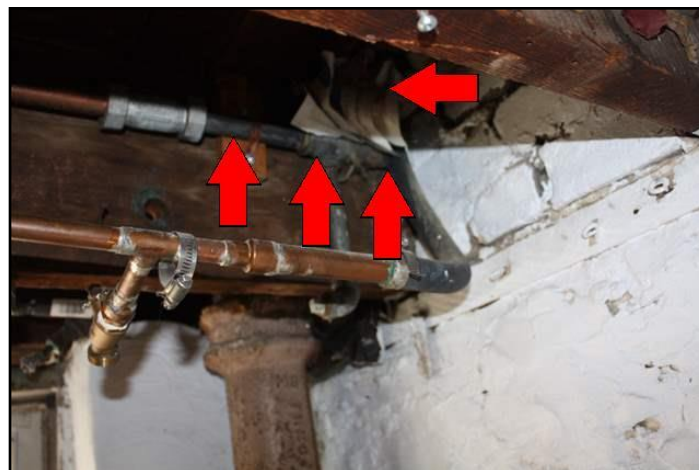
**Condition:** • [Galvanized steel](#)

We observed one galvanized steel pipe riser. We could not determine if this riser is continuous or capped. Most insurance companies will require removal of Galvanized plumbing. Consult with your insurance company (Most of the piping that we observed was copper piping).

rusting of galvanized pipe can greatly reduce water pressure and will eventually cause leaks as rust creates holes in the pipe walls

23. Galvanized steel

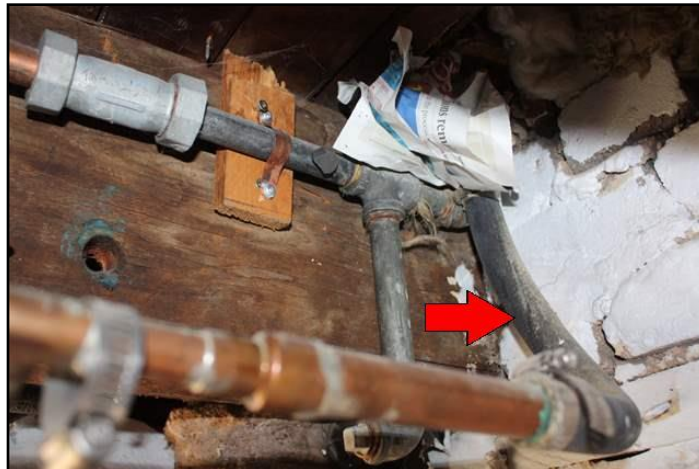
**Condition:** • [Non-standard material](#)

Possible temporary repair.

**Implication(s):** Chance of water damage to contents, finishes and/or structure | Reduced system life expectancy | No water

24. Non-standard material

**Task:** Replace

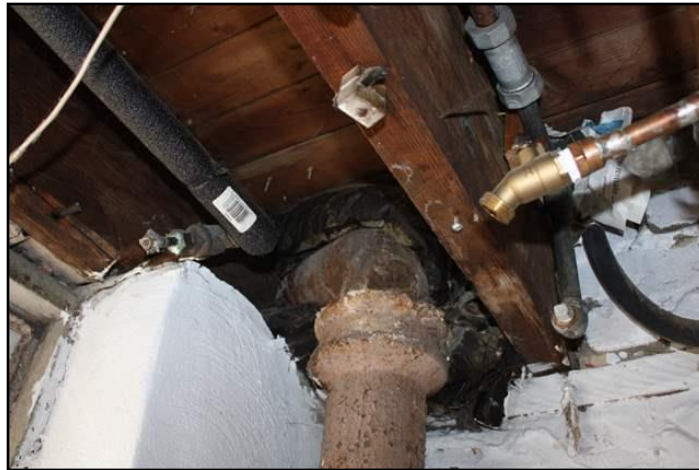
**Condition:** • The cast iron waste piping is near the end of its normal life expectancy and is prone to rusting through or splitting. Replacement may be required in the near future.

25. Rust noted

**Task:** Replace

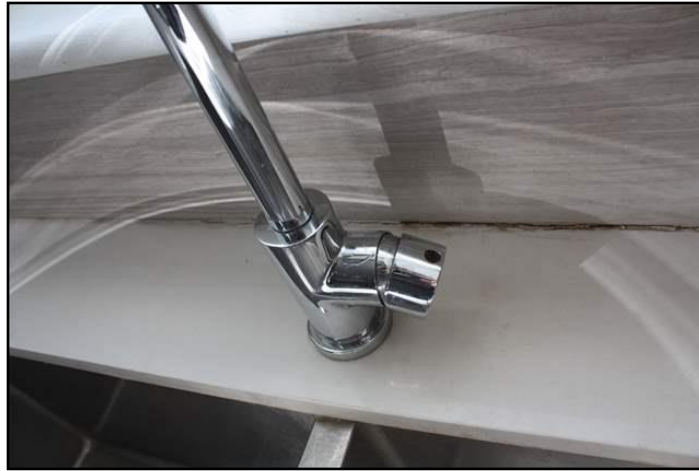
26.

**Condition:** • Kitchen faucet handle missing

**Task:** Repair or replace

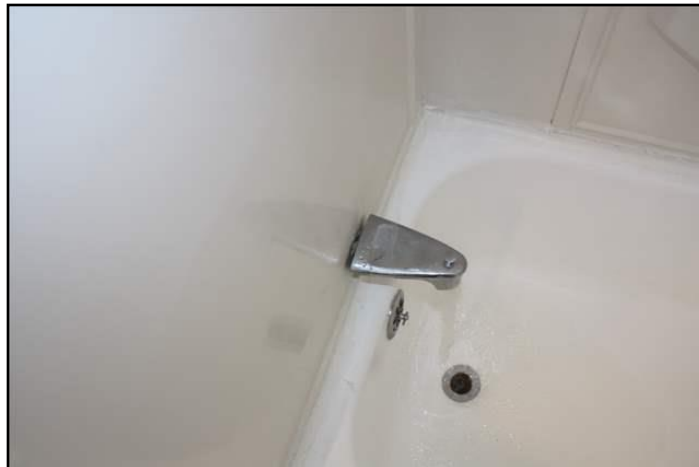
**Condition:** • [Loose](#)

**Implication(s):** Equipment failure

27. Loose

**Task:** Secure and Seal

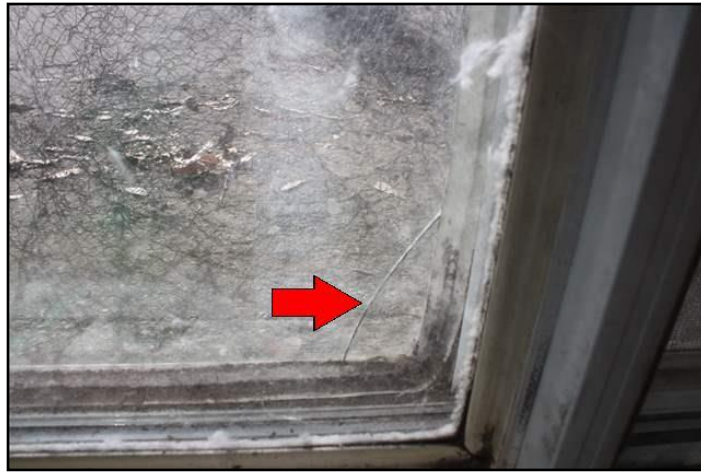
**Condition:** • [Cracked](#)

28. Cracked

**Task:** Replace

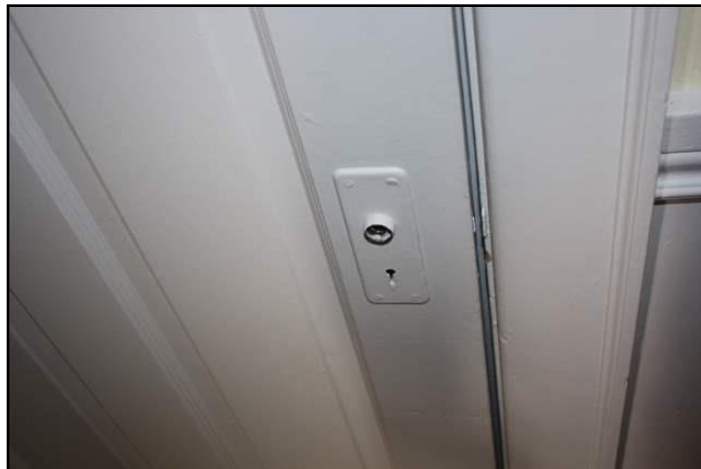
**Condition:** • [Missing](#)

29. Missing

**Task:** Repair

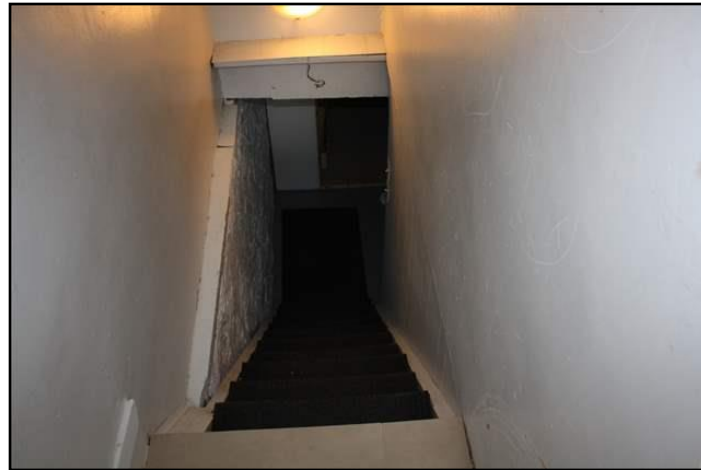
Condition: • [Missing](#)

Implication(s): Fall hazard

30. Missing

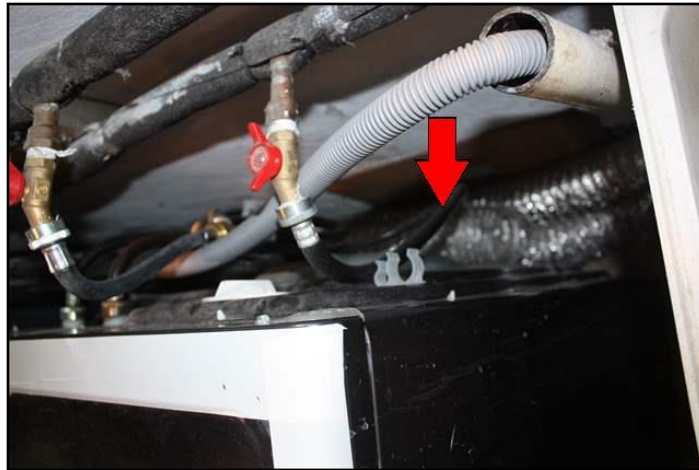
**Condition:** • Dryer not vented to exterior

**Implication(s):** Chance of condensation damage to finishes and/or structure

31. Dryer not vented to exterior

**Task:** Correct
