3000 Falcon Lane, Whistler, BC May 9, 2012

Report No. 2170, v.2

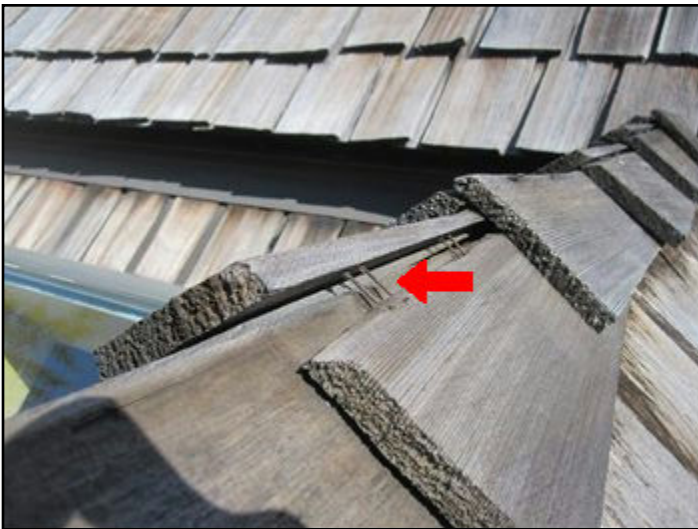
Condition: • Damaged, broken or missing pieces

There are multiple roof lines on the house making the application of the shakes more of a challenge. As well with the snow piling up between the dormers the stress of the snow and ice is tearing at and dislodging some shakes. There is a series of shakes where the shake is tapered so much the shake is very thin so there are holes in the shake that are not covered and this exposes the roofing paper below.

1. Ridge Cap Pulling Away

Task: Have roofer make repairs to extend life of roof

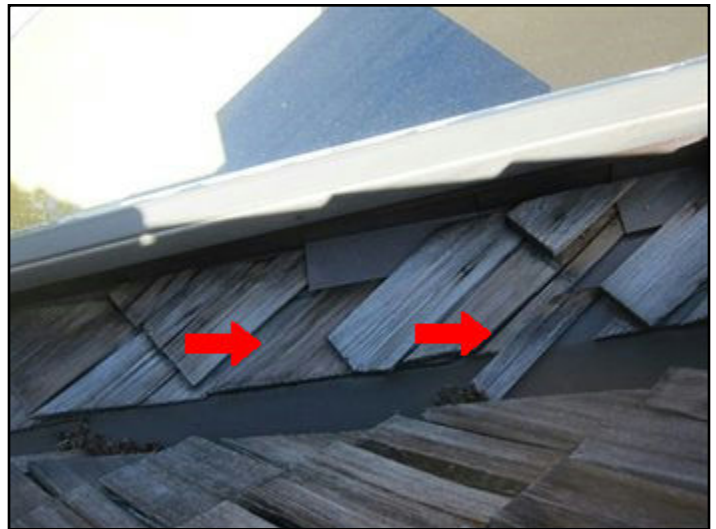
2. Loose and missing pieces

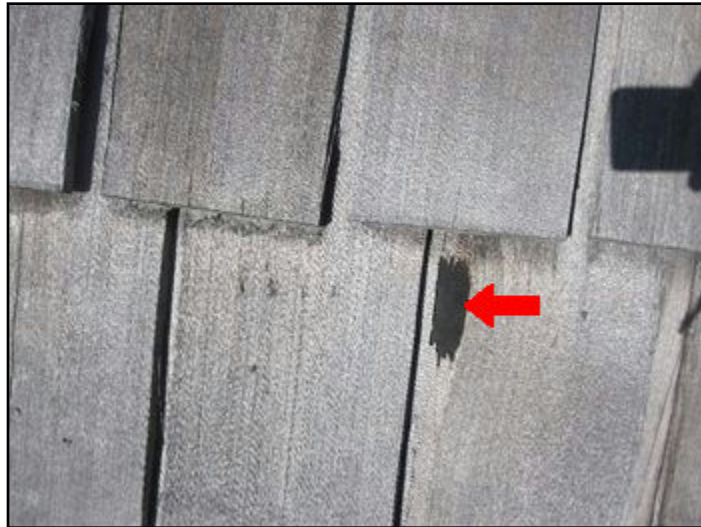
3. *Holes in the shakes*

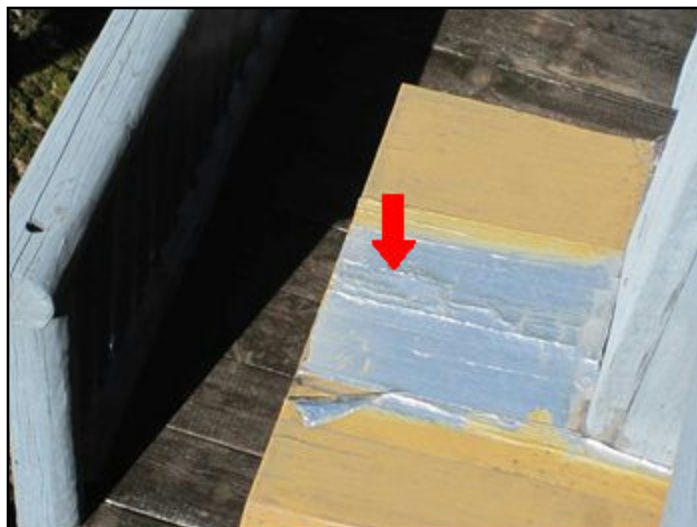
Condition: • Flashings missing

4. Uncapped log end needs flashing

Task: Provide Flashing Caps over Unprotected Log Ends

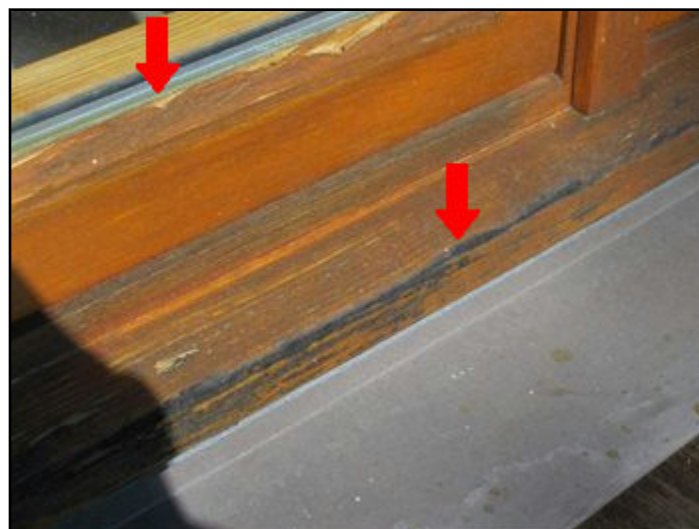
Condition: • Paint or stain needed

5. East facing Window

Task: Re-finish

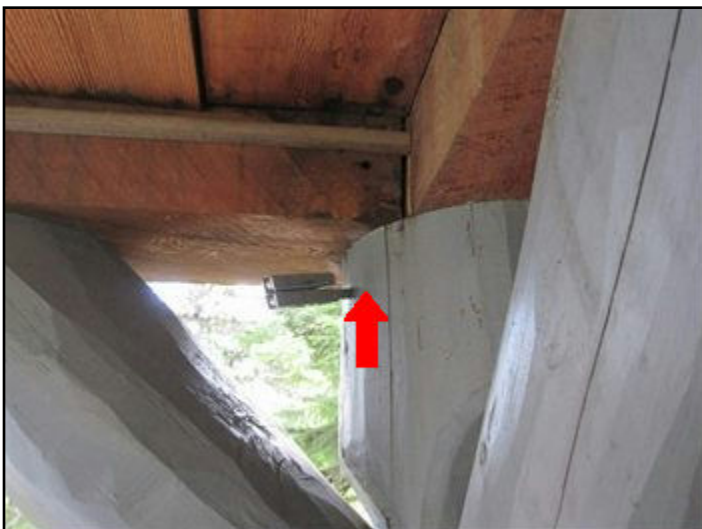
Condition: • Rather than using a torch down or similar membrane on top of the decking to act as a roof for the exterior staircase, a membrane or plastic (hard to tell) was used below the upper deck joists but above the upper deck soffit. Water still drips through this "membrane" because it is not sealed and water may become trapped causing rot to any wood that the water continually drips on.

6. Rot in support post not extensive yet

Task: Further evaluation

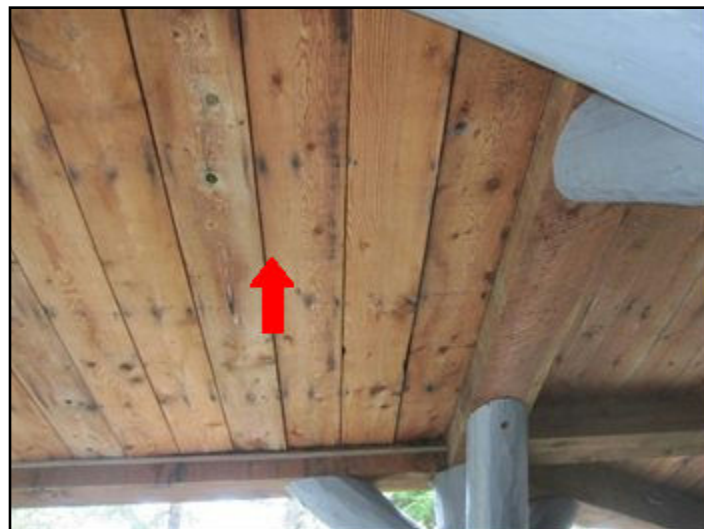
7. Membrane or plastic above

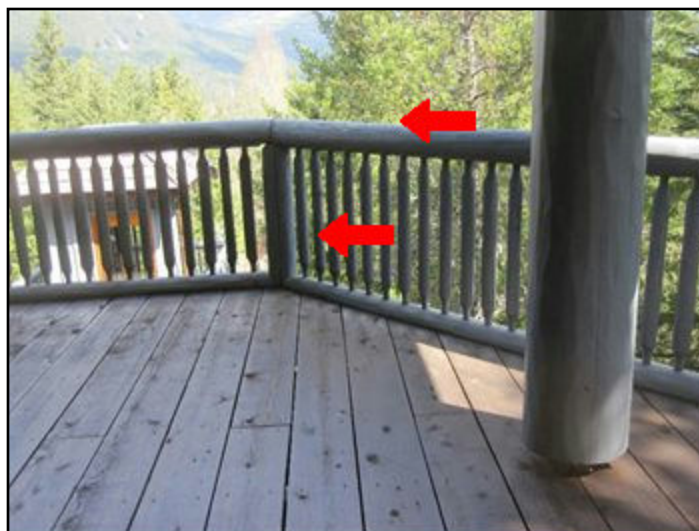
Condition: • The deck guards are log top and bottom rails and wood pickets. Many of the guards are protected to some degree by the roof but others are exposed to the weather. Because of the natural occurring splits in the wood (especially the top rails) water penetrates the wood causing it to rot. Sand or otherwise prep the guards and refinish.

8. Deck guards

Task: Further evaluation

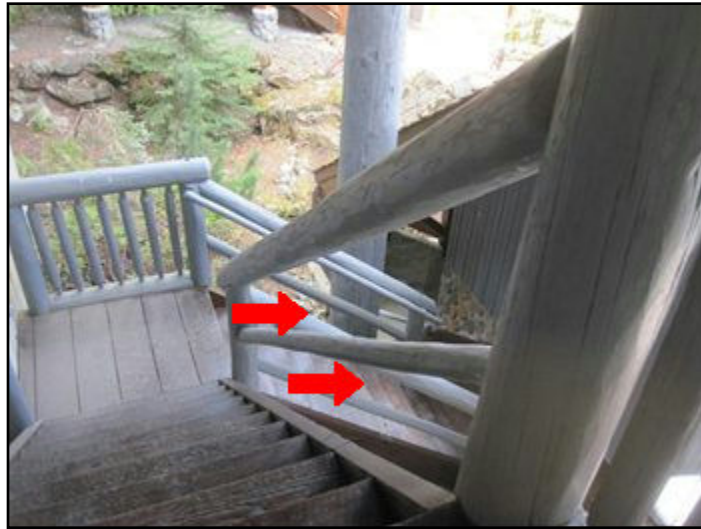
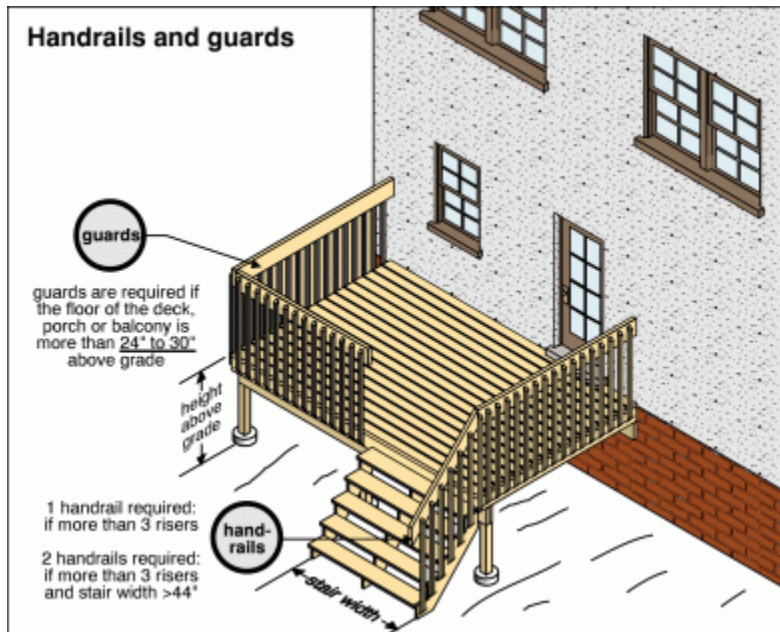
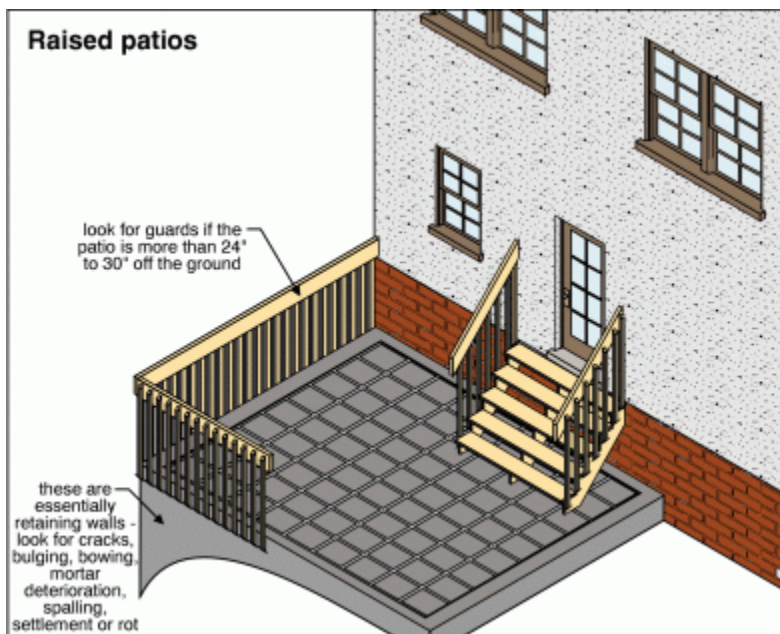
Condition: • Ineffective

Implication(s): Fall hazard

9. Stair guards ineffective for children

Task: Correct

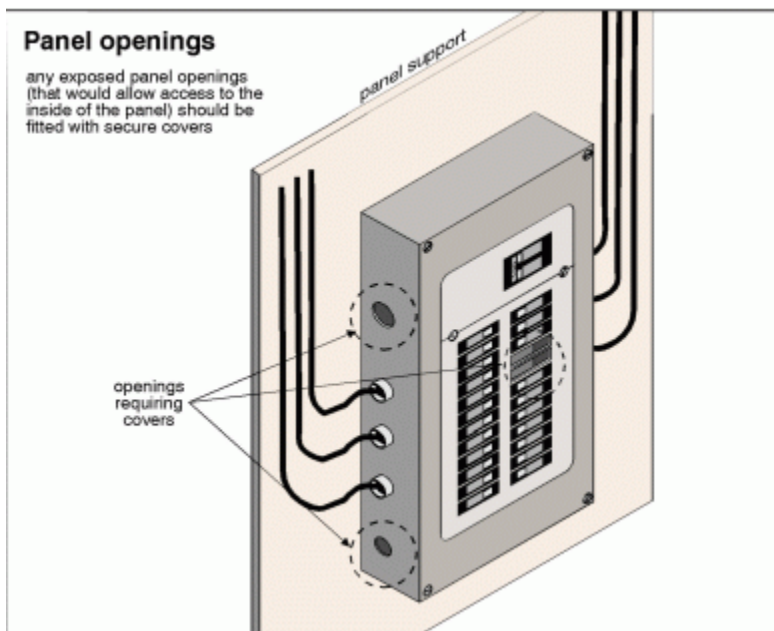
Condition: • Openings in panel

Implication(s): Electric shock | Fire hazard

Task: Correct

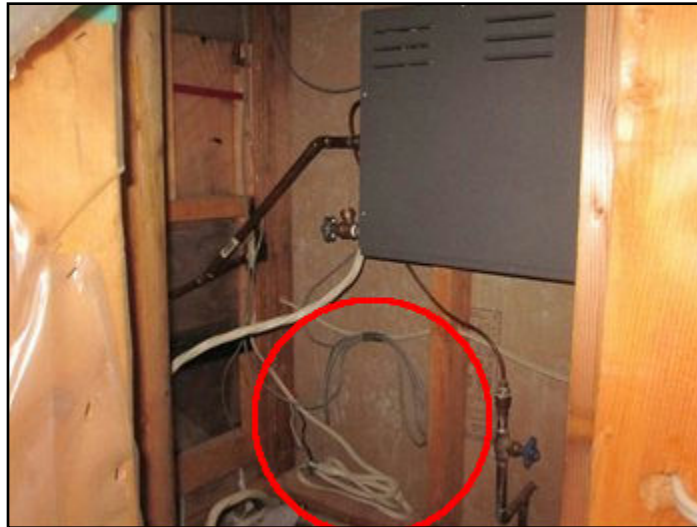
Condition: • Abandoned wire

12. Abandoned wire

Task: Further evaluation

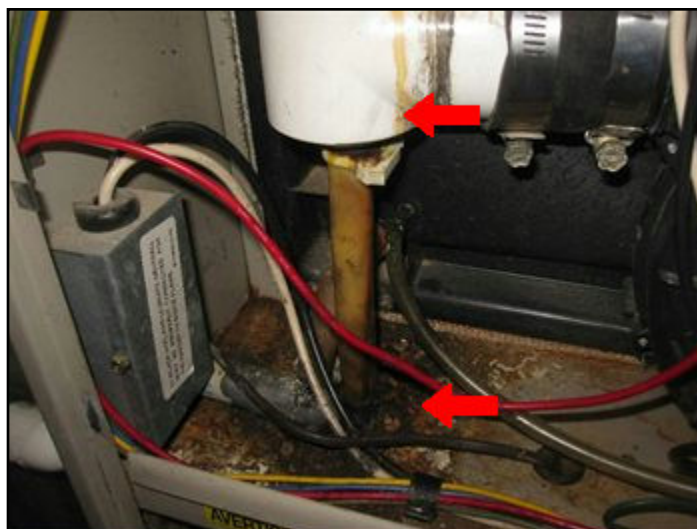
Condition: • Rust

Have a heating service person review the furnace. The unit is functional but it is older so in the short term it should be serviced with plans to review to consider replacement in the next few years.

14. Rust, moisture dripping

Task: Further evaluation

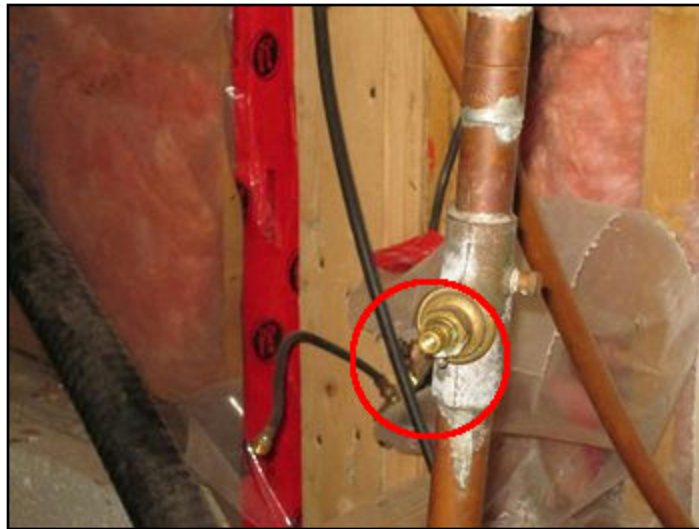
15. Shut off valve handle missing

Condition: • Damaged handle

Task: Replace

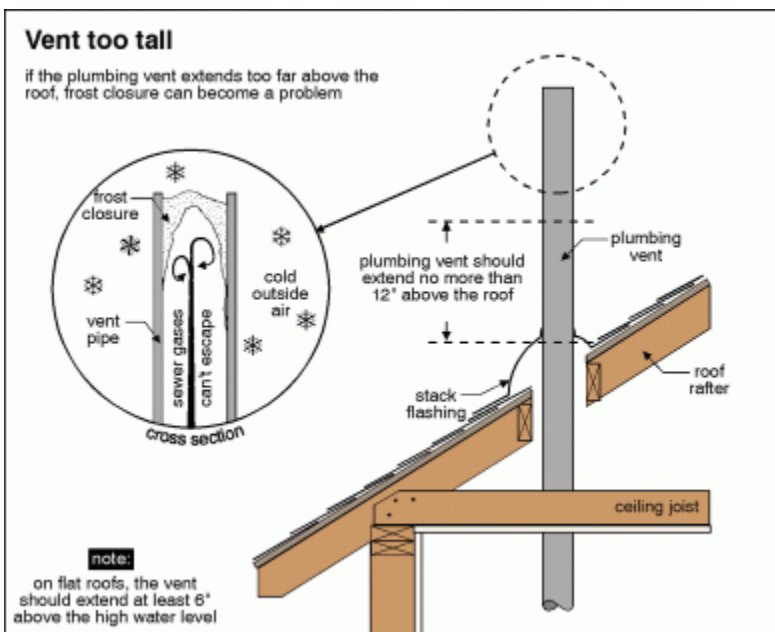
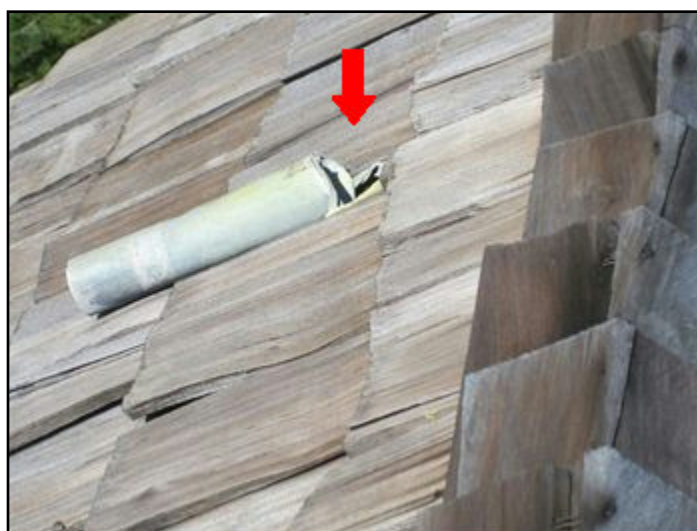
Condition: • Vent termination problems

16. Vent pipe torn off roof by snow

Task: Repair

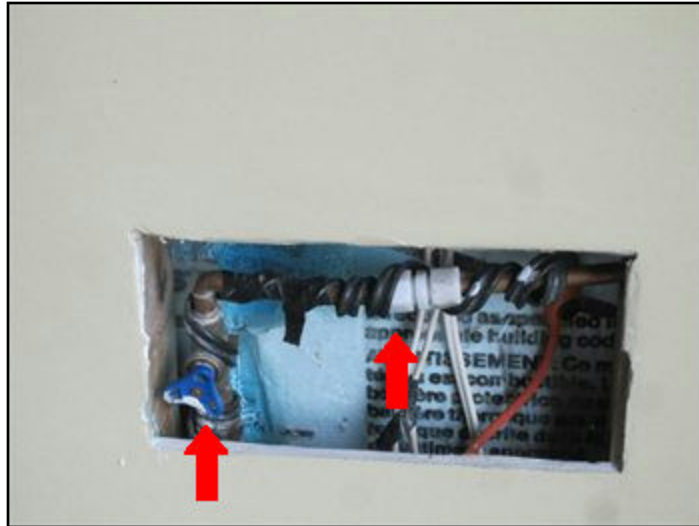
Condition: • Ensure the heat trace on the water line in the garage is operational each fall to prevent a freeze up and damage of the copper line to the hose bibb.

17. Shut off for hose bibb & heat trace

Task: Further evaluation

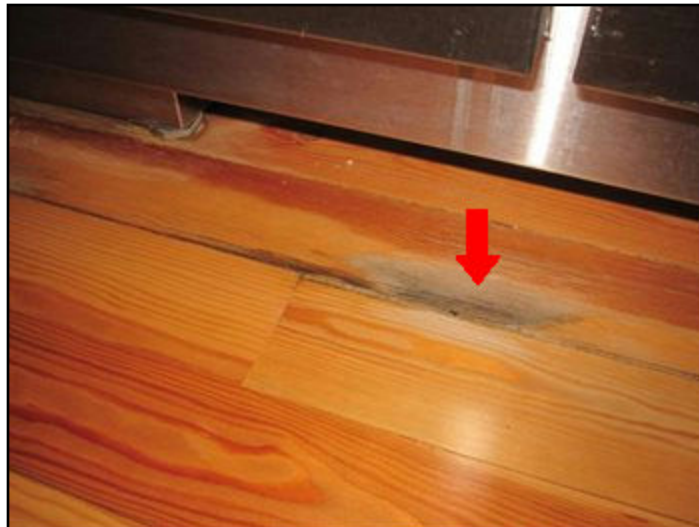
Condition: • Stained

The freezer was not turned on. When you turn it on monitor it for leaks to ensure whatever caused the damage to the floor isn't still an issue.

19. Water damaged from refrigerator

Task: Monitor

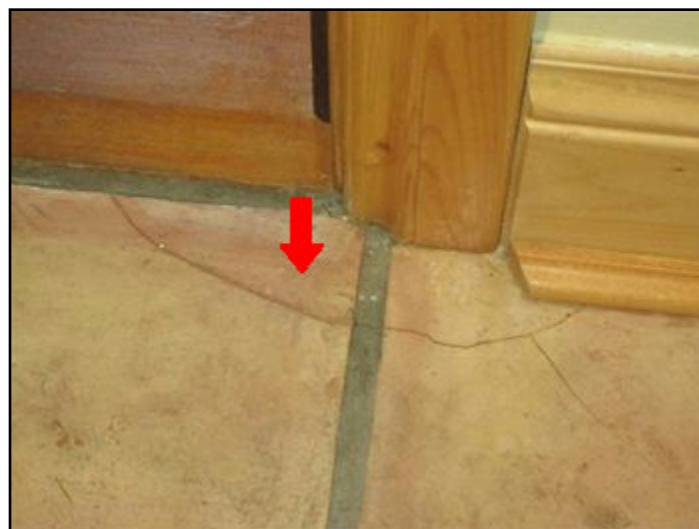
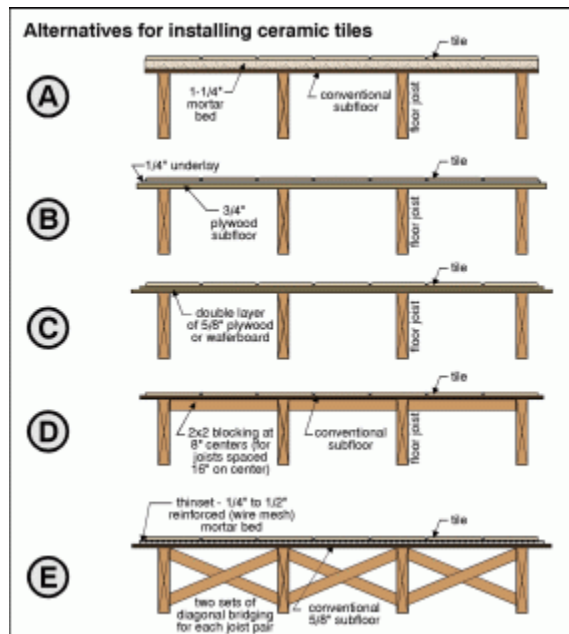
Condition: • Tiles cracked

There are a number of cracked tiles some in the entry, sauna bathroom and the bedroom bathroom. The tiles are still functional.

20. Cracked floor tile

Task: Replace

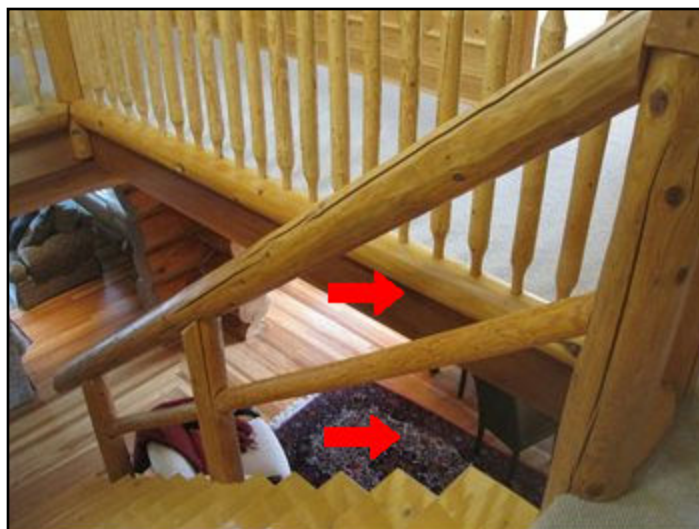
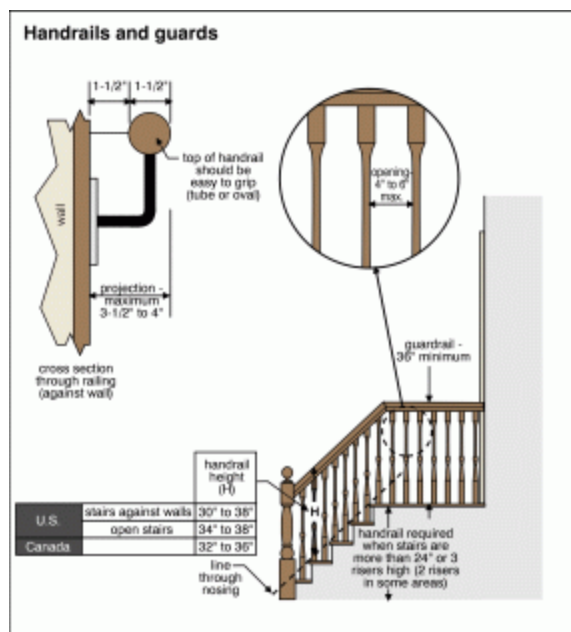
Condition: • Missing

Implication(s): Fall hazard

21. Missing stair guard

Task: Correct
