INSPECTION REPORT

For the Property at:
999 SALTY DOG ROAD
FREELAND, WASHINGTON, WA 98249

Prepared for: GINNY VALENTINE
Inspection Date: Wednesday, December 21, 2016
Prepared by: James Canby

RE: Report No. 1005, v.3
999 Salty Dog Road
Freeland, Washington, WA
98249

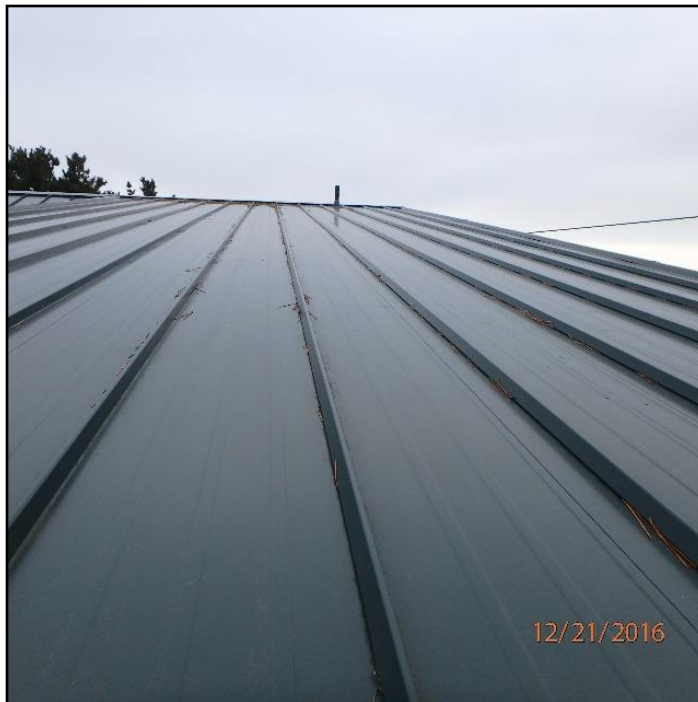
1. Metal

Aluminum roof in early stage of material life. New addition to original roofing material

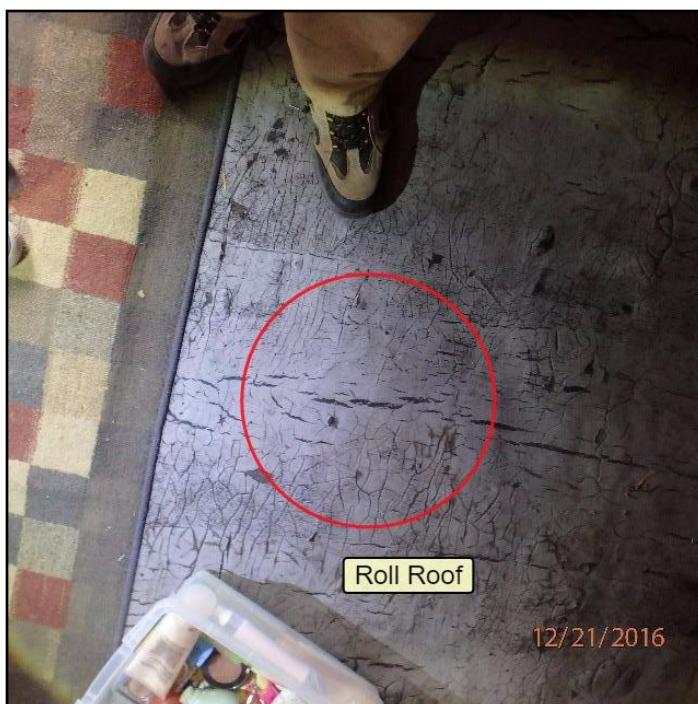
2. Built-up membrane

Built up asphalt roof original construction, metal roof-attic is an addition.

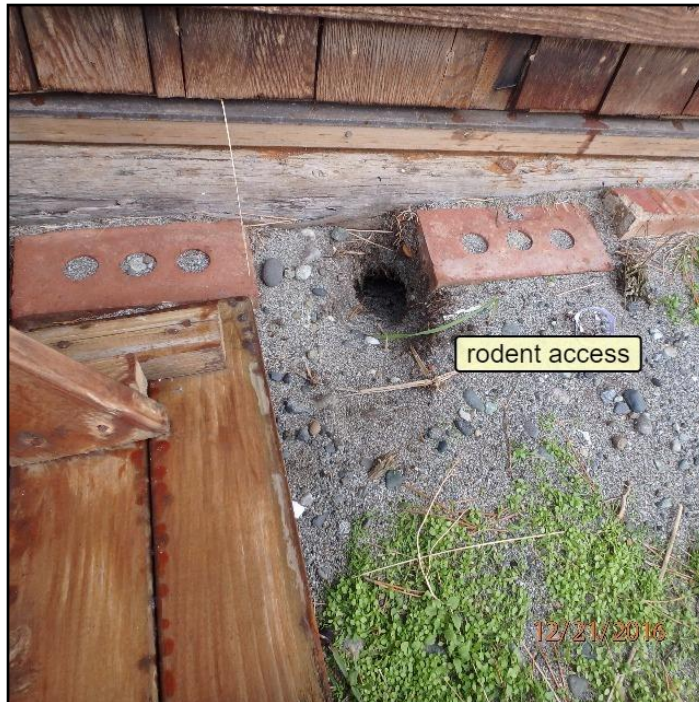
5. Other

A Rodent access point is at the edge of the house. Inspector recommends a Pest Control Survey and mitigation.

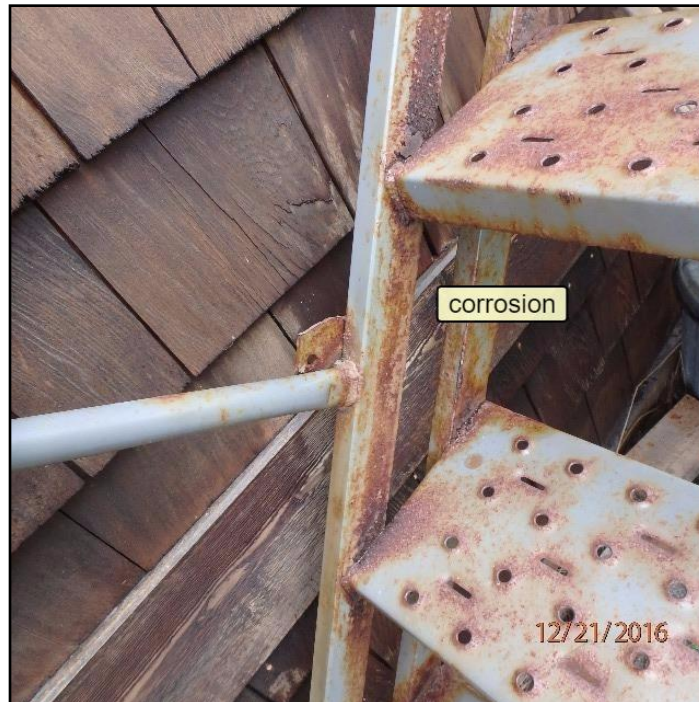
6. Other

Attic stairs exhibit corrosion due to salt water exposure. Inspector recommends cleaning and refurbishment, as needed, to deter climatic effect.

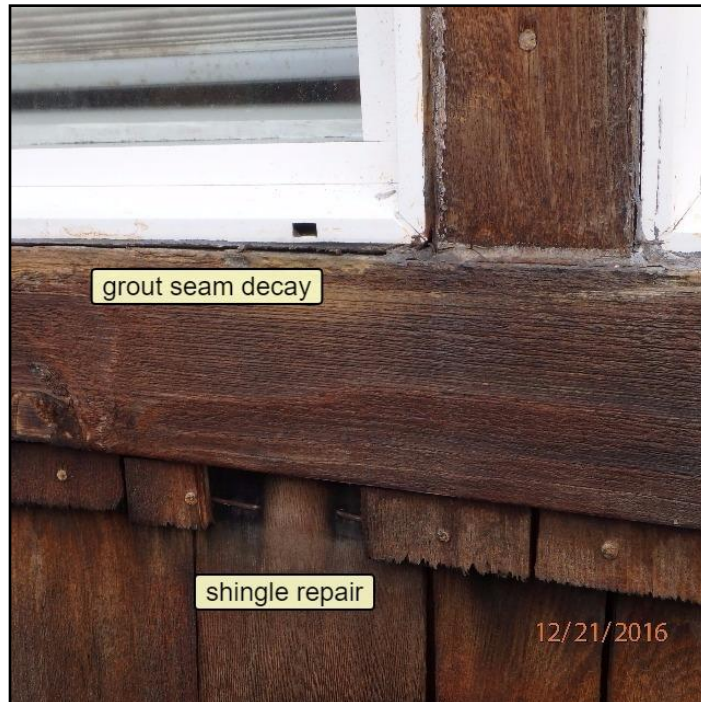
7. Caulking missing or ineffective

Surface Wear. Inspector recommends that some window-trim interfaces be cleaned and grouted.

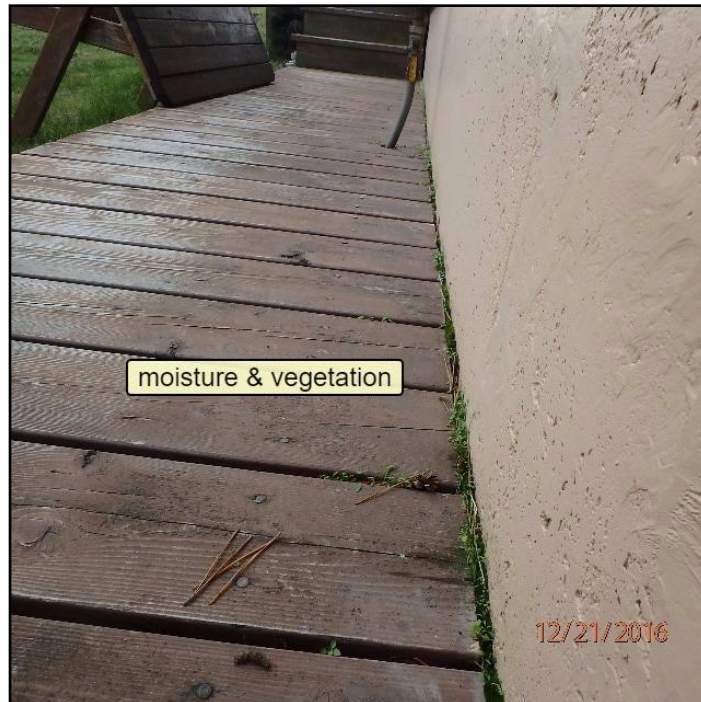
8. Too close to grade

Wood Decay. Wood-To-Foundation contact can cause moisture-trapping. It also promotes vegetation, decay, rot and wood destroying organisms. Inspector recommends a minimum of 6 inch clearance.

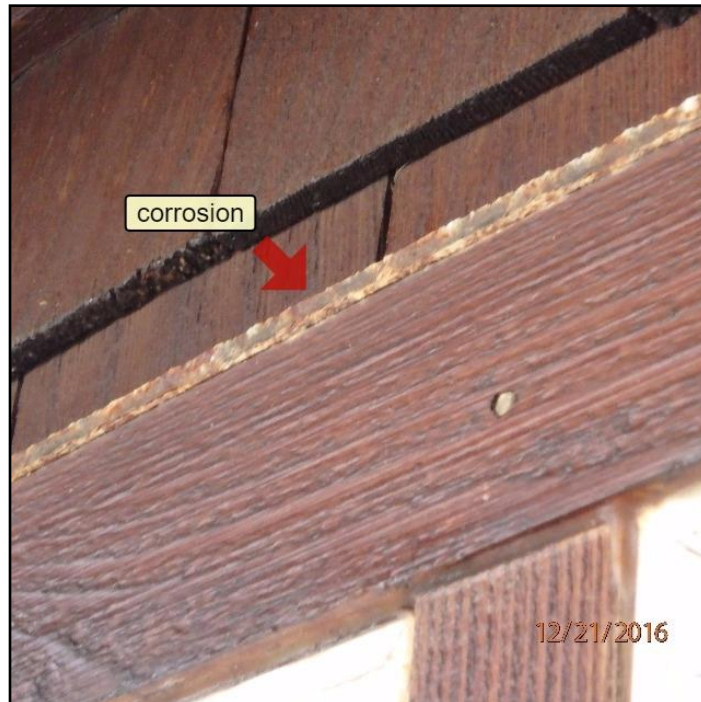
9. Rust

Window Flashing. The "Drip Cap" at top is corroding and deteriorating on a number of exposed windows. This moisture-rust effect can cause further materiel damage to building materials.

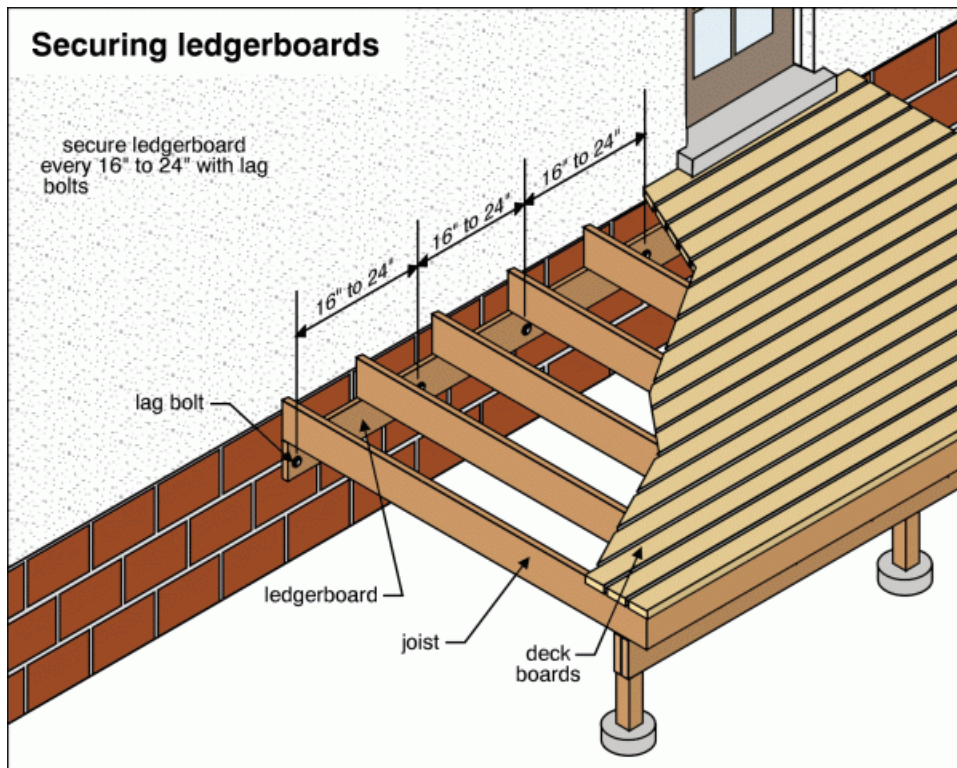
Deck to House Connection. Wood interface is severely weakened due to wood decay. Inspector recommends removal and replacement to include Ledgerboard flashing.

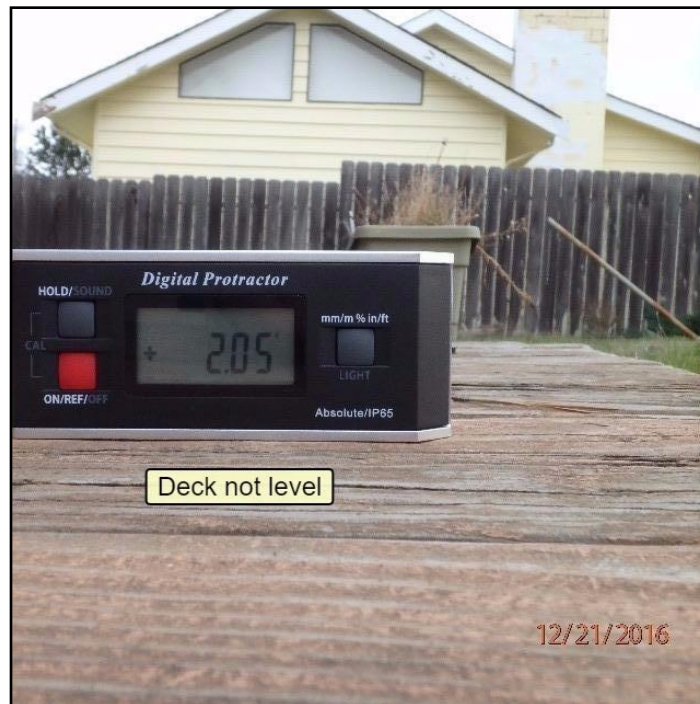
12. Disturbed ground

Tide and Wind effect has caused an accumulation of sand, resulting in a "heaving" pressure under deck area.

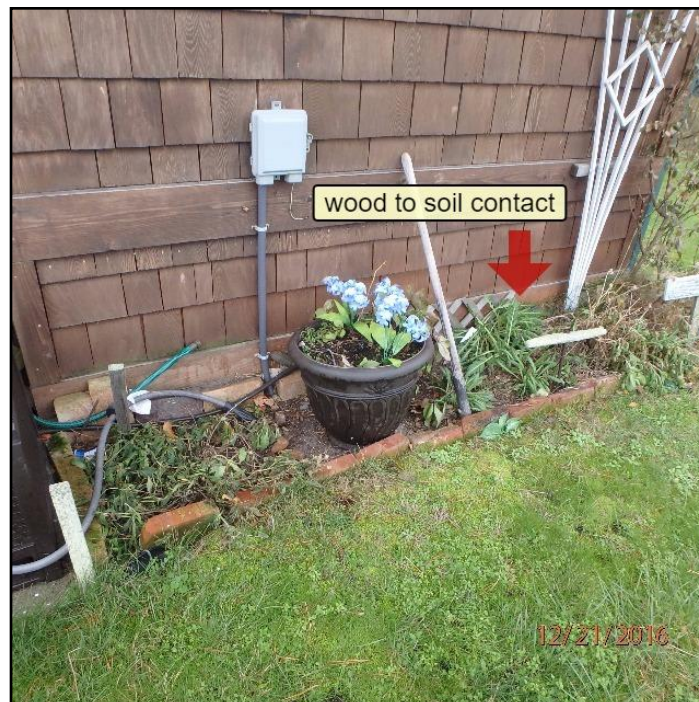
13. Cracked, split or broken

Wood Shingles serve to deter moisture and resist exposure to elements. Inspector recommends missing shingles be replaced.

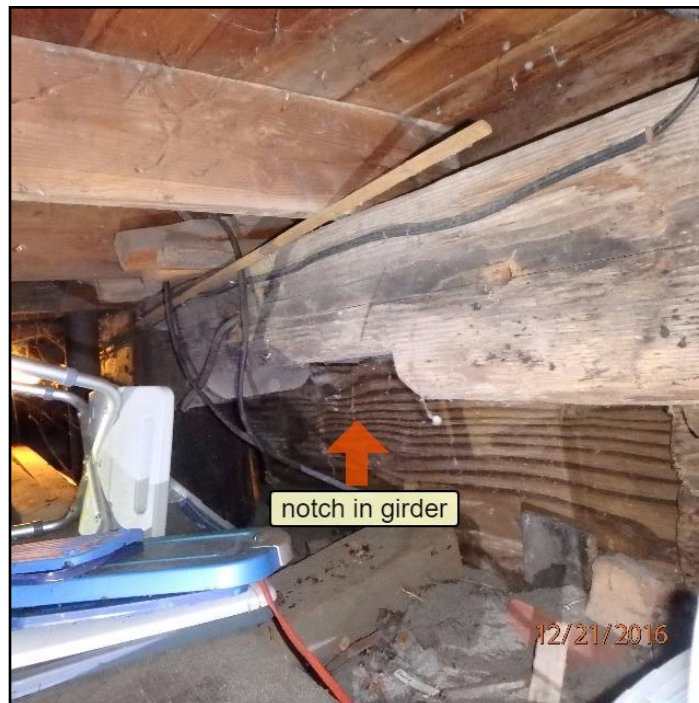
14. Notches or holes

Notch in Girder. Inspector recommends a licensed Structural Engineer evaluate the capacity of the truss to sustain stress.

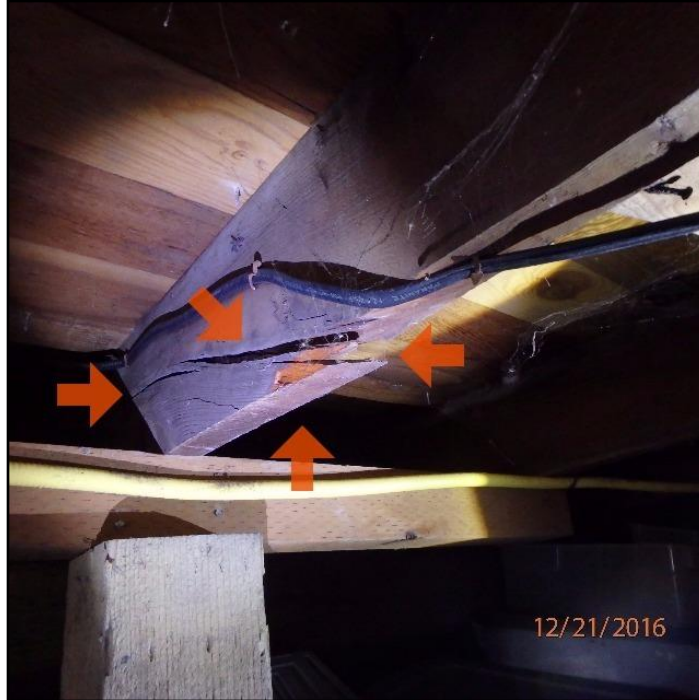
15. Sag

Girder Strain. Inspector recommends evaluation by licensed structural engineer.

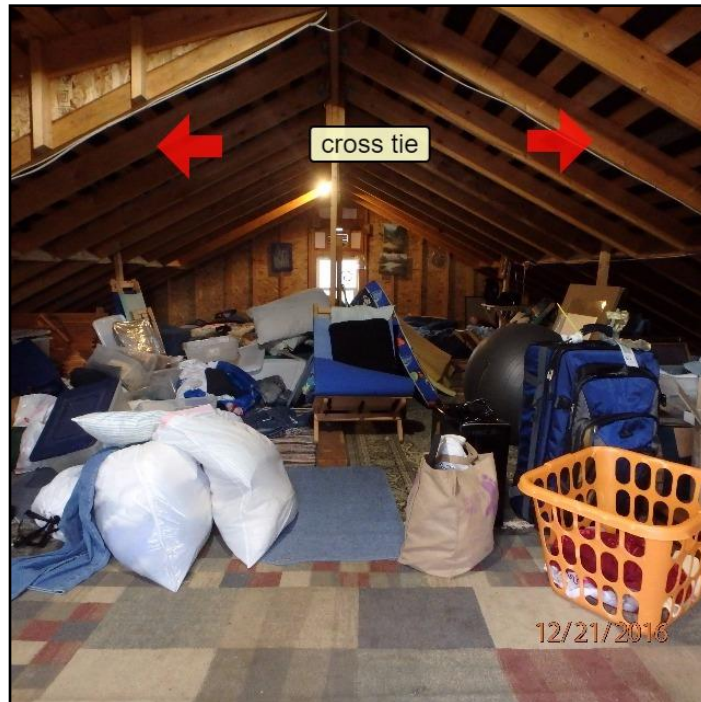
16. Trusses

No evidence of Collar Ties to attic roof structure. Inspector recommends evaluation by Washington State licensed Structural Engineer.

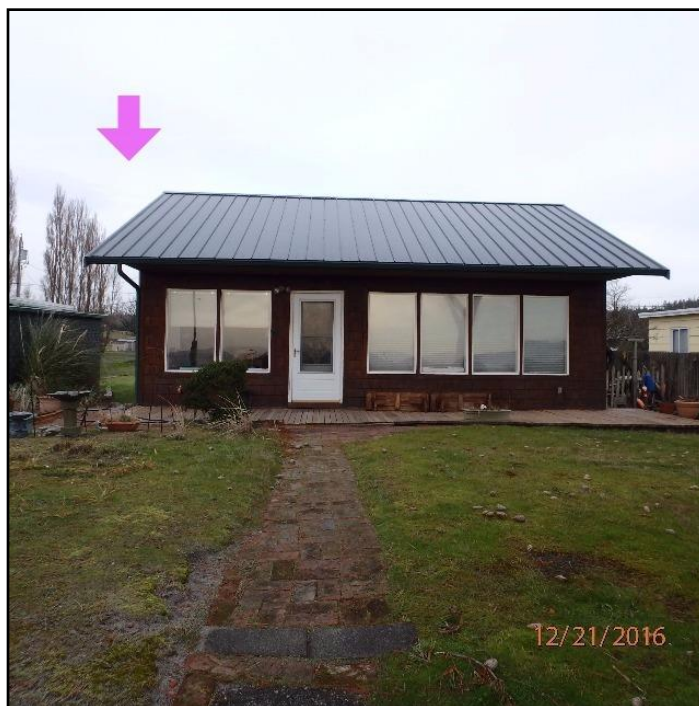
17. Need lateral bracing

Possible "sagging" of SouthWest corner to Roof Structure. Inspector recommends review by Washington State Licensed, Structural Engineer.

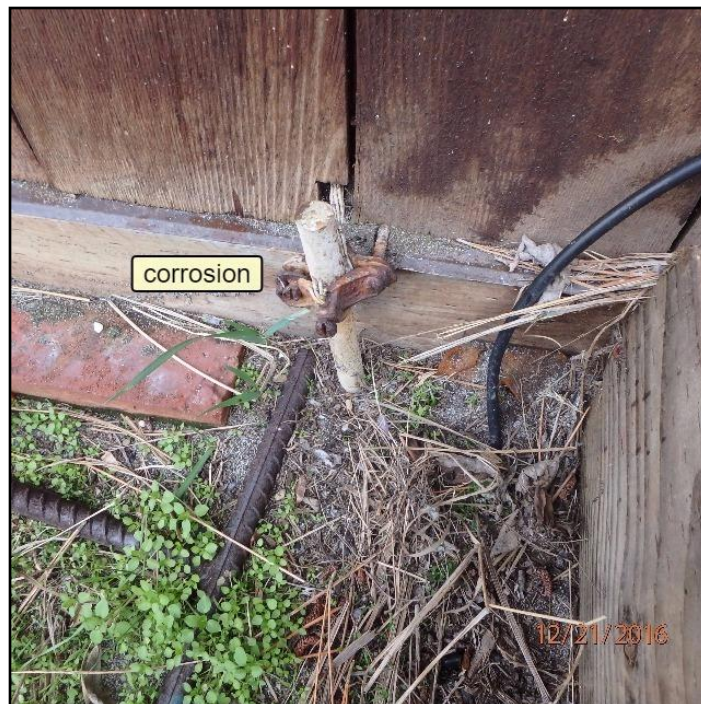
19. Corroded ground wire

Electrical Ground Corroded. Inspector recommends replace with a "Brass with brass screws" Grounding Clamp installed by a Licensed Electrician.

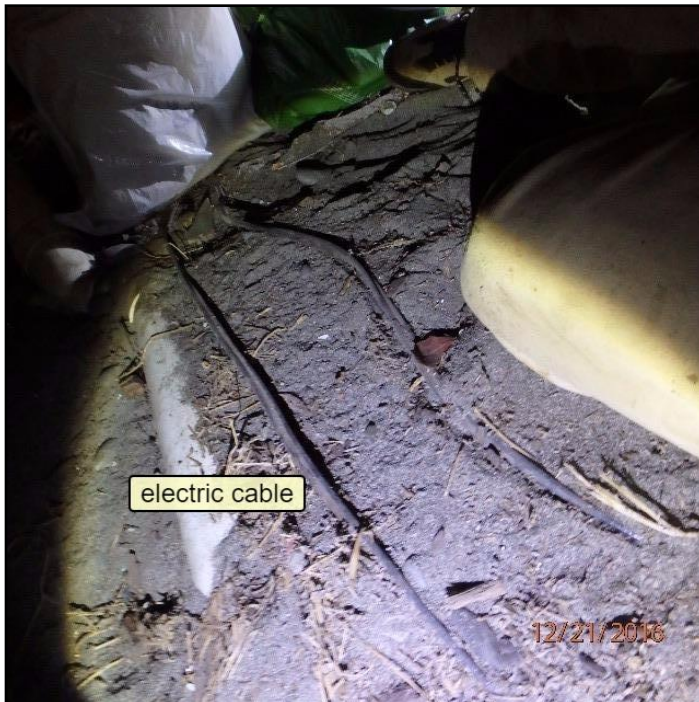
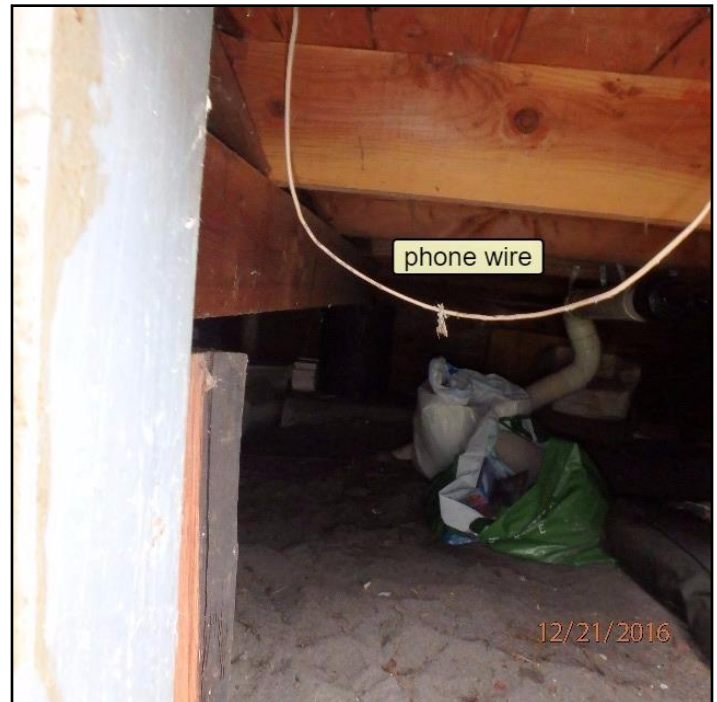
Crawlspace Electrical. Inspector recommends electrical wiring in basement be fastened every 4 to 6 feet above ground.

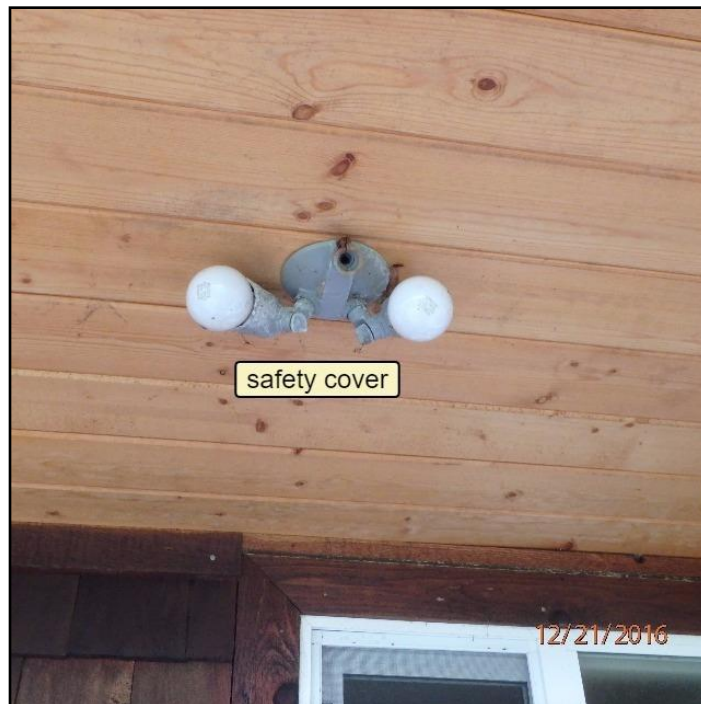
22. Missing

Porch Light Missing Safety Cover. Inspector recommends replacement or repair.

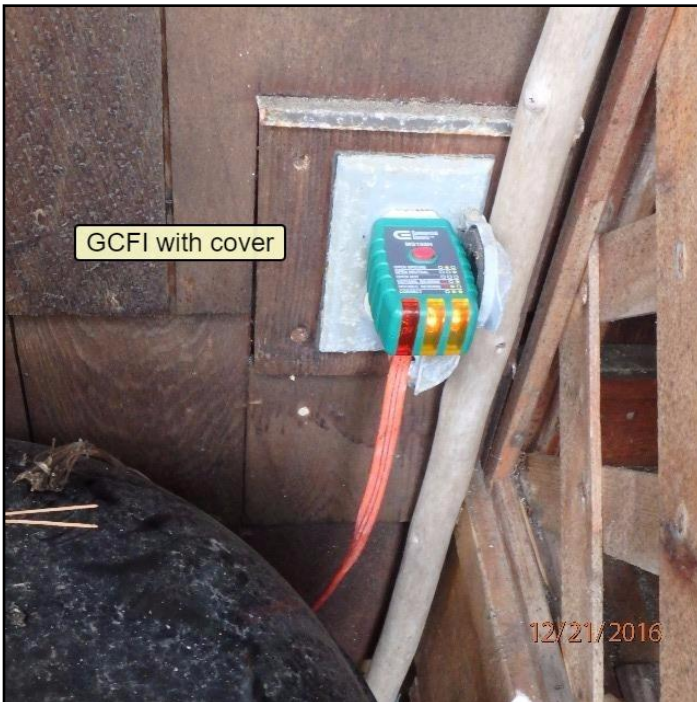
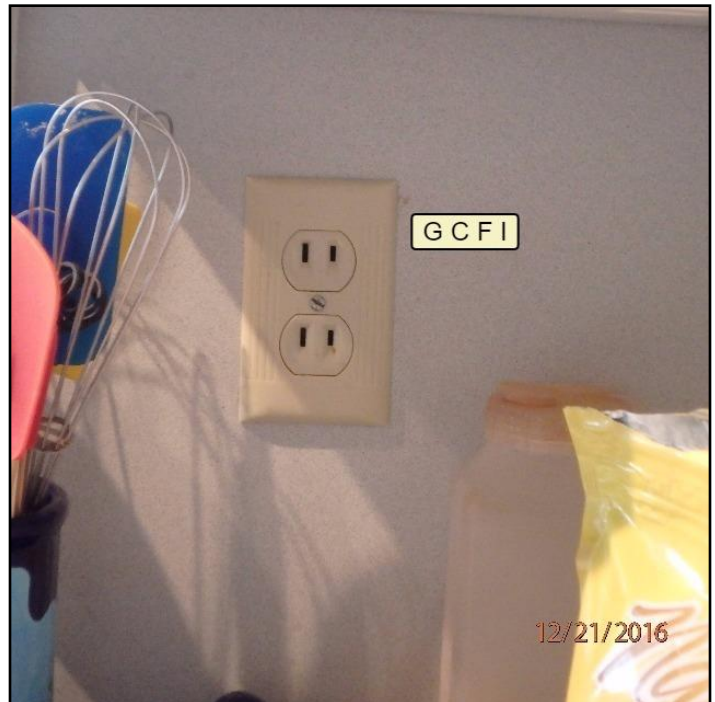
No GFCI in Kitchen or exterior. Inspector recommends GFCI receptacles (with foul weather covers!) be installed on exterior outlets, and in kitchen.

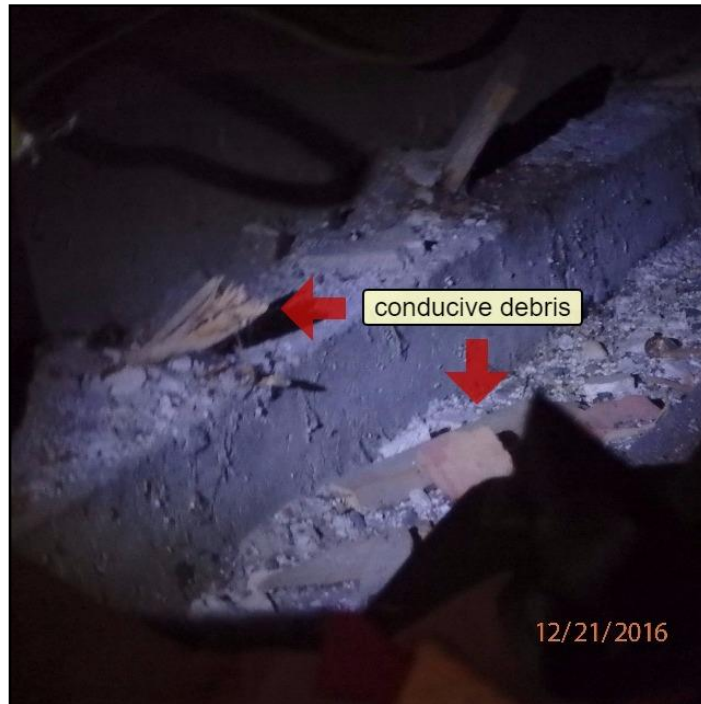
25.

23. Condition: • Conductive debris and obstructions. Inspector recommends removal of storage items, and conductive debris (wood, straw, etc) that promote rodent activity and wood destructive organisms.

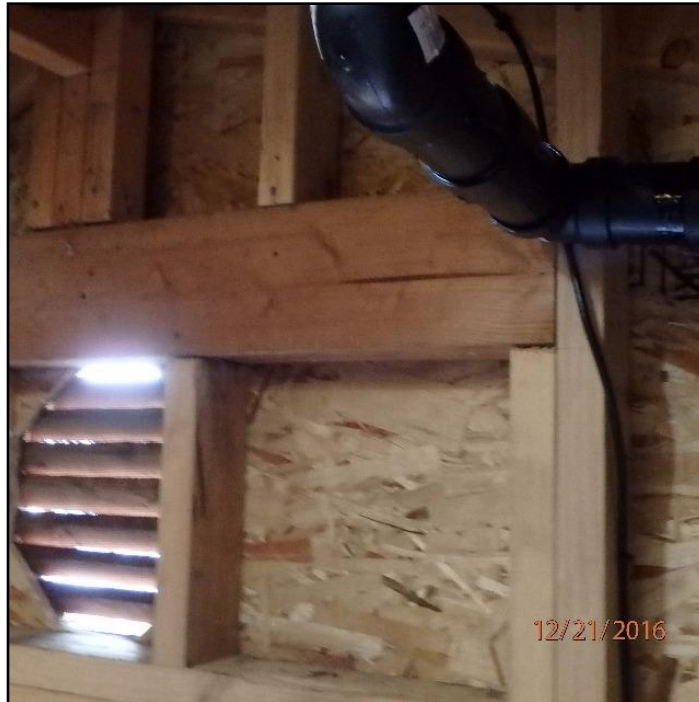
26. Amount less than current standards

Poorly insulated homes are expensive to heat. Inspector recommends batt style insulation throughout attic.

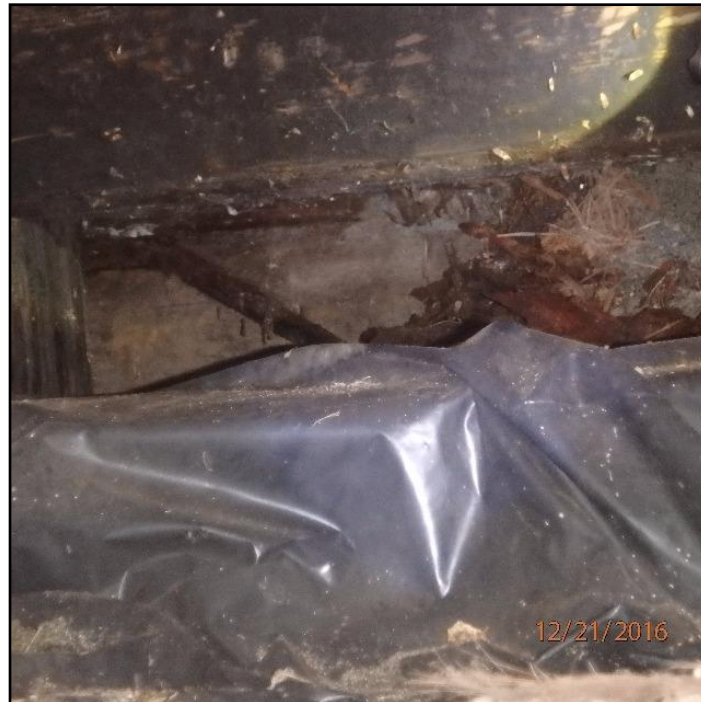
27. No vapor barrier

Crawlspace vapor barrier. Moisture is not managed adequately, Inspector recommends the standard 6mil. polyvinyl crawlspace vapor barrier.

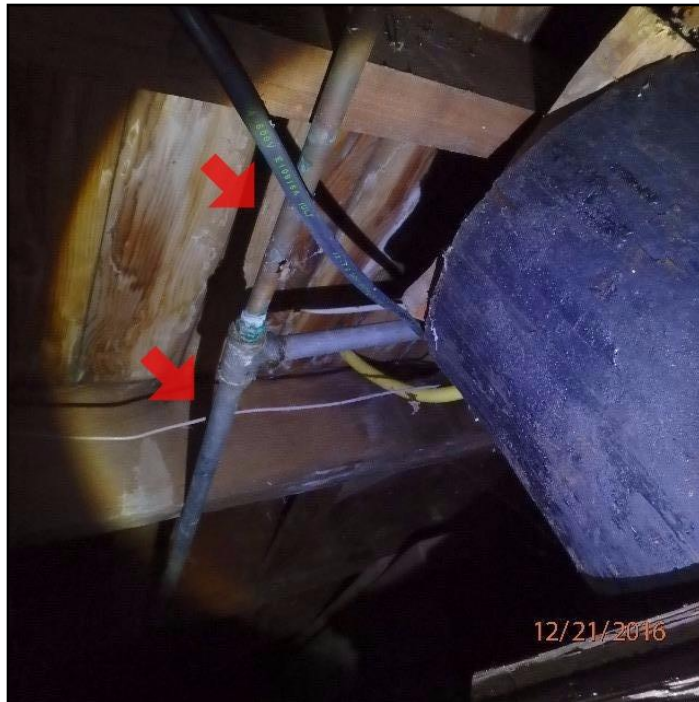
28. Freezing

Water Pipe Insulation. Inspector recommends a licensed Plumber inspect and insulate water pipe in crawlspace.

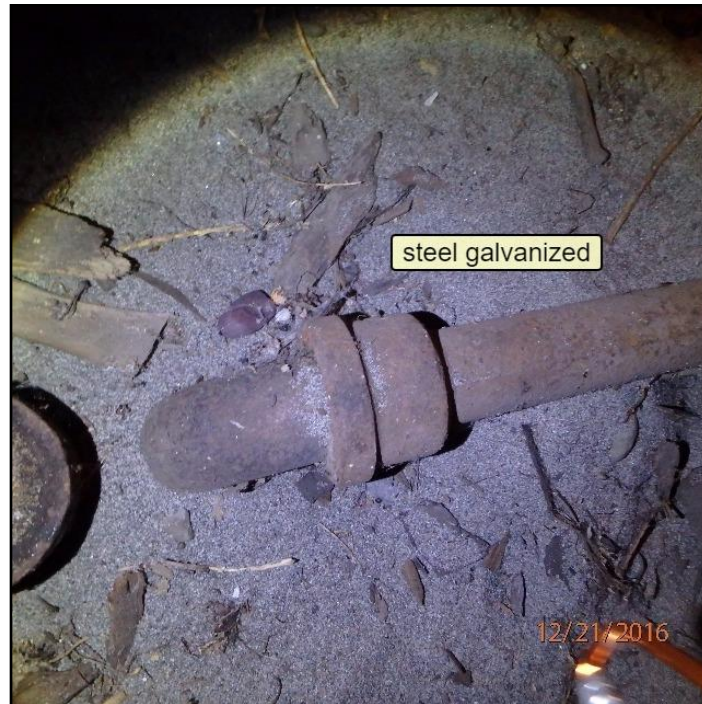
29. Galvanized steel

Galvanized Piping Crawlspace. Galvanized pipe corrodes with age affecting potable water quality.

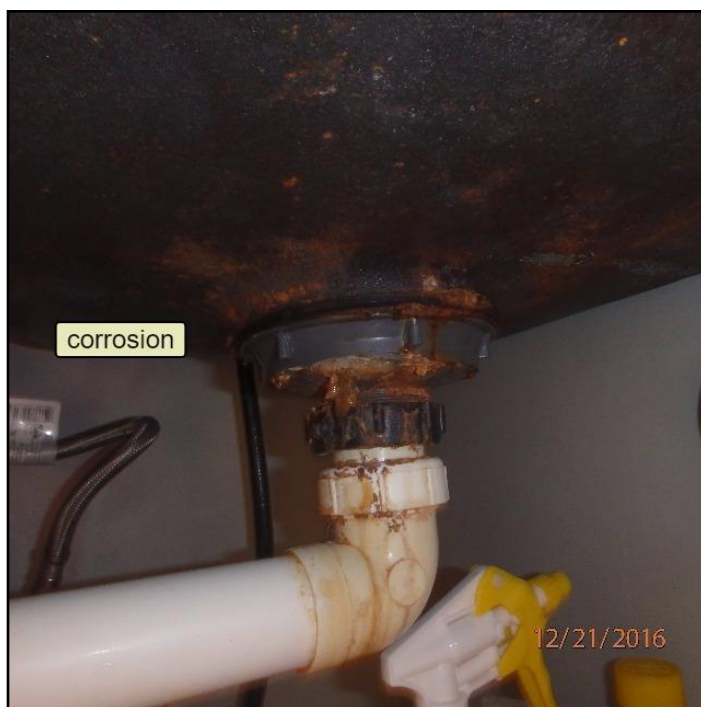
30. Overflows missing, leak, rust or...

Kitchen Sink. Inspector recommends replacement due to leakage, rust and corrosion.

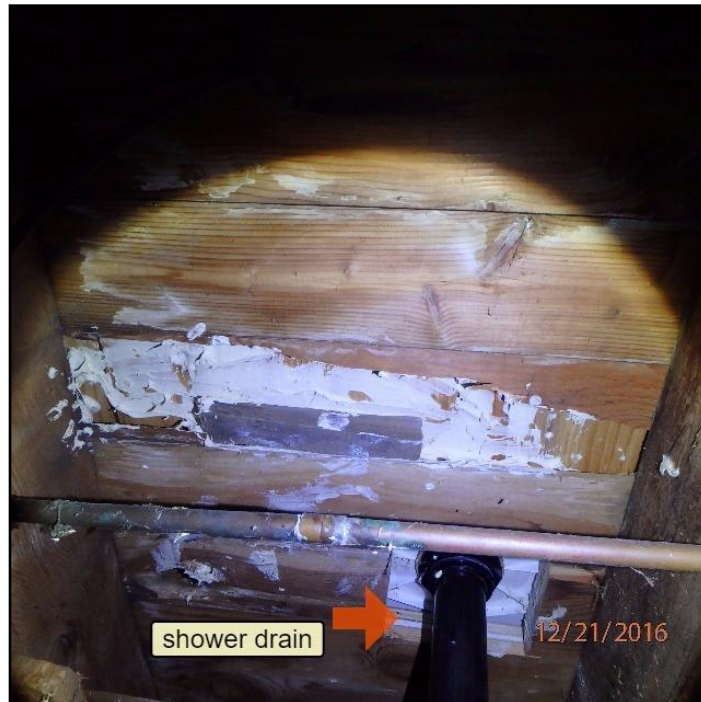
31. Damage

Subfloor Damage. Inspector recommends a licensed contractor evaluate subfloor damage.

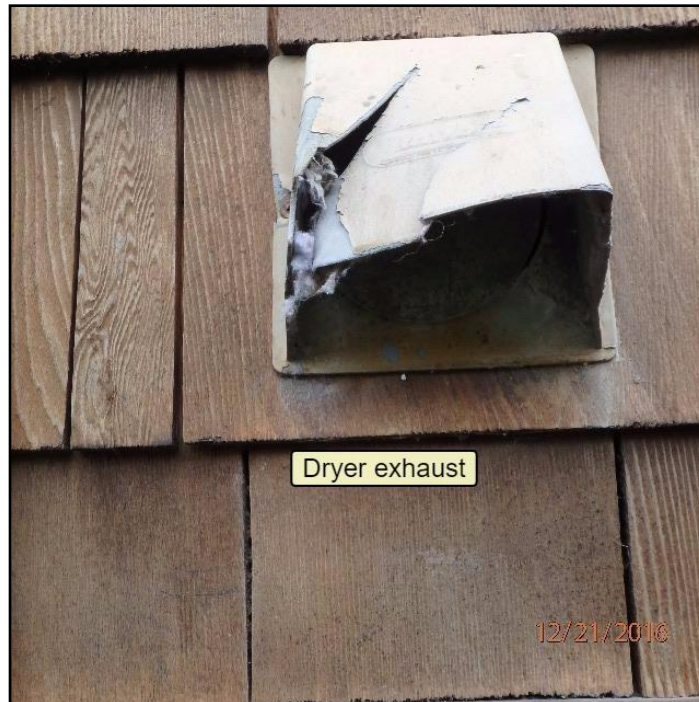
32. Plastic dryer vent

Dryer Vent Damage. Inspector recommends replacement with screen to prevent birds/rodents, etc.
