YOUR INSPECTION REPORT

27 Nelles Avenue

Toronto, ON M6S 1T6

Sunday, September 22, 2019

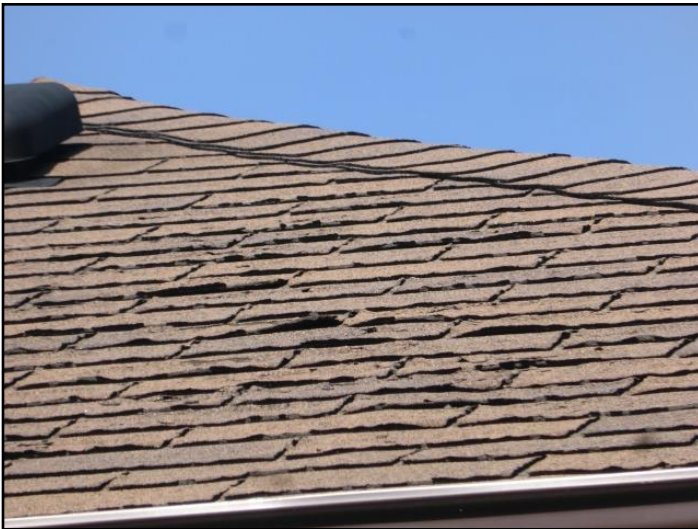
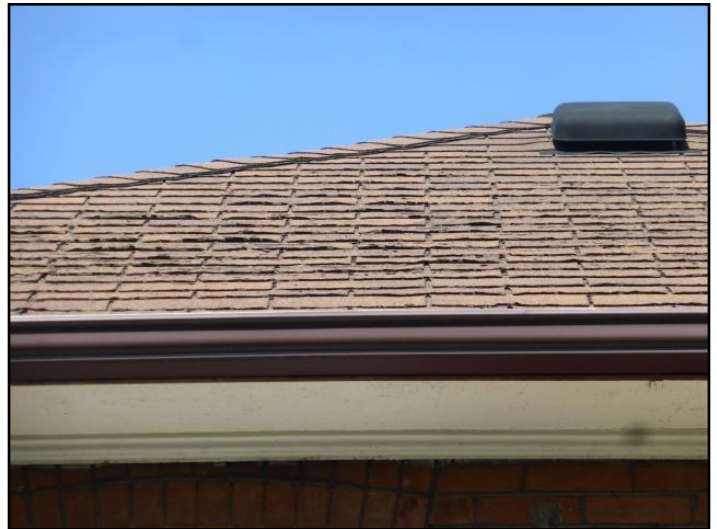
Typical Life Expectancy for this type of roof covering is 13-17 years. The current roof is approximately 20 years and is aging. Advanced deterioration noted at South side of roof which typical due to sun exposure.

1. Aging

2. Aging

Task: Replace

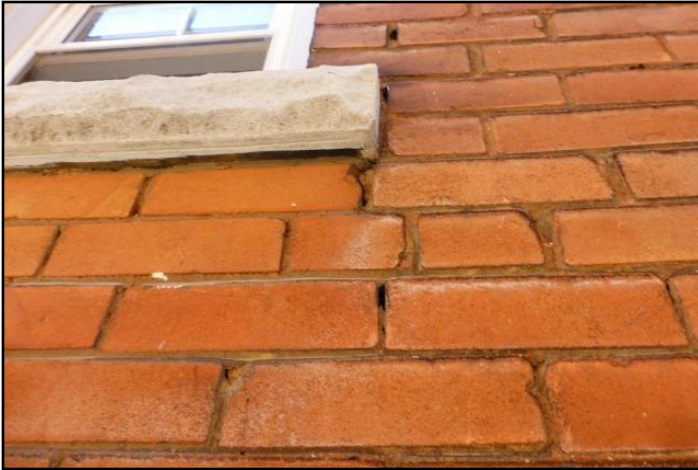
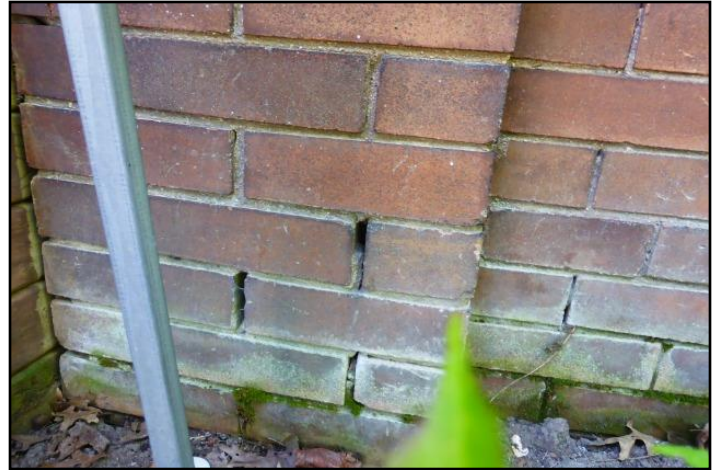
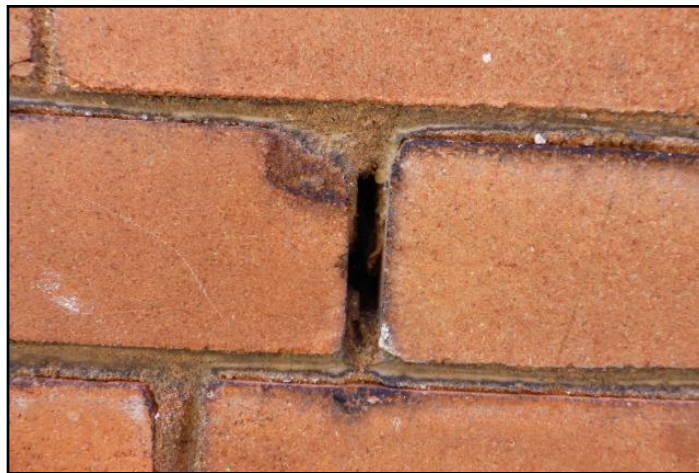
Condition: • [Mortar deterioration](#)

Implication(s): Chance of structural movement | Weakened structure | Chance of water entering building

3. Mortar deterioration

4. Mortar deterioration

5. Mortar deterioration

Task: Tuck-point

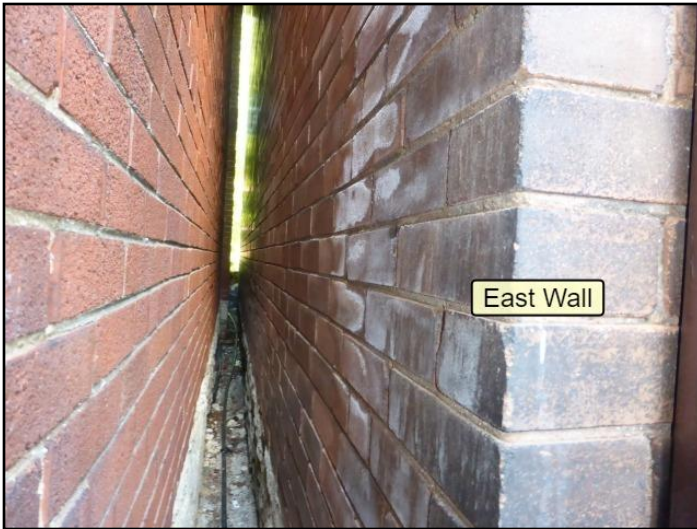
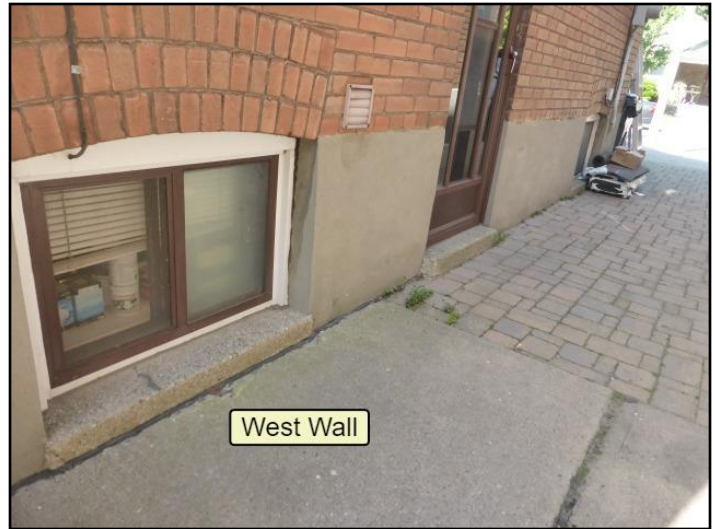
Water has recently infiltrated the basement via the east and west exterior walls. Grading or dampproofing solutions are required at both these locations.

6. Low Areas.

7. Low Areas.

Task: Upgrade/repair

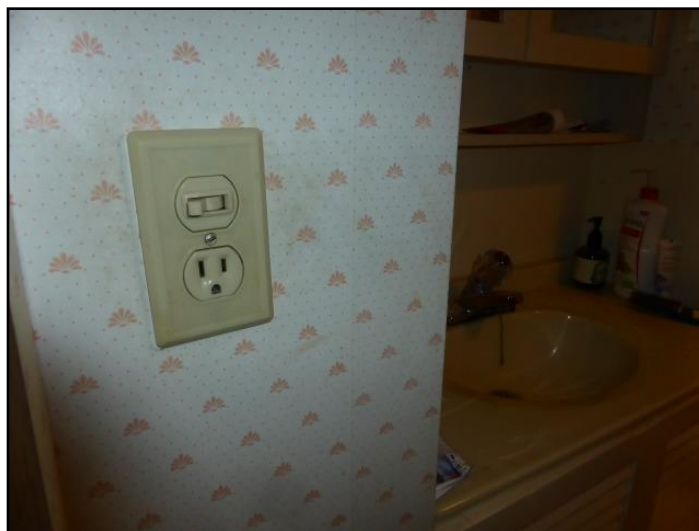
Condition: • [GFCI/GFI needed \(Ground Fault Circuit Interrupter\)](#)

11. GFCI/GFI needed (Ground Fault Circuit...

Task: Install

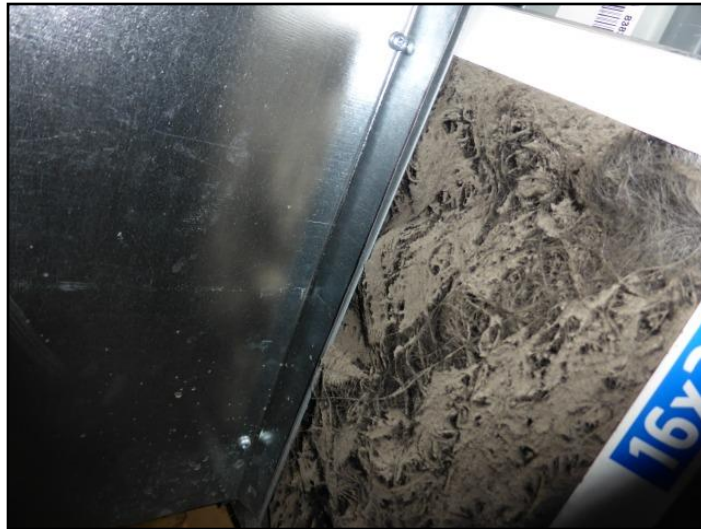
Condition: • [Dirty](#)

14. Dirty

Task: Replace

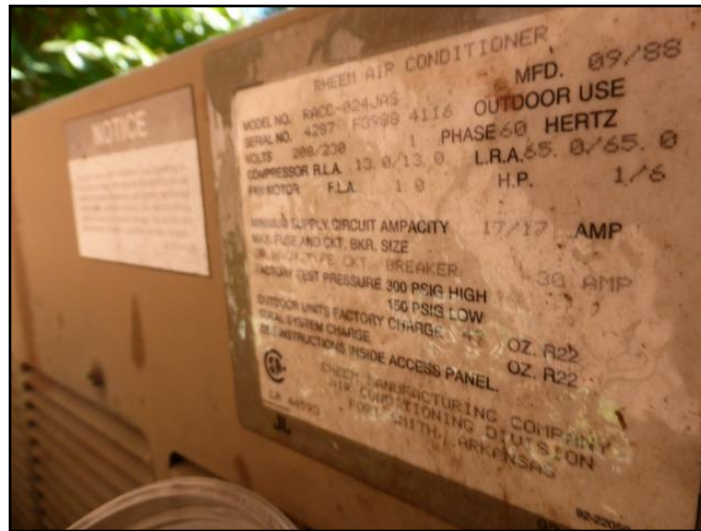
Condition: • Past life expectancy

Implication(s): Reduced comfort | Equipment failure

16. Past life expectancy

Task: Replace

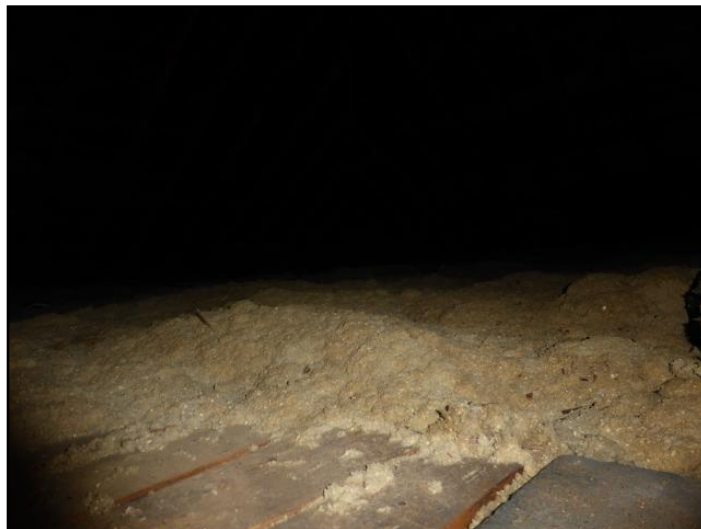
Condition: • [Amount inadequate](#)

17. Amount inadequate

Task: Improve

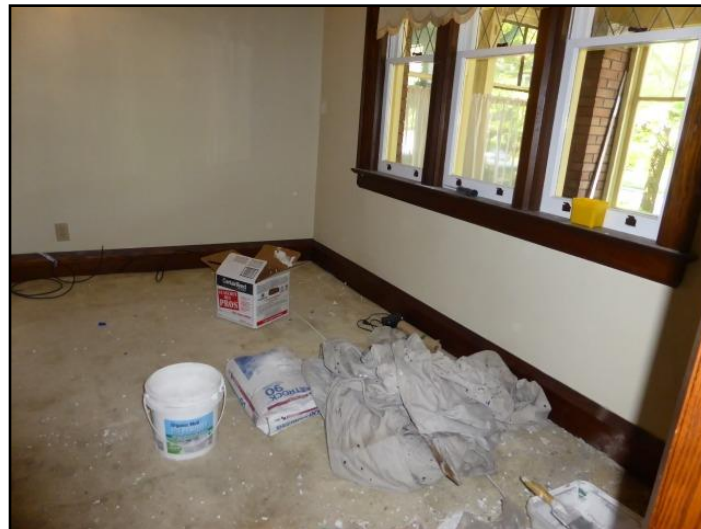
Cosmetic improvements were being performed at the time of inspection.

19. Work in Progress Observed

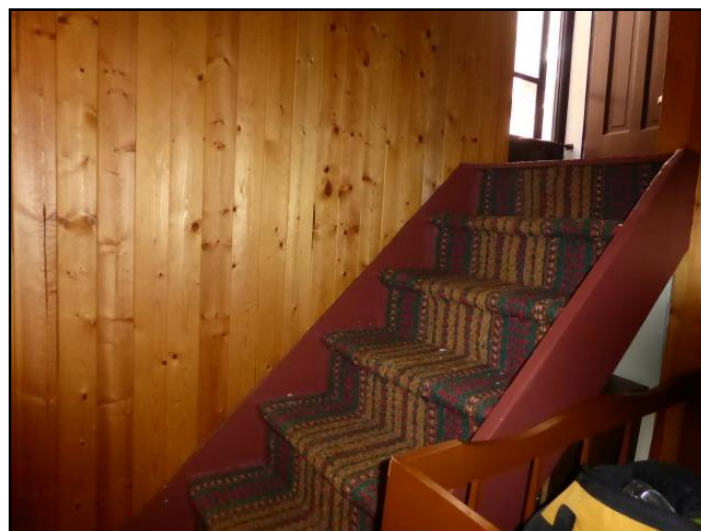
Condition: • [Missing](#)

Implication(s): Fall hazard

20. Missing

Task: Install

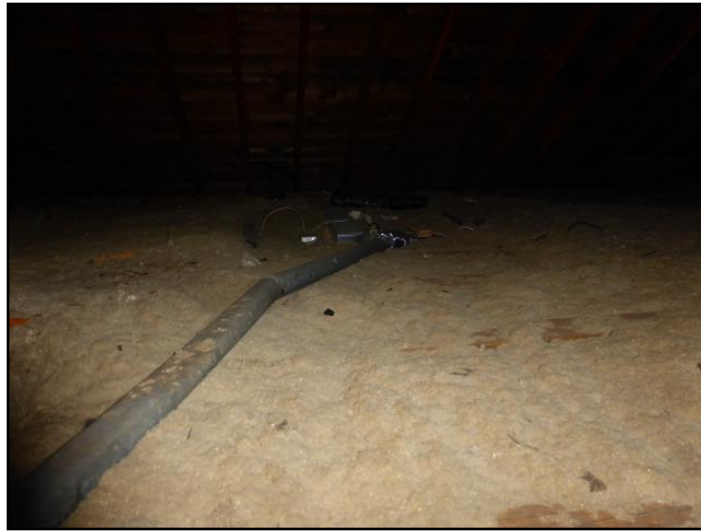
Condition: • [Not insulated in unconditioned space](#)

Metal bathroom exhaust duct is not insulated in the attic. Duct should be insulated to protect against moisture damage.

21. Not insulated in unconditioned space

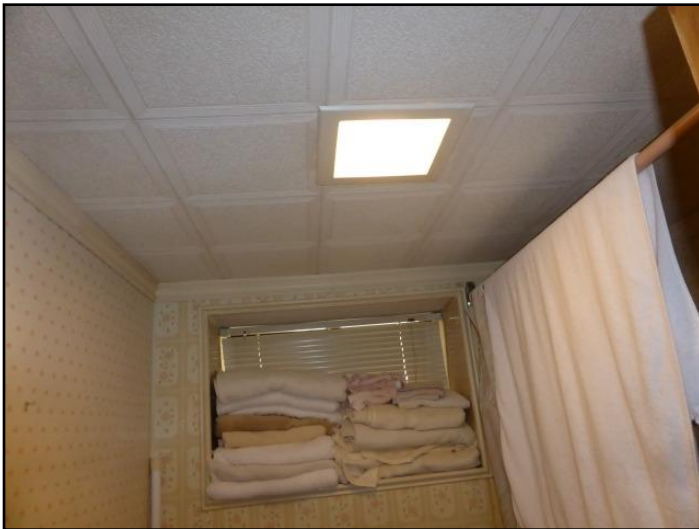
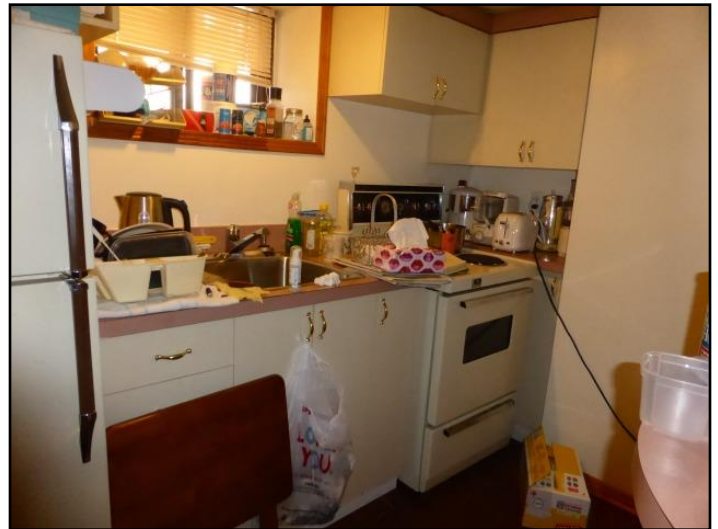
Condition: • [Not vented to exterior](#)

Implication(s): Chance of condensation damage to finishes and/or structure

22. Not vented to exterior

23. Not vented to exterior

Task: Install

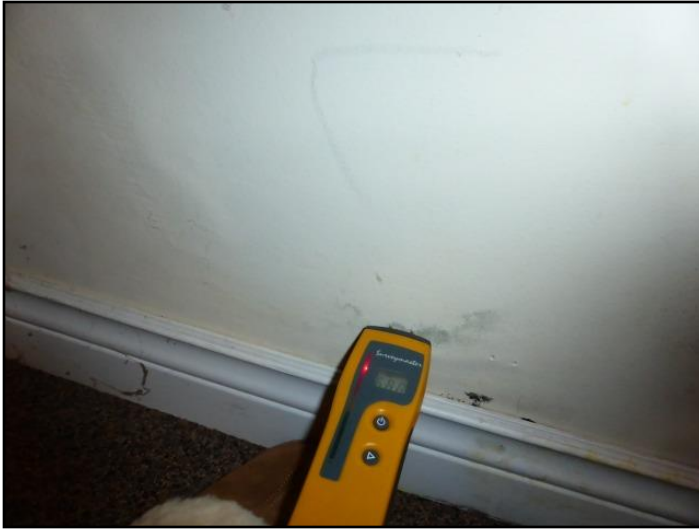
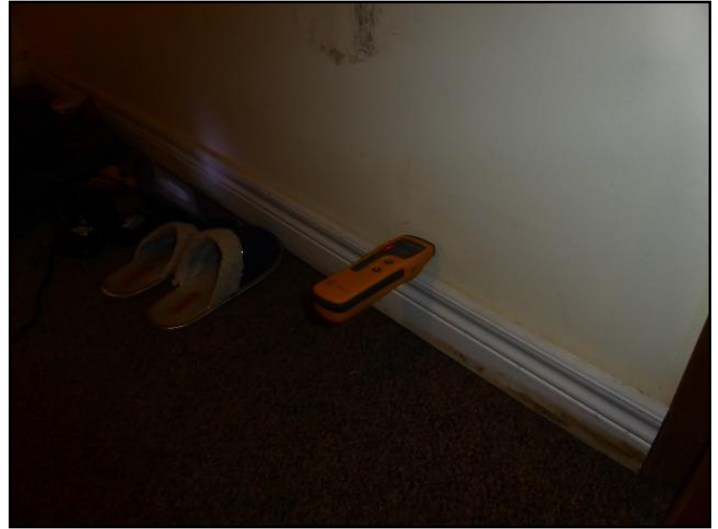
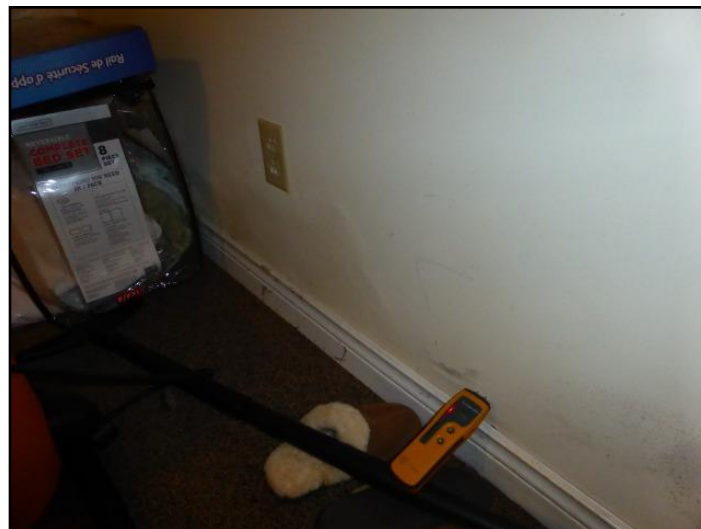
High moisture levels were found along the East and West exterior walls as well as residual moisture found wicking at

centrally located walls. The source of the moisture is impossible to determine during a non-invasive. home inspection. Further evaluation is required.

24. Dampness on floor or walls

25. Dampness on floor or walls

26. Dampness on floor or walls

Task: Further evaluation

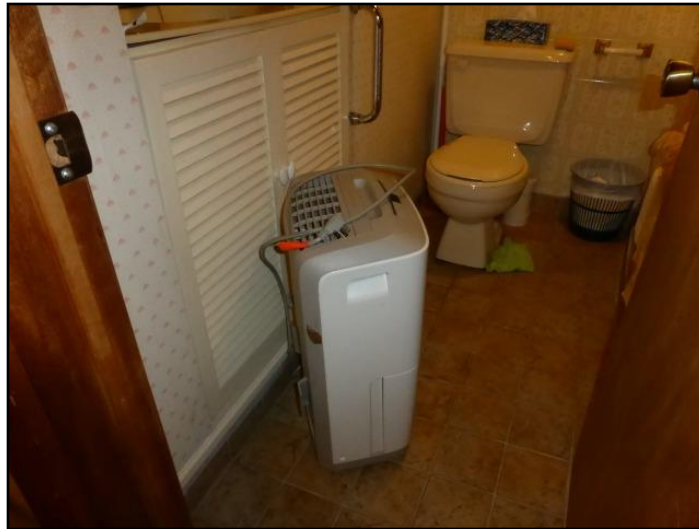
Condition: • [Dehumidifier in basement](#)

Implication(s): Chance of water damage to contents, finishes and/or structure

27. Dehumidifier in basement
