YOUR INSPECTION REPORT

FOR THE PROPERTY AT:
490 Windermere Avenue
Toronto, ON M6S 3L6

INSPECTION DATE:
Monday, September 18, 2023

RE: Report No. 7274
490 Windermere Avenue
Toronto, ON
M6S 3L6

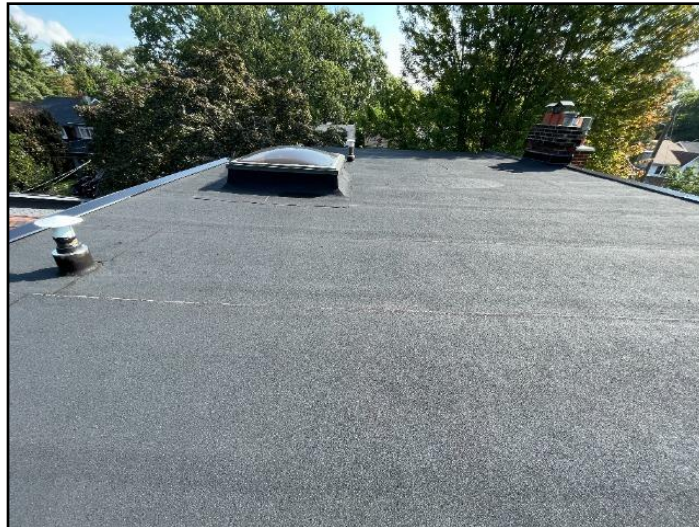
1. Modified bitumen membrane

Upper level roof is in good condition

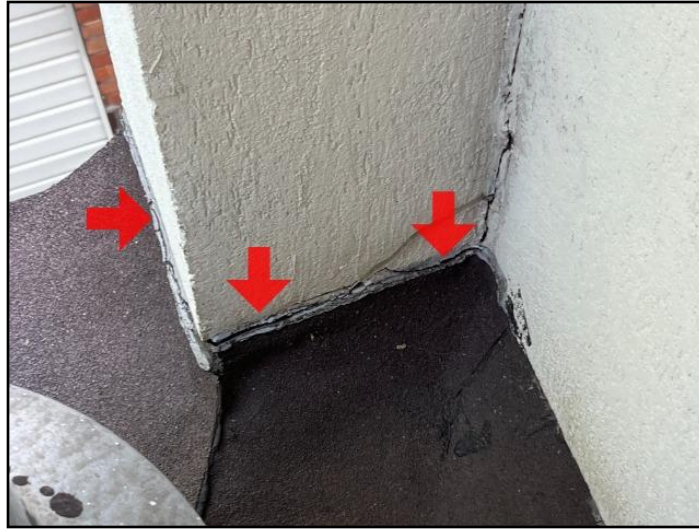
2. Openings at seams or flashings

Condition: • [Openings at seams or flashings](#)

Task: Repair

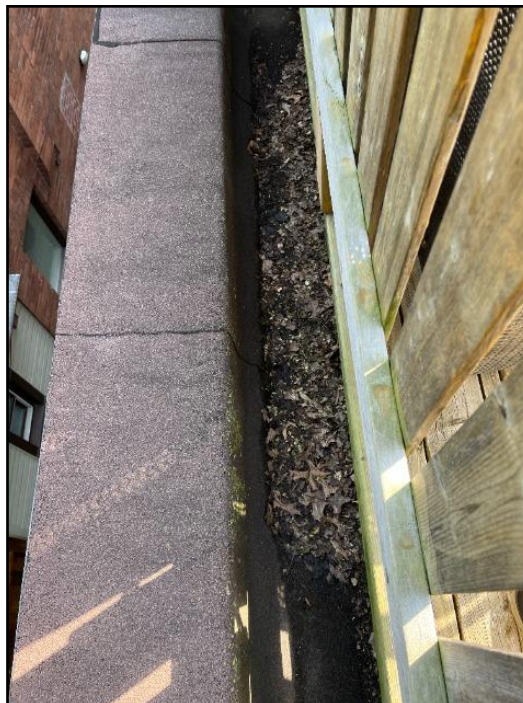
3. Debris on roof

Condition: • [Debris on roof](#)

Task: Clean

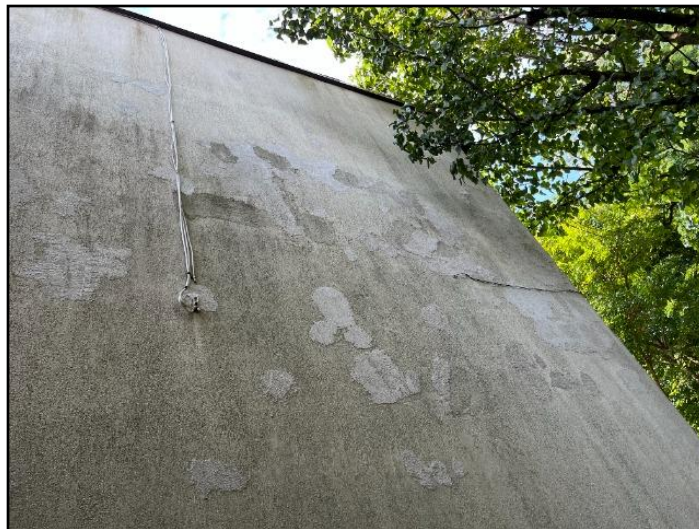
4. Patched

Condition: • [Patched](#)

Location: Various Right Exterior Wall

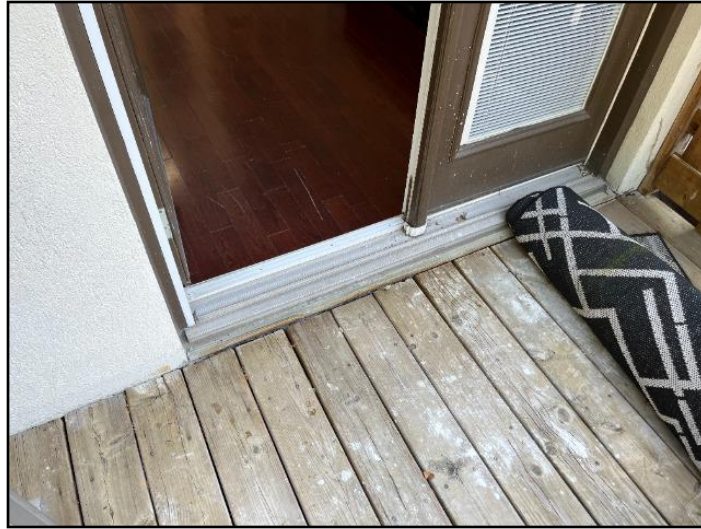
8. Threshold too low

Condition: • Threshold too low

On the other hand, it also makes it more prone to snow buildup/leakage.

While it is probably not practical to improve the current situation (unless rebuilding the deck), it will be important to keep any weatherstripping/caulking in good condition.

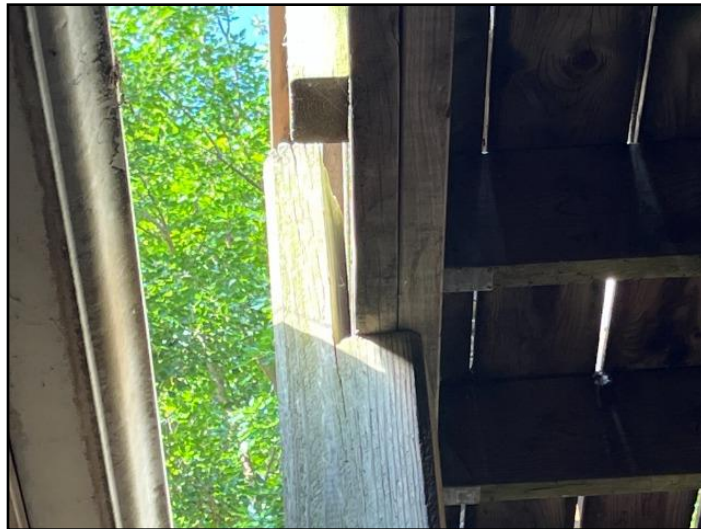
9.

Condition: • Post is twisted and not fastened to deck

Task: Correct - Fasten with bracket to deck

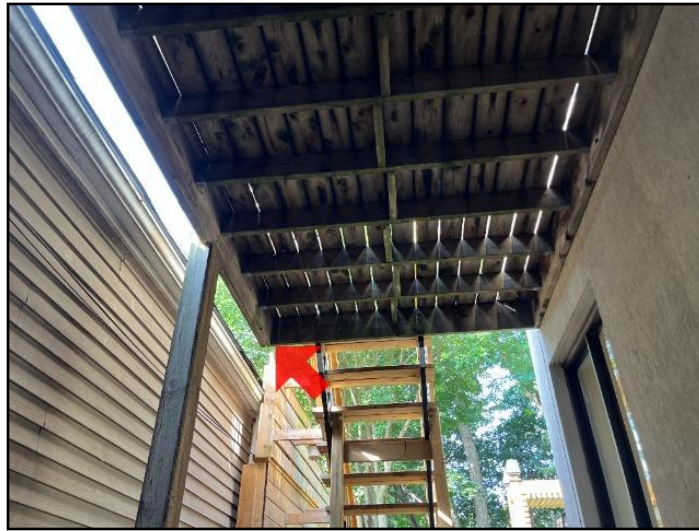
10.

Condition: • Additional post required

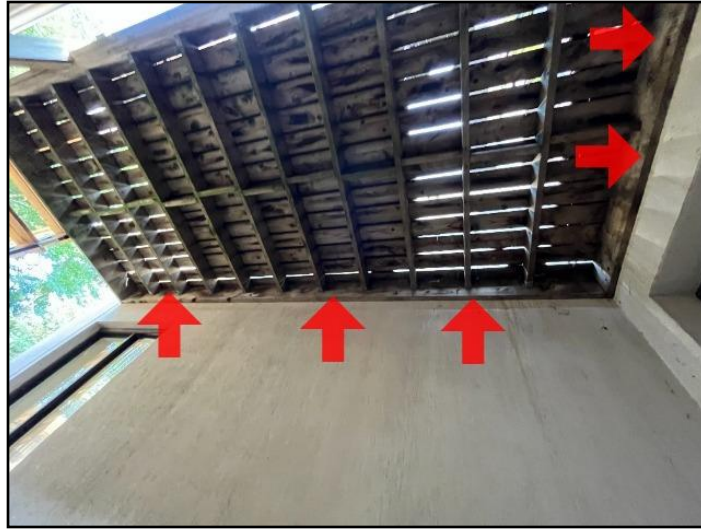
11.

Condition: • Provide additional fasteners at deck ledgerboard to wall

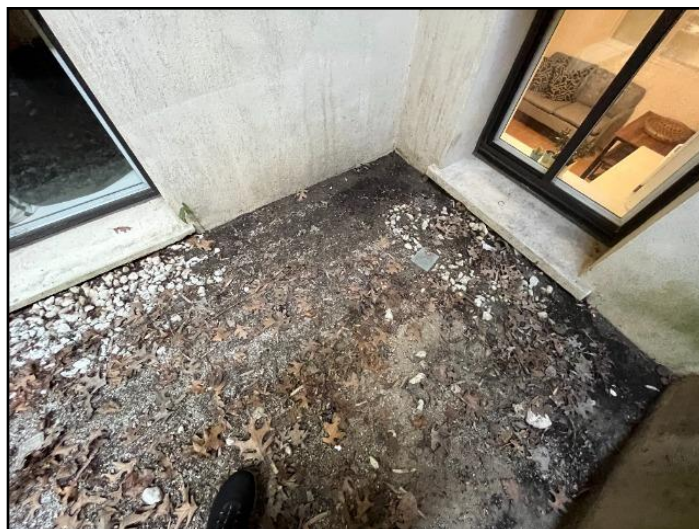
12. Low Areas.

Condition: • Low Areas.

Low areas / settlement was noted at / near wall. Improve grade to slope away from home for at least 6 feet to help promote good drainage away from home. This is normal maintenance for all homes.

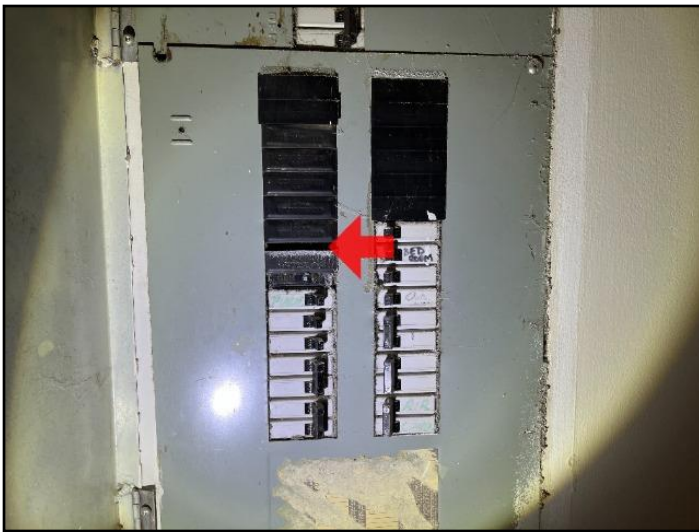
15. Openings in panel

Condition: • [Openings in panel](#)

any exposed panel openings (that would allow access to the inside of the panel) should be fitted with secure covers

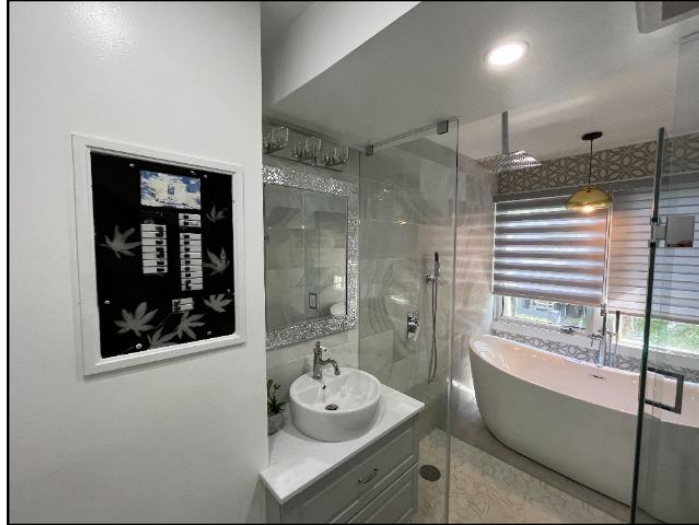
17. Sub panel at bathroom

Condition: • [Poor location](#)

(This rule is in place due to shower steam causing condensation / moisture at the panel which is a fire hazard)

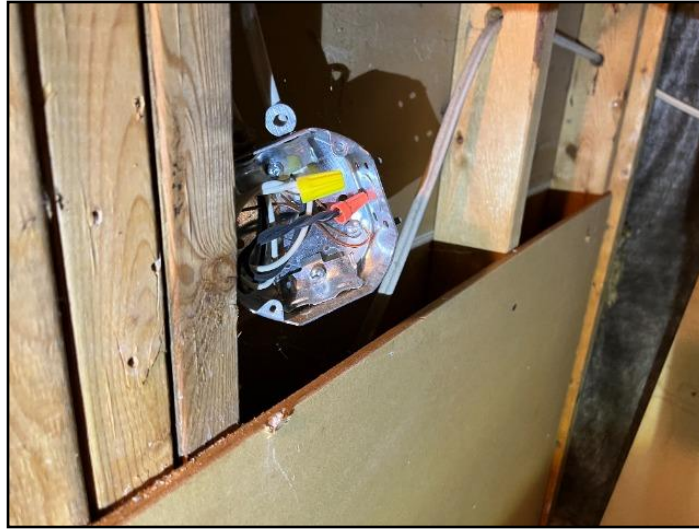
18. Cover missing

Condition: • [Cover loose or missing](#)

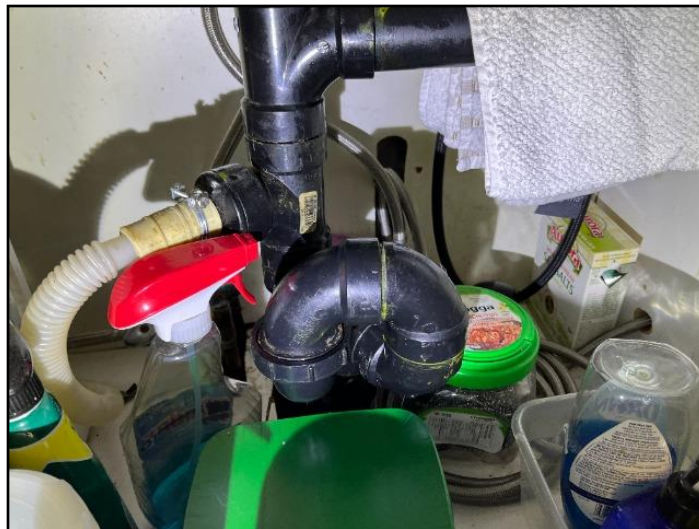
20. *Wrong type*

Condition: • [Wrong type](#)

S-traps can lead to siphoning

Task: Monitor / Replace

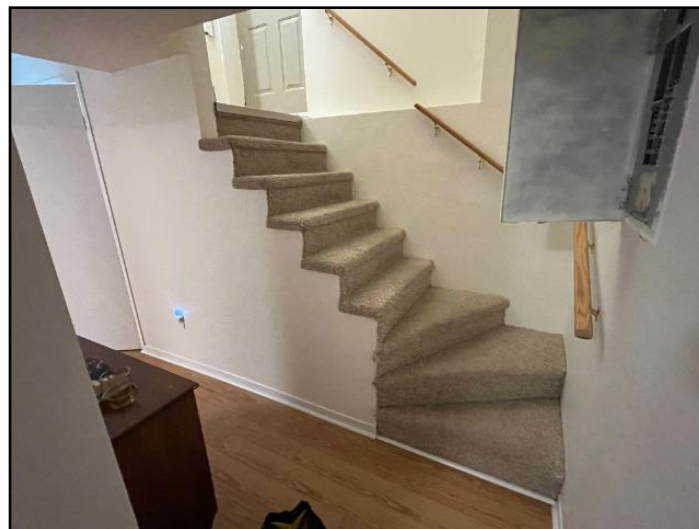
21. Basement staircase

Condition: • [Missing](#)

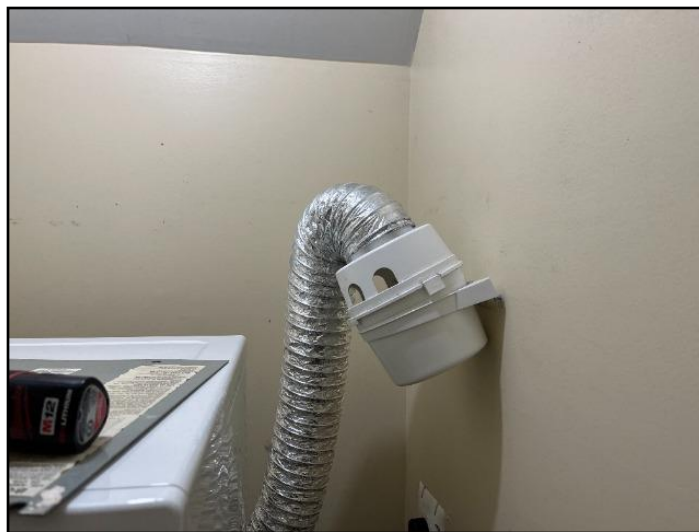
22. Dryer not vented to exterior

Condition: • Dryer not vented to exterior
